Building Survey & Cost Estimates

**Changing Rooms Cornmill Lane
Tutbury
Staffs
DE13 9HA**

**Client: Tutbury Parish Council
Date: September 2025
Job number: 25.357**

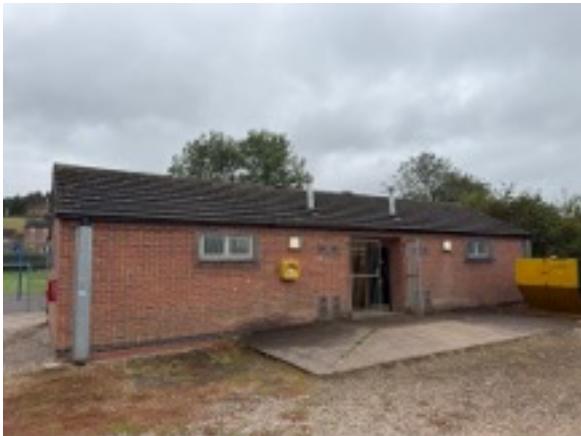
Front elevation.

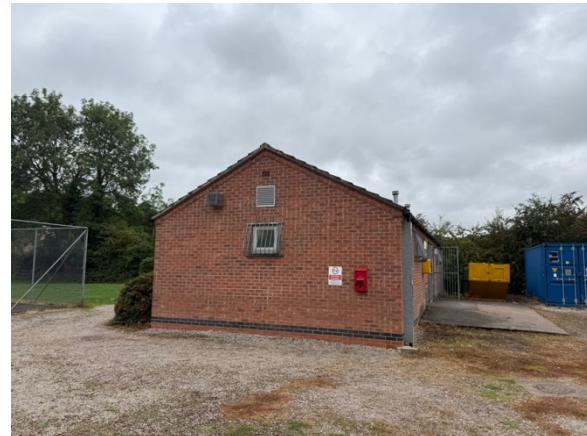
Left hand side elevation.

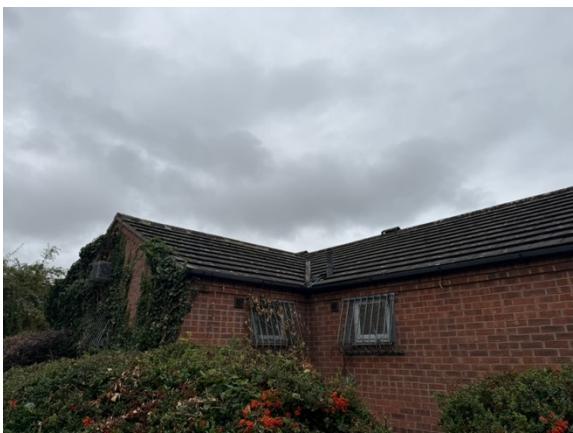
View of the ivy growth to the rear of the building that requires maintaining.

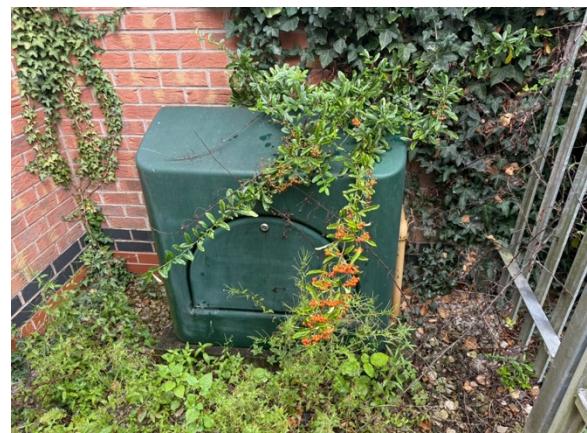
View of the incoming main gas supply.

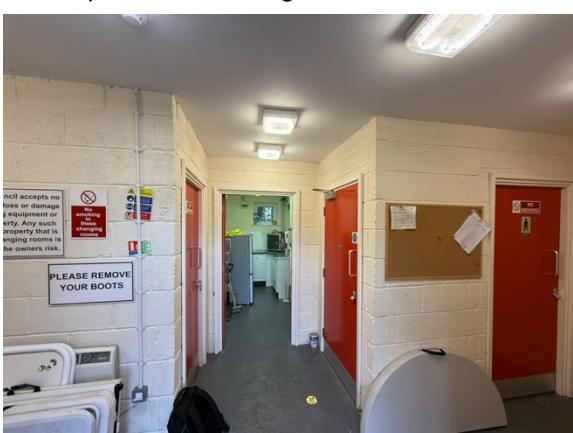
General view of the hallway within the changing room block.

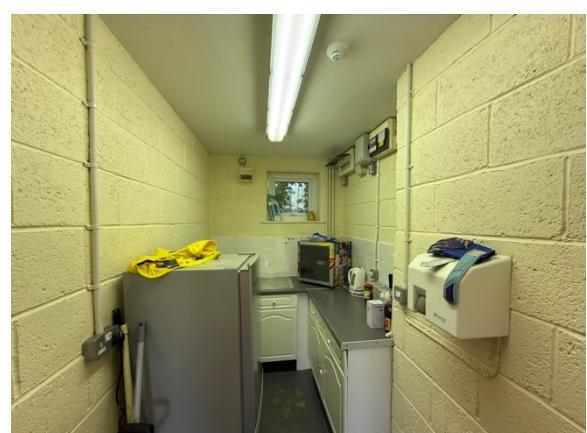
View of the kitchen area that would benefit from being upgraded.

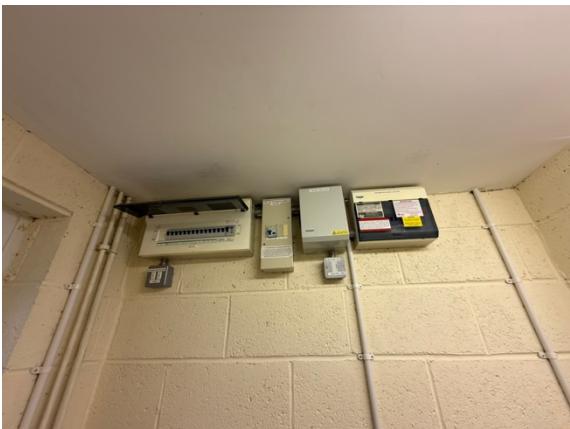
View of the existing electrical distribution board.

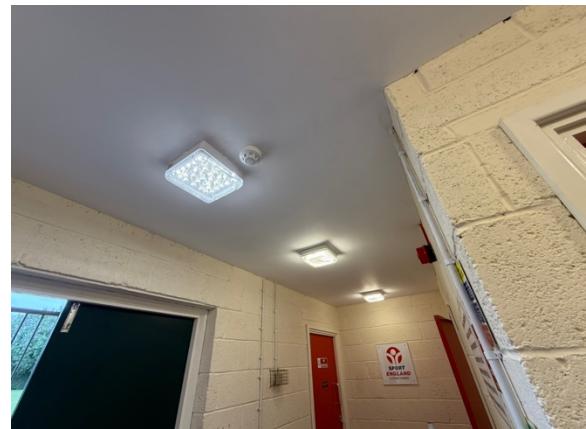
- 2.4.1 The fluorescent lighting installation is at end-of-life: several fittings flicker or fail and overall illumination is uneven.
- 2.4.2 Heating is provided by wall-mounted electric panel and fan heaters. These remain operational but are inherently energy-inefficient, lacking modern thermostatic control.

View of the existing light fittings. 1 no light fitting has been replaced for LED.

- 2.7.1 All fluorescent lighting fittings would benefit from being removed and replaced with LED linear battens or LED panels. LED lighting will improve visual conditions and reduce energy consumption.

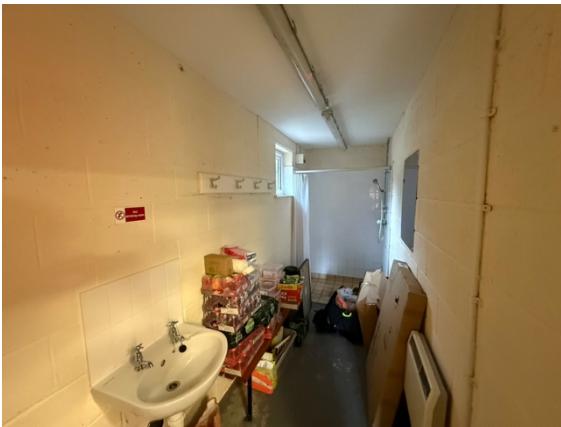
View of the store room that is currently used by the referee as a changing facility.

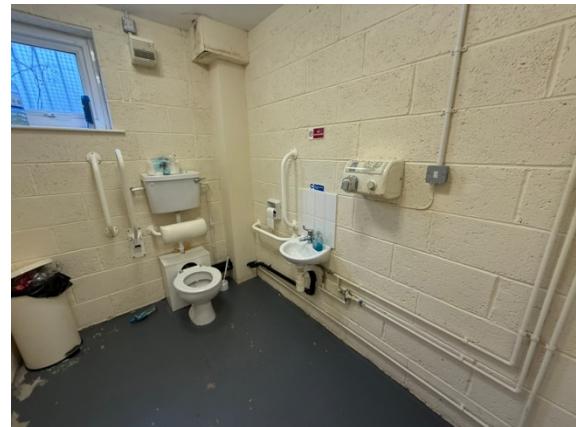
View of the disabled WC.

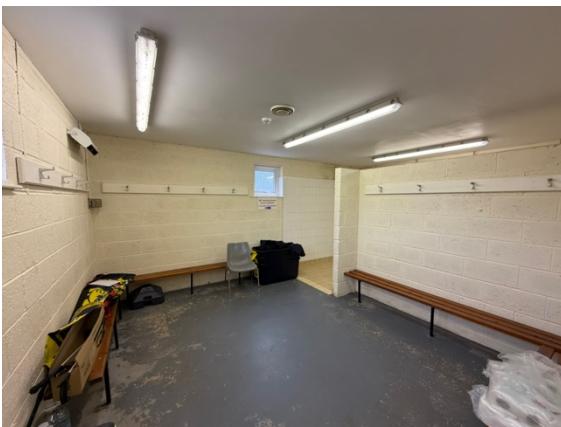
General view of the changing room.

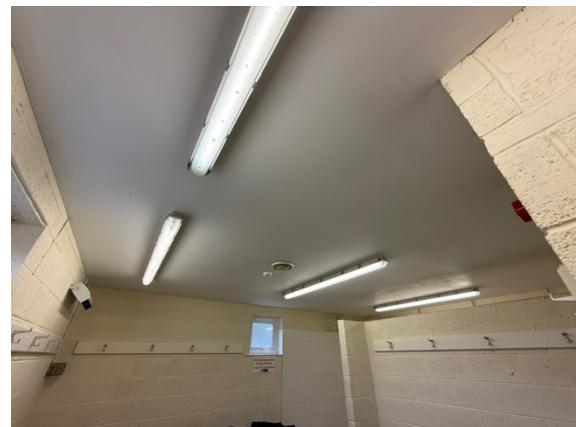
View of the changing room ceiling.

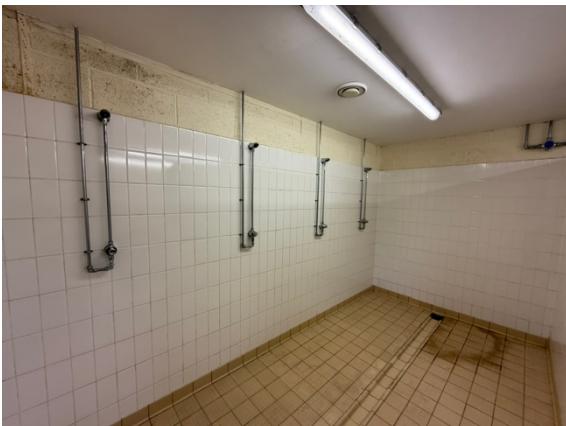
- 2.3.1 The internal walls, largely painted blockwork, are sound but display surface wear, scuffing and a dated finish. Ceilings of painted plasterboard are intact, with some localised staining in the shower area likely caused by condensation.
- 2.3.2 The changing room floors are painted concrete. The coating has deteriorated significantly, with flaking and areas of bare concrete, resulting in a surface that is porous, hard to clean and visually poor.
- 2.3.3 The shower area is finished with floor tiles draining to a central channel. While the drainage is functional, the tiles are stained and the grout joints have become darkened. The existing open-plan shower layout provides no privacy to users.

View of the existing shower facility.

- 2.5.1 The building is structurally suitable for the intended upgrade. Works will focus on improving internal conditions, hygiene and services efficiency.
- 2.5.2 Shower Facilities
- 2.5.3 The existing communal shower should be replaced with individual cubicles formed from waterproof composite partitions with doors and privacy locks. Existing hot and cold feeds can be adapted to minimise new plumbing, though localised rerouting and installation of isolation valves will be required. The tiled floor should be replaced with a continuous slip-resistant wet-room flooring system that can be coved up to the cubicle walls to form a hygienic seal.
- 2.5.4 Mechanical extraction should be installed to reduce humidity and protect finishes.

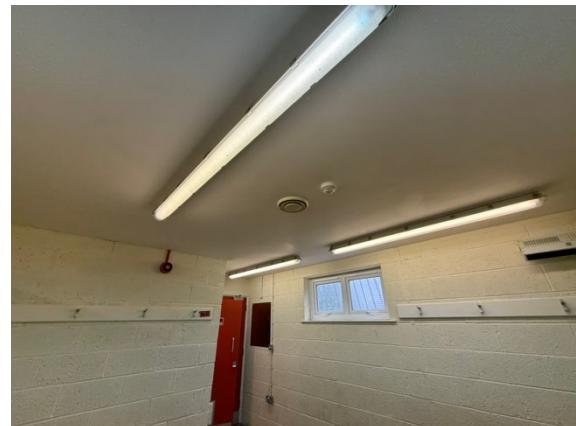
View of the light fittings to the changing room.

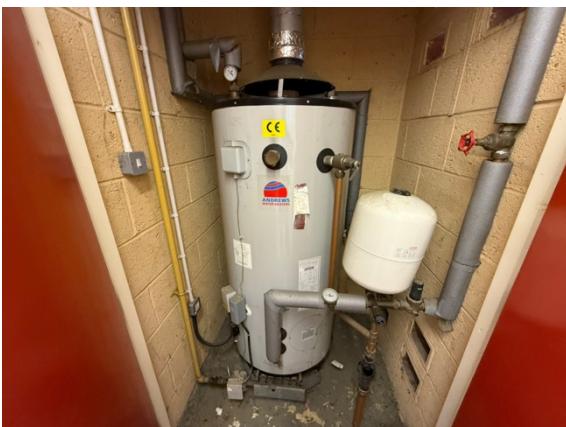
View of the existing watertank.

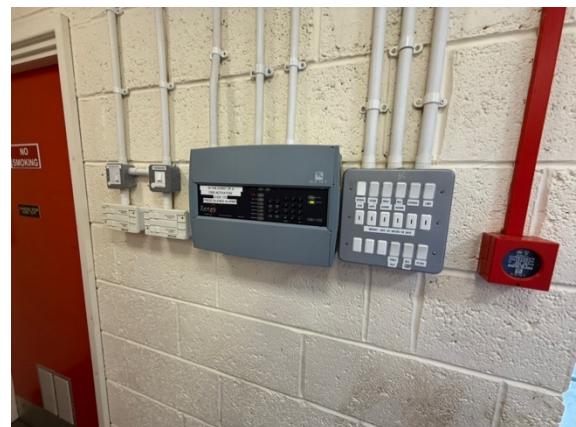
View of the electrical lighting controls and alarm etc.

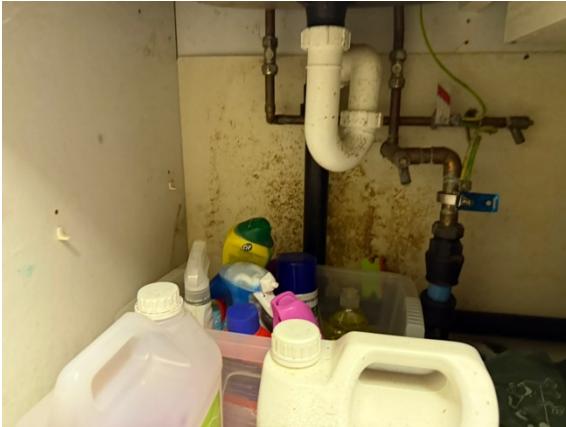
View of the drainage to the sink within the kitchen area.

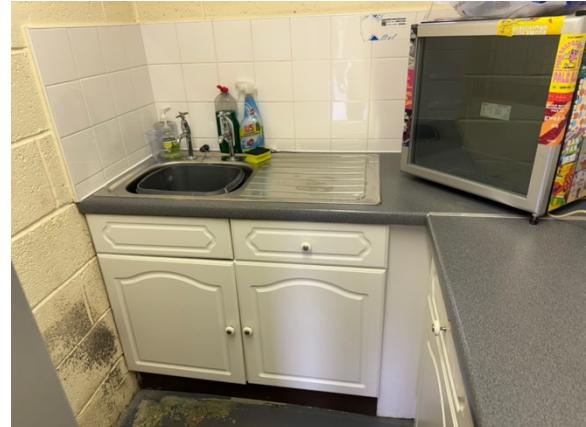
General view of the kitchen.
