ASBESTOS SURVEY REPORT

THE MUNICIPAL BUILDINGS INCLUDING THE ART GALLERY THE MOOR FALMOUTH

FALMOUTH TOWN COUNCIL

On 12 September 2016

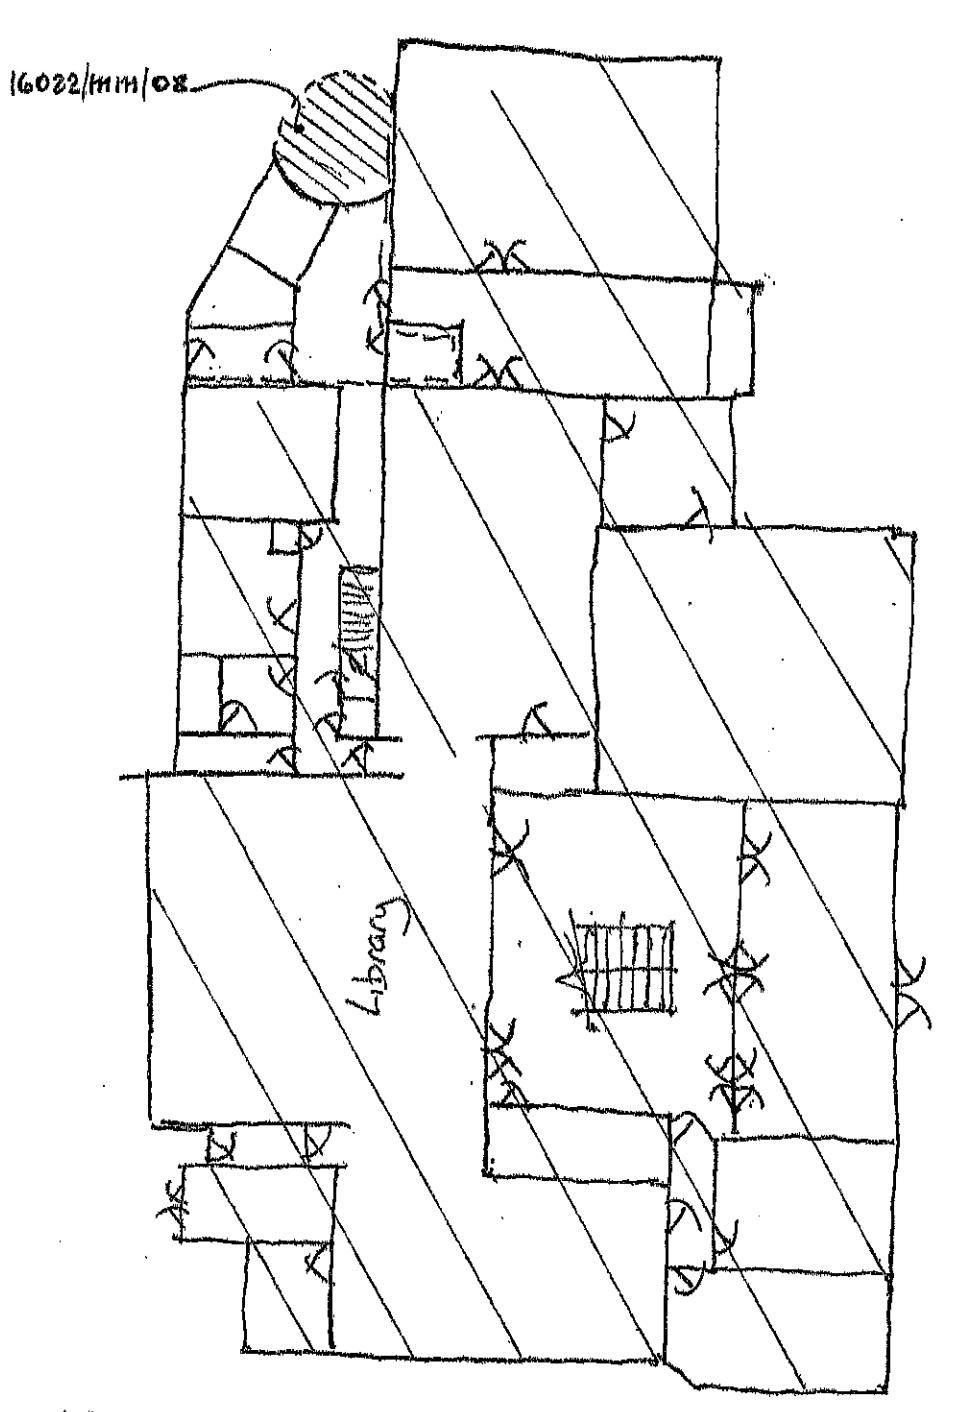
Ground Floor

Ground Areas Previously Surveyed Nob uncluded in this Survey and report.
