# TIVERTON FAS ASSET INSPECTION

## PHASE 2 DIVING WORKS

| Diving Works Summary | ENV6007048R | 23 April 2025 |
| ENV6007048R-ATK-DW-1ZZ-TM-C-000001 | n/a | n/a |

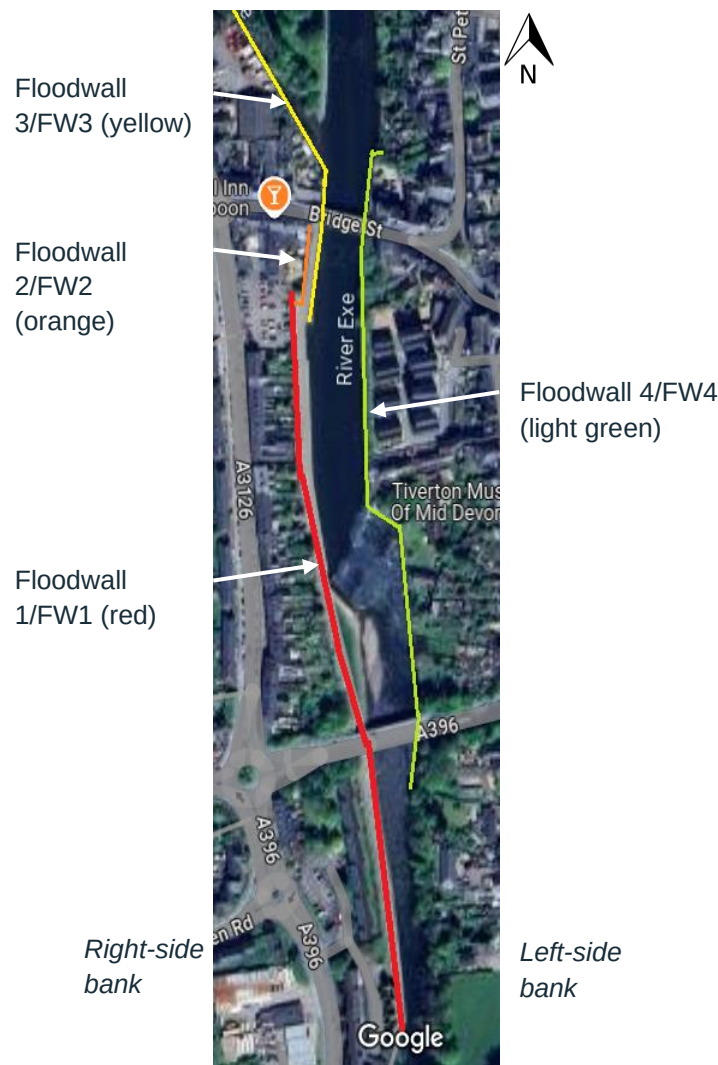
Error! Reference source not found.**Figure 1 – Map identifying different sections of flood wall along the River Exe (Imagery ©2025 Airbus, Maxar Technologies, Map data ©2025 Google)**

The floodwalls along the River Exe through the centre of Tiverton have been divided into four wall sections for this project, as shown in Figure 1. Two drawings showing the chainage alignment for each flood wall are included in Appendix C.

Table 1 shows the start and end chainage for the full extent of each wall section. The River Exe flows from north to south in Figure 1, so Floodwalls 1, 2 & 3 are on the right-side riverbank and Floodwall 4 is on the left-side riverbank.

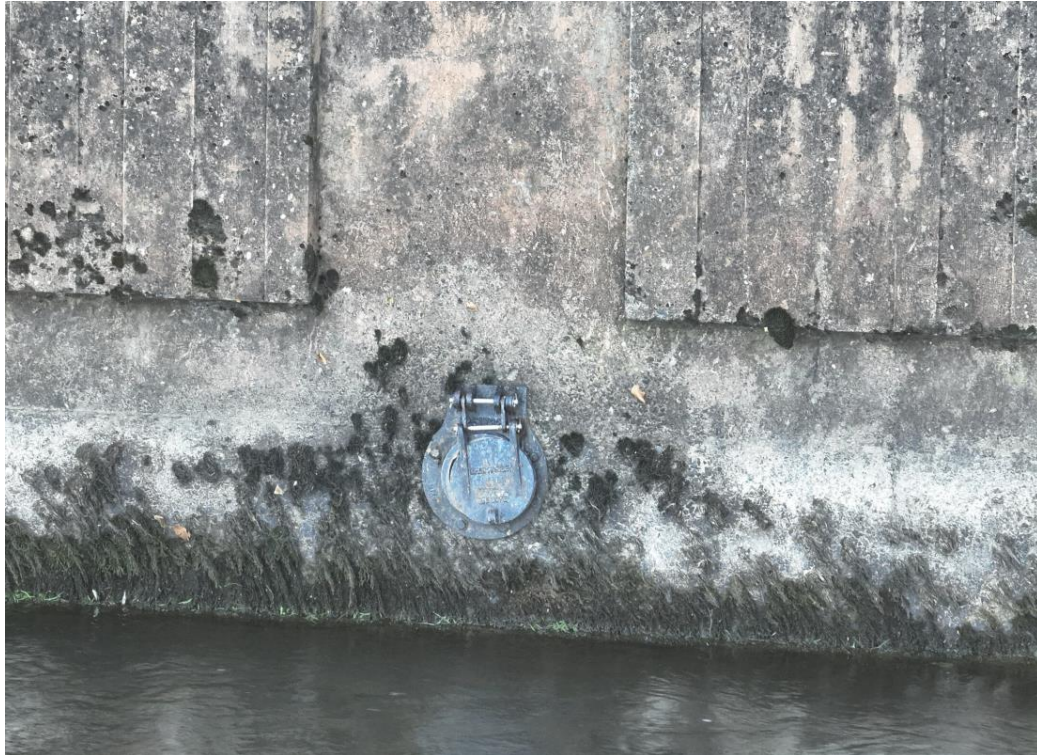
Figure 2 - Photograph showing skewed flap valve cover on floodwall 4

An example of a flap valve in the flood wall is shown in a photograph in Figure 2.

There are approximately 12 flap valves along floodwalls 3 & 4. The exact number is to be confirmed during the survey. The survey shall include an inspection of the condition of each visible flap valve, both those above and below the water level.

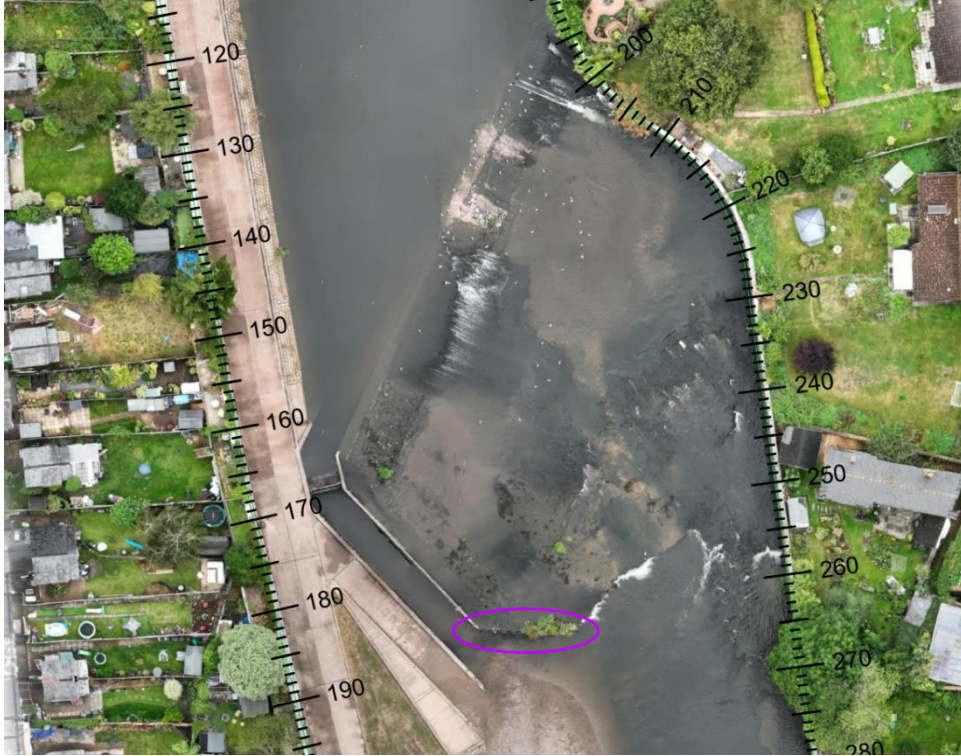
Figure 3 - Extract from chainage drawing 01 showing the section of sheet piling downstream of the weir, encircled in pink.

There is a weir positioned diagonally across the river just upstream of the A396 road bridge. Downstream of the weir is a section of sheet piling approximately 6m in length, circled in pink in Figure 3 and shown in a photograph in Figure 4.

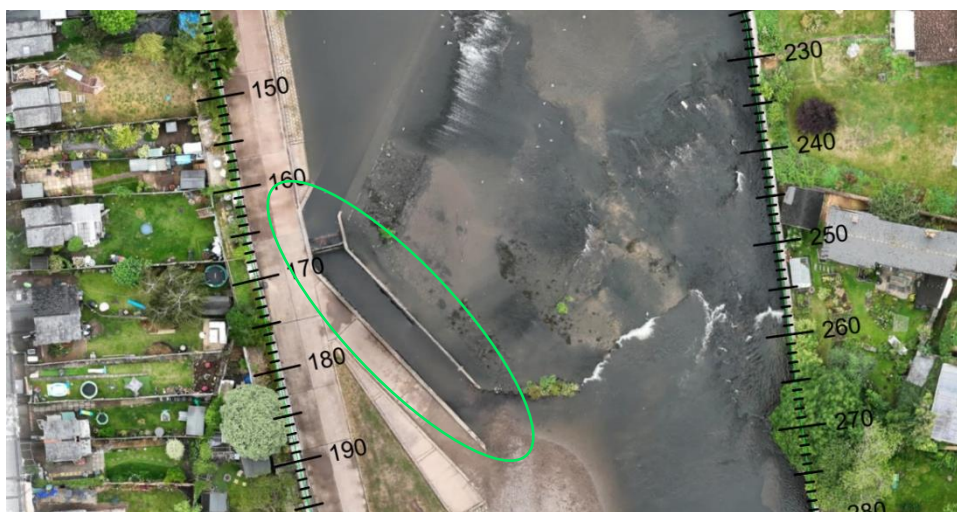
**Figure 5 - Extract from chainage drawing 01 showing the stop-log structure and concrete wall downstream of it encircled in green.**

Adjacent to the weir there is a stop-log structure to control the water levels and concrete walls either side of it to provide a channel. This structure is circled in green in Figure 5 and shown in photographs in Figure 6 and Figure 7. The length of the right concrete wall is approximately 35m and the length of the left concrete wall is approximately 25m. The survey extent shall include the wet side of the right concrete wall and both sides of the left concrete wall (where possible, dependent on weir water levels and safe access), so the total length of wall surveyed will be approximately  $35\text{m} + 25\text{m} + 25\text{m} = 85\text{m}$ . The condition survey for this section is to include:

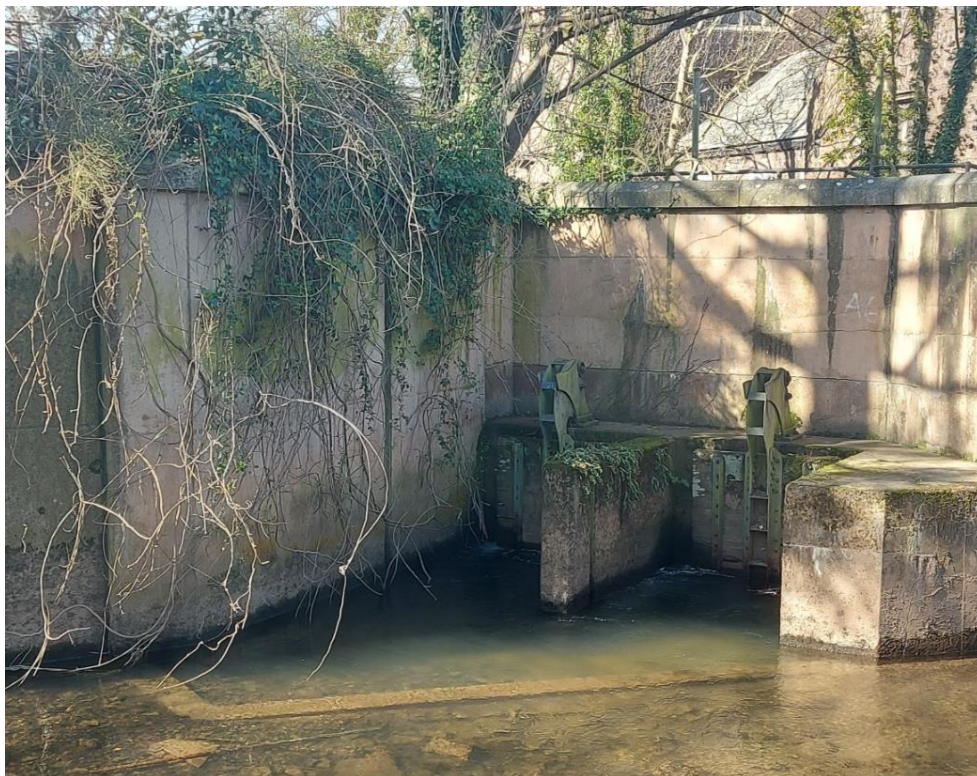
**Figure 8 - Photograph showing two sluice gates on Heathcoat Mill leat**

A leat from the River Exe runs through the Heathcoat Mill site supplying water for operations and hydropower for the factory. The outlet of the hydropower plant discharges back into the River Exe through two timber outfall flaps, shown in Figure 8. These are located between 5m to 10m chainage on Floodwall 3.

1. Summary of the condition of each outfall flap, especially noting the condition of the timber below the waterline;
2. Assessment of whether the flaps provide an adequate seal and operate properly (i.e. hinge operates smoothly, if safe to inspect);
3. Record of any blockage or damage to any visible pipe sections upstream, which may impact the operation of the outfall flaps;
4. Summary of the condition of the concrete headwall and concrete wall separating outfall flaps, including any cracks or scour (with measurements where possible); and
5. Photographs.

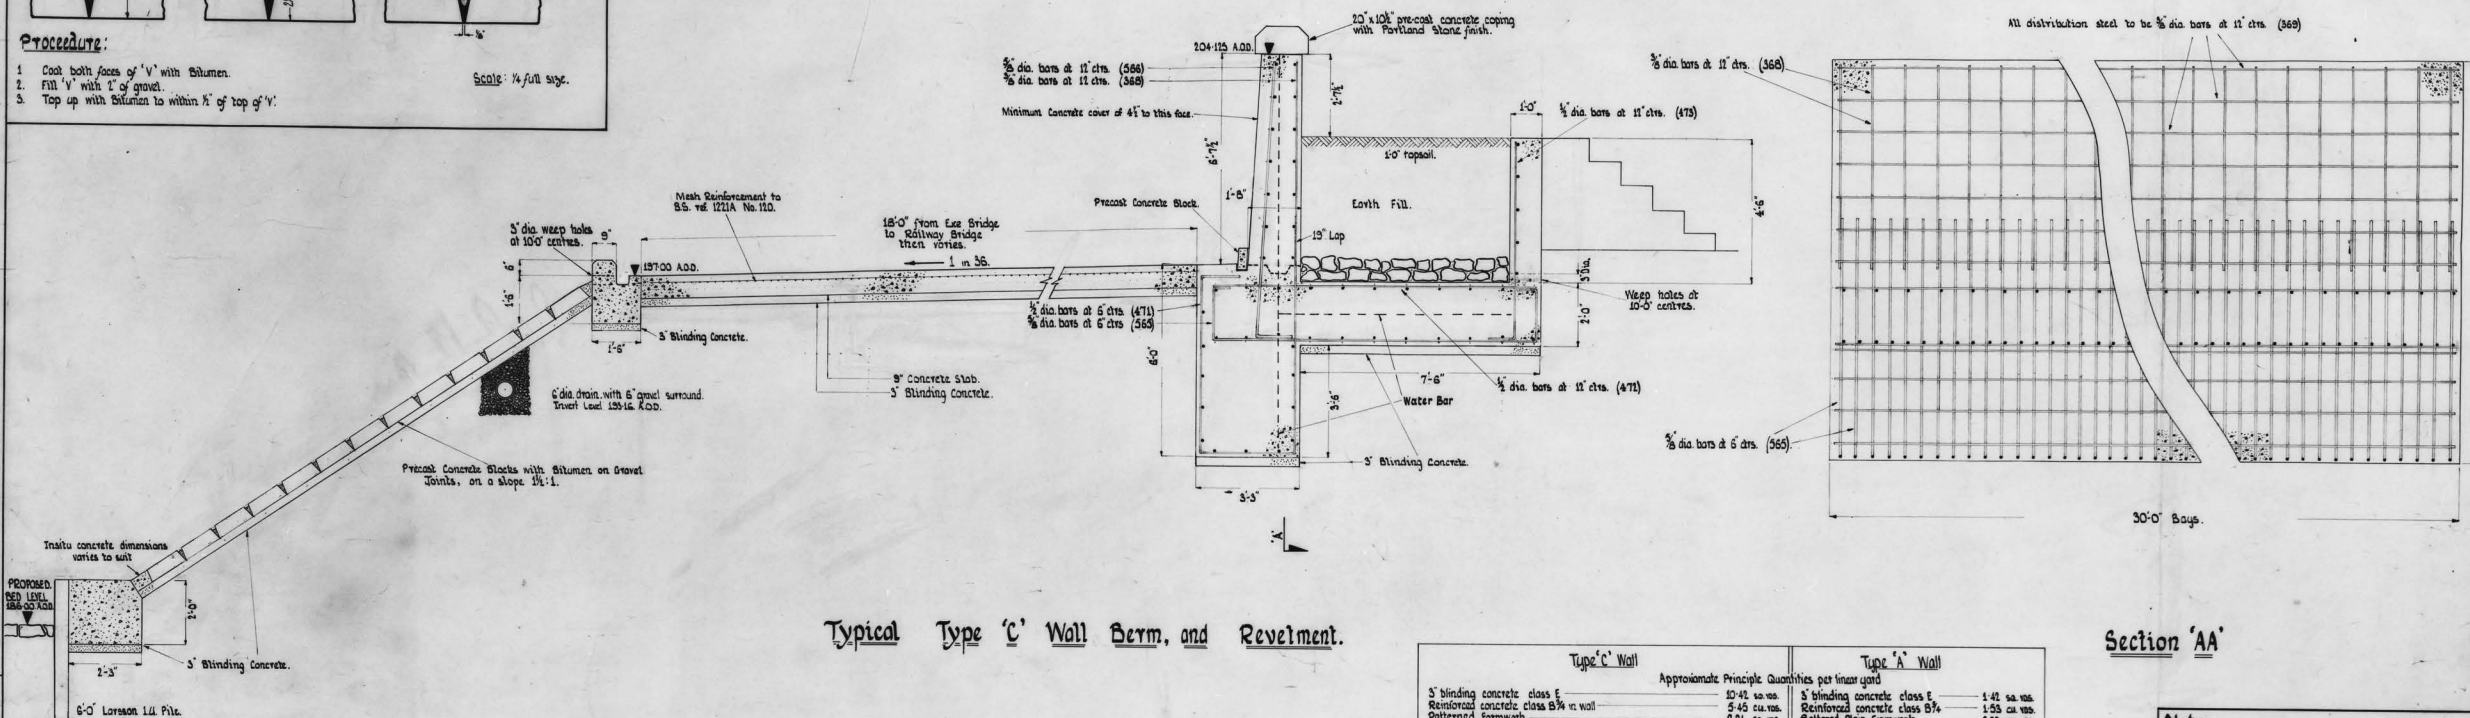
Typical Type 'C' Wall Berm, and Revetment.

1. All steel to have a minimum of  $\frac{1}{8}$ " coat.
2.  $\frac{1}{2}$ " Expansion joints to be provided at 60'-0" c/c.
3. 5" Water Bars to be provided in expansion joints & vertical construction joints
4. Berm to have wood float finish

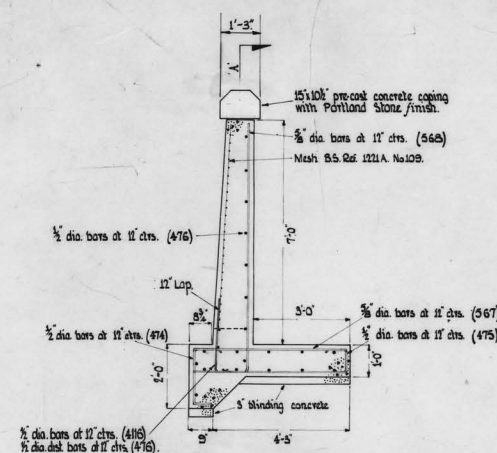
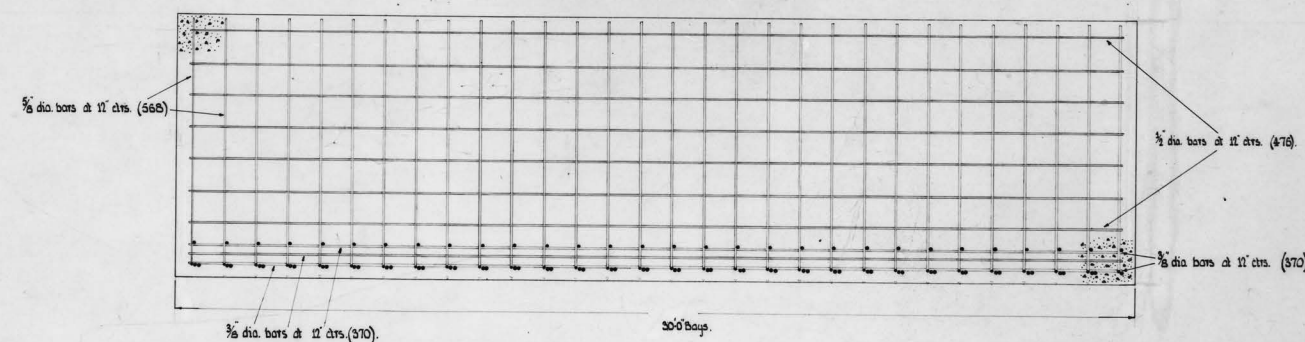
Typical Type 'A' Wall.

Section 'AA'

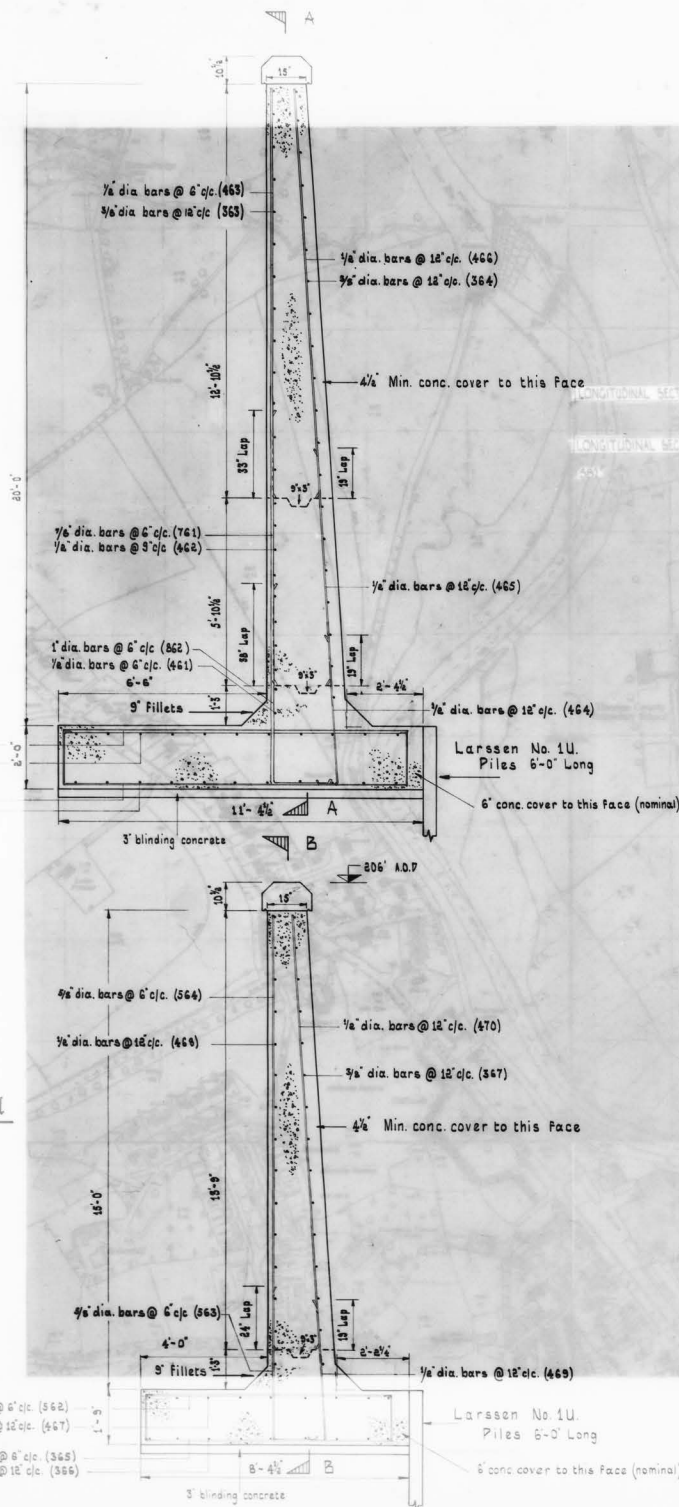
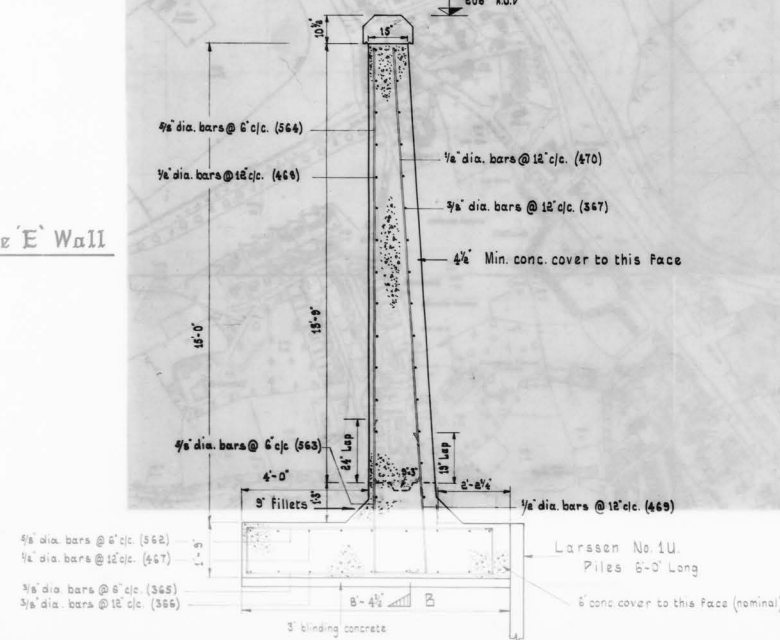
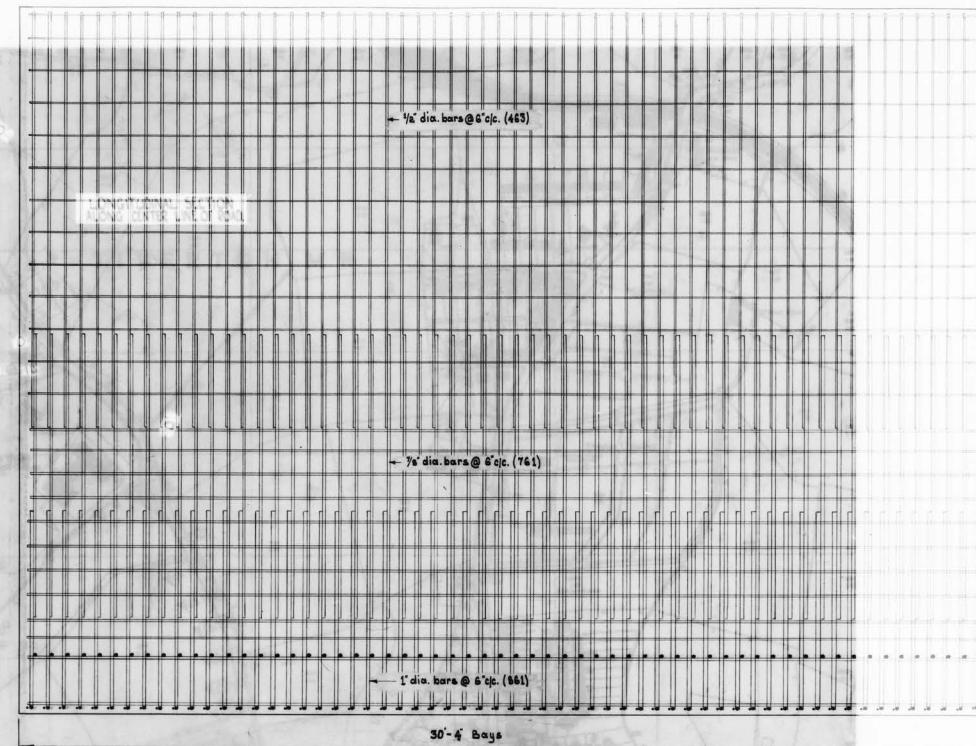
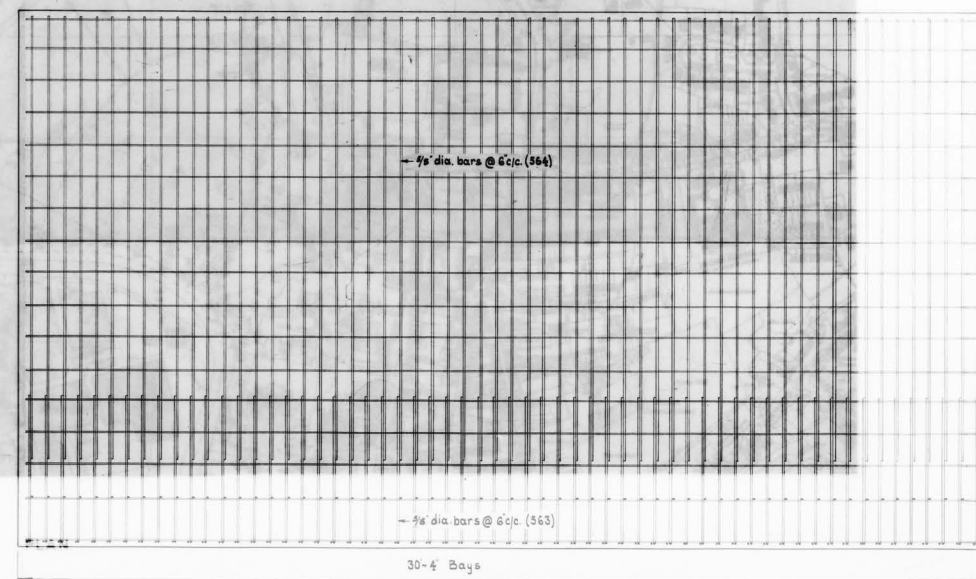
DRG. NO. 14/45/02/202

Type 'D' Wall

Type 'E' Wall

Section A-A.

Section B-B.

- 1/2" Expansion joint to be provided at 60'-0" c/c.
- 6" Drains with Tide Flaps to be provided through Types D & E Walls from drainage layers (shown on Cross Sections) at 30'-0" c/c (14.1 per Bay).
