# Asbestos Management Survey Report

Chippenham Town Hall, High Street, Chippenham, Wiltshire, SN15 3ER

Date of Survey:	18 Nov 2025 to 7 Dec 2025
Date of Report:	18 Dec 2025
<u>Job No:</u>	<u>J012946</u>
Authorising Surveyor:	Jim Hook
Verified/Signature:

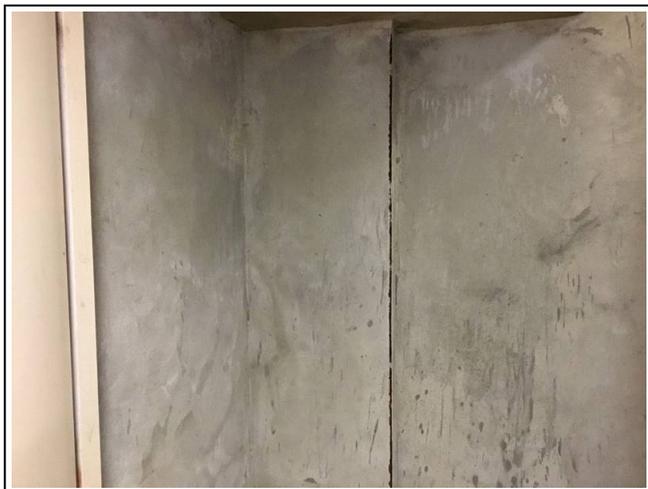
Survey Data Sheet: Conclusions & Recommendations  
 Site Location: Chippenham Town Hall, High Street, Chippenham, Wiltshire, SN15 3ER  
 Building Designation: Building 01  
 Unique item Number: 1

Sample Ref	FI	Location	Description	Qty	Analysis Result	Total M.A.S	Licensed Material Y/N
Surveyed	Z-Sub Level 1	B.01 - Stairwell	No asbestos detected		N/A	0	N/A

Recommended Action:  
 -

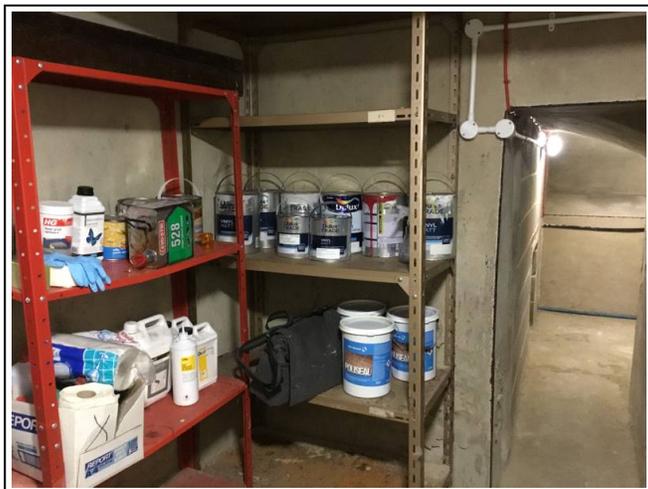
Survey Data Sheet: Conclusions & Recommendations  
 Site Location: Chippenham Town Hall, High Street, Chippenham, Wiltshire, SN15 3ER  
 Building Designation: Building 01  
 Unique item Number: 2

Sample Ref	FI	Location	Description	Qty	Analysis Result	Total M.A.S	Licensed Material Y/N
Surveyed	Z-Sub Level 1	B.02 - Store	No asbestos detected		N/A	0	N/A

Recommended Action:  
 -

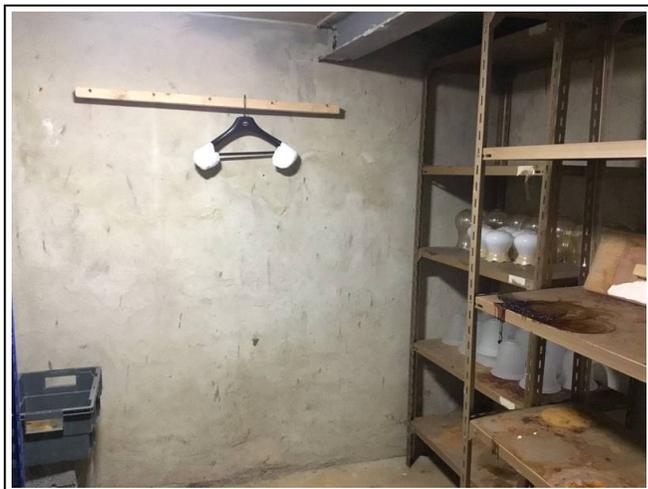
Survey Data Sheet: Conclusions & Recommendations  
 Site Location: Chippenham Town Hall, High Street, Chippenham, Wiltshire, SN15 3ER  
 Building Designation: Building 01  
 Unique item Number: 3

Sample Ref	FI	Location	Description	Qty	Analysis Result	Total M.A.S	Licensed Material Y/N
Surveyed	Z-Sub Level 1	B.03 - Store	No asbestos detected		N/A	0	N/A

Recommended Action:  
-

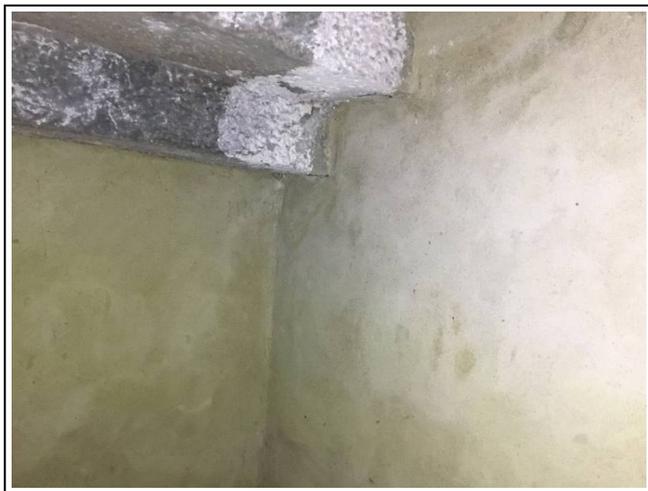
Survey Data Sheet: Conclusions & Recommendations  
 Site Location: Chippenham Town Hall, High Street, Chippenham, Wiltshire, SN15 3ER  
 Building Designation: Building 01  
 Unique item Number: 4

Sample Ref	FI	Location	Description	Qty	Analysis Result	Total M.A.S	Licensed Material Y/N
Surveyed	Z-Sub Level 1	B.04	No asbestos detected		N/A	0	N/A

Recommended Action:  
 -

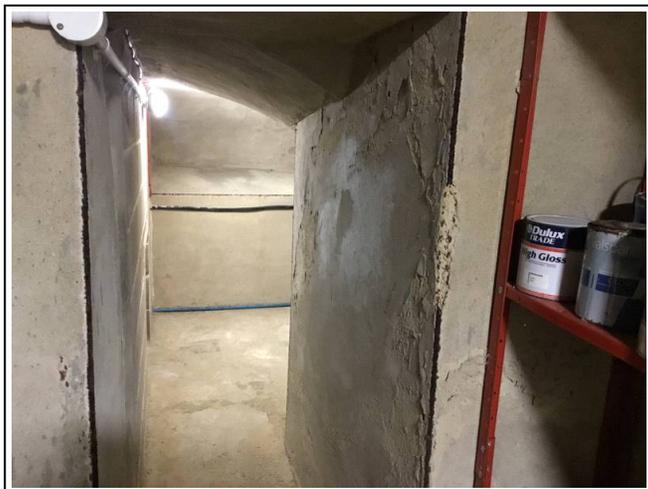
Survey Data Sheet: Conclusions & Recommendations  
 Site Location: Chippenham Town Hall, High Street, Chippenham, Wiltshire, SN15 3ER  
 Building Designation: Building 01  
 Unique item Number: 5

Sample Ref	FI	Location	Description	Qty	Analysis Result	Total M.A.S	Licensed Material Y/N
Surveyed	Z-Sub Level 1	B.05	No asbestos detected		N/A	0	N/A

Recommended Action:  
-

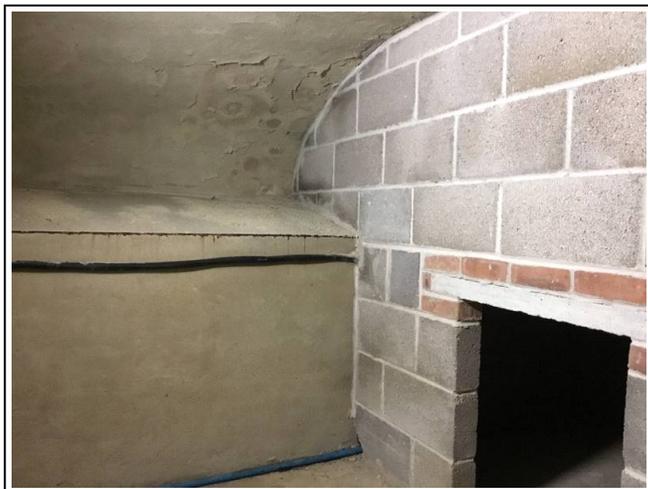
Survey Data Sheet: Conclusions & Recommendations  
 Site Location: Chippenham Town Hall, High Street, Chippenham, Wiltshire, SN15 3ER  
 Building Designation: Building 01  
 Unique item Number: 6

Sample Ref	FI	Location	Description	Qty	Analysis Result	Total M.A.S	Licensed Material Y/N
Surveyed	Z-Sub Level 1	B.06	No asbestos detected		N/A	0	N/A

Recommended Action:  
 -

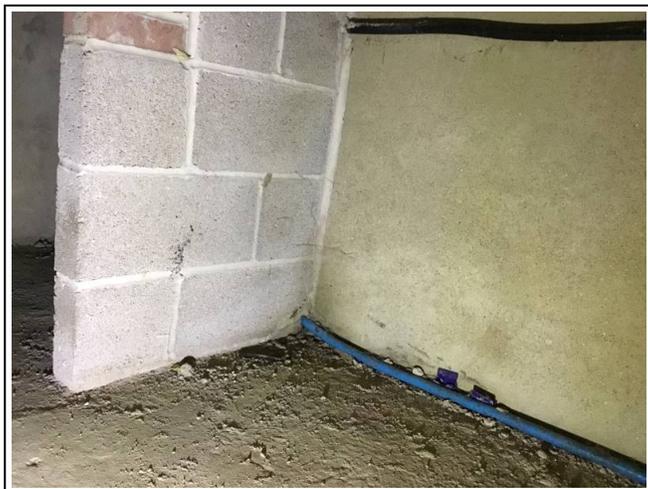
Survey Data Sheet: Conclusions & Recommendations  
 Site Location: Chippenham Town Hall, High Street, Chippenham, Wiltshire, SN15 3ER  
 Building Designation: Building 01  
 Unique item Number: 7

Sample Ref	FI	Location	Description	Qty	Analysis Result	Total M.A.S	Licensed Material Y/N
Surveyed	Z-Sub Level 1	B.07	No asbestos detected		N/A	0	N/A

Recommended Action:  
 -

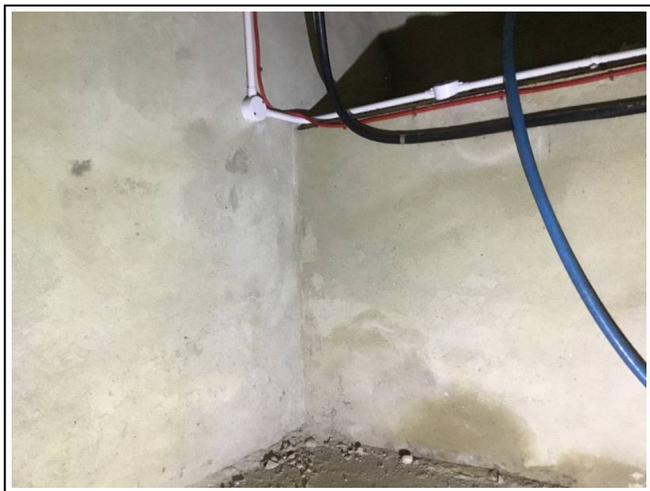
Survey Data Sheet: Conclusions & Recommendations  
 Site Location: Chippenham Town Hall, High Street, Chippenham, Wiltshire, SN15 3ER  
 Building Designation: Building 01  
 Unique item Number: 8

Sample Ref	FI	Location	Description	Qty	Analysis Result	Total M.A.S	Licensed Material Y/N
Surveyed	Z-Sub Level 1	B.08	No asbestos detected		N/A	0	N/A

Recommended Action:  
-

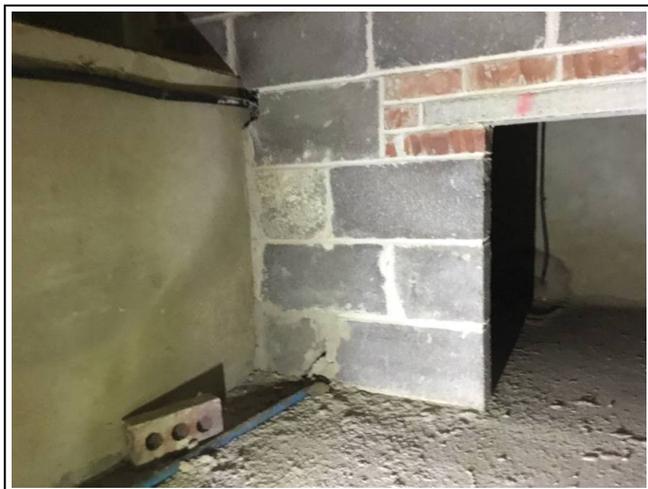
Survey Data Sheet: Conclusions & Recommendations  
 Site Location: Chippenham Town Hall, High Street, Chippenham, Wiltshire, SN15 3ER  
 Building Designation: Building 01  
 Unique item Number: 9

Sample Ref	FI	Location	Description	Qty	Analysis Result	Total M.A.S	Licensed Material Y/N
Surveyed	Z-Sub Level 1	B.09	No asbestos detected		N/A	0	N/A

Recommended Action:  
-

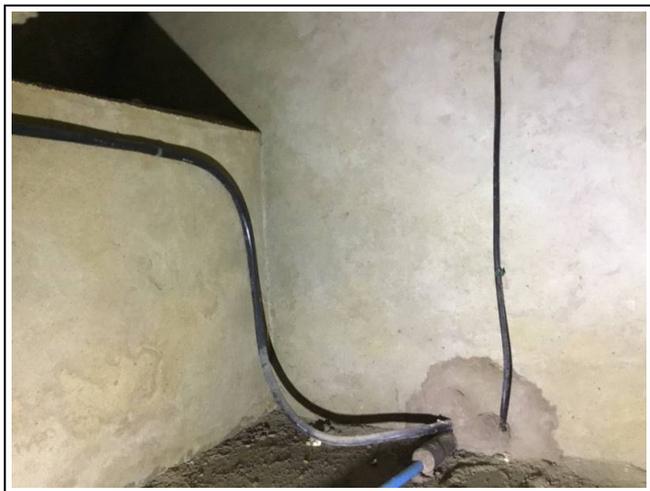
Survey Data Sheet: Conclusions & Recommendations  
 Site Location: Chippenham Town Hall, High Street, Chippenham, Wiltshire, SN15 3ER  
 Building Designation: Building 01  
 Unique item Number: 10

Sample Ref	FI	Location	Description	Qty	Analysis Result	Total M.A.S	Licensed Material Y/N
Surveyed	Z-Sub Level 1	B.10	No asbestos detected		N/A	0	N/A

Recommended Action:  
 -

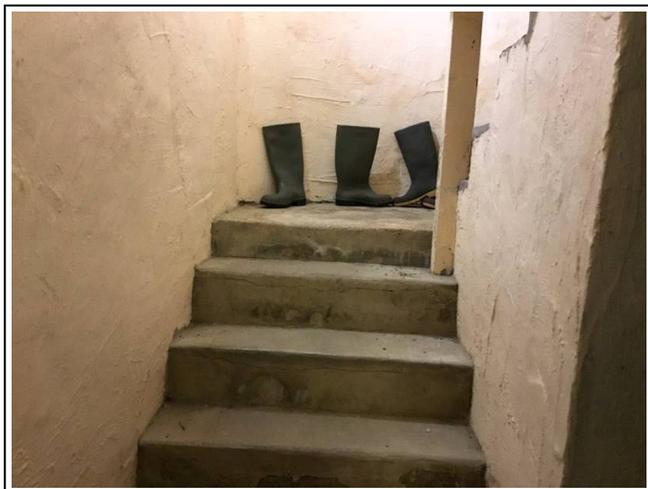
Sample Ref	Fl	Location	Description	Qty	Analysis Result	Total M.A.S	Licensed Material Y/N
CT004811	Z-Sub Level 1	B.11 - Stairwell	Walls - Textured coating - Textured Coating	6m <sup>2</sup>	NADIS	0	N/A

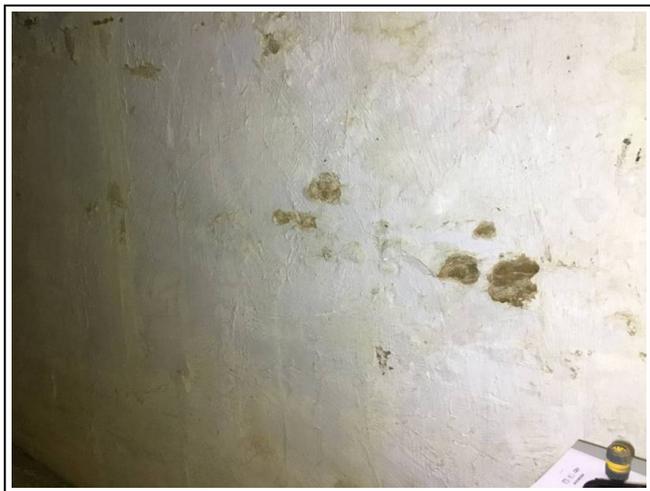
Survey Data Sheet: Conclusions & Recommendations  
 Site Location: Chippenham Town Hall, High Street, Chippenham, Wiltshire, SN15 3ER  
 Building Designation: Building 01  
 Unique item Number: 12

Sample Ref	FI	Location	Description	Qty	Analysis Result	Total M.A.S	Licensed Material Y/N
REFER (CT004811)	Z-Sub Level 1	B.12	Walls - Textured coating - Textured Coating	28m <sup>2</sup>	NADIS	0	N/A

Recommended Action:  
 -

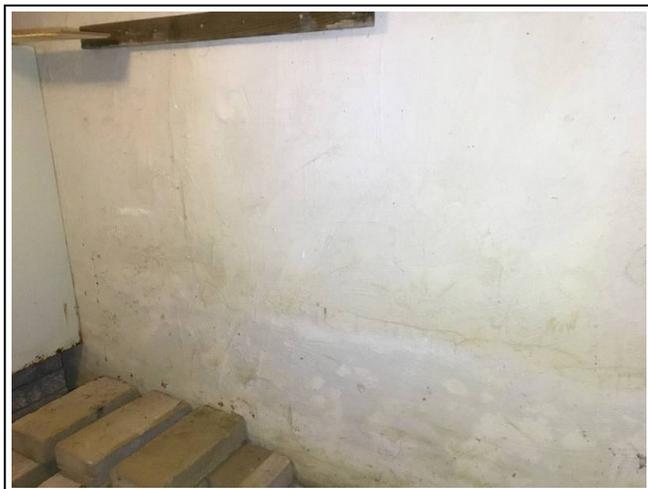
Survey Data Sheet: Conclusions & Recommendations  
 Site Location: Chippenham Town Hall, High Street, Chippenham, Wiltshire, SN15 3ER  
 Building Designation: Building 01  
 Unique item Number: 13

Sample Ref	FI	Location	Description	Qty	Analysis Result	Total M.A.S	Licensed Material Y/N
REFER (CT004811)	Z-Sub Level 1	B.13	Walls - Textured coating - Textured Coating	28m <sup>2</sup>	NADIS	0	N/A

Recommended Action:  
 -

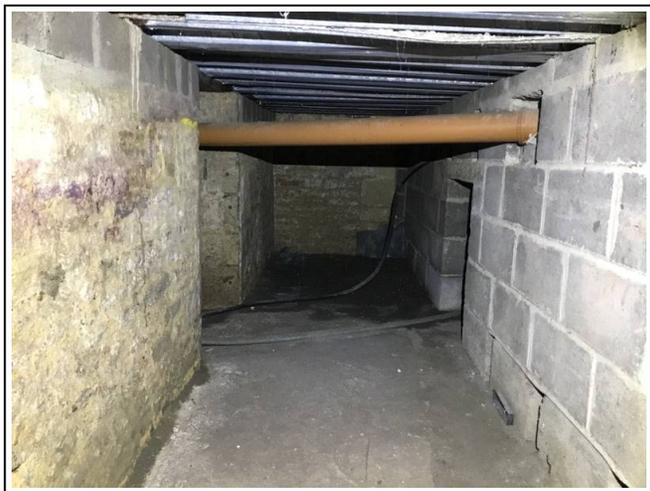
Survey Data Sheet: Conclusions & Recommendations  
 Site Location: Chippenham Town Hall, High Street, Chippenham, Wiltshire, SN15 3ER  
 Building Designation: Building 01  
 Unique item Number: 14

Sample Ref	FI	Location	Description	Qty	Analysis Result	Total M.A.S	Licensed Material Y/N
Surveyed	Z-Sub Level 1	B.14	No asbestos detected		N/A	0	N/A

Recommended Action:  
-

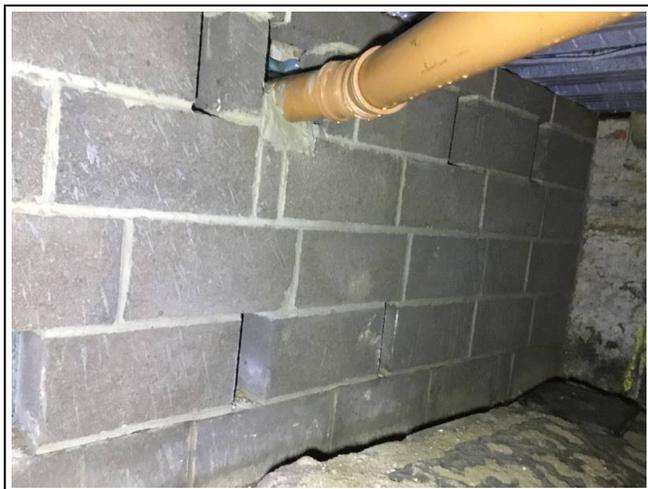
Survey Data Sheet: Conclusions & Recommendations  
 Site Location: Chippenham Town Hall, High Street, Chippenham, Wiltshire, SN15 3ER  
 Building Designation: Building 01  
 Unique item Number: 15

Sample Ref	FI	Location	Description	Qty	Analysis Result	Total M.A.S	Licensed Material Y/N
Surveyed	Z-Sub Level 1	B.15	No asbestos detected		N/A	0	N/A

Recommended Action:  
-

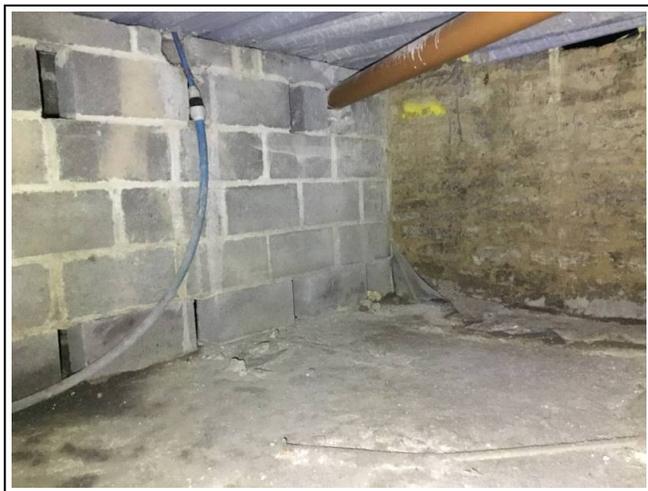
Survey Data Sheet: Conclusions & Recommendations  
 Site Location: Chippenham Town Hall, High Street, Chippenham, Wiltshire, SN15 3ER  
 Building Designation: Building 01  
 Unique item Number: 16

Sample Ref	FI	Location	Description	Qty	Analysis Result	Total M.A.S	Licensed Material Y/N
Surveyed	Z-Sub Level 1	B.16	No asbestos detected		N/A	0	N/A

Recommended Action:  
 -

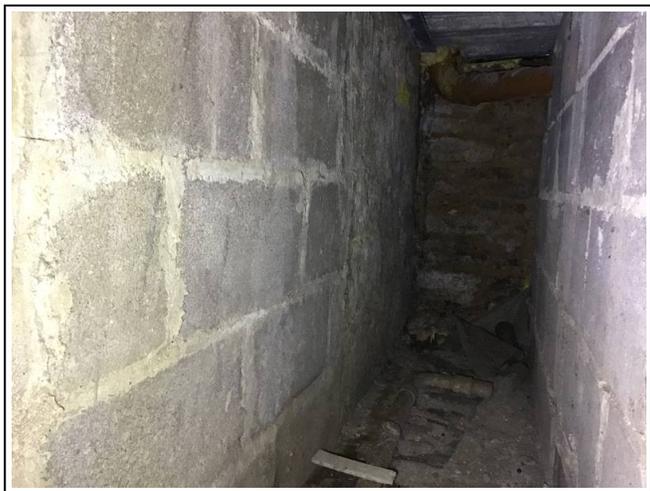
Survey Data Sheet: Conclusions & Recommendations  
 Site Location: Chippenham Town Hall, High Street, Chippenham, Wiltshire, SN15 3ER  
 Building Designation: Building 01  
 Unique item Number: 17

Sample Ref	FI	Location	Description	Qty	Analysis Result	Total M.A.S	Licensed Material Y/N
Surveyed	Z-Sub Level 1	B.17	No asbestos detected		N/A	0	N/A

Recommended Action:  
-

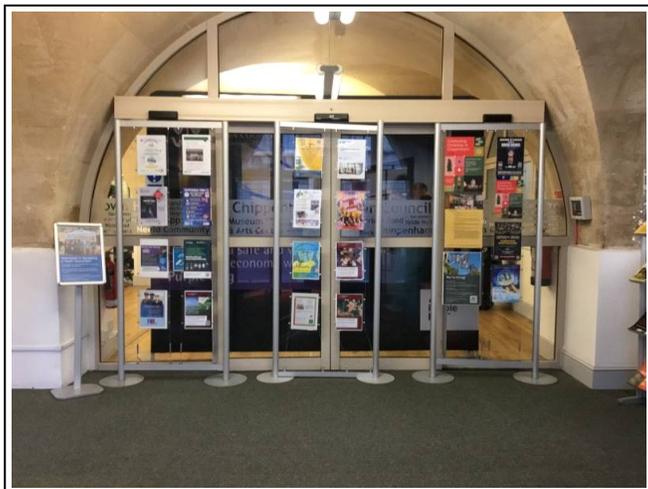
Survey Data Sheet: Conclusions & Recommendations  
 Site Location: Chippenham Town Hall, High Street, Chippenham, Wiltshire, SN15 3ER  
 Building Designation: Building 01  
 Unique item Number: 18

Sample Ref	FI	Location	Description	Qty	Analysis Result	Total M.A.S	Licensed Material Y/N
Surveyed	Ground Floor	G.01 - Entrance Lobby	No asbestos detected		N/A	0	N/A

Recommended Action:  
 -

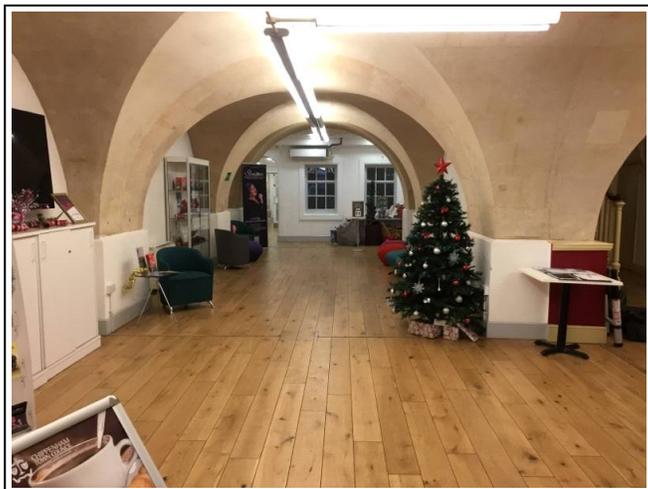
Survey Data Sheet: Conclusions & Recommendations  
 Site Location: Chippenham Town Hall, High Street, Chippenham, Wiltshire, SN15 3ER  
 Building Designation: Building 01  
 Unique item Number: 19

Sample Ref	Fl	Location	Description	Qty	Analysis Result	Total M.A.S	Licensed Material Y/N
Surveyed	Ground Floor	G.02 - Reception	No asbestos detected - No asbestos detected		N/A	0	N/A

Recommended Action:  
-

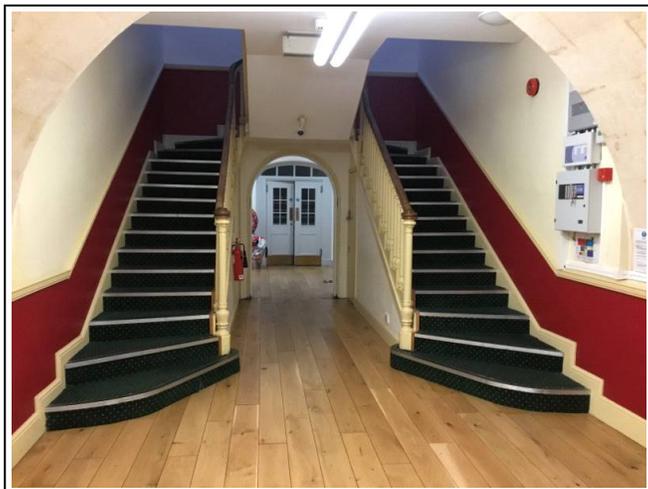
Survey Data Sheet: Conclusions & Recommendations  
 Site Location: Chippenham Town Hall, High Street, Chippenham, Wiltshire, SN15 3ER  
 Building Designation: Building 01  
 Unique item Number: 20

Sample Ref	Fl	Location	Description	Qty	Analysis Result	Total M.A.S	Licensed Material Y/N
Surveyed	Ground Floor	G.03 - Lobby Area	No asbestos detected - No asbestos detected		N/A	0	N/A

Recommended Action:  
 -

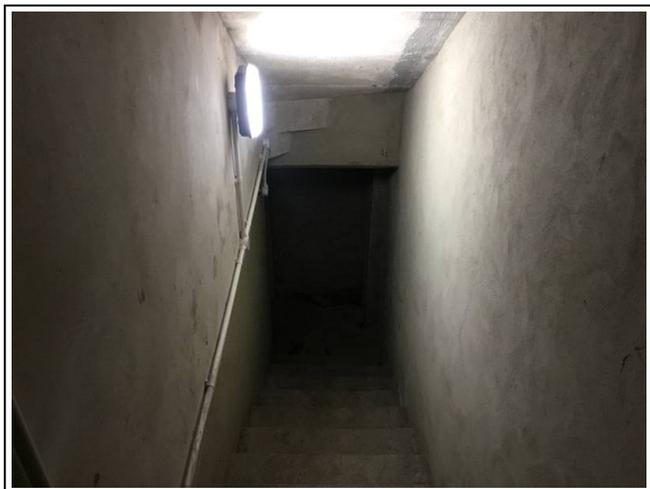
Survey Data Sheet: Conclusions & Recommendations  
 Site Location: Chippenham Town Hall, High Street, Chippenham, Wiltshire, SN15 3ER  
 Building Designation: Building 01  
 Unique item Number: 21

Sample Ref	Fl	Location	Description	Qty	Analysis Result	Total M.A.S	Licensed Material Y/N
Surveyed	Ground Floor	G.04 - Basement Stairs	No asbestos detected		N/A	0	N/A

Recommended Action:  
 -

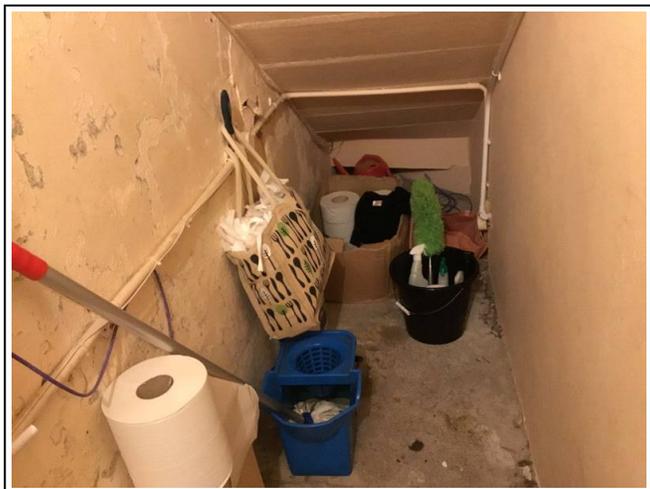
Survey Data Sheet: Conclusions & Recommendations  
 Site Location: Chippenham Town Hall, High Street, Chippenham, Wiltshire, SN15 3ER  
 Building Designation: Building 01  
 Unique item Number: 22

Sample Ref	FI	Location	Description	Qty	Analysis Result	Total M.A.S	Licensed Material Y/N
Surveyed	Ground Floor	G.05 - Cupboard	No asbestos detected		N/A	0	N/A

Recommended Action:  
 -

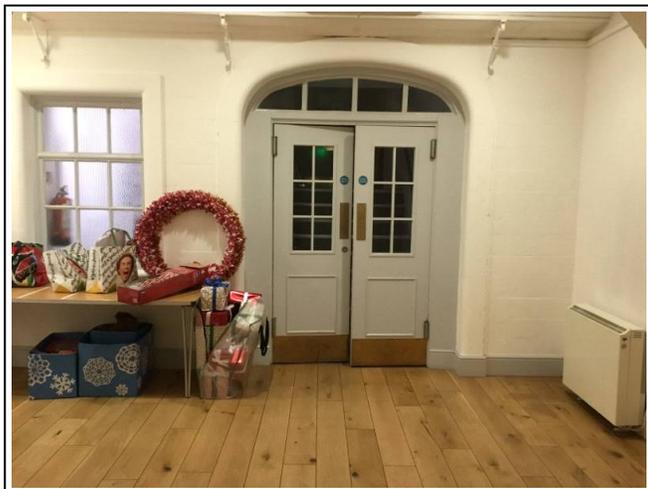
Survey Data Sheet: Conclusions & Recommendations  
 Site Location: Chippenham Town Hall, High Street, Chippenham, Wiltshire, SN15 3ER  
 Building Designation: Building 01  
 Unique item Number: 23

Sample Ref	Fl	Location	Description	Qty	Analysis Result	Total M.A.S	Licensed Material Y/N
Surveyed	Ground Floor	G.06 - Lobby	No asbestos detected		N/A	0	N/A

Recommended Action:  
-

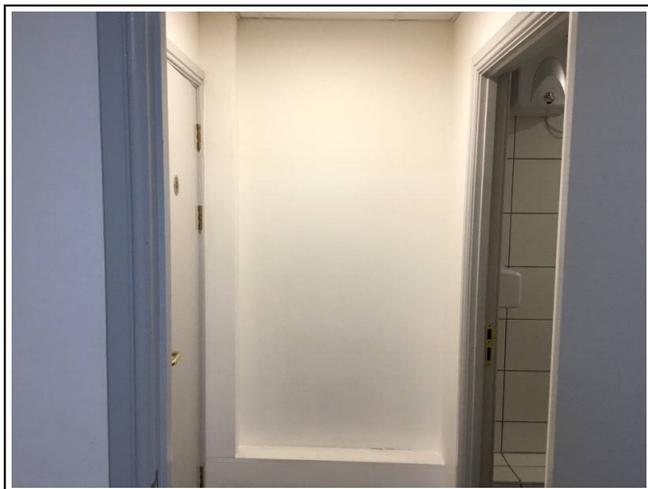
Survey Data Sheet: Conclusions & Recommendations  
 Site Location: Chippenham Town Hall, High Street, Chippenham, Wiltshire, SN15 3ER  
 Building Designation: Building 01  
 Unique item Number: 25

Sample Ref	FI	Location	Description	Qty	Analysis Result	Total M.A.S	Licensed Material Y/N
Surveyed	Ground Floor	G.08 - Lobby to W/Cs	No asbestos detected		N/A	0	N/A

Recommended Action:  
 -

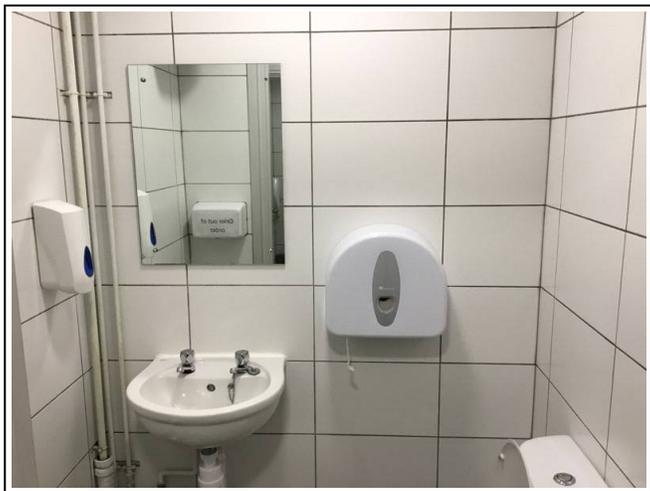
Survey Data Sheet: Conclusions & Recommendations  
 Site Location: Chippenham Town Hall, High Street, Chippenham, Wiltshire, SN15 3ER  
 Building Designation: Building 01  
 Unique item Number: 26

Sample Ref	FI	Location	Description	Qty	Analysis Result	Total M.A.S	Licensed Material Y/N
Surveyed	Ground Floor	G.09 - Unisex W/C	No asbestos detected		N/A	0	N/A

Recommended Action:  
 -

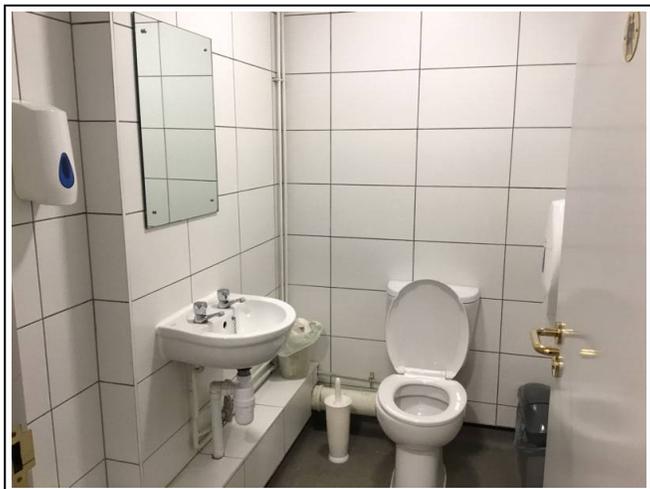
Survey Data Sheet: Conclusions & Recommendations  
 Site Location: Chippenham Town Hall, High Street, Chippenham, Wiltshire, SN15 3ER  
 Building Designation: Building 01  
 Unique item Number: 27

Sample Ref	FI	Location	Description	Qty	Analysis Result	Total M.A.S	Licensed Material Y/N
Surveyed	Ground Floor	G.10 - Unisex W/C	No asbestos detected		N/A	0	N/A

Recommended Action:  
 -

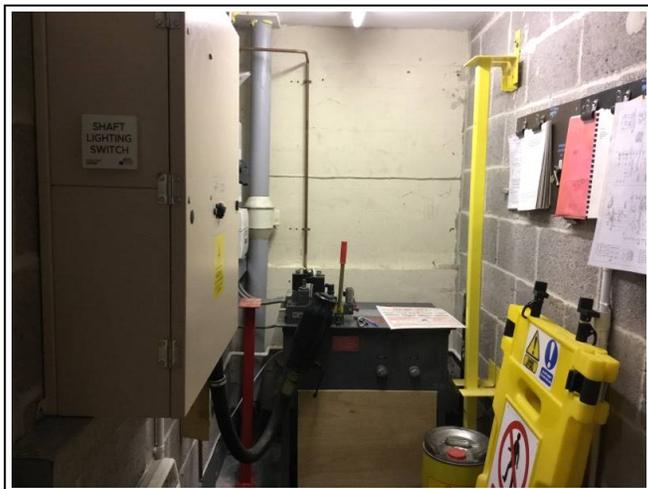
Survey Data Sheet: Conclusions & Recommendations  
 Site Location: Chippenham Town Hall, High Street, Chippenham, Wiltshire, SN15 3ER  
 Building Designation: Building 01  
 Unique item Number: 29

Sample Ref	Fl	Location	Description	Qty	Analysis Result	Total M.A.S	Licensed Material Y/N
Surveyed	Ground Floor	G.12 - Lift Motor Room	No asbestos detected		N/A	0	N/A

Recommended Action:  
 -

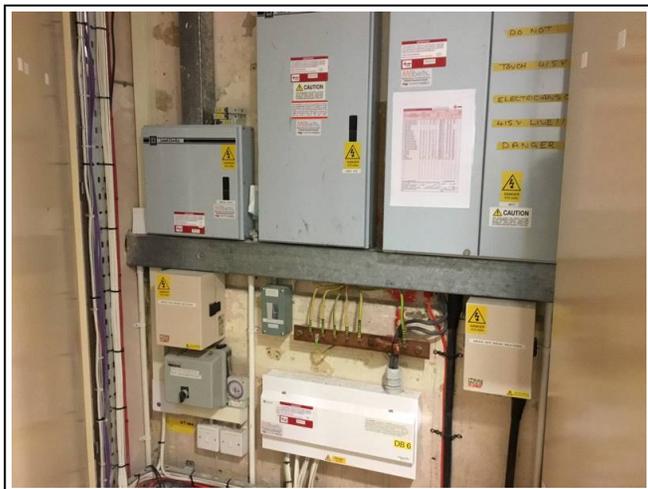
Survey Data Sheet: Conclusions & Recommendations  
 Site Location: Chippenham Town Hall, High Street, Chippenham, Wiltshire, SN15 3ER  
 Building Designation: Building 01  
 Unique item Number: 30

Sample Ref	Fl	Location	Description	Qty	Analysis Result	Total M.A.S	Licensed Material Y/N
Surveyed	Ground Floor	G.13 - Electrical Cupboard	No asbestos detected		N/A	0	N/A

Recommended Action:  
-

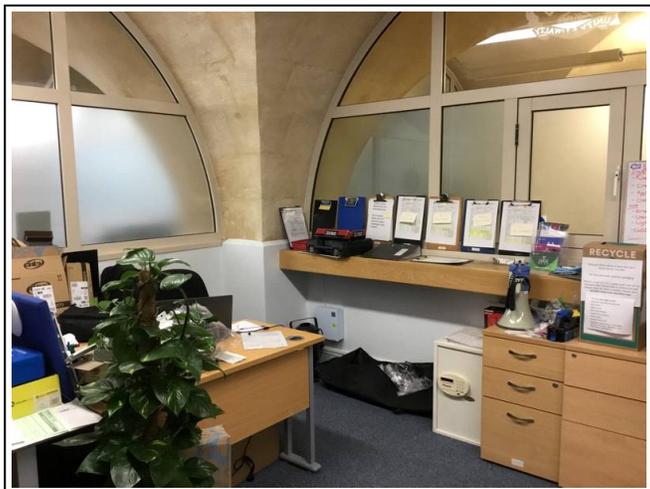
Survey Data Sheet: Conclusions & Recommendations  
 Site Location: Chippenham Town Hall, High Street, Chippenham, Wiltshire, SN15 3ER  
 Building Designation: Building 01  
 Unique item Number: 31

Sample Ref	Fl	Location	Description	Qty	Analysis Result	Total M.A.S	Licensed Material Y/N
Surveyed	Ground Floor	G.14 - Office	No asbestos detected - No asbestos detected		N/A	0	N/A

Recommended Action:  
 -

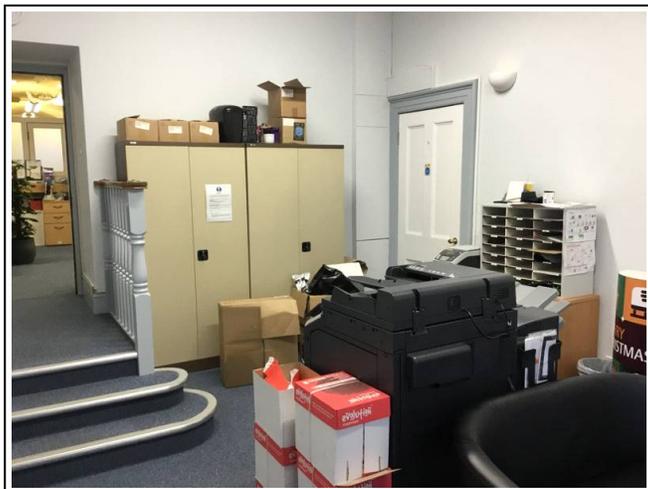
Survey Data Sheet: Conclusions & Recommendations  
 Site Location: Chippenham Town Hall, High Street, Chippenham, Wiltshire, SN15 3ER  
 Building Designation: Building 01  
 Unique item Number: 32

Sample Ref	Fl	Location	Description	Qty	Analysis Result	Total M.A.S	Licensed Material Y/N
Surveyed	Ground Floor	G.15 - Office	No asbestos detected		N/A	0	N/A

Recommended Action:  
 -

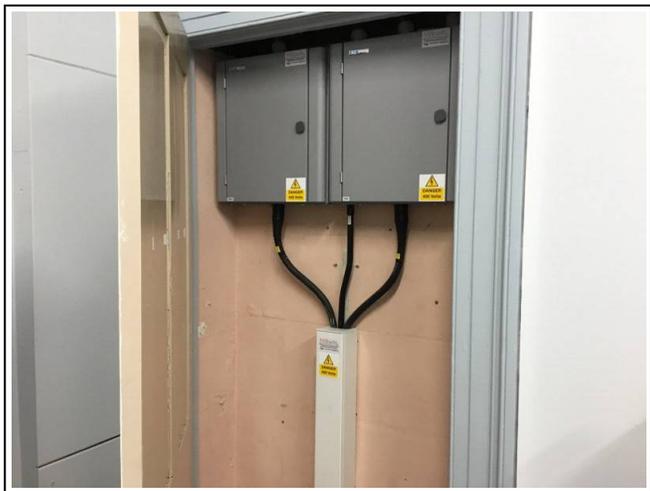
Survey Data Sheet: Conclusions & Recommendations  
 Site Location: Chippenham Town Hall, High Street, Chippenham, Wiltshire, SN15 3ER  
 Building Designation: Building 01  
 Unique item Number: 33

Sample Ref	Fl	Location	Description	Qty	Analysis Result	Total M.A.S	Licensed Material Y/N
Surveyed	Ground Floor	G.16 - Electrical Cupboard	No asbestos detected		N/A	0	N/A

Recommended Action:  
 -

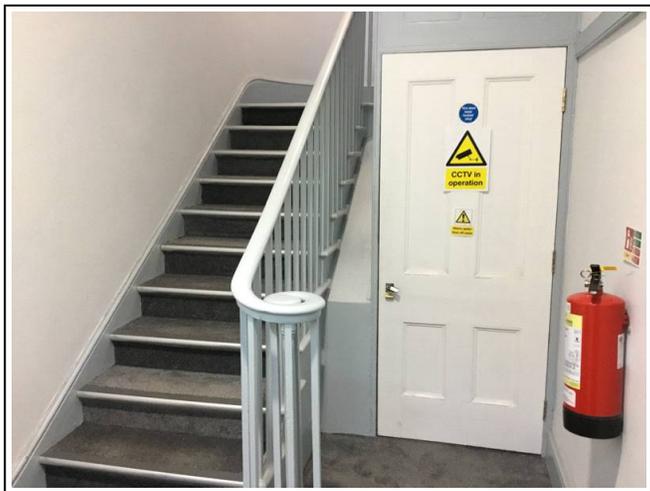
Survey Data Sheet: Conclusions & Recommendations  
 Site Location: Chippenham Town Hall, High Street, Chippenham, Wiltshire, SN15 3ER  
 Building Designation: Building 01  
 Unique item Number: 34

Sample Ref	FI	Location	Description	Qty	Analysis Result	Total M.A.S	Licensed Material Y/N
Surveyed	Ground Floor	G.17 - Entrance Lobby	No asbestos detected		N/A	0	N/A

Recommended Action:  
 -

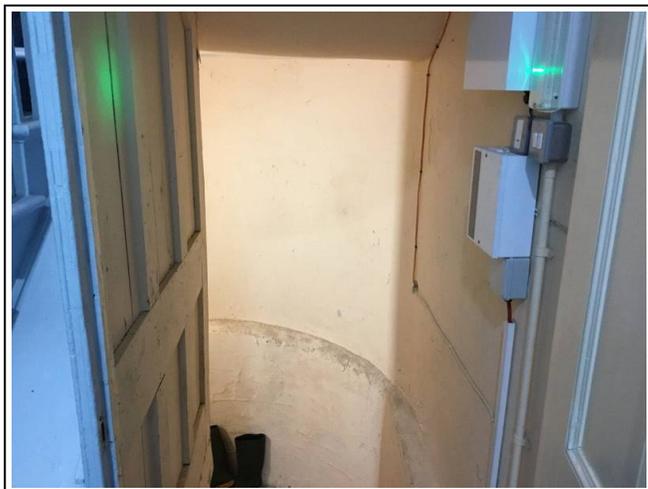
Survey Data Sheet: Conclusions & Recommendations  
 Site Location: Chippenham Town Hall, High Street, Chippenham, Wiltshire, SN15 3ER  
 Building Designation: Building 01  
 Unique item Number: 35

Sample Ref	Fl	Location	Description	Qty	Analysis Result	Total M.A.S	Licensed Material Y/N
Surveyed	Ground Floor	G.18 - Basement Stairs	No asbestos detected		N/A	0	N/A

Recommended Action:  
 -

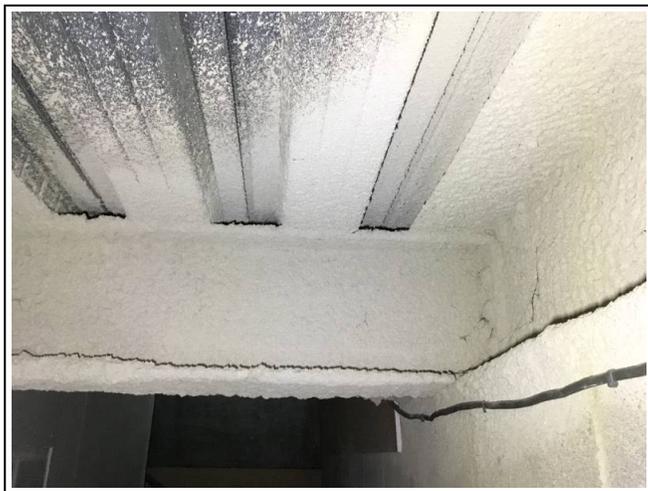
Sample Ref	FI	Location	Description	Qty	Analysis Result	Total M.A.S	Licensed Material Y/N
CT004810	Ground Floor	G.19 - Fire Escape Lobby	Steel beams - Sprayed coating - Insulation	4.5lm	NADIS	0	N/A

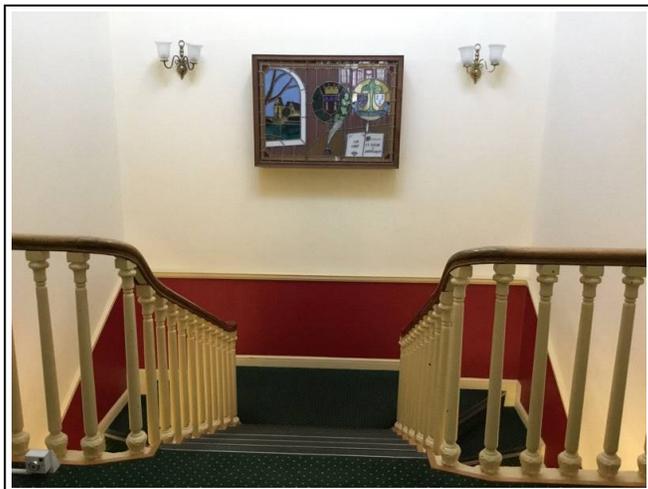
Survey Data Sheet: Conclusions & Recommendations  
 Site Location: Chippenham Town Hall, High Street, Chippenham, Wiltshire, SN15 3ER  
 Building Designation: Building 01  
 Unique item Number: 37

Sample Ref	Fl	Location	Description	Qty	Analysis Result	Total M.A.S	Licensed Material Y/N
Surveyed	1st Floor	1.01 - Landing	No asbestos detected		N/A	0	N/A

Recommended Action:  
 -

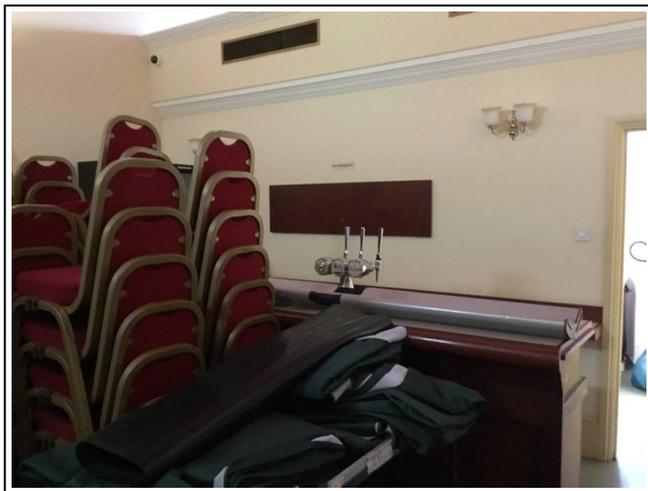
Survey Data Sheet: Conclusions & Recommendations  
 Site Location: Chippenham Town Hall, High Street, Chippenham, Wiltshire, SN15 3ER  
 Building Designation: Building 01  
 Unique item Number: 38

Sample Ref	Fl	Location	Description	Qty	Analysis Result	Total M.A.S	Licensed Material Y/N
Surveyed	1st Floor	1.02 - Bar	No asbestos detected		N/A	0	N/A

Recommended Action:  
-

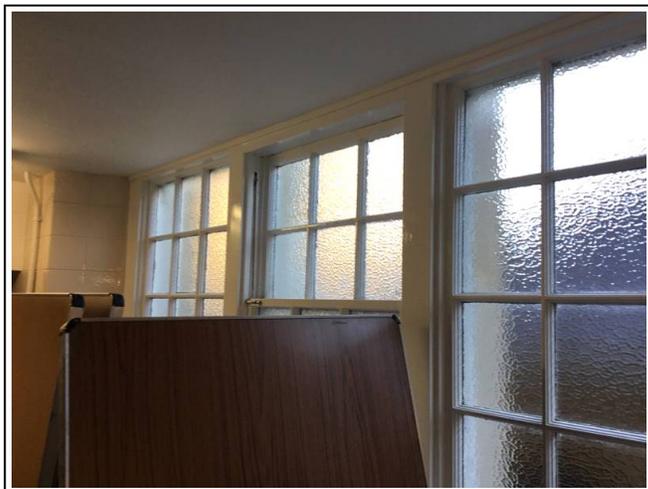
Sample Ref	Fl	Location	Description	Qty	Analysis Result	Total M.A.S	Licensed Material Y/N
REFER (CT004783)	1st Floor	1.03 - Kitchen	Sash windows - Sash cord - Textiles/Paper	2no.	NADIS	0	N/A

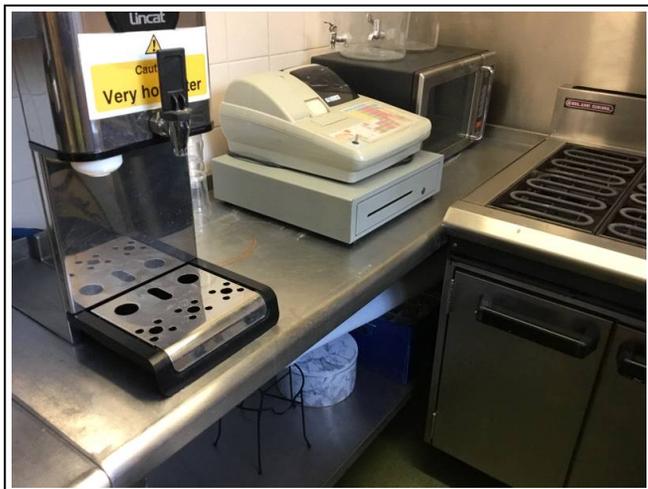
Sample Ref	Fl	Location	Description	Qty	Analysis Result	Total M.A.S	Licensed Material Y/N
CT004808	1st Floor	1.03 - Kitchen	Underside of table - Painted coating - Well Bound Material	1no.	NADIS	0	N/A

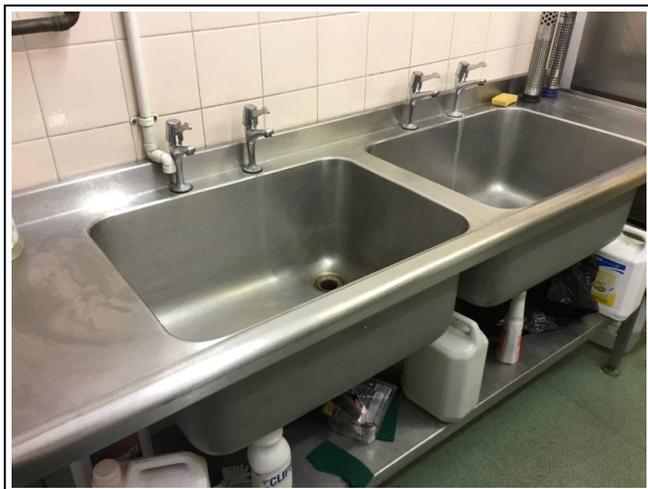
Sample Ref	Fl	Location	Description	Qty	Analysis Result	Total M.A.S	Licensed Material Y/N
CT004809	1st Floor	1.04 - Wash-up	Underside of table - Painted coating - Well Bound Material	1no.	NADIS	0	N/A

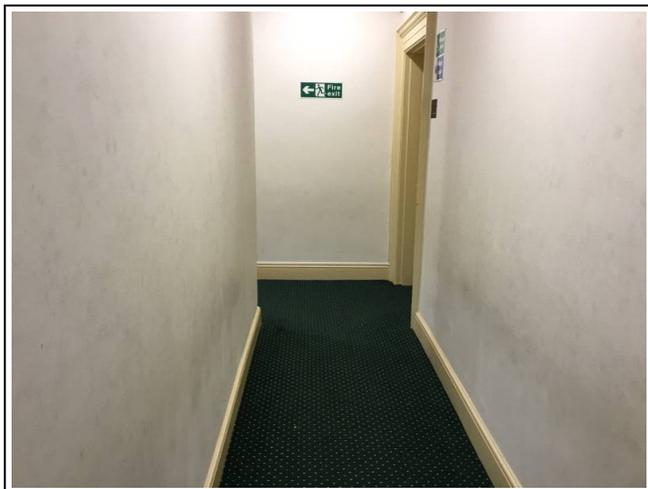
Survey Data Sheet: Conclusions & Recommendations  
 Site Location: Chippenham Town Hall, High Street, Chippenham, Wiltshire, SN15 3ER  
 Building Designation: Building 01  
 Unique item Number: 42

Sample Ref	Fl	Location	Description	Qty	Analysis Result	Total M.A.S	Licensed Material Y/N
Surveyed	1st Floor	1.05 - Corridor	No asbestos detected		N/A	0	N/A

Recommended Action:  
 -

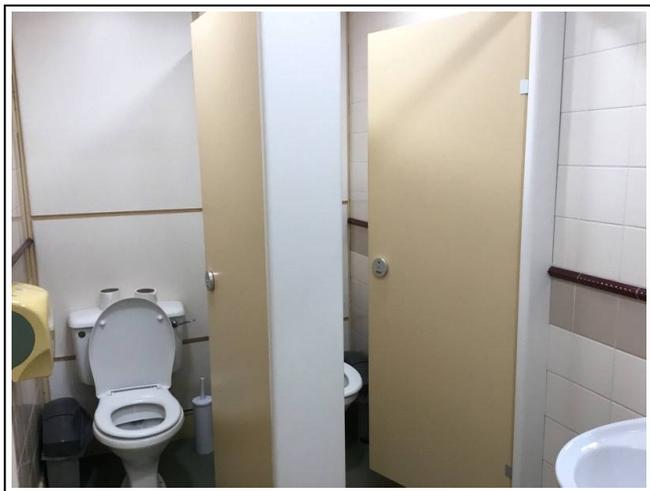
Survey Data Sheet: Conclusions & Recommendations  
 Site Location: Chippenham Town Hall, High Street, Chippenham, Wiltshire, SN15 3ER  
 Building Designation: Building 01  
 Unique item Number: 43

Sample Ref	Fl	Location	Description	Qty	Analysis Result	Total M.A.S	Licensed Material Y/N
Surveyed	1st Floor	1.06 - Female W/C	No asbestos detected		N/A	0	N/A

Recommended Action:  
 -

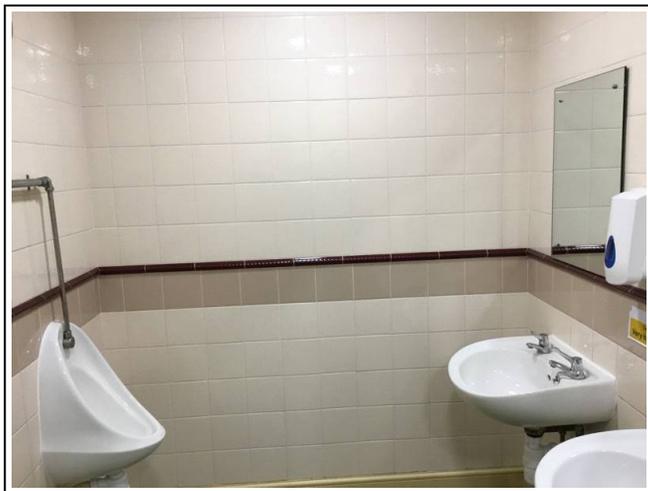
Survey Data Sheet: Conclusions & Recommendations  
 Site Location: Chippenham Town Hall, High Street, Chippenham, Wiltshire, SN15 3ER  
 Building Designation: Building 01  
 Unique item Number: 44

Sample Ref	Fl	Location	Description	Qty	Analysis Result	Total M.A.S	Licensed Material Y/N
Surveyed	1st Floor	1.07 - Male W/C	No asbestos detected		N/A	0	N/A

Recommended Action:  
 -

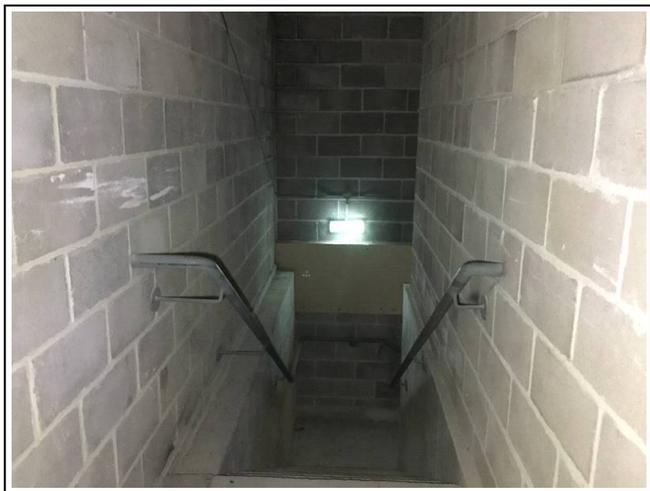
Survey Data Sheet: Conclusions & Recommendations  
 Site Location: Chippenham Town Hall, High Street, Chippenham, Wiltshire, SN15 3ER  
 Building Designation: Building 01  
 Unique item Number: 45

Sample Ref	Fl	Location	Description	Qty	Analysis Result	Total M.A.S	Licensed Material Y/N
Surveyed	1st Floor	1.08 - Fire Escape	No asbestos detected		N/A	0	N/A

Recommended Action:  
 -

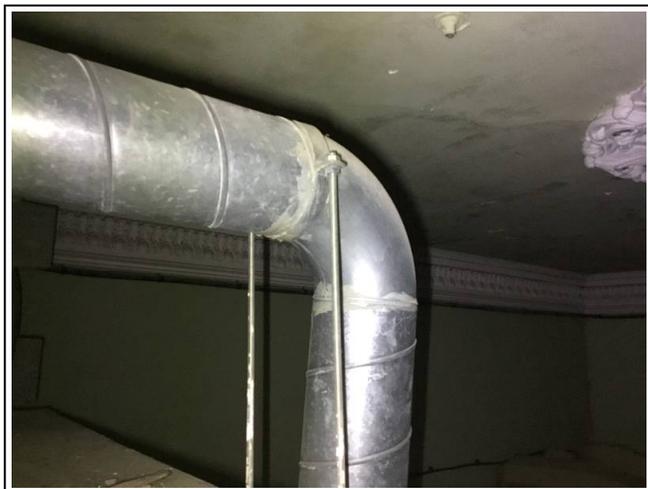
Sample Ref	Fl	Location	Description	Qty	Analysis Result	Total M.A.S	Licensed Material Y/N
REFER (CT004800)	1st Floor	Ceiling Void	Ducting joints - Mastic sealant - Well Bound Material	1Im	NADIS	0	N/A

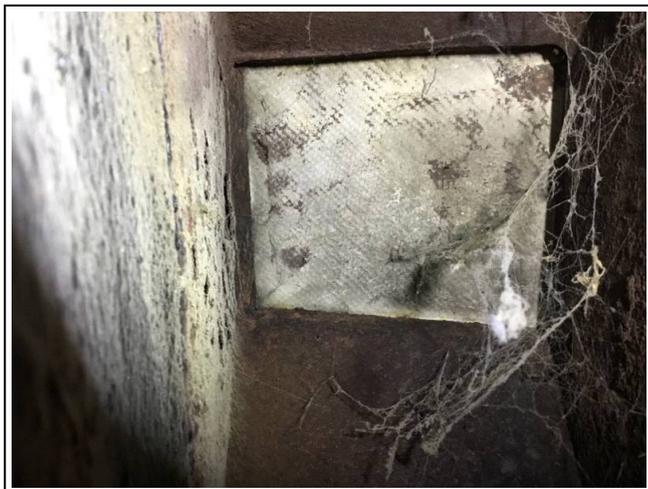
Sample Ref	Fl	Location	Description	Qty	Analysis Result	Total M.A.S	Licensed Material Y/N
Presumed	1st Floor	1.09 - Main Hall	Fireplace (West) - Soffit - Asbestos Cement	<0.25m <sup>2</sup>	Crocidolite (or unknown)	5	N

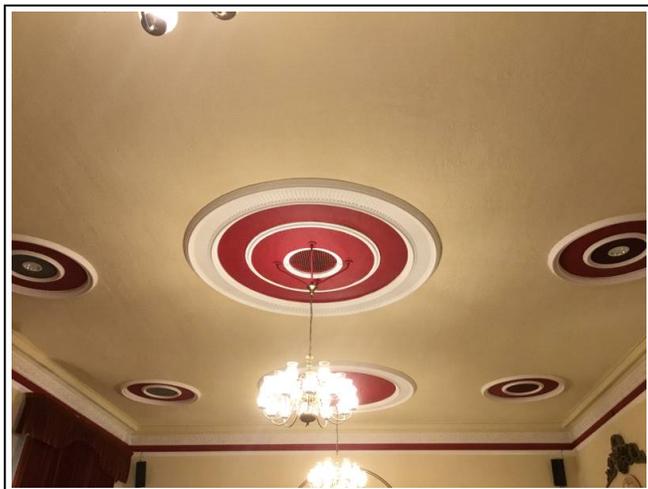
Sample Ref	Fl	Location	Description	Qty	Analysis Result	Total M.A.S	Licensed Material Y/N
CT004778	1st Floor	1.09 - Main Hall	Ceiling - Sprayed coating - Asbestos Insulation/Coating	160m <sup>2</sup>	Chrysotile	6	Y

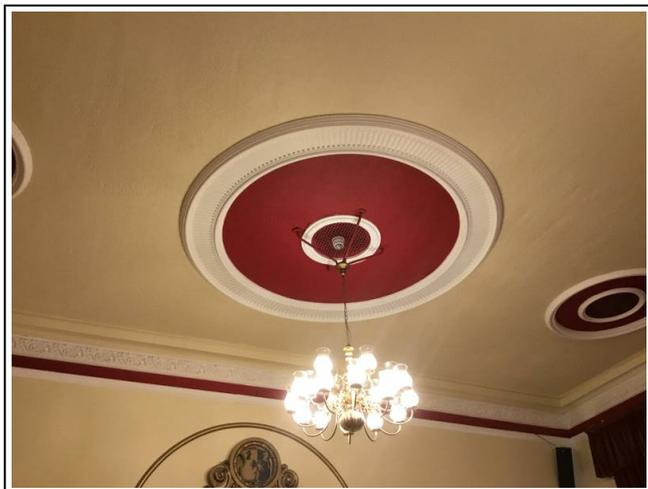
Sample Ref	Fl	Location	Description	Qty	Analysis Result	Total M.A.S	Licensed Material Y/N
CT004779	1st Floor	1.09 - Main Hall	Main ceiling light medallions - Decorative plaster moulding - Textured Coating	3no.	Chrysotile	2	N

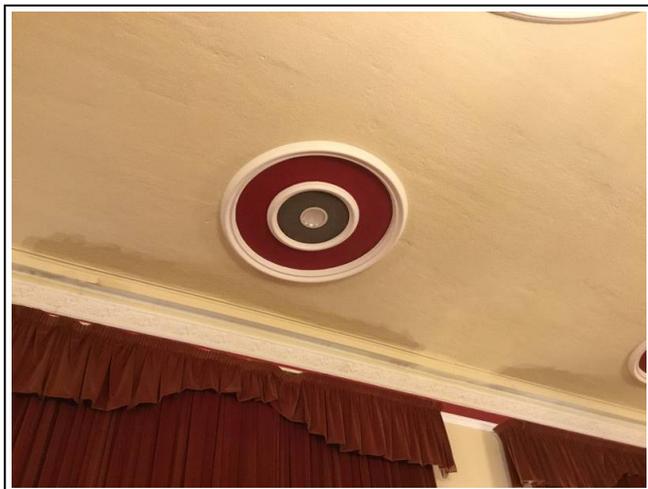
Sample Ref	Fl	Location	Description	Qty	Analysis Result	Total M.A.S	Licensed Material Y/N
CT004780	1st Floor	1.09 - Main Hall	Light & ventilation medallions - Decorative plaster moulding - Textured Coating	6	NADIS	0	N/A

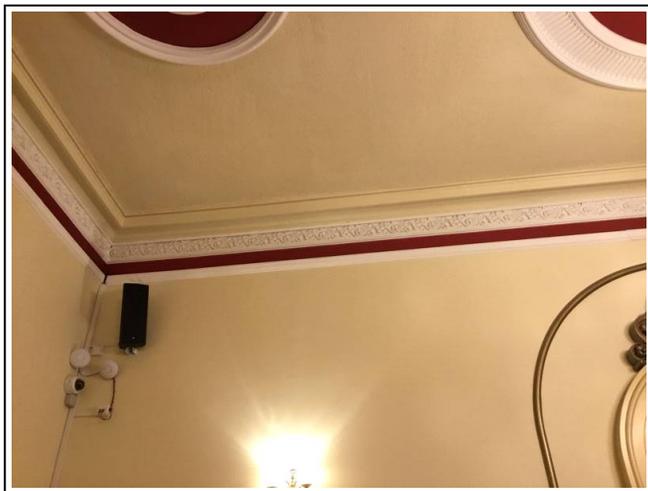
Sample Ref	Fl	Location	Description	Qty	Analysis Result	Total M.A.S	Licensed Material Y/N
CT004781	1st Floor	1.09 - Main Hall	Walls - Decorative plaster coving - Textured Coating	52lm	NADIS	0	N/A

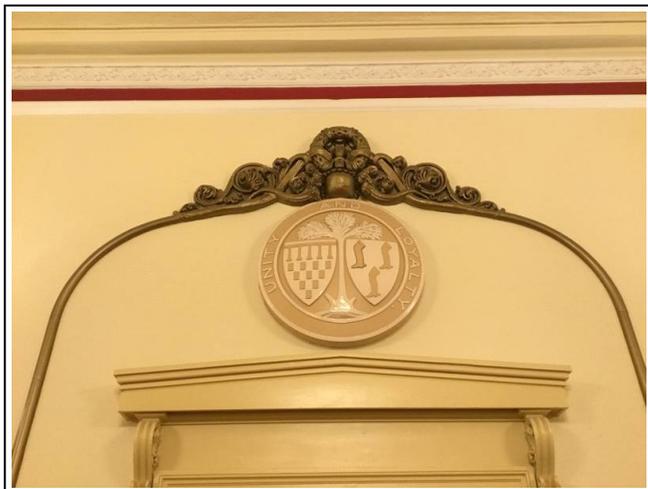
Sample Ref	Fl	Location	Description	Qty	Analysis Result	Total M.A.S	Licensed Material Y/N
CT004782	1st Floor	1.09 - Main Hall	Walls - Decorative plaster moulding - Textured Coating	5no.	NADIS	0	N/A

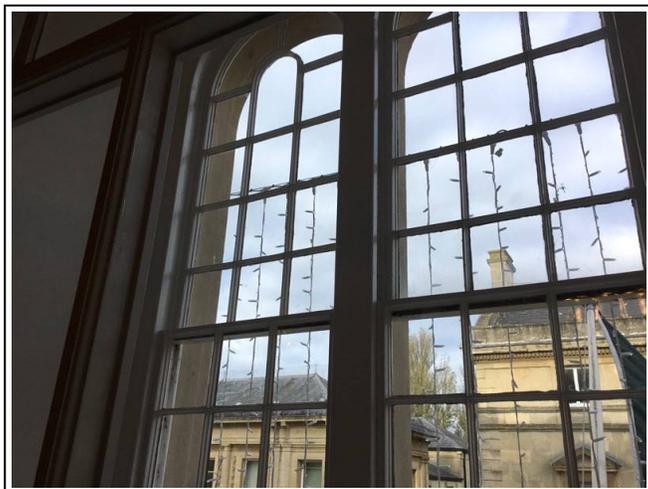
Sample Ref	Fl	Location	Description	Qty	Analysis Result	Total M.A.S	Licensed Material Y/N
CT004783	1st Floor	1.09 - Main Hall	Sash windows - Sash cord - Textiles/Paper	6no.	NADIS	0	N/A

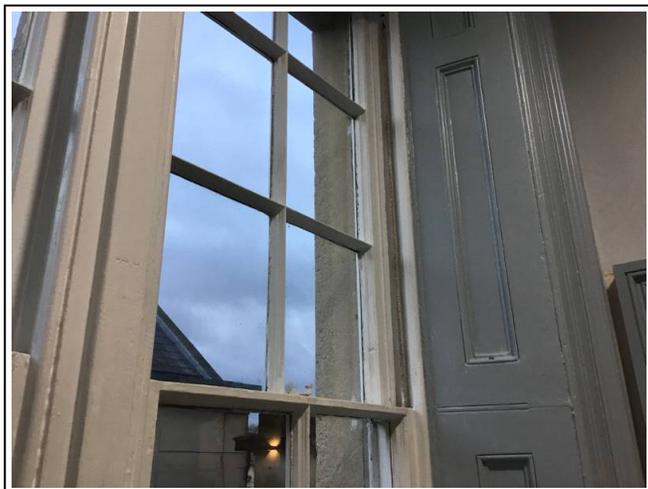
Survey Data Sheet: Conclusions & Recommendations  
 Site Location: Chippenham Town Hall, High Street, Chippenham, Wiltshire, SN15 3ER  
 Building Designation: Building 01  
 Unique item Number: 54

Sample Ref	Fl	Location	Description	Qty	Analysis Result	Total M.A.S	Licensed Material Y/N
REFER (CT004783)	1st Floor	1.10 - Landing	Sash windows - Sash cord - Textiles/Paper	2no.	NADIS	0	N/A

Recommendations:  
 No asbestos detected in sample

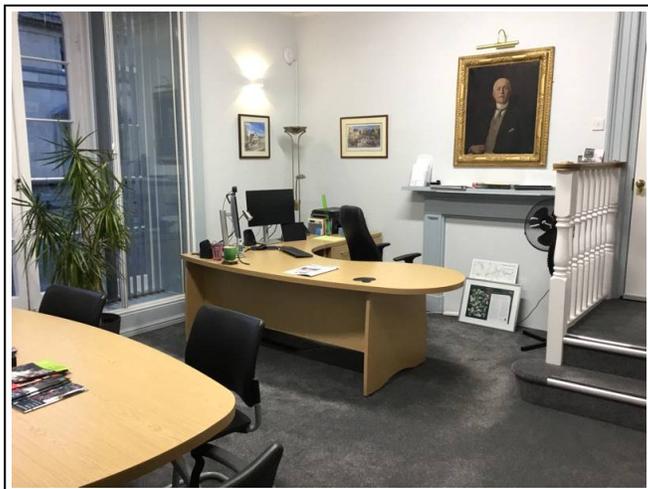
Survey Data Sheet: Conclusions & Recommendations  
 Site Location: Chippenham Town Hall, High Street, Chippenham, Wiltshire, SN15 3ER  
 Building Designation: Building 01  
 Unique item Number: 55

Sample Ref	Fl	Location	Description	Qty	Analysis Result	Total M.A.S	Licensed Material Y/N
Surveyed	1st Floor	1.11 - Office (Cheif Executive)	No asbestos detected		N/A	0	N/A

Recommended Action:  
 -

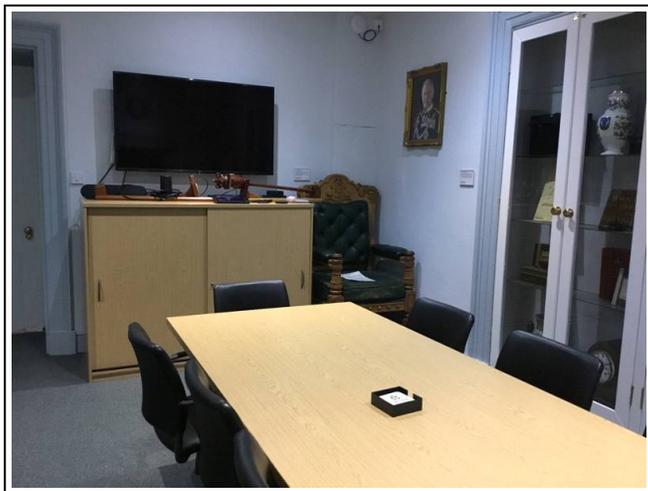
Survey Data Sheet: Conclusions & Recommendations  
 Site Location: Chippenham Town Hall, High Street, Chippenham, Wiltshire, SN15 3ER  
 Building Designation: Building 01  
 Unique item Number: 56

Sample Ref	Fl	Location	Description	Qty	Analysis Result	Total M.A.S	Licensed Material Y/N
Surveyed	1st Floor	1.12 - Office (Mayors Parlor)	No asbestos detected		N/A	0	N/A

Recommended Action:  
 -

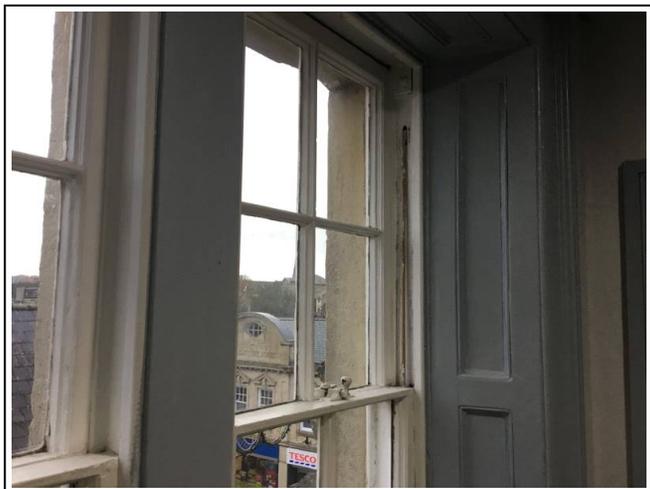
Survey Data Sheet: Conclusions & Recommendations  
 Site Location: Chippenham Town Hall, High Street, Chippenham, Wiltshire, SN15 3ER  
 Building Designation: Building 01  
 Unique item Number: 57

Sample Ref	FI	Location	Description	Qty	Analysis Result	Total M.A.S	Licensed Material Y/N
REFER (CT004783)	2nd Floor	2.01 - Landing	Sash windows - Sash cord - Textiles/Paper	2no.	NADIS	0	N/A

Recommendations:  
 No asbestos detected in sample
