# Asbestos Management Survey Report

Chippenham Town Hall, High Street, Chippenham, Wiltshire, SN15 3ER

Date of Survey:	18 Nov 2025 to 7 Dec 2025
Date of Report:	18 Dec 2025
<u>Job No:</u>	<u>J012946</u>
Authorising Surveyor:	Jim Hook
Verified/Signature:

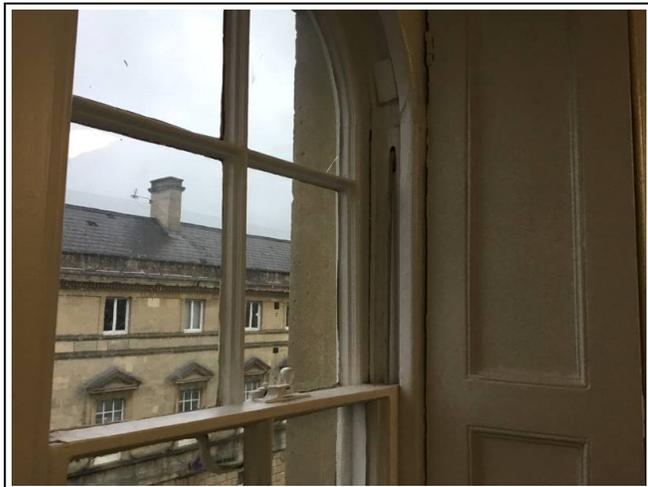
Survey Data Sheet: Conclusions & Recommendations  
 Site Location: Chippenham Town Hall, High Street, Chippenham, Wiltshire, SN15 3ER  
 Building Designation: Building 01  
 Unique item Number: 58

Sample Ref	Fl	Location	Description	Qty	Analysis Result	Total M.A.S	Licensed Material Y/N
REFER (CT004783)	2nd Floor	2.02 - Office (Finance)	Sash windows - Sash cord - Textiles/Paper	2no.	NADIS	0	N/A

Recommendations:  
 No asbestos detected in sample

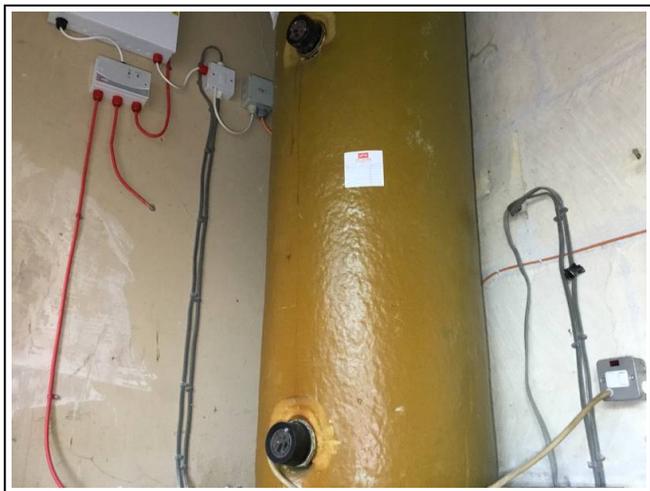
Sample Ref	Fl	Location	Description	Qty	Analysis Result	Total M.A.S	Licensed Material Y/N
CT004807	2nd Floor	2.04 - Store	Side of Cylinder - Gasket - Asbestos Textiles/Paper	2no.	Chrysotile	4	N

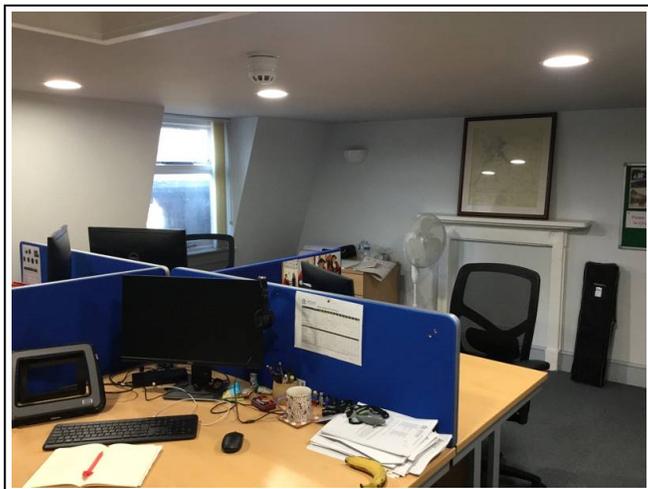
Survey Data Sheet: Conclusions & Recommendations  
 Site Location: Chippenham Town Hall, High Street, Chippenham, Wiltshire, SN15 3ER  
 Building Designation: Building 01  
 Unique item Number: 62

Sample Ref	Fl	Location	Description	Qty	Analysis Result	Total M.A.S	Licensed Material Y/N
Surveyed	3rd Floor	3.02 - Office (Democratic Services)	No asbestos detected		N/A	0	N/A

Recommended Action:  
 -

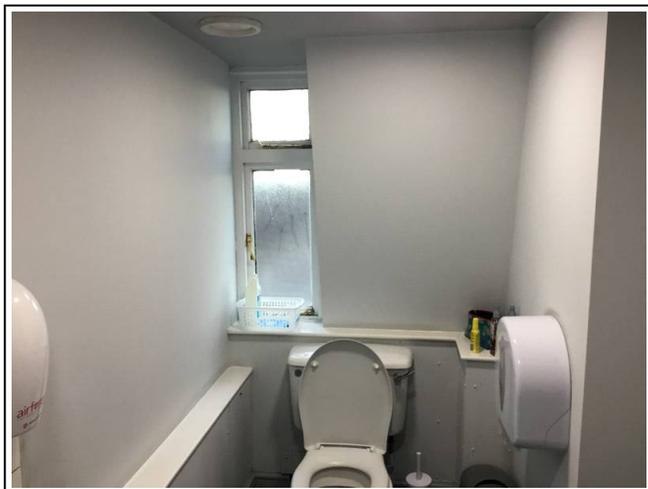
Survey Data Sheet: Conclusions & Recommendations  
 Site Location: Chippenham Town Hall, High Street, Chippenham, Wiltshire, SN15 3ER  
 Building Designation: Building 01  
 Unique item Number: 64

Sample Ref	Fl	Location	Description	Qty	Analysis Result	Total M.A.S	Licensed Material Y/N
Surveyed	3rd Floor	3.04 - W/C	No asbestos detected		N/A	0	N/A

Recommended Action:  
 -

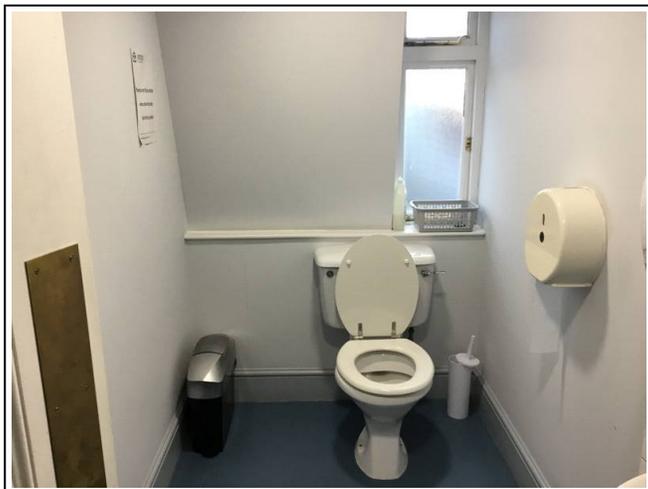
Survey Data Sheet: Conclusions & Recommendations  
 Site Location: Chippenham Town Hall, High Street, Chippenham, Wiltshire, SN15 3ER  
 Building Designation: Building 01  
 Unique item Number: 65

Sample Ref	Fl	Location	Description	Qty	Analysis Result	Total M.A.S	Licensed Material Y/N
Surveyed	3rd Floor	3.05 - W/C	No asbestos detected		N/A	0	N/A

Recommended Action:  
 -

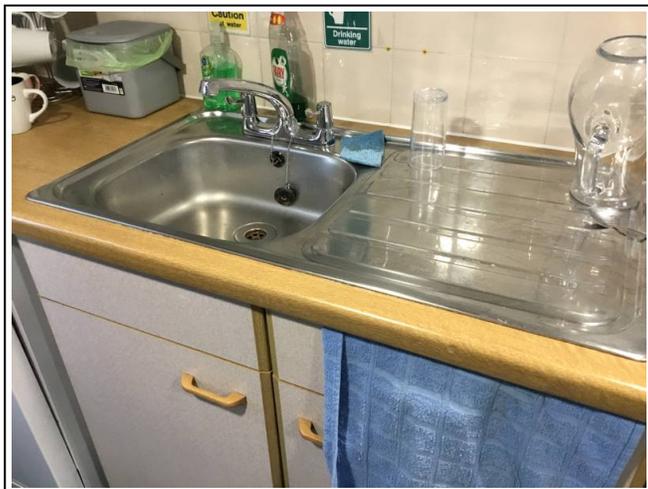
Survey Data Sheet: Conclusions & Recommendations  
 Site Location: Chippenham Town Hall, High Street, Chippenham, Wiltshire, SN15 3ER  
 Building Designation: Building 01  
 Unique item Number: 66

Sample Ref	Fl	Location	Description	Qty	Analysis Result	Total M.A.S	Licensed Material Y/N
CT004799	3rd Floor	3.06 - Kitchen	Underside of sink - Sink pad - Well Bound Material	1no.	NADIS	0	N/A

Recommended Action:  
 -

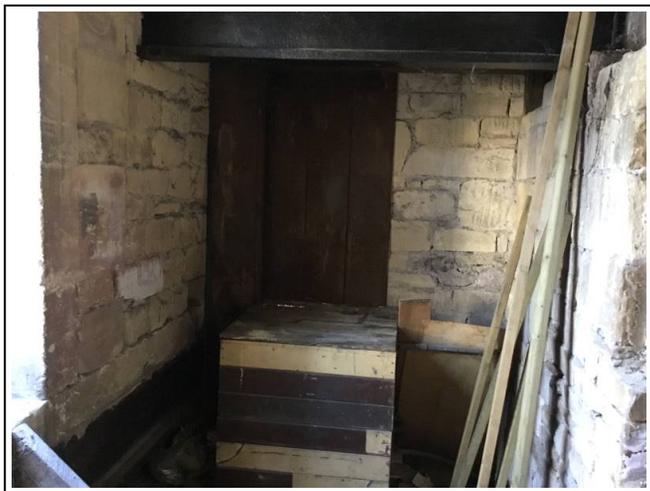
Survey Data Sheet: Conclusions & Recommendations  
 Site Location: Chippenham Town Hall, High Street, Chippenham, Wiltshire, SN15 3ER  
 Building Designation: Building 01  
 Unique item Number: 67

Sample Ref	FI	Location	Description	Qty	Analysis Result	Total M.A.S	Licensed Material Y/N
Surveyed	3rd Floor	3.07 - Roof Access	No asbestos detected		N/A	0	N/A

Recommended Action:  
-

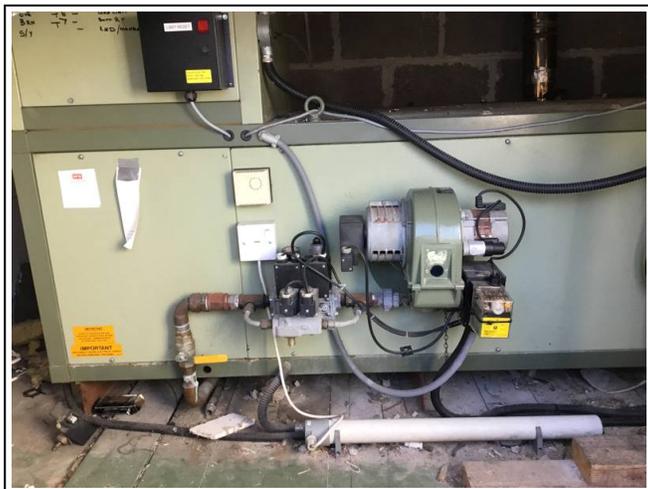
Survey Data Sheet: Conclusions & Recommendations  
 Site Location: Chippenham Town Hall, High Street, Chippenham, Wiltshire, SN15 3ER  
 Building Designation: Building 01  
 Unique item Number: 68

Sample Ref	Fl	Location	Description	Qty	Analysis Result	Total M.A.S	Licensed Material Y/N
Presumed	3rd Floor	Plant Room (Roof)	Within Powermatic heater - Gaskets - Asbestos Textiles/Paper	1no.	Chrysotile	4	N

**Recommended Action:**  
 Further investigation

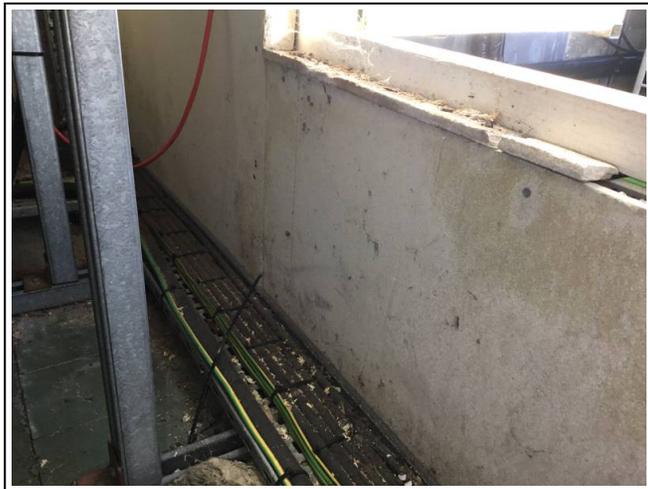
Survey Data Sheet: Conclusions & Recommendations  
 Site Location: Chippenham Town Hall, High Street, Chippenham, Wiltshire, SN15 3ER  
 Building Designation: Building 01  
 Unique item Number: 69

Sample Ref	Fl	Location	Description	Qty	Analysis Result	Total M.A.S	Licensed Material Y/N
CT004805	3rd Floor	Plant Room (Roof)	Walls - Panelling - Insulating Board	5m <sup>2</sup>	NADIS	0	N/A

Recommended Action:  
-

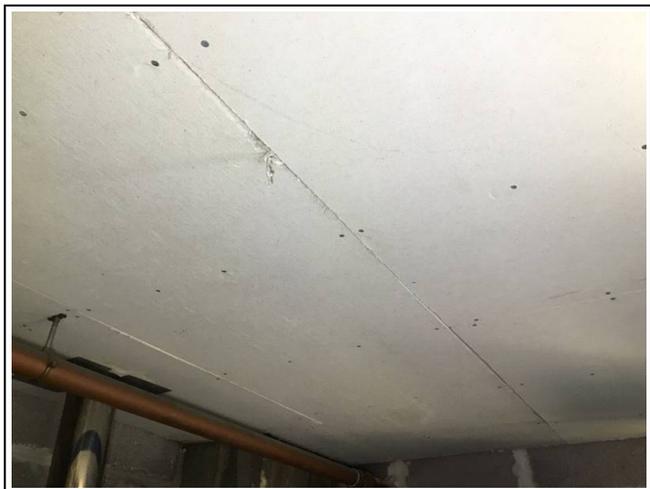
Survey Data Sheet: Conclusions & Recommendations  
 Site Location: Chippenham Town Hall, High Street, Chippenham, Wiltshire, SN15 3ER  
 Building Designation: Building 01  
 Unique item Number: 70

Sample Ref	Fl	Location	Description	Qty	Analysis Result	Total M.A.S	Licensed Material Y/N
REFER (CT004805)	3rd Floor	Plant Room (Roof)	Ceiling - Paneling - Insulating Board	6m <sup>2</sup>	NADIS	0	N/A

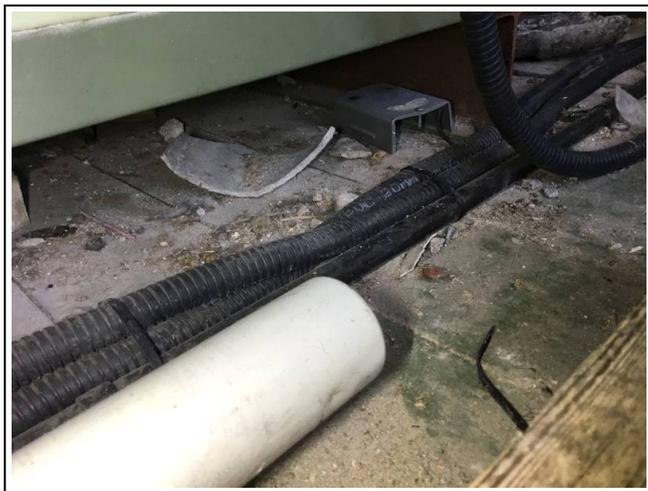
Survey Data Sheet: Conclusions & Recommendations  
 Site Location: Chippenham Town Hall, High Street, Chippenham, Wiltshire, SN15 3ER  
 Building Designation: Building 01  
 Unique item Number: 71

Sample Ref	Fl	Location	Description	Qty	Analysis Result	Total M.A.S	Licensed Material Y/N
CT004806	3rd Floor	Plant Room (Roof)	Floor - Debris - Asbestos Cement	<1m <sup>2</sup>	Chrysotile	6	N

**Recommended Action:**  
 Remove

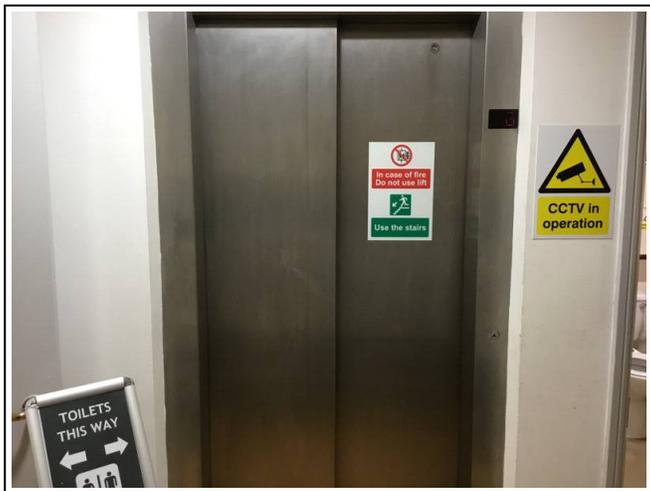
Survey Data Sheet: Conclusions & Recommendations  
 Site Location: Chippenham Town Hall, High Street, Chippenham, Wiltshire, SN15 3ER  
 Building Designation: Building 01  
 Unique item Number: 72

Sample Ref	FI	Location	Description	Qty	Analysis Result	Total M.A.S	Licensed Material Y/N
No Access	Lift Shaft	Lift Shaft	Inaccessible		No Access	0

Recommended Action:  
 -

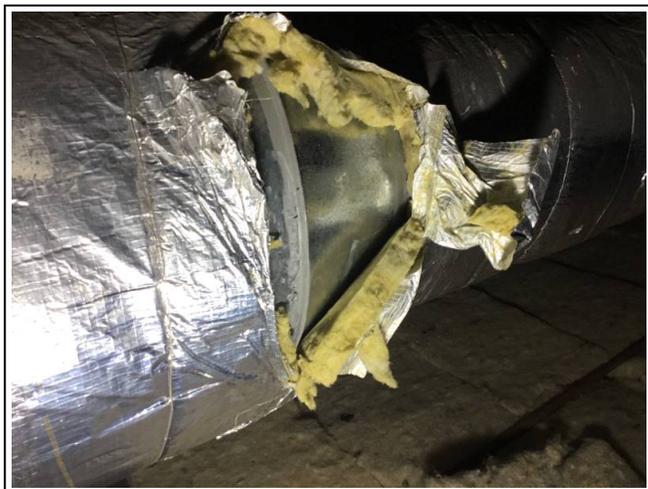
Survey Data Sheet: Conclusions & Recommendations  
 Site Location: Chippenham Town Hall, High Street, Chippenham, Wiltshire, SN15 3ER  
 Building Designation: Building 01  
 Unique item Number: 73

Sample Ref	FI	Location	Description	Qty	Analysis Result	Total M.A.S	Licensed Material Y/N
CT004801	Roof Void	Attic 01	Ducting joints - Mastic sealant (grey) - Well Bound Material	6lm	NADIS	0	N/A

Recommended Action:  
 -

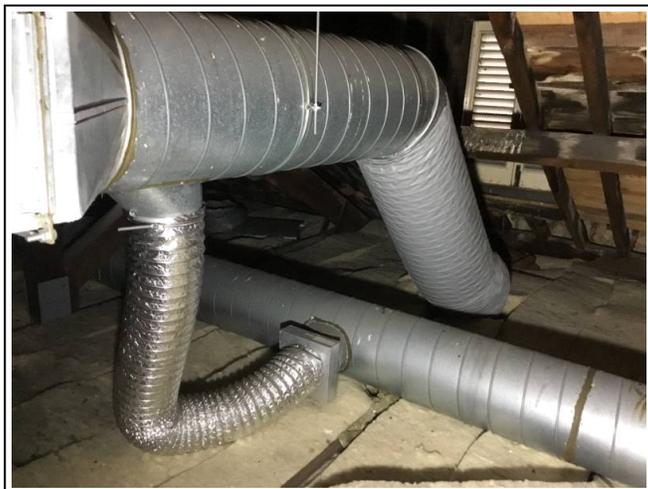
Survey Data Sheet: Conclusions & Recommendations  
 Site Location: Chippenham Town Hall, High Street, Chippenham, Wiltshire, SN15 3ER  
 Building Designation: Building 01  
 Unique item Number: 74

Sample Ref	FI	Location	Description	Qty	Analysis Result	Total M.A.S	Licensed Material Y/N
CT004802	Roof Void	Attic 01	Ducting joints - Mastic sealant (dark green) - Well Bound Material	12lm	NADIS	0	N/A

Recommended Action:  
 -

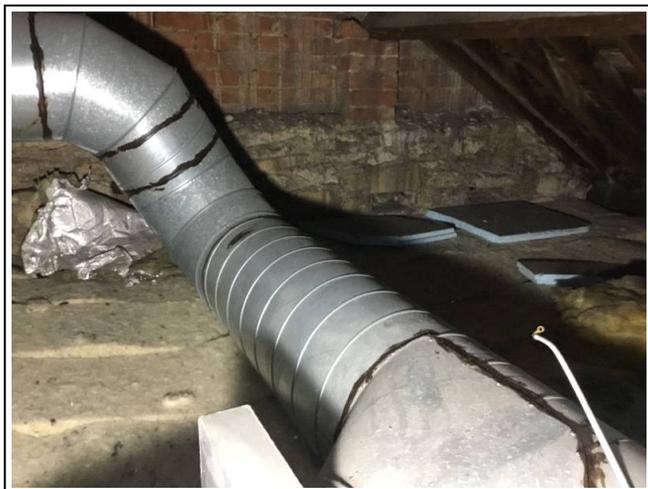
Survey Data Sheet: Conclusions & Recommendations  
 Site Location: Chippenham Town Hall, High Street, Chippenham, Wiltshire, SN15 3ER  
 Building Designation: Building 01  
 Unique item Number: 75

Sample Ref	FI	Location	Description	Qty	Analysis Result	Total M.A.S	Licensed Material Y/N
CT004803	Roof Void	Attic 01	Ducting joints - Mastic sealant (dark brown) - Well Bound Material	6lm	NADIS	0	N/A

Recommended Action:  
 -

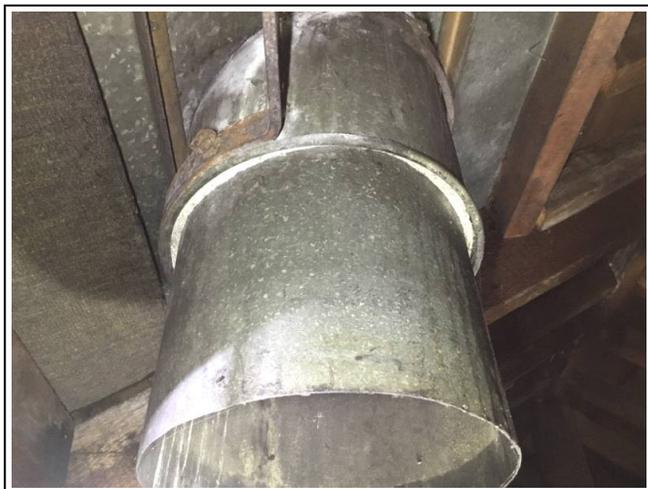
Survey Data Sheet: Conclusions & Recommendations  
 Site Location: Chippenham Town Hall, High Street, Chippenham, Wiltshire, SN15 3ER  
 Building Designation: Building 01  
 Unique item Number: 76

Sample Ref	FI	Location	Description	Qty	Analysis Result	Total M.A.S	Licensed Material Y/N
CT004804	Roof Void	Attic 01	Redundant flue pipe - Rope seal - Asbestos Textiles/Paper	1no.	Chrysotile	5	N

**Recommended Action:**  
 Leave & Manage

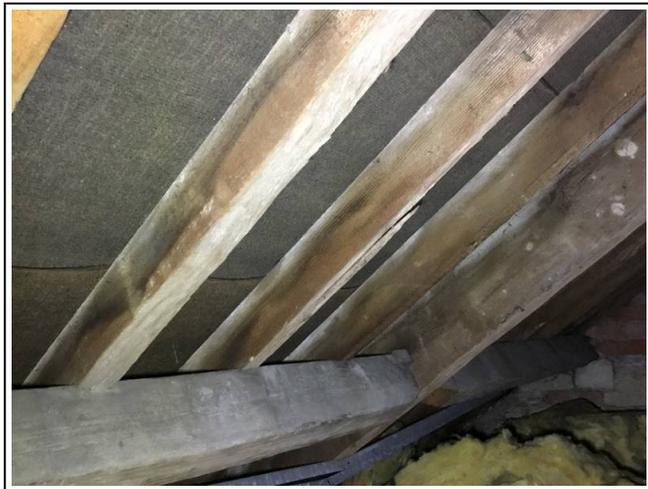
Survey Data Sheet: Conclusions & Recommendations  
 Site Location: Chippenham Town Hall, High Street, Chippenham, Wiltshire, SN15 3ER  
 Building Designation: Building 01  
 Unique item Number: 77

Sample Ref	FI	Location	Description	Qty	Analysis Result	Total M.A.S	Licensed Material Y/N
CT004798	Roof Void	Attic 02	Inner roof - Underfelt - Well Bound Material	14m <sup>2</sup>	NADIS	0	N/A

Recommended Action:  
 -

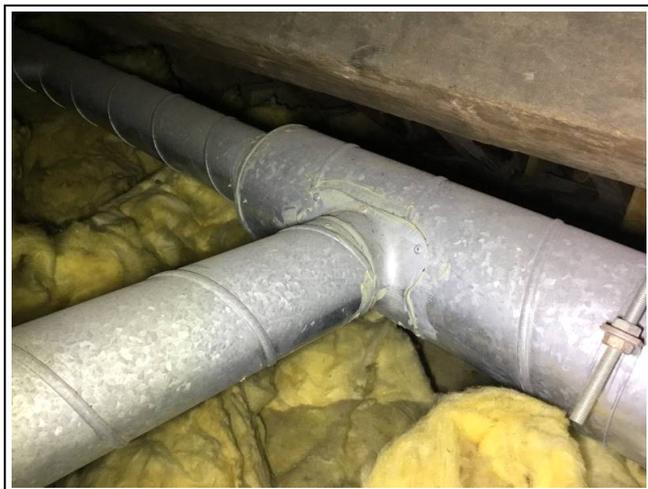
Survey Data Sheet: Conclusions & Recommendations  
 Site Location: Chippenham Town Hall, High Street, Chippenham, Wiltshire, SN15 3ER  
 Building Designation: Building 01  
 Unique item Number: 79

Sample Ref	FI	Location	Description	Qty	Analysis Result	Total M.A.S	Licensed Material Y/N
CT004800	Roof Void	Attic 03	Ducting joints - Mastic sealant - Well Bound Material	<1m	NADIS	0	N/A

Recommended Action:  
-

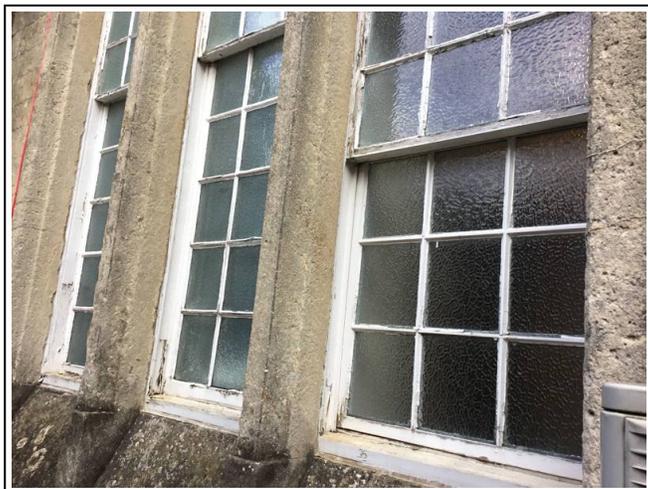
Survey Data Sheet: Conclusions & Recommendations  
 Site Location: Chippenham Town Hall, High Street, Chippenham, Wiltshire, SN15 3ER  
 Building Designation: Building 01  
 Unique item Number: 80

Sample Ref	FI	Location	Description	Qty	Analysis Result	Total M.A.S	Licensed Material Y/N
CT004789	External	External	Windows (rear of building) - Putty to glazing - Well Bound Material	80lm	NADIS	0	N/A

Recommended Action:  
 -

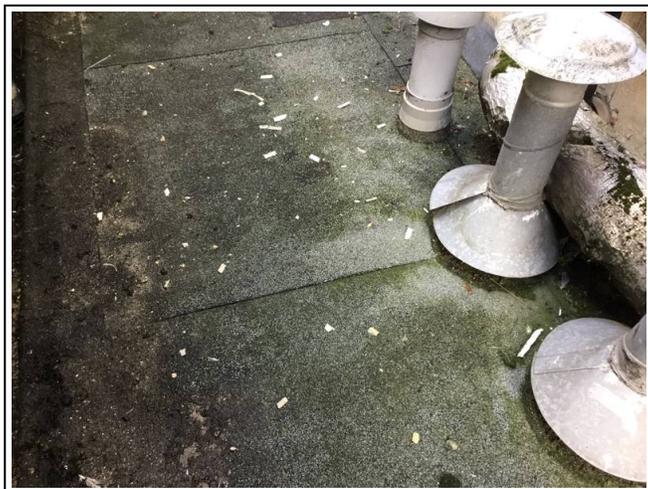
Survey Data Sheet: Conclusions & Recommendations  
 Site Location: Chippenham Town Hall, High Street, Chippenham, Wiltshire, SN15 3ER  
 Building Designation: Building 01  
 Unique item Number: 81

Sample Ref	FI	Location	Description	Qty	Analysis Result	Total M.A.S	Licensed Material Y/N
REFER (CT004789)	External	External	Flat roof area (rear of building) - Debris - Well Bound Material	2m <sup>2</sup>	NADIS	0	N/A

Recommended Action:  
 -

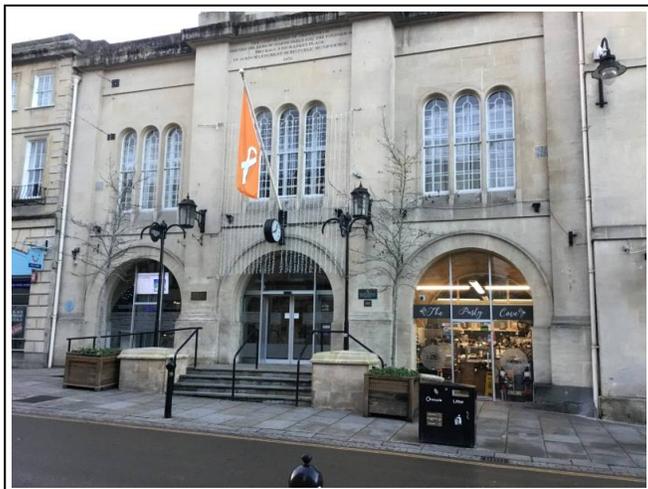
Survey Data Sheet: Conclusions & Recommendations  
 Site Location: Chippenham Town Hall, High Street, Chippenham, Wiltshire, SN15 3ER  
 Building Designation: Building 01  
 Unique item Number: 82

Sample Ref	FI	Location	Description	Qty	Analysis Result	Total M.A.S	Licensed Material Y/N
CT004790	External	External	Windows (front and side of building) - Putty to glazing - Well Bound Material	60	NADIS	0	N/A

Recommended Action:  
 -

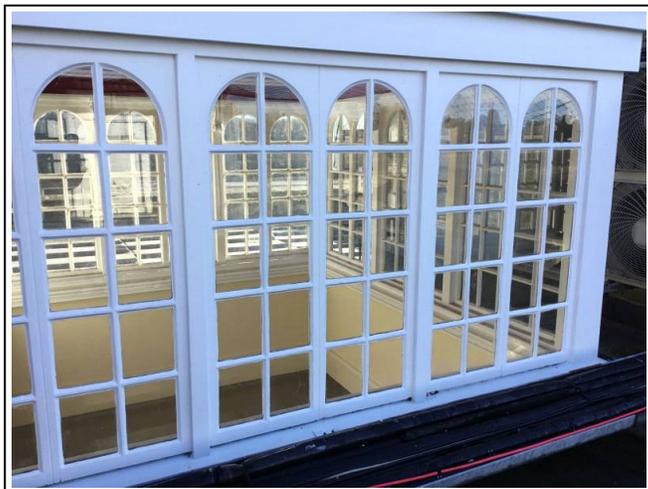
Survey Data Sheet: Conclusions & Recommendations  
 Site Location: Chippenham Town Hall, High Street, Chippenham, Wiltshire, SN15 3ER  
 Building Designation: Building 01  
 Unique item Number: 83

Sample Ref	FI	Location	Description	Qty	Analysis Result	Total M.A.S	Licensed Material Y/N
REFER (CT004790)	External	External	Roof lantern - Putty to glazing - Well Bound Material	50lm	NADIS	0	N/A

Recommended Action:  
-
