Phase 2 Ground Investigation

Boscawen Park, Malpas Road, Truro TR1 1SG

SI21757/PH2

Client	Ward Williams Associates
Project Title	Boscawen Park, Malpas Road, Truro TR1 1SG
Document Title	Phase 2 Site Investigation
Document No.	SI21757/PH2

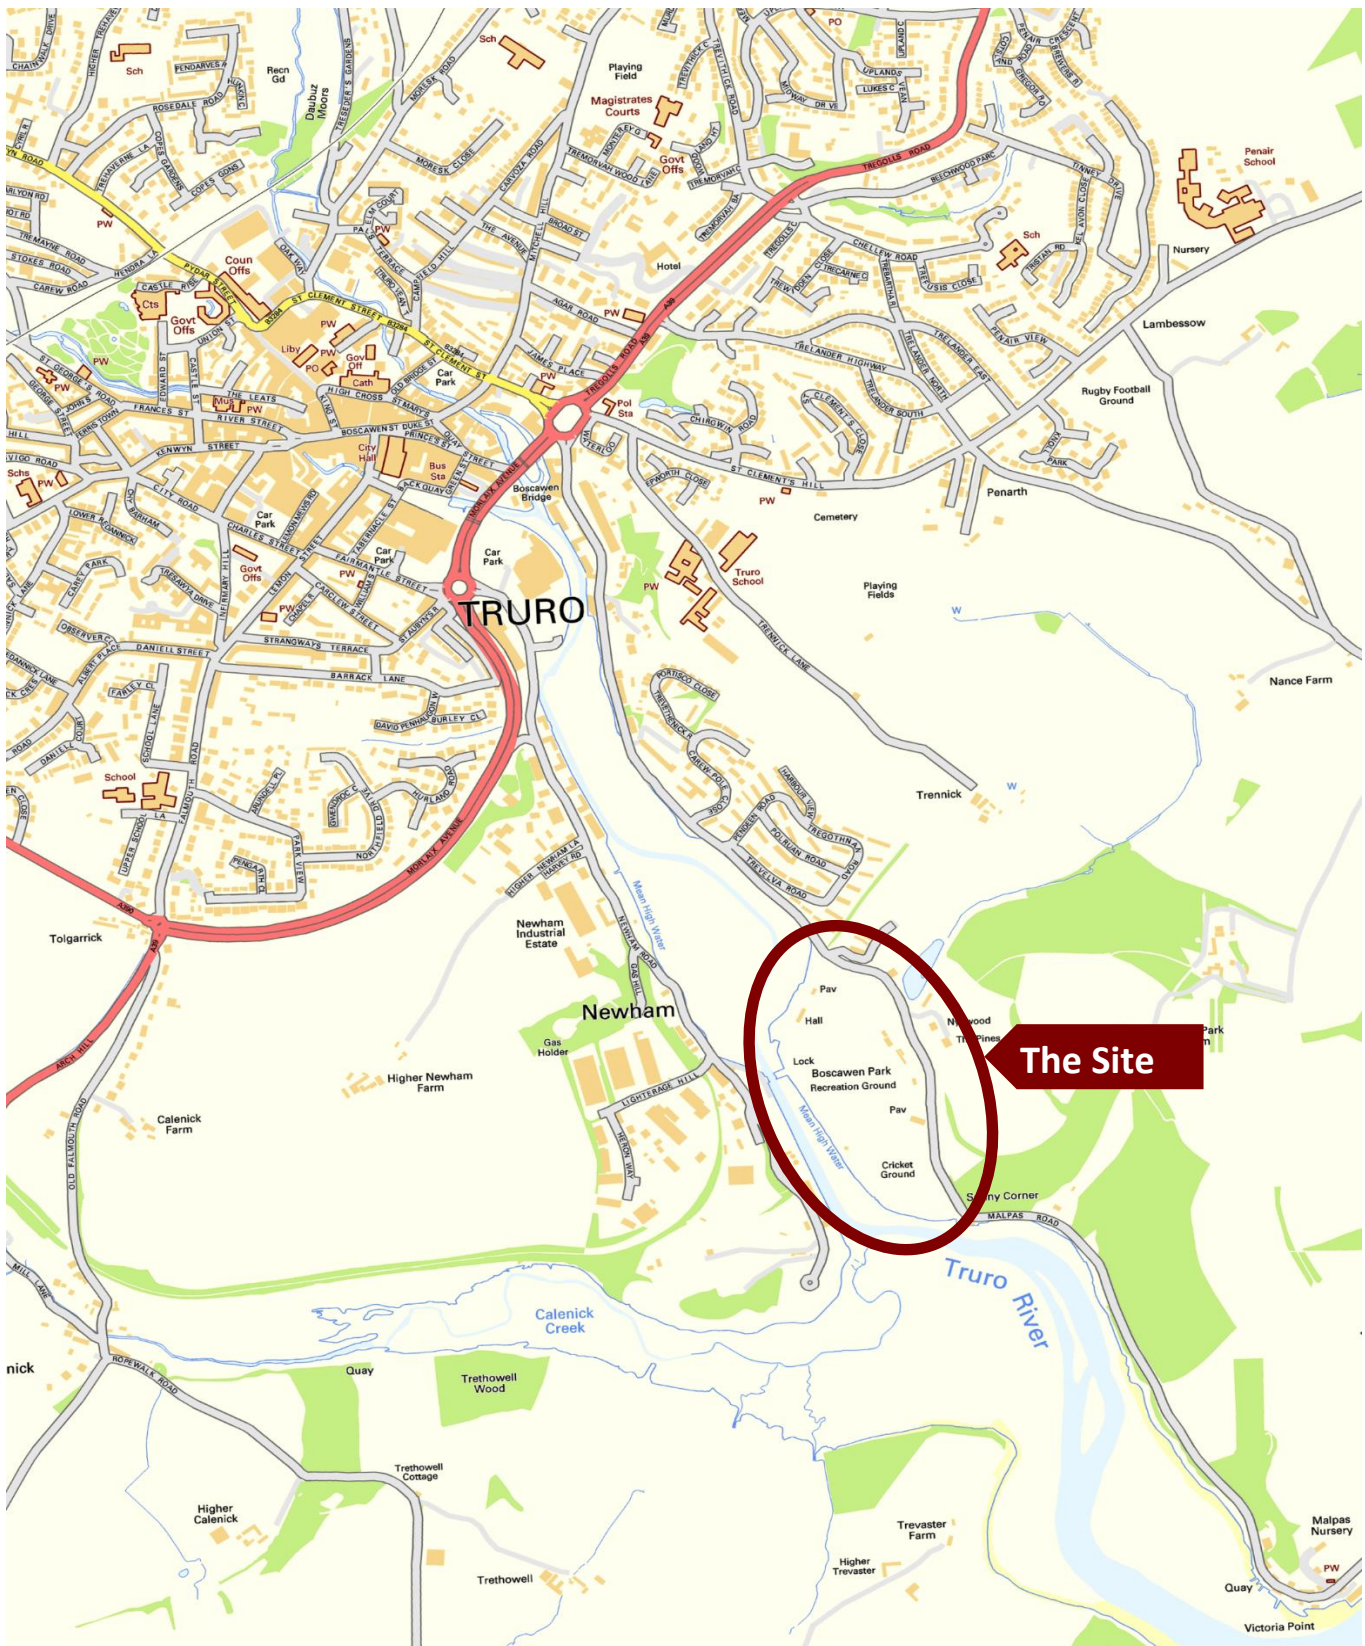
Title: **Site Location Plan**

- 2.1.1 The site is located at Malpas Road approximately 1.4 km to the southeast of the city centre of Truro. The site is approximately centred on National Grid Reference SW 8345 4358.
- 2.1.2 The site is irregular in shape and covers an area of approximately 10.8 ha.
- 2.1.3 A site location plan (SLP) is contained in Figure 2.1, to the rear of the report.
- 2.1.4 The current site plan is contained in Figure 2.2, to the rear of the report.

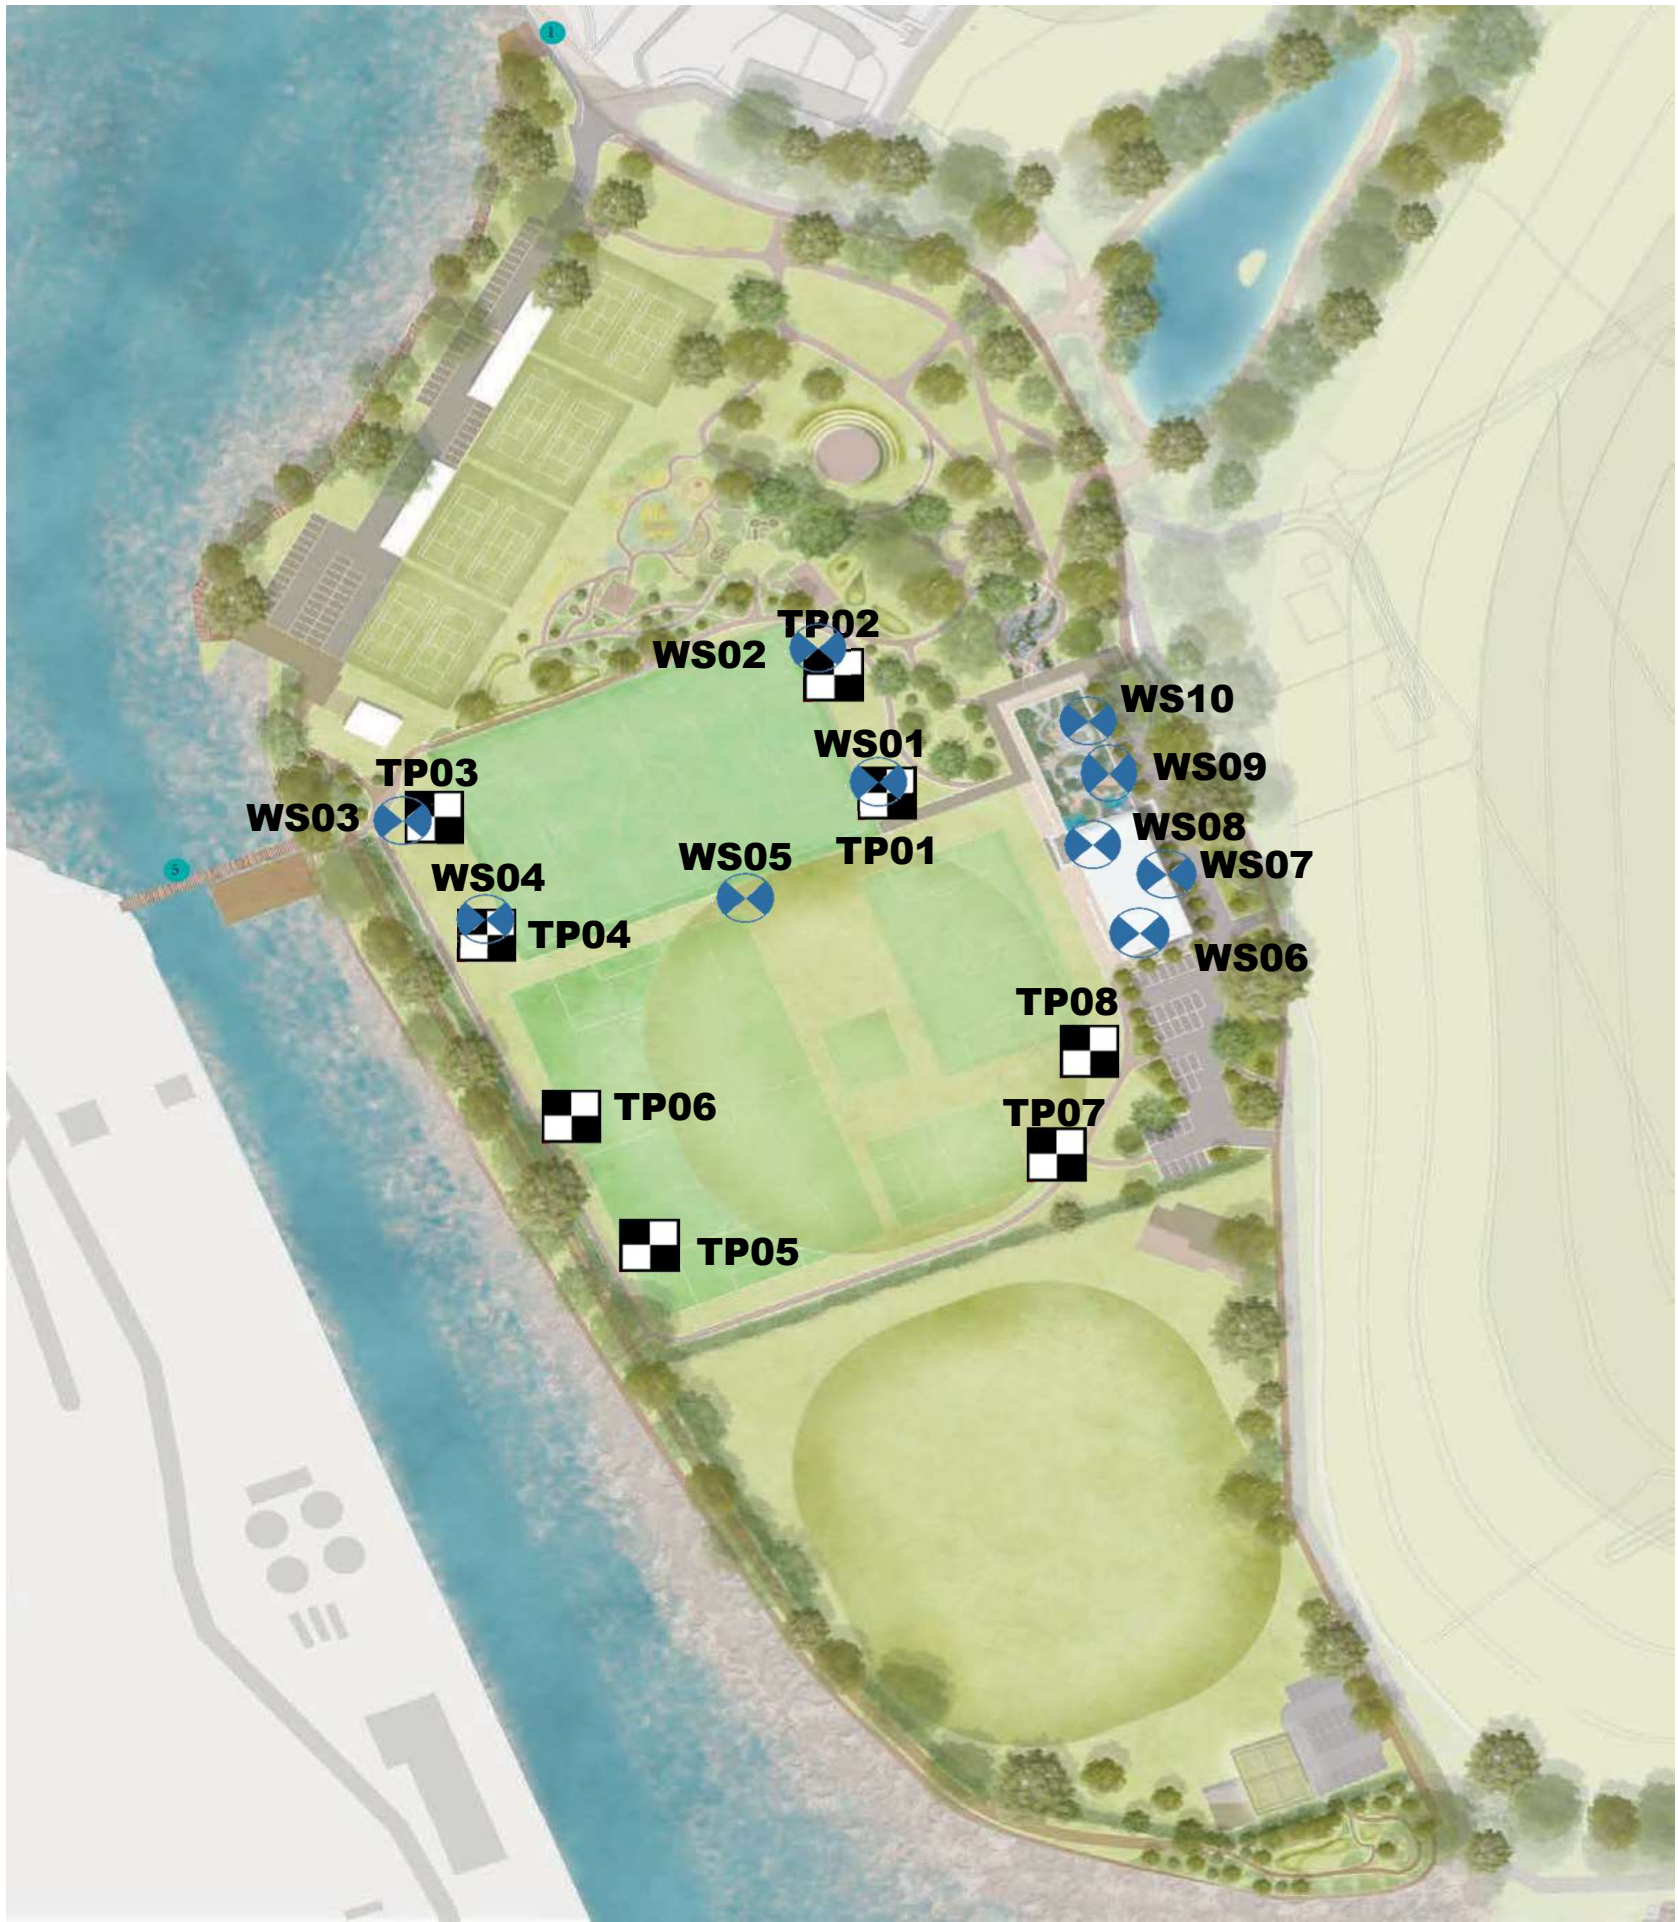
Figure: 2.3

- 2.3.1 It is proposed to develop the site with improved play areas, performance spaces, a new 3G all-weather sports pitch, water play area, and a new sports hub/café.
- 2.3.2 An indicative proposed site plan is contained in Figure 2.3, to the rear of the report.

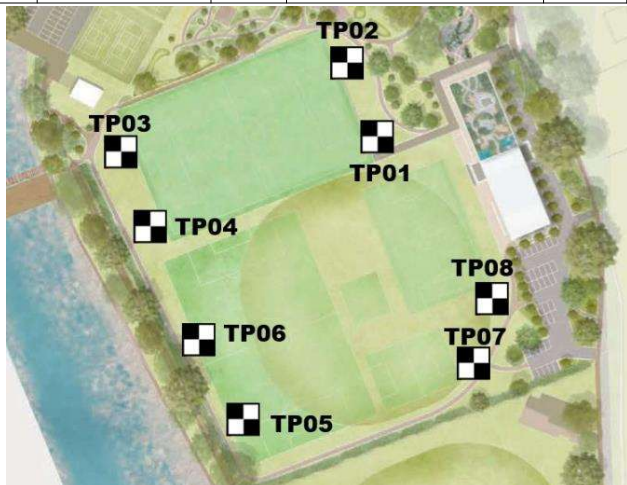
0.80	ES				(1.00)				
1.20-1.50	BS				1.20	Very soft, grey to black, slightly silty organic CLAY. Preserved roots and tree branches. Rich in organic material.

Remarks Backfilled with arisings upon completion. Sidewalls were stable, with some minor spalling. Hole complete at natural ground. Groundwater encountered at 1.30 m.			
						Scale (approx) 1:20	Logged By TG	Figure No. 21757.TP03

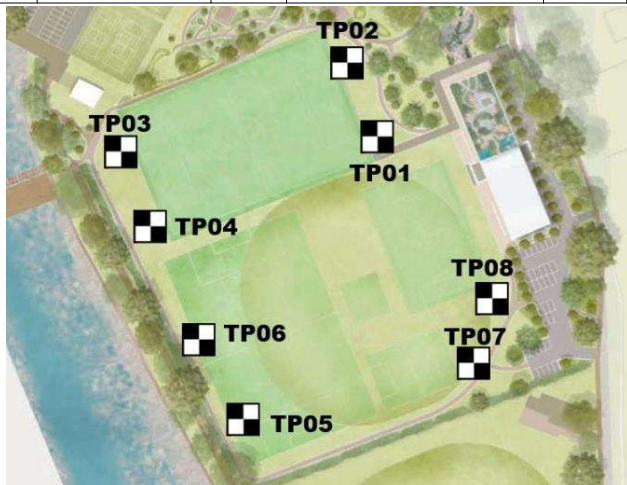
Remarks Backfilled with arisings upon completion. Sidewalls were unstable, with significant spalling of the deeper strata. Hole abandoned due to groundwater incursion, and poor sidewall stability. Groundwater encountered at 1.50 m. Significant visual and olfactory signs of contamination.		
Scale (approx)		Logged By		Figure No.	
1:20		TG		21757.TP05

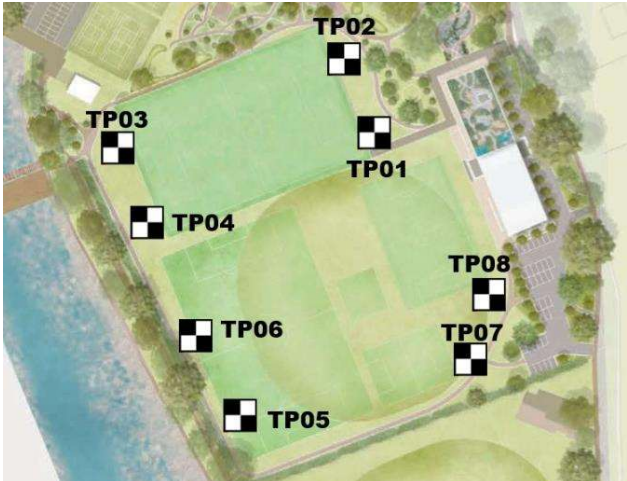
Remarks Backfilled with arisings upon completion. Sidewalls were unstable, with significant spalling of the deeper strata. Hole abandoned due to groundwater incursion, and poor sidewall stability. Groundwater encountered at 1.1 m. Significant visual and olfactory signs of contamination.		
	Scale (approx) 1:20	Logged By TG	Figure No. 21757.TP05

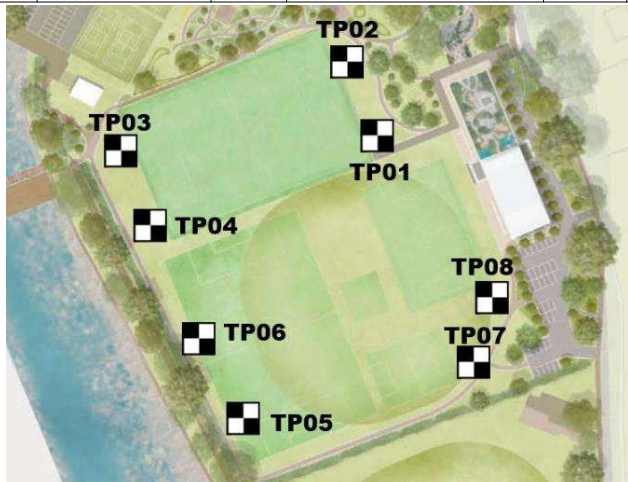
0.70	ES				0.60 (0.30)	MADE GROUND. Tarmac.			
					0.90 (0.50)	MADE GROUND. Black clayey, sandy, angular to sub-angular, fine to coarse GRAVEL of anthropogenic fill materials, including glass bottles, ceramics, and metal. Landfill waste.

Remarks Significant visual and olfactory signs of contamination. Groundwater encountered at 0.40 m. Hole abandoned due to groundwater incursion, and poor sidewall stability. Sidewalls were unstable, with significant spalling of the deeper strata. Backfilled with arisings upon completion.	
Scale (approx) 1:20			Logged By TG	Figure No. 21757.TP07

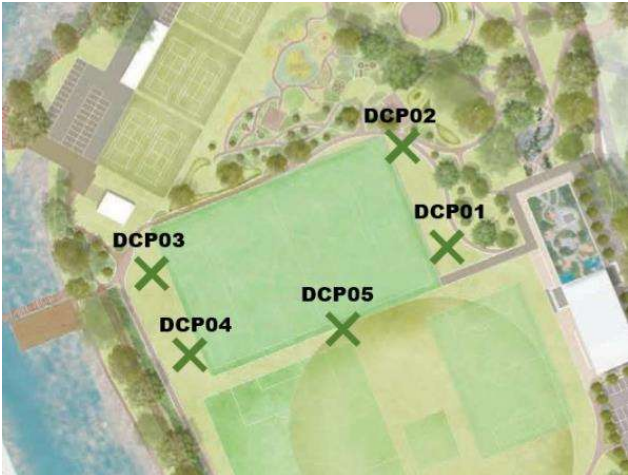
Remarks		
	Scale (approx) 1:10	Logged By	Figure No. 21757.DCP04

Depth (m)	Sample / Tests	Layer CBR % Value	CBR Value Per Blow	Level (mOD)	Depth (m) (Thickness)	Description	Legend	Water
			<div> <div>1</div> <div>10</div> <div>100</div> <div>1000</div> </div>					
		20						
		12						
		115						
						Complete at 0.81m
