Castle Walk Bridgnorth Slope Stabilisation Project

Biodiversity Net Gain Assessment Report

BRIDGNORTH TOWN COUNCIL

25 January 2025

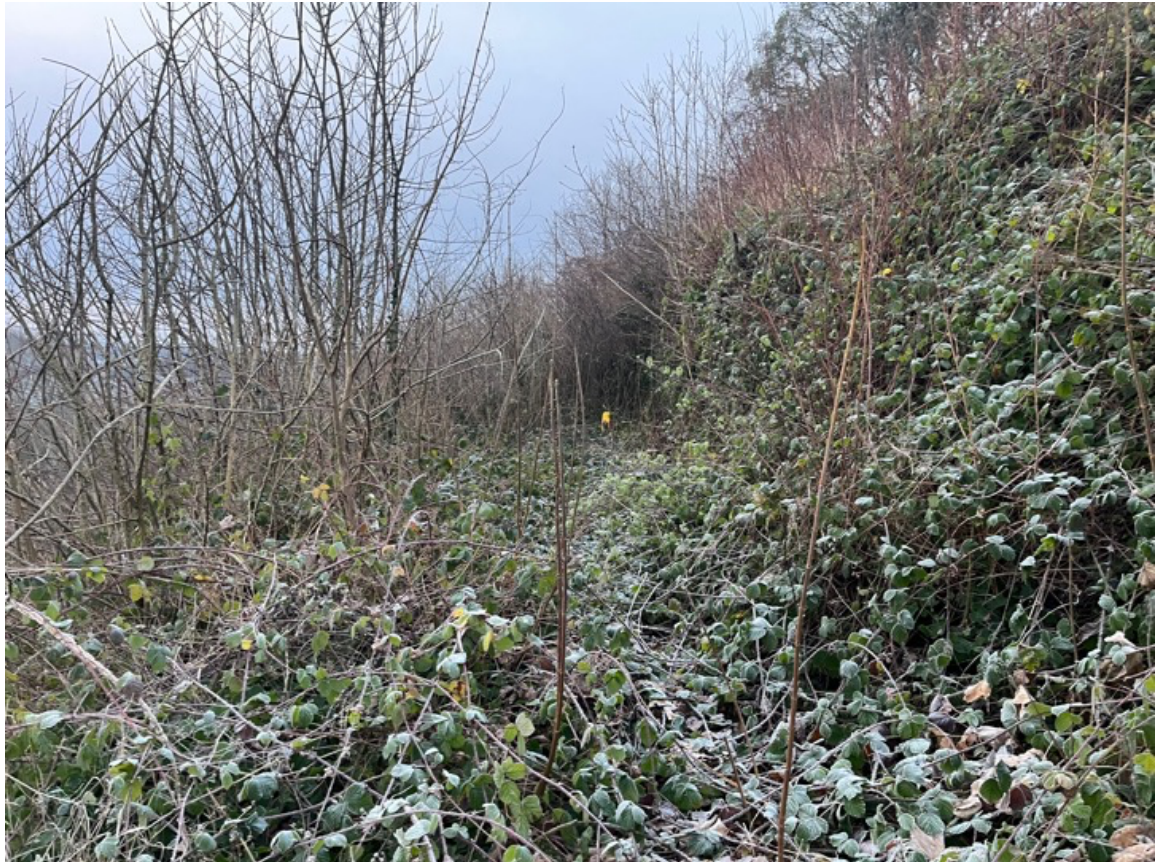
Photograph 1. Typical area of vegetation within the site

The site comprised dense bramble *Rubus fruticosus* agg. scrub and sapling trees (predominantly Sycamore *Platanus occidentalis*) (**Photograph 1**).

The site had been historically terraced with various walls present along with a single cave within the sandstone cliff face also present. Much Ivy *Hedera helix* growth was evident.

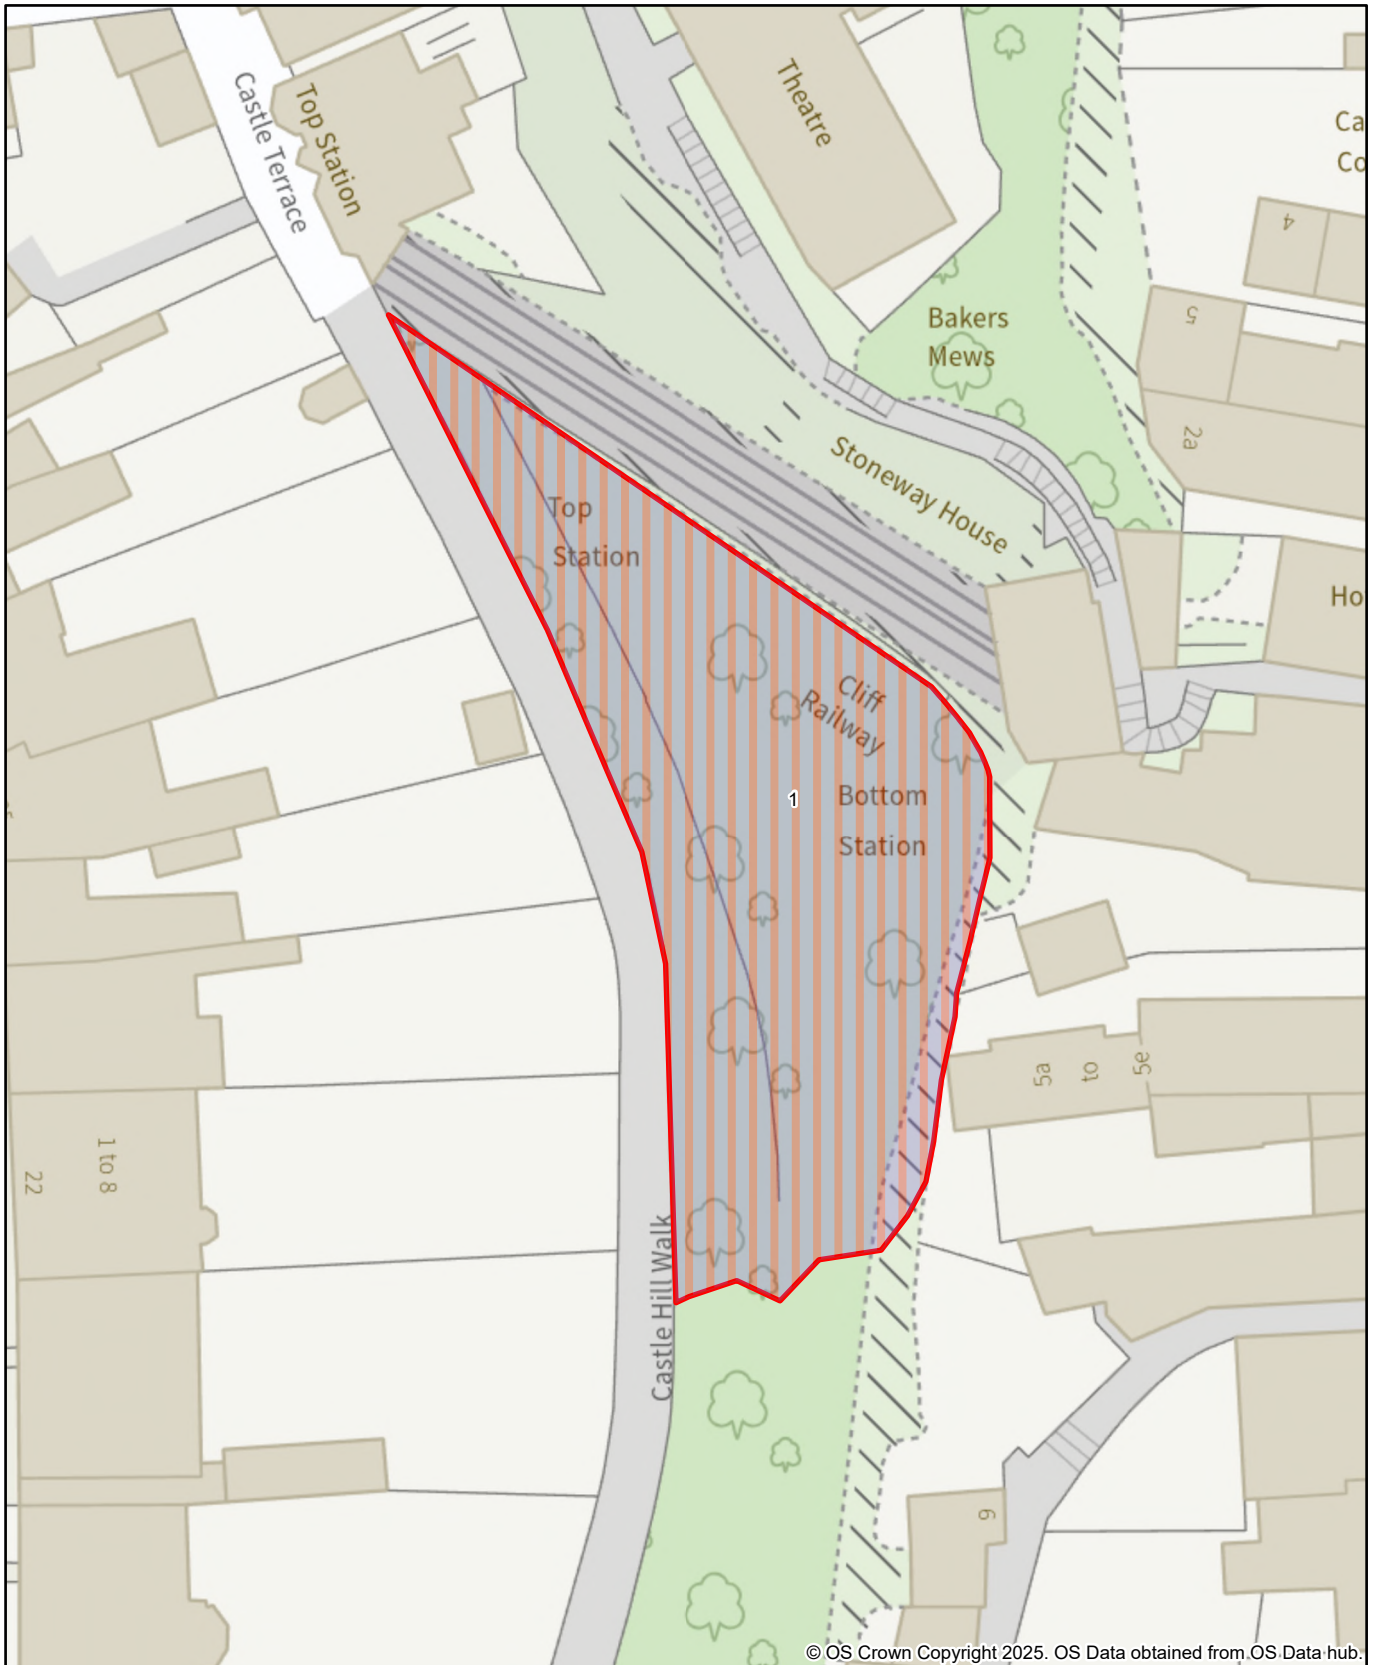
Figure 2
Baseline Habitats

Baseline area habitats on-site are shown on **Figure 2**.

| Habitat | Area (Ha) | Notes |
|---|---|--|
| UKHab: h3d – Bramble Scrub Defra Metric Definition: Heathland and scrub – Bramble Scrub Parcel/s & Condition: N/A | 1.072 | Dense bramble and sapling trees (<i>Sycamore Platanus occidentalis</i>). Prolonged maintenance has limited succession and species diversity. Infrequent <i>Buddleia Buddleja davidii</i> . |

Table 1 details the baseline area habitats present within the site with UKHab classifications and Defra Metric habitat definitions included.
