Statement Heritage

Municipal Building, The Moor, Falmouth, Cornwall, TR11 2RT

Historic Building Record, Statement of Significance and
Impact Assessment

SH Ref FALMUN0524 v1.1 Submission

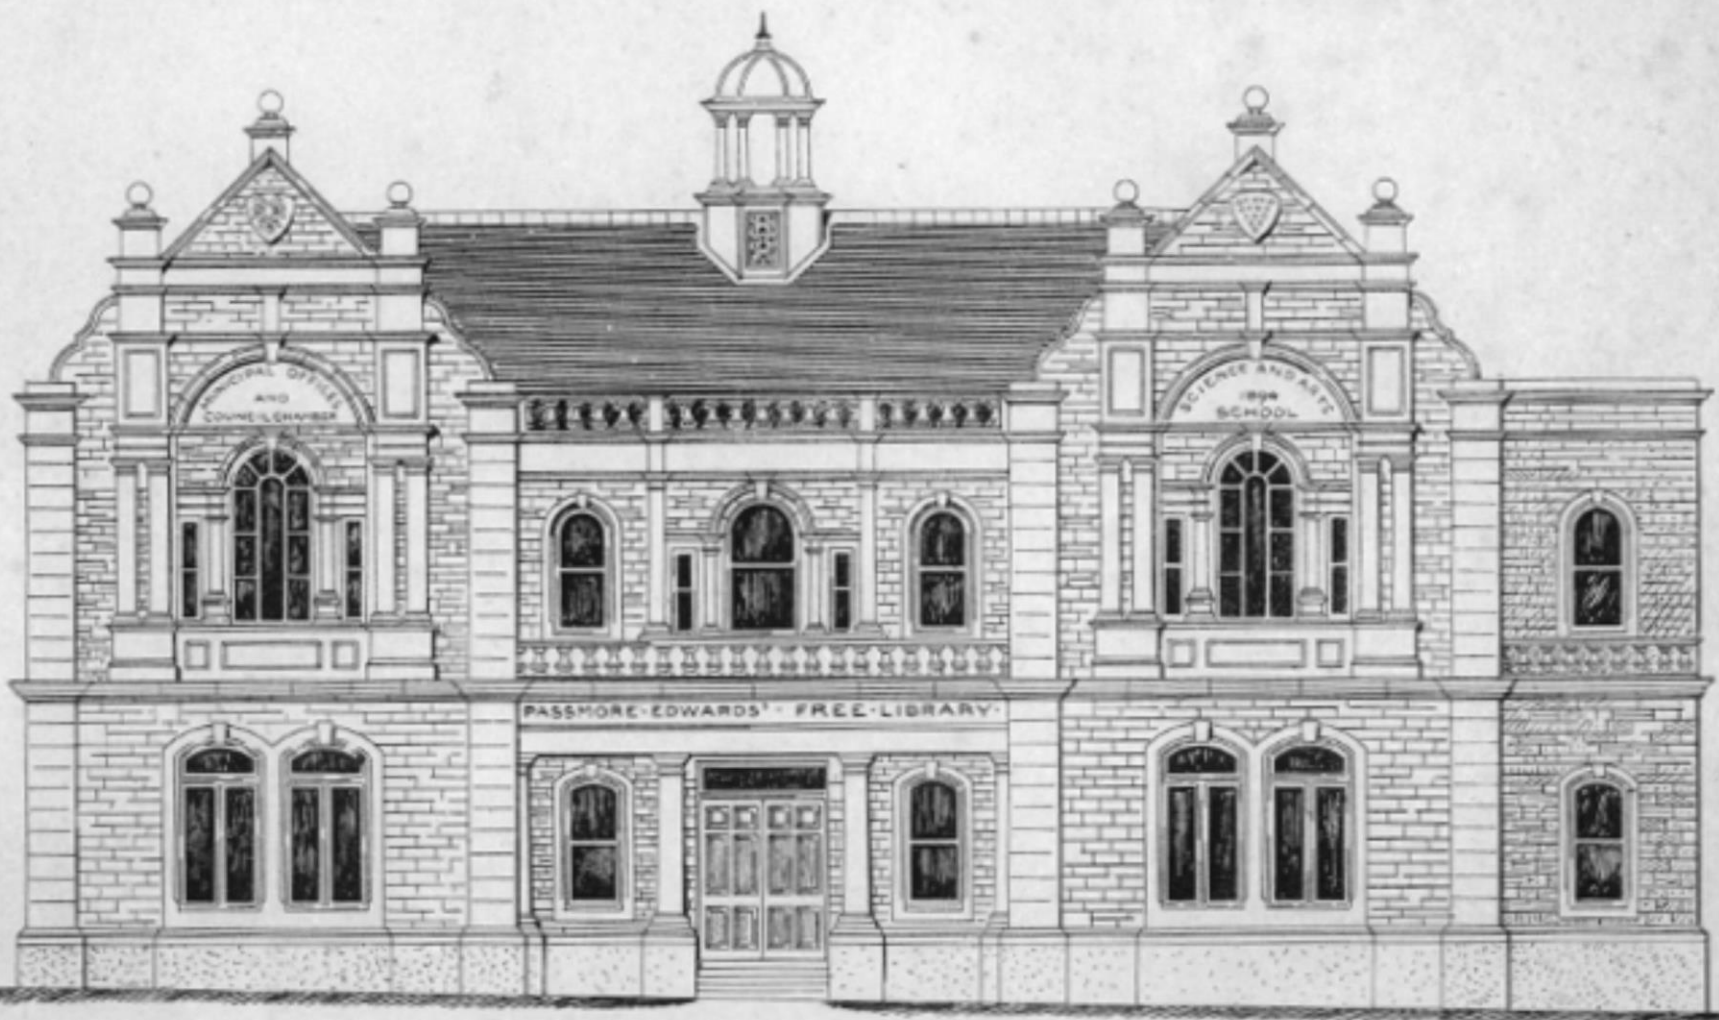
THE PASSMORE EDWARDS FREE LIBRARY.
THE MUNICIPAL OFFICES AND SCHOOL OF ART. FALMOUTH.
W.H. TRESIDDER ARCHT

- 3.16. The original plans of the building as built between 1894-1896 (construction was hampered by an exceptionally cold winter in 1894/5) are reproduced at **figure 4** (reproduced by kind permission of Falmouth Art Gallery). The building as first developed is also described in articles taken from *The Builder* and *The Echo* (London), both published by *Passmore Edwards*. The article in *The Echo* (2/5/1896) noted the design of the building by *WH Tresidder, Borough Architect* working with *Mr FJ Bellamy*, and its facing in *Plymouth Limestone* detailed with *Cornish Granite* the rest of the building being in *local stone*. The building contained *entrance hall, stair, newspaper room* (the current Main Library Hall), *lending* (now housing 'Non-Fiction') *and reference* (Non-Fiction and Catalogue Room) *libraries... above which are three commodious, well lighted rooms for technical instruction* (The Art Gallery) *for which there is a great and growing want in Falmouth*. The article notes that one wing of the building *is reserved for municipal offices with council chamber and ante room* (as surviving today, but originally with offices at ground floor level, two of which now house the Children's Library). The first floor rooms between the two main wings, directly above the vestibule are shown on the original plans as a 'Science' (presumably a laboratory) and 'Science Cloak Room'. Rooms in the northeast corner of the ground floor contained a small one bedroomed flat for a caretaker.

- The fenestration of the elevation at first floor and in the windows within the portico, matches the patterns shown on the original elevation drawing **figure 4** although there has been modification of the windows of the wings with a slight change in design. We understand from client that the first-floor windows above the portico were replaced in recent years using well detailed like-for-like replacements.

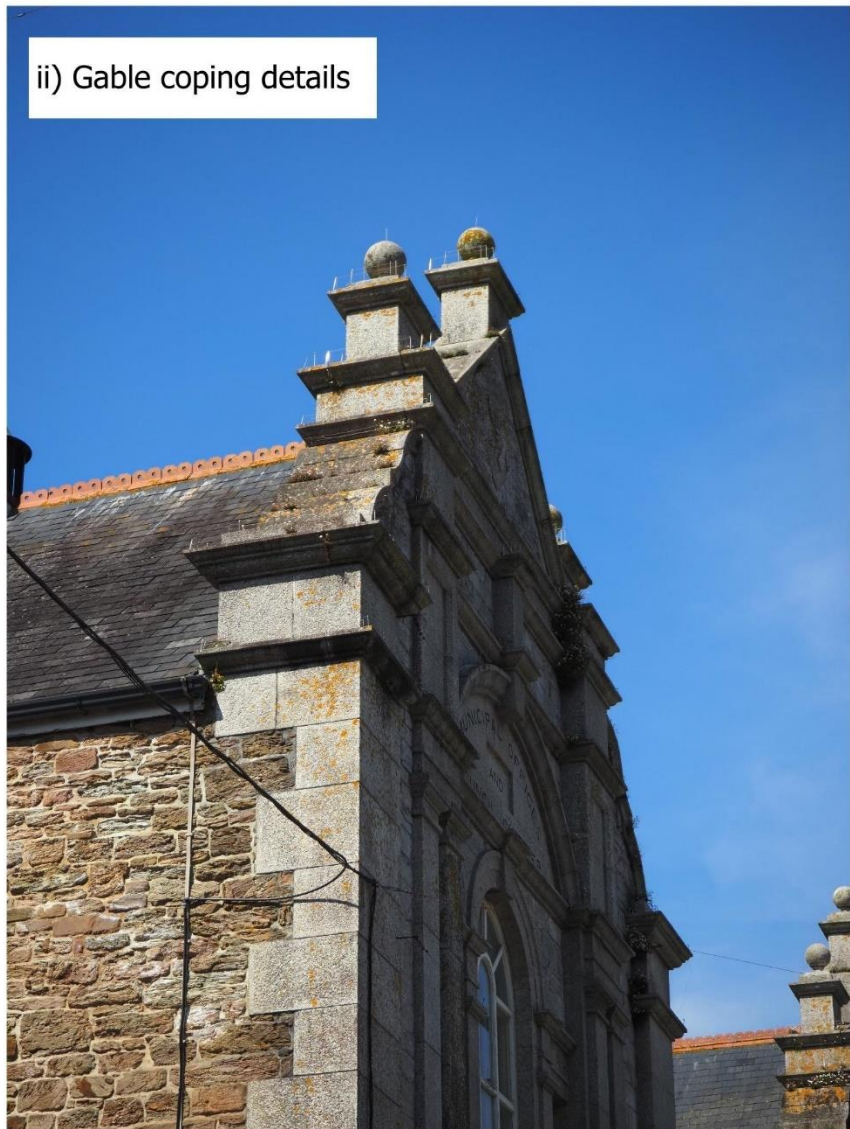
iii) String coursing cornice details

- 4.7. The southwest elevation is shown at **figure 7i**. Originally abutting the earlier *Market* (a roofline scar is visible at the lower right-hand corner of the elevation) the elevation does not share the fine stonework of the principal elevation and is instead faced in semi-coursed local killas sandstone rubble with brick dressings around the windows, which retain probably original 4 and 8 pane horned vertical sashes. The eaves steps down to the left, above the *Mayor's Parlour*, reflecting its separate roof structure and subservience to the front of the building. The roof shares the same sized natural-slate roof coverings as the principal elevations, reusing the original crested roof tiles. Two ventilation cowls relate to the internal ventilation system, shown on historic photographs and apparently of painted zinc.

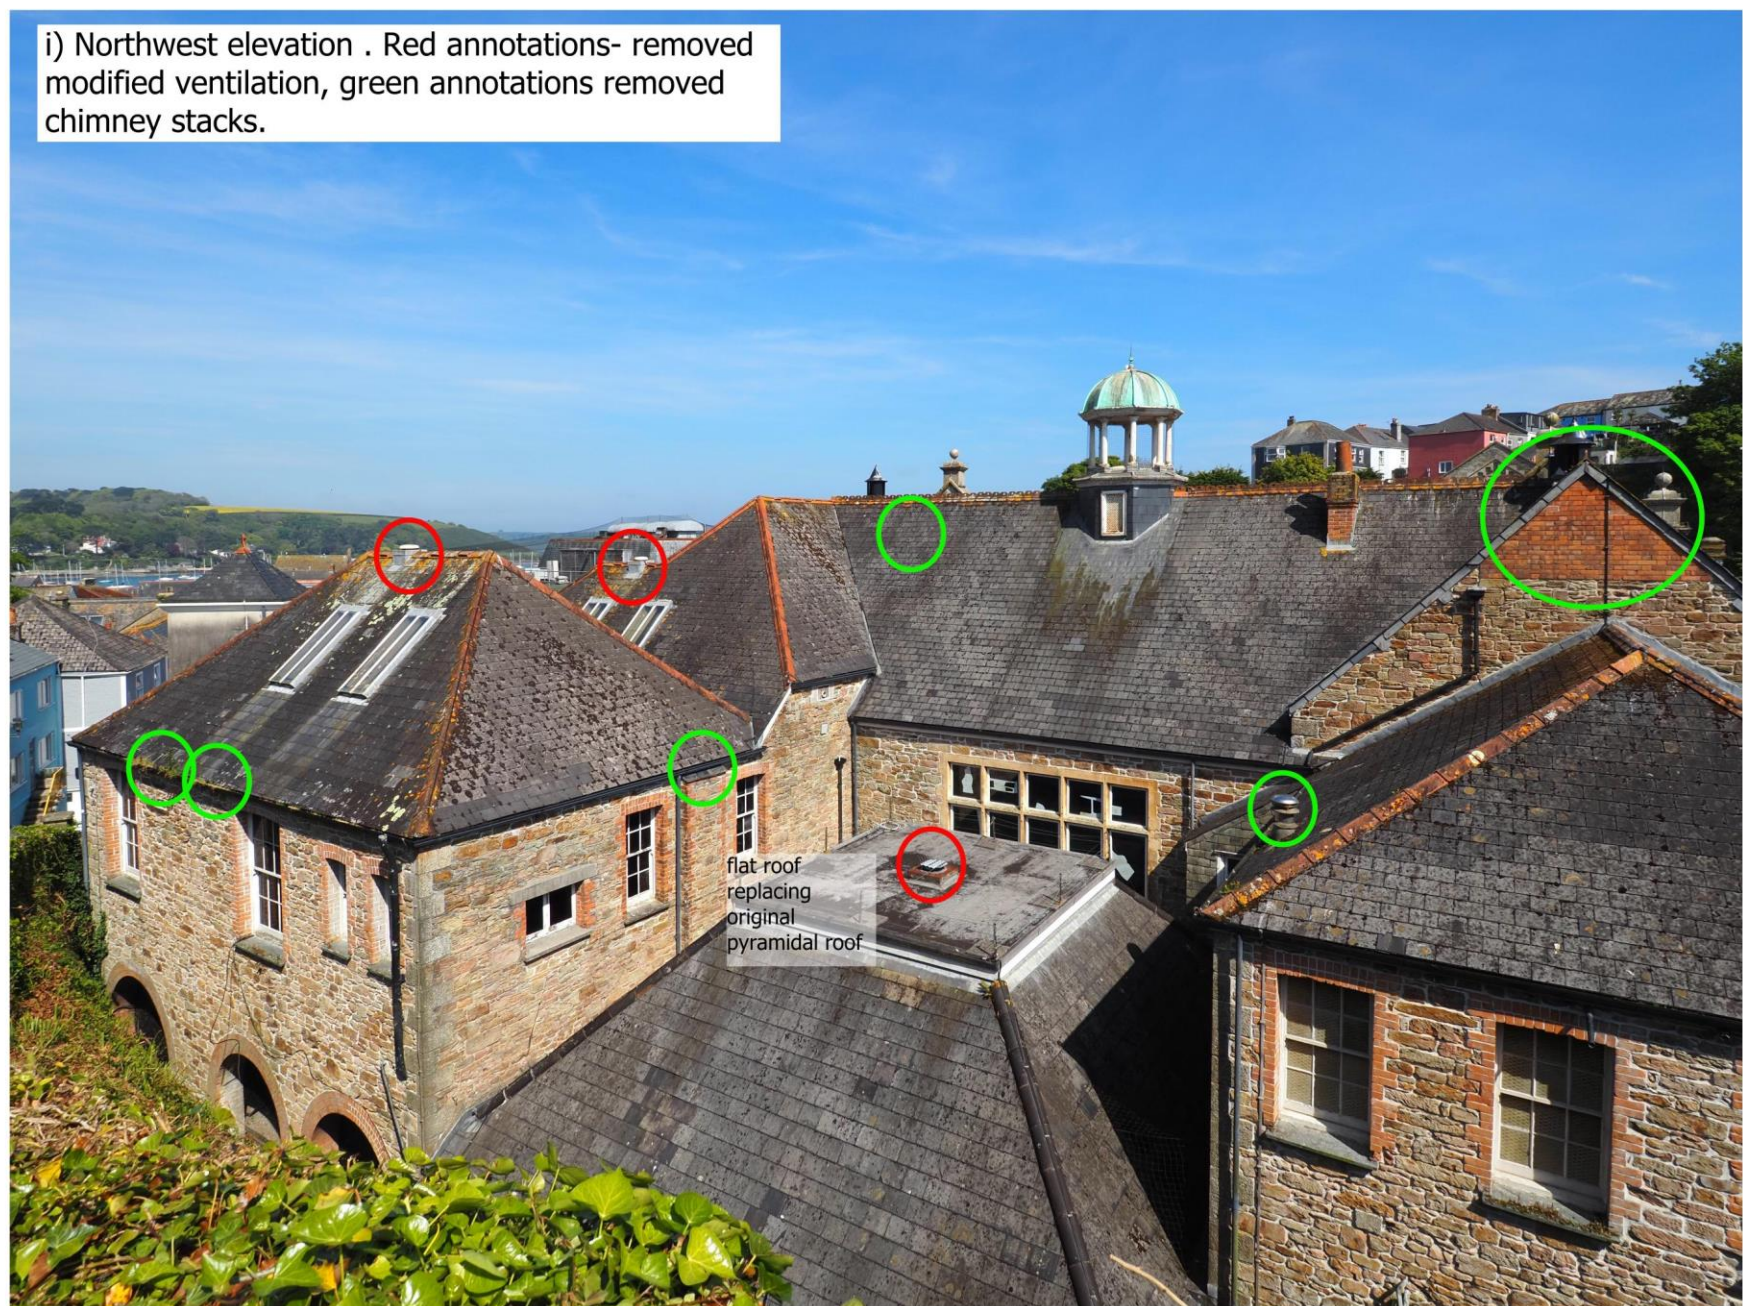
Figure 8: Northwest elevation

- 4.8. The northwest elevation is shown at **figure 8**. As with the southwest elevation the walling is of killas rubble with red brick used to dress openings. The building here, reusing work likely undertaken for the earlier market which occupied the site stands in an engineered terrace (probably originally a quarry) below *Webber Hill* which provides an elevated viewpoint from which the roofs of the building can be appreciated. The roof forms are mostly hipped, with simple ceramic ridge tiles. Slating matches other parts of the roof already described, except in the flat central section above the *Newspaper Reading Room* a modern intervention replacing a room indicated on historic plans to have formed a four-sided pyramid. Historic ventilation cowl (probably originally similar to those above the Council Chamber) have generally been replaced with simpler modern vents (as shown on **figure 8i**) and a number of chimney stacks have been removed, the only survivor rising from the northeast wall of the southwest wing within the rear-facing roof slope of the central range. Windows in the side ranges are mostly original 12 pane horned vertical sliding sashes. The *main stair Hall* is lit in its rear elevation by a large late-16th century style mullioned and transomed window. The ground floor of the rear ranges integrates large open arcades providing service areas. **Figure 8iii** shows a detail of the lantern. **Figure 8iv** shows a detail of the modern (now blind) roof lights in the north faces of the original *Technical School Rooms (Gallery 1 and 2)*.

i) Northwest elevation . Red annotations- removed modified ventilation, green annotations removed chimney stacks.

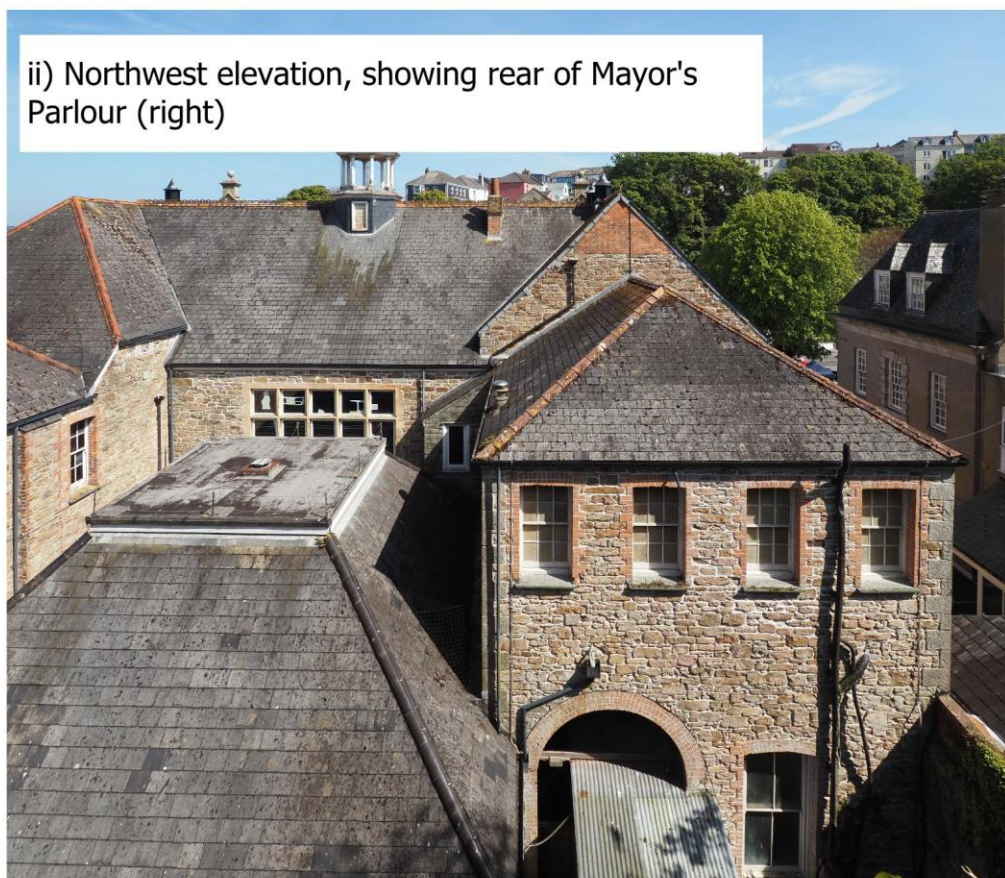
ii) Northwest elevation, showing rear of Mayor's Parlour (right)

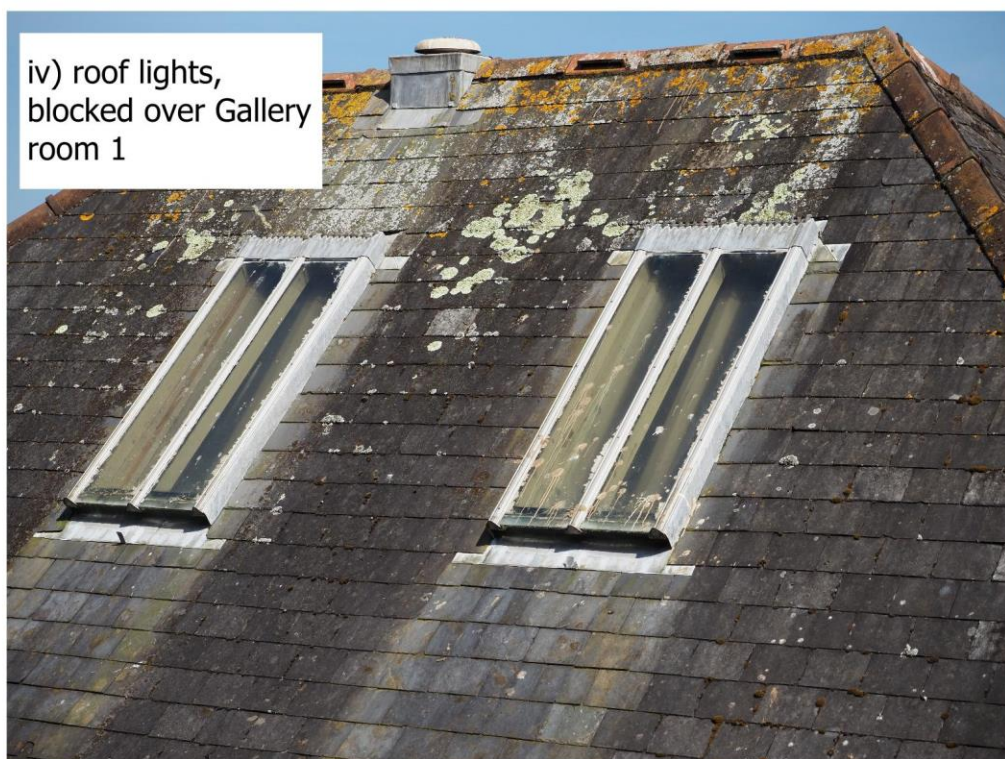
iv) roof lights, blocked over Gallery room 1

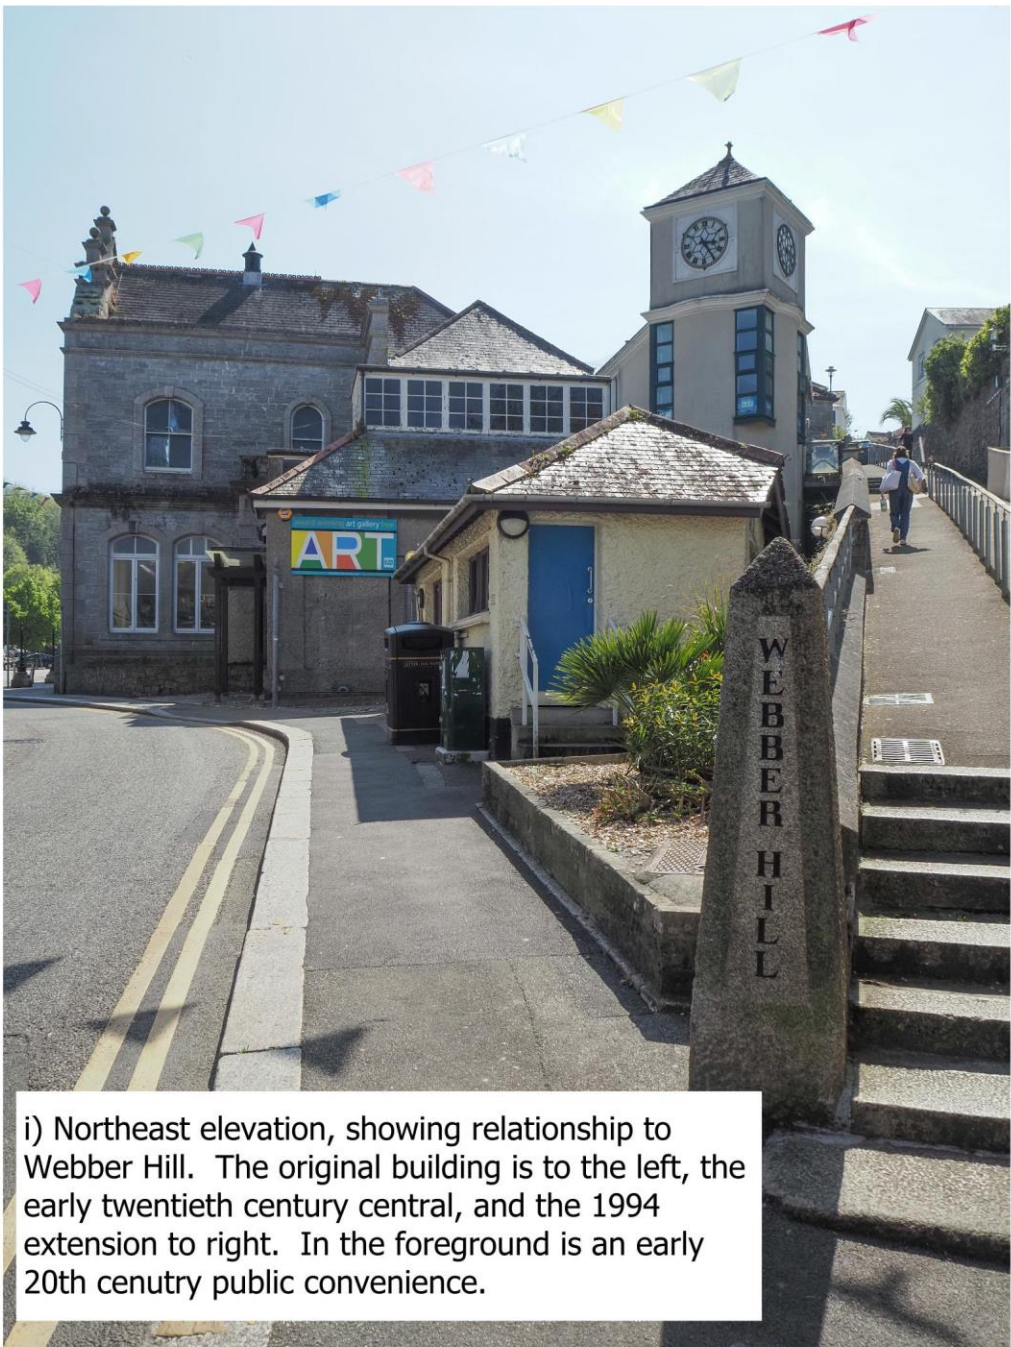
Figure 9: Northeast elevation

i) Northeast elevation, showing relationship to Webber Hill. The original building is to the left, the early twentieth century central, and the 1994 extension to right. In the foreground is an early 20th century public convenience.

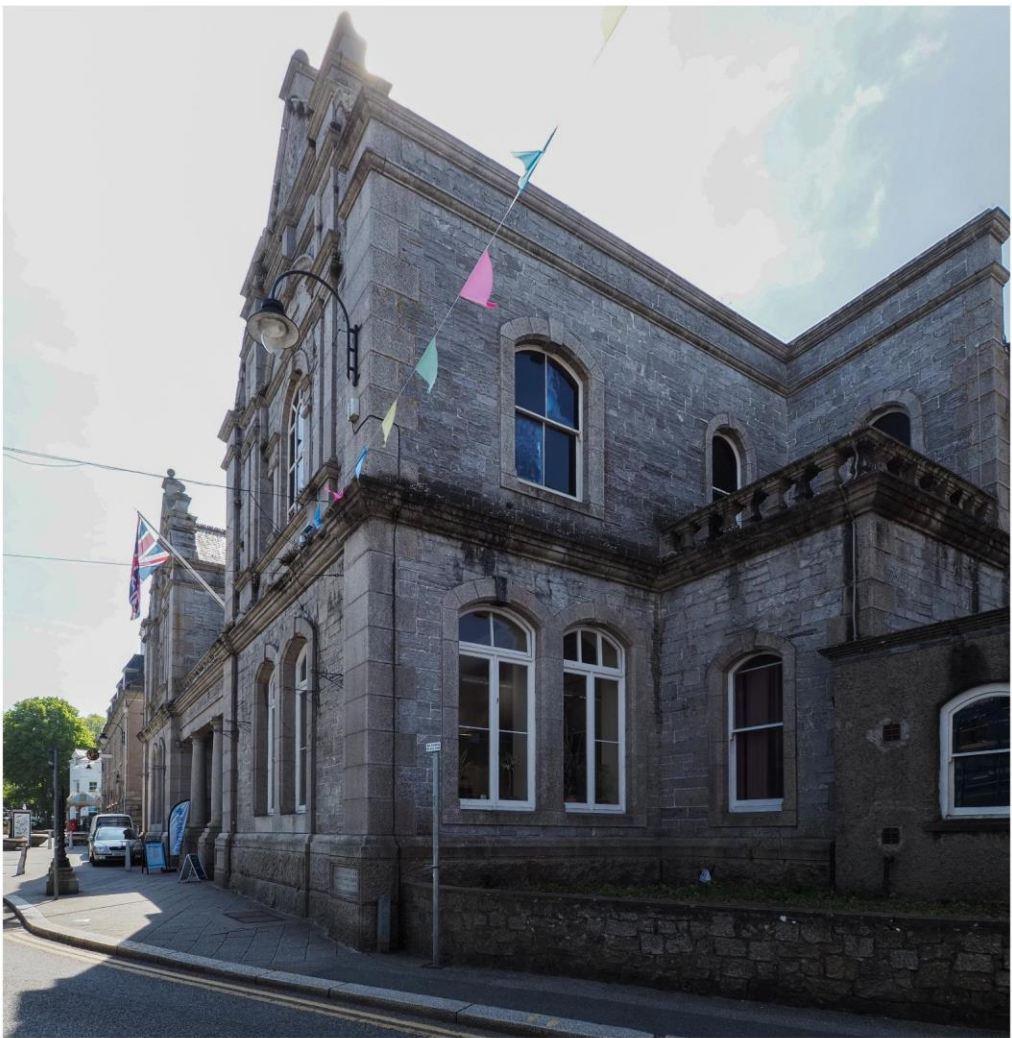
ii) detail showing the northeast elevation of the Lending Library (former 'Science Classroom' above). The single storey projecting was originally a Librarian's Office.

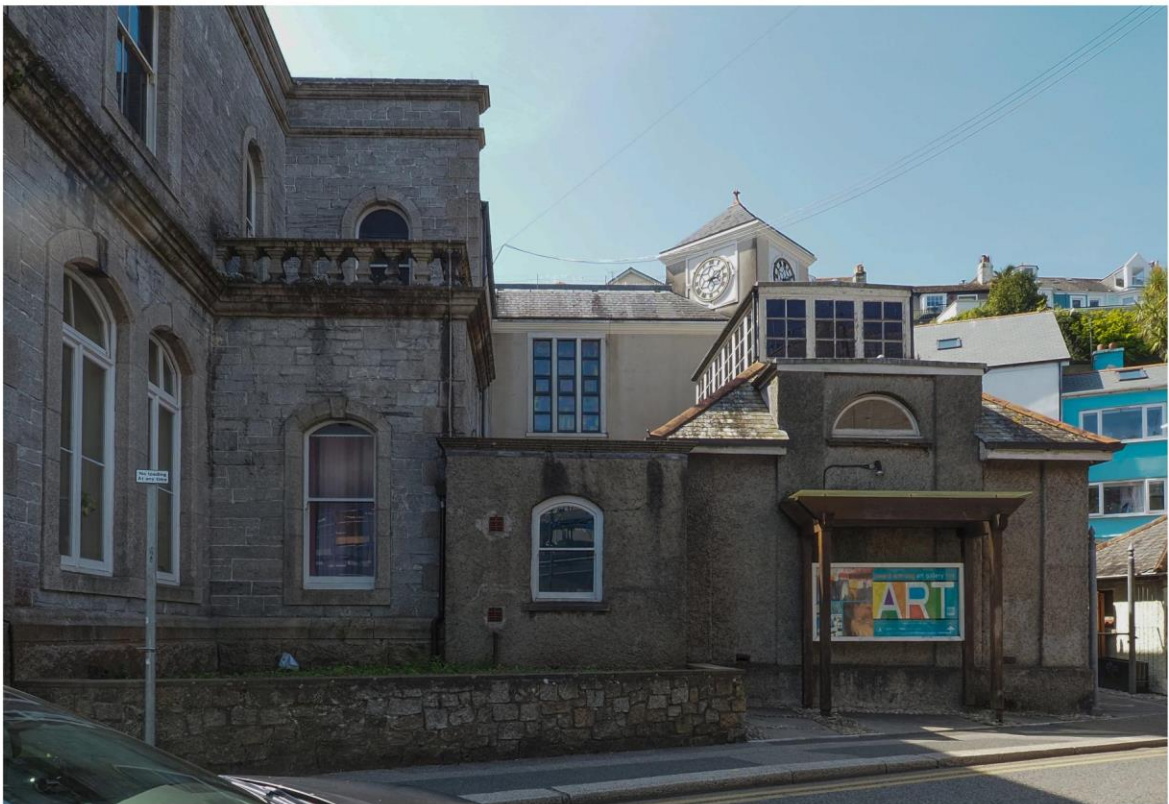
iv) The southeast elevation of the library extension, showing the stepping out of the technical school wing to rear.

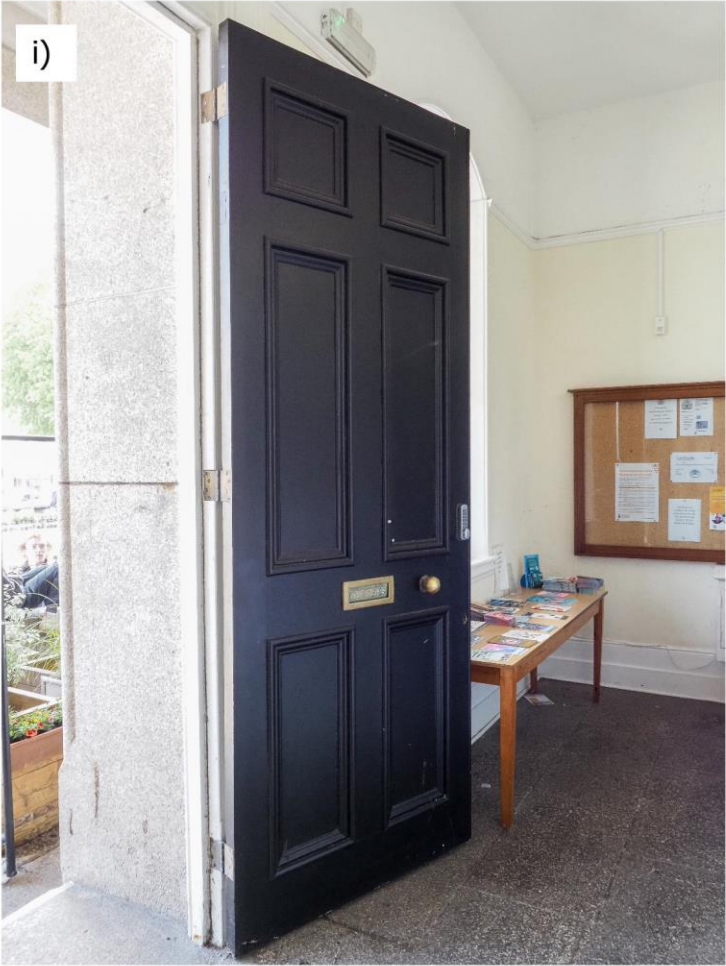
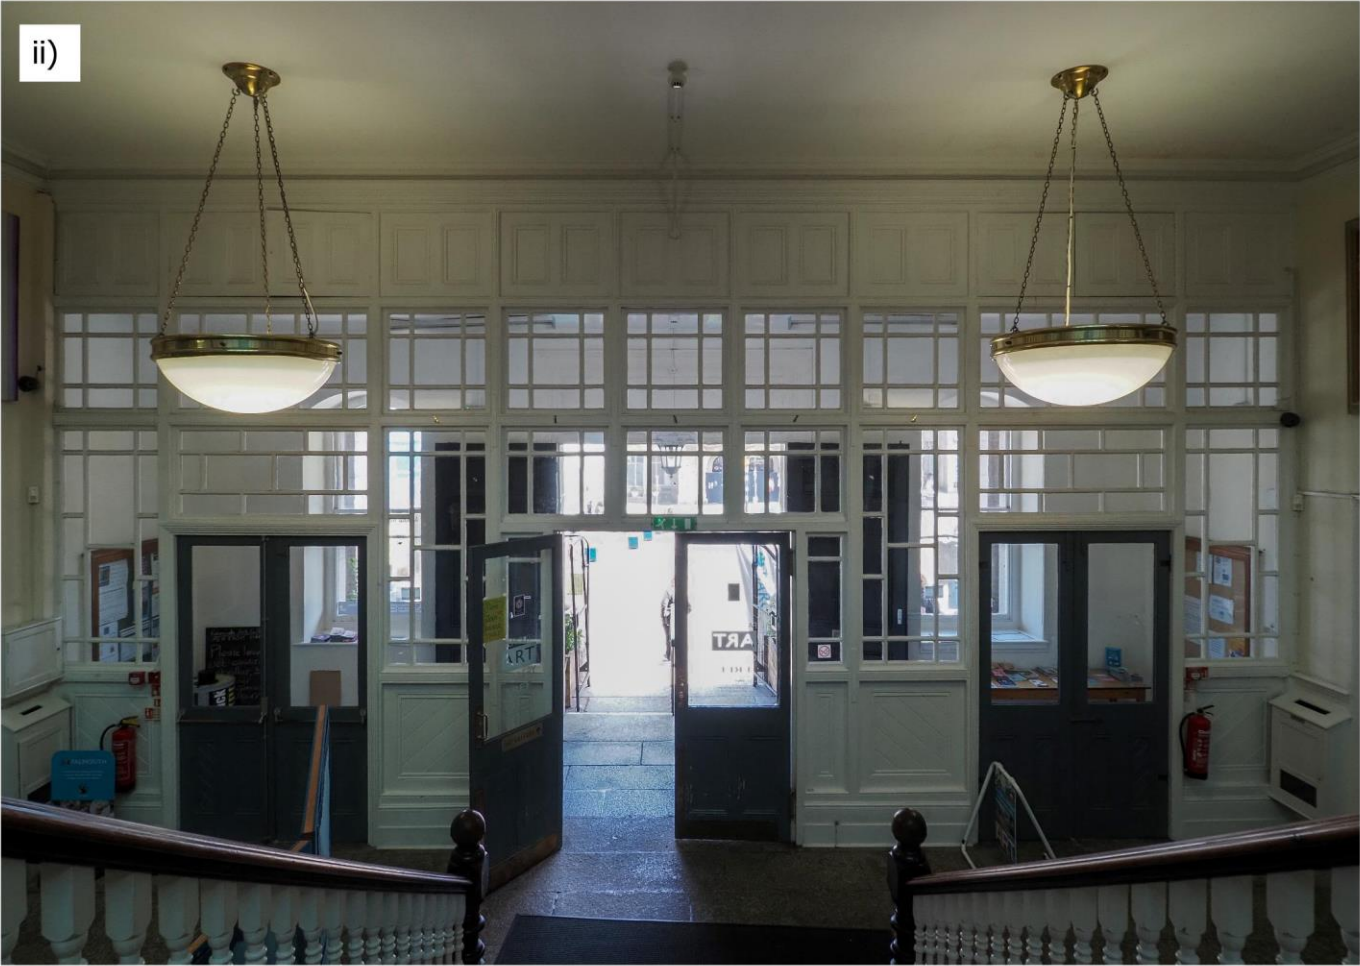
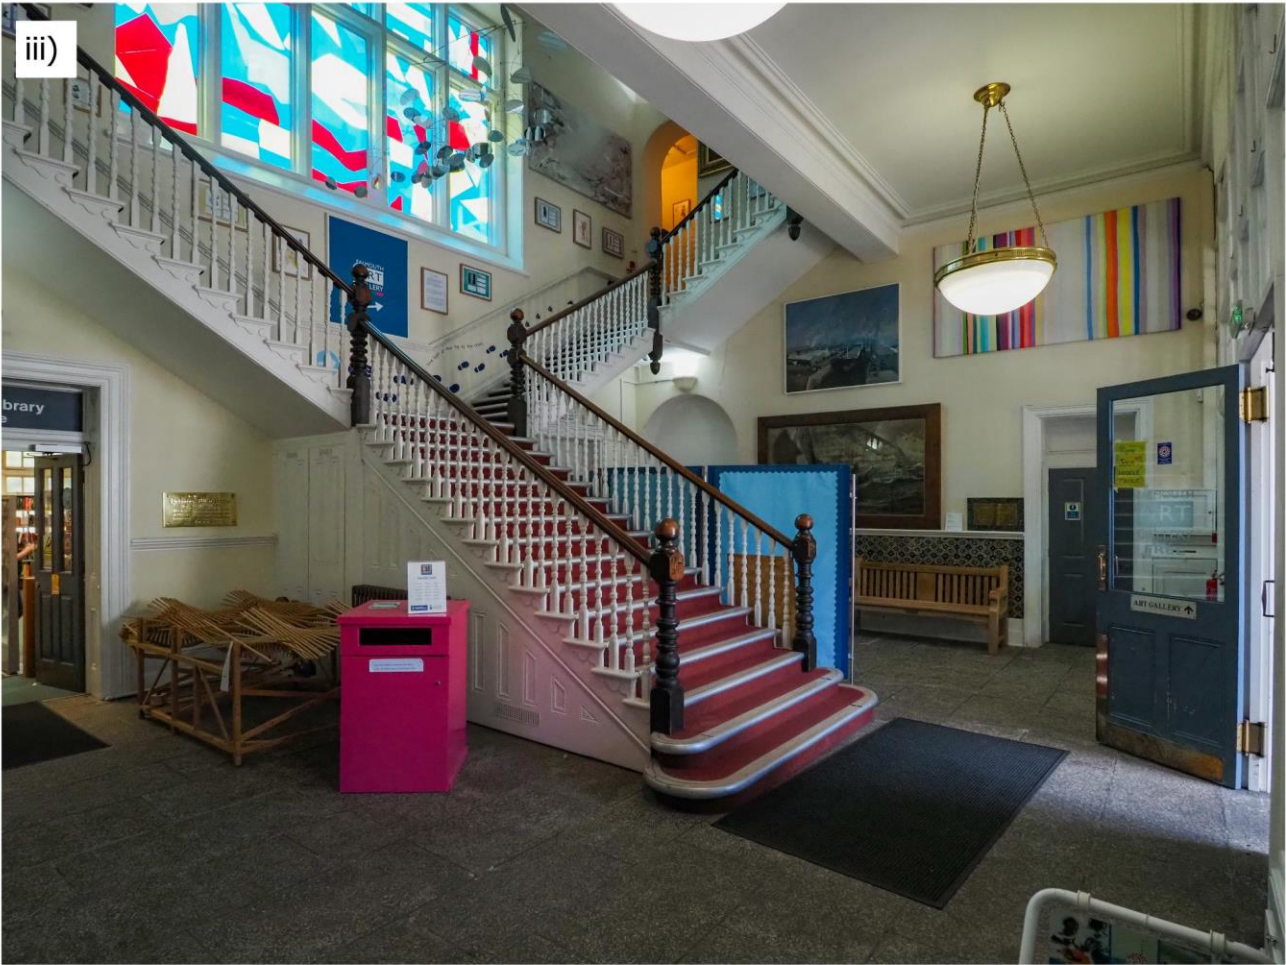
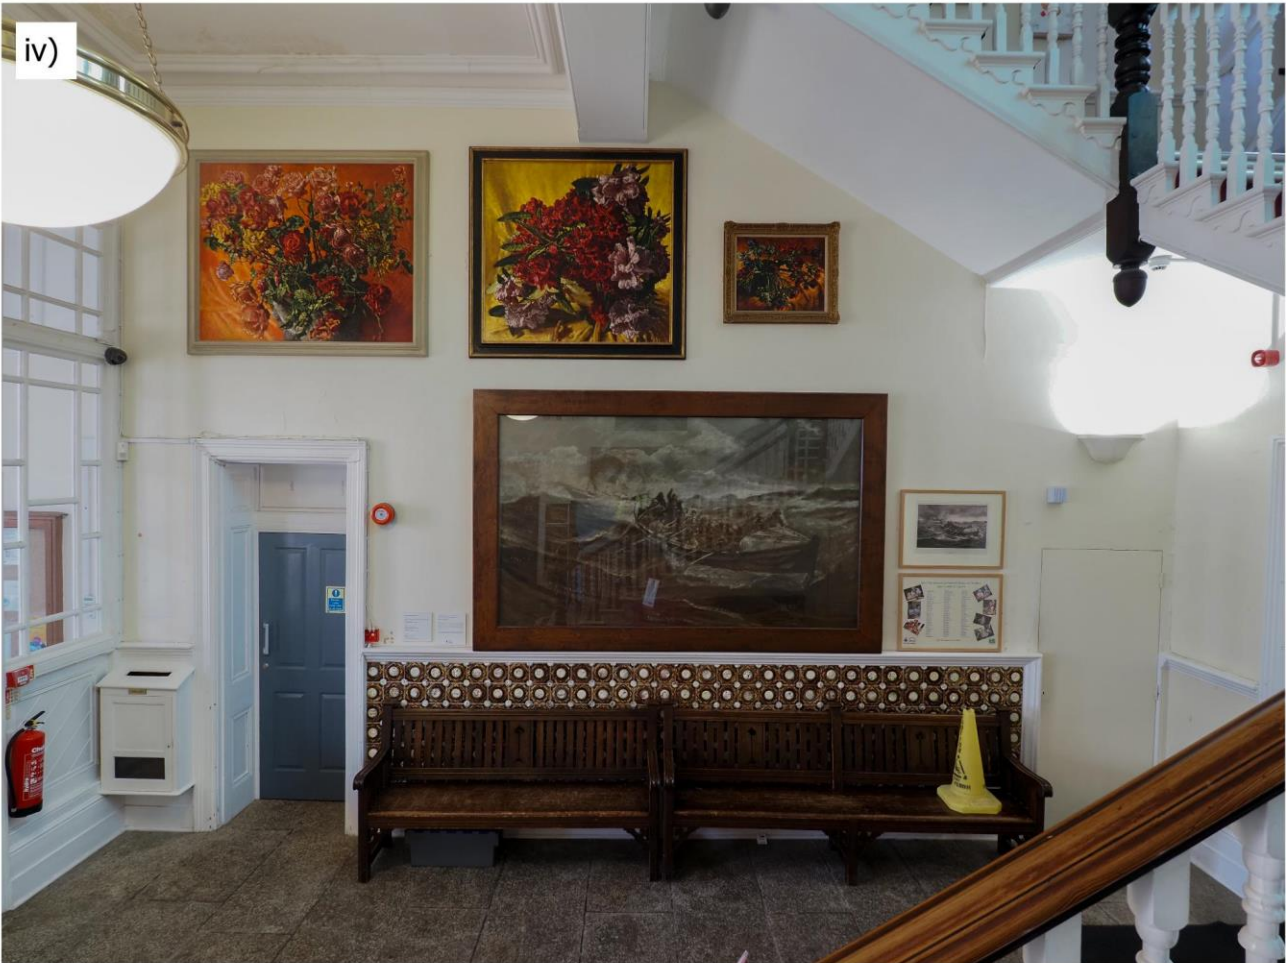
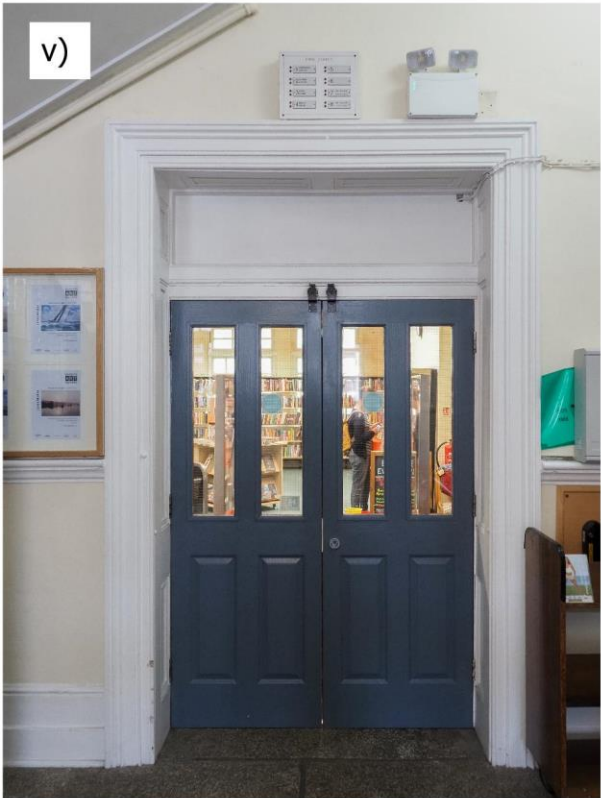
Figure 10: Entrance Hall

- 4.10. The main entrance to the building retains its original 6 panel double doors (**figure 10i**) leading into a vestibule, separated from the *Entrance Hall* via an original timber screen (**figure 10ii**) which incorporates three sets of double doors and margin glazing. The vestibule opens into the *Hall (figure 10iii)* the main features of which are its granite flagged floor, the moulded cornice around its ground floor ceiling and a central bifurcated open string staircase with turned newels and balusters, and lit by a mullion and transomed window – this incorporating modern stained glass designed in 2009 by service users of *Falcare* with Heritage Lottery Funding⁶. Doors to side rooms are mostly original with panel doors in moulded cases. Further part glazed double doors lead into the former *Newspaper and Reading Room*, now the main library hall containing the fiction collection.

- i) One of the original double doors into the building
- ii) Glazed vestibule screen
- iii) Main stair, stained glass window and moulded ceiling, looking north
- iv) Southwest wall, showing typical internal door
- v) doors into main library hall

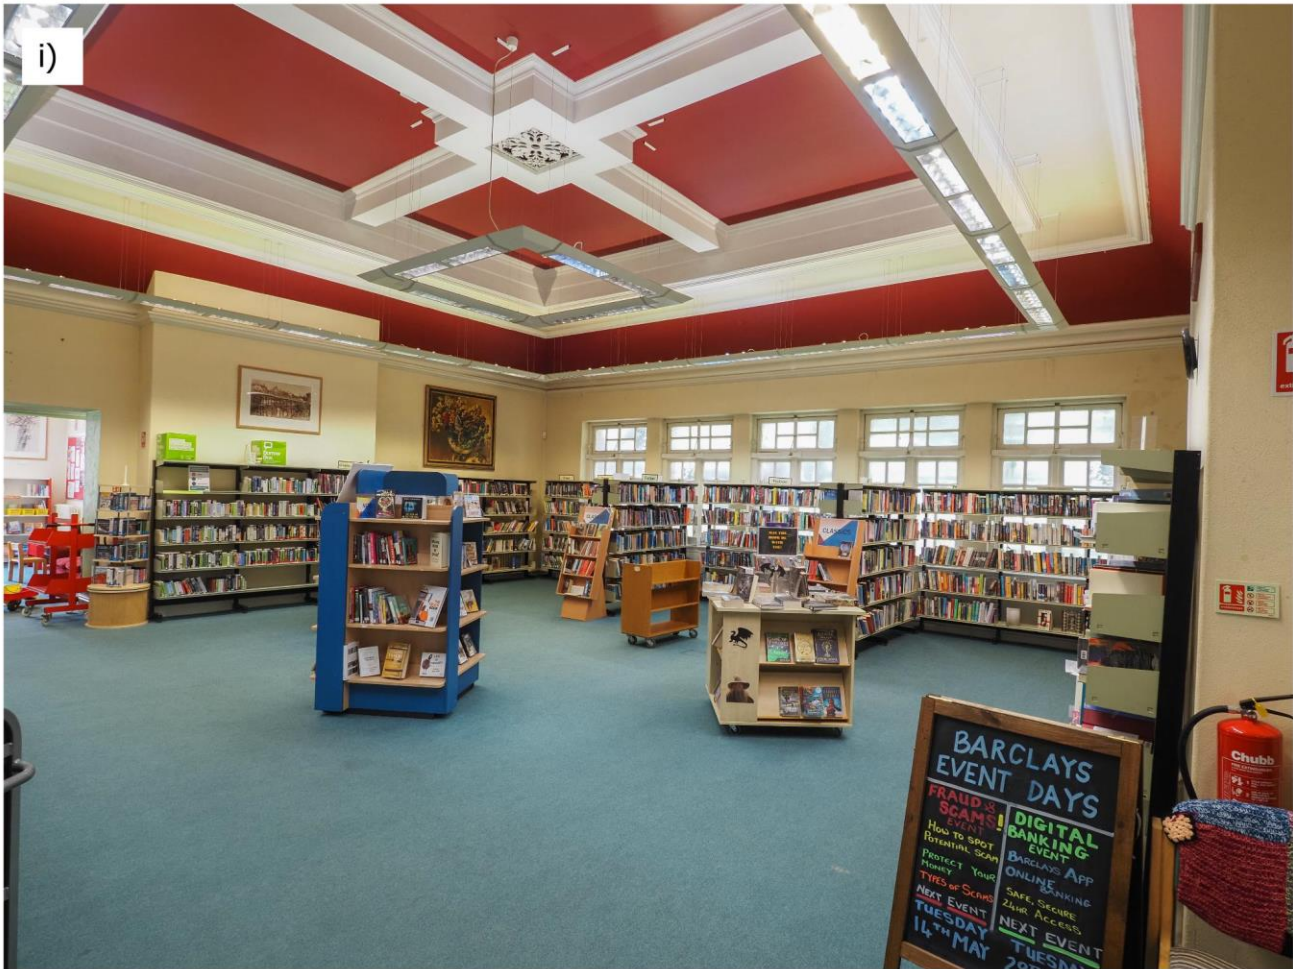
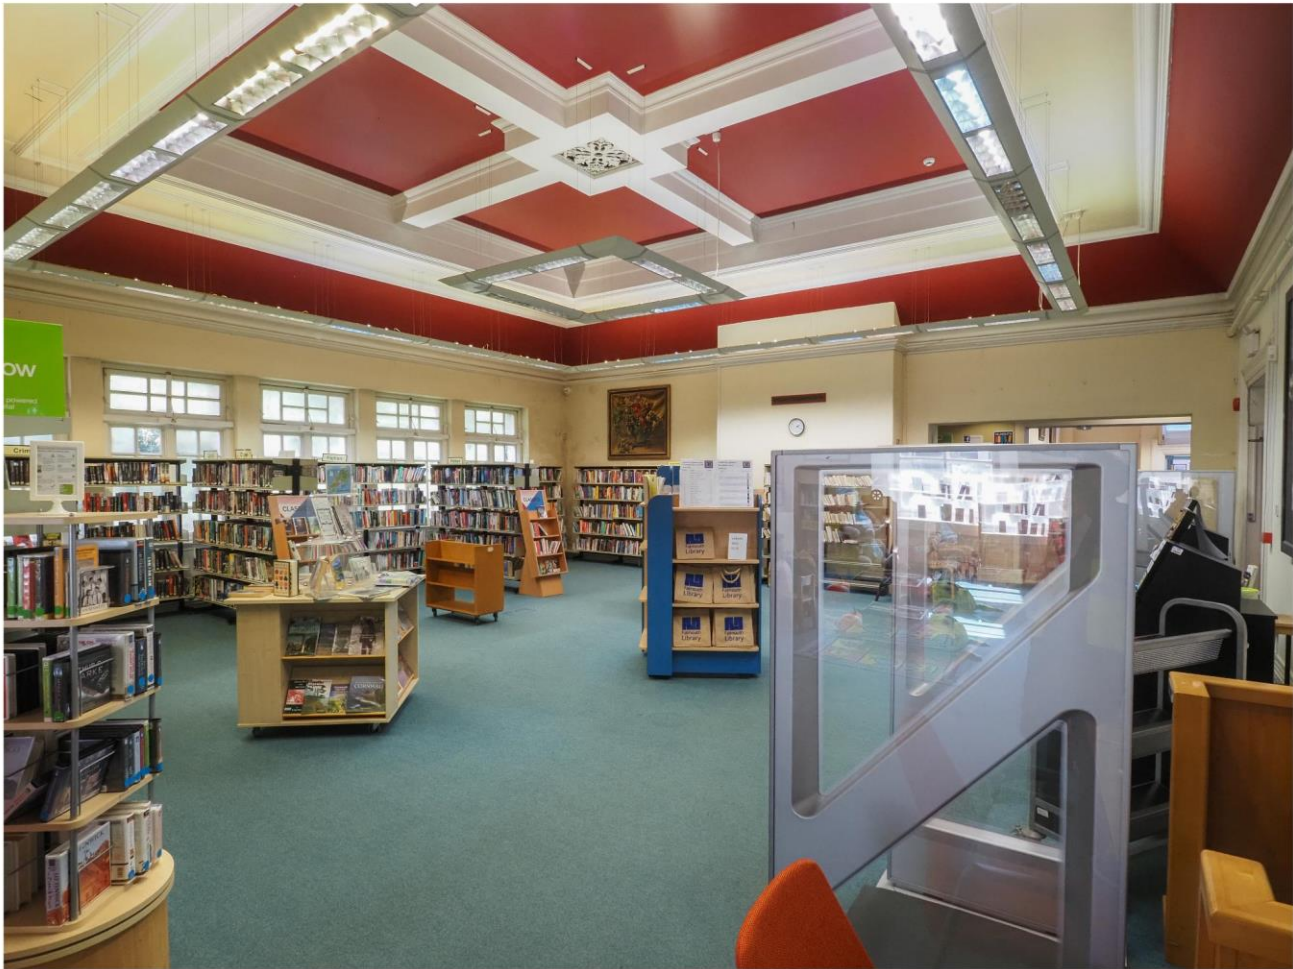
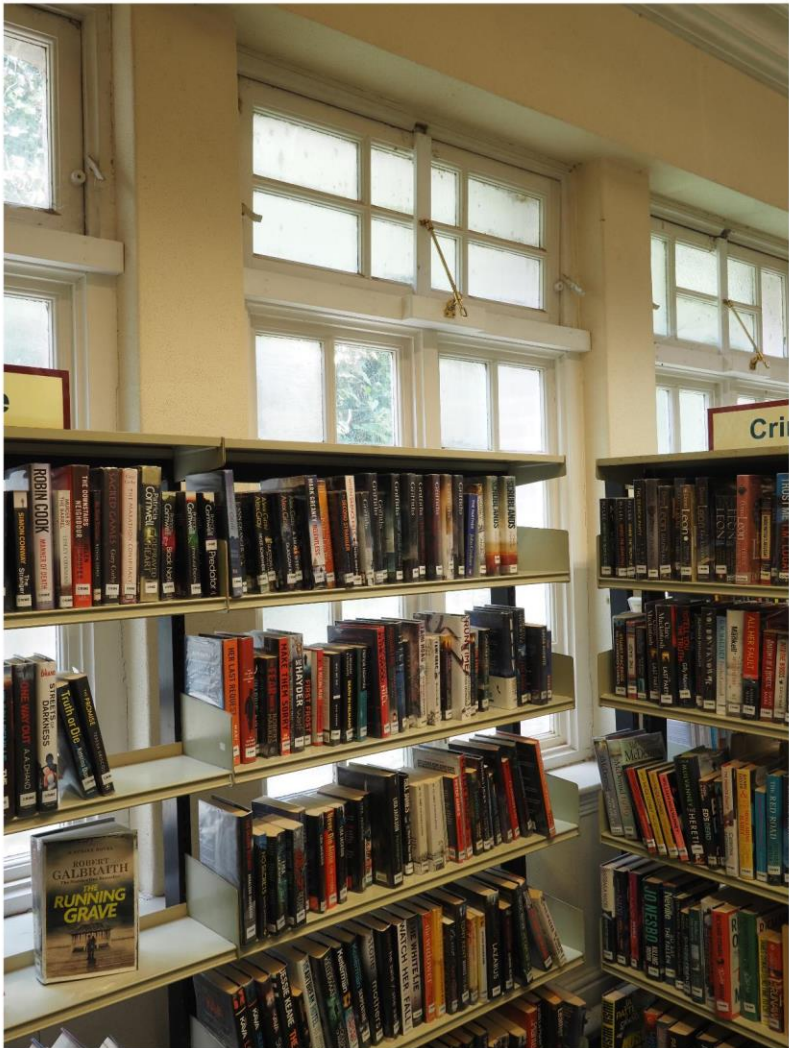
Figure 11: Main Library Hall

i) Main Library Hall, looking west

ii) Main Library looking north

iii) Detail showing the original windows.
