Statement Heritage

Municipal Building, The Moor, Falmouth, Cornwall, TR11 2RT

Historic Building Record, Statement of Significance and
Impact Assessment

SH Ref FALMUN0524 v1.1 Submission

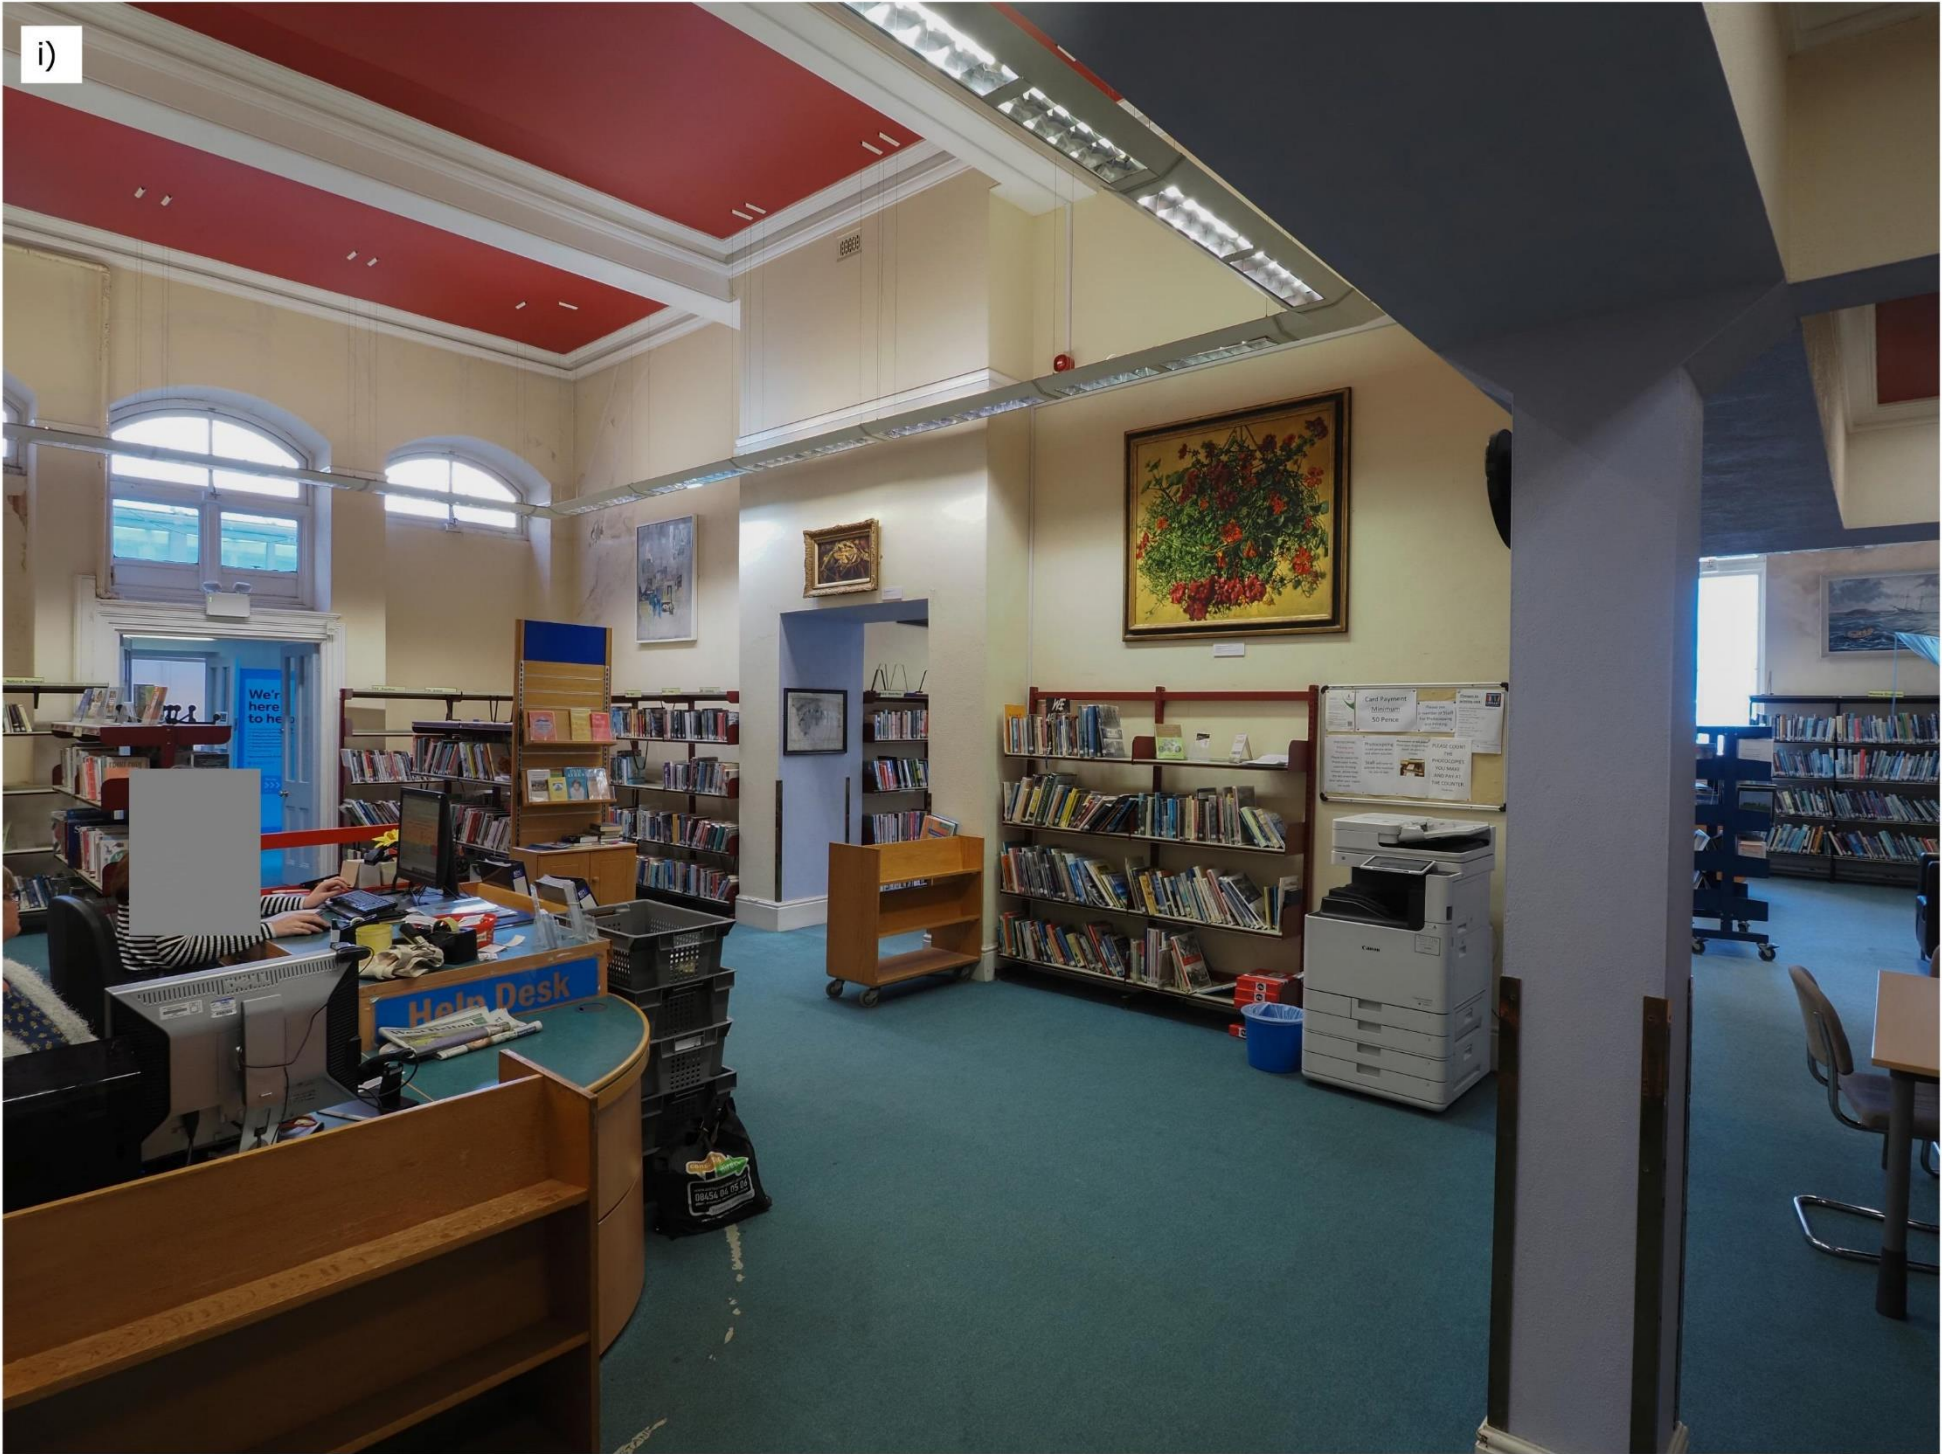
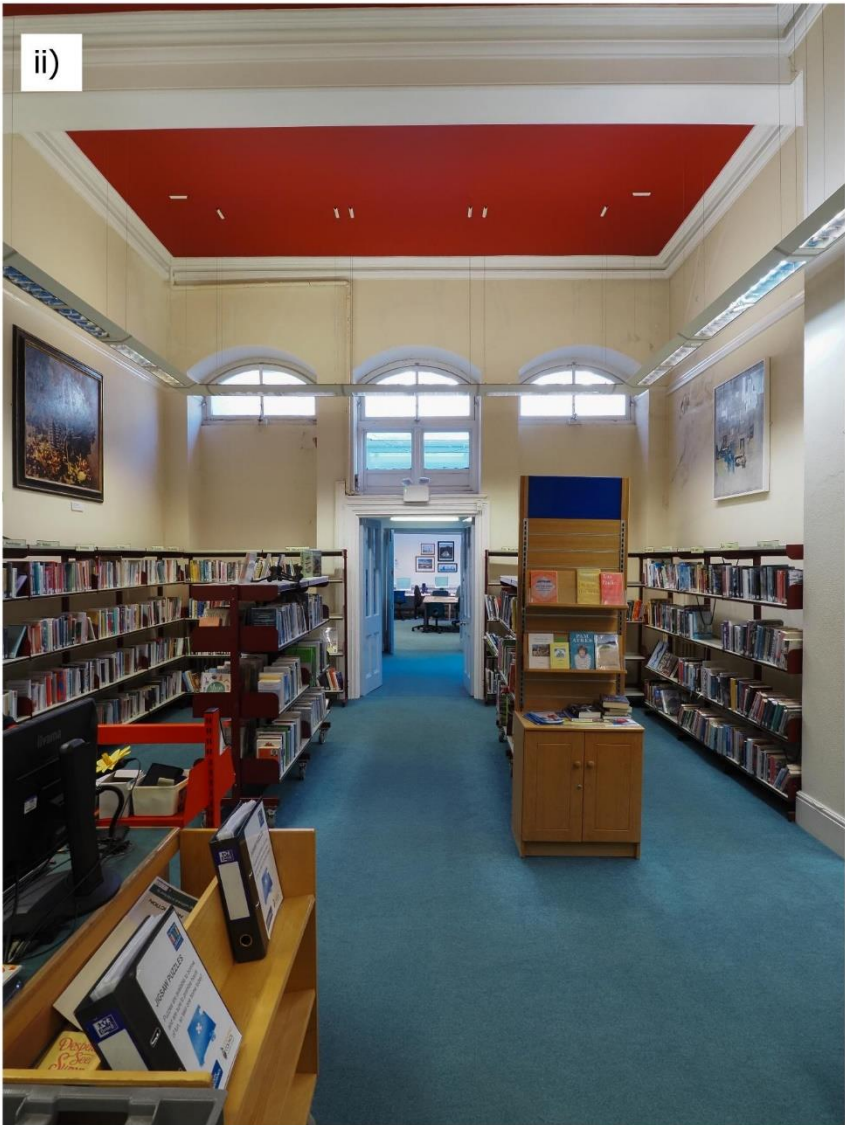
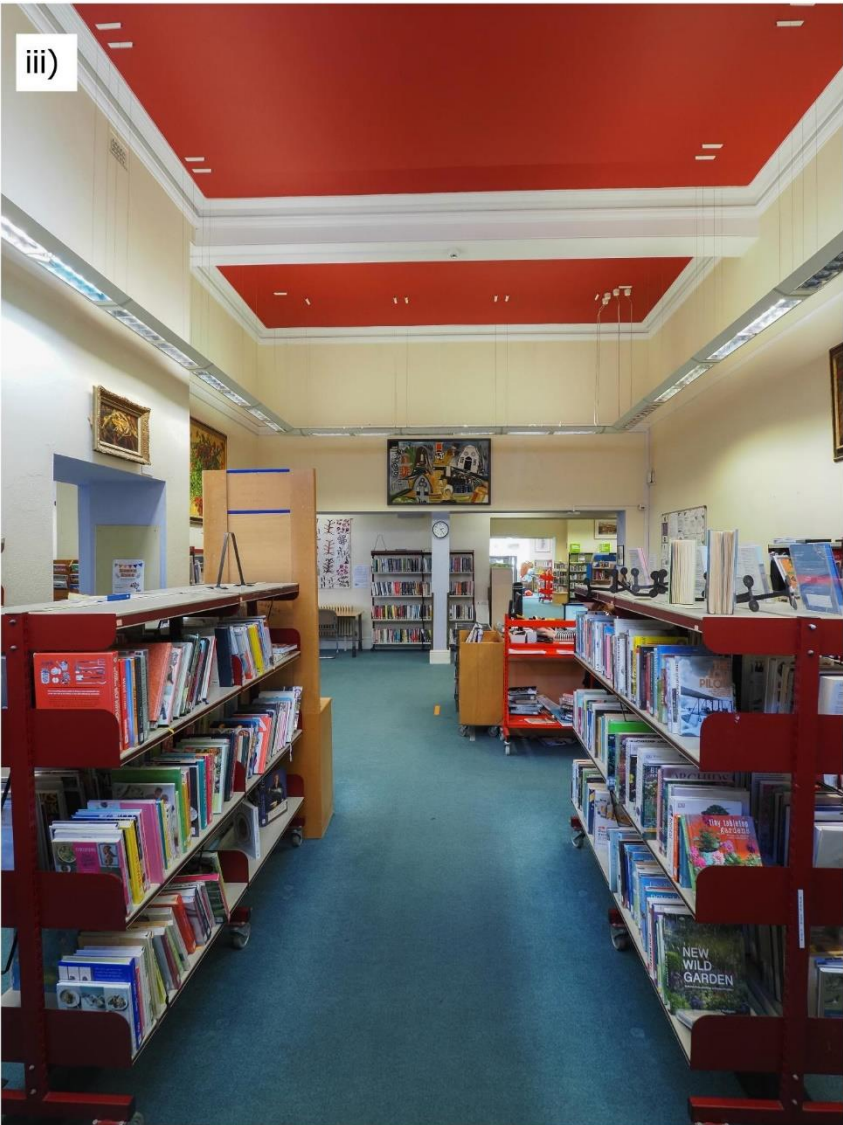
Figure 12 Catalogue Hall, originally the Reference Library.

i) Looking east. Note that the door to the non-fiction collection (originally the Lending Library) is a modern opening created within a chimney breast. The southwestern wall of this space has been removed, opening it up into what was originally a corridor. Note original subdivided cornice details of ceiling.

ii) Looking northeast across the catalogue hall to what were originally three tall windows, altered in the early 20th century, first to create access into the Library Extension, and again in the mid 20th century when the space between was infilled.

iii) looking southwest along the catalogue hall towards the opened out corridor.

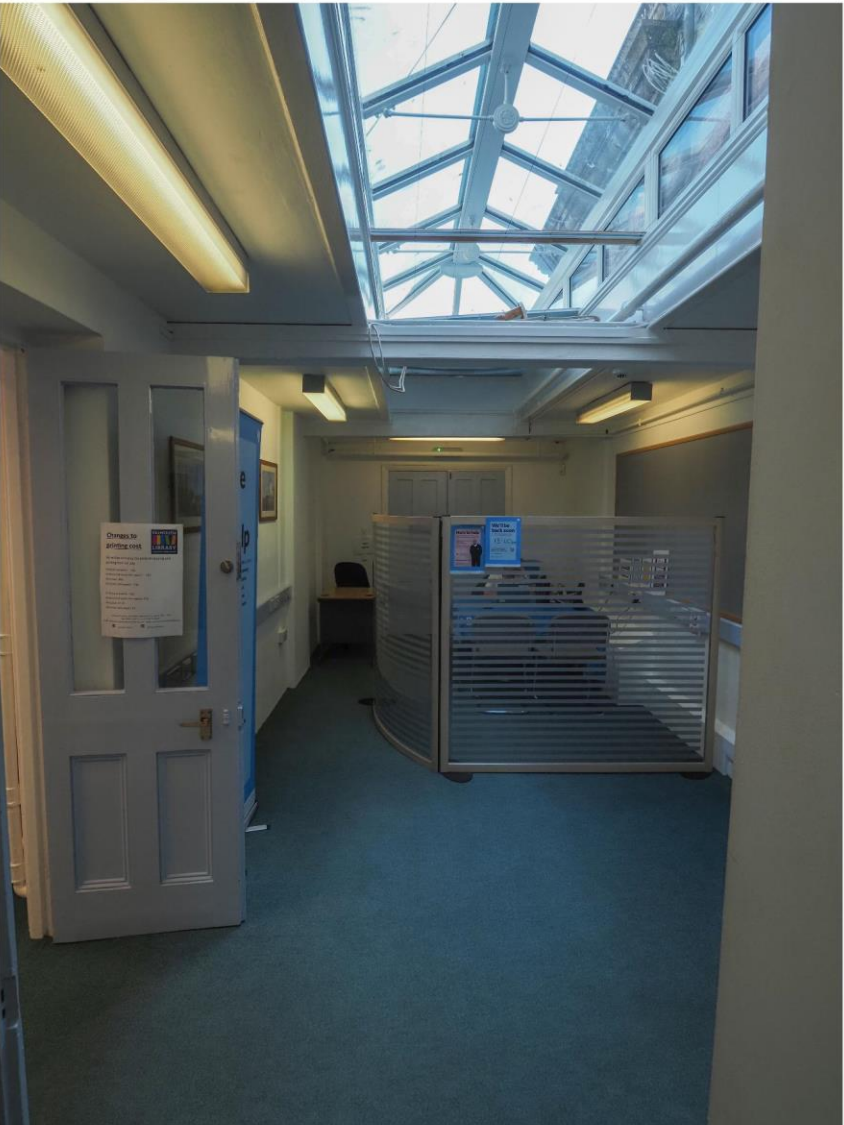
Figure 13: Non Fiction Library, Library Extension and Linking Space

ii) Linking space, created in the mid 20th cenutry between the Catalogue hall (to left) and Library Extension (right)

- 4.13. The *Non-Fiction Library* (**figure 13**) originally the *Public Lending Library*, occupies the ground floor space of the northeast wing of the building. Historic accounts and plans record that this room was not freely accessible to the public, instead it had an enclosed enquiry counter in its west corner, with members of the public requesting books from a printed catalogue, which were then collected from the collection. The room retains an original ceiling cornice and is lit by 4 original windows in the northeast and southeast walls. An original door provides access into the *Librarian's Office*. 2 modern openings have been created in the northwest wall to either side of the original fireplace, which is now blocked. Like the other library spaces the room is lit today by suspended lighting arrays.

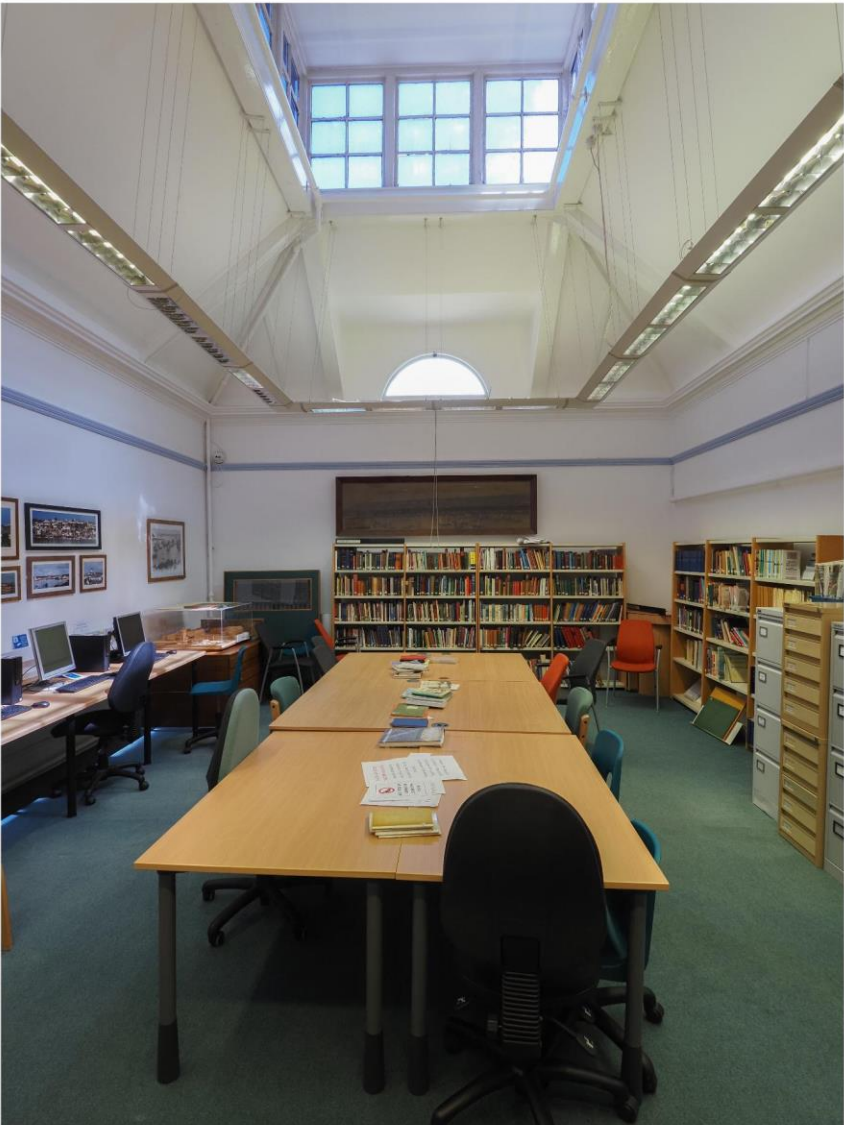
iii) Library Extension looking southeast today containing a reference collection and computer suite.

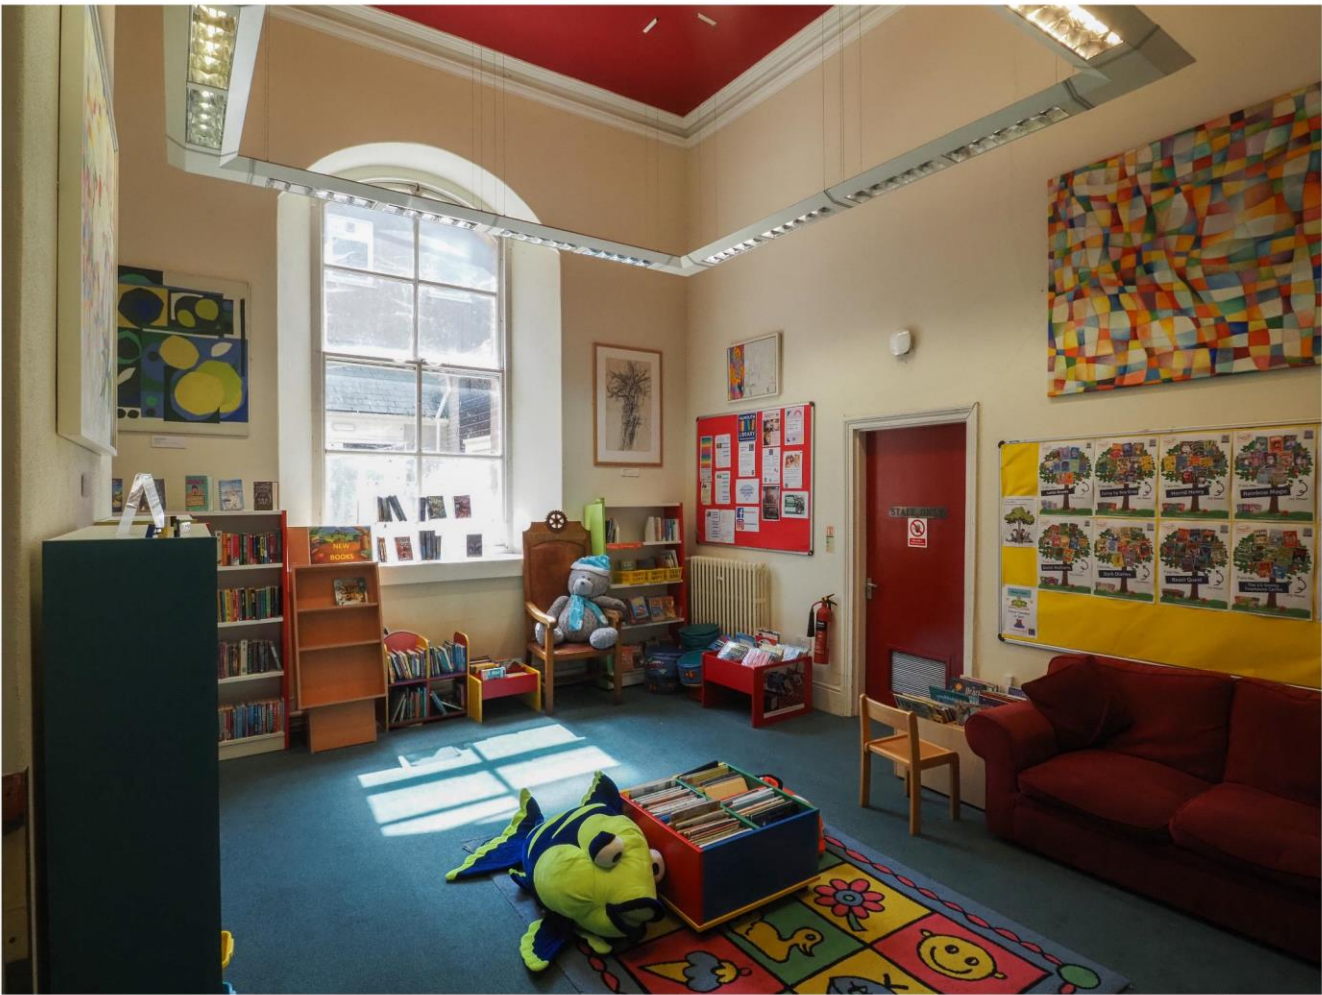
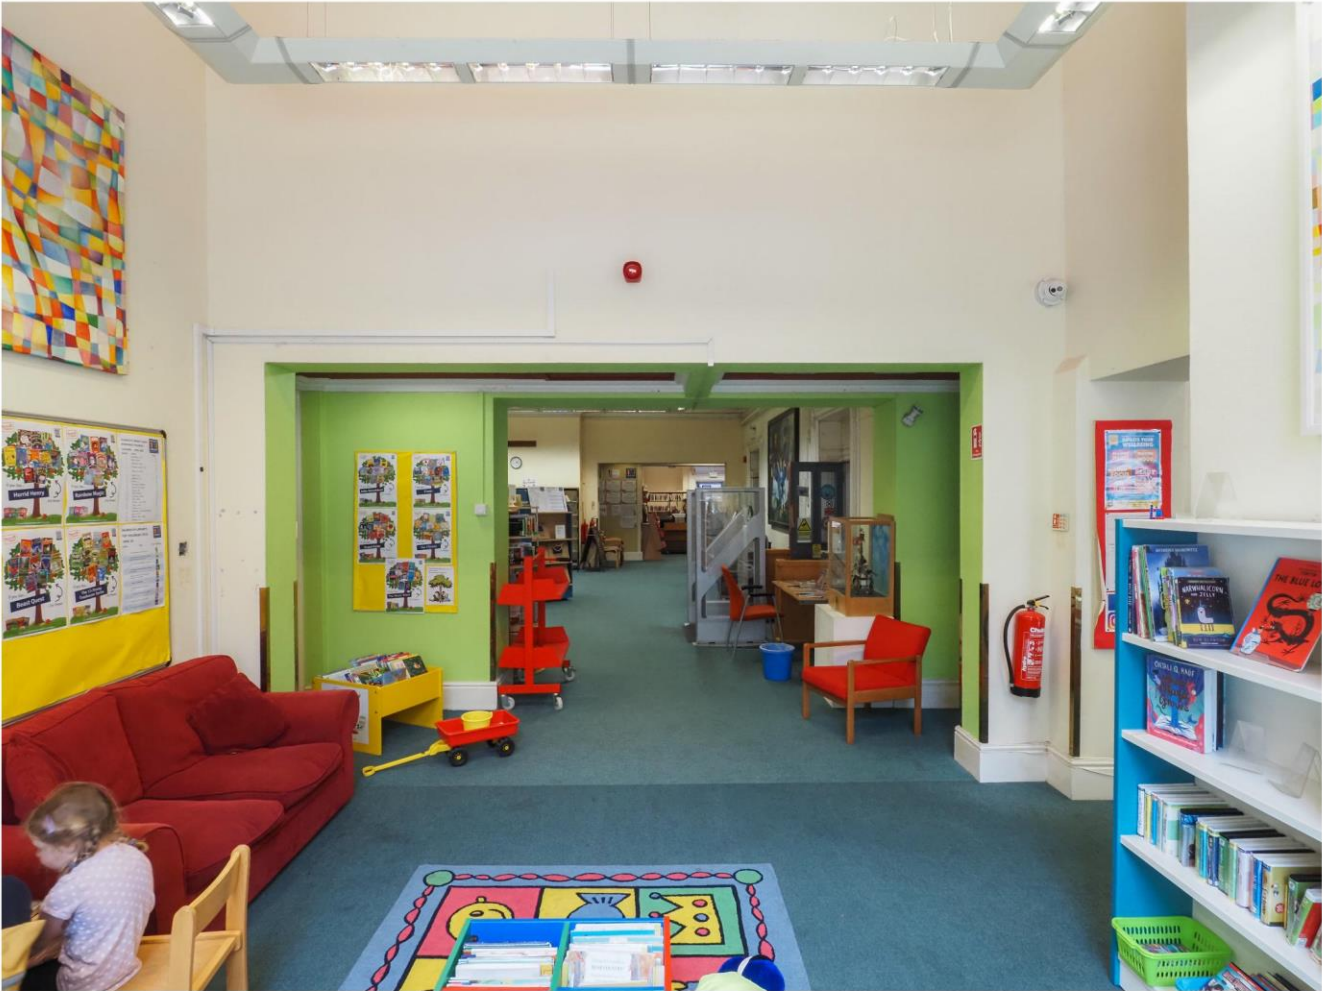
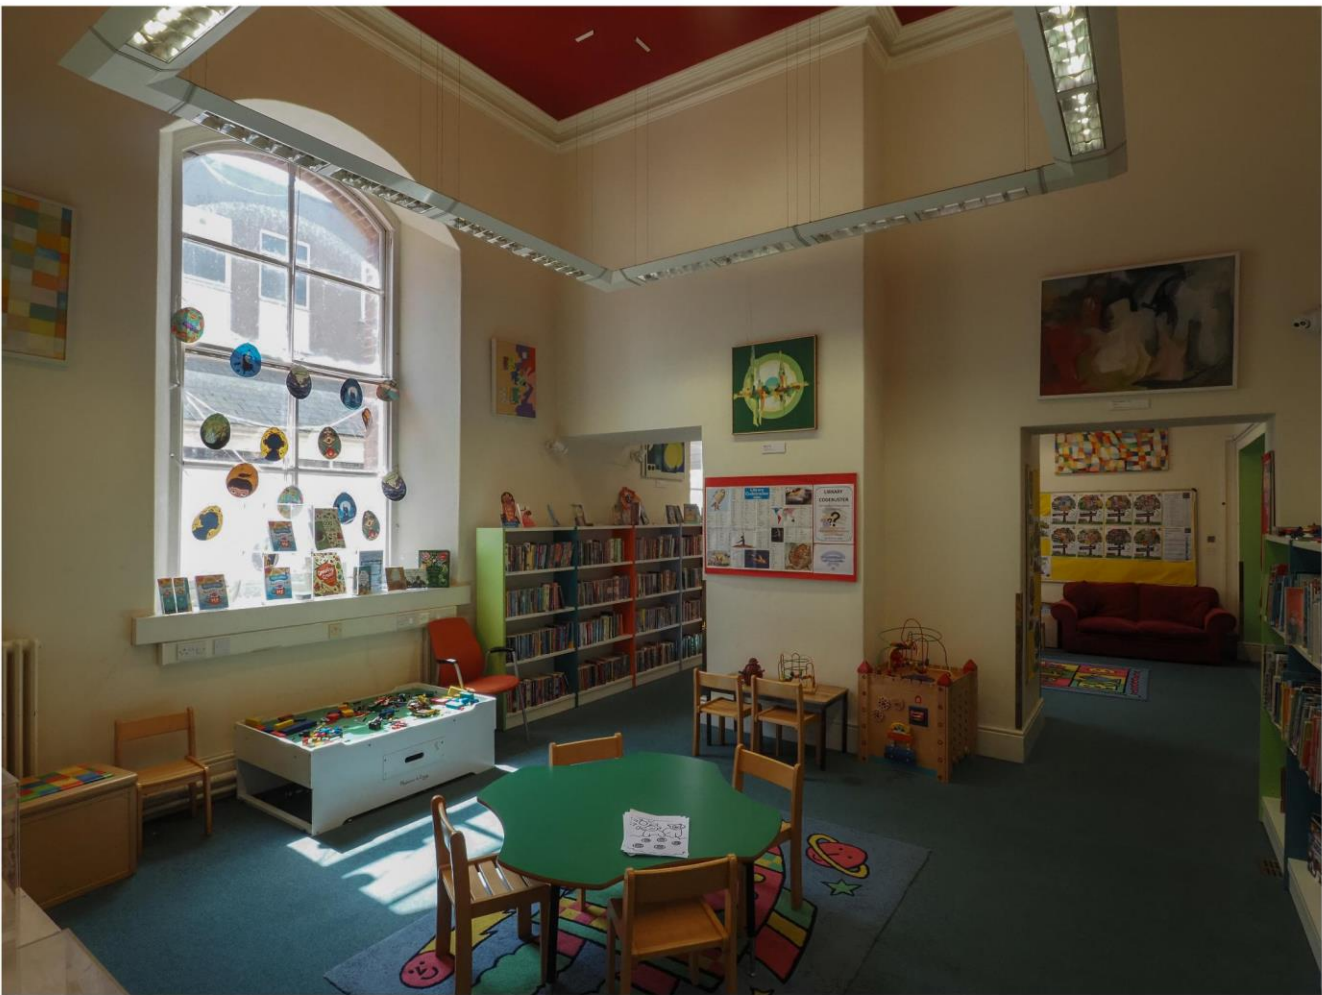
Figure 14:
Children's Library

i) Childrens library 1, looking west. Originally a municipal office. Simple cornice, 8 pane original vertical sash. The door to right is a modern opening. originally heated by an open fireplace (now blocked) to left

ii) Modern opening in the northeast wall of Children's :Library 1, resulting from the opening out of what was originally a corridor between this space and the Main Library Hall.

iii) Children's Library 2, also originally a municipal office, note modern openings in far wall. Original plans show an enquiry counter against the inner wall of this space to right. Originally heated by a fireplace (now blocked) in the chimney breast in far wall

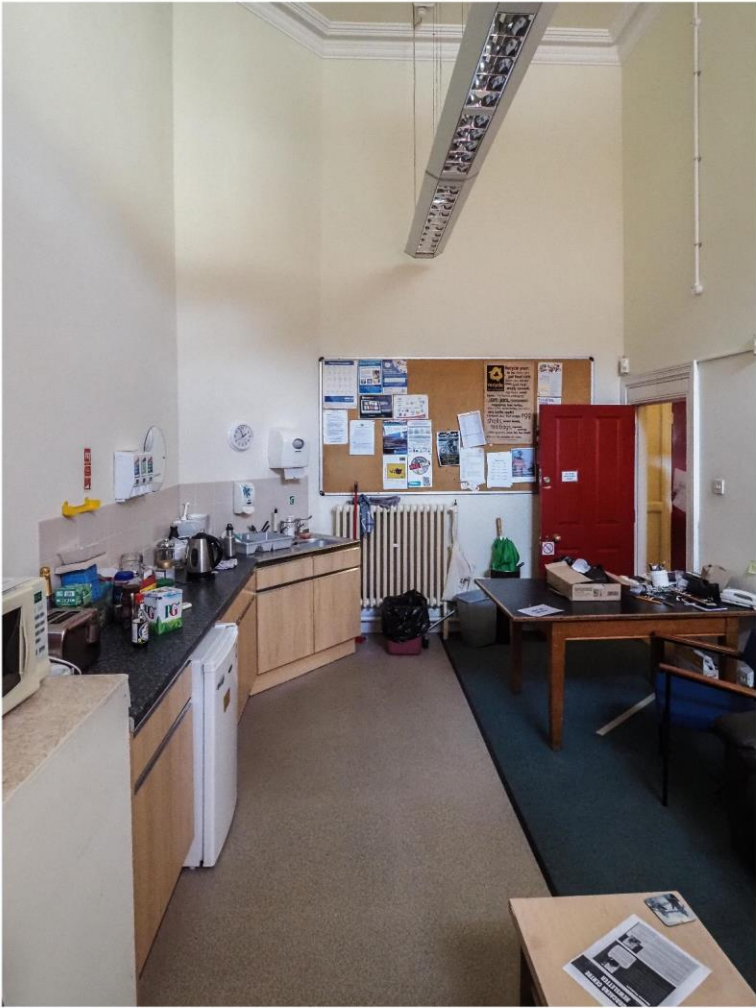
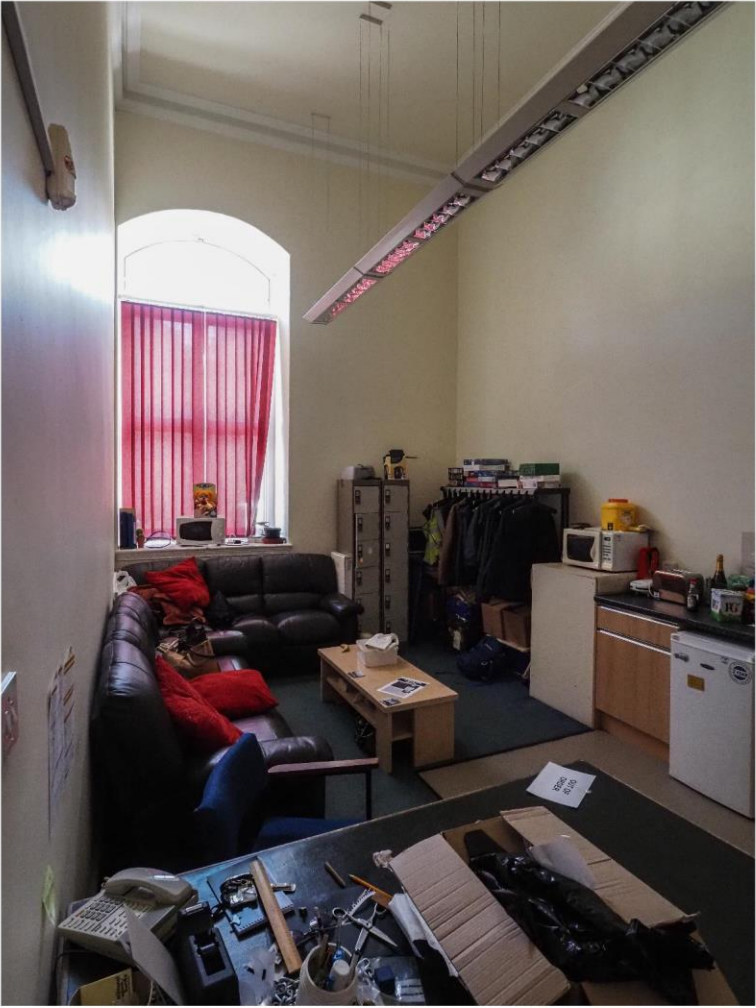
Figure 15: Ground floor offices in southwest range

i) [left] GF Office 1, looking northwest
[right] GF Office 1, looking southeast

- 4.15. At the southeastern end of the southwest wing are two former municipal offices, now in use as a staff room and office used by Library staff (**figure 15**). These spaces and the adjacent corridor that connects them retain their original volumes, ceiling cornices, windows and doors, but both have had their original fireplace surrounds removed and their hearths blocked.

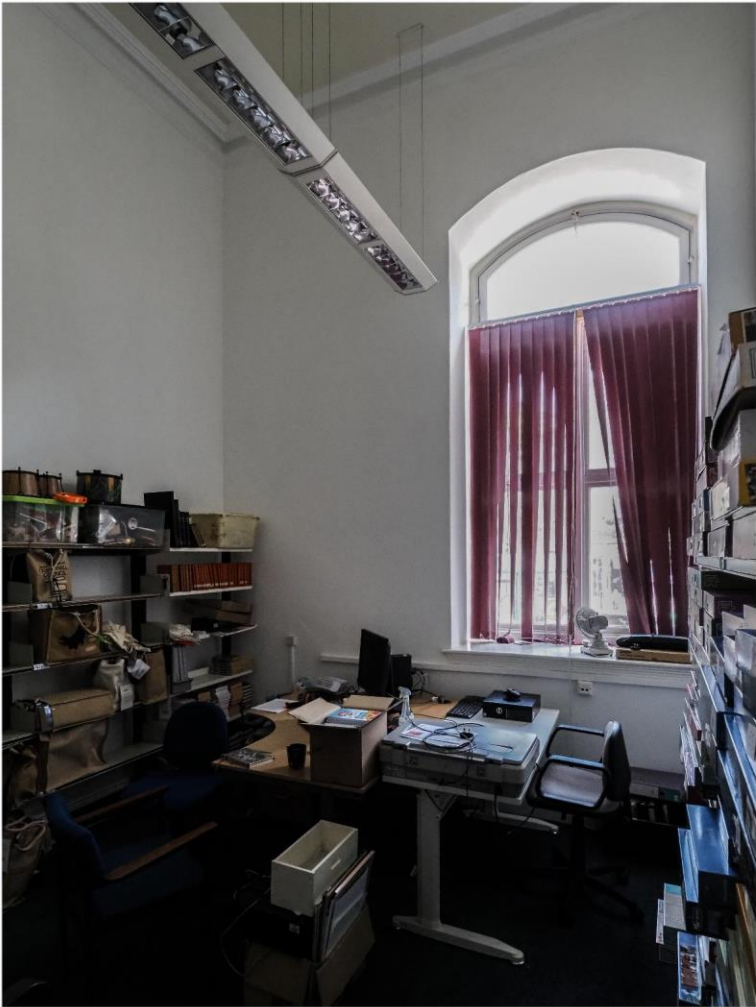
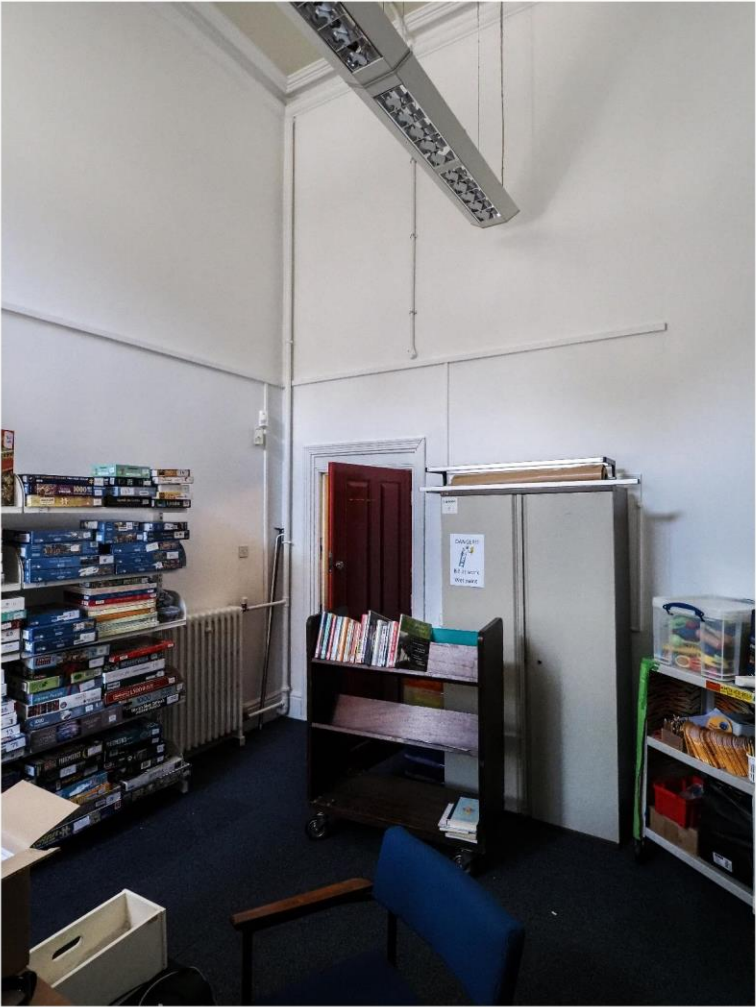
ii) [left] GF Office 2 looking east
[right] GF Office 2 looking west

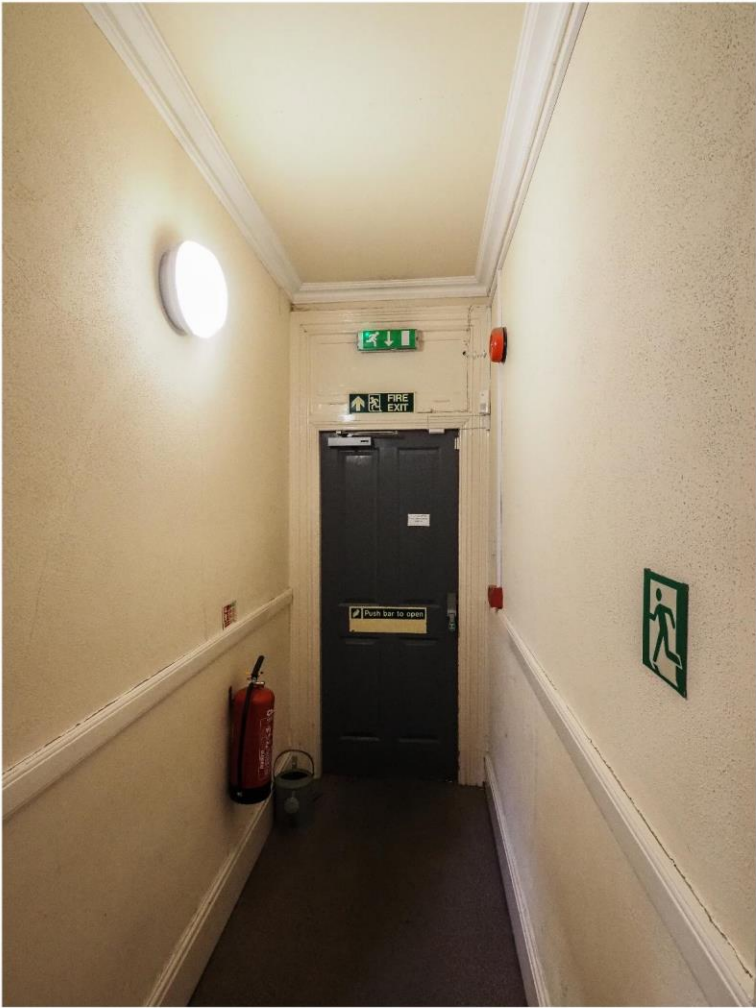
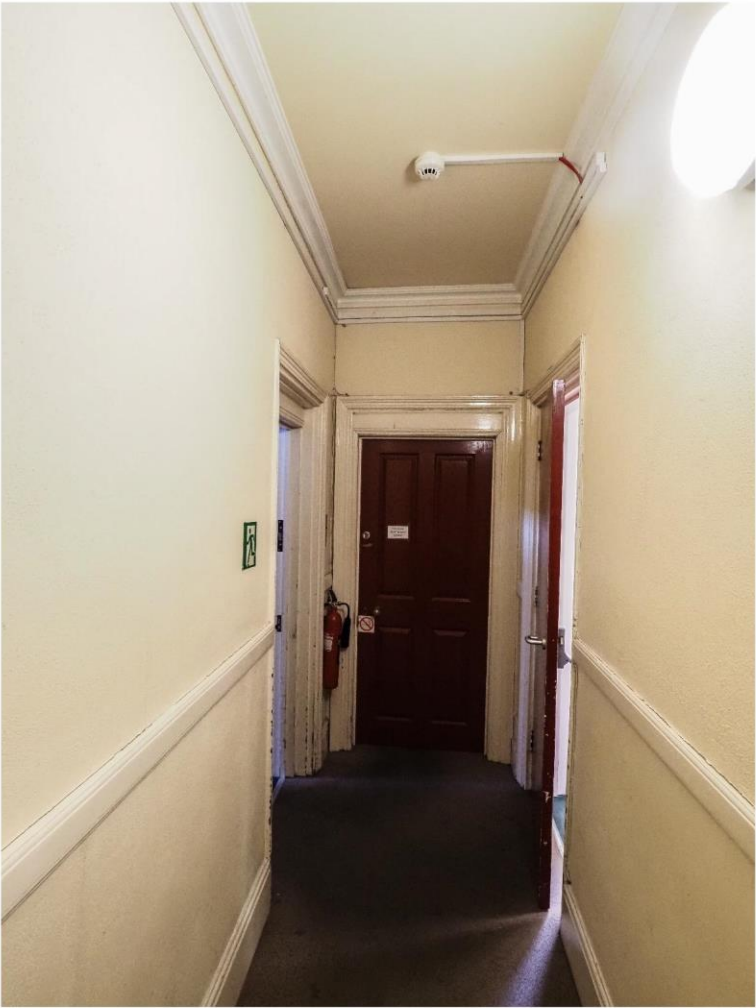
iii) Corridor leading to GF Offices 1 and 2
looking northeast [left] and southwest [left]

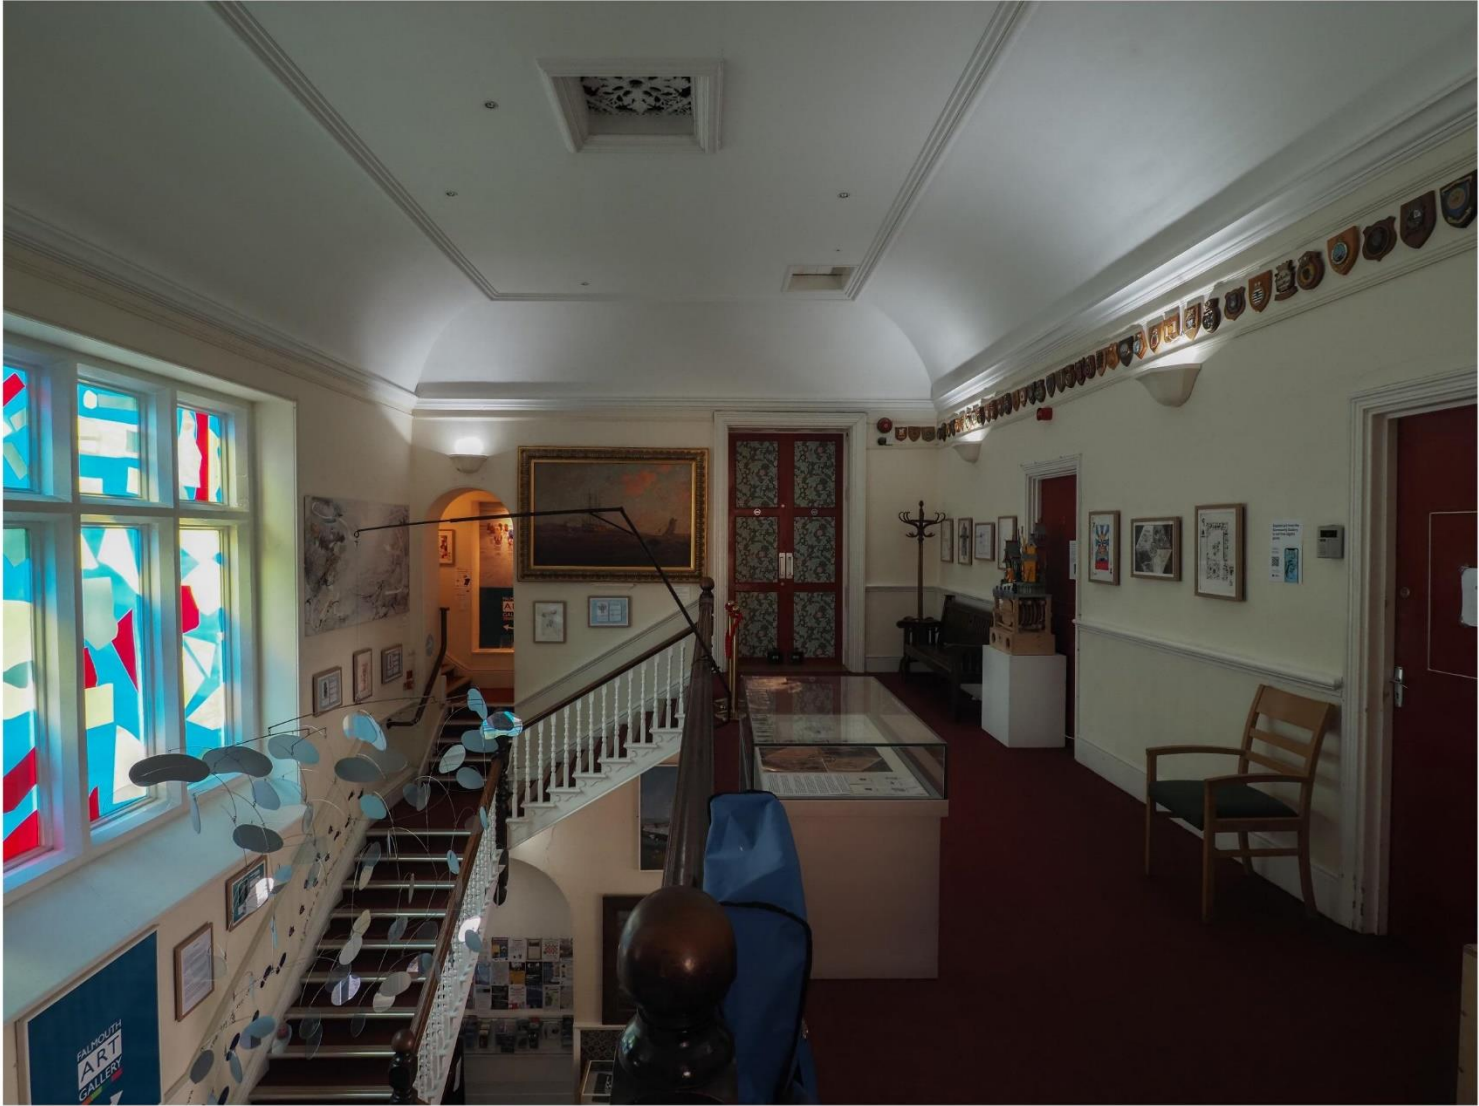
Figure 16: First floor landing

i) First floor landing, looking northeast, showing covered ceiling and original details throughout

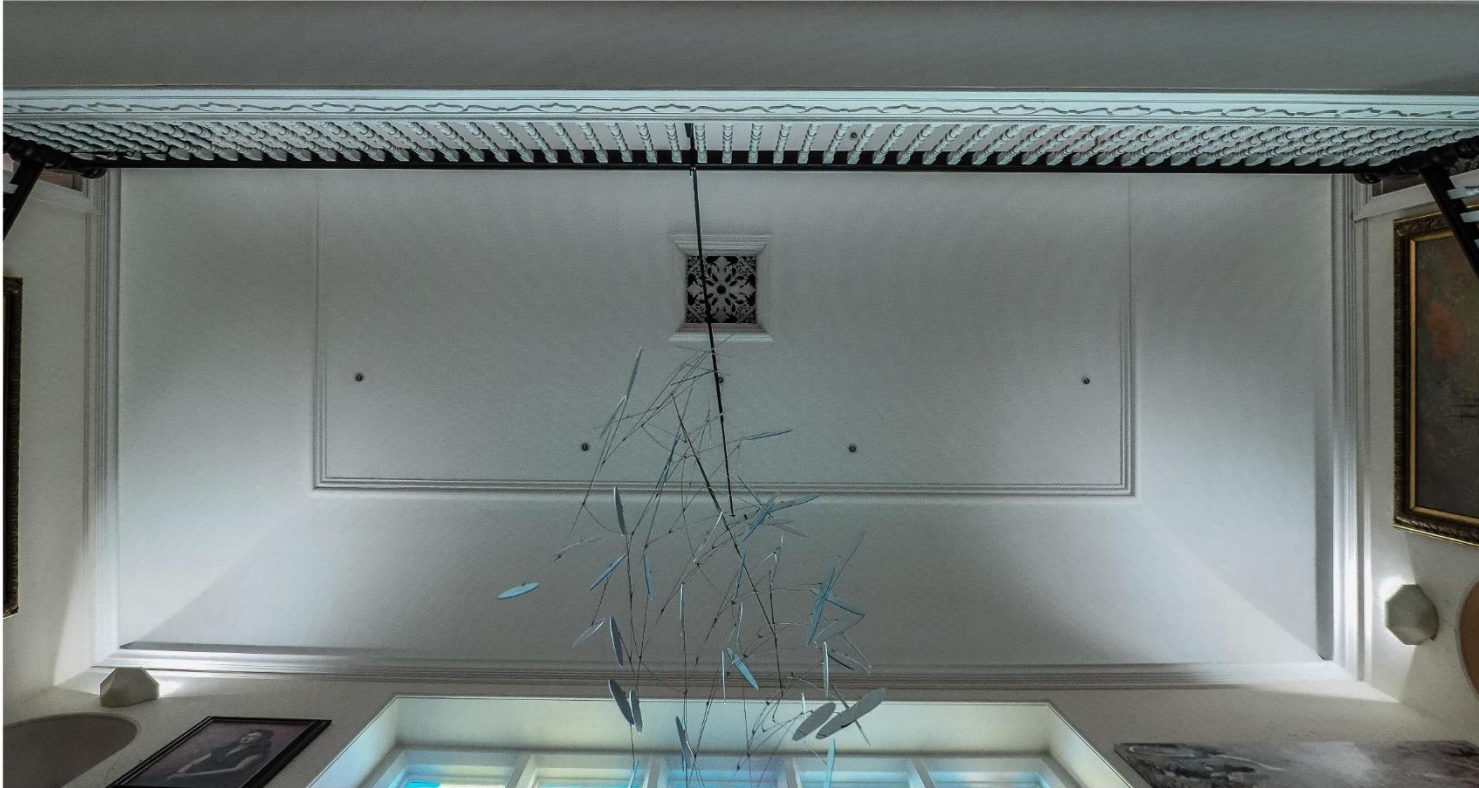
iii) Ceiling, and ventilation grille
