Statement Heritage

Municipal Building, The Moor, Falmouth, Cornwall, TR11 2RT

Historic Building Record, Statement of Significance and
Impact Assessment

SH Ref FALMUN0524 v1.1 Submission

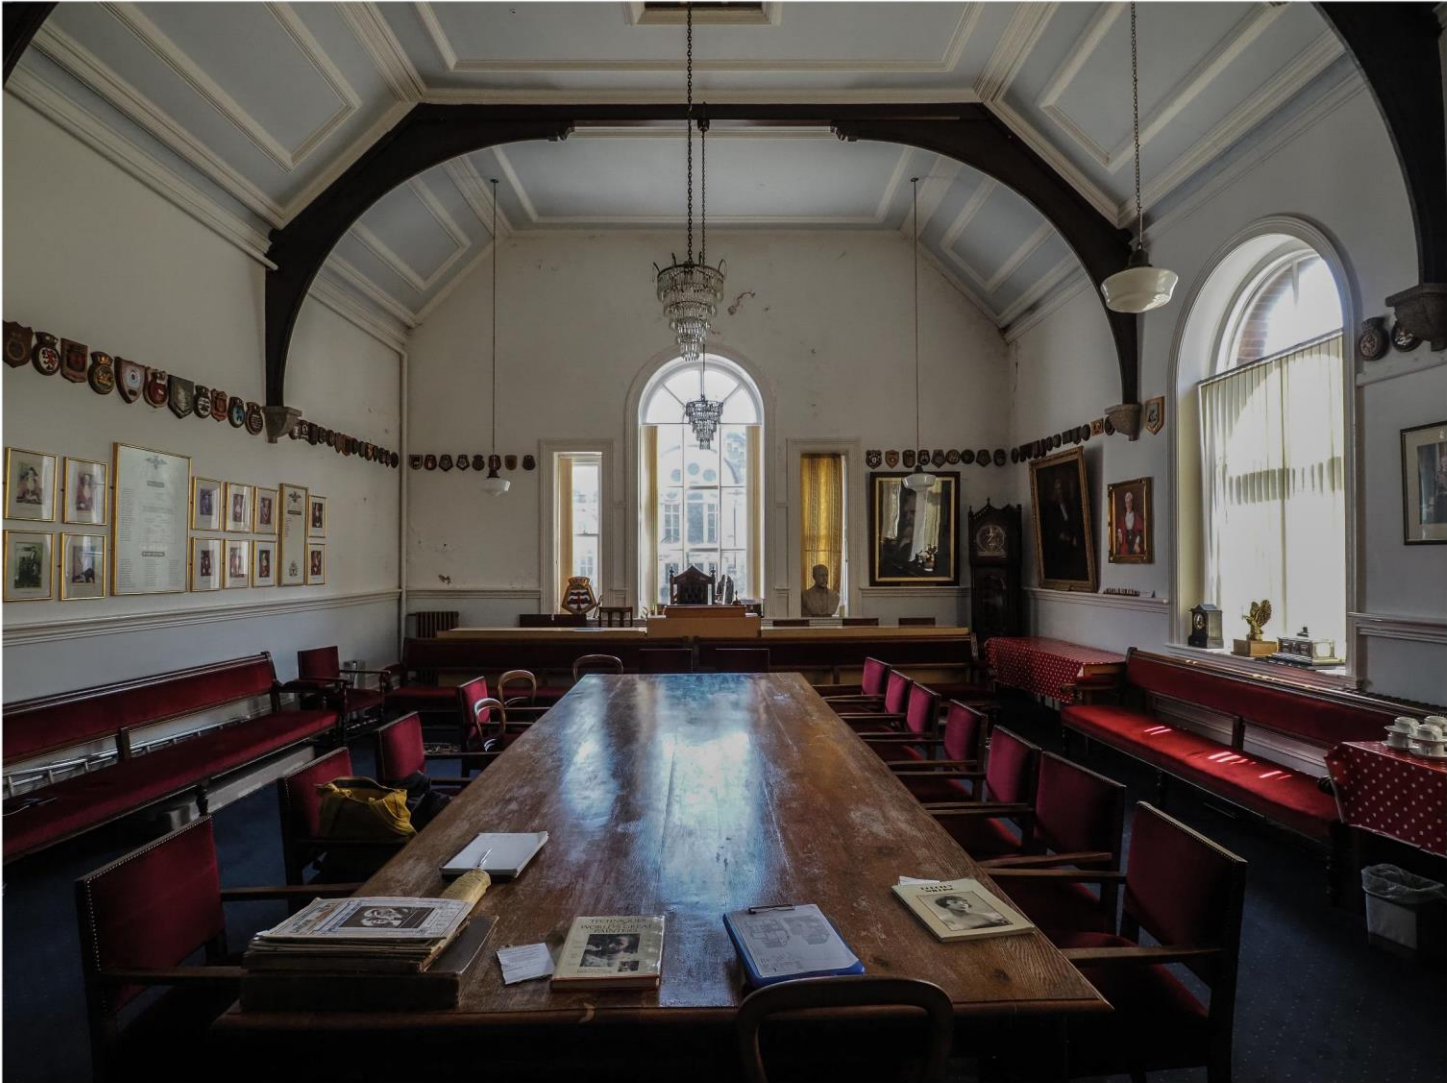
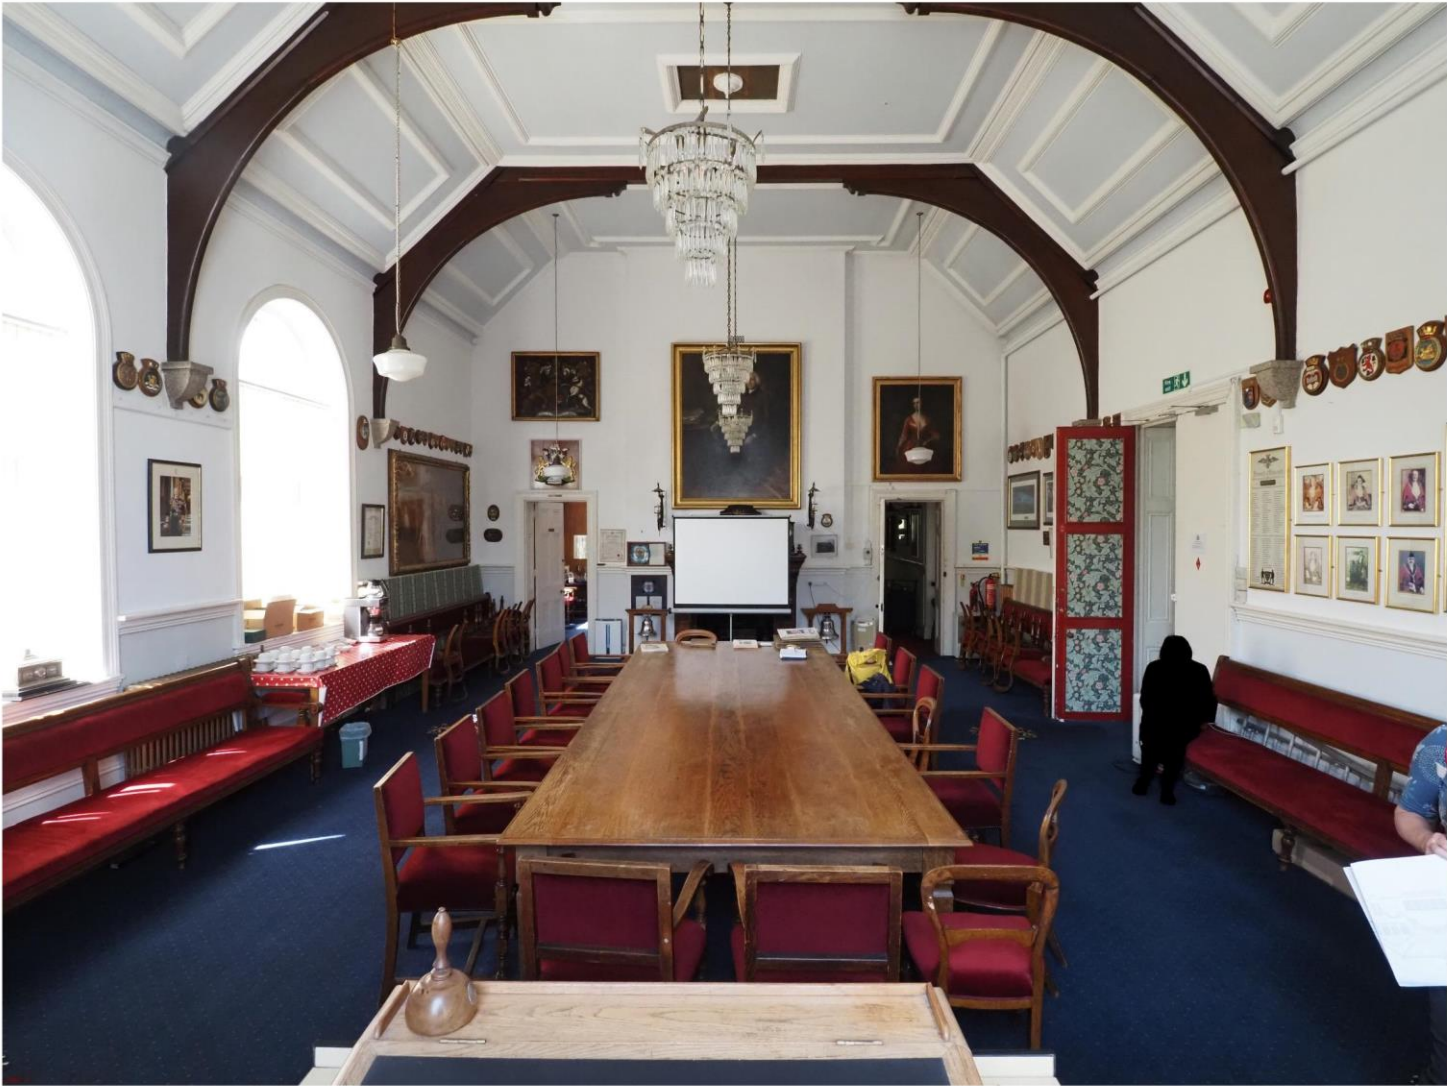
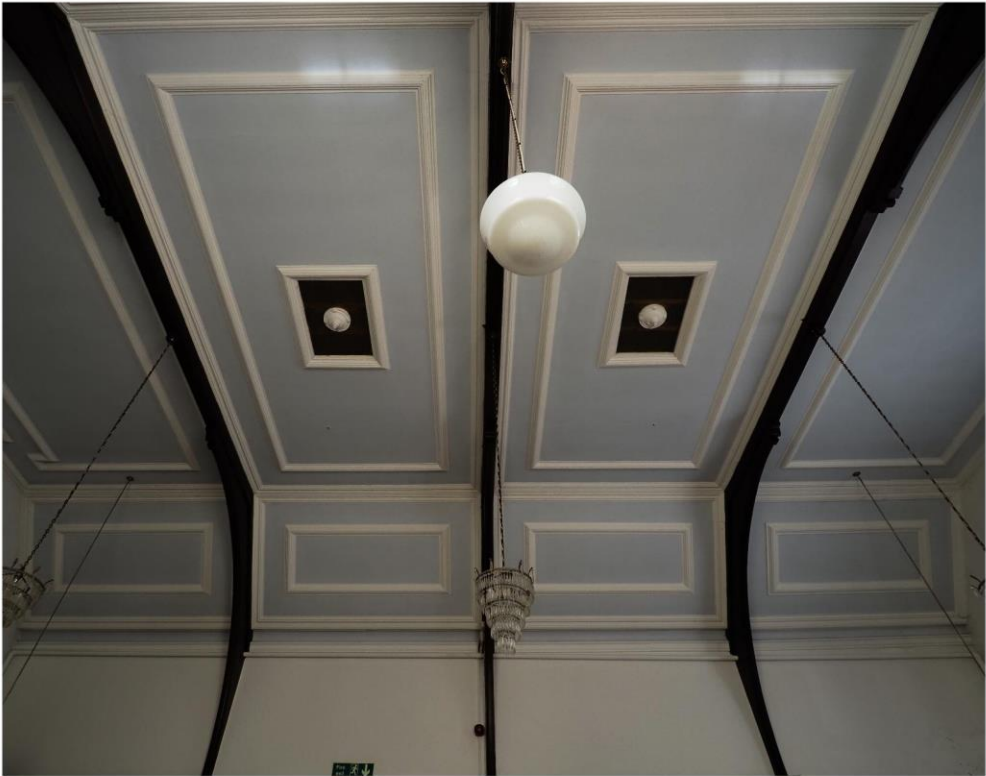
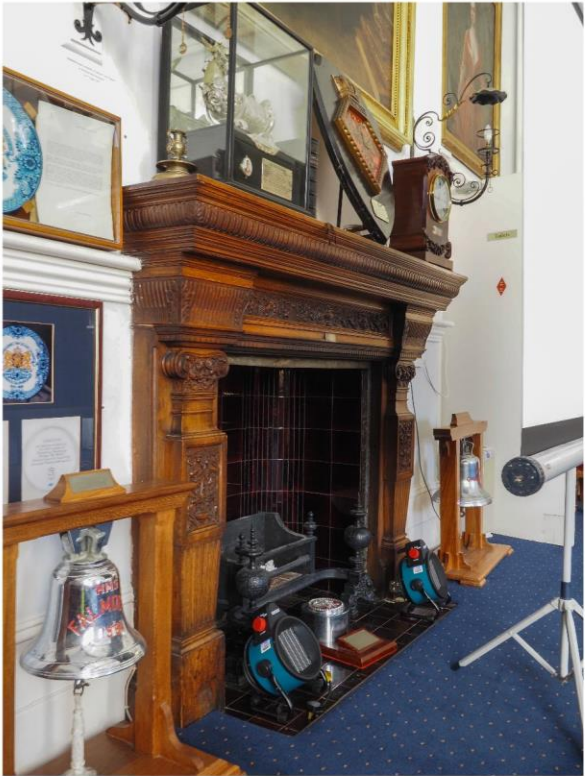
Figure 17: Council Chamber

- 4.17. The main space of the south-west wing is the *Council Chamber* (**figure 17**). This space has a canopied ceiling taking advantage of the raised collar design of the roof above. The panels of the roof are detailed with plaster mouldings forming rectangular panels, with two square ventilation openings (with plain grilles) between the two central trusses. The underside of the trusses are exposed and ornamented by false hammerbeams, each sitting on decorative stone corbels. The room is lit by two large semi-circular windows in the southwest elevation, and by the tripartite Venetian window in the southeast principal elevation. The room was originally heated by a very large fireplace, surviving *in situ* at the room's northwest end (**figure 17iii**) being of 17th century details with nulled, acanthus and floral carving. The room contains probably original table benches and chairs. The southeast wall of this room has some evidence of blown plasterwork and salts resulting from water ingress on this elevation (probably related to the poor shedding characteristics of original detailing, compounded by vegetation, prevailing winds and the use of gypsum plasters).

i) Council Chamber looking southwest

ii) Council Chamber looking northwest

iii) [left] detail, ceiling. Note simpler, probably replaced ventilation grilles

iv) [right] fire surround

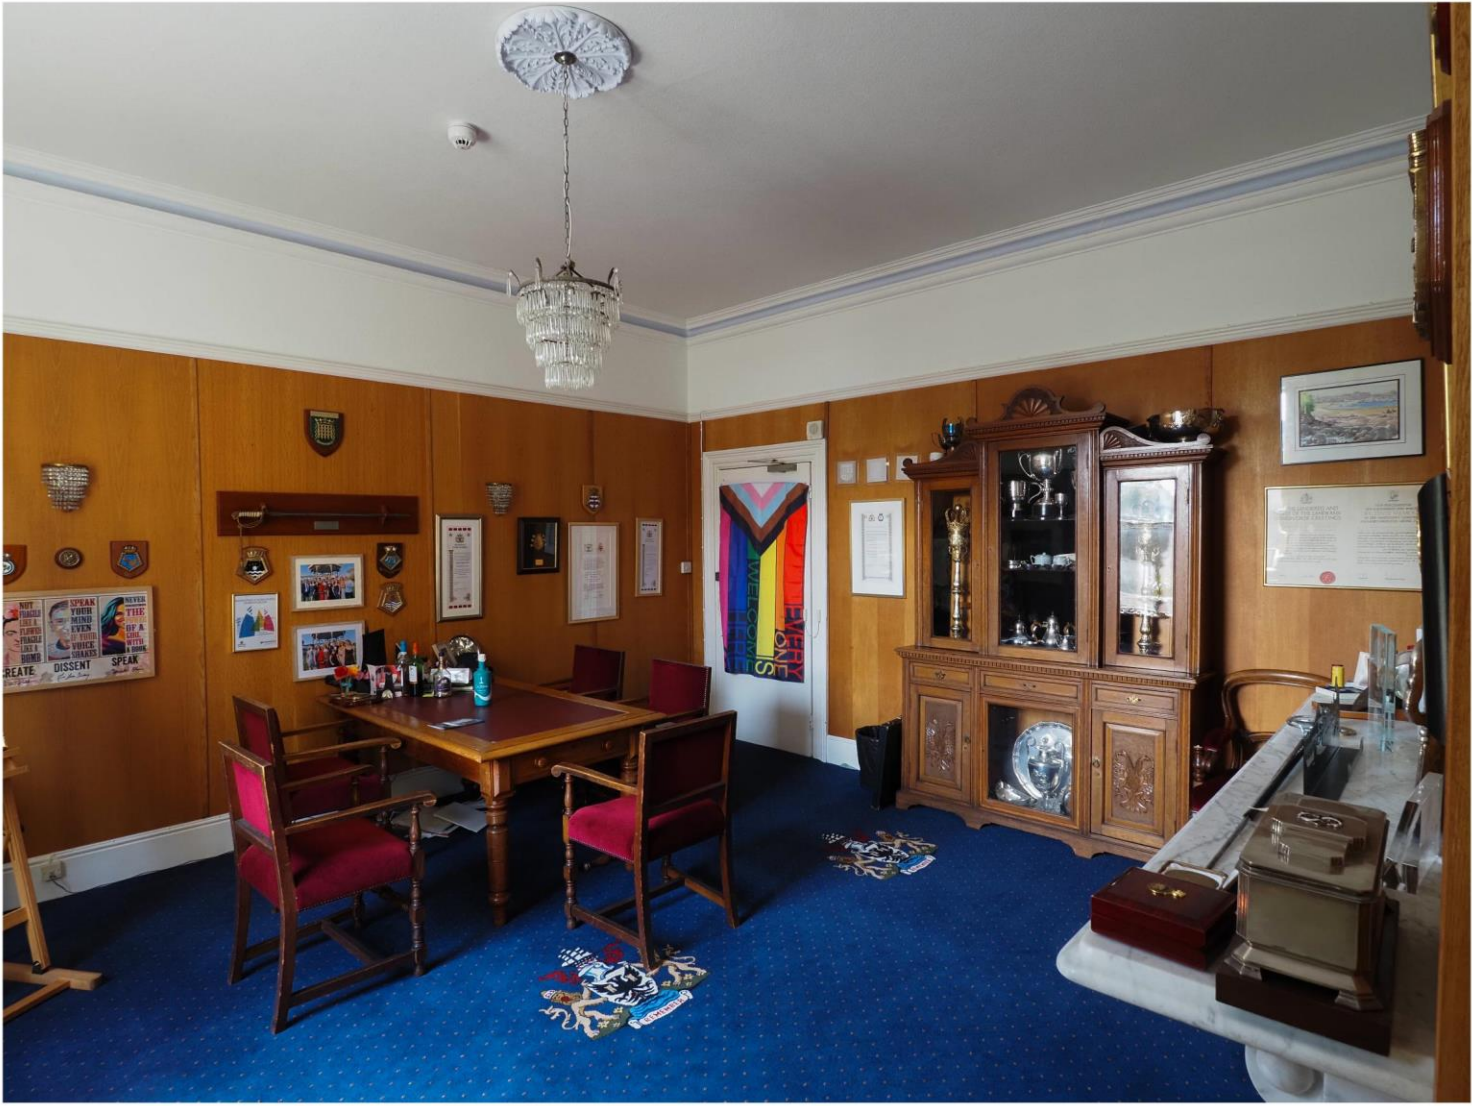
Figure 18: Mayor's Parlour

i) Mayor's Parlour, looking north

- 4.18. The *Mayor's Parlour* (**figure 18**) is accessed via an original six panel door. It retains original cornice, and a marble fire surround. It is lit by a single 4 pane horned sash in its southwest wall. Walls have been panelled in the 20th century in light timber. The room contains a carved cabinet containing the Town's civic regalia and plate.

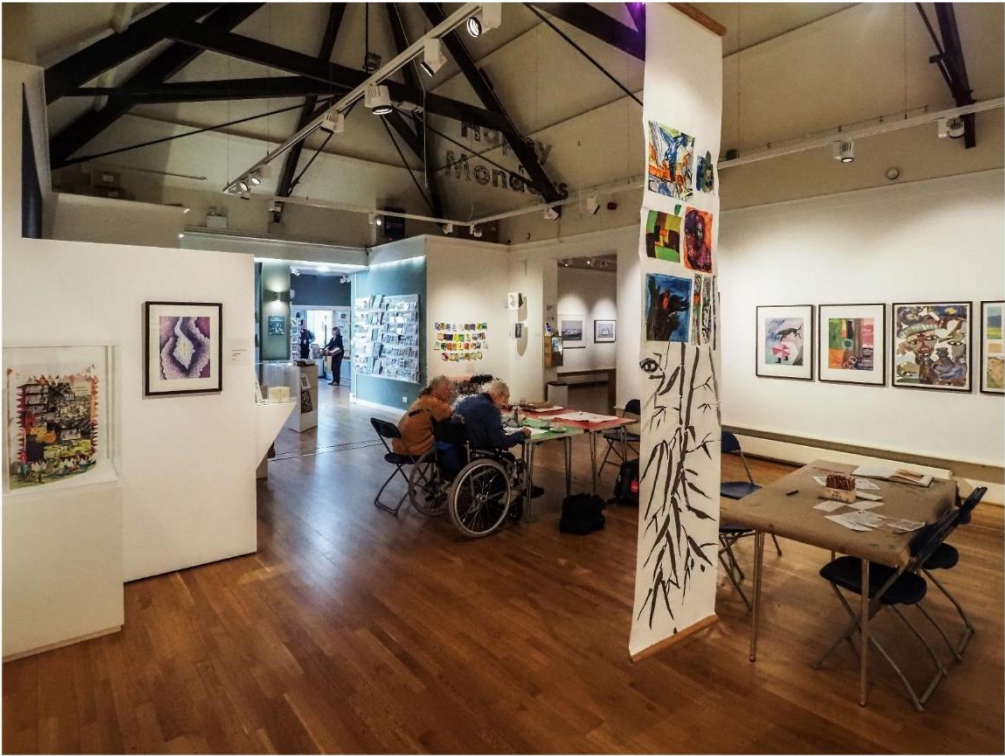
Figure 19: Falmouth Art Gallery

i) Gallery 1 (originally a Science Classroom), looking east

- 4.19. The *Art Gallery* (**figure 19**), occupies rooms originally designed for the *Science, Arts and Technical School* within the northeastern wing of the building and used during the mid-20th century as municipal offices. There are three rooms, within the historic part of the building, with a modern extension to the northwest (added in the 1990s) which today provides level access from Webber Hill. When approached from the main landing *Gallery 1* (**figure 19i, ii**) is the first space encountered. The room is open to a raised collar roof, given additional restraint laterally by steel bar tension members providing triangulation between wall plates and the centres of the collars, and vertically by further tension rods acting as king posts. The space has a larger volume than originally, a staircase and landing having been removed at its southwestern end in the later 20th century. Two windows to the northeastern wall of what original plans show was a *Science Classroom* have been removed, creating a large opening to the 1990s extension. The original plans show a larger opening in the southeast wall of the space (now the door to *Gallery 2*), probably originally containing a bifold timber screen. Today the space is artificially lit and presented with the neutral 'white box' aesthetic that has proved the dominant gallery paradigm since the early 20th century. This is produced by boarding across three walls creating white hanging space which obscures the original windows in the original southwest and northwest external walls, and simple, modern natural wood flooring throughout. North-light skylights in the northwestern roof slope are blocked by modern white ceiling boarding. Original plans show the space as heated by a fireplace centrally in the northwest wall, now blocked and behind a modern information and sales counter.

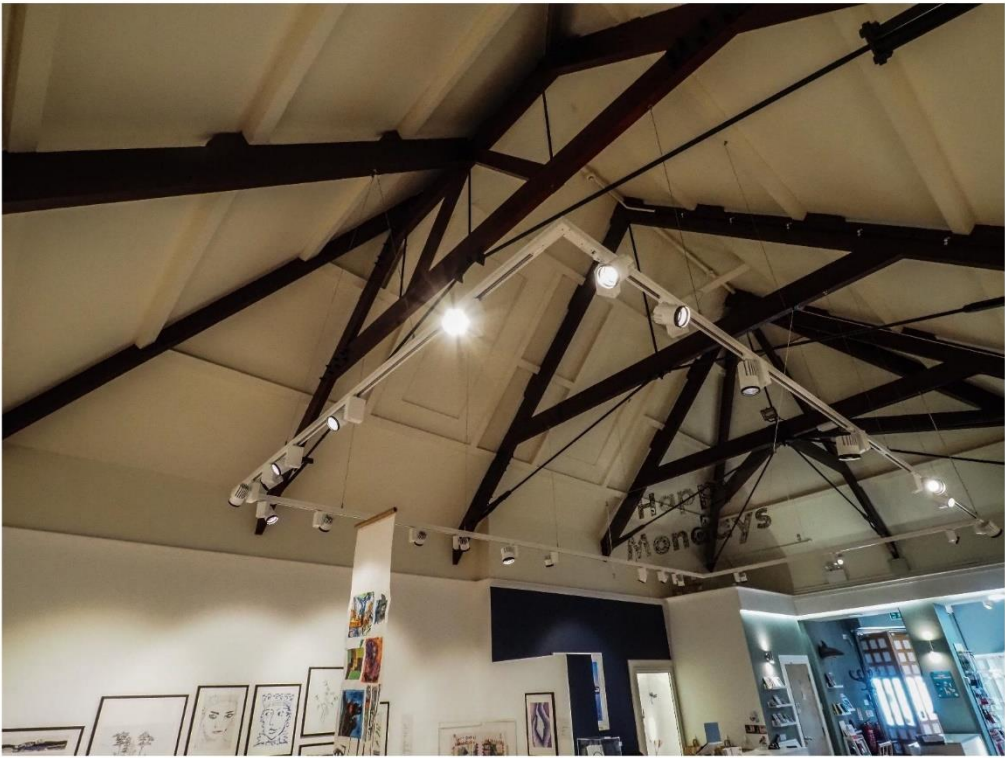
ii) Gallery 1, looking north, showing blocked rooflights.

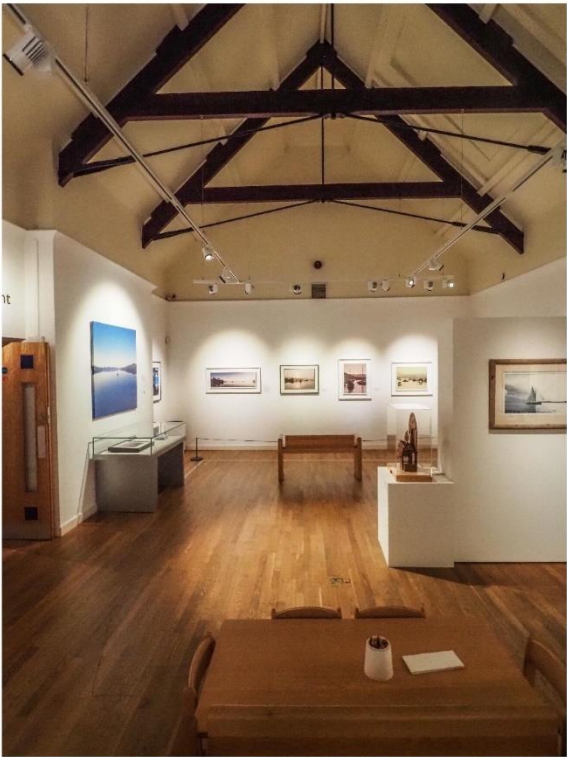
iii) Gallery 2, (originally a Science and Art Schoolroom) looking southeast

- 4.20. *Gallery 2* (**figure 19iii**), originally labelled as a *Science and Art School* has been given a similar treatment to *Gallery 1* with modern white hanging boards across the original fireplace within the southeastern wall of the space and the original two windows in the northeast wall. The space has a similar exposed roof structure and again there are blocked skylights in the northwest roof slope.

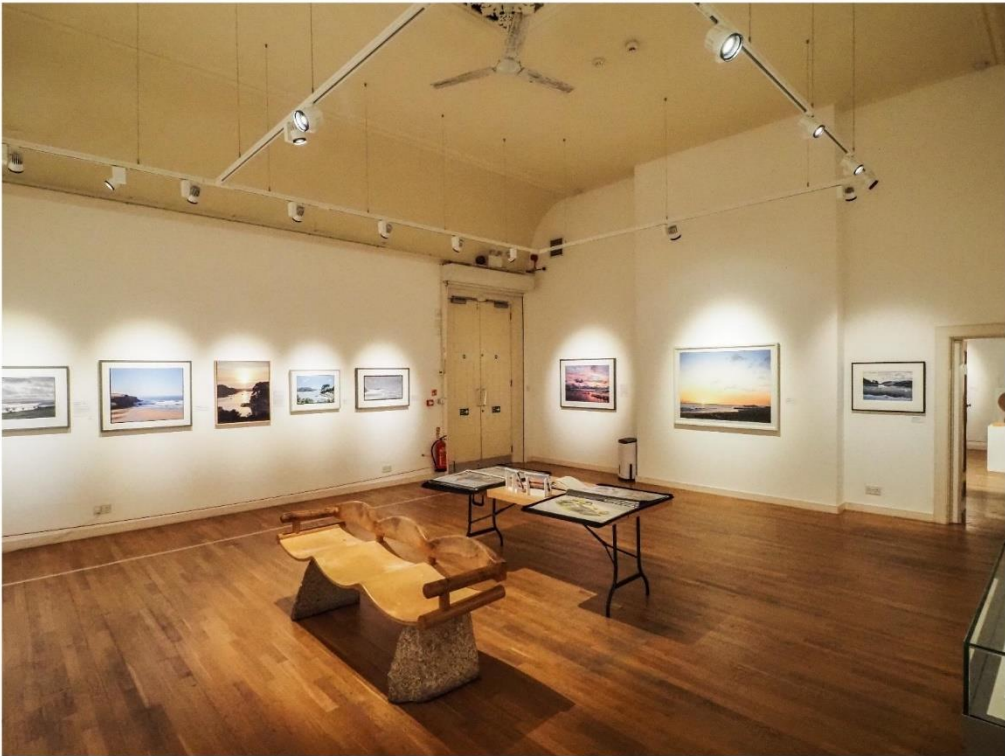
v) Gallery 3 looking west. Note blocked chimney breast.

- 4.21. *Gallery 3* (**figure 19iii**), originally labelled a *Science Classroom* but later used as a *Falmouth Borough Council* committee room. The room retains its original ceiling, coved to the southwest and northeast sides of the room. The ceiling has a central floral ventilation grille, matching the details of that above the landing. There is a blocked fireplace in the northwest elevation and , as with the other gallery rooms, walls have been lined in modern gallery boarding, covering original windows in the northeast and southeast elevations. There are modern fire doors within original openings to *Gallery 2* and to the *Landing*.

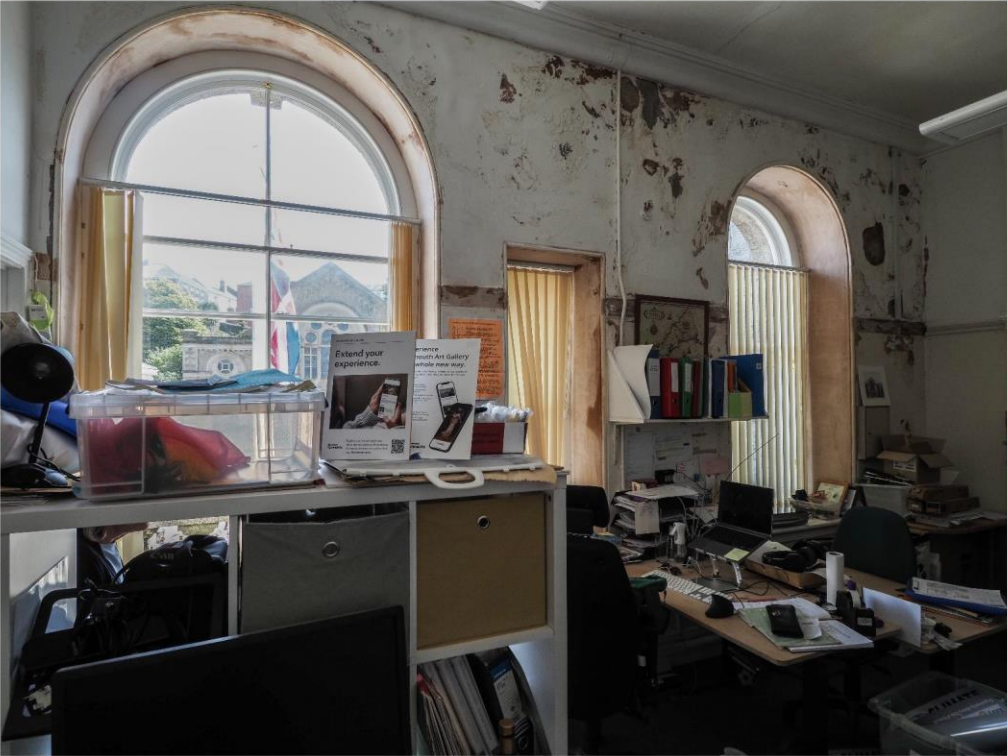
Figure 20: Office
and store off the
landing.

- 4.22. An *Office and Store* (**figure 20**) to the southeast of the *Landing* are shown on the original plans of the building as a *Science* room and *Science Cloakroom*. These rooms are lit by original windows opening onto the balcony above the portico. They retain original cornices, and room volumes, but both have had their original doors replaced by modern fire doors presumably part of a scheme to ensure the fire safety of the escape route via the main stairs. As with the Council Chamber there is further extensive evidence of water ingress on the external southeast wall of this space.

i) Office to the southeast of the landing.
Looking southeast. Note water damage from
ingress into the masonry of the principal
elevation

Replacement of internal plaster	Repair of water damage and improvement of thermal and breathability performance	As shown on proposed plans, and described within Cornish Lime Company Advice Report. Insulating plaster to be installed within Library 3 (non-fiction) against southeast wall, and against southwest walls of Council chamber, and office / store southeast of landing. Renovating lime plaster to be used to repair northeast walls of Library 2 (catalogue and Librarians office) and parts of ceiling of Gallery 3	The works are remedial to existing water damage to existing design values evident within Statement Heritage and Cornish Lime Company photography. As detailed within Cornish Lime Report the use of insulating plaster in the Council Chamber and offices above the portico will require careful detailing to mimise impacts to surrounding plaster moulding details.	These works are considered to enhance the design values of the building	It is recommended that design and detailing is expanded on within submitted method statements, which can be agreed by condition as necessary.	Para 88 <i>“Internal wall insulation will be acceptable in some cases. The special interest of most listed buildings owes much to the character of their interiors. This includes their finishes, such as historic plaster, joinery, cornices, chimneypieces and other fittings. The introduction of internal wall insulation will generally disrupt these, to harmful effect. Internal wall insulation may be acceptable in buildings whose historic interiors have been lost or largely compromised and in some buildings whose interiors may not be sensitive to such changes. If it is appropriate to line previously unplastered internal walls as part of a conversion, then the opportunity to introduce insulation will exist. In the case of buildings of traditional construction, internal wall insulation may also lead to maladaptation, particularly through lack of ventilation, cold bridging and condensation on the wall. It is strongly recommended that permeable materials are used to avoid damage to the building”</i>

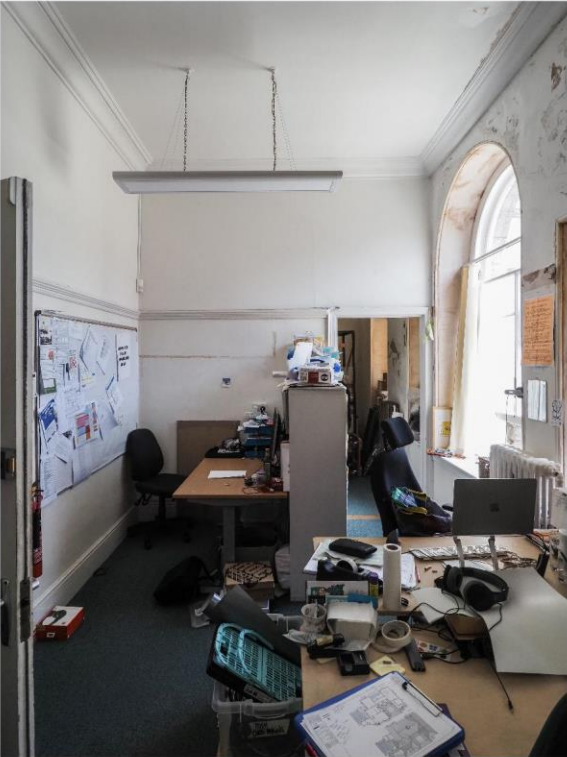
ii) Office, looking southwest
showing cornice details

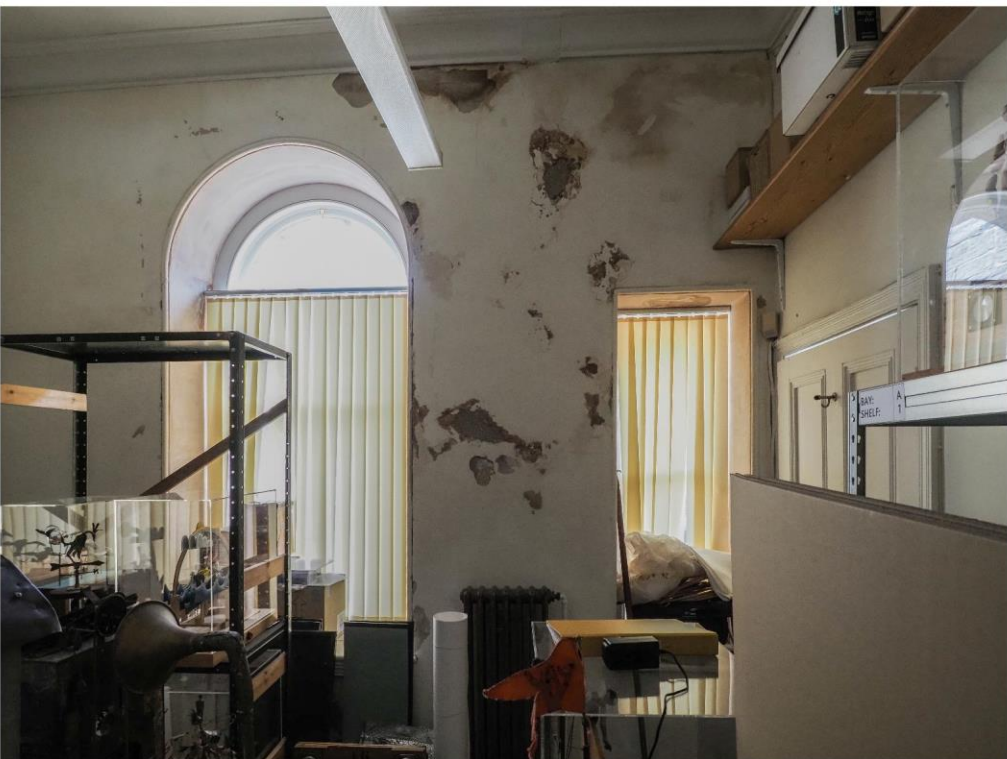
v) Southwest wall of store,
showing similar water damage

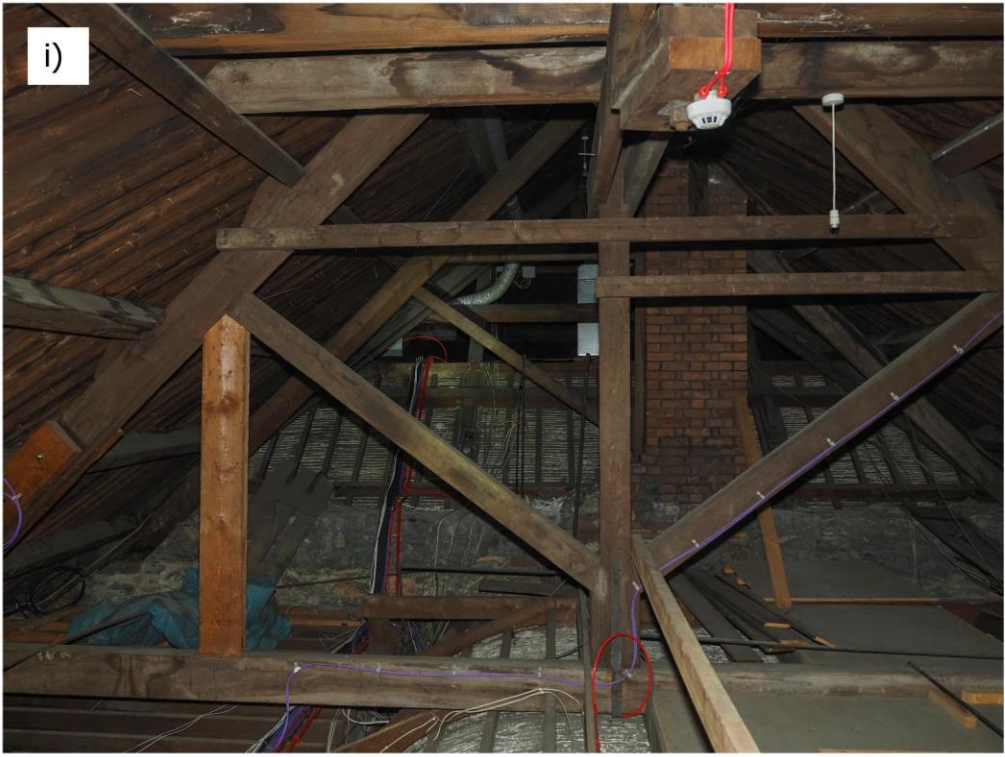
i) Roofspace above stairs, looking southwest towards the coved ceiling of the Council chamber, note staining from water ingress on roof collars and purlins.

- the replacement and upgrading of roof coverings,
- the replacement of lantern windows to the *Library Extension*
- the reinstatement of passive ventilation within the roof space
- review and repair of the lantern cupola
- replacement and upgrading of rainwater goods
- installation of fire curtains within the roof-space
- works to replace and improve rendering to the rear faces of parapet walls
- masonry repairs and repointing
- improving the detail of ledges above string course details to address penetrating damp
- internal plaster repairs

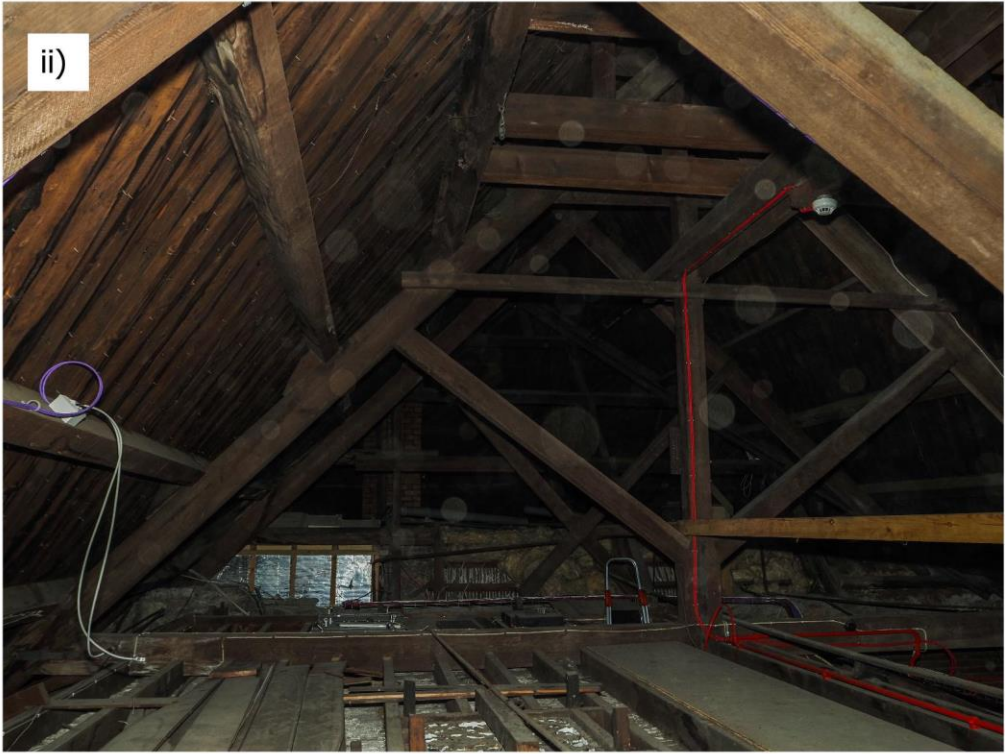
Figure 21: Roof Space

ii) Looking northesast towards the coved ceiling of Gallery 3

- 4.23. **Figure 21** shows the roof spaces above the central range and into those above the Council Chamber and *Gallery 3*. These spaces have king post trusses, those above the side wings having raised collars to accommodate the coved ceilings of those spaces. The original lath and plaster ceilings of these spaces are exposed, and currently without insulation. The roof incorporates sarking boards throughout, these showing extensive evidence of water penetration. Modern probably electrically powered ventilation plant is evident above the grilles of the Council Chamber (**figure 21vi**), but the original ventilation grilles of the lantern (**figure 21 v**), above that in the ceiling of the *Landing* have been blocked. **Figure 22** presents some images of the passive

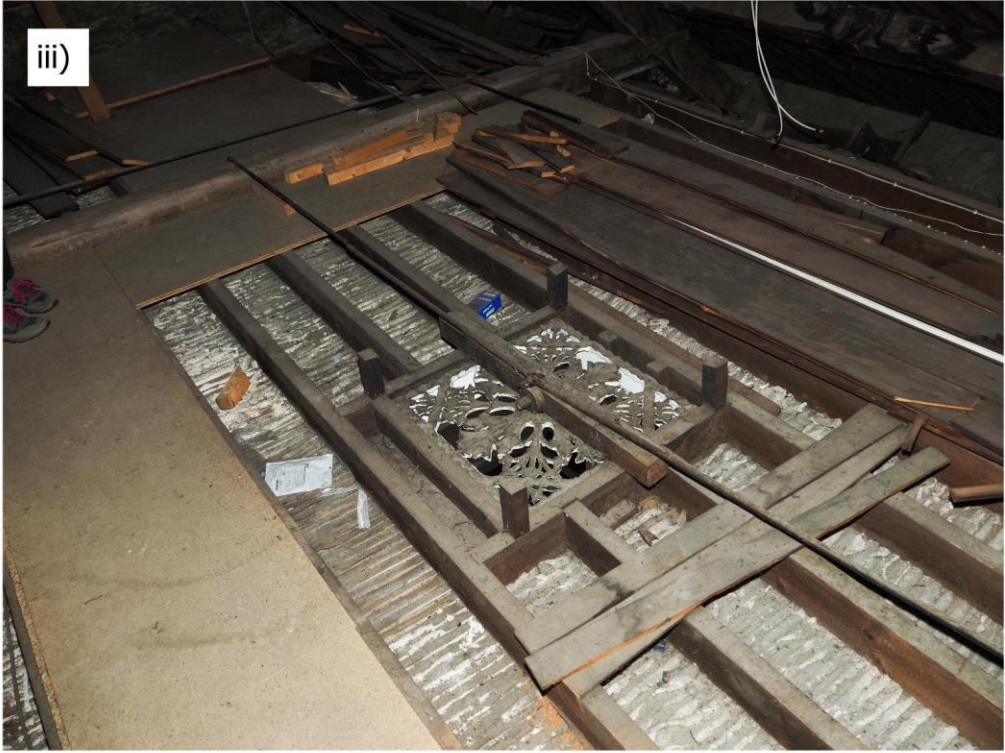
iii) Showing the ventilation grille in the landing ceiling

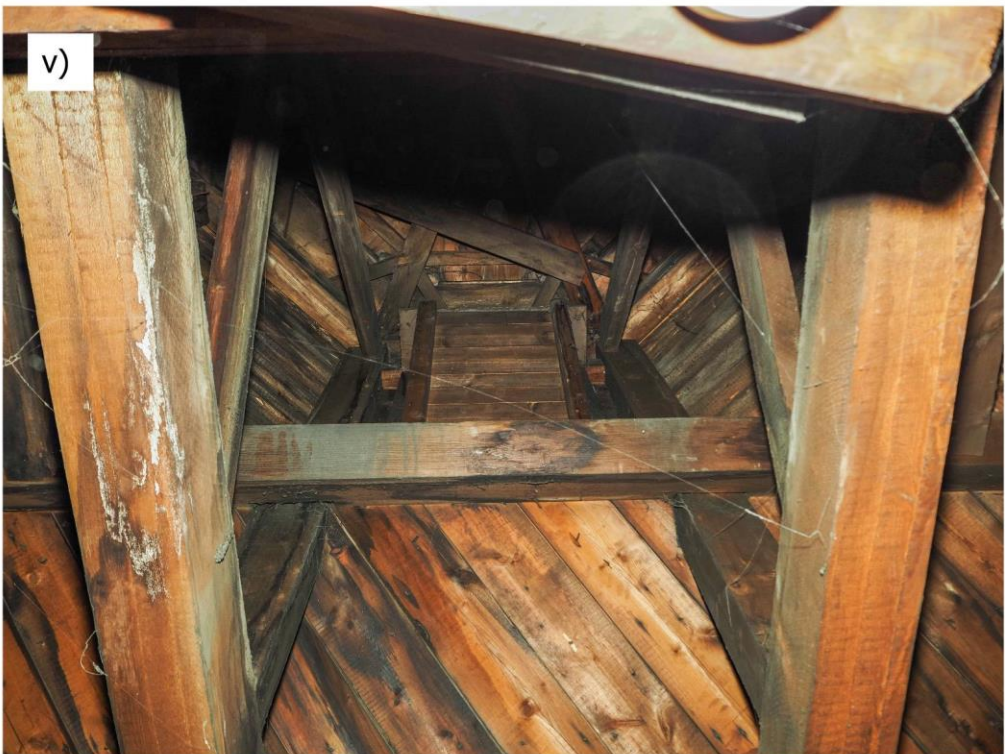
iv) Looking upwards to the base of the lantern. The ventilation grilles to the northwest and southeast sides of the structure are blocked and there is much evidence of (probably historic) water ingress

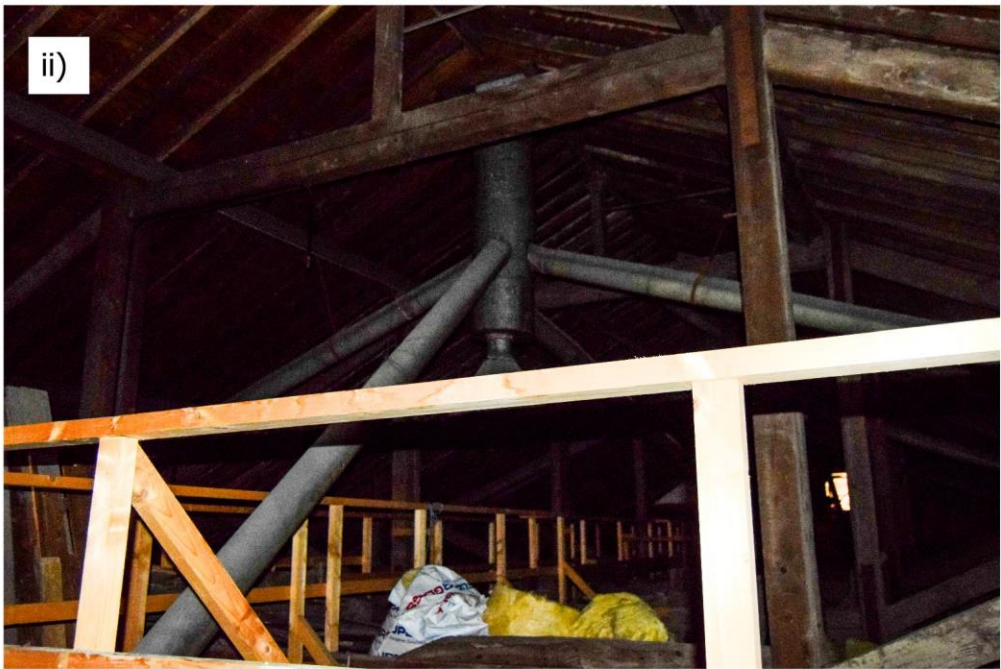
ventilation systems installed at *Truro Methodist Church* (dating to the renovation of that building by *Sylvanus Trevail* in 1885 and at the *Old Fire Station*, Redruth (c1907). The system installed at *Redruth* is likely similar to that which has been removed at *Falmouth*, where pipework was connected directly to grilles set into ceilings. Both systems draw on both convection, the 'passive stack' effect and the *venturi* principle, with pipework which narrows in section from the main riser grilles, accelerating the air (and so lowering its pressure) before venting via copper vents set on the ridge of the building. The system at *Truro Methodist Church* (recently made functional again after becoming redundant in the mid-20th century ⁷ is more sophisticated. Here central risers with wide intakes gather the rising air from the building, which in use would have included that created by a large population and gas lighting, the low pressure pipework above drawing in further air from vents incorporated into floral mouldings around the cornice, air being replaced from low ventilation grilles around the plinth of the building via openings set in the internal window sills and disguised as further mouldings.

i), ii) and iii). The passive ventilation system installed at Truro Methodist Church is a complex arrangement (i) which maximises use of the Venturi principle. The dramatic narrowing of the central risers, which draw heat generated by the congregation and gas lighting by convection, increases the airflow in the narrow pipe above, reducing its pressure and inducing strong airflow through the perimeter vents, concealed within floral mouldings in the cornice. The air is discharged through turrets along the ridge, here probably the patented 'Ewarts' design. The air is replaced by inlets set in the ground floor windows. Installed c1885.

iii) and iv) A simpler system survives at the Old Fire Station in Redruth. Two vents above the main garage within a now removed ceiling directed air to a copper turret. A larger turret was used to ventilate the tower (provided in order to dry hoses)

Reinstatement of ducting to reinstate traditional performance of passive ventilation vents in historic ceilings ridge turrets and the cupola tower (designed to provide passive stack ventilation). Main roofs.	Reinstatement of historic passive ventilation system and vent turrets	Details to be confirmed, but anticipated to involve ducting of existing ceiling grilles to roof turrets (to be reinstated or replaced in copper to historic designs as required)	The system, removed in the 20 th century, dates to the construction of the building.	These works, which will be informed by but modified from historic precedents will provide some fire protection from the existing ceiling grilles which are currently open to the roof space as well as improving natural ventilation throughout the building whilst minimising the energy requirements of a mechanical extraction system. The works are assessed as enhancing the sustainability and environment of the building, and delivering better conservation of the building fabric through delivering more effective ventilation of the building and roof space.	It is recommended that specialists in passive stack ventilation are employed to model and design the reinstated system. Conflicts with fire compartmentalisation, and temperature differentials in the summer (when it is increasingly possible that on some days outside temperatures may exceed internal ones) that some additional mechanical extraction may be required.	The guidance notes that ventilation of historic buildings is particularly important where new insulation is being introduced and that in some cases supplementary mechanical ventilation may be acceptable. "Improved insulation has the potential to cause humidity issues even when permeable materials have been used and passive ventilation measures installed. Installing mechanical ventilation and heat recovery systems can sometimes be the best way of managing this. The impact of these systems on the significance of a building can normally be minimised by careful siting of equipment and ductwork. Mechanical ventilation and heat recovery are unlikely to be appropriate in high quality historic interiors" Para 93 p27
