PHASE II GEOTECHNICAL &
CONTAMINATION
ASSESSMENT

STUBBINS WOOD NURSERY
LANGWITH JUNCTION

TEAM EDUCATION TRUST

MARCH 2025

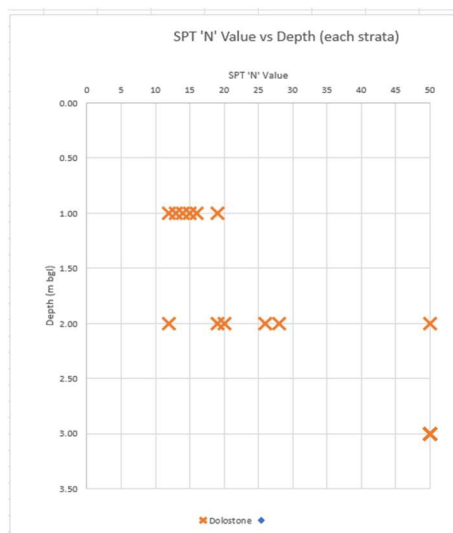
Figure 5.1: SPT 'N' Value vs Depth for Cadeby Formation deposits

Figure 5.1 illustrates a gradual increase of SPT 'N' Values with depth (m bgl) recorded in weathered Cadeby deposits and shallow refusals in boreholes WS1 and WS4.

Standard Penetration Tests (SPT) were undertaken during drilling of all windowless sampler boreholes. Figure 5.1 shows SPT 'N' Values vs Depth (m bgl) for tests within the weathered solid geology (Cadeby Formation). Figure 5.2 illustrates the individual SPT 'N' Value profile for each borehole.

Standard Penetration Tests (SPT's) were undertaken at approximately 1.0m intervals in each borehole to assess soil strength/relative density. Figures 5.1 and 5.2, overleaf, show SPT 'N' Values vs separate geology and each borehole, respectively.

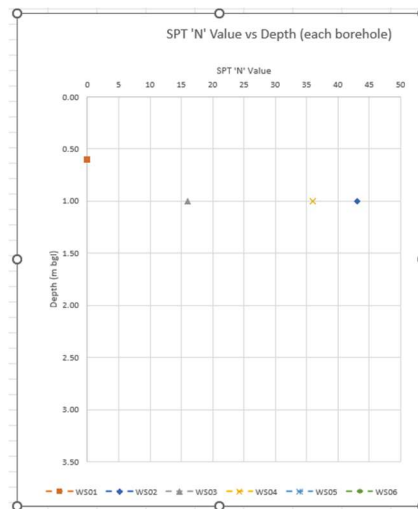
Figure 5.2: SPT 'N' Value vs Depth for Individual Borehole Profiles

Figure 5.2 shows that the SPT refusals at shallow depths across the site, illustrating the presence of shallow rock.

The ground conditions encountered were generally consistent in that shallow refusals were encountered in 50% of the boreholes with WS1 and WS4 refusing on rock at 1.0mbgl and boreholes WS2 and WS3 drilling through weathered solid strata to refusal at 2.1 and 1.70mbgl respectively.

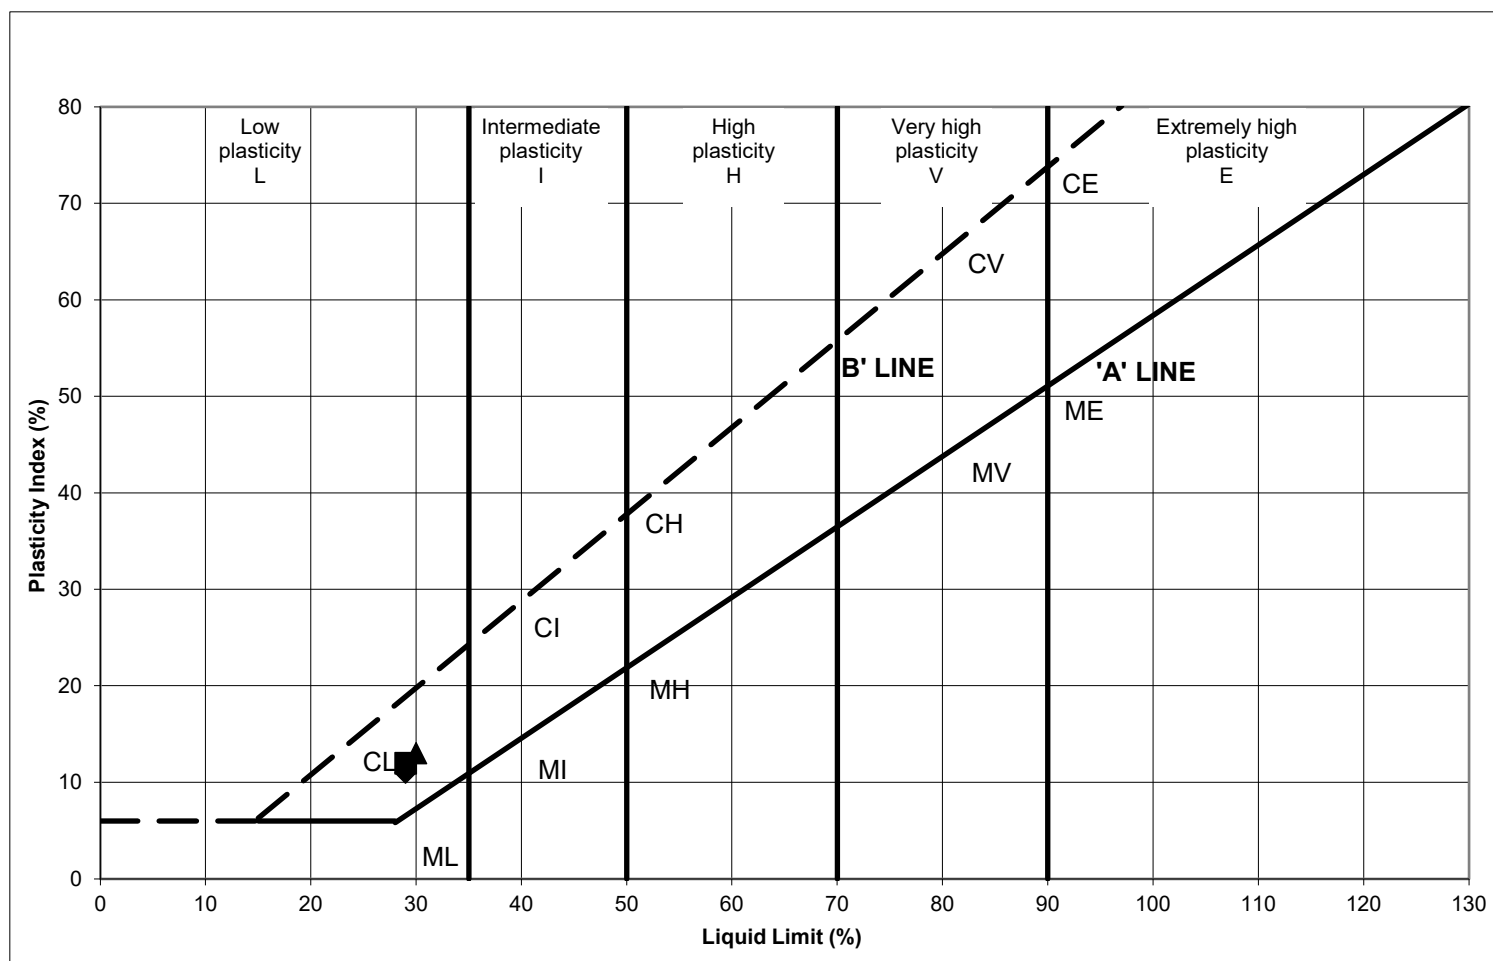
SUMMARY OF WATER CONTENT TEST RESULTS

Symbol	Borehole	Sample	Depth	Water Content (%)	Liquid Limit (%)	Plastic Limit (%)	Plasticity Index (%)	% Passing 0.425mm Sieve	Remarks
■	WS2	S0208	1.00	12.1	29	17	12	65	Clay with low plasticity
◆	WS2	S0209	1.80	11.1	29	18	11	76	Clay with low plasticity
▲	WS3	S0210	1.00	11.0	30	17	13	63	Clay with low plasticity
●									
□									
◇									
△									
○									
×									
✱

All samples were tested in accordance with BS 1377 - 2 : 2022 : Clause 5.3 and 6
All samples were washed on a 0.425mm test sieve prior to test.

The results contained in Appendix D illustrate modified Plasticity values of between 7 and 8.3% and moisture contents between 11.0 and 12.1%, indicating the underlying weathered strata to be of low plasticity and non – shrinkable.
