Job Number: 24-004

Biodiversity Statement for: **Extension and remodelling** at Knowle Village Hall, Knowle Avenue, Fareham PO17 5GR

Date : 27/06/2024
Revision: #

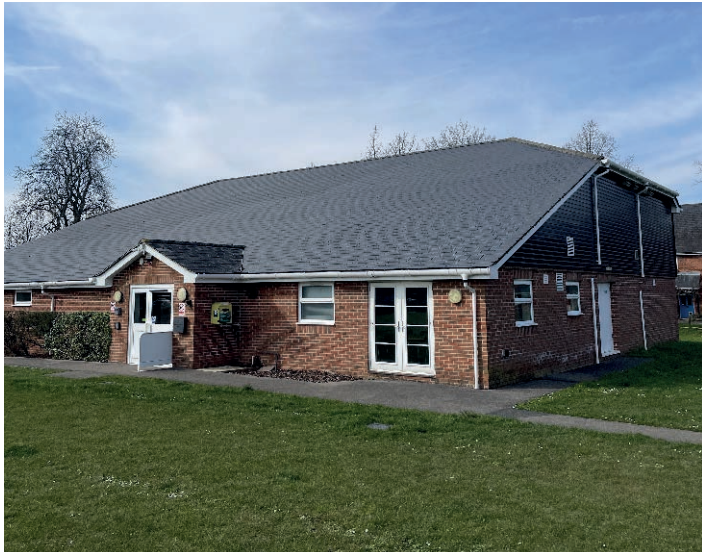
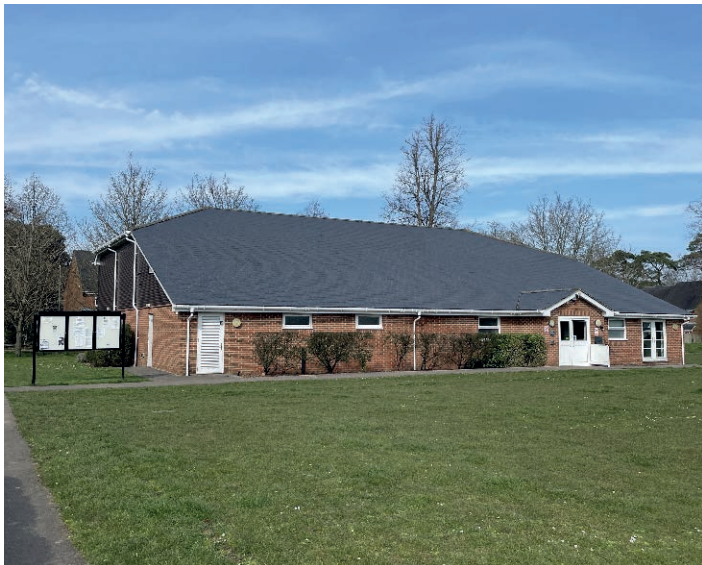
PHOTOS OF THE ROOF IN IMACULATE CONDITIONS

The client, Wickham and Knowle Parish Council, is retaining the existing roof wherever possible. There is no intention to disturb any protected species, but none are expected to be found: the buildings is of recent construction, therefore it is highly unlikely that bat roosts are present. Furthermore, the building has no a ceiling void above the ground floor plan and no loft space and there is no evidence of bat dropping was found ithin the building. Also, the immaculate roof tiles show no evidence of any external point of access (from the roof or anywhere in the building). Last, during our survey no bat dropping was found anywhere inside or near the building.

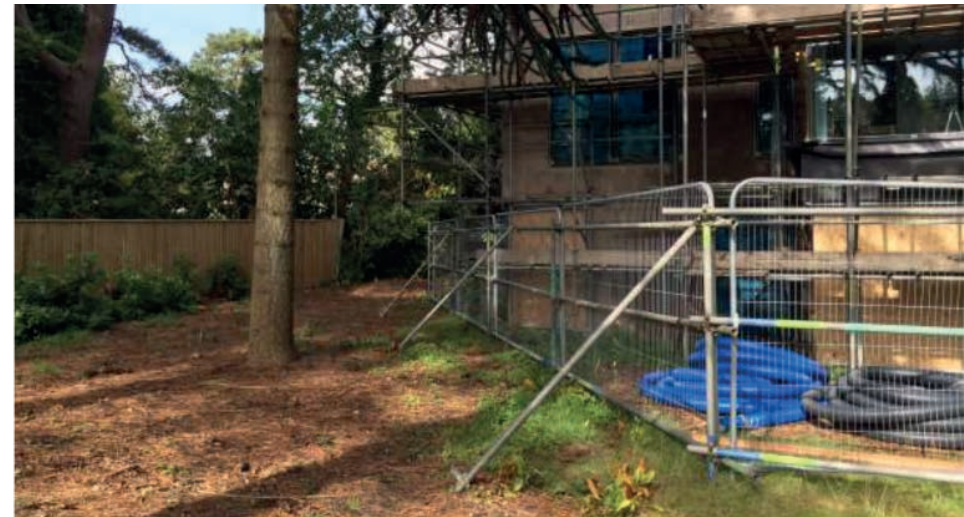
A WORKED EXAMPLE OF THE DEFAULT SPEC FOR PROTECTIVE BARRIER
