# **Invasive Species Survey Oxford Flood Alleviation Scheme**

## **2020 Update Survey**

**July 2020**

**For: Jacobs**

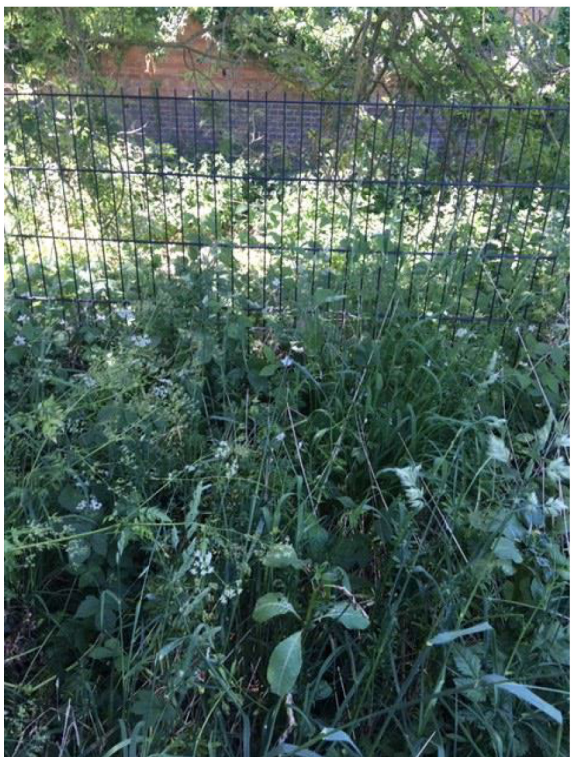
**Photo 2:** Himalayan balsam along channel adjacent to Botley Park (Appendix 1.1).

- 3.7 Smaller isolated clumps were recorded throughout the survey areas. Many of these have again expanded which have not been restricted by woodland and scrub which dominated those sections. Additional areas added to the 2020 survey all recorded some incidences of this species (Photo 1 & 2), particularly the water channels.

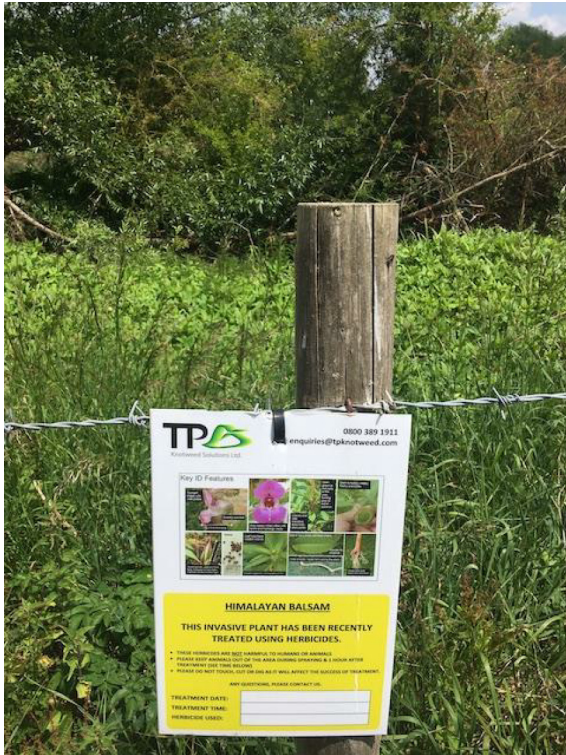
**Photo 3:** Signage adjacent to Himalayan balsam stands close to North Hinksey village, where treatments has not impacted the stand.

- 3.8 A number of sites have had eradication treatments applied, with varying levels of success. A small ditch section in Hinksey Meadows (Appendix 1.1 – HB2), seem to be eradicated. However, other sections of river, which have been identified as being treated (Appendix 1.2 – HB15), has not been affected (Photo 3).

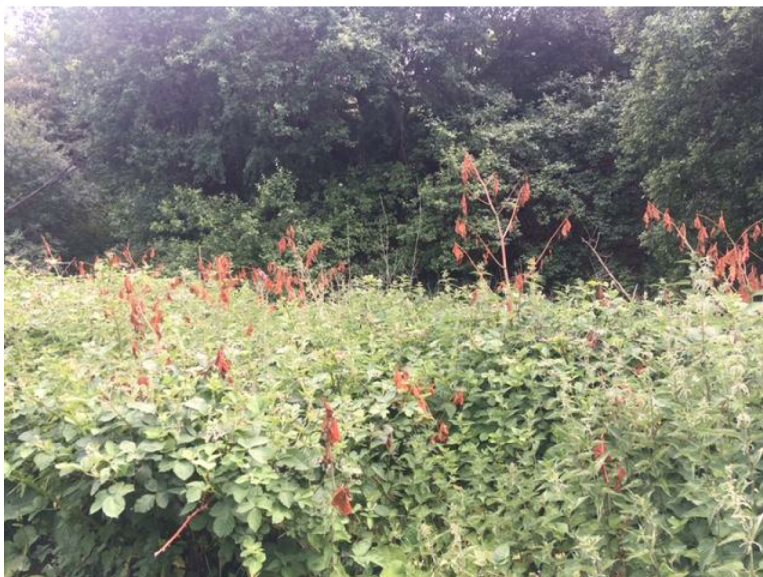
**Photo 4:** Japanese knotweed within Kendall copse (west of Kennington Road), show eradication treatments.
