Asbestos Management Survey Report

Cheese Hall, High Street, Chippenham, Wiltshire, SN15 3ER

Date of Survey:	2 Dec 2025 to 7 Dec 2025
Date of Report:	15 Dec 2025
<u>Job No:</u>	<u>J012948</u>
Authorising Surveyor:	Jim Hook
Verified/Signature:

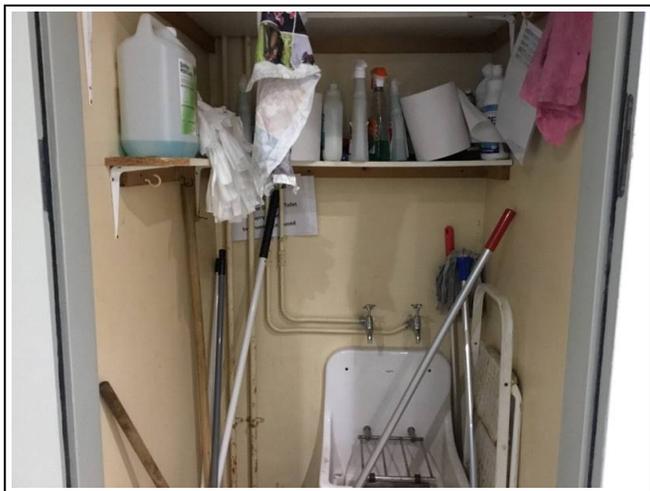
Survey Data Sheet: Conclusions & Recommendations
 Site Location: Cheese Hall, High Street, Chippenham, Wiltshire, SN15 3ER
 Building Designation: Building 01
 Unique item Number: 2

Sample Ref	Fl	Location	Description	Qty	Analysis Result	Total M.A.S	Licensed Material Y/N
Surveyed	Ground Floor	G.02 - Store	No asbestos detected		N/A	0	N/A

Recommended Action:
 -

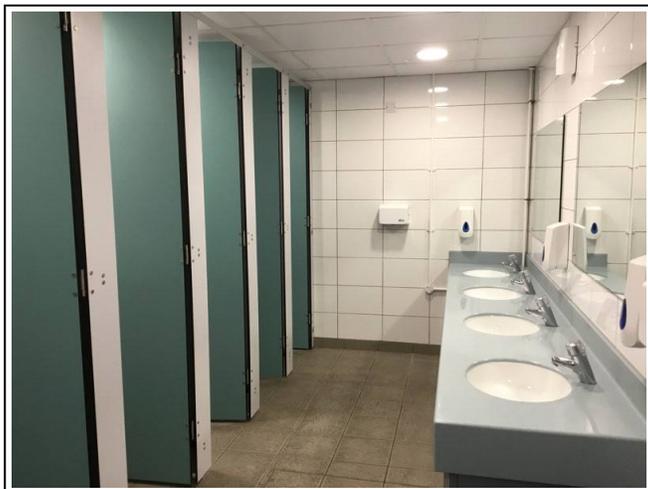
Survey Data Sheet: Conclusions & Recommendations
 Site Location: Cheese Hall, High Street, Chippenham, Wiltshire, SN15 3ER
 Building Designation: Building 01
 Unique item Number: 4

Sample Ref	FI	Location	Description	Qty	Analysis Result	Total M.A.S	Licensed Material Y/N
Surveyed	Ground Floor	G.04 - Female Toilets	No asbestos detected		N/A	0	N/A

Recommended Action:
 -

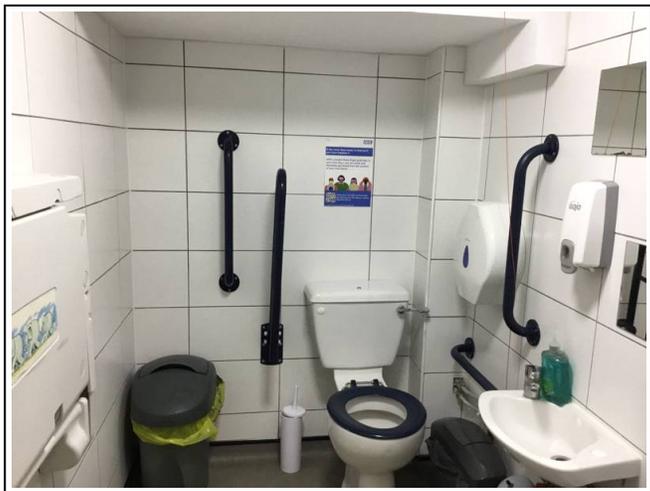
Survey Data Sheet: Conclusions & Recommendations
 Site Location: Cheese Hall, High Street, Chippenham, Wiltshire, SN15 3ER
 Building Designation: Building 01
 Unique item Number: 5

Sample Ref	FI	Location	Description	Qty	Analysis Result	Total M.A.S	Licensed Material Y/N
Surveyed	Ground Floor	G.05 - Accessible W/C	No asbestos detected		N/A	0	N/A

Recommended Action:
 -

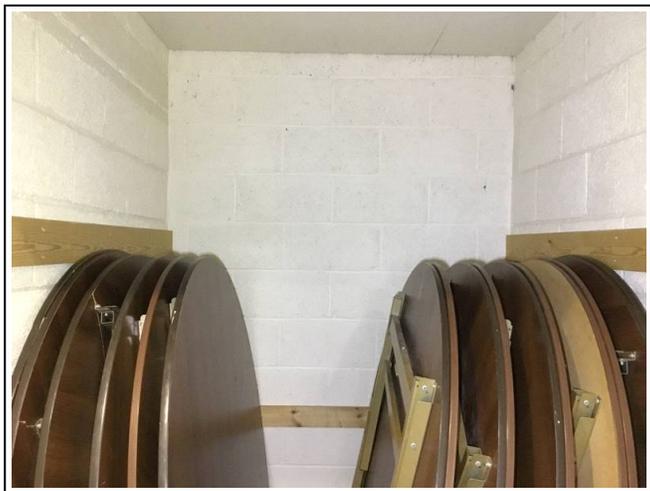
Survey Data Sheet: Conclusions & Recommendations
 Site Location: Cheese Hall, High Street, Chippenham, Wiltshire, SN15 3ER
 Building Designation: Building 01
 Unique item Number: 6

Sample Ref	Fl	Location	Description	Qty	Analysis Result	Total M.A.S	Licensed Material Y/N
Surveyed	Ground Floor	G.06 - Store	No asbestos detected		N/A	0	N/A

Recommended Action:
 -

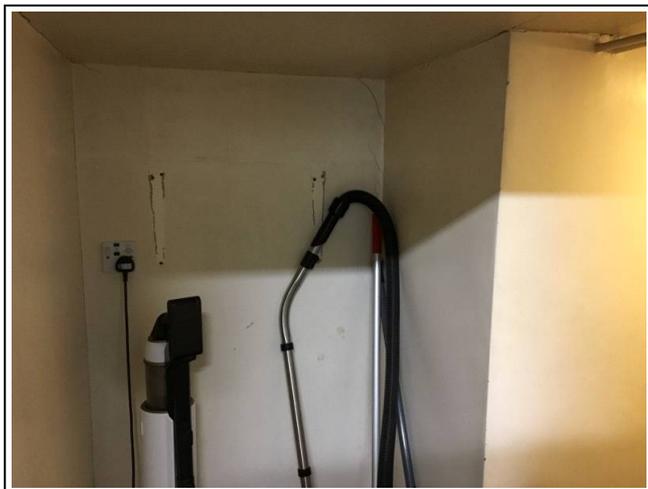
Survey Data Sheet: Conclusions & Recommendations
 Site Location: Cheese Hall, High Street, Chippenham, Wiltshire, SN15 3ER
 Building Designation: Building 01
 Unique item Number: 9

Sample Ref	FI	Location	Description	Qty	Analysis Result	Total M.A.S	Licensed Material Y/N
Surveyed	Ground Floor	G.08 - Cupboard	No asbestos detected		N/A	0	N/A

Recommended Action:
 -

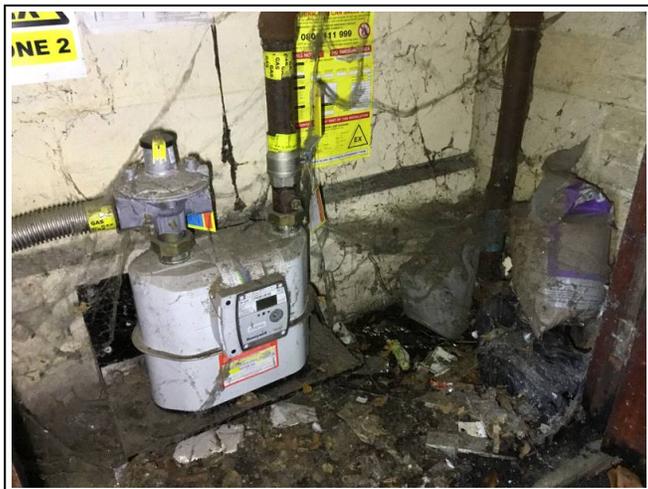
Survey Data Sheet: Conclusions & Recommendations
 Site Location: Cheese Hall, High Street, Chippenham, Wiltshire, SN15 3ER
 Building Designation: Building 01
 Unique item Number: 13

Sample Ref	Fl	Location	Description	Qty	Analysis Result	Total M.A.S	Licensed Material Y/N
Surveyed	Ground Floor	G.11 - Gas Meter Cupboard	No asbestos detected		N/A	0	N/A

Recommended Action:
 -

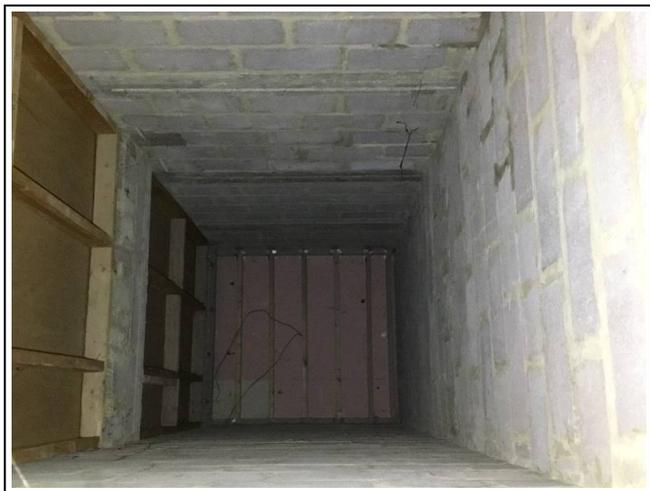
Survey Data Sheet: Conclusions & Recommendations
 Site Location: Cheese Hall, High Street, Chippenham, Wiltshire, SN15 3ER
 Building Designation: Building 01
 Unique item Number: 31

Sample Ref	FI	Location	Description	Qty	Analysis Result	Total M.A.S	Licensed Material Y/N
Surveyed	Lift Shaft	Lift Shaft	No asbestos detected		N/A	0	N/A

Recommended Action:
-
