# Asbestos Management Survey Report

Neeld Hall, High Street, Chippenham, Wiltshire, SN15 3ER

Date of Survey:	18 Nov 2025 to 7 Dec 2025
Date of Report:	15 Dec 2025
<u>Job No:</u>	<u>J012947</u>
Authorising Surveyor:	Jim Hook
Verified/Signature:

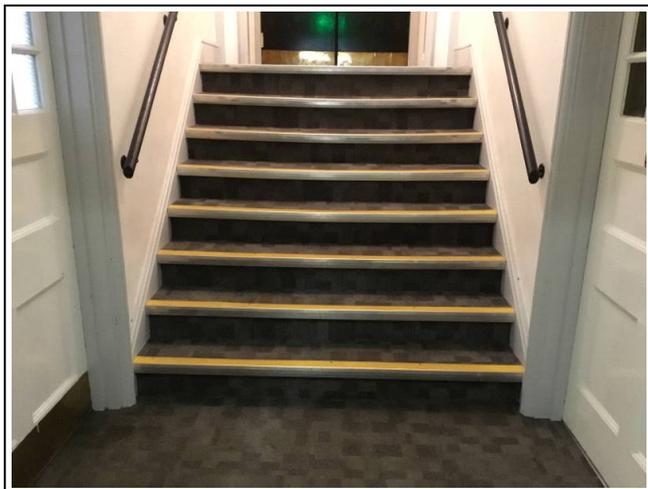
Survey Data Sheet: Conclusions & Recommendations  
 Site Location: Needd Hall, High Street, Chippenham, Wiltshire, SN15 3ER  
 Building Designation: Building 01  
 Unique item Number: 9

Sample Ref	FI	Location	Description	Qty	Analysis Result	Total M.A.S	Licensed Material Y/N
Surveyed	Ground Floor	G.01 - Stair Lobby	No asbestos detected		N/A	0	N/A

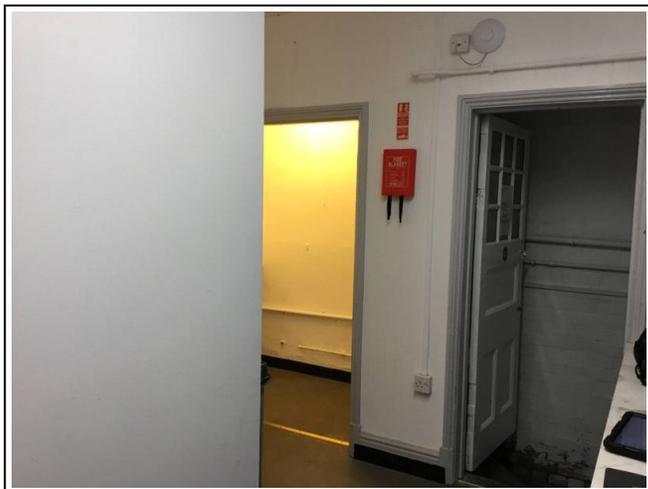
Survey Data Sheet: Conclusions & Recommendations  
 Site Location: Needd Hall, High Street, Chippenham, Wiltshire, SN15 3ER  
 Building Designation: Building 01  
 Unique item Number: 10

Sample Ref	Fl	Location	Description	Qty	Analysis Result	Total M.A.S	Licensed Material Y/N
Surveyed	Ground Floor	G.02 - Kitchen	No asbestos detected		N/A	0	N/A

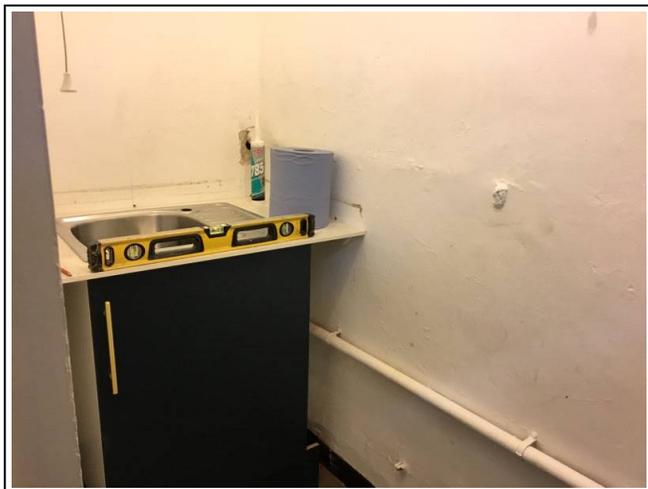
Survey Data Sheet: Conclusions & Recommendations  
 Site Location: Needd Hall, High Street, Chippenham, Wiltshire, SN15 3ER  
 Building Designation: Building 01  
 Unique item Number: 11

Sample Ref	Fl	Location	Description	Qty	Analysis Result	Total M.A.S	Licensed Material Y/N
Surveyed	Ground Floor	G.03 - Kitchenette	No asbestos detected		N/A	0	N/A

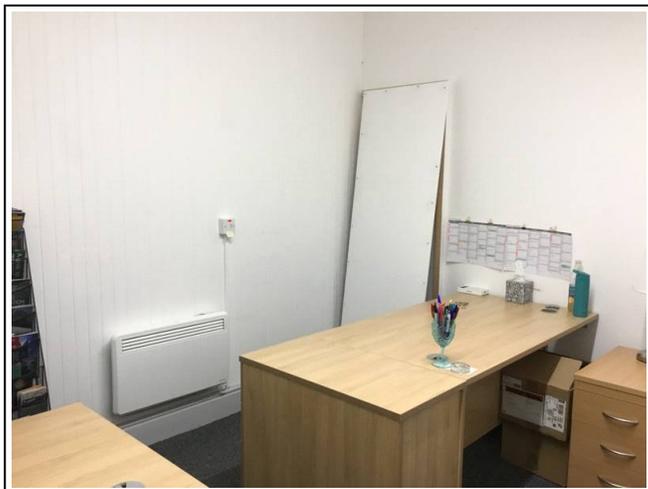
Survey Data Sheet: Conclusions & Recommendations  
 Site Location: Needl Hall, High Street, Chippenham, Wiltshire, SN15 3ER  
 Building Designation: Building 01  
 Unique item Number: 12

Sample Ref	Fl	Location	Description	Qty	Analysis Result	Total M.A.S	Licensed Material Y/N
Surveyed	Ground Floor	G.04 - Office	No asbestos detected		N/A	0	N/A

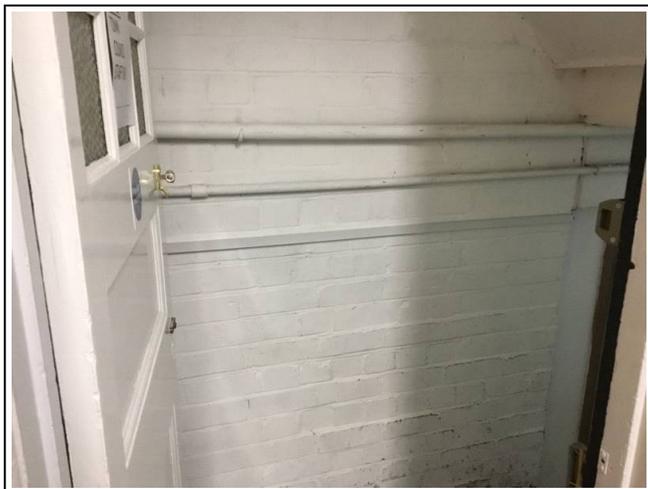
Survey Data Sheet: Conclusions & Recommendations  
 Site Location: Needd Hall, High Street, Chippenham, Wiltshire, SN15 3ER  
 Building Designation: Building 01  
 Unique item Number: 14

Sample Ref	FI	Location	Description	Qty	Analysis Result	Total M.A.S	Licensed Material Y/N
Surveyed	Ground Floor	G.06 - Lower Stage Stairs	No asbestos detected		N/A	0	N/A

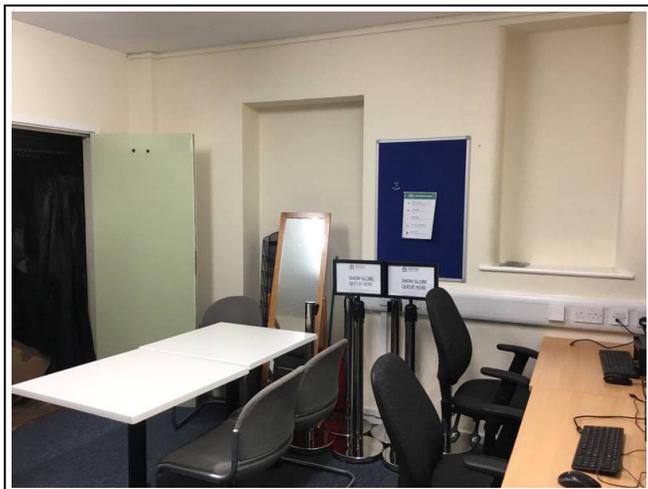
Survey Data Sheet: Conclusions & Recommendations  
 Site Location: Needl Hall, High Street, Chippenham, Wiltshire, SN15 3ER  
 Building Designation: Building 01  
 Unique item Number: 15

Sample Ref	FI	Location	Description	Qty	Analysis Result	Total M.A.S	Licensed Material Y/N
Surveyed	Ground Floor	G.07 - Hot Desk Room	No asbestos detected		N/A	0	N/A

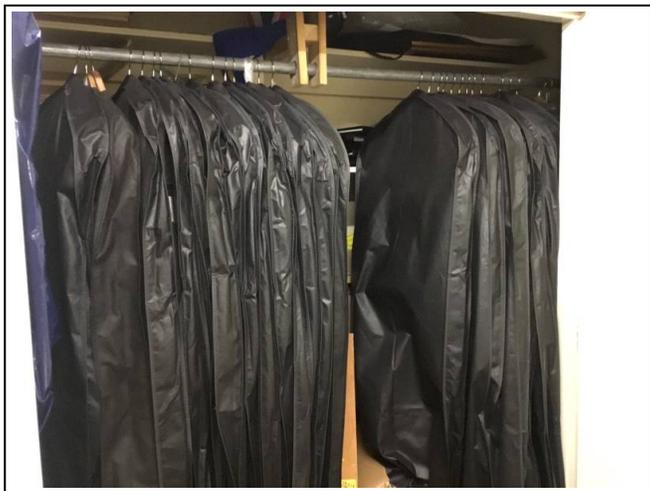
Survey Data Sheet: Conclusions & Recommendations  
 Site Location: Needd Hall, High Street, Chippenham, Wiltshire, SN15 3ER  
 Building Designation: Building 01  
 Unique item Number: 16

Sample Ref	FI	Location	Description	Qty	Analysis Result	Total M.A.S	Licensed Material Y/N
Surveyed	Ground Floor	G.08 - Store	No asbestos detected		N/A	0	N/A

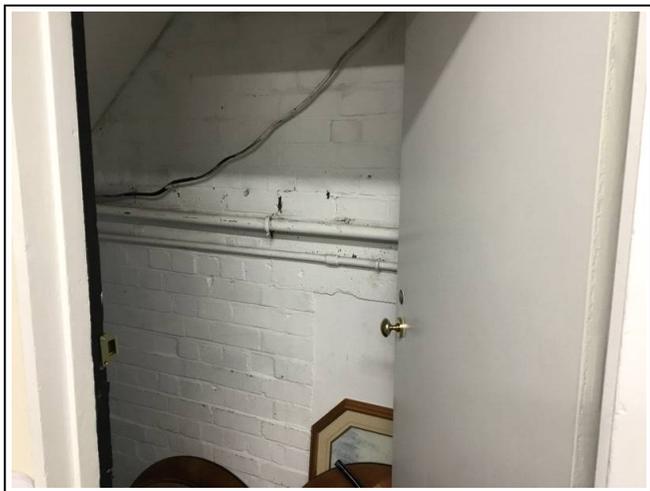
Survey Data Sheet: Conclusions & Recommendations  
 Site Location: Needd Hall, High Street, Chippenham, Wiltshire, SN15 3ER  
 Building Designation: Building 01  
 Unique item Number: 17

Sample Ref	Fl	Location	Description	Qty	Analysis Result	Total M.A.S	Licensed Material Y/N
Surveyed	Ground Floor	G.09 - Lower Stage Stairs	No asbestos detected		N/A	0	N/A

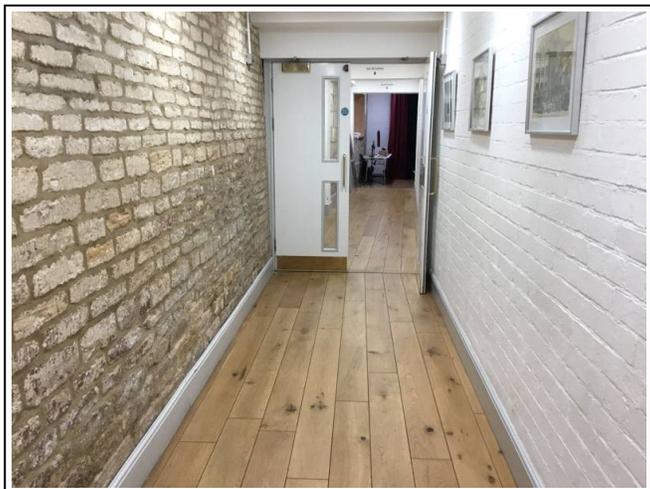
Survey Data Sheet: Conclusions & Recommendations  
 Site Location: Needl Hall, High Street, Chippenham, Wiltshire, SN15 3ER  
 Building Designation: Building 01  
 Unique item Number: 18

Sample Ref	Fl	Location	Description	Qty	Analysis Result	Total M.A.S	Licensed Material Y/N
Surveyed	Ground Floor	G.10 - Corridor	No asbestos detected		N/A	0	N/A

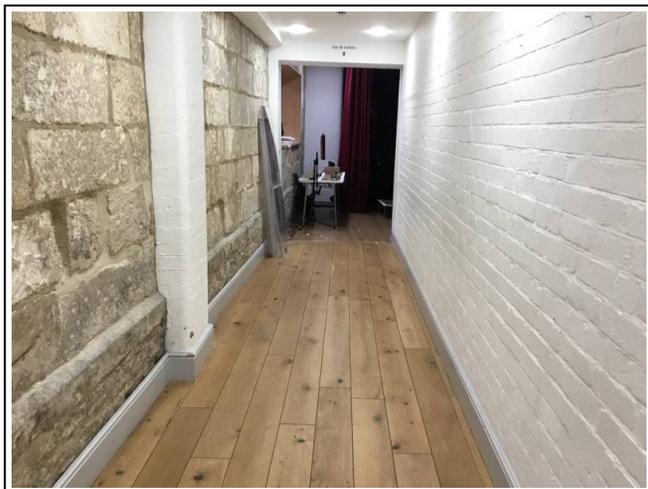
Survey Data Sheet: Conclusions & Recommendations  
 Site Location: Needl Hall, High Street, Chippenham, Wiltshire, SN15 3ER  
 Building Designation: Building 01  
 Unique item Number: 19

Sample Ref	Fl	Location	Description	Qty	Analysis Result	Total M.A.S	Licensed Material Y/N
Surveyed	Ground Floor	G.11 - Corridor	No asbestos detected		N/A	0	N/A

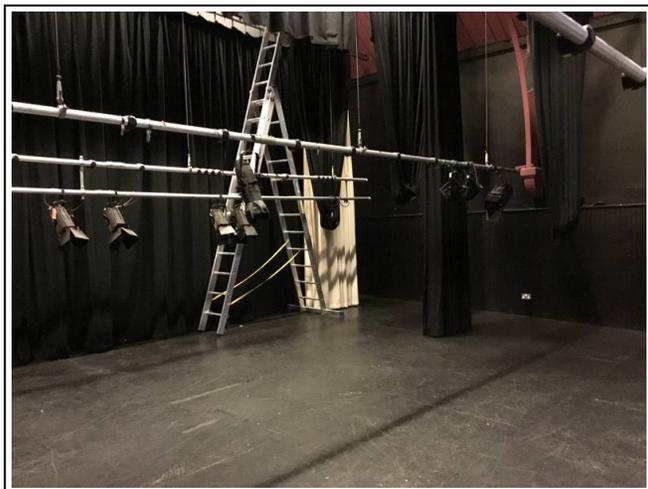
Survey Data Sheet: Conclusions & Recommendations  
 Site Location: Needd Hall, High Street, Chippenham, Wiltshire, SN15 3ER  
 Building Designation: Building 01  
 Unique item Number: 20

Sample Ref	Fl	Location	Description	Qty	Analysis Result	Total M.A.S	Licensed Material Y/N
Surveyed	Ground Floor	G.12 - Stage	No asbestos detected		N/A	0	N/A

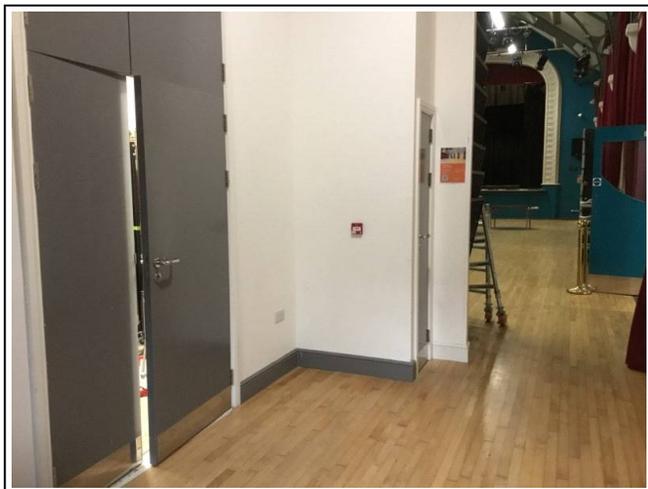
Survey Data Sheet: Conclusions & Recommendations  
 Site Location: Needl Hall, High Street, Chippenham, Wiltshire, SN15 3ER  
 Building Designation: Building 01  
 Unique item Number: 23

Sample Ref	Fl	Location	Description	Qty	Analysis Result	Total M.A.S	Licensed Material Y/N
Surveyed	Ground Floor	G.14 - Main Hall Foyer	No asbestos detected		N/A	0	N/A

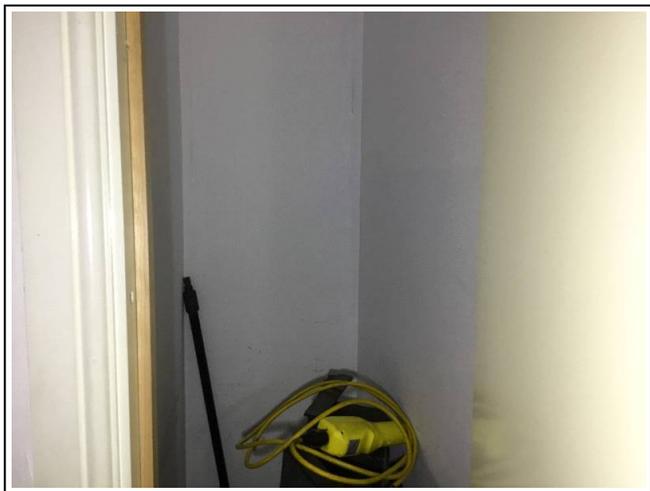
Survey Data Sheet: Conclusions & Recommendations  
 Site Location: Needd Hall, High Street, Chippenham, Wiltshire, SN15 3ER  
 Building Designation: Building 01  
 Unique item Number: 24

Sample Ref	Fl	Location	Description	Qty	Analysis Result	Total M.A.S	Licensed Material Y/N
Surveyed	Ground Floor	G.15 - Main Hall Foyer Cupboard	No asbestos detected		N/A	0	N/A

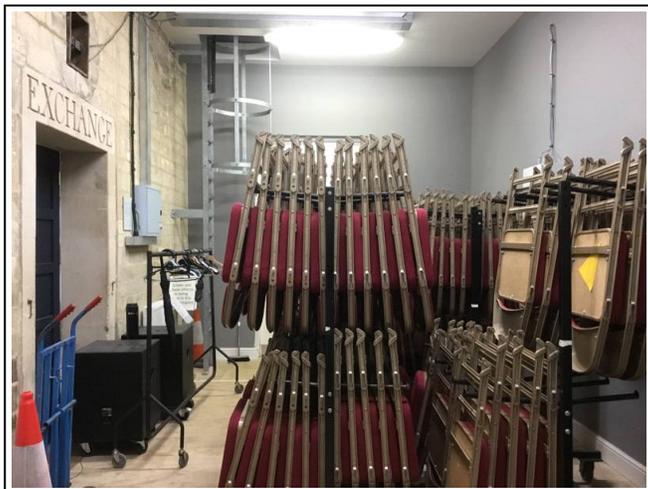
Survey Data Sheet: Conclusions & Recommendations  
 Site Location: Needd Hall, High Street, Chippenham, Wiltshire, SN15 3ER  
 Building Designation: Building 01  
 Unique item Number: 25

Sample Ref	FI	Location	Description	Qty	Analysis Result	Total M.A.S	Licensed Material Y/N
Surveyed	Ground Floor	G.15 - Store Room	No asbestos detected		N/A	0	N/A

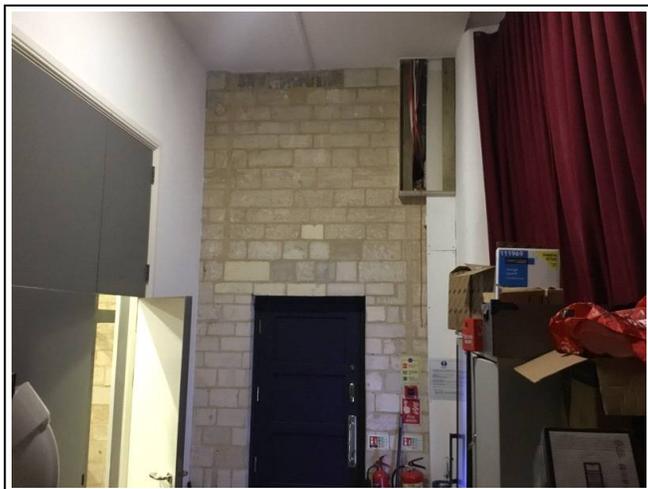
Survey Data Sheet: Conclusions & Recommendations  
 Site Location: Neeld Hall, High Street, Chippenham, Wiltshire, SN15 3ER  
 Building Designation: Building 01  
 Unique item Number: 26

Sample Ref	Fl	Location	Description	Qty	Analysis Result	Total M.A.S	Licensed Material Y/N
Surveyed	Ground Floor	G.17 - Main Hall Bar Foyer	No asbestos detected		N/A	0	N/A

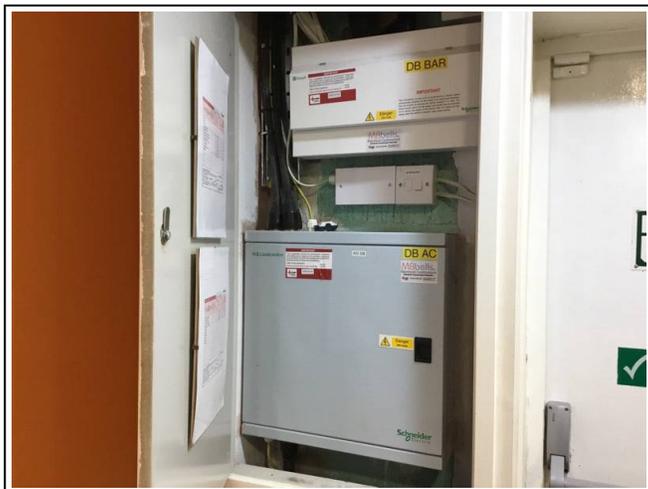
Survey Data Sheet: Conclusions & Recommendations  
 Site Location: Needl Hall, High Street, Chippenham, Wiltshire, SN15 3ER  
 Building Designation: Building 01  
 Unique item Number: 28

Sample Ref	FI	Location	Description	Qty	Analysis Result	Total M.A.S	Licensed Material Y/N
Surveyed	Ground Floor	G.19 - Electrical Cupboard	No asbestos detected		N/A	0	N/A

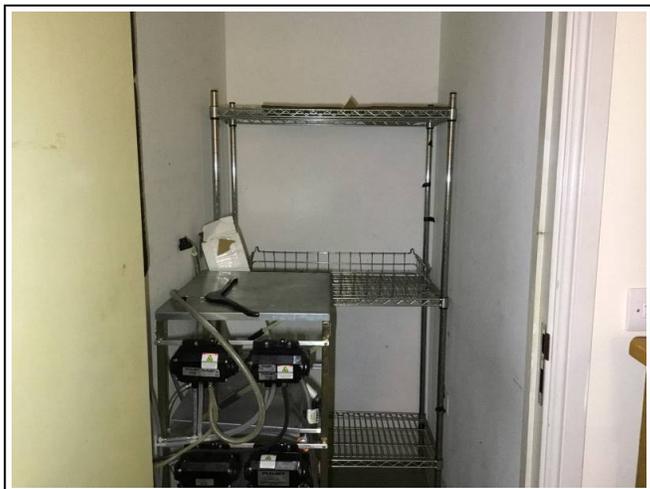
Survey Data Sheet: Conclusions & Recommendations  
 Site Location: Needl Hall, High Street, Chippenham, Wiltshire, SN15 3ER  
 Building Designation: Building 01  
 Unique item Number: 29

Sample Ref	FI	Location	Description	Qty	Analysis Result	Total M.A.S	Licensed Material Y/N
Surveyed	Ground Floor	G.20 - Cupboard	No asbestos detected		N/A	0	N/A

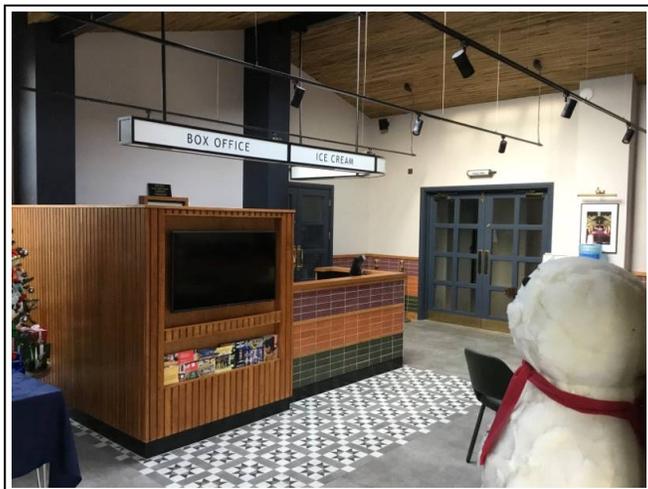
Survey Data Sheet: Conclusions & Recommendations  
 Site Location: Needl Hall, High Street, Chippenham, Wiltshire, SN15 3ER  
 Building Designation: Building 01  
 Unique item Number: 30

Sample Ref	Fl	Location	Description	Qty	Analysis Result	Total M.A.S	Licensed Material Y/N
Surveyed	Ground Floor	G.21 - Box Office Foyer	No asbestos detected		N/A	0	N/A

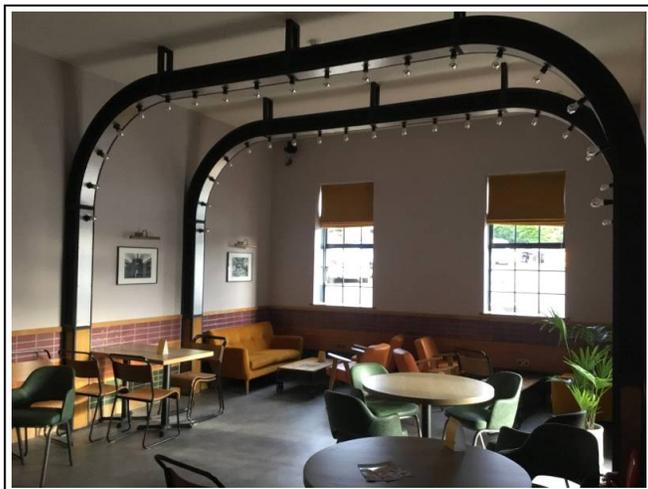
Survey Data Sheet: Conclusions & Recommendations  
 Site Location: Needd Hall, High Street, Chippenham, Wiltshire, SN15 3ER  
 Building Designation: Building 01  
 Unique item Number: 31

Sample Ref	FI	Location	Description	Qty	Analysis Result	Total M.A.S	Licensed Material Y/N
Surveyed	Ground Floor	G.22 - Foyer Lounge	No asbestos detected		N/A	0	N/A

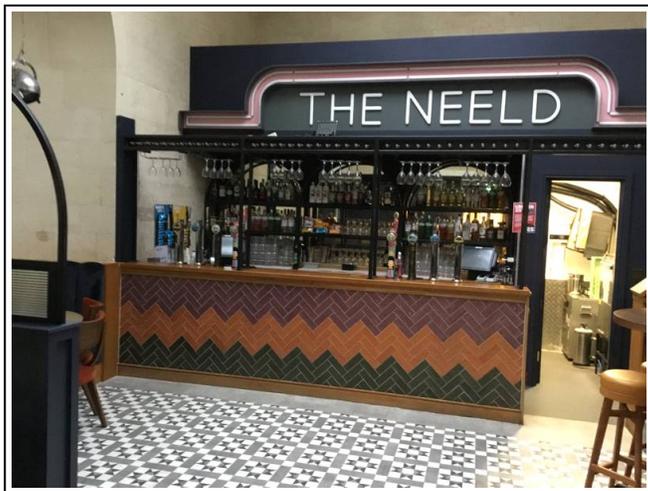
Survey Data Sheet: Conclusions & Recommendations  
 Site Location: Needl Hall, High Street, Chippenham, Wiltshire, SN15 3ER  
 Building Designation: Building 01  
 Unique item Number: 32

Sample Ref	FI	Location	Description	Qty	Analysis Result	Total M.A.S	Licensed Material Y/N
Surveyed	Ground Floor	G.23 - The Needl Bar	No asbestos detected		N/A	0	N/A

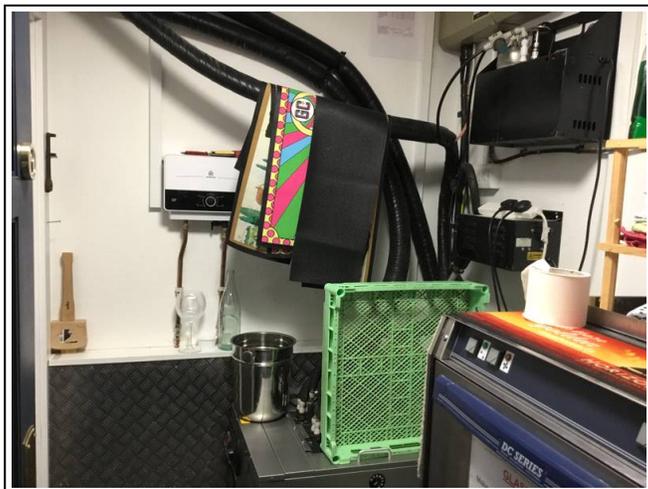
Survey Data Sheet: Conclusions & Recommendations  
 Site Location: Needd Hall, High Street, Chippenham, Wiltshire, SN15 3ER  
 Building Designation: Building 01  
 Unique item Number: 33

Sample Ref	FI	Location	Description	Qty	Analysis Result	Total M.A.S	Licensed Material Y/N
Surveyed	Ground Floor	G.24 - Bar Wash-Up	No asbestos detected		N/A	0	N/A

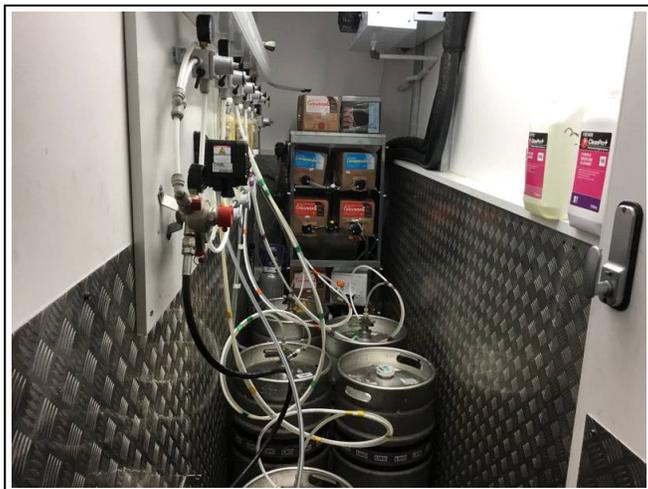
Survey Data Sheet: Conclusions & Recommendations  
 Site Location: Needd Hall, High Street, Chippenham, Wiltshire, SN15 3ER  
 Building Designation: Building 01  
 Unique item Number: 34

Sample Ref	Fl	Location	Description	Qty	Analysis Result	Total M.A.S	Licensed Material Y/N
Surveyed	Ground Floor	G.25 - Cellar	No asbestos detected		N/A	0	N/A

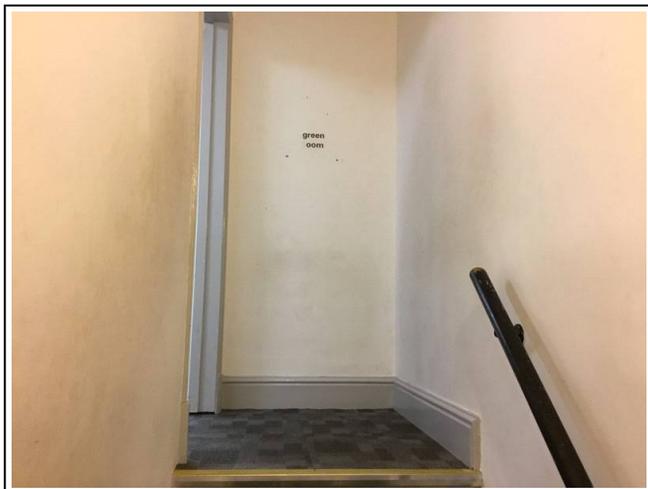
Survey Data Sheet: Conclusions & Recommendations  
 Site Location: Needl Hall, High Street, Chippenham, Wiltshire, SN15 3ER  
 Building Designation: Building 01  
 Unique item Number: 35

Sample Ref	Fl	Location	Description	Qty	Analysis Result	Total M.A.S	Licensed Material Y/N
Surveyed	1st Floor	1.01 - Green Room Landing	No asbestos detected		N/A	0	N/A

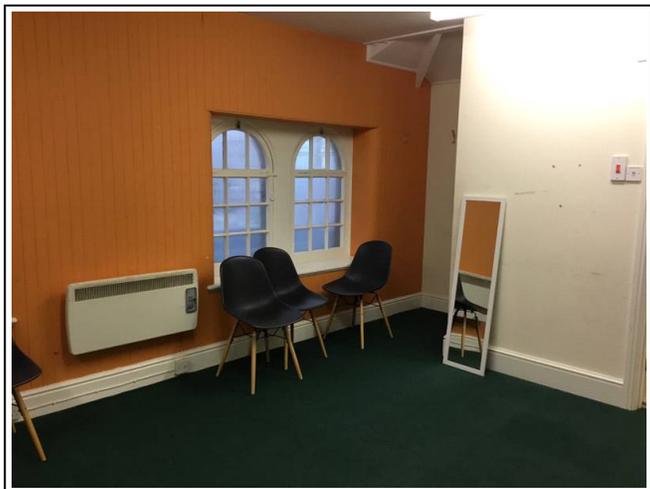
Survey Data Sheet: Conclusions & Recommendations  
 Site Location: Needl Hall, High Street, Chippenham, Wiltshire, SN15 3ER  
 Building Designation: Building 01  
 Unique item Number: 36

Sample Ref	Fl	Location	Description	Qty	Analysis Result	Total M.A.S	Licensed Material Y/N
Surveyed	1st Floor	1.02 - Green Room	No asbestos detected		N/A	0	N/A

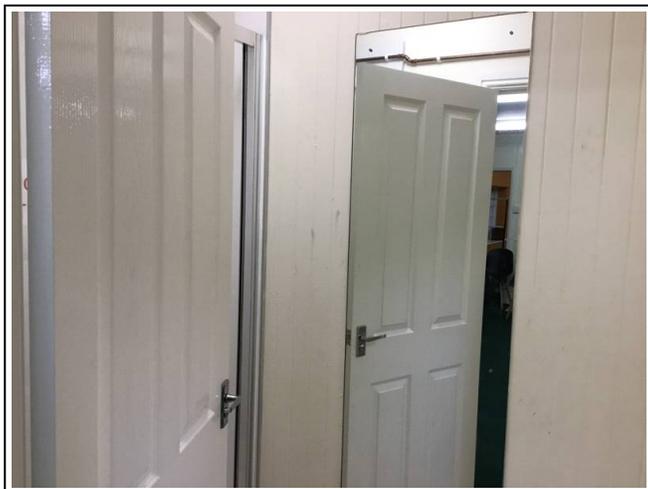
Survey Data Sheet: Conclusions & Recommendations  
 Site Location: Needd Hall, High Street, Chippenham, Wiltshire, SN15 3ER  
 Building Designation: Building 01  
 Unique item Number: 37

Sample Ref	Fl	Location	Description	Qty	Analysis Result	Total M.A.S	Licensed Material Y/N
Surveyed	1st Floor	1.03 - Shower Room	No asbestos detected		N/A	0	N/A

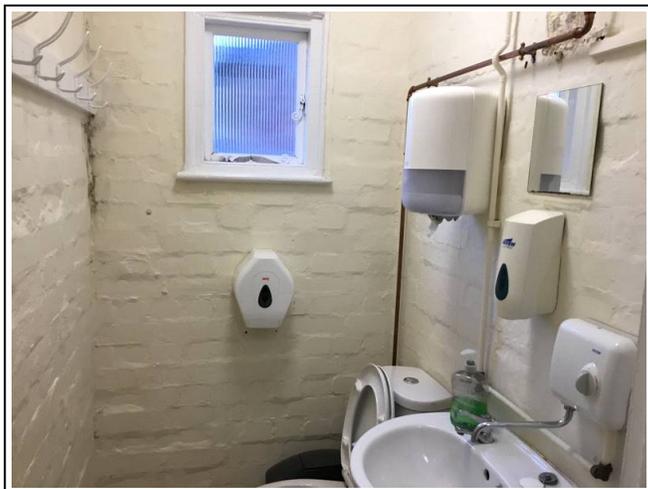
Survey Data Sheet: Conclusions & Recommendations  
 Site Location: Needl Hall, High Street, Chippenham, Wiltshire, SN15 3ER  
 Building Designation: Building 01  
 Unique item Number: 38

Sample Ref	Fl	Location	Description	Qty	Analysis Result	Total M.A.S	Licensed Material Y/N
Surveyed	1st Floor	1.04 - W/C	No asbestos detected		N/A	0	N/A

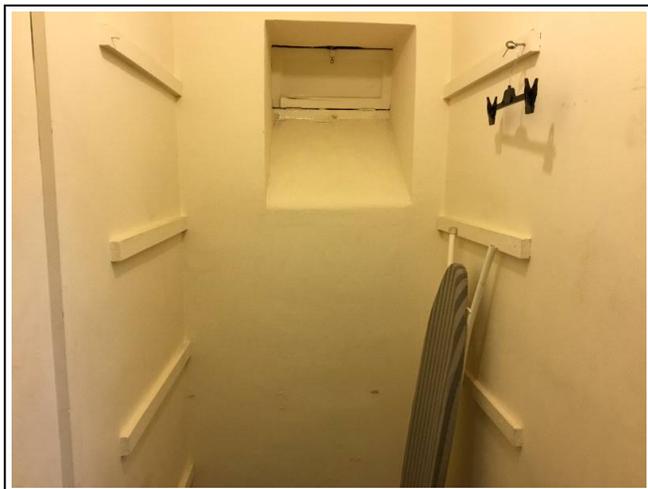
Survey Data Sheet: Conclusions & Recommendations  
 Site Location: Needl Hall, High Street, Chippenham, Wiltshire, SN15 3ER  
 Building Designation: Building 01  
 Unique item Number: 40

Sample Ref	Fl	Location	Description	Qty	Analysis Result	Total M.A.S	Licensed Material Y/N
Surveyed	1st Floor	1.06 - Store Room	No asbestos detected		N/A	0	N/A

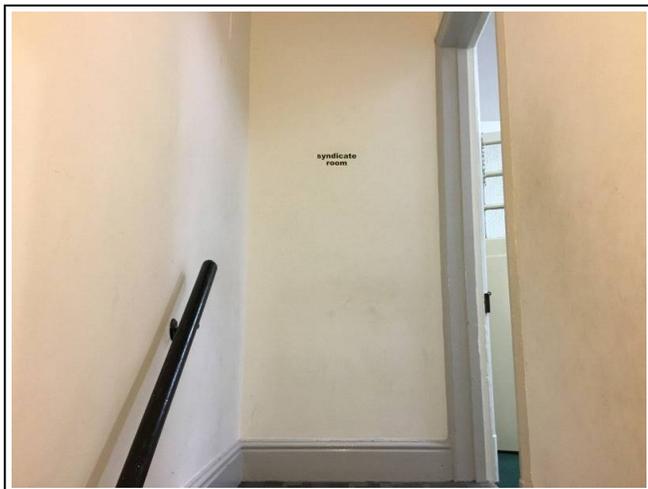
Survey Data Sheet: Conclusions & Recommendations  
 Site Location: Needl Hall, High Street, Chippenham, Wiltshire, SN15 3ER  
 Building Designation: Building 01  
 Unique item Number: 41

Sample Ref	Fl	Location	Description	Qty	Analysis Result	Total M.A.S	Licensed Material Y/N
Surveyed	1st Floor	1.07 - Syndicate Room Landing	No asbestos detected		N/A	0	N/A

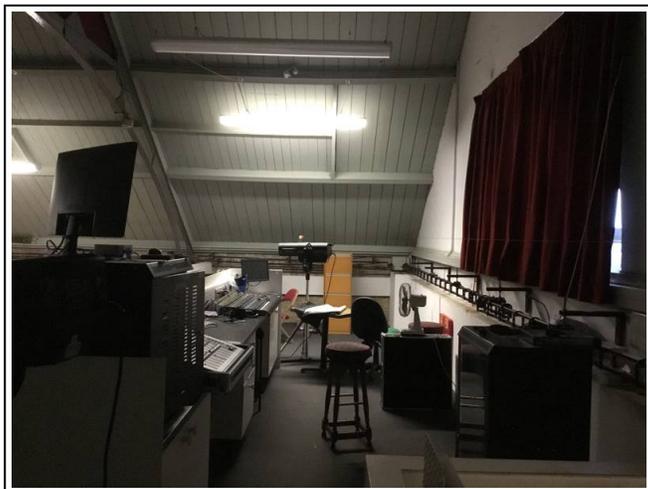
Survey Data Sheet: Conclusions & Recommendations  
 Site Location: Needl Hall, High Street, Chippenham, Wiltshire, SN15 3ER  
 Building Designation: Building 01  
 Unique item Number: 42

Sample Ref	Fl	Location	Description	Qty	Analysis Result	Total M.A.S	Licensed Material Y/N
Surveyed	1st Floor	1.08 - Tech Booth	No asbestos detected		N/A	0	N/A

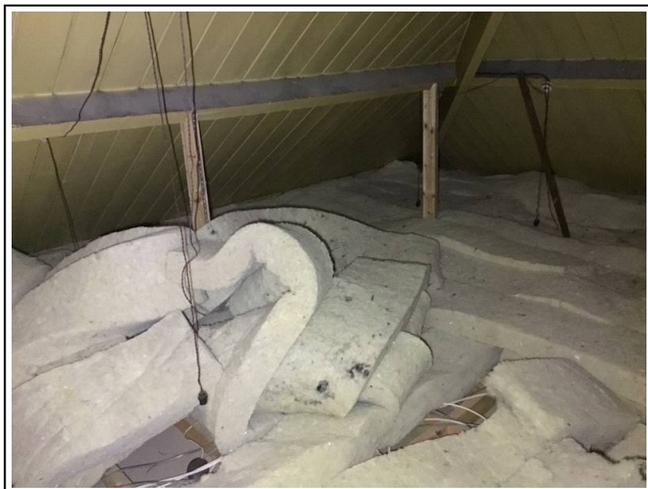
Survey Data Sheet: Conclusions & Recommendations  
 Site Location: Needd Hall, High Street, Chippenham, Wiltshire, SN15 3ER  
 Building Designation: Building 01  
 Unique item Number: 43

Sample Ref	FI	Location	Description	Qty	Analysis Result	Total M.A.S	Licensed Material Y/N
Surveyed	Roof Void	Attic 01	No asbestos detected		N/A	0	N/A

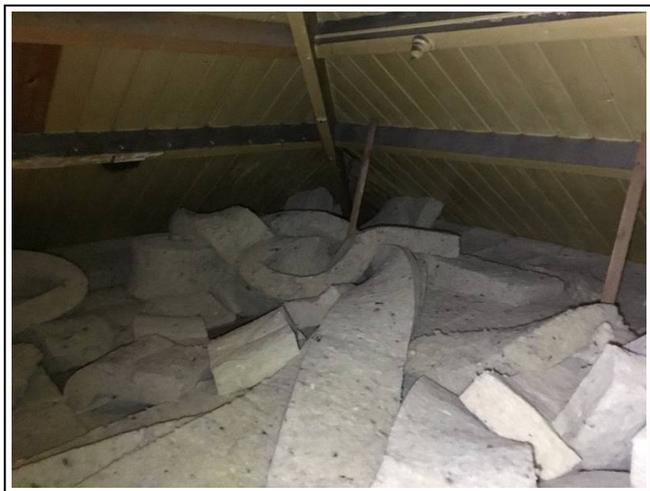
Survey Data Sheet: Conclusions & Recommendations  
 Site Location: Needd Hall, High Street, Chippenham, Wiltshire, SN15 3ER  
 Building Designation: Building 01  
 Unique item Number: 44

Sample Ref	FI	Location	Description	Qty	Analysis Result	Total M.A.S	Licensed Material Y/N
Surveyed	Roof Void	Attic 02	No asbestos detected		N/A	0	N/A

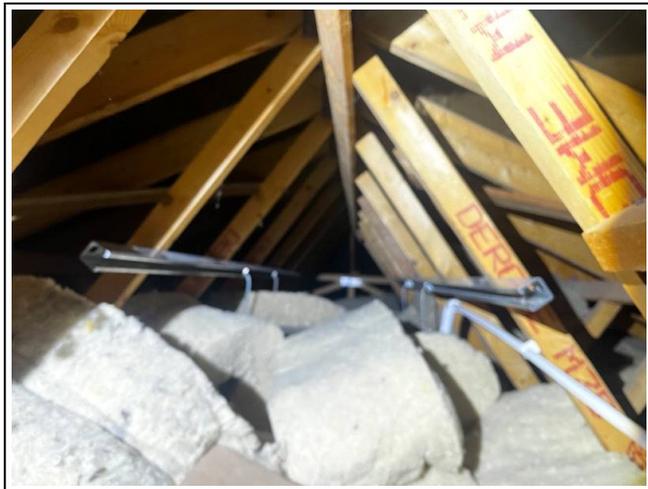
Survey Data Sheet: Conclusions & Recommendations  
 Site Location: Needd Hall, High Street, Chippenham, Wiltshire, SN15 3ER  
 Building Designation: Building 01  
 Unique item Number: 45

Sample Ref	FI	Location	Description	Qty	Analysis Result	Total M.A.S	Licensed Material Y/N
Surveyed	Roof Void	Attic 03	No asbestos detected		N/A	0	N/A
