EXTERNAL WINDOW AND DOOR CONDITION REPORT

SHIRE HALL, WOODBRIDGE, SUFFOLK

Inspecting Architect: Philip Orchard

PEO/Pra/cm/S7303
17th December 2024

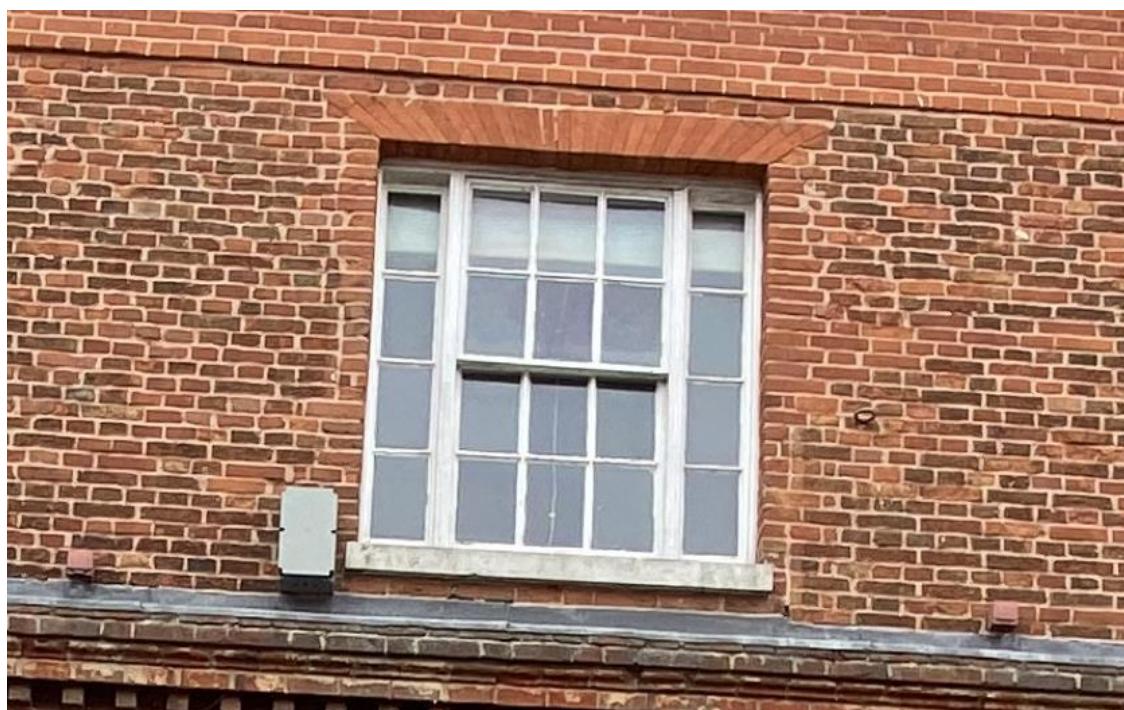
3.5 Window W07

3.5 **Window W07:** north elevation central window: three lights with central vertical sliding sash, six-pane lower and six-pane upper sash flanked by fixed lights, each with four panes. Stone sill, brick jambs and flat arched brick head. Timberwork painted and glass set in putty. The glass has had some film applied on the inside. Sash cords and pulleys survive. Glass appears generally to be clear float except the lower sash upper central pane, old glass; the east light second pane up from the sill Cordele replacement.

Repairs recommended: repair timberwork, reputty, redecorate.
