14 April, 2025

LEGIONELLA RISK ASSESSMENT

West Wimbledon Primary School

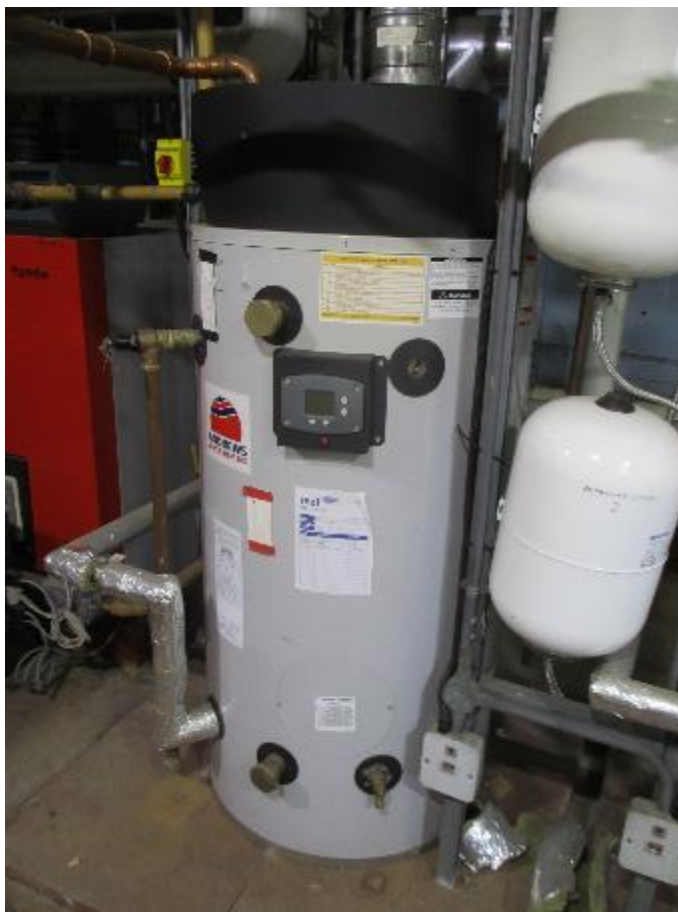
Asset Reference	Cal 1	
	DETAIL	ACTION?
Location	Boiler room	
Services fed	DHWS	
Access for inspection and maintenance	Good	
Volume/Capacity (litres)?	300l	
Primary / supplementary heat source(s)	Gas	
Cold water source	MCWS	
Cold water supply pipe size & material	35mm copper	
Cold supply pipe sufficiently insulated	Yes	
Cold supply pipe labelled	Yes	
Water temperature at flow/nearest outlet	55	
Temperature within acceptable limits	No	✓
Flow pipe size & material	35mm copper	
Flow pipe sufficiently insulated	Yes	
Flow pipe labelled	Yes	
Recirculation pump(s) fitted	Yes	
Return water temperature (at pipe surface)	38	
Return temperature within acceptable limits	No	✓
Return pipe size & material	22mm copper	
Return pipe sufficiently insulated	Yes	
Return pipe labelled	Yes	
Is calorifier/cylinder sufficiently insulated?	Yes	
Is an anti-stratification pump fitted to the vessel?	No	
Is there evidence of stratification in vessel?	No

Is an inspection hatch fitted?	Yes	
Inspection hatch size	150mm	
Drain valve fitted	Yes	
Drain water condition	Clear	
Is a pressure vessel fitted?	Yes	
Pressure vessel correctly aligned	Yes	
Other observations or concerns

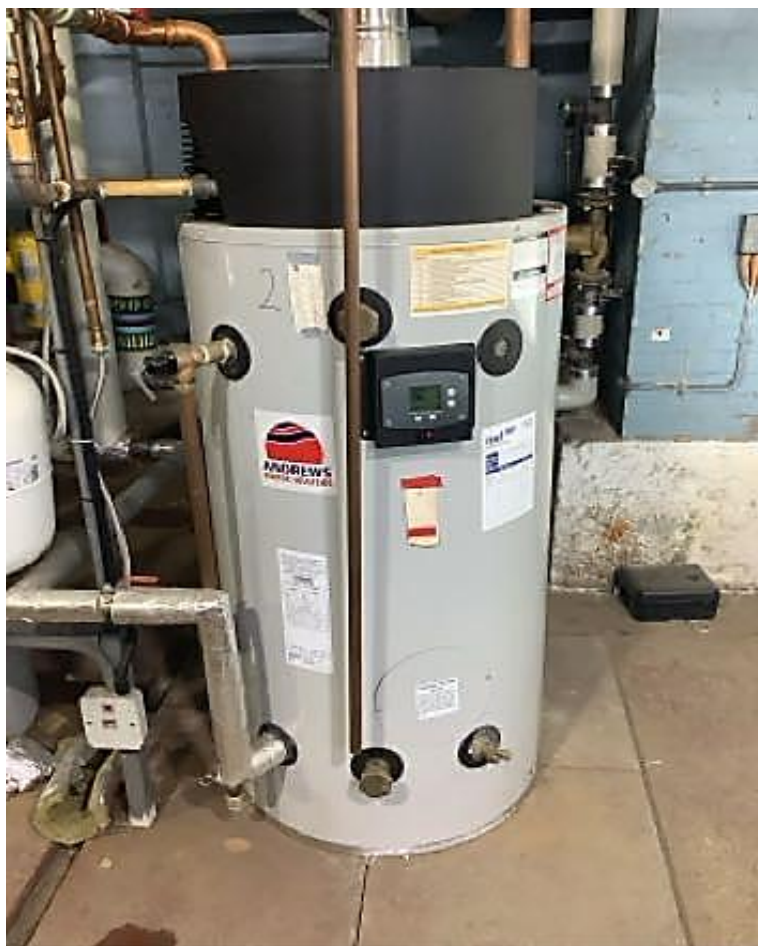
Asset Reference
Cal 2

DETAIL	ACTION?
Location	Boiler room	
Services fed	DHWS	
Access for inspection and maintenance	Good	
Volume/Capacity (litres)?	300l	
Primary / supplementary heat source(s)	Gas	
Cold water source	MCWS	
Cold water supply pipe size & material	35mm copper	
Cold supply pipe sufficiently insulated	Yes	
Cold supply pipe labelled	Yes	
Water temperature at flow/nearest outlet	55	
Temperature within acceptable limits	No	✓
Flow pipe size & material	35mm copper	
Flow pipe sufficiently insulated	Yes	
Flow pipe labelled	Yes	
Recirculation pump(s) fitted	Yes	
Return water temperature (at pipe surface)	38	
Return temperature within acceptable limits	No	✓
Return pipe size & material	22mm copper	
Return pipe sufficiently insulated	Yes	
Return pipe labelled	Yes	
Is calorifier/cylinder sufficiently insulated?	Yes	
Is an anti-stratification pump fitted to the vessel?	No	
Is there evidence of stratification in vessel?	No	
Is an inspection hatch fitted?	Yes

Inspection hatch size	150mm	
Drain valve fitted	Yes	
Drain water condition	Clear	
Is a pressure vessel fitted?	Yes	
Pressure vessel correctly aligned	Yes	
Other observations or concerns

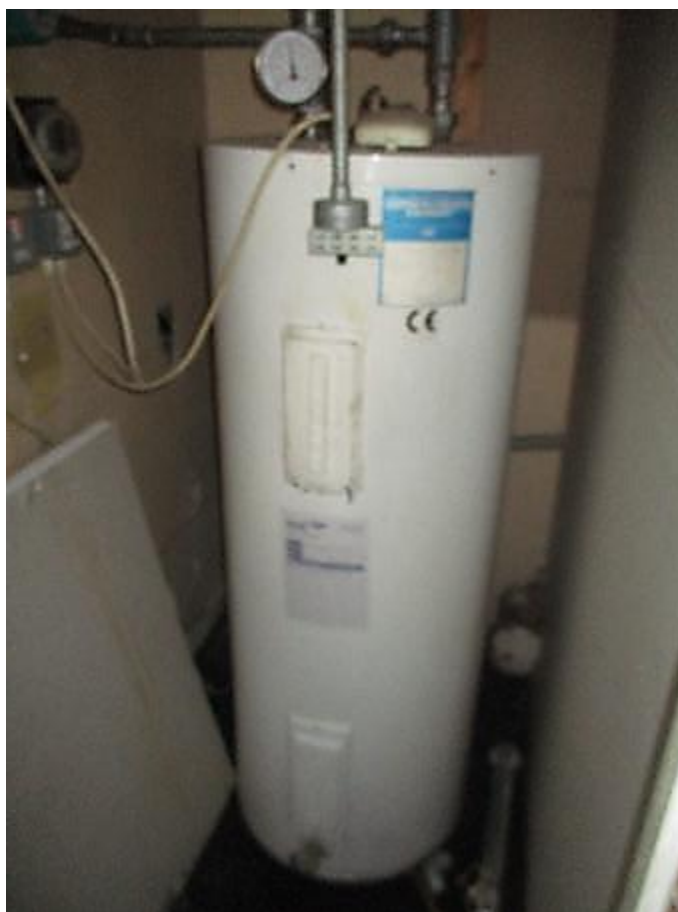
DETAIL	ACTION?
Location	Office cupboard	
Services fed	DHWS	
Access for inspection and maintenance	Good	
Volume/Capacity (litres)?	190mm	
Primary / supplementary heat source(s)	Immersion	
Cold water source	CWDS	
Cold water supply pipe size & material	¾" galvanised	
Cold supply pipe sufficiently insulated	No	✓
Cold supply pipe labelled	No	✓
Water temperature at flow/nearest outlet	60	
Temperature within acceptable limits	Yes	
Flow pipe size & material	¾" galvanised	
Flow pipe sufficiently insulated	No	✓
Flow pipe labelled	No	✓
Recirculation pump(s) fitted	Yes	
Return water temperature (at pipe surface)	20	
Return temperature within acceptable limits	No	✓
Return pipe size & material	¾" galvanised	
Return pipe sufficiently insulated	No	✓
Return pipe labelled	No	✓
Is calorifier/cylinder sufficiently insulated?	Yes	
Is an anti-stratification pump fitted to the vessel?	No	
Is there evidence of stratification in vessel?	No

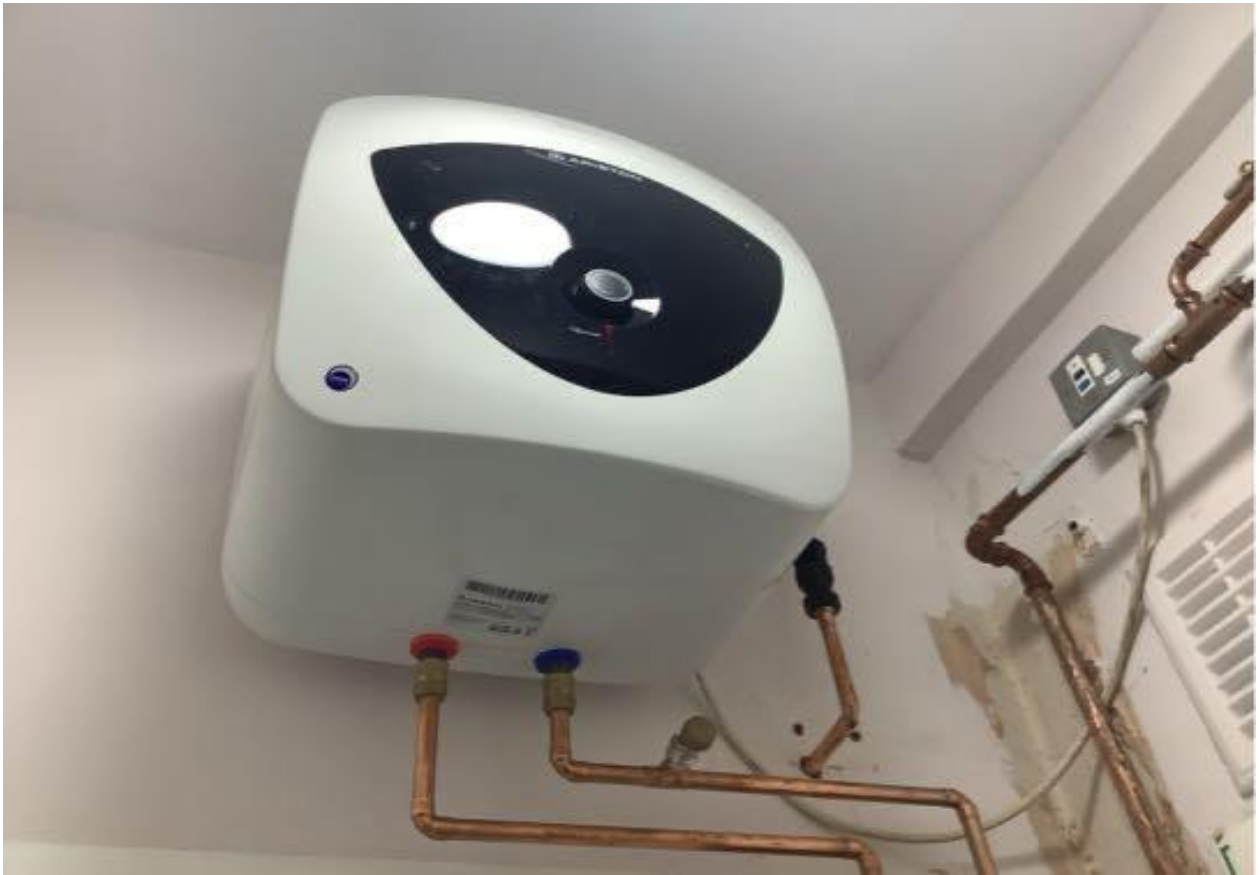
Asset Reference
Cal 4

DETAIL	ACTION?
Location	Pupils Toilet Albatross	
Services fed	DHWS	
Access for inspection and maintenance	Good	
Volume/Capacity (litres)?	30	
Primary / supplementary heat source(s)	Immersion	
Cold water source	MCWS	
Cold water supply pipe size & material	15mm copper	
Cold supply pipe sufficiently insulated	No	✓
Cold supply pipe labelled	No	✓
Water temperature at flow/nearest outlet	60	
Temperature within acceptable limits	Yes	
Flow pipe size & material	15mm copper	
Flow pipe sufficiently insulated	No	✓
Flow pipe labelled	No	✓
Recirculation pump(s) fitted	No	
Is calorifier/cylinder sufficiently insulated?	Yes	
Is an anti-stratification pump fitted to the vessel?	No	
Is there evidence of stratification in vessel?	No	
Is an inspection hatch fitted?	No	✓
Drain valve fitted	No	
Is a pressure vessel fitted?	Yes	
Pressure vessel correctly aligned	No	✓
Other observations or concerns

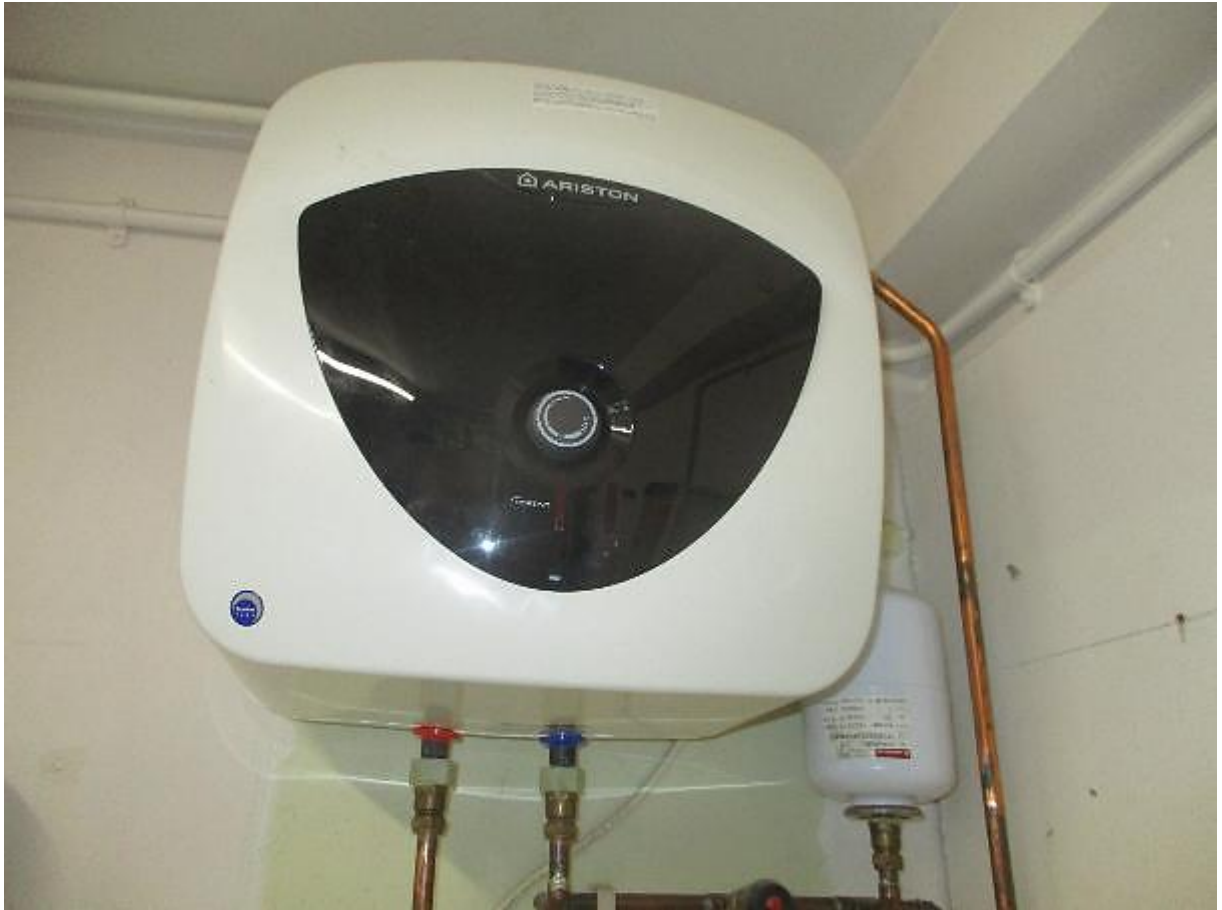
Asset Reference
Cal 5

DETAIL	ACTION?
Location	First Aid	
Services fed	DHWS	
Access for inspection and maintenance	Good	
Volume/Capacity (litres)?	30	
Primary / supplementary heat source(s)	Immersion	
Cold water source	MCWS	
Cold water supply pipe size & material	15mm copper	
Cold supply pipe sufficiently insulated	No	✓
Cold supply pipe labelled	No	✓
Water temperature at flow/nearest outlet	42	
Temperature within acceptable limits	No	✓
Flow pipe size & material	15mm copper	
Flow pipe sufficiently insulated	No	✓
Flow pipe labelled	No	✓
Recirculation pump(s) fitted	No	
Is calorifier/cylinder sufficiently insulated?	Yes	
Is an anti-stratification pump fitted to the vessel?	No	
Is there evidence of stratification in vessel?	No	
Is an inspection hatch fitted?	No	✓
Drain valve fitted	No	
Is a pressure vessel fitted?	Yes	
Pressure vessel correctly aligned	Yes	
Other observations or concerns

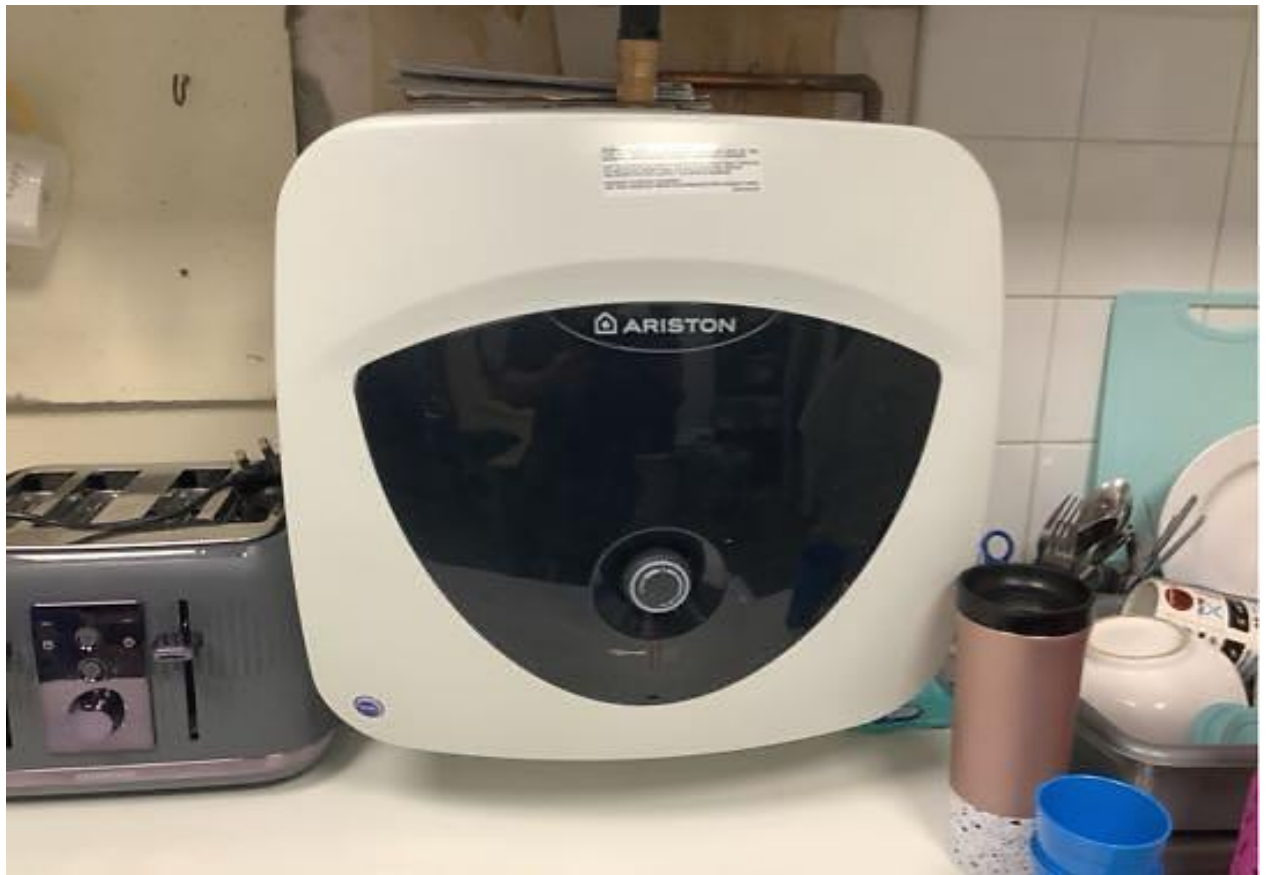
Cal 6

DETAIL	ACTION?
Location	Office 12	
Services fed	DHWS	
Access for inspection and maintenance	Good	
Volume/Capacity (litres)?	30	
Primary / supplementary heat source(s)	Immersion	
Cold water source	MCWS	
Cold water supply pipe size & material	15mm copper	
Cold supply pipe sufficiently insulated	No	✓
Cold supply pipe labelled	No	✓
Water temperature at flow/nearest outlet	33	
Temperature within acceptable limits	No	✓
Flow pipe size & material	15mm copper	
Flow pipe sufficiently insulated	No	✓
Flow pipe labelled	No	✓
Recirculation pump(s) fitted	No	
Is calorifier/cylinder sufficiently insulated?	Yes	
Is an anti-stratification pump fitted to the vessel?	No	
Is there evidence of stratification in vessel?	No	
Is an inspection hatch fitted?	No	✓
Drain valve fitted	No	
Is a pressure vessel fitted?	Yes	
Pressure vessel correctly aligned	Yes	
Other observations or concerns

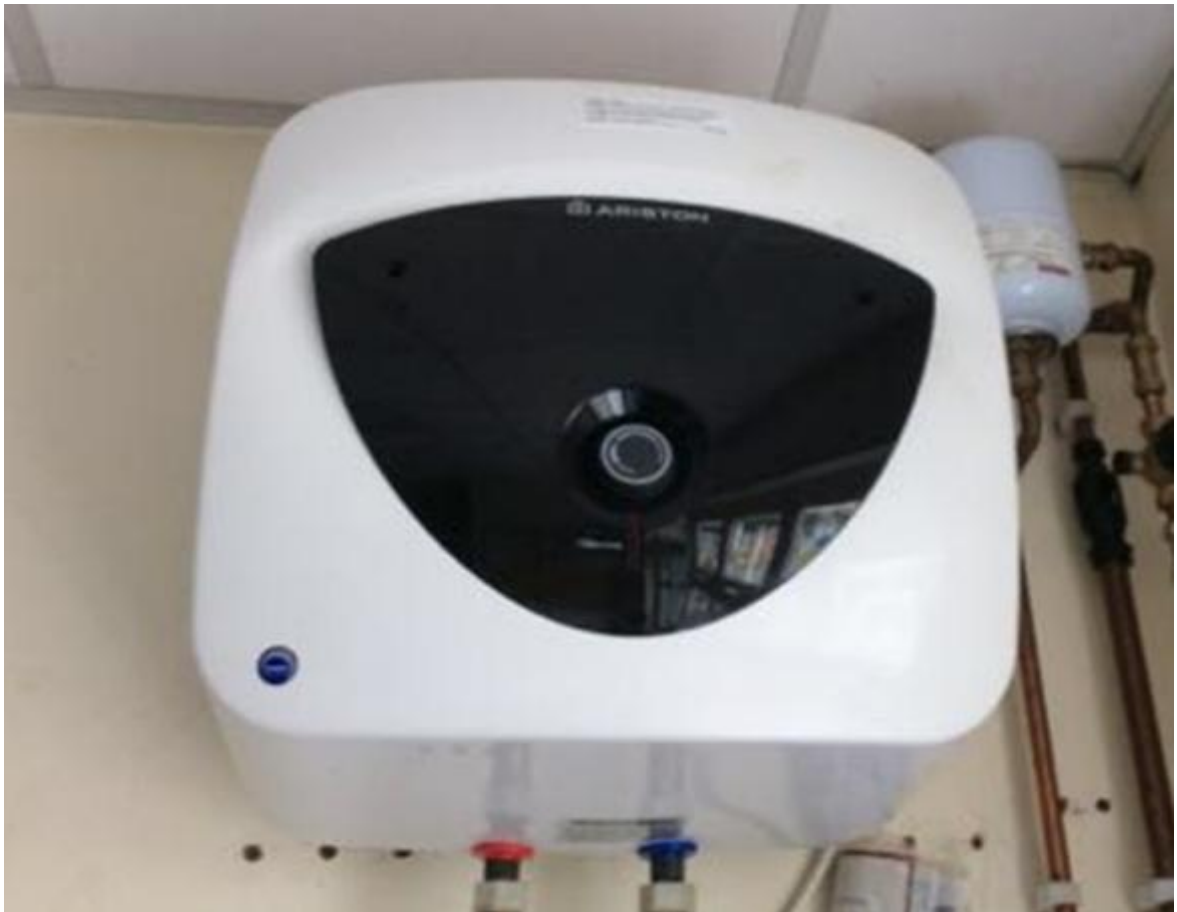
Asset Reference
Cal 7

DETAIL	ACTION?
Location	Classroom 10	
Services fed	DHWS	
Access for inspection and maintenance	Good	
Volume/Capacity (litres)?	30	
Primary / supplementary heat source(s)	Immersion	
Cold water source	MCWS	
Cold water supply pipe size & material	15mm copper	
Cold supply pipe sufficiently insulated	No	✓
Cold supply pipe labelled	No	✓
Water temperature at flow/nearest outlet	60	
Temperature within acceptable limits	Yes	
Flow pipe size & material	15mm copper	
Flow pipe sufficiently insulated	No	✓
Flow pipe labelled	No	✓
Recirculation pump(s) fitted	No	
Is calorifier/cylinder sufficiently insulated?	Yes	
Is an anti-stratification pump fitted to the vessel?	No	
Is there evidence of stratification in vessel?	No	
Is an inspection hatch fitted?	No	✓
Drain valve fitted	No	
Is a pressure vessel fitted?	Yes	
Pressure vessel correctly aligned	Yes	
Other observations or concerns

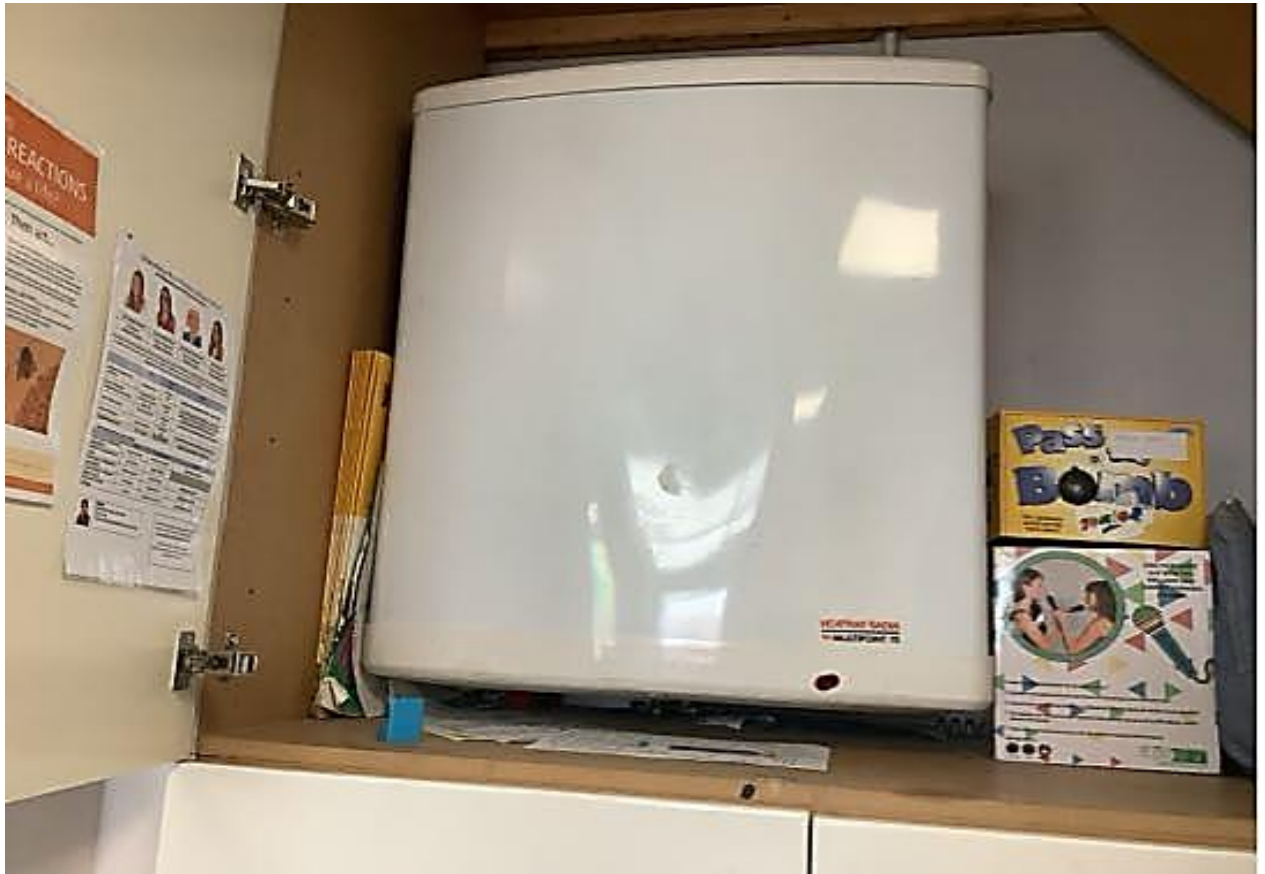
Cal 8

DETAIL	ACTION?
Location	Room 20 Cupboard	
Services fed	DHWS	
Access for inspection and maintenance	Poor	✓
Volume/Capacity (litres)?	75l	
Primary / supplementary heat source(s)	Immersion	
Cold water source	MCWS	
Cold water supply pipe size & material	15mm copper	
Cold supply pipe sufficiently insulated	No	✓
Cold supply pipe labelled	No	✓
Water temperature at flow/nearest outlet	54	
Temperature within acceptable limits	No	✓
Flow pipe size & material	15mm copper	
Flow pipe sufficiently insulated	No	✓
Flow pipe labelled	No	✓
Recirculation pump(s) fitted	No	
Is calorifier/cylinder sufficiently insulated?	Yes	
Is an anti-stratification pump fitted to the vessel?	No	
Is there evidence of stratification in vessel?	No	
Is an inspection hatch fitted?	No	✓
Drain valve fitted	No	
Is a pressure vessel fitted?	Yes	
Pressure vessel correctly aligned	Yes	
Other observations or concerns

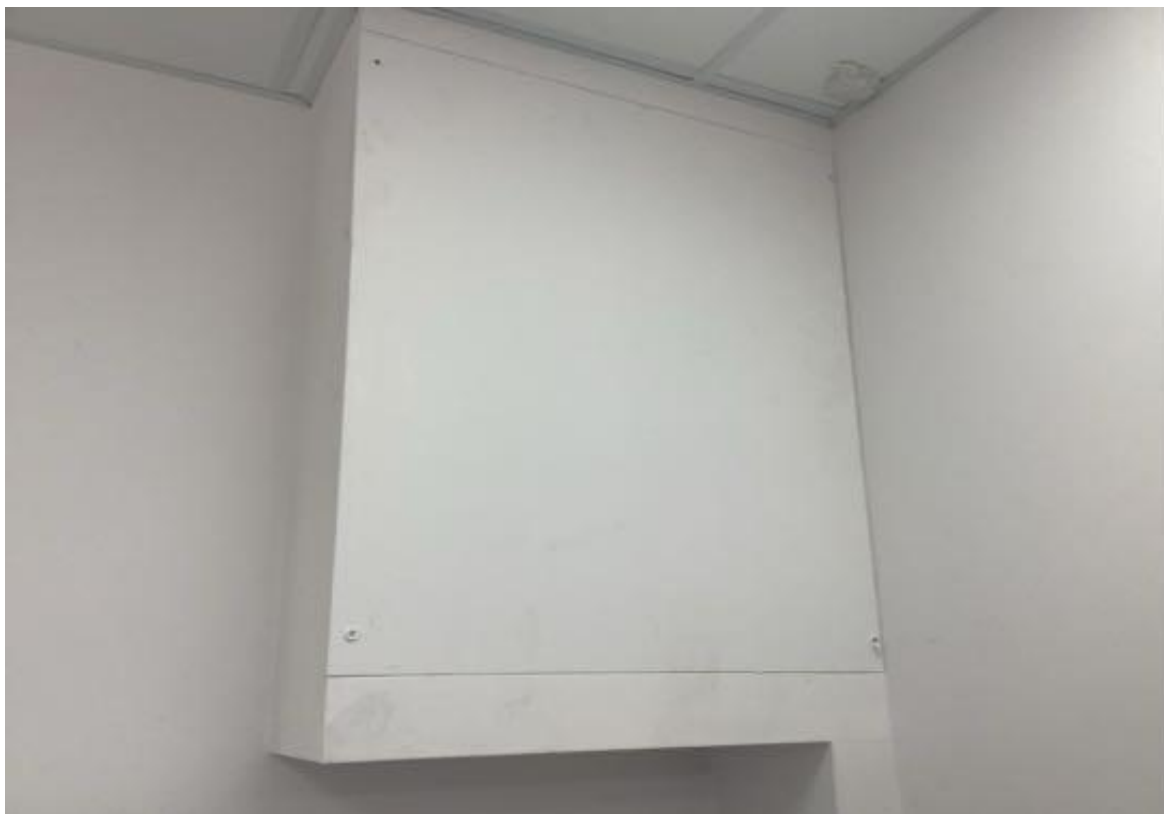
Asset Reference
Cal 9

DETAIL	ACTION?
Location	Female toilets 68	
Services fed	DHWS	
Access for inspection and maintenance	Poor	✓
Volume/Capacity (litres)?	50l	
Primary / supplementary heat source(s)	Immersion	
Cold water source	MCWS	
Cold water supply pipe size & material	15mm copper	
Cold supply pipe sufficiently insulated	No	✓
Cold supply pipe labelled	No	✓
Water temperature at flow/nearest outlet	60	
Temperature within acceptable limits	Yes	
Flow pipe size & material	22mm copper	
Flow pipe sufficiently insulated	No	✓
Flow pipe labelled	No	✓
Recirculation pump(s) fitted	No	
Is calorifier/cylinder sufficiently insulated?	Yes	
Is an anti-stratification pump fitted to the vessel?	No	
Is there evidence of stratification in vessel?	No	
Is an inspection hatch fitted?	No	✓
Drain valve fitted	No	
Is a pressure vessel fitted?	No	
Other observations or concerns

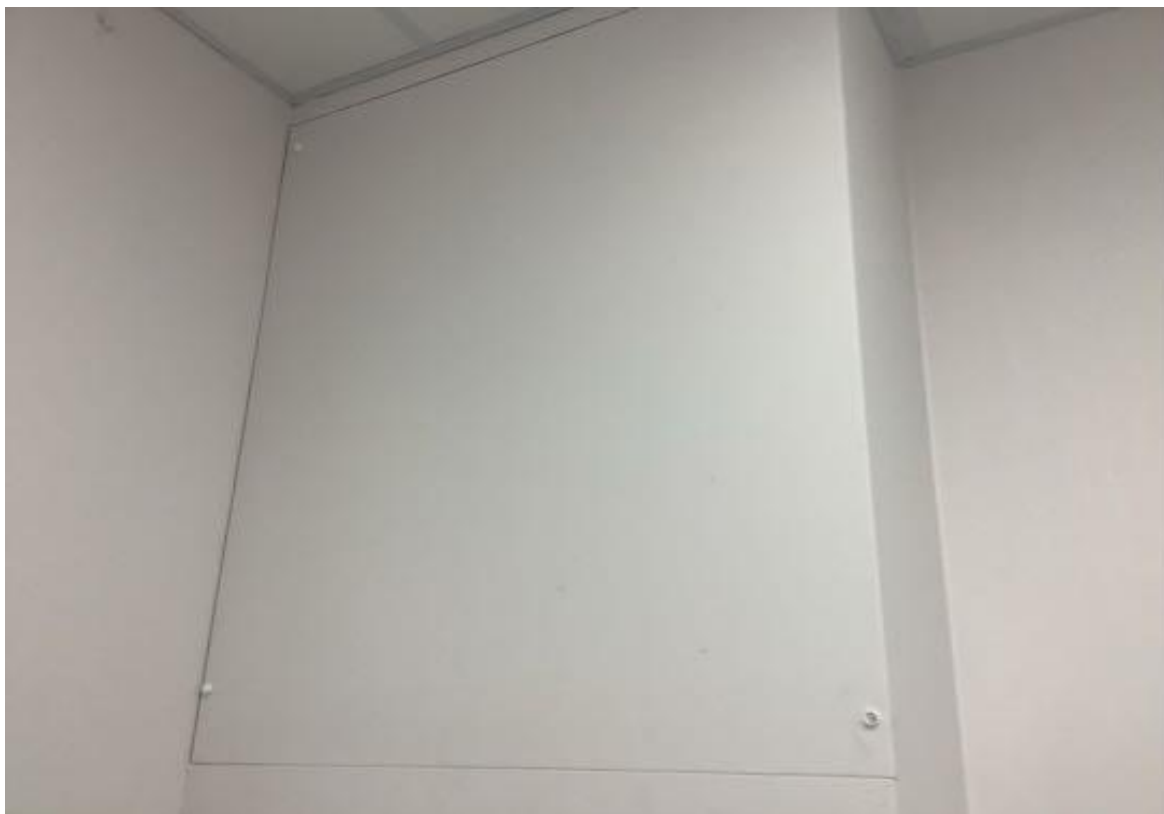
Cal 10

DETAIL	ACTION?
Location	Male toilets 67	
Services fed	DHWS	
Access for inspection and maintenance	Poor	✓
Volume/Capacity (litres)?	50l	
Primary / supplementary heat source(s)	Immersion	
Cold water source	MCWS	
Cold water supply pipe size & material	15mm copper	
Cold supply pipe sufficiently insulated	No	✓
Cold supply pipe labelled	No	✓
Water temperature at flow/nearest outlet	No Access	
Temperature within acceptable limits	No Access	
Flow pipe size & material	22mm copper	
Flow pipe sufficiently insulated	No	✓
Flow pipe labelled	No	✓
Recirculation pump(s) fitted	No	
Is calorifier/cylinder sufficiently insulated?	Yes	
Is an anti-stratification pump fitted to the vessel?	No	
Is there evidence of stratification in vessel?	No	
Is an inspection hatch fitted?	No	✓
Drain valve fitted	No	
Is a pressure vessel fitted?	No	
Other observations or concerns

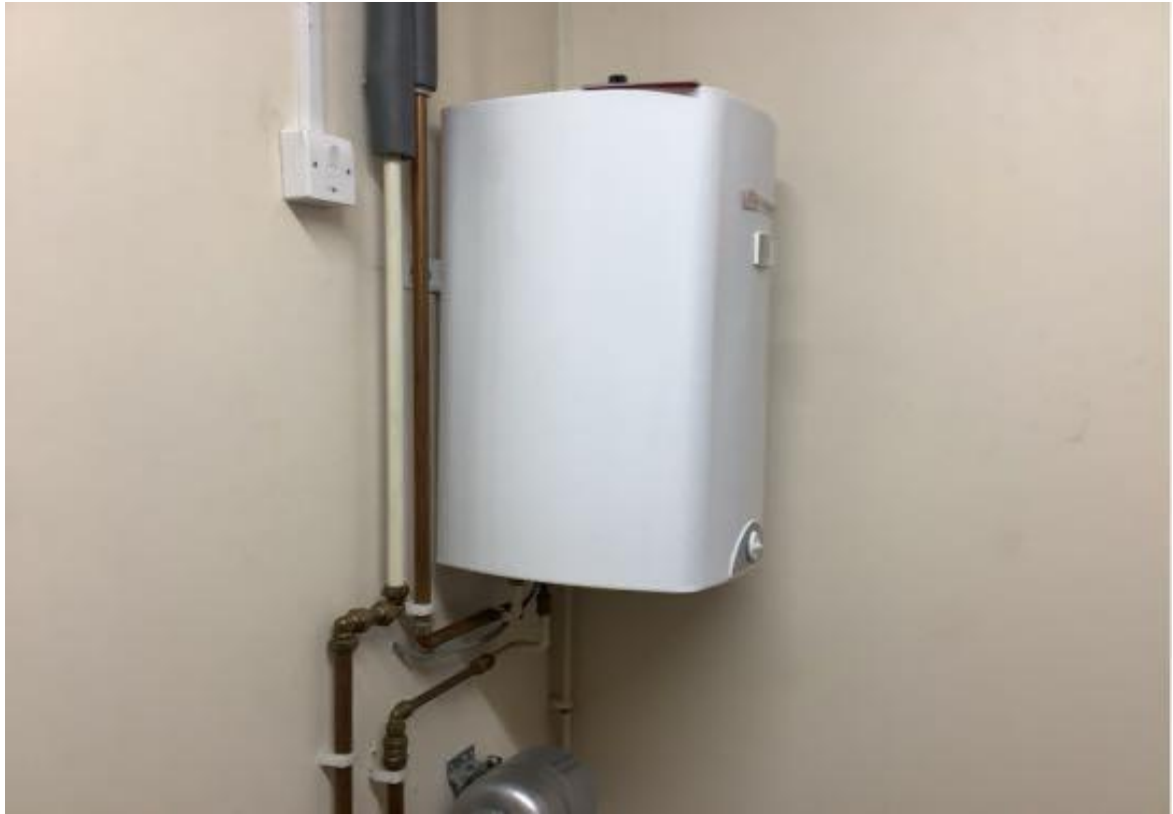
Asset Reference
Cal 11

DETAIL	ACTION?
Location	External building store	
Services fed	DHWS	
Access for inspection and maintenance	Good	
Volume/Capacity (litres)?	50l	
Primary / supplementary heat source(s)	Immersion	
Cold water source	MCWS	
Cold water supply pipe size & material	15mm copper	
Cold supply pipe sufficiently insulated	No	✓
Cold supply pipe labelled	No	✓
Water temperature at flow/nearest outlet	57	
Temperature within acceptable limits	No	✓
Flow pipe size & material	22mm copper	
Flow pipe sufficiently insulated	No	✓
Flow pipe labelled	No	✓
Recirculation pump(s) fitted	No	
Is calorifier/cylinder sufficiently insulated?	Yes	
Is an anti-stratification pump fitted to the vessel?	No	
Is there evidence of stratification in vessel?	No	
Is an inspection hatch fitted?	No	✓
Drain valve fitted	No	
Is a pressure vessel fitted?	Yes	
Pressure vessel correctly aligned	No	✓
Other observations or concerns

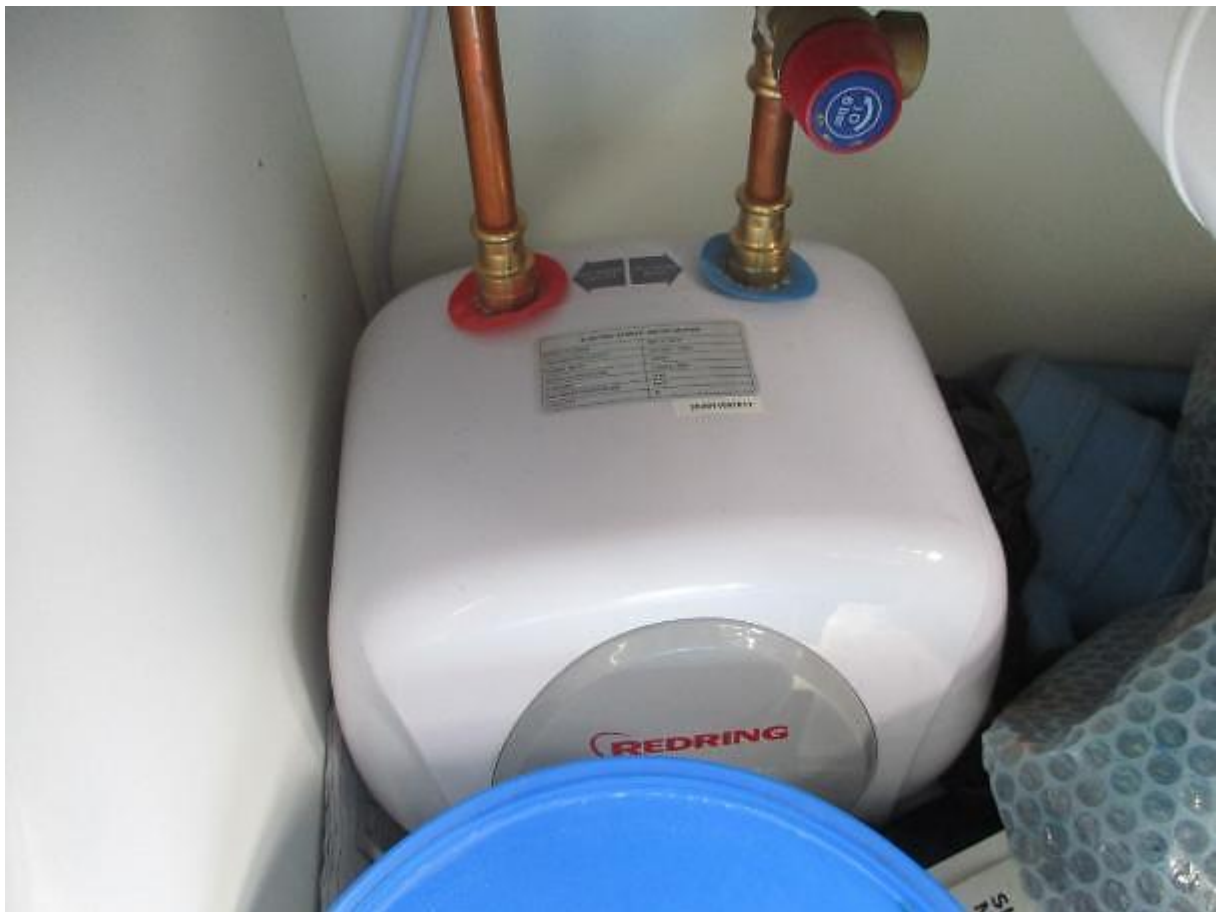
Asset Reference	LVWH 1	
	DETAIL	ACTION?
Location	Classroom 27	
Services fed	DHWS	
Does heater supply multiple outlets?	No	
Access is required for inspection, maintenance and testing	Good	
Nominal storage volume	10l	
Stored water temperature (°C)	60	
Temperature within acceptable limits	Yes	
Used daily	Yes	
Cold water source	MCWS	
Cold supply pipe size & material	15mm copper	
Cold supply pipe insulated	No	✓
Integral TMV fitted	No	
Flow/outlet type	Piped to taps	
Flow pipe size & material	15mm copper	
Flow pipe insulated	No	✓
Is a pressure vessel fitted?	Yes	
Is pressure vessel correctly aligned?	No	✓
Other observations or concerns

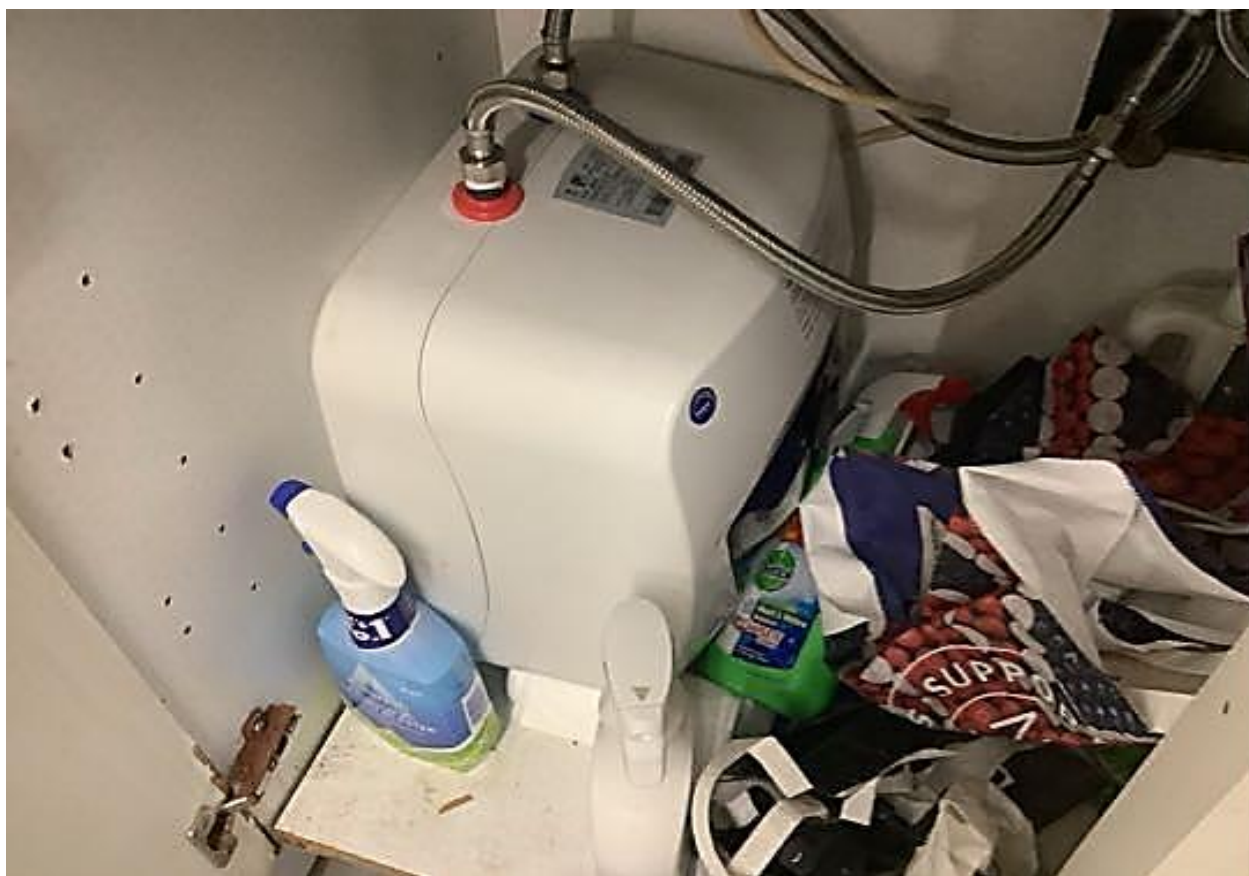
LVWH 2

DETAIL	ACTION?
Location	Staff room	
Services fed	DHWS	
Does heater supply multiple outlets?	No	
Access is required for inspection, maintenance and testing	Good	
Nominal storage volume	10l	
Stored water temperature (°C)	30	
Temperature within acceptable limits	No	✓
Used daily	Yes	
Cold water source	MCWS	
Cold supply pipe size & material	15mm flexible	
Cold supply pipe insulated	No	✓
Integral TMV fitted	No	
Flow/outlet type	Piped to taps	
Flow pipe size & material	15mm flexible	
Flow pipe insulated	No	✓
Is a pressure vessel fitted?	No	
Other observations or concerns

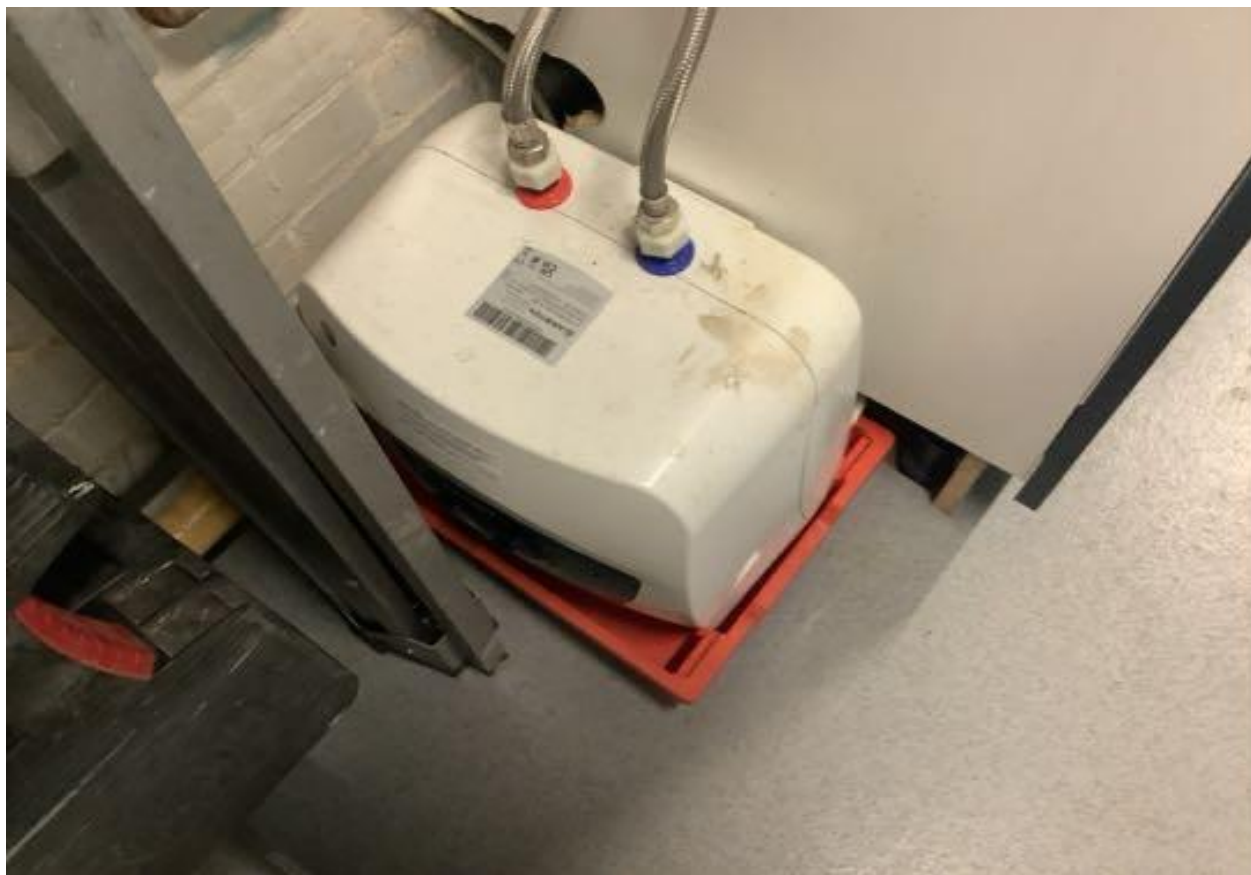
Asset Reference
LVWH 3

DETAIL	ACTION?
Location	Workshop	
Services fed	DHWS	
Does heater supply multiple outlets?	No	
Access is required for inspection, maintenance and testing	Good	
Nominal storage volume	10l	
Stored water temperature (°C)	55	
Temperature within acceptable limits	Yes	
Used daily	Yes	
Cold water source	MCWS	
Cold supply pipe size & material	15mm copper	
Cold supply pipe insulated	No	✓
Integral TMV fitted	No	
Flow/outlet type	Piped to taps	
Flow pipe size & material	15mm copper	
Flow pipe insulated	No	✓
Is a pressure vessel fitted?	Yes	
Is pressure vessel correctly aligned?	No	✓
Other observations or concerns

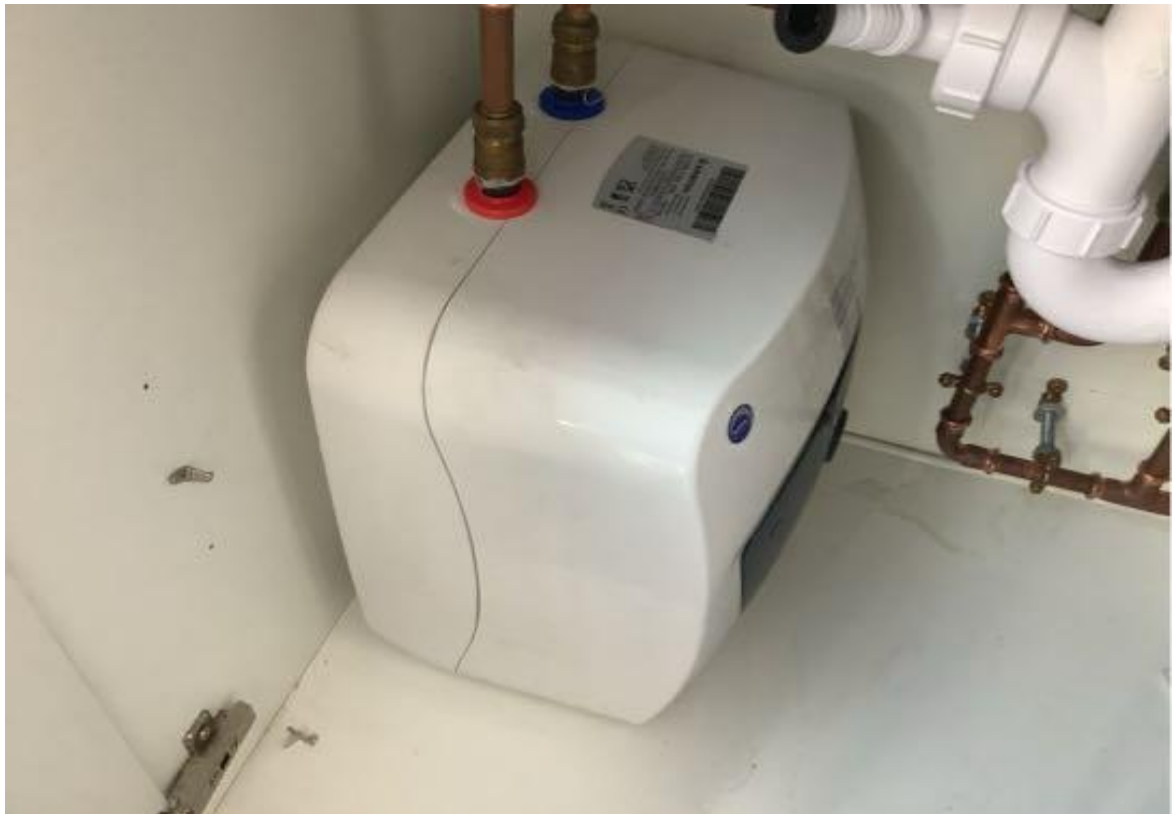
LVWH 4

DETAIL	ACTION?
Location	Class room 60	
Services fed	DHWS	
Does heater supply multiple outlets?	No	
Access is required for inspection, maintenance and testing	Good	
Nominal storage volume	10l	
Stored water temperature (°C)	60	
Temperature within acceptable limits	Yes	
Used daily	Yes	
Cold water source	MCWS	
Cold supply pipe size & material	15mm copper	
Cold supply pipe insulated	No	✓
Integral TMV fitted	No	
Flow/outlet type	Piped to taps	
Flow pipe size & material	15mm copper	
Flow pipe insulated	No	✓
Is a pressure vessel fitted?	Yes	
Is pressure vessel correctly aligned?	Yes	
Other observations or concerns

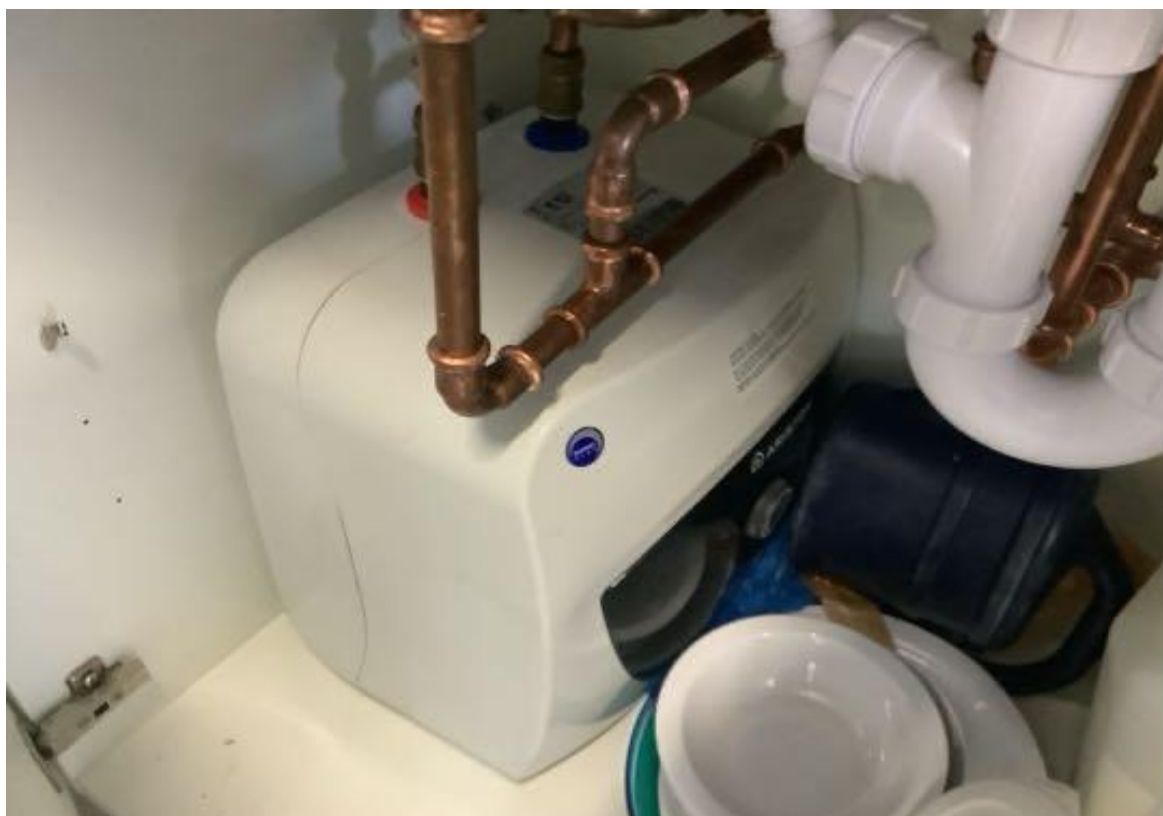
LVWH 5

DETAIL	ACTION?
Location	Class room 61	
Services fed	DHWS	
Does heater supply multiple outlets?	No	
Access is required for inspection, maintenance and testing	Good	
Nominal storage volume	10l	
Stored water temperature (°C)	38	
Temperature within acceptable limits	No	✓
Used daily	Yes	
Cold water source	MCWS	
Cold supply pipe size & material	15mm copper	
Cold supply pipe insulated	No	✓
Integral TMV fitted	No	
Flow/outlet type	Piped to taps	
Flow pipe size & material	15mm copper	
Flow pipe insulated	No	✓
Is a pressure vessel fitted?	Yes	
Is pressure vessel correctly aligned?	Yes	
Other observations or concerns

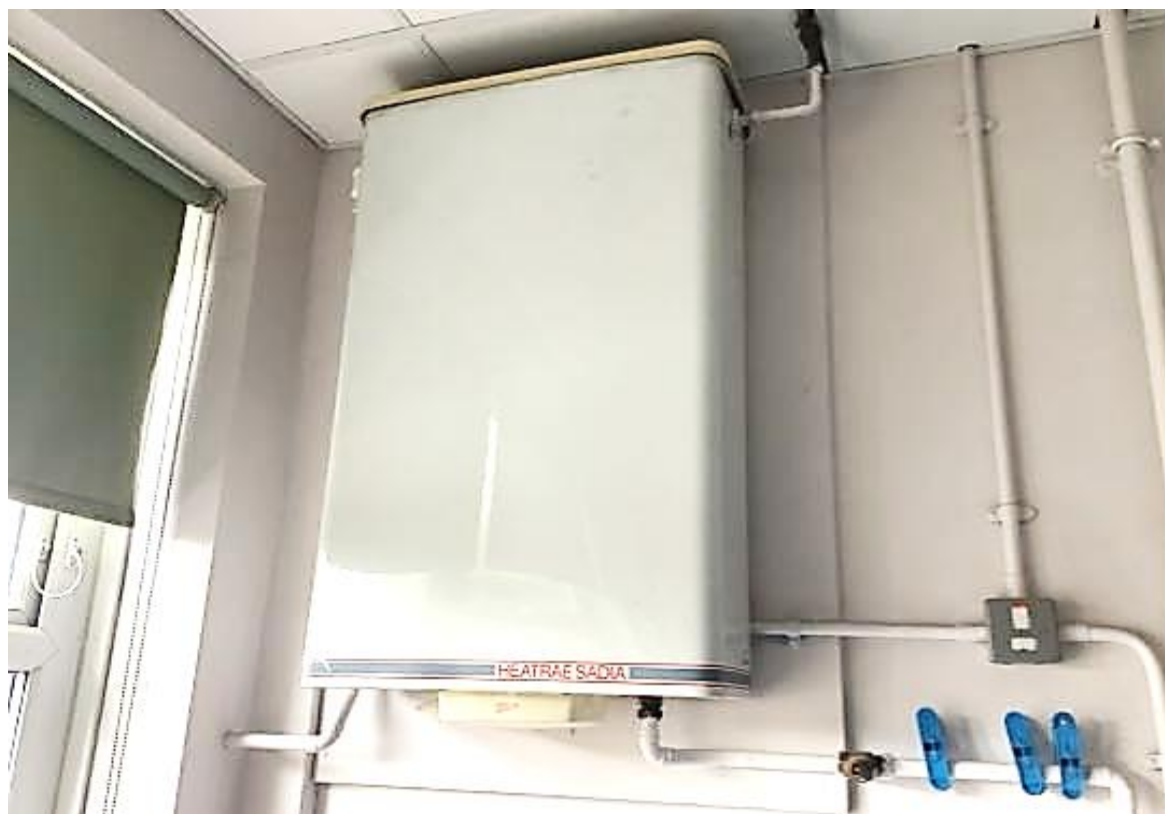
Asset Reference	Classroom 65	
	DETAIL	ACTION?
Reference	CH 1	
Access for inspection & maintenance	Good	
Cold water header tank		
Cold water source	CWDS	
Cold water feed temperature	15	
Temperature within acceptable limits	Yes	
Cold water pipe size & material	15mm copper	
Cold water pipe insulated	No	✓
Lid/cover fitted and secure	Yes	
Screened vent fitted to tank lid/cover	Yes	
Stored water temperature	27	
Temperature within acceptable limits	Yes	
Visual condition of stored water	Light debris and sediment present	✓
Visual condition of tank	Clean and sound	
Are cold water outlets fed from header tank?		
Water heater & storage vessel		
Services fed	DHWS	
Primary heat/energy source	Immersion	
Vessel storage capacity (litres)	50l	
Temperature of hot water at nearest outlet	55	
Temperature within acceptable limits	No	✓
Hot water feed pipe size & material	22mm copper	
Hot water feed pipe insulated	No	✓
Drain valve fitted	No

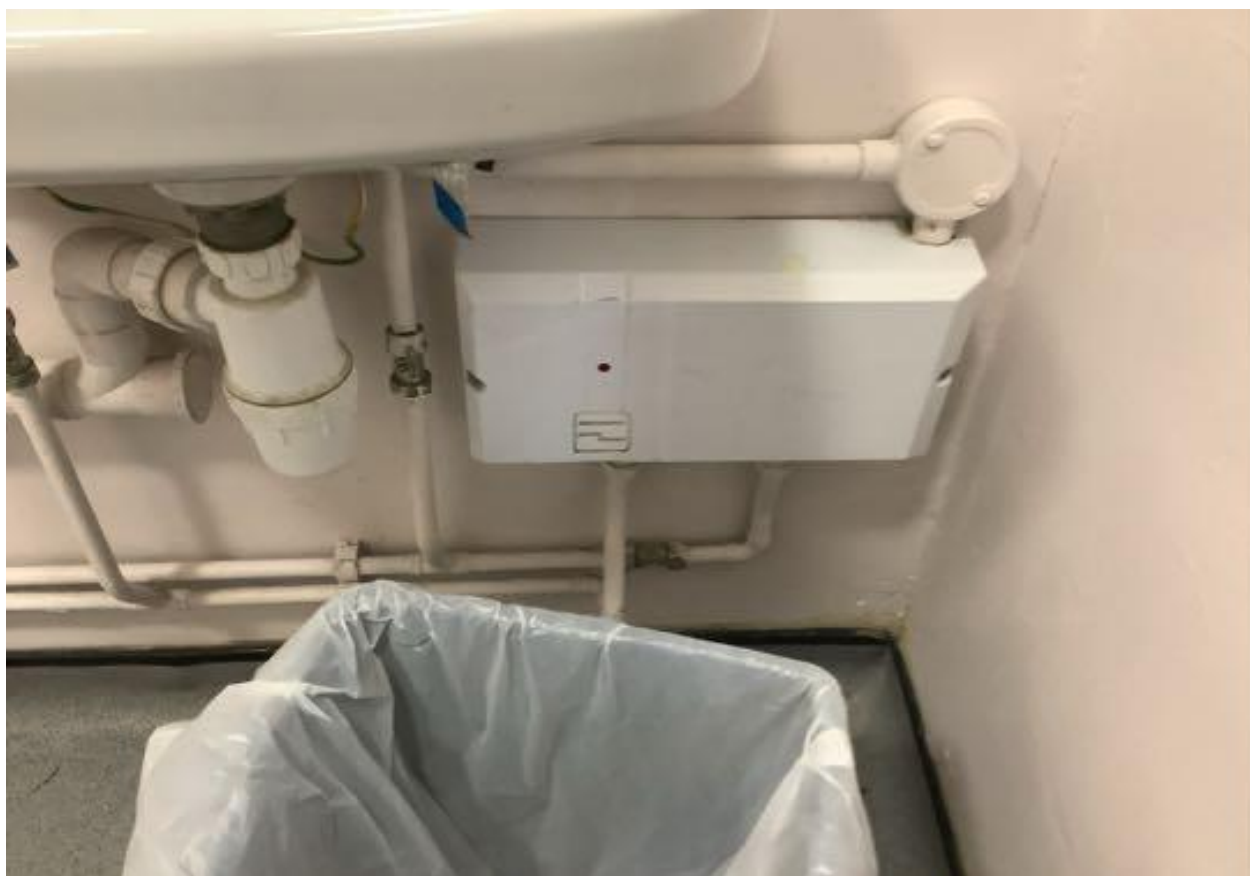
Asset Reference	POU 1	
	DETAIL	ACTION?
Location	Female toilet 14	
Primary heat/energy source	Immersion	
Cold water source	MCWS	
Cold water pipe insulated	No	✓
Cold water supply temperature	13	
Cold water temperature over 21 °C	No	
Hot water temperature within acceptable limits	No	✓
Other observations or concerns
