14 April, 2025

LEGIONELLA RISK ASSESSMENT

West Wimbledon Primary School

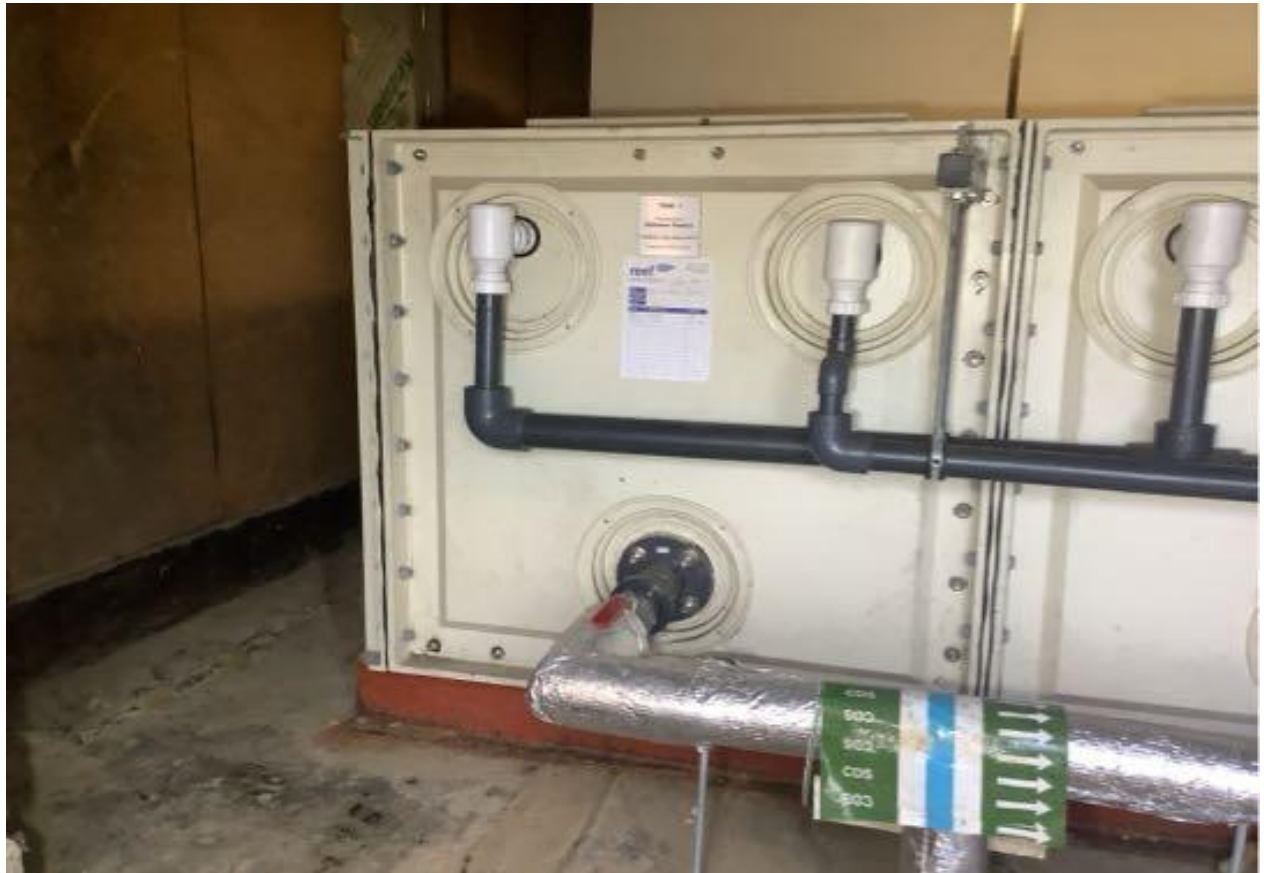
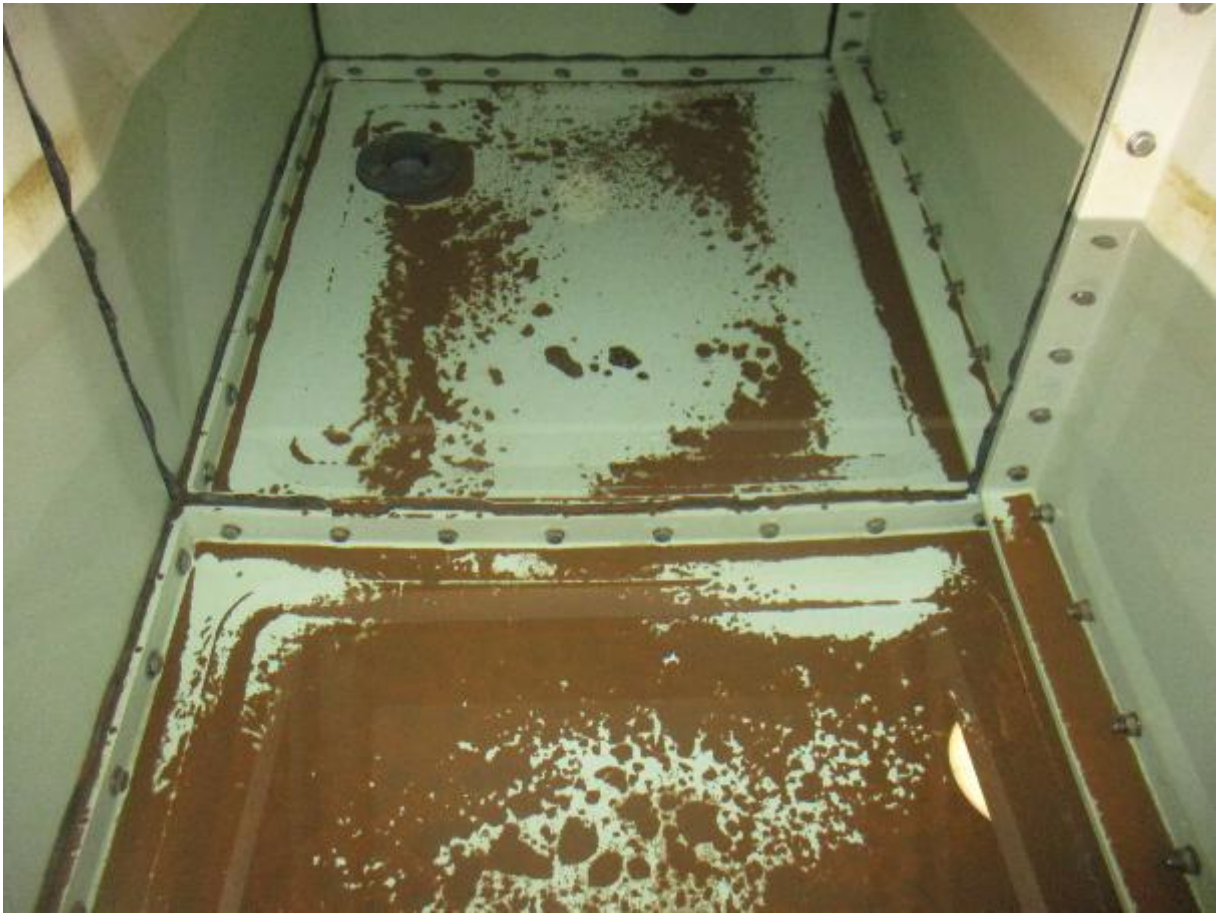
Asset Reference	Roof Tank Room LH	
	DETAIL	ACTION?
Reference	CWST 1	
Services supplied	CWDS	
Access for inspection & maintenance	Good	
Is there a need for internal ladders?	No	
Ambient temperature around tank	12	
Is confined space access required to clean and maintain the tank?	Yes	✓
Tank area lighting and power	Lighting but no power nearby	
Material of construction	GRP/Fibreglass	
Has tank been lined or coated?	No	
Tank dimensions (L x W x H)	2.0 x 1.0 x 1.0	
Approximate stored water volume (litres)	1400	
Tank sufficiently insulated	Yes - integrated insulation	
Potential for stagnant areas in tank	Negligible - inlets and outlets opposing	
Inlet pipework size and material	28mm copper	
Inlet pipework insulated?	Yes	
Inlet pipework labelled	Yes	
Outlet pipe size and material	2" plastic	
Outlet pipework labelled	Yes	
Outlet pipe insulated	Yes	
Tank lid/cover fitted and secure	Yes	
Screened vent fitted to tank lid/cover	Yes

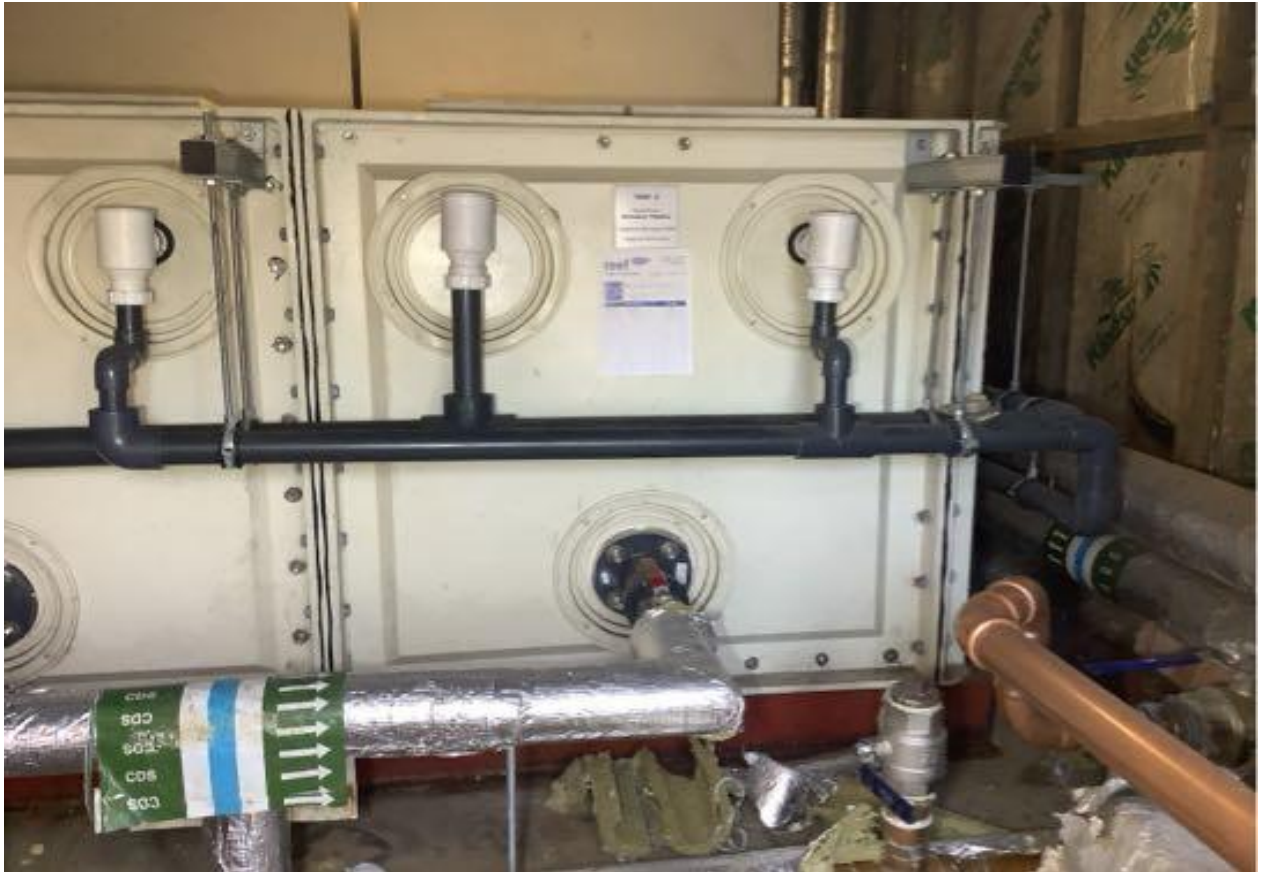
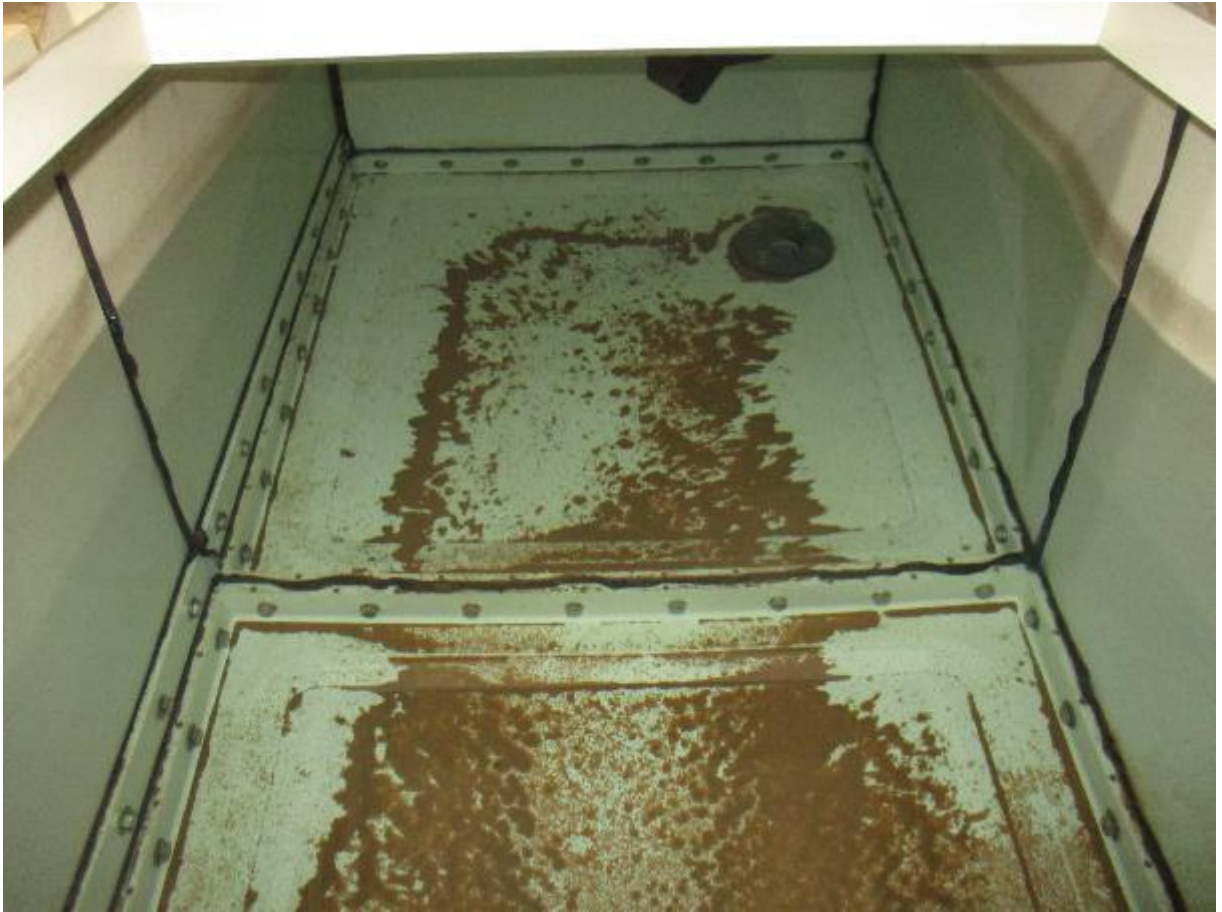
Asset Reference	Roof Tank Room LH	
	DETAIL	ACTION?
Reference	CWST 2	
Services supplied	CWDS	
Access for inspection & maintenance	Good	
Is there a need for internal ladders?	No	
Ambient temperature around tank	14	
Is confined space access required to clean and maintain the tank?	Yes	✓
Tank area lighting and power	Lighting but no power nearby	
Material of construction	GRP/Fibreglass	
Has tank been lined or coated?	No	
Tank dimensions (L x W x H)	2.0 x 1.0 x 1.0	
Approximate stored water volume (litres)	1400	
Tank sufficiently insulated	Yes - integrated insulation	
Potential for stagnant areas in tank	Negligible - inlets and outlets opposing	
Inlet pipework size and material	28mm copper	
Inlet pipework insulated?	Yes	
Inlet pipework labelled	Yes	
Outlet pipe size and material	2" plastic	
Outlet pipework labelled	No	✓
Outlet pipe insulated	Yes	
Tank lid/cover fitted and secure	Yes	
Screened vent fitted to tank lid/cover	Yes

Overflow fitted to tank	Yes - screened	
Warning pipe fitted to tank	Yes - screened	
Is an open vent from HWS able to discharge into tank?	No	
Stored water temperature	14	
Temperature within acceptable limits	Yes	
Incoming water temperature	12	
Temperature within acceptable limits	Yes	
Visual condition of stored water	Light debris and sediment present	✓
Visual condition of tank	Clean and sound	
Other observations or concerns

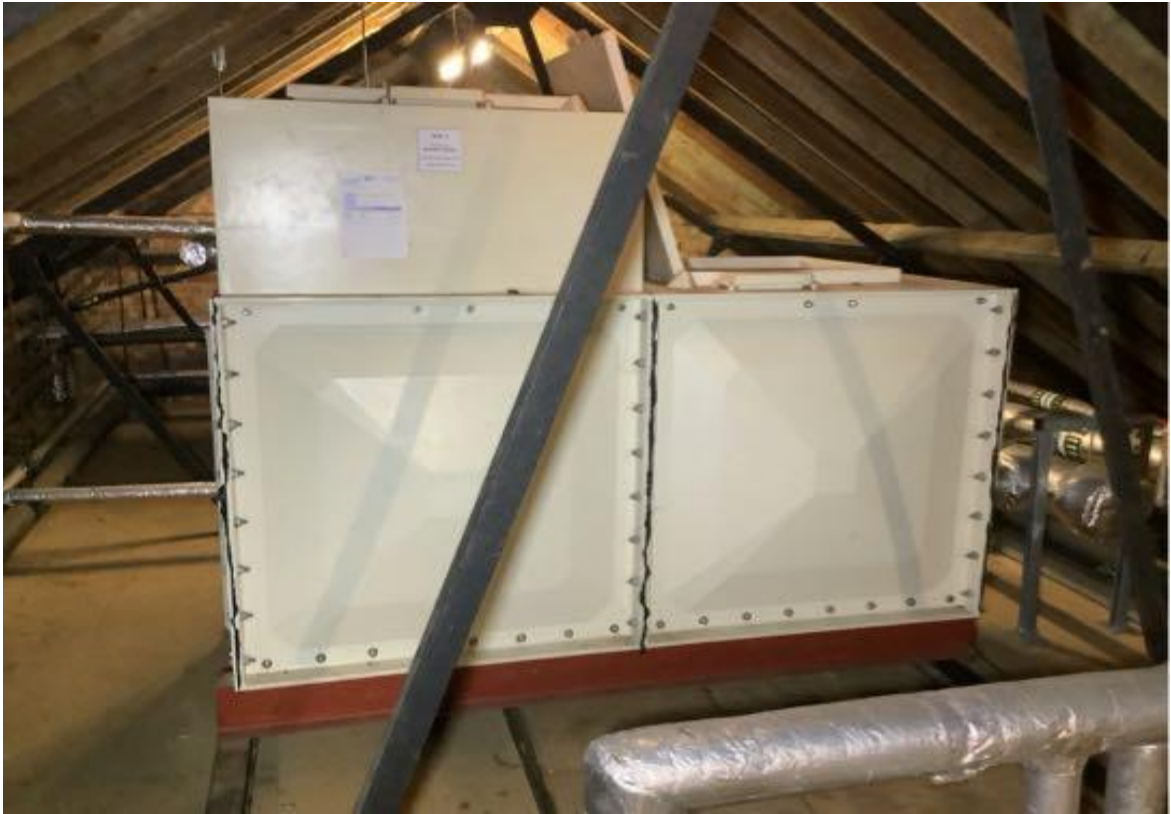
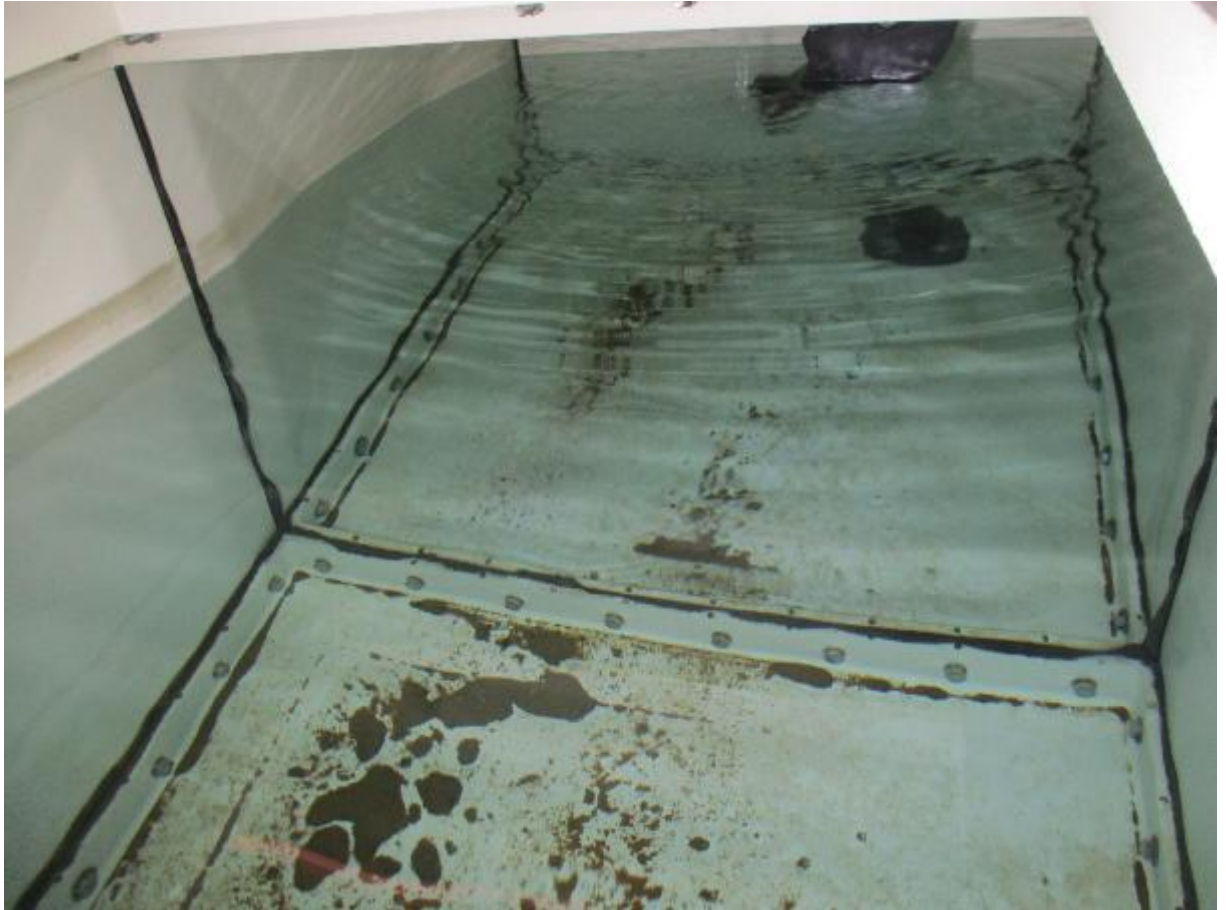
Asset Reference	Loft Tank Room RH	
	DETAIL	ACTION?
Reference	CWST 3	
Services supplied	CWDS	
Access for inspection & maintenance	Good	
Is there a need for internal ladders?	No	
Ambient temperature around tank	16	
Is confined space access required to clean and maintain the tank?	Yes	✓
Tank area lighting and power	Lighting but no power nearby	
Material of construction	GRP/Fibreglass	
Has tank been lined or coated?	No	
Tank dimensions (L x W x H)	2.0 x 1.0 x 1.0	
Approximate stored water volume (litres)	1400	
Tank sufficiently insulated	Yes - integrated insulation	
Potential for stagnant areas in tank	Negligible - inlets and outlets opposing	
Inlet pipework size and material	28mm copper	
Inlet pipework insulated?	Yes	
Inlet pipework labelled	Yes	
Outlet pipe size and material	150mm copper	
Outlet pipework labelled	Yes	
Outlet pipe insulated	Yes	
Tank lid/cover fitted and secure	Yes	
Screened vent fitted to tank lid/cover	Yes

Overflow fitted to tank	Yes - screened	
Warning pipe fitted to tank	Yes - screened	
Is an open vent from HWS able to discharge into tank?	No	
Stored water temperature	16	
Temperature within acceptable limits	Yes	
Incoming water temperature	12	
Temperature within acceptable limits	Yes	
Visual condition of stored water	Light debris and sediment present	✓
Visual condition of tank	Clean and sound	
Other observations or concerns

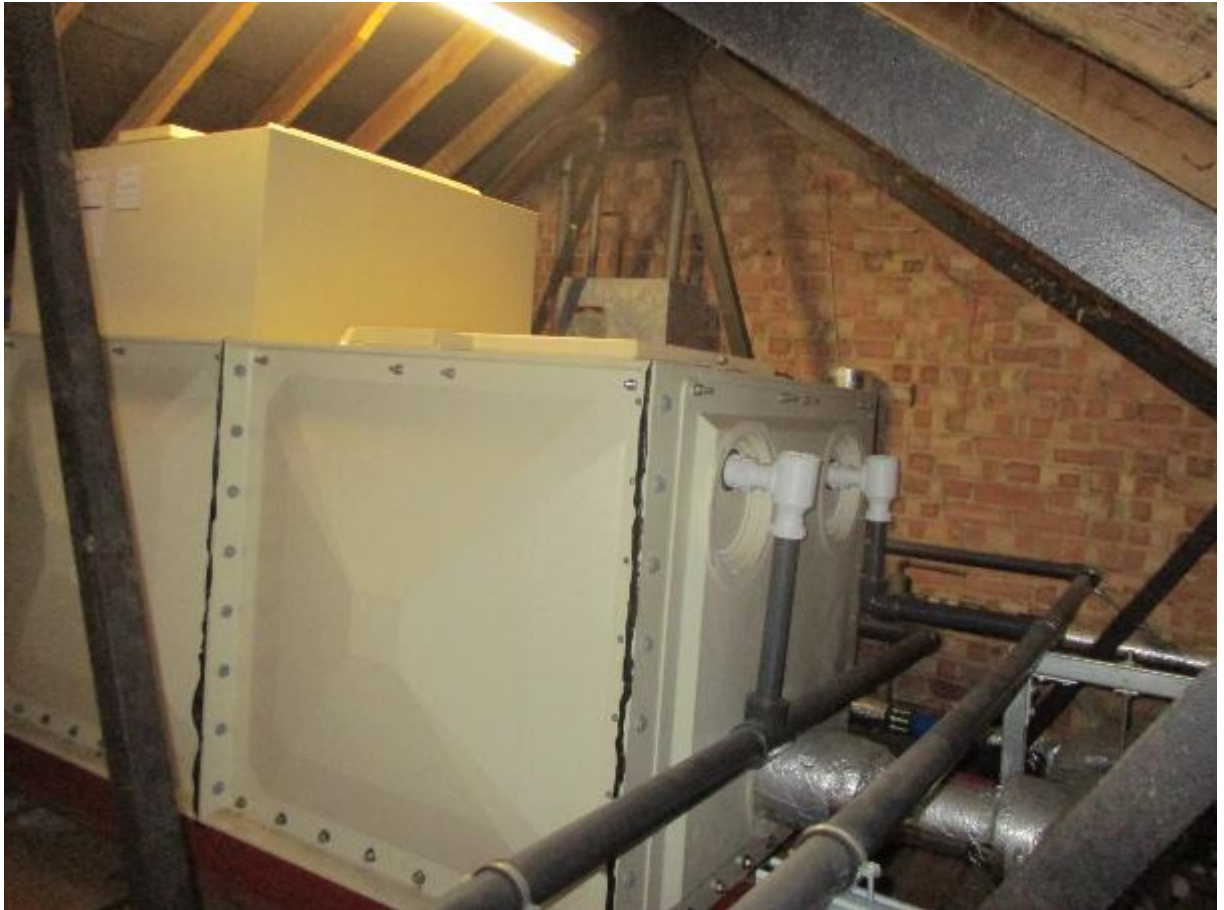
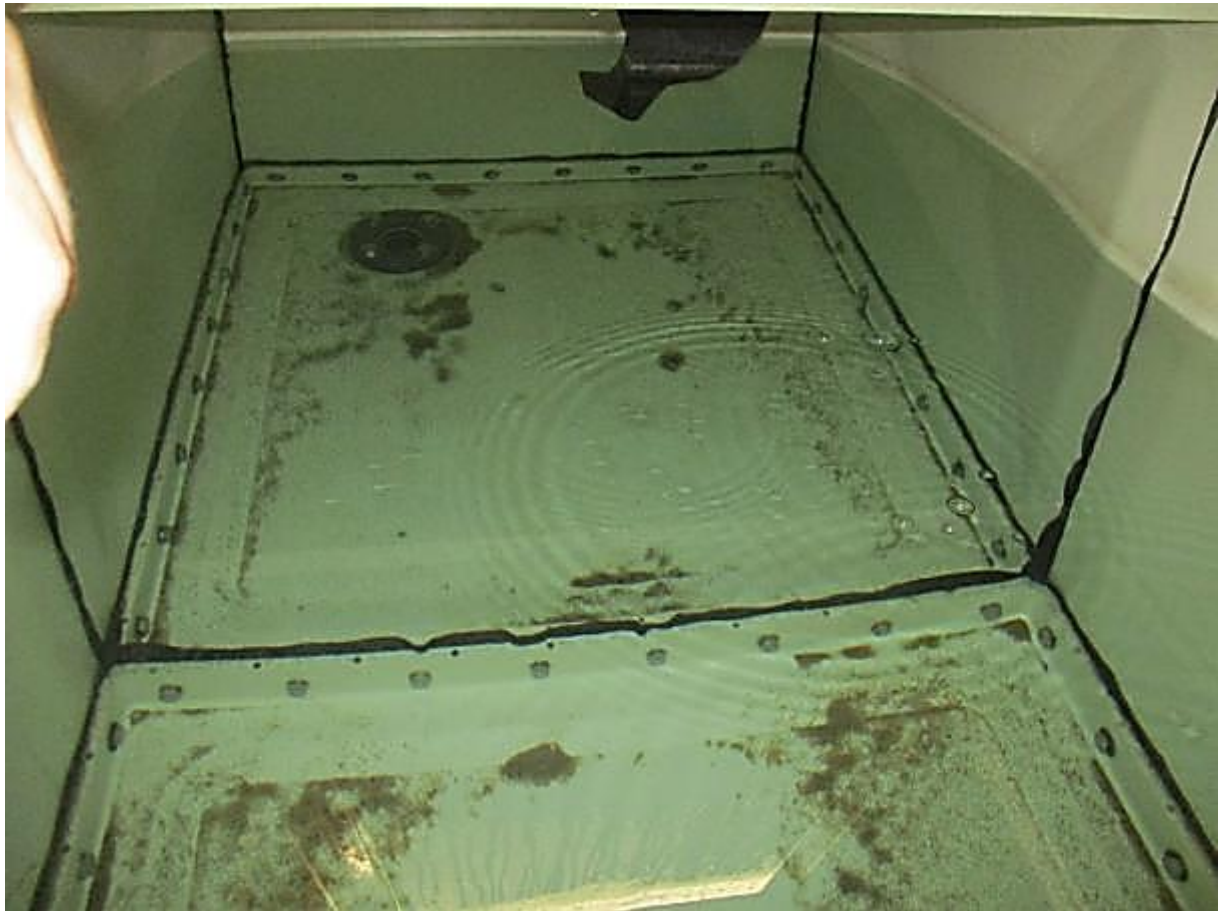
Asset Reference	Loft Tank Room RH	
	DETAIL	ACTION?
Reference	CWST 4	
Services supplied	CWDS	
Access for inspection & maintenance	Good	
Is there a need for internal ladders?	No	
Ambient temperature around tank	16	
Is confined space access required to clean and maintain the tank?	Yes	✓
Tank area lighting and power	Lighting but no power nearby	
Material of construction	GRP/Fibreglass	
Has tank been lined or coated?	No	
Tank dimensions (L x W x H)	2.0 x 1.0 x 1.0	
Approximate stored water volume (litres)	1400	
Tank sufficiently insulated	Yes - integrated insulation	
Potential for stagnant areas in tank	Negligible - inlets and outlets opposing	
Inlet pipework size and material	28mm copper	
Inlet pipework insulated?	Yes	
Inlet pipework labelled	Yes	
Outlet pipe size and material	150mm copper	
Outlet pipework labelled	Yes	
Outlet pipe insulated	Yes	
Tank lid/cover fitted and secure	Yes	
Screened vent fitted to tank lid/cover	Yes

Overflow fitted to tank	Yes - screened	
Warning pipe fitted to tank	Yes - screened	
Is an open vent from HWS able to discharge into tank?	No	
Stored water temperature	16	
Temperature within acceptable limits	Yes	
Incoming water temperature	12	
Temperature within acceptable limits	Yes	
Visual condition of stored water	Light debris and sediment present	✓
Visual condition of tank	Clean and sound	
Other observations or concerns
