Inspection Halton Village Hall

Date of issue: 20th November 2024

BATTRAM ASSOCIATES

HALTON VILLAGE HALL, INSPECTION

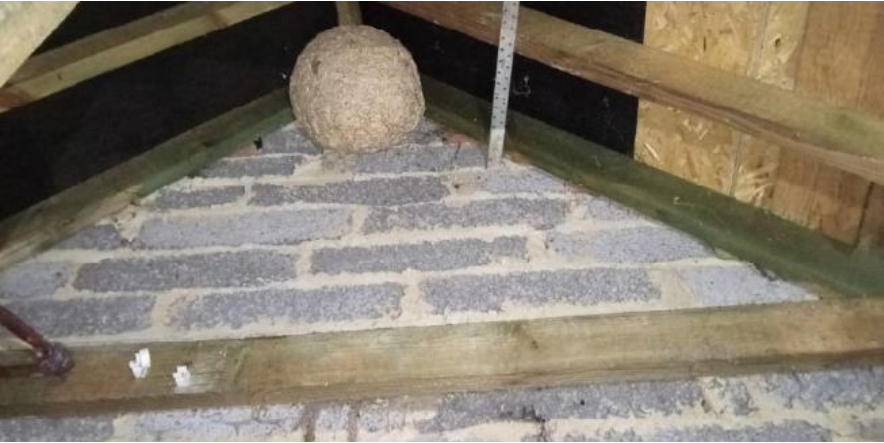
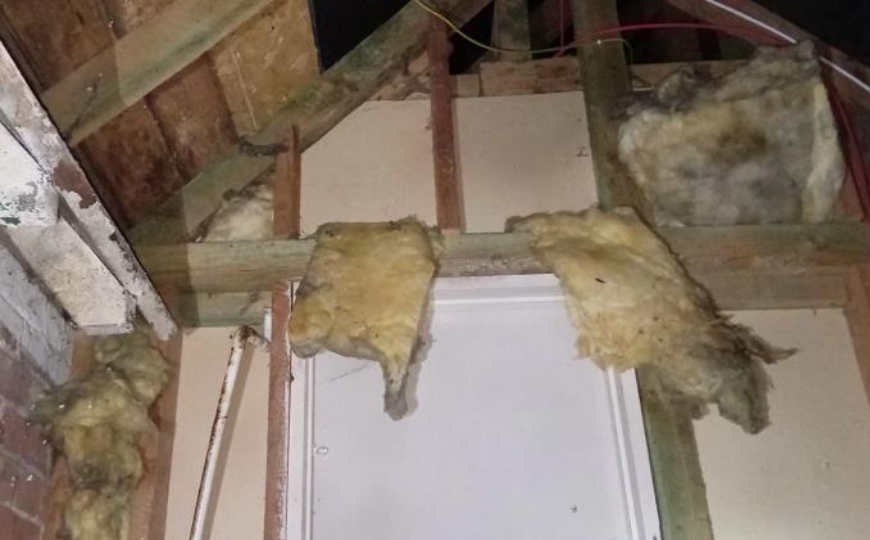
26	Roof void above Kitchen	Timber carcass construction, and remnants of the original Hall roof eaves built over.

<p>Wasp nest build up on the rear gable wall— need to find entry point to stop future infestations.</p> <p>Maint`</p> <p>The use of unsupported insulation at the wall partition to the rising WC atrium well is not ideal—renew the glass fibre with boarded PIR insulation firmly fixed into place</p> <p>Maint`</p>
----	-------------------------	---	--	--

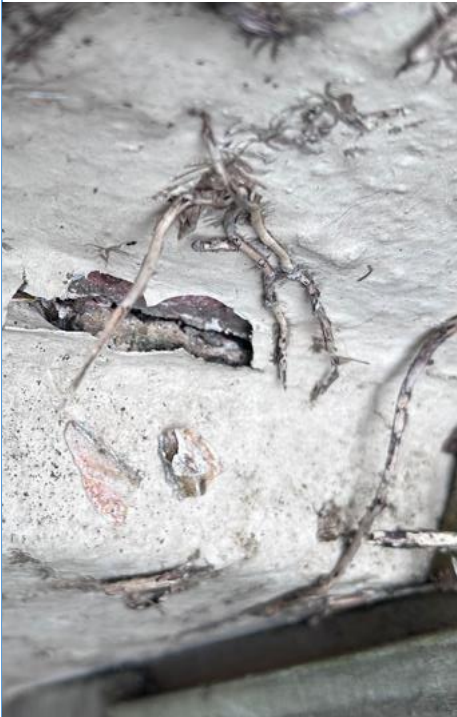
<p>EW 5</p>	<p>Main hall – north wall: brickwork</p>	<p>Bubbles seen coming through, raised and slightly bubbling mortar joints. Paint sections peeled to RHS mid height. Peeling paint at the head of the plinth.</p> <p>The paint covering is incompatible with the age and construction of the brickwork behind. The paint is preventing the brickwork from breathing, trapping moisture within the walling.</p>

<p>Remove paint covering and paint with fully breathable paint system. Some lime repointing of joints may be required when paint is removed.</p>

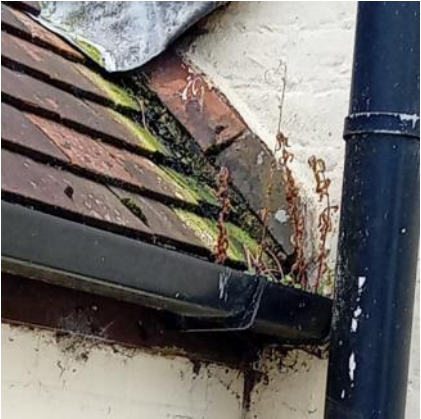
RW 4	West elevation– guttering: neighbours’ courtyard	<p>We have commented in EXTERNAL WALL ELEMENTS, the effects of blocked guttering is having on the walls at the foot of the stairs.</p>

<p>Ensure the guttering and downpipe are clear and the vegetation below is removed from the base of the external walls.</p>	1
---------	---	--	---	---

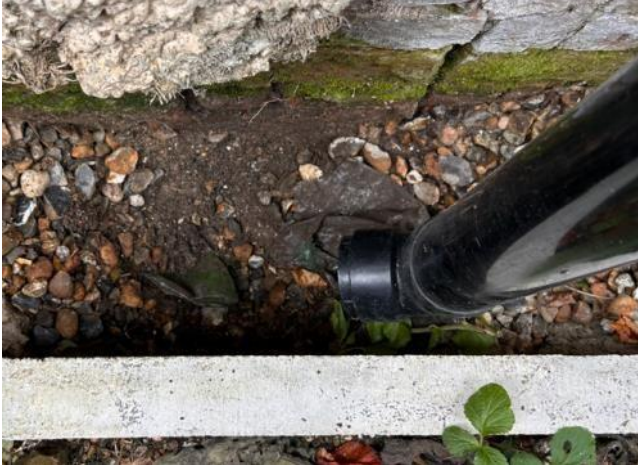
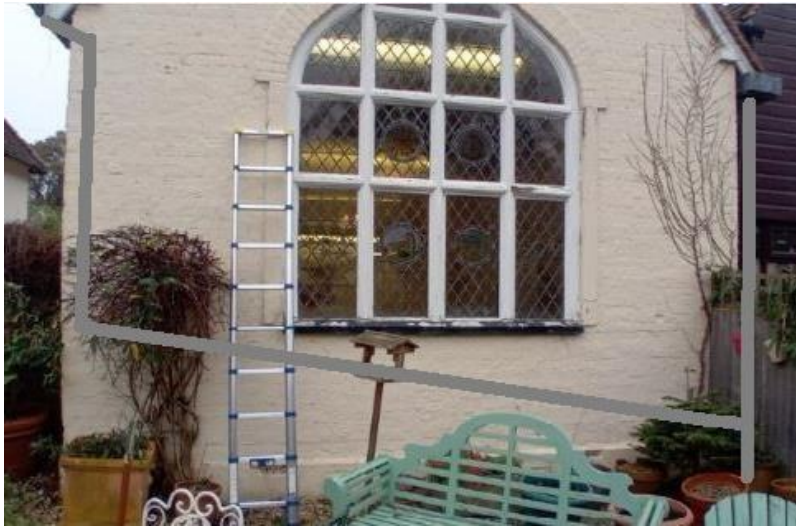
<p>RW 5</p>	<p>East elevation– main hall guttering and downpipe</p>	<p>We have commented in EXTERNAL WALLS about the effects an incorrectly installed ‘French drain’ have had on the walls. The downpipe which serves the entire roof slope on the east side discharges directly into the plastic/concrete/gravel lined channel.</p> <div data-bbox="504 359 1140 826">

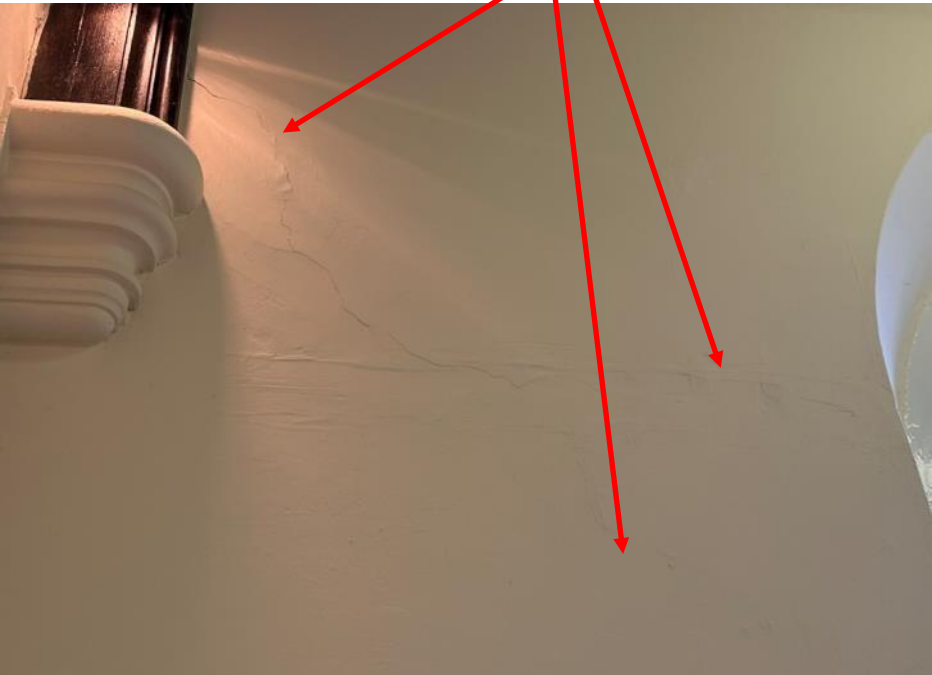
IW1	Main hall– north wall: upper RHS	<p>At high level, a crack between the NW corner corbel and window arch was present. The crack split into two nearing the arch. The crack had been previously made good several times, re-opened likely due to seasonal movement. This relatively slender area of brickwork will always be more susceptible to such movement.</p>

To monitor into the long term.	Monitor
-----	-------------------------------------	--	--------------------------------	---------

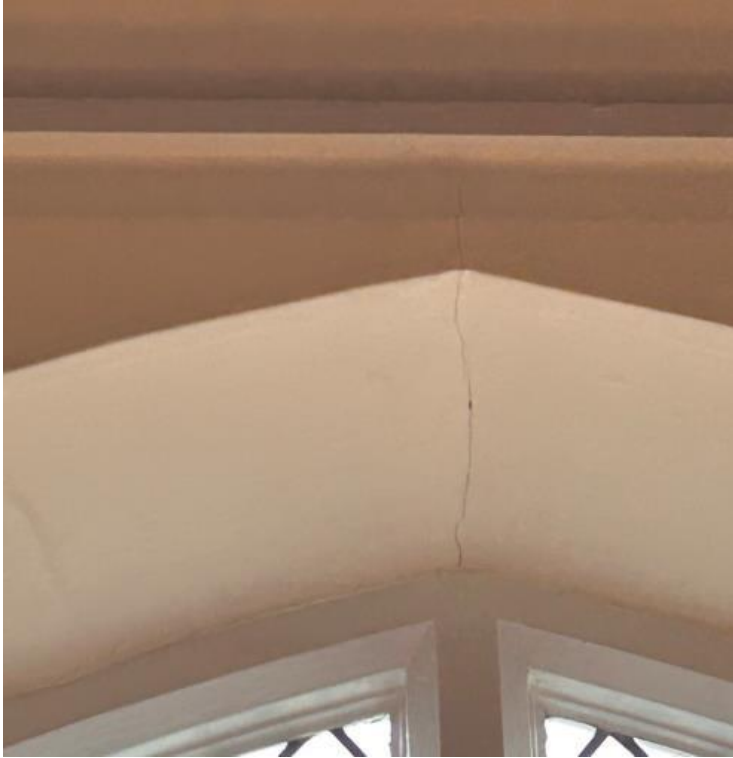
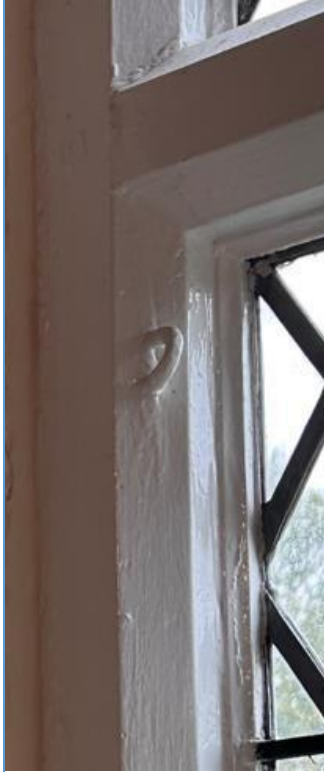
IW2	Main hall– north wall	<p>At high level from the ceiling to the arch, a hairline crack was noted. This continued around and down the window reveal on both sides. Again, a weaker point which will always be more susceptible to seasonal movement and stress.</p>

<p>To monitor into the long term. When the window is overhauled, the internal cracks can be raked out and made good.</p>

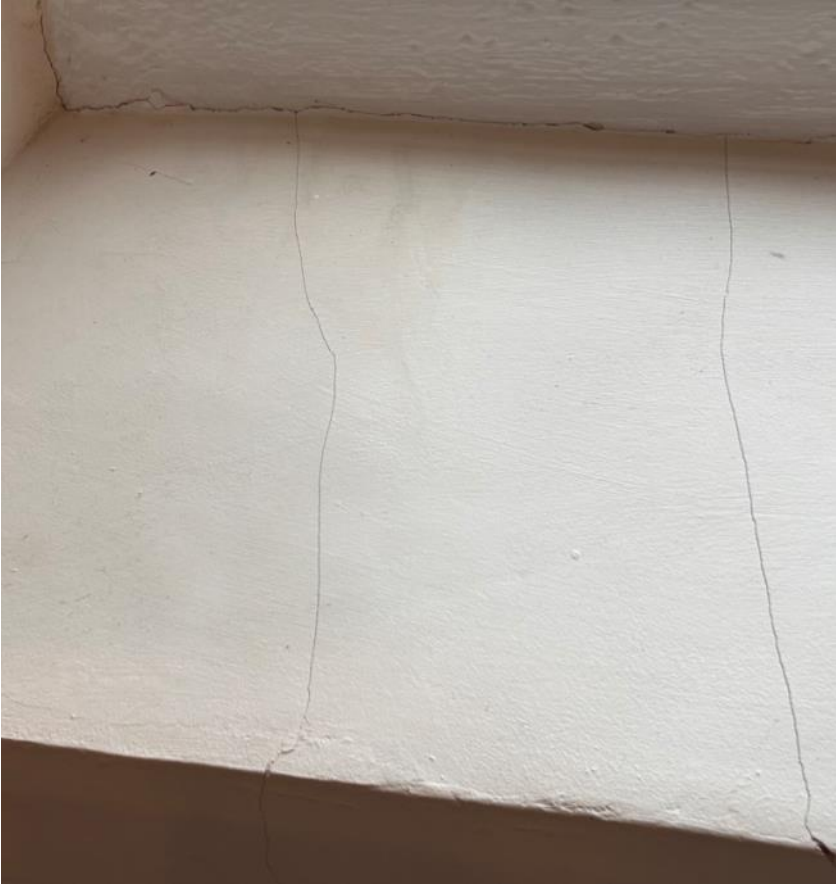
IW3	Main hall– north wall—sill	<p>4no hairline cracks through the sill into the wall below. The sill was cold with higher damp readings– externally repairs are needed to the window and sill. These are assisting moisture to ingress into the fabric of the wall.</p>

<p>Make external repairs. The plaster on the sill can then be made good.</p>	<p>2/3—for sill works</p>
-----	----------------------------	--	--	---------------------------

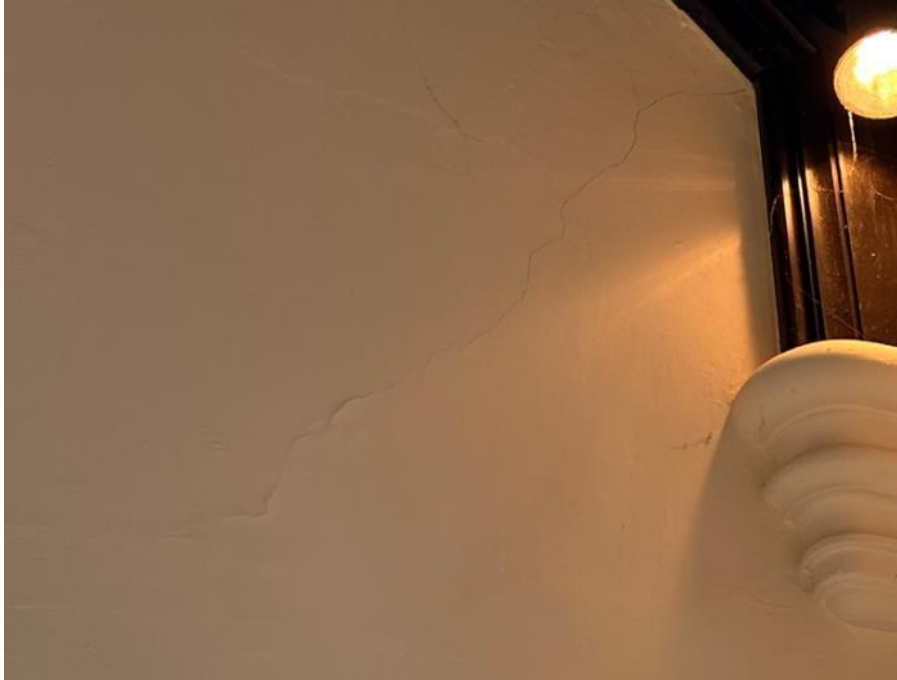
IW5	Main hall– north wall: upper LHS	<p>Diagonal crack from above the corbel down into the window. Some signs of making good. As before, stress cracks/seasonal movement are more likely in these locations.</p>

Monitor	Monitor
-----	----------------------------------	---	---------	---------

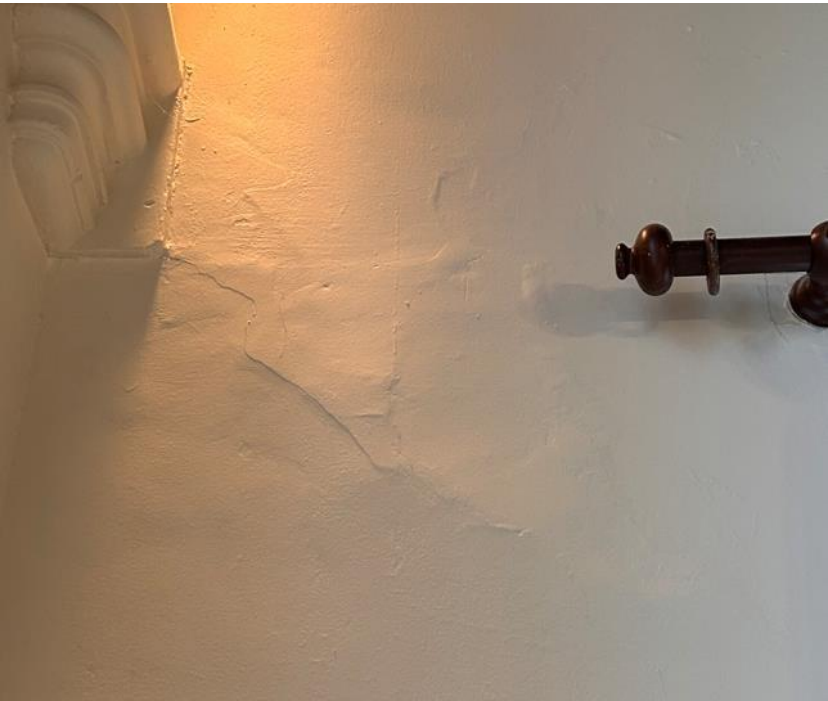
IW6	Eastern flank wall– north end: NE corbel	<p>Crack from the NE corner corbel raking towards the window. The plaster appeared to have lofted slightly despite historical making good. Externally, the render is in very poor condition with substantial cracking. This will exacerbate the plaster damage as a result of migrating moisture.</p>

Intact for now, monitor and make good in the medium term if condition worsens.	Monitor
-----	--	---	--	---------

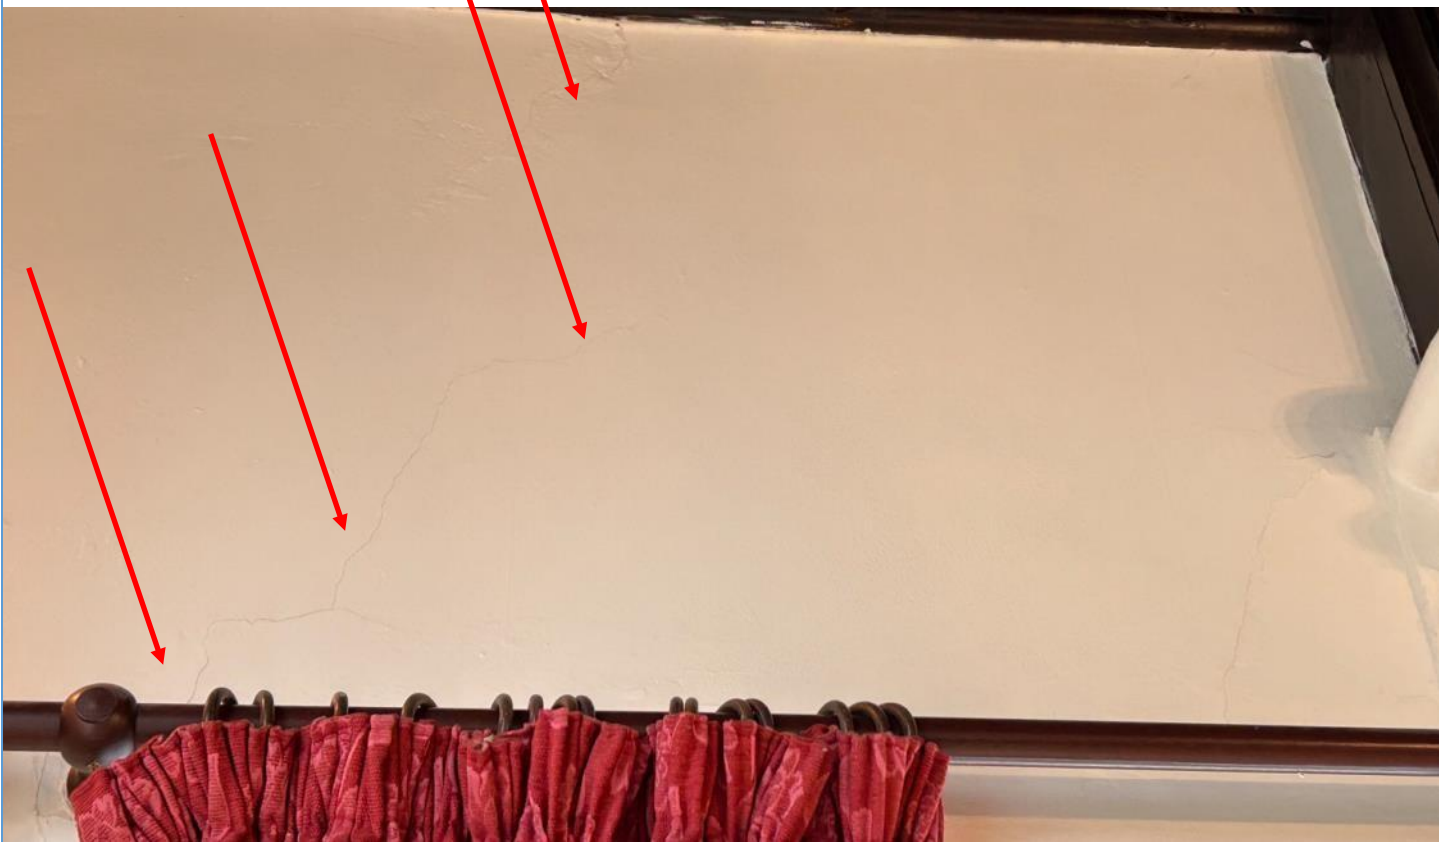
<p>IW7 Eastern flank wall– over fire escape</p>	<p>Hairline cracks across plasterwork., likely due to seasonal movement. As before, the condition of the external render is poor which will bring to affect the internal plasterwork.</p>

<p>Intact at present. Monitor and make good if condition worsens.</p>	<p>Monitor</p>
---	---	---	----------------

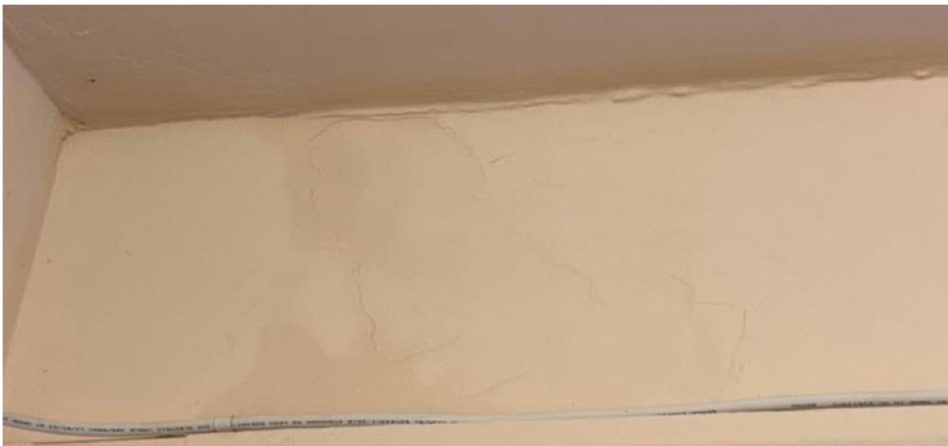
IW11	Eastern flank wall: gable end section	Slightly undulating plaster.	Intact for now. To monitor.	Monitor
IW12	South elevation: SE corner at ceiling level	Shading and very high damp readings.

Ensure downpipe is clear. That is directly opposite this on the outside. However, rendering has recently been made good outside in the same spot, and we suspect a fine “drying” crack may exist between new and old render, that should be looked into and filled with flexible long terms sealant. Then monitor.	1

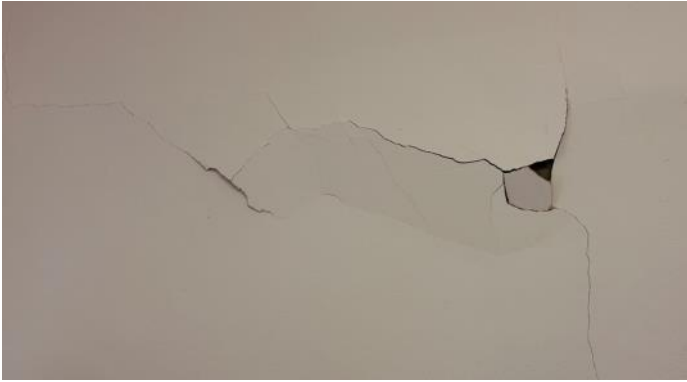
Ref	Element & description	Condition	Recommendation	Year
<i>Our observations commence in the NW corner of the main hall and working clockwise around the building</i>				
IW 14	Party wall line	<p>Plaster failed and detached. Without removing a large amount of the plaster, we were unable to see if any cracks were present to the wall behind.</p>

There were some cracks to the upper element of the party wall (in the meeting room)- for peace of mind the plaster should be removed to assess the condition of the wall behind, and a check to ensure the party wall is actually bonded to the main front wall. We may need to make further comment.	1
IW 15	Main hall – eastern wall	Slight hairline cracking noted between row of corbels., previously made good.	Intact for now. To monitor.	Monitor

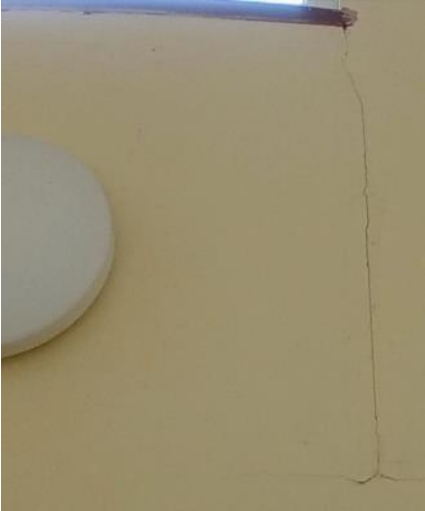
IW 16	WC	Cracks travelling down from the high level window and small areas of plaster damage at the

sills	Make good. This cracking could be due to dampness in the studs of the upper window wall, as there is ingress noted on the other side of this photo, in the adjacent toilet. As noted elsewhere take the cladding off and rectify the ingress.	Maint'
----------	----	---	--	--------

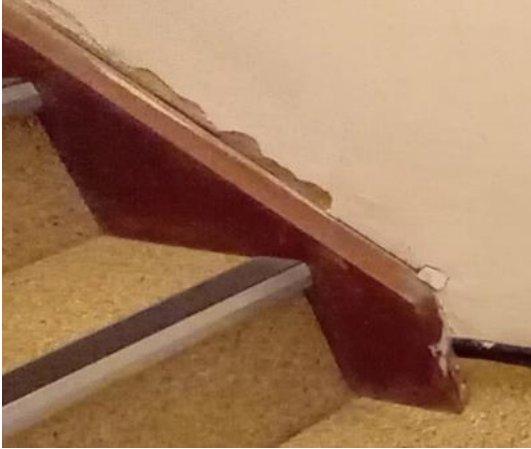
IW 17	Foot of rising stairs	<p>Slight bubbling of plaster. Cracking of plaster and damage to plaster at stair string.</p>

<p>We have commented earlier in the report about guttering and the external wall at this point– follow recommendations made.</p> <p>Make good plaster at stair string.</p>	Maint'
IW 18	SE corner in upper meeting room	<p>Lifted lining paper , plaster tapping hollow to the rear. Hairline vertical cracks to the low on and from mid to low level on the E wall. There was cracked plaster in the main hall below there was no significant movement noted, removal of the paper/failed plaster to make good</p>

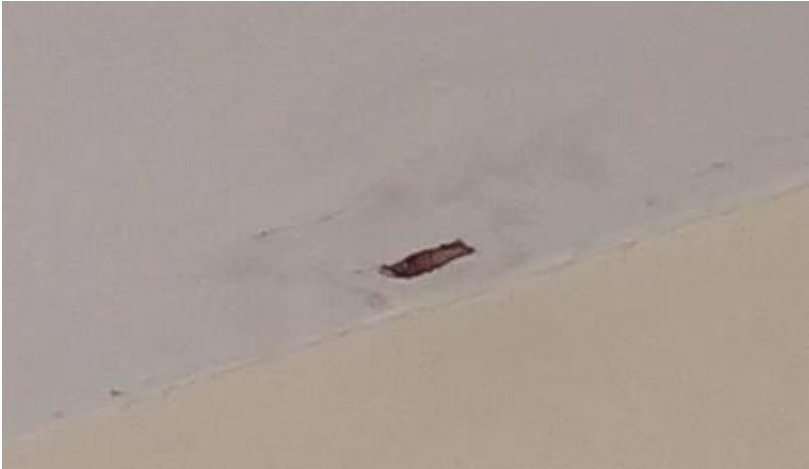
Ref	Element & description	Condition	Recommendation	Year
<i>Unless commented upon, all ceilings were found to be in good order.</i>				
C1	WC ceiling	Signs of leak/water damage. No external sign of leak.

Although there was no direct evidence of ingress point we suspect the cladding is allowing wind driven rain—see our notes at item 15A on page 10.	1

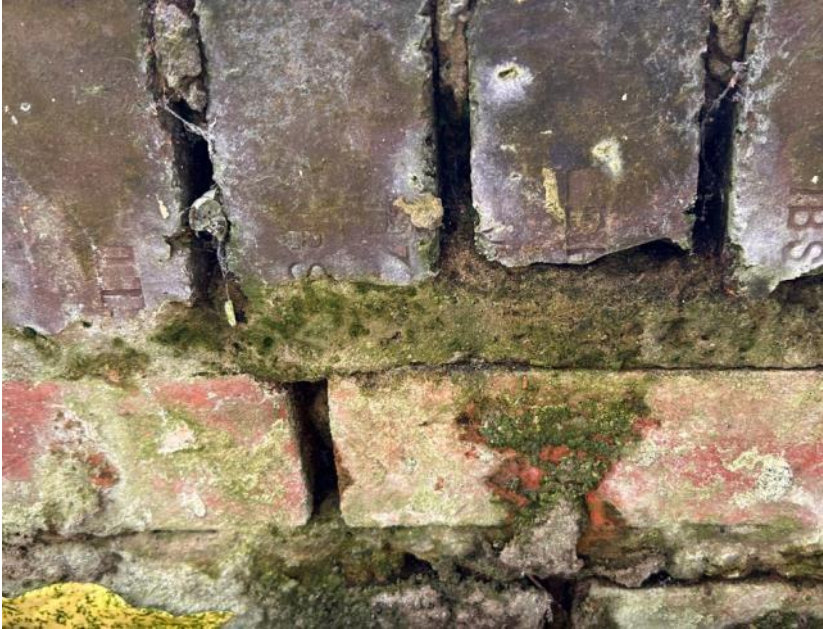
E1	Side path on the eastern side.	The path was part concrete, with half of the quarry tiles having being removed.	To assist with drainage and permeability, in tandem with reducing levels around the airbricks,, ideally the concrete should be renewed with a more permeable surface. Bearing in mind this path is a fire escape route, it is essential to be easily traversed (especially given the slope of the upper path). SUDS specific permeable paving should be used– see proposed plan on p.36	2
E2	S elevation: retaining wall	We have commented in RW2 on the condition of the rear of the shallow retaining wall due in part to splash back from rainwater.

Clear channel, rake out loose material and re-point the rear of the wall.	1

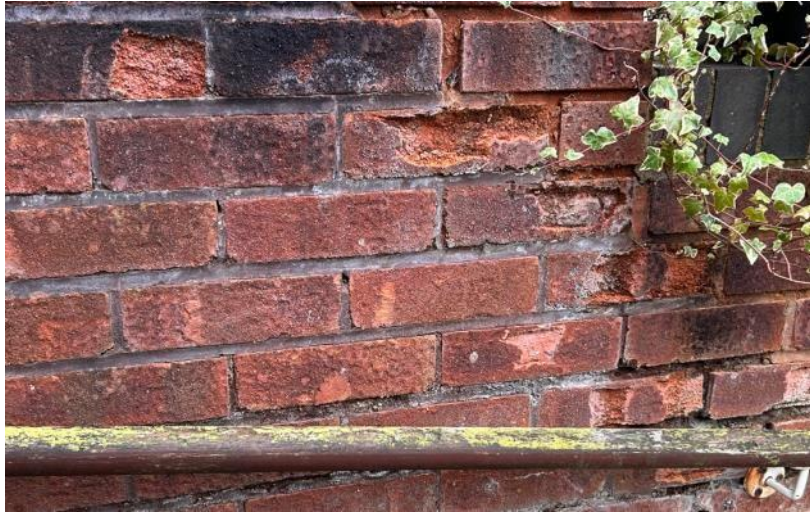
Ref	Element & description	Condition	Recommendation	Year
E3	Shared wall with neighbour	<p>Spalling brickwork and damaged mortar joints. Possibly caused by pots on the wall being watered.</p>

<p>Rake out loose material and re-point. Remove all pots. Some significantly spalled bricks will need to be replaced.</p>	<p>As only boundary wall— 3</p>

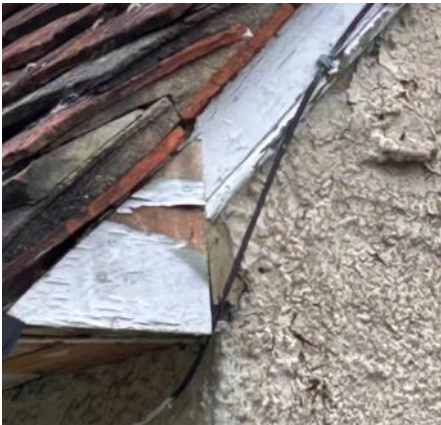
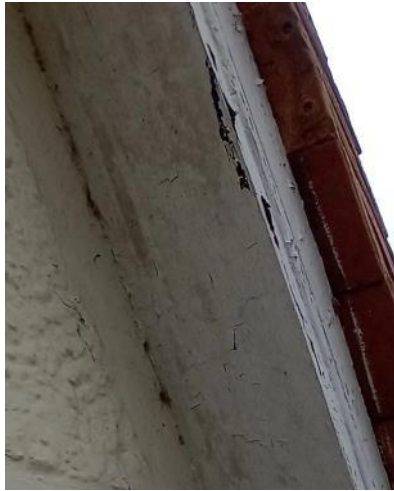
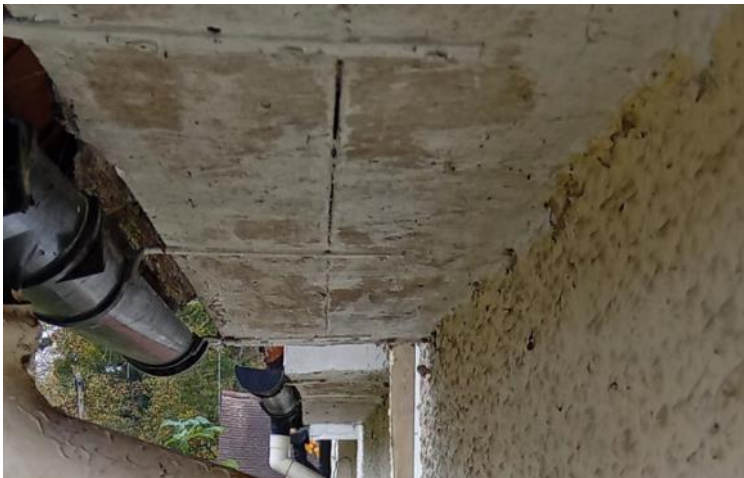
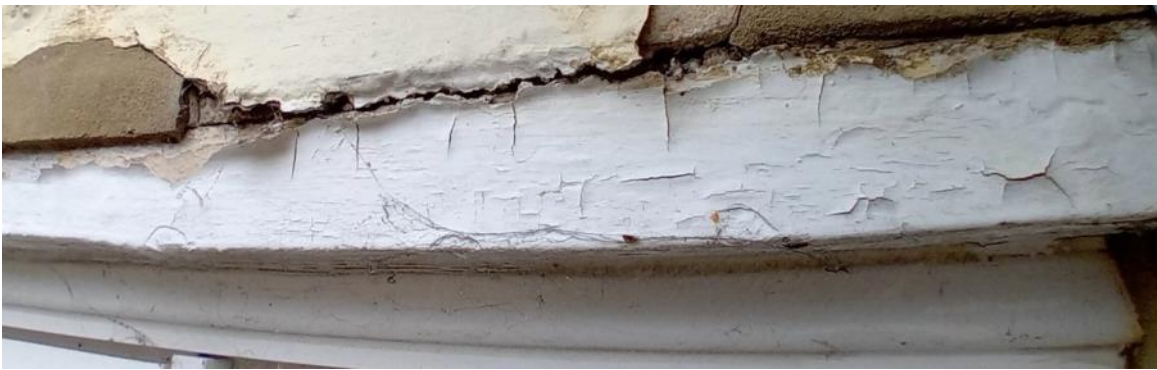
E5 External joinery— S elevation and western gable

There was much evidence of overpainting without proper attention to preparation.
Peeling and flaking paint noted to the following areas:
All gable timbers and soffits. On the SW corner, the soffit had been repaired but not painted.
Timber lintels above the first floor windows

All require burning back and full redecoration. Timbers should be scraped back and preservative applied at areas which are starting to rot to the surface.

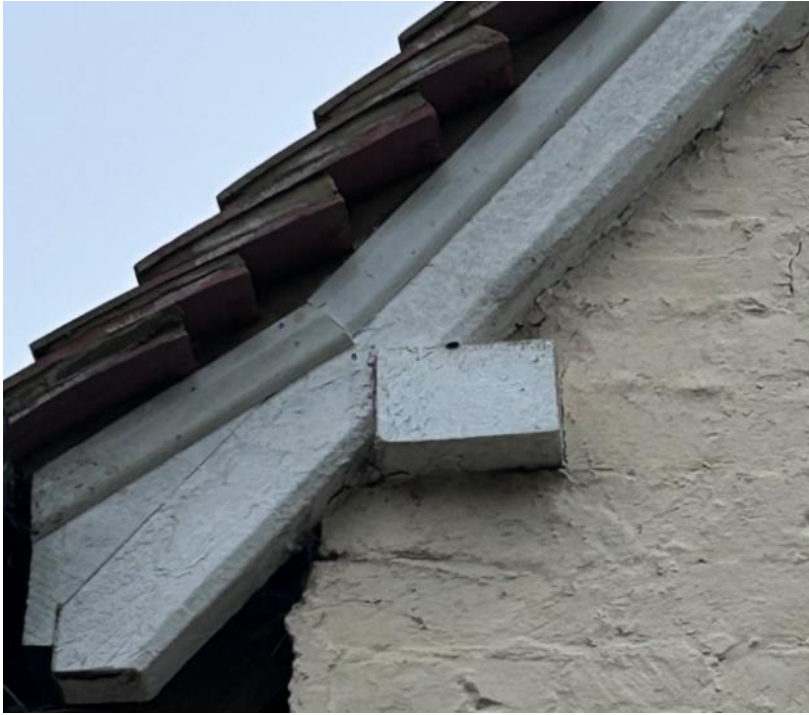
E6	External joinery– N elevation: main hall	Paint starting to peel at the gable timbers.

Re-decoration required in the medium term.	5
----	---	---	--	---
