# Asbestos Re-inspection Report (with Priority Assessments)

**Dundonald Primary School**  
**Dundonald Road, London, SW19 3QH**

Job Number: B119310/1  
Issue Date: 06/11/2023  
Issue No: 1

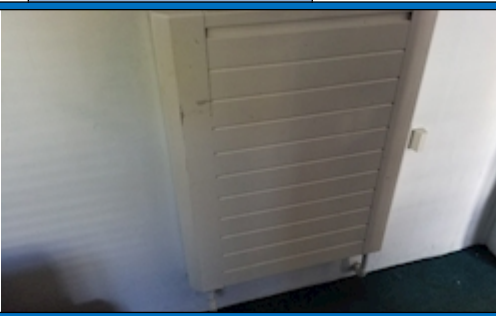
<b>Building</b>	Dundonald Primary School			<b>Floor</b>	0		
<b>Location Description</b>	1/015: Server Room			<b>Record Origin Report</b>	B2228		
<b>Item</b>	No suspect items observed

<b>Level of Identification (ID)</b>	Inspected Area (IA)	<b>Sample No.</b>					
<b>Material</b>		<b>Extent</b>					
<b>Accessibility</b>	Usually inaccessible or unlikely to be disturbed						
<b>Identification</b>							
<b>Material Assessment</b>							
<b>Product Type</b>		<b>Condition</b>		<b>Surface Treatment</b>		<b>Asbestos Type</b>	
<b>Priority Assessment (for more detail see Section 4.0)</b>							
<b>Occupant Activity</b>		<b>Disturbance</b>		<b>Human Exposure</b>		<b>Maintenance Activity</b>	
<b>Scoring Summary</b>							
<b>Material Score</b>		<b>Priority Score</b>		<b>Total Risk</b>		<b>Risk Priority</b>	
<b>Recommended Action</b>	<b>No Recommendation Required</b>						
<b>Further Information</b>	Modern radiator fitted to brick wall - No floor penetrations Modern radiator to brick wall

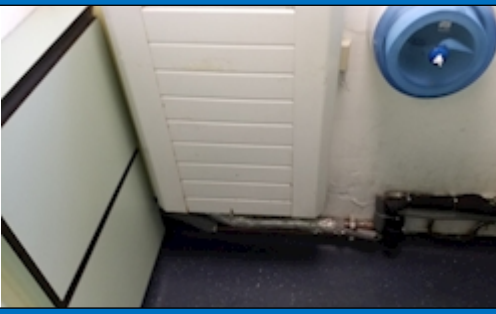
<b>Building</b>	Dundonald Primary School			<b>Floor</b>	0		
<b>Location Description</b>	1/017: Pupils Toilets			<b>Record Origin Report</b>	B2228		
<b>Item</b>	No suspect items observed

<b>Level of Identification (ID)</b>	Inspected Area (IA)	<b>Sample No.</b>					
<b>Material</b>		<b>Extent</b>					
<b>Accessibility</b>	Usually inaccessible or unlikely to be disturbed						
<b>Identification</b>							
<b>Material Assessment</b>							
<b>Product Type</b>		<b>Condition</b>		<b>Surface Treatment</b>		<b>Asbestos Type</b>	
<b>Priority Assessment (for more detail see Section 4.0)</b>							
<b>Occupant Activity</b>		<b>Disturbance</b>		<b>Human Exposure</b>		<b>Maintenance Activity</b>	
<b>Scoring Summary</b>							
<b>Material Score</b>		<b>Priority Score</b>		<b>Total Risk</b>		<b>Risk Priority</b>	
<b>Recommended Action</b>	<b>No Recommendation Required</b>						
<b>Further Information</b>	Modern radiator fitted to brick wall- No floor penetration Modern radiator fitted to brick wall

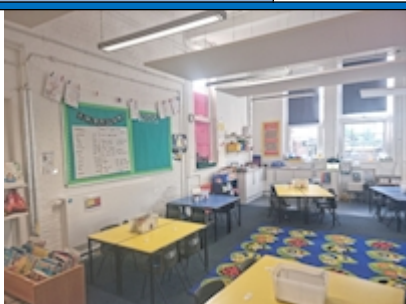
<b>Building</b>	Dundonald Primary School			<b>Floor</b>	0		
<b>Location Description</b>	1/019: Classroom 2D			<b>Record Origin Report</b>	B72208		
<b>Item</b>	Whole Area

<b>Level of Identification (ID)</b>	Inspected Area (IA)	<b>Sample No.</b>					
<b>Material</b>		<b>Extent</b>					
<b>Accessibility</b>	Usually inaccessible or unlikely to be disturbed						
<b>Identification</b>							
<b>Material Assessment</b>							
<b>Product Type</b>		<b>Condition</b>		<b>Surface Treatment</b>		<b>Asbestos Type</b>	
<b>Priority Assessment (for more detail see Section 4.0)</b>							
<b>Occupant Activity</b>		<b>Disturbance</b>		<b>Human Exposure</b>		<b>Maintenance Activity</b>	
<b>Scoring Summary</b>							
<b>Material Score</b>		<b>Priority Score</b>		<b>Total Risk</b>		<b>Risk Priority</b>	
<b>Recommended Action</b>	<b>No Recommendation Required</b>						
<b>Further Information</b>	Plaster Ceiling, Brick And Plasterboard Walls Carpet And Modern Lino to Timber Floor

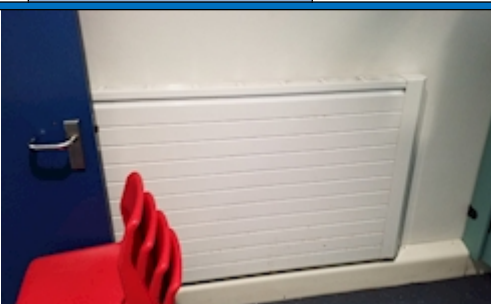
<b>Building</b>	Dundonald Primary School			<b>Floor</b>	1		
<b>Location Description</b>	1/111: Boys Toilets			<b>Record Origin Report</b>	B2228		
<b>Item</b>	No suspect items observed

<b>Level of Identification (ID)</b>	Inspected Area (IA)	<b>Sample No.</b>					
<b>Material</b>		<b>Extent</b>					
<b>Accessibility</b>	Usually inaccessible or unlikely to be disturbed						
<b>Identification</b>							
<b>Material Assessment</b>							
<b>Product Type</b>		<b>Condition</b>		<b>Surface Treatment</b>		<b>Asbestos Type</b>	
<b>Priority Assessment (for more detail see Section 4.0)</b>							
<b>Occupant Activity</b>		<b>Disturbance</b>		<b>Human Exposure</b>		<b>Maintenance Activity</b>	
<b>Scoring Summary</b>							
<b>Material Score</b>		<b>Priority Score</b>		<b>Total Risk</b>		<b>Risk Priority</b>	
<b>Recommended Action</b>	<b>No Recommendation Required</b>						
<b>Further Information</b>	Modern radiator fitted to brick wall

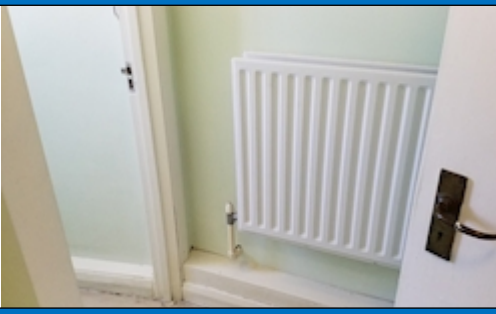
<b>Building</b>	Dundonald Primary School			<b>Floor</b>	1		
<b>Location Description</b>	1/114: Staff Toilets			<b>Record Origin Report</b>	B2228		
<b>Item</b>	No suspect items observed

<b>Level of Identification (ID)</b>	Inspected Area (IA)	<b>Sample No.</b>					
<b>Material</b>		<b>Extent</b>					
<b>Accessibility</b>	Usually inaccessible or unlikely to be disturbed						
<b>Identification</b>							
<b>Material Assessment</b>							
<b>Product Type</b>		<b>Condition</b>		<b>Surface Treatment</b>		<b>Asbestos Type</b>	
<b>Priority Assessment (for more detail see Section 4.0)</b>							
<b>Occupant Activity</b>		<b>Disturbance</b>		<b>Human Exposure</b>		<b>Maintenance Activity</b>	
<b>Scoring Summary</b>							
<b>Material Score</b>		<b>Priority Score</b>		<b>Total Risk</b>		<b>Risk Priority</b>	
<b>Recommended Action</b>	<b>No Recommendation Required</b>						
<b>Further Information</b>	Modern radiator fitted to brick wall

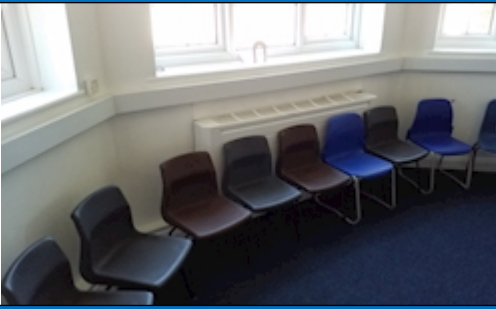
<b>Building</b>	Dundonald Primary School			<b>Floor</b>	1		
<b>Location Description</b>	1/118: Music Room			<b>Record Origin Report</b>	B2228		
<b>Item</b>	No suspect items observed

<b>Level of Identification (ID)</b>	Inspected Area (IA)	<b>Sample No.</b>					
<b>Material</b>		<b>Extent</b>					
<b>Accessibility</b>	Usually inaccessible or unlikely to be disturbed						
<b>Identification</b>							
<b>Material Assessment</b>							
<b>Product Type</b>		<b>Condition</b>		<b>Surface Treatment</b>		<b>Asbestos Type</b>	
<b>Priority Assessment (for more detail see Section 4.0)</b>							
<b>Occupant Activity</b>		<b>Disturbance</b>		<b>Human Exposure</b>		<b>Maintenance Activity</b>	
<b>Scoring Summary</b>							
<b>Material Score</b>		<b>Priority Score</b>		<b>Total Risk</b>		<b>Risk Priority</b>	
<b>Recommended Action</b>	<b>No Recommendation Required</b>						
<b>Further Information</b>	Modern radiator fitted to brick wall

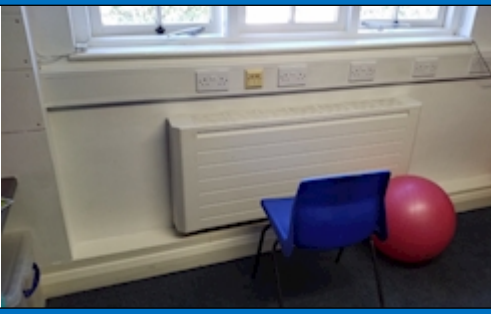
<b>Building</b>	Dundonald Primary School			<b>Floor</b>	1		
<b>Location Description</b>	1/M04: Group Room			<b>Record Origin Report</b>	B2228		
<b>Item</b>	No suspect items observed

<b>Level of Identification (ID)</b>	Inspected Area (IA)	<b>Sample No.</b>					
<b>Material</b>		<b>Extent</b>					
<b>Accessibility</b>	Usually inaccessible or unlikely to be disturbed						
<b>Identification</b>							
<b>Material Assessment</b>							
<b>Product Type</b>		<b>Condition</b>		<b>Surface Treatment</b>		<b>Asbestos Type</b>	
<b>Priority Assessment (for more detail see Section 4.0)</b>							
<b>Occupant Activity</b>		<b>Disturbance</b>		<b>Human Exposure</b>		<b>Maintenance Activity</b>	
<b>Scoring Summary</b>							
<b>Material Score</b>		<b>Priority Score</b>		<b>Total Risk</b>		<b>Risk Priority</b>	
<b>Recommended Action</b>	<b>No Recommendation Required</b>						
<b>Further Information</b>	No suspect items observed

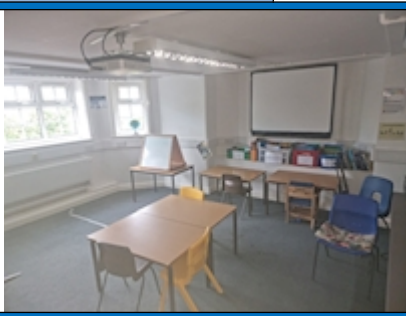
<b>Building</b>	Dundonald Primary School			<b>Floor</b>	1		
<b>Location Description</b>	1/M05: Group Room			<b>Record Origin Report</b>	B72208		
<b>Item</b>	Whole Area

<b>Level of Identification (ID)</b>	Inspected Area (IA)	<b>Sample No.</b>					
<b>Material</b>		<b>Extent</b>					
<b>Accessibility</b>	Usually inaccessible or unlikely to be disturbed						
<b>Identification</b>							
<b>Material Assessment</b>							
<b>Product Type</b>		<b>Condition</b>		<b>Surface Treatment</b>		<b>Asbestos Type</b>	
<b>Priority Assessment (for more detail see Section 4.0)</b>							
<b>Occupant Activity</b>		<b>Disturbance</b>		<b>Human Exposure</b>		<b>Maintenance Activity</b>	
<b>Scoring Summary</b>							
<b>Material Score</b>		<b>Priority Score</b>		<b>Total Risk</b>		<b>Risk Priority</b>	
<b>Recommended Action</b>	<b>No Recommendation Required</b>						
<b>Further Information</b>	Ceiling, Plaster to Brickwork Walls, Carpet to Concrete Floor

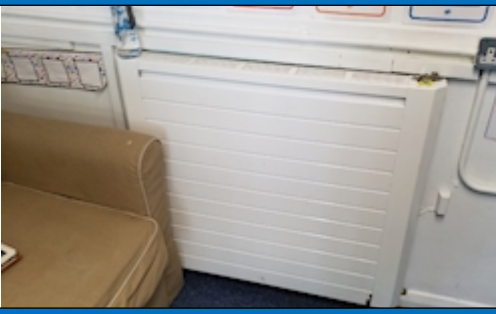
<b>Building</b>	Dundonald Primary School			<b>Floor</b>	1		
<b>Location Description</b>	1/M07: Rainbow Classroom			<b>Record Origin Report</b>	B2228		
<b>Item</b>	No suspect items observed

<b>Level of Identification (ID)</b>	Inspected Area (IA)	<b>Sample No.</b>					
<b>Material</b>		<b>Extent</b>					
<b>Accessibility</b>	Usually inaccessible or unlikely to be disturbed						
<b>Identification</b>							
<b>Material Assessment</b>							
<b>Product Type</b>		<b>Condition</b>		<b>Surface Treatment</b>		<b>Asbestos Type</b>	
<b>Priority Assessment (for more detail see Section 4.0)</b>							
<b>Occupant Activity</b>		<b>Disturbance</b>		<b>Human Exposure</b>		<b>Maintenance Activity</b>	
<b>Scoring Summary</b>							
<b>Material Score</b>		<b>Priority Score</b>		<b>Total Risk</b>		<b>Risk Priority</b>	
<b>Recommended Action</b>	<b>No Recommendation Required</b>						
<b>Further Information</b>	Modern radiator fitted to brick wall

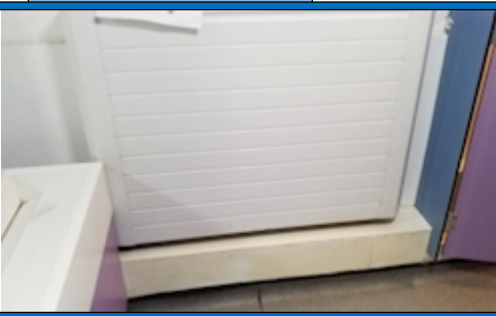
<b>Building</b>	Dundonald Primary School			<b>Floor</b>	1		
<b>Location Description</b>	1/M09: Girls Toilets			<b>Record Origin Report</b>	B2228		
<b>Item</b>	No suspect items observed

<b>Level of Identification (ID)</b>	Inspected Area (IA)	<b>Sample No.</b>					
<b>Material</b>		<b>Extent</b>					
<b>Accessibility</b>	Usually inaccessible or unlikely to be disturbed						
<b>Identification</b>							
<b>Material Assessment</b>							
<b>Product Type</b>		<b>Condition</b>		<b>Surface Treatment</b>		<b>Asbestos Type</b>	
<b>Priority Assessment (for more detail see Section 4.0)</b>							
<b>Occupant Activity</b>		<b>Disturbance</b>		<b>Human Exposure</b>		<b>Maintenance Activity</b>	
<b>Scoring Summary</b>							
<b>Material Score</b>		<b>Priority Score</b>		<b>Total Risk</b>		<b>Risk Priority</b>	
<b>Recommended Action</b>	<b>No Recommendation Required</b>						
<b>Further Information</b>	No suspect items observed in boxing
