Paston Great Barn – South Range, Paston. North Walsham.Norfolk

Structural Condition Report

Ref: 241057/S Paterson

Date: 26 Mar 2025

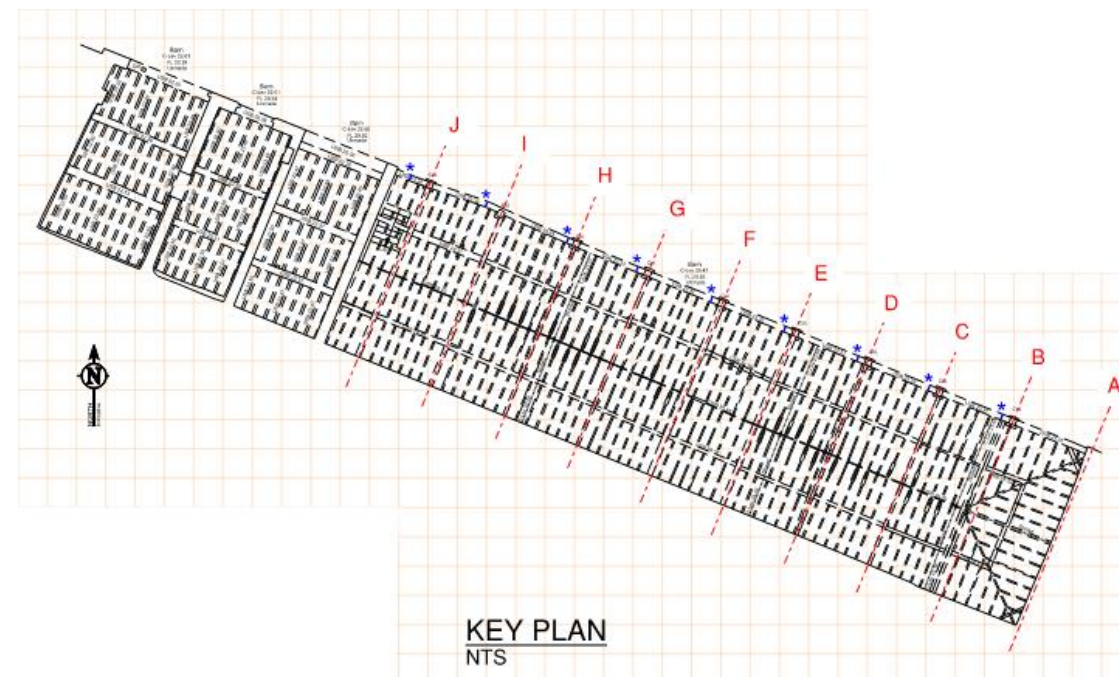
- 4.1.1 To assist in locating observations and subsequent recommendations around the structure, the open-sided range has been split into lettered bays in accordance with the plan below, coinciding with the end wall and truss locations.
