EDWINSTOWE VILLAGE HALL

BUILDING CONDITION SURVEY

THURSDAY 20TH JULY 2023

Smith and Roper
Architects and Surveyors
65-67 Church Street
Sutton in Ashfield, NG17 1FE

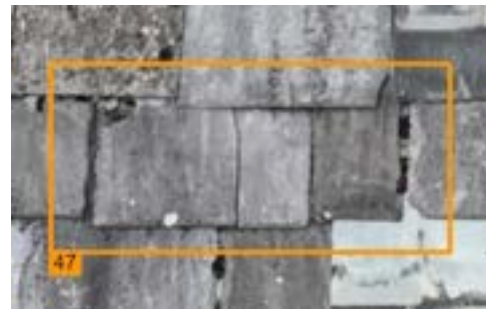
46 Misaligned slate

Severity: 2
