**Asbestos Inspection Report (HSG 264)**  
*Refurbishment Survey*  
Swanspool Pavillion  
Swanspool Parade, Wellingborough NN8 2BZ, UK

Surveyed by Nye Phillips on 11 Jun 2025

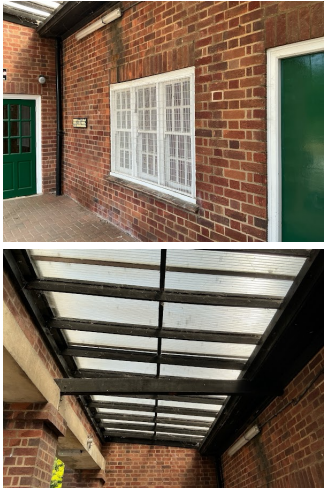
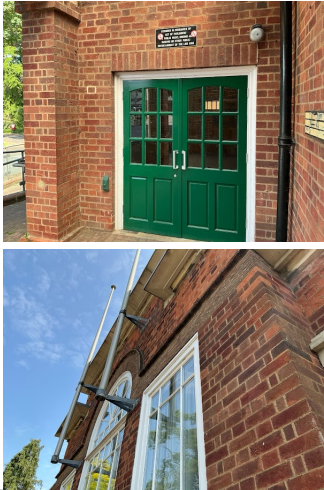
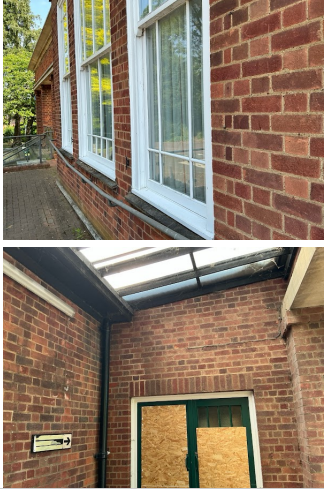
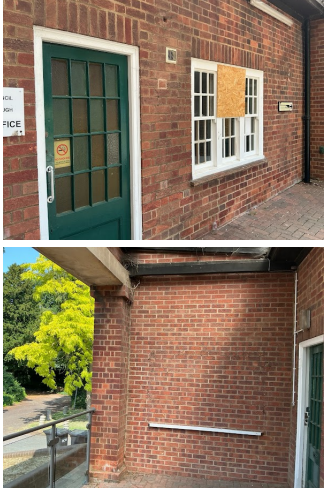
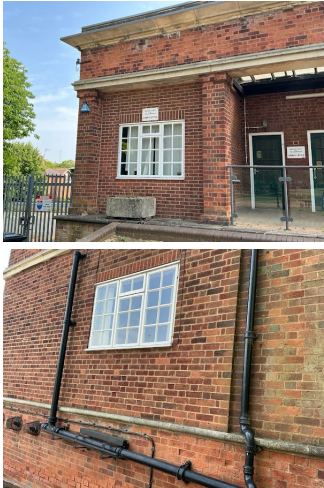
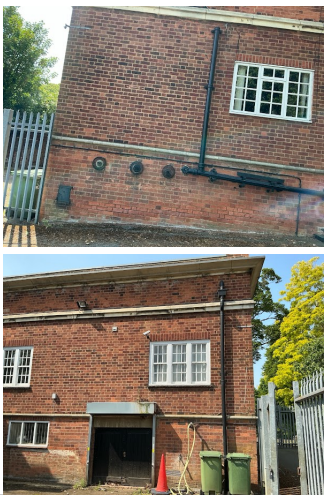
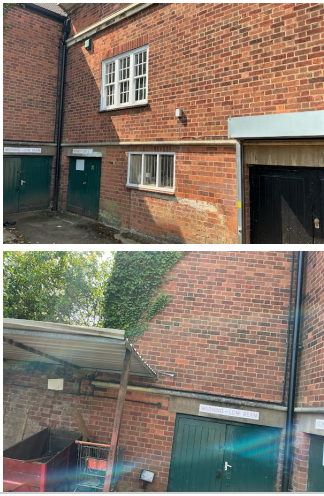
| <p>External &gt; All walls, windows, doors and water goods<br/>Area</p> | <p><i>No Asbestos Detected</i><br/>Area inspected in detail and no suspected asbestos containing materials identified.</p> | |

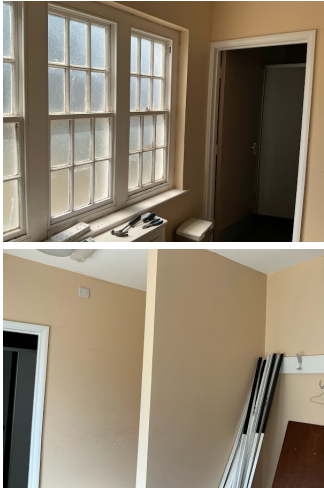
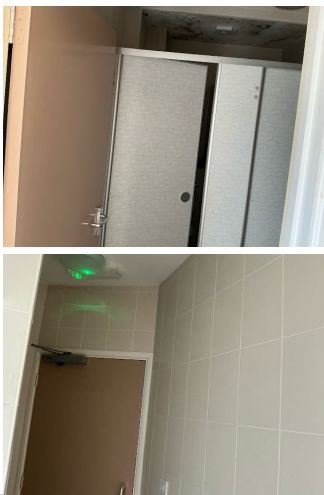
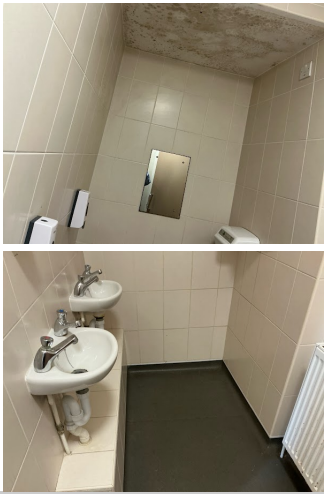
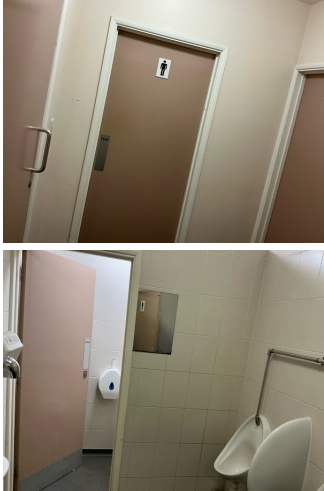
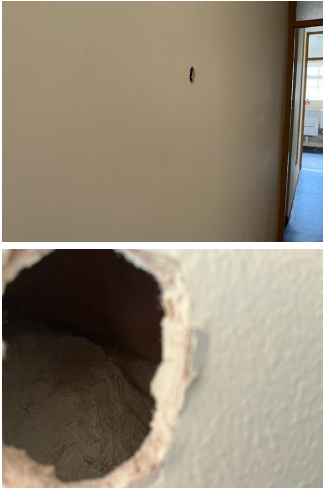
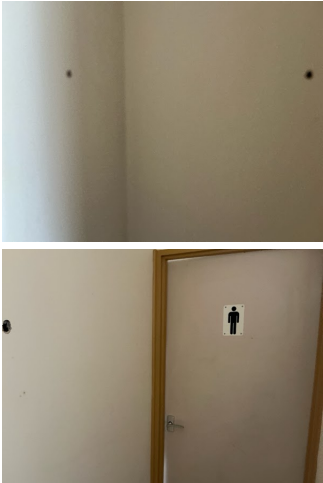
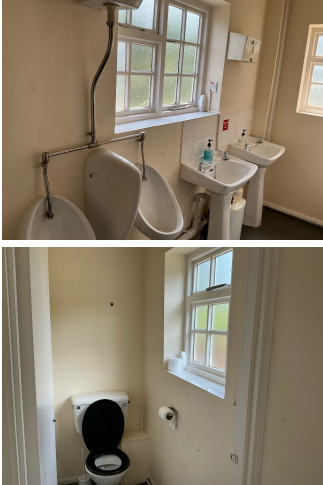
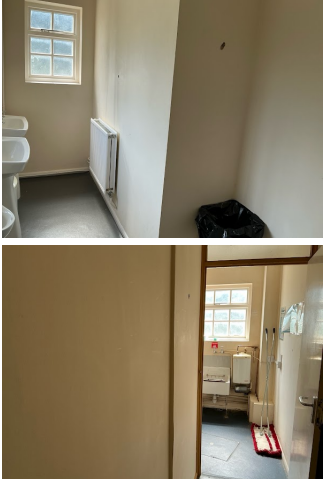
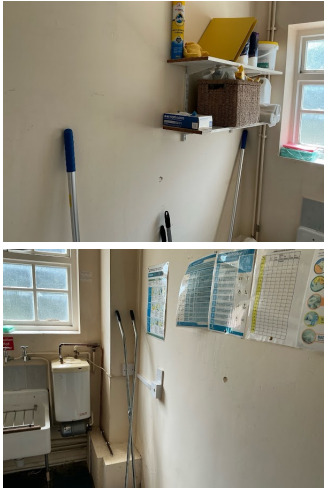
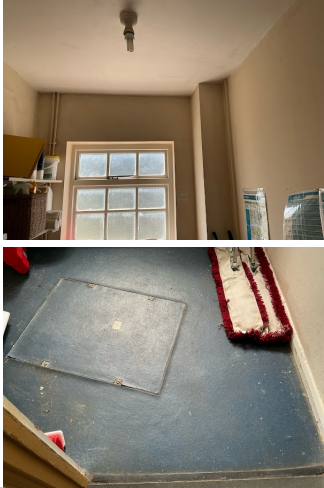
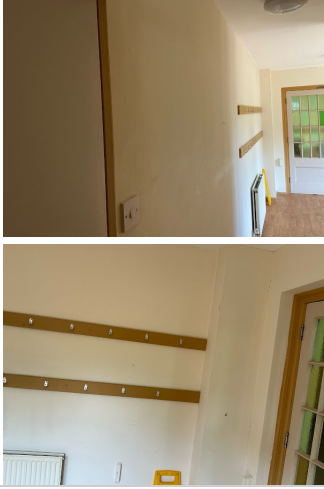
| <p>[All walls, ceilings and floors]<br/>Ground floor &gt; Area 1<br/>Area</p> <p><i>Limited access to roof space and tiled walls in the toilets.</i></p> | <p><i>No Asbestos Detected</i><br/>Area inspected in detail and no suspected asbestos containing materials identified.</p> | |

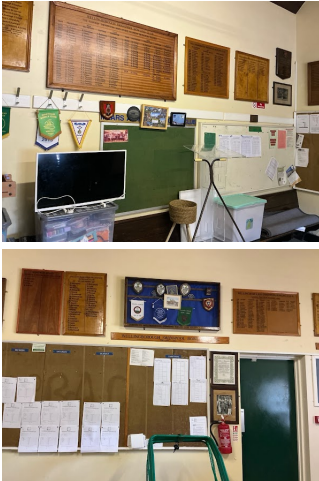
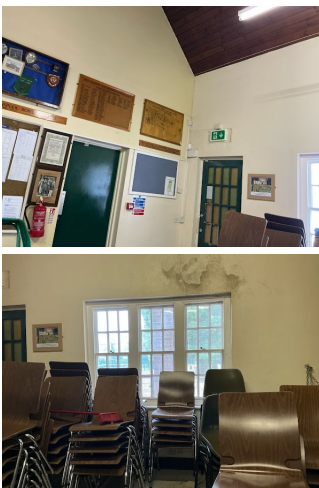
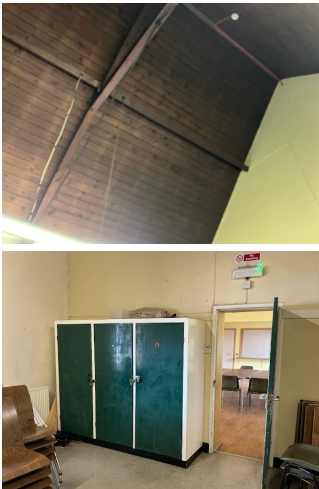
| <p>[All the walls and ceilings]<br/>Ground floor &gt; Store room<br/>Area</p> <p><i>Limited access behind wall<br/>plaques and noticeboards to<br/>include storage cupboards.</i></p> | <p><i>No Asbestos Detected</i><br/>Area inspected in detail and no<br/>suspected asbestos containing<br/>materials identified.</p> | |

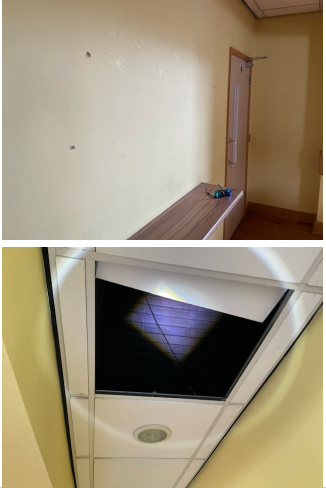
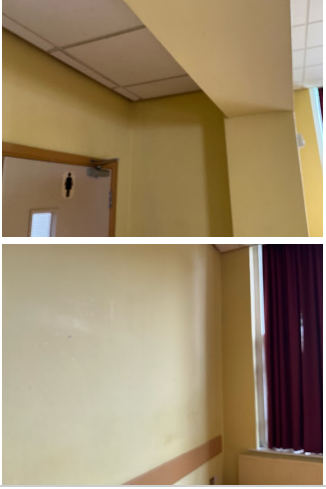
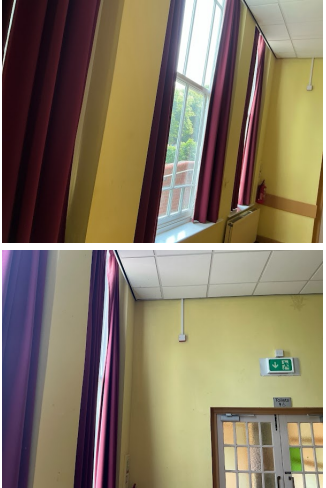
| <p>[All walls suspended ceilings and flooring] Ground floor &gt; Hall Area</p> <p><i>*Due to height restriction a limited access behind suspended ceiling caution advised*</i></p> | <p><i>No Asbestos Detected</i></p> <p>Area inspected in detail and no suspected asbestos containing materials identified.</p> | |

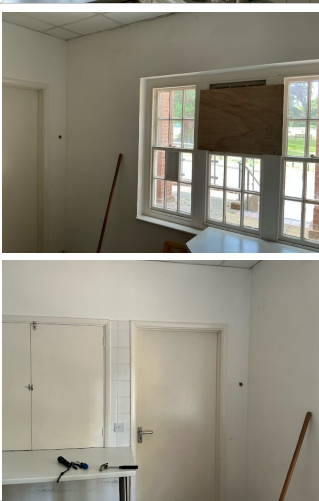
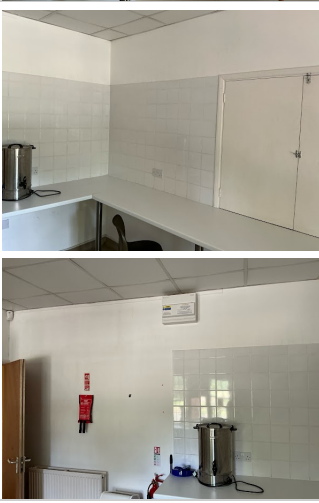
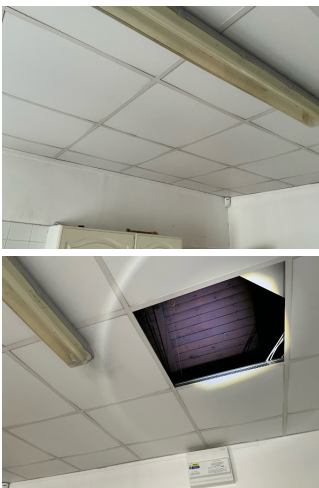
| <p>[All walls suspended ceilings and flooring] Ground floor &gt; Kitchen Area</p> <p><i>*Due to height restriction a limited access behind suspended ceiling caution advised*</i></p> | <p><b>No Asbestos Detected</b></p> <p>Area inspected in detail and no suspected asbestos containing materials identified.</p> | |

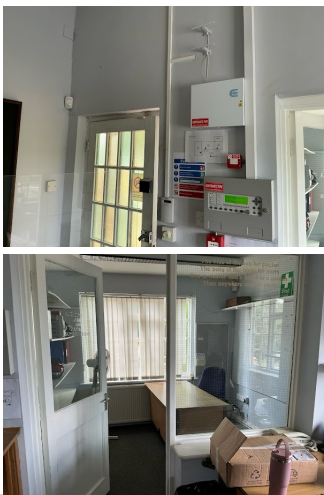
| <p>[All walls ceilings and flooring]<br/>Ground floor &gt; Area 2<br/>Area</p> <p><i>*Due to height restriction a limited access behind suspended ceiling caution advised*</i></p> | <p><b>No Asbestos Detected</b><br/>Area inspected in detail and no suspected asbestos containing materials identified.</p> | |

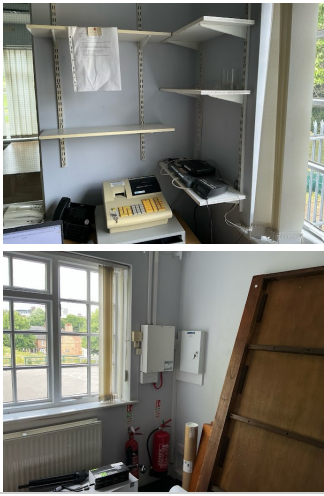
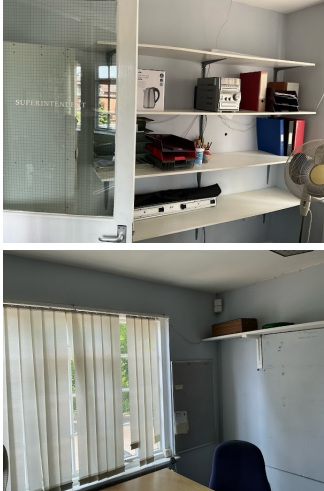
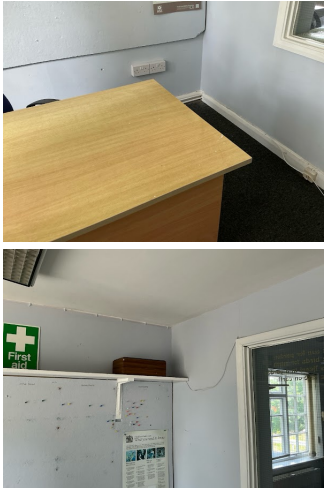
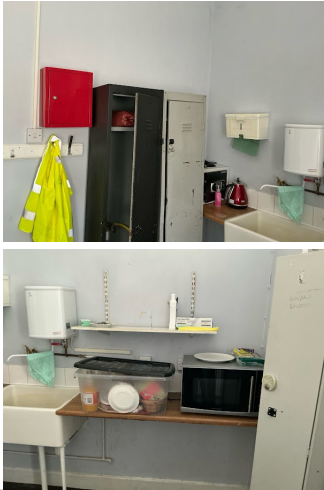
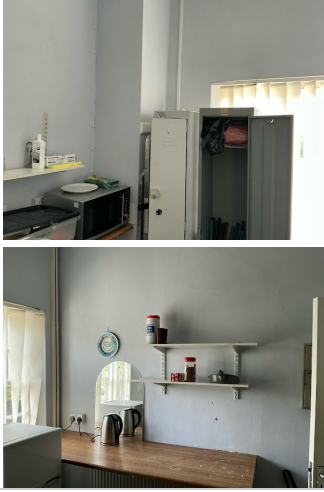
| <p>[All walls ceilings and flooring]<br/>Ground floor &gt; Area 2<br/>Area</p> <p><i>*Due to height restriction a limited access behind suspended ceiling caution advised*</i></p> | <p><b>No Asbestos Detected</b><br/>Area inspected in detail and no suspected asbestos containing materials identified.</p> | |

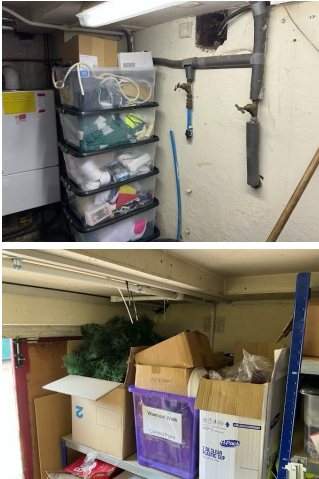
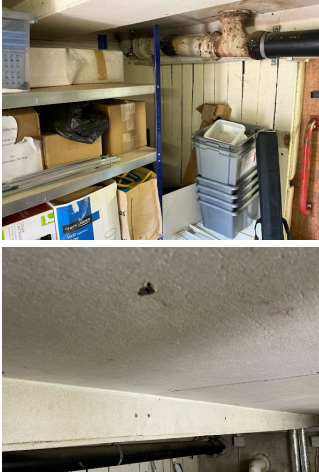
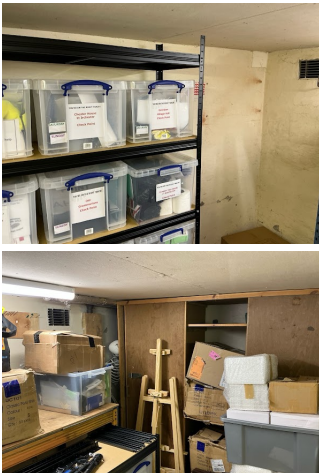
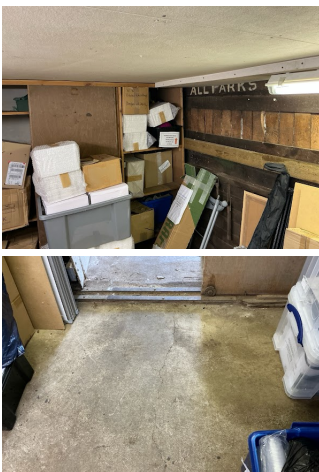
| <p>[All walls ceilings and flooring]<br/>Basement &gt; Area A<br/>Area</p> <p><i>Ceilings aligned with a material called Supalux, which looks very similar to Asbestos but contains no asbestos fibres.<br/>Limited access due to storage items.</i></p> | <p><i>No Asbestos Detected</i><br/>Area inspected in detail and no suspected asbestos containing materials identified.</p> | |

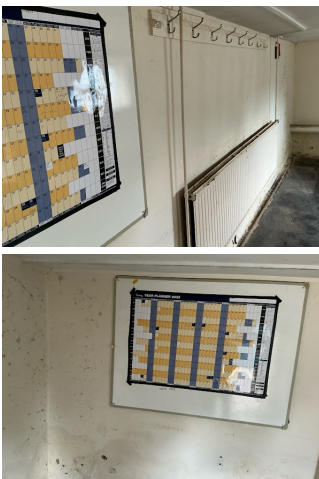
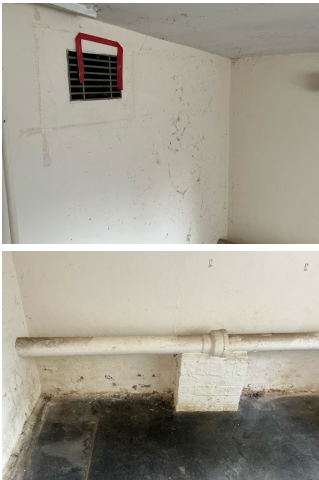
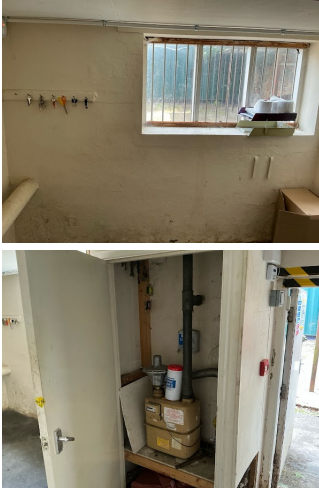
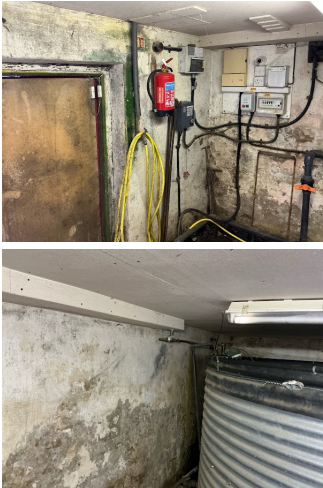
| <p>[All walls ceilings and flooring]<br/>Basement &gt; Area B<br/>Area</p> <p><i>Ceilings are lined with a material called Supalux, which looks very similar to Asbestos but contains no asbestos fibres.</i></p> | <p><i>No Asbestos Detected</i><br/>Area inspected in detail and no suspected asbestos containing materials identified.</p> | |

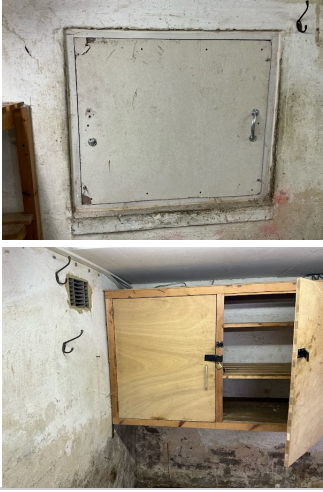
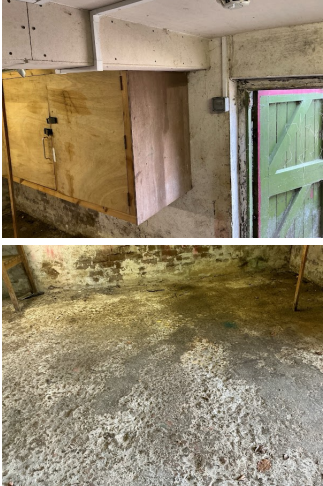
| <p>[All walls ceilings and flooring]<br/>Basement &gt; Area C<br/>Area</p> <p><i>Ceilings are lined with a material called Supalux, which looks very similar to Asbestos but contains no asbestos fibres.</i></p> | <p><i>No Asbestos Detected</i><br/>Area inspected in detail and no suspected asbestos containing materials identified.</p> | |
