**Asbestos Re-Inspection for
Wokingham Town Council**

**The Town Hall (V2)
Market Place
Wokingham
RG40 1AS**

Amicus Environmental Limited	Project Number:	S14069_2025
	Survey Date:	21 January 2025
	Printed On:	28 January 2025
	Page:	Page 1 of 1

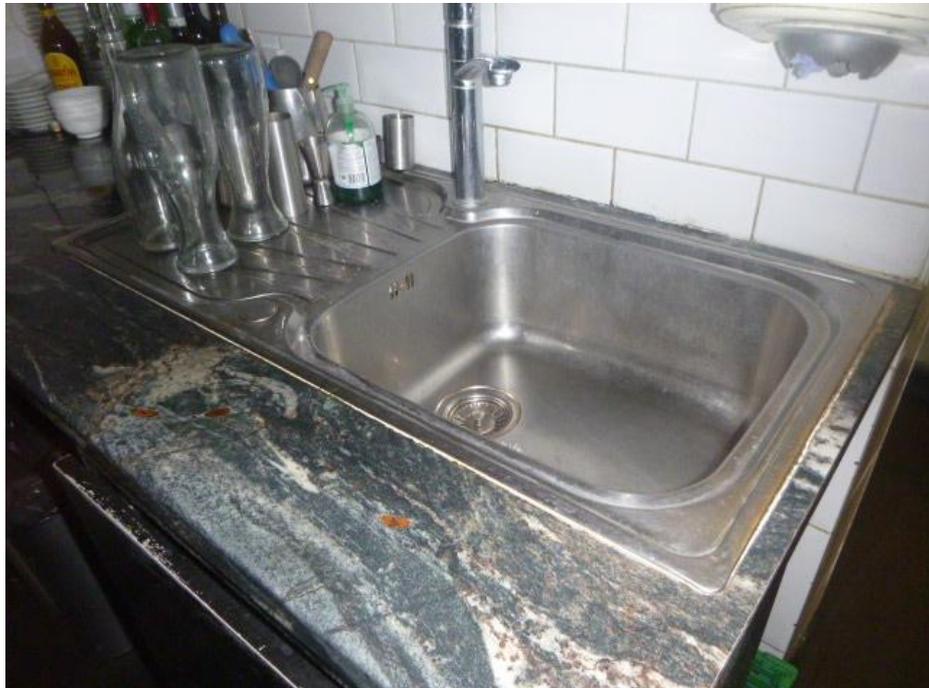
Location ID:	<input type="text" value="41361"/>	Survey Type:	<input type="text" value="MS"/>
Location Ref:	<input type="text" value="01"/>	Product Type:	<input type="text" value="NADIS"/>
Product:	<input type="text" value="Sink Pad"/>	Damage:	<input type="text" value="NADIS"/>
Area:	<input type="text" value="Piccolo Arco Restaurant"/>	Treatment:	<input type="text" value="NADIS"/>
Floor:	<input type="text" value="Ground floor"/>	Asbestos Type:	<input type="text" value="NADIS"/>
Room:	<input type="text" value="G.01"/>	Identification:	<input type="text" value="Identified"/>
Surveyor Name:	<input type="text" value="D.Jeffs"/>	Quantity:	<input type="text" value="N/A"/>
Drawing Ref:	<input type="text" value="As location ref"/>		
Asbestos ?	<input type="text" value="No"/>		
Date:	<input type="text" value="07 September 2023"/>		
Next Inspection:	<input type="text" value="Not Applicable"/>

Material Risk Score:	<input type="text" value="0"/>
Material Risk Band:	<input type="text" value="NADIS"/>
Priority Risk Score:	<input type="text" value="N/A"/>

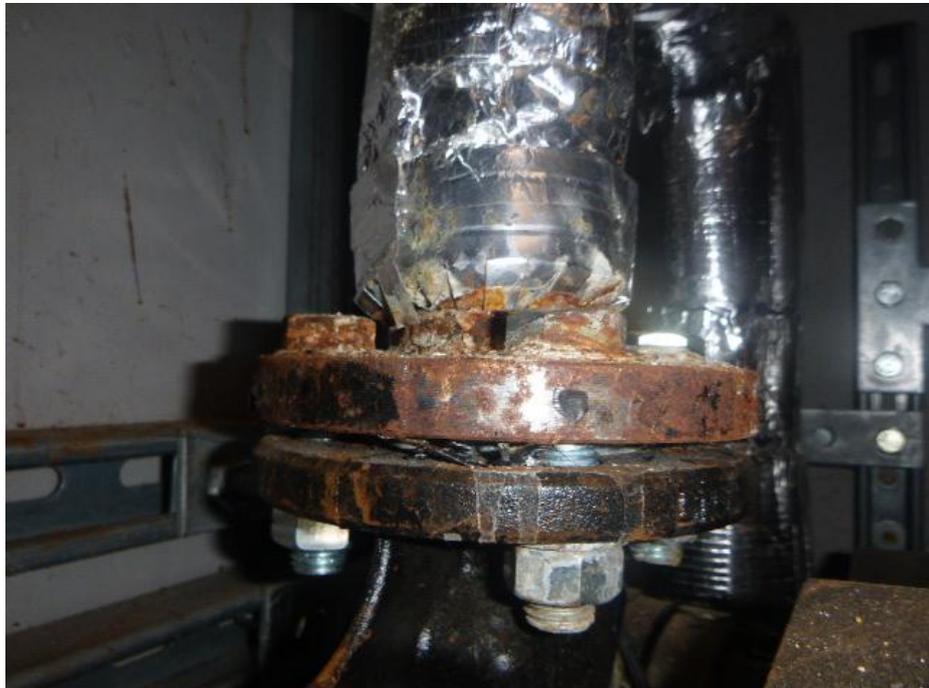
Location ID:	<input type="text" value="41363"/>	Survey Type:	<input type="text" value="MS"/>
Location Ref:	<input type="text" value="03"/>	Product Type:	<input type="text" value="NADIS"/>
Product:	<input type="text" value="Gasket"/>	Damage:	<input type="text" value="NADIS"/>
Area:	<input type="text" value="Piccolo Arco Restaurant"/>	Treatment:	<input type="text" value="NADIS"/>
Floor:	<input type="text" value="Ground floor"/>	Asbestos Type:	<input type="text" value="NADIS"/>
Room:	<input type="text" value="G.03"/>	Identification:	<input type="text" value="Identified"/>
Surveyor Name:	<input type="text" value="D.Jeffs"/>	Quantity:	<input type="text" value="N/A"/>
Drawing Ref:	<input type="text" value="As location ref"/>		
Asbestos ?	<input type="text" value="No"/>		
Date:	<input type="text" value="07 September 2023"/>		
Next Inspection:	<input type="text" value="Not Applicable"/>

Material Risk Score:	<input type="text" value="0"/>
Material Risk Band:	<input type="text" value="NADIS"/>
Priority Risk Score:	<input type="text" value="N/A"/>

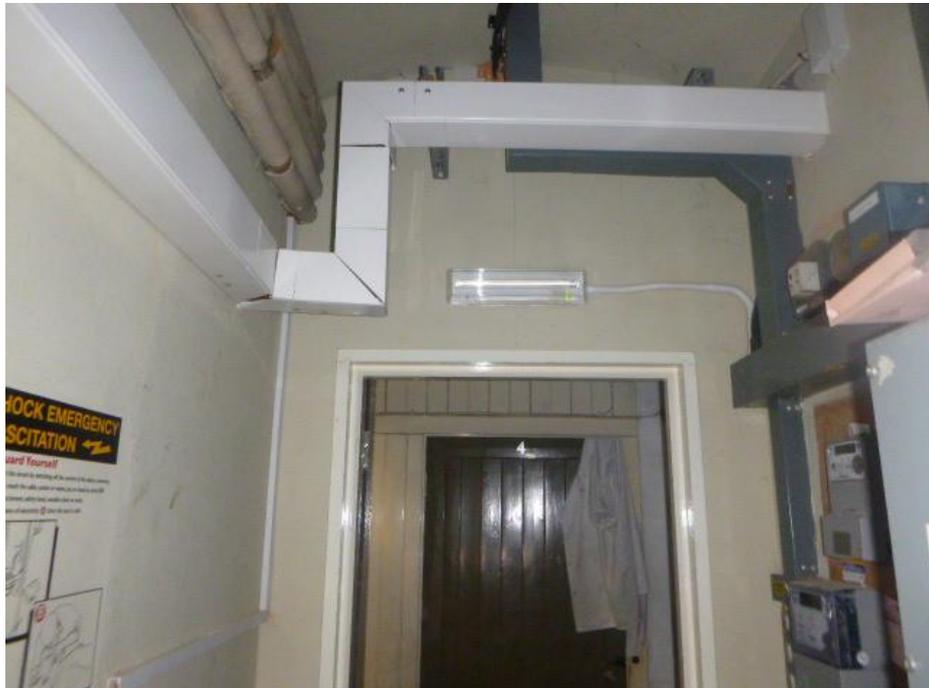
Location ID:	<input type="text" value="41364"/>	Survey Type:	<input type="text" value="MS"/>
Location Ref:	<input type="text" value="04"/>	Product Type:	<input type="text" value="NADIS"/>
Product:	<input type="text" value="Wall panel"/>	Damage:	<input type="text" value="NADIS"/>
Area:	<input type="text" value="Piccolo Arco Restaurant"/>	Treatment:	<input type="text" value="NADIS"/>
Floor:	<input type="text" value="Ground floor"/>	Asbestos Type:	<input type="text" value="NADIS"/>
Room:	<input type="text" value="G.04"/>	Identification:	<input type="text" value="Identified"/>
Surveyor Name:	<input type="text" value="D.Jeffs"/>	Quantity:	<input type="text" value="N/A"/>
Drawing Ref:	<input type="text" value="As location ref"/>		
Asbestos ?	<input type="text" value="No"/>		
Date:	<input type="text" value="07 September 2023"/>		
Next Inspection:	<input type="text" value="Not Applicable"/>

Material Risk Score:	<input type="text" value="0"/>
Material Risk Band:	<input type="text" value="NADIS"/>
Priority Risk Score:	<input type="text" value="N/A"/>

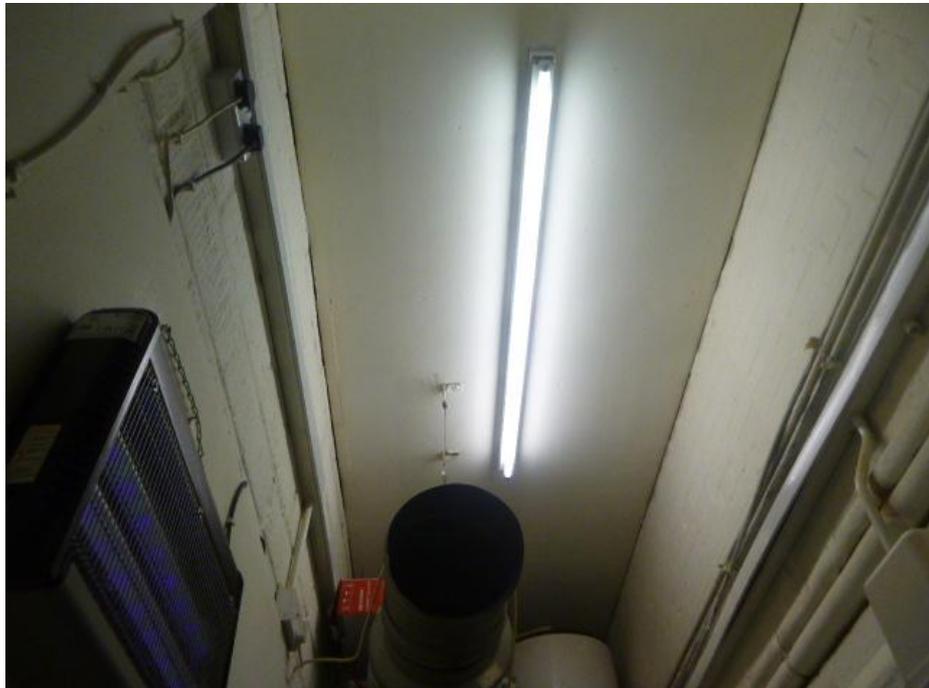
Location ID:	<input type="text" value="41367"/>	Survey Type:	<input type="text" value="MS"/>
Location Ref:	<input type="text" value="07"/>	Product Type:	<input type="text" value="NADIS"/>
Product:	<input type="text" value="Ceiling panel"/>	Damage:	<input type="text" value="NADIS"/>
Area:	<input type="text" value="Piccolo Arco Restaurant"/>	Treatment:	<input type="text" value="NADIS"/>
Floor:	<input type="text" value="Ground floor"/>	Asbestos Type:	<input type="text" value="NADIS"/>
Room:	<input type="text" value="G.01"/>	Identification:	<input type="text" value="Identified"/>
Surveyor Name:	<input type="text" value="D.Jeffs"/>	Quantity:	<input type="text" value="N/A"/>
Drawing Ref:	<input type="text" value="As location ref"/>		
Asbestos ?	<input type="text" value="No"/>		
Date:	<input type="text" value="07 September 2023"/>		
Next Inspection:	<input type="text" value="Not Applicable"/>

Material Risk Score:	<input type="text" value="0"/>
Material Risk Band:	<input type="text" value="NADIS"/>
Priority Risk Score:	<input type="text" value="N/A"/>

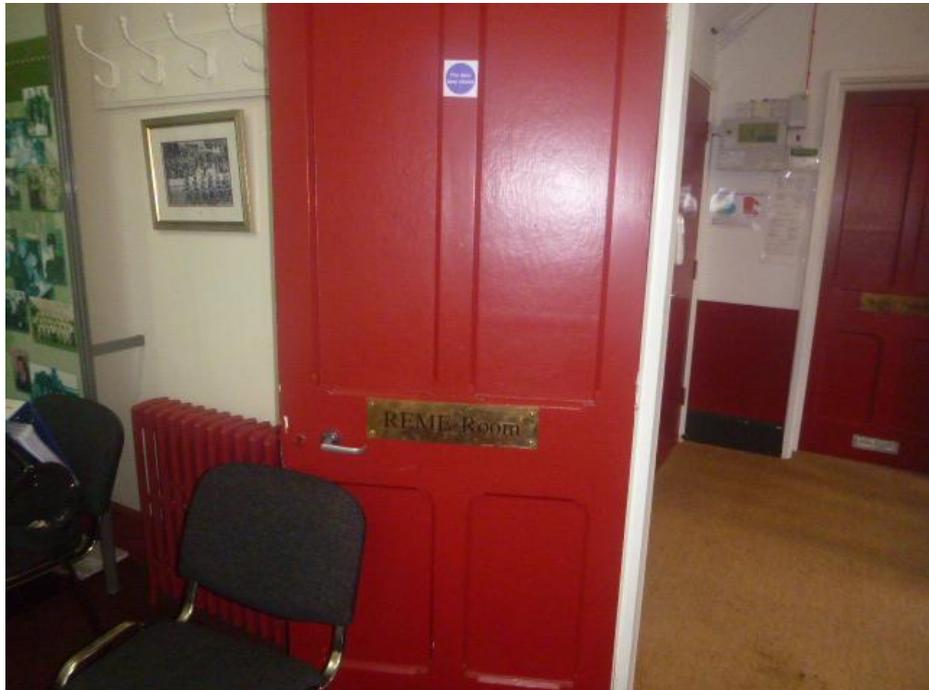
Location ID:	<input type="text" value="41368"/>	Survey Type:	<input type="text" value="MS"/>
Location Ref:	<input type="text" value="08"/>	Product Type:	<input type="text" value="NADIS"/>
Product:	<input type="text" value="Infill panel"/>	Damage:	<input type="text" value="NADIS"/>
Area:	<input type="text" value="Town Hall"/>	Treatment:	<input type="text" value="NADIS"/>
Floor:	<input type="text" value="Ground floor"/>	Asbestos Type:	<input type="text" value="NADIS"/>
Room:	<input type="text" value="G.06"/>	Identification:	<input type="text" value="Identified"/>
Surveyor Name:	<input type="text" value="D.Jeffs"/>	Quantity:	<input type="text" value="N/A"/>
Drawing Ref:	<input type="text" value="As location ref"/>		
Asbestos ?	<input type="text" value="No"/>		
Date:	<input type="text" value="07 September 2023"/>		
Next Inspection:	<input type="text" value="Not Applicable"/>

Material Risk Score:	<input type="text" value="0"/>
Material Risk Band:	<input type="text" value="NADIS"/>
Priority Risk Score:	<input type="text" value="N/A"/>

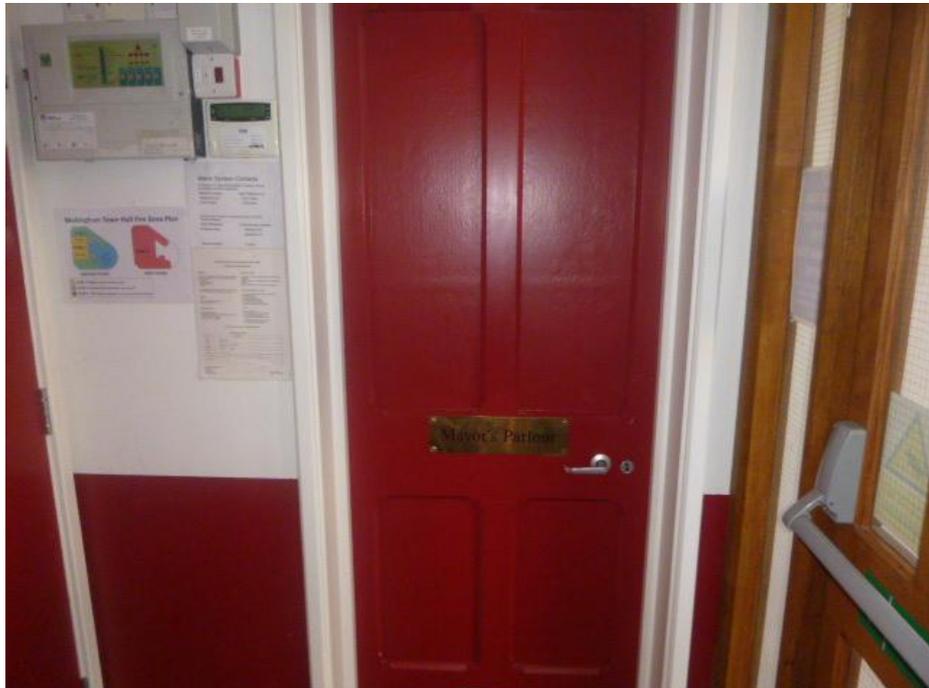
Location ID:	<input type="text" value="41369"/>	Survey Type:	<input type="text" value="MS"/>
Location Ref:	<input type="text" value="09"/>	Product Type:	<input type="text" value="NADIS"/>
Product:	<input type="text" value="Infill panel"/>	Damage:	<input type="text" value="NADIS"/>
Area:	<input type="text" value="Town Hall"/>	Treatment:	<input type="text" value="NADIS"/>
Floor:	<input type="text" value="Ground floor"/>	Asbestos Type:	<input type="text" value="NADIS"/>
Room:	<input type="text" value="G.07"/>	Identification:	<input type="text" value="Strongly Presumed as previous sample"/>
Surveyor Name:	<input type="text" value="D.Jeffs"/>	Quantity:	<input type="text" value="N/A"/>

Material Risk Score:	<input type="text" value="0"/>
Material Risk Band:	<input type="text" value="NADIS"/>
Priority Risk Score:	<input type="text" value="N/A"/>

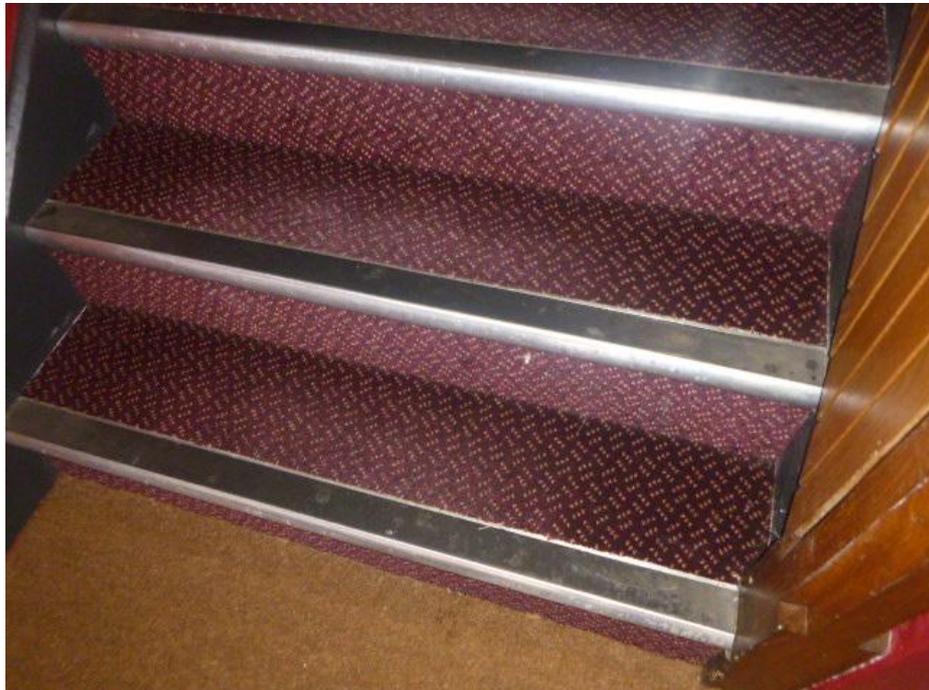
Location ID:	<input type="text" value="41370"/>	Survey Type:	<input type="text" value="MS"/>
Location Ref:	<input type="text" value="10"/>	Product Type:	<input type="text" value="NADIS"/>
Product:	<input type="text" value="Stair nosing"/>	Damage:	<input type="text" value="NADIS"/>
Area:	<input type="text" value="Town Hall"/>	Treatment:	<input type="text" value="NADIS"/>
Floor:	<input type="text" value="Ground floor"/>	Asbestos Type:	<input type="text" value="NADIS"/>
Room:	<input type="text" value="G.07"/>	Identification:	<input type="text" value="Identified"/>
Surveyor Name:	<input type="text" value="D.Jeffs"/>	Quantity:	<input type="text" value="N/A"/>
Drawing Ref:	<input type="text" value="As location ref"/>		
Asbestos ?	<input type="text" value="No"/>		
Date:	<input type="text" value="07 September 2023"/>		
Next Inspection:	<input type="text" value="Not Applicable"/>

Material Risk Score:	<input type="text" value="0"/>
Material Risk Band:	<input type="text" value="NADIS"/>
Priority Risk Score:	<input type="text" value="N/A"/>

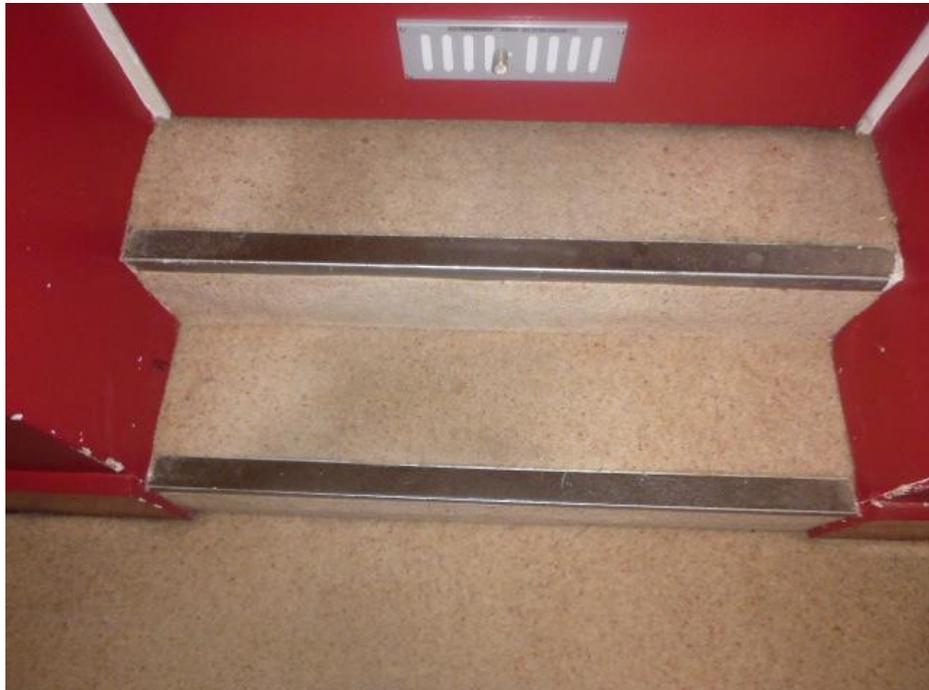
Location ID:	<input type="text" value="41371"/>	Survey Type:	<input type="text" value="MS"/>
Location Ref:	<input type="text" value="11"/>	Product Type:	<input type="text" value="NADIS"/>
Product:	<input type="text" value="Stair nosing"/>	Damage:	<input type="text" value="NADIS"/>
Area:	<input type="text" value="Town Hall"/>	Treatment:	<input type="text" value="NADIS"/>
Floor:	<input type="text" value="Ground floor"/>	Asbestos Type:	<input type="text" value="NADIS"/>
Room:	<input type="text" value="G.09"/>	Identification:	<input type="text" value="Identified"/>
Surveyor Name:	<input type="text" value="D.Jeffs"/>	Quantity:	<input type="text" value="N/A"/>
Drawing Ref:	<input type="text" value="As location ref"/>		
Asbestos ?	<input type="text" value="No"/>		
Date:	<input type="text" value="07 September 2023"/>		
Next Inspection:	<input type="text" value="Not Applicable"/>

Material Risk Score:	<input type="text" value="0"/>
Material Risk Band:	<input type="text" value="NADIS"/>
Priority Risk Score:	<input type="text" value="N/A"/>

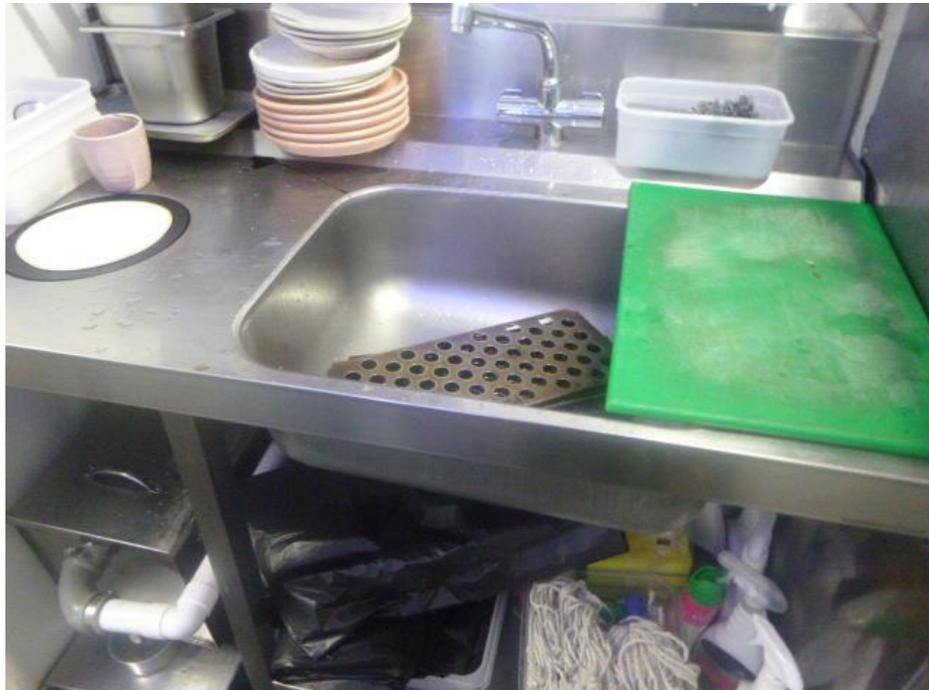
Location ID:	<input type="text" value="41372"/>	Survey Type:	<input type="text" value="MS"/>
Location Ref:	<input type="text" value="12"/>	Product Type:	<input type="text" value="NADIS"/>
Product:	<input type="text" value="Sink Pad"/>	Damage:	<input type="text" value="NADIS"/>
Area:	<input type="text" value="RYND Restaurant"/>	Treatment:	<input type="text" value="NADIS"/>
Floor:	<input type="text" value="Ground floor"/>	Asbestos Type:	<input type="text" value="NADIS"/>
Room:	<input type="text" value="G.13"/>	Identification:	<input type="text" value="Identified"/>
Surveyor Name:	<input type="text" value="D.Jeffs"/>	Quantity:	<input type="text" value="N/A"/>
Drawing Ref:	<input type="text" value="As location ref"/>		
Asbestos ?	<input type="text" value="No"/>		
Date:	<input type="text" value="07 September 2023"/>		
Next Inspection:	<input type="text" value="Not Applicable"/>

Material Risk Score:	<input type="text" value="0"/>
Material Risk Band:	<input type="text" value="NADIS"/>
Priority Risk Score:	<input type="text" value="N/A"/>

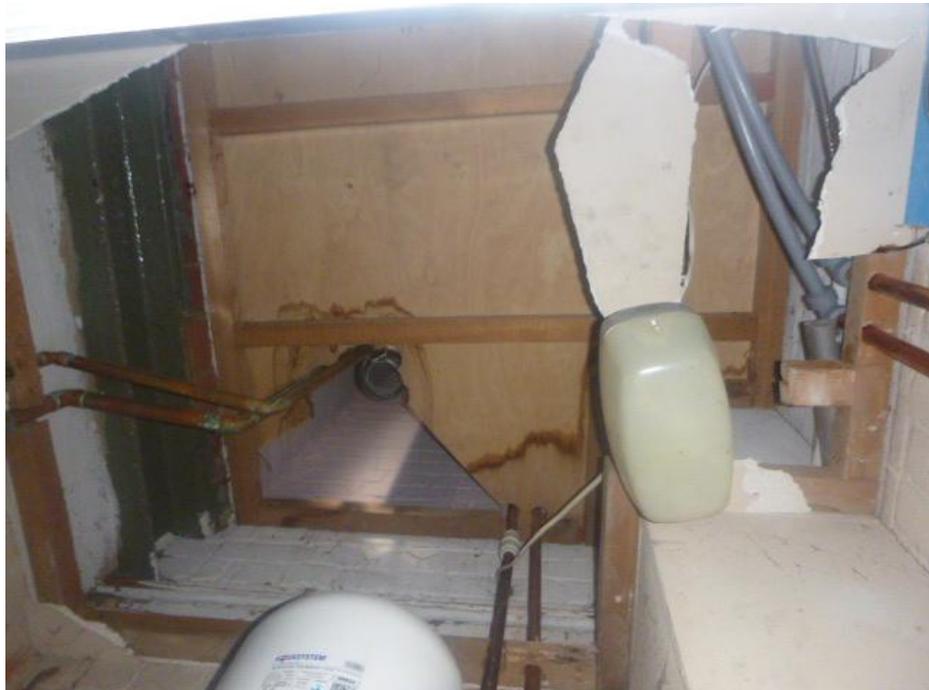
Location ID:	<input type="text" value="41373"/>	Survey Type:	<input type="text" value="MS"/>
Location Ref:	<input type="text" value="13"/>	Product Type:	<input type="text" value="NADIS"/>
Product:	<input type="text" value="Ceiling panel"/>	Damage:	<input type="text" value="NADIS"/>
Area:	<input type="text" value="RYND Restaurant"/>	Treatment:	<input type="text" value="NADIS"/>
Floor:	<input type="text" value="Ground floor"/>	Asbestos Type:	<input type="text" value="NADIS"/>
Room:	<input type="text" value="G.14"/>	Identification:	<input type="text" value="Identified"/>
Surveyor Name:	<input type="text" value="D.Jeffs"/>	Quantity:	<input type="text" value="N/A"/>
Drawing Ref:	<input type="text" value="As location ref"/>		
Asbestos ?	<input type="text" value="No"/>		
Date:	<input type="text" value="07 September 2023"/>		
Next Inspection:	<input type="text" value="Not Applicable"/>

Material Risk Score:	<input type="text" value="0"/>
Material Risk Band:	<input type="text" value="NADIS"/>
Priority Risk Score:	<input type="text" value="N/A"/>

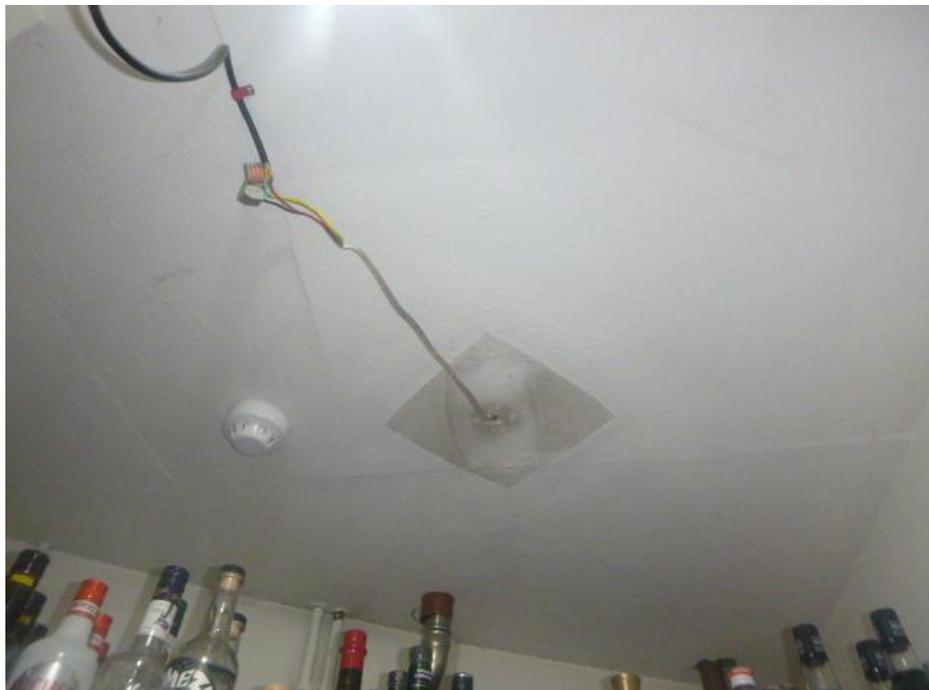
Location ID:	<input type="text" value="41374"/>	Survey Type:	<input type="text" value="MS"/>
Location Ref:	<input type="text" value="14"/>	Product Type:	<input type="text" value="NADIS"/>
Product:	<input type="text" value="Ceiling panel"/>	Damage:	<input type="text" value="NADIS"/>
Area:	<input type="text" value="RYND Restaurant"/>	Treatment:	<input type="text" value="NADIS"/>
Floor:	<input type="text" value="Ground floor"/>	Asbestos Type:	<input type="text" value="NADIS"/>
Room:	<input type="text" value="G.16"/>	Identification:	<input type="text" value="Strongly Presumed as previous sample"/>
Surveyor Name:	<input type="text" value="D.Jeffs"/>	Quantity:	<input type="text" value="N/A"/>

Material Risk Score:	<input type="text" value="0"/>
Material Risk Band:	<input type="text" value="NADIS"/>
Priority Risk Score:	<input type="text" value="N/A"/>
