Our Ref: 18258/EO/RPT/01  
Date: 06 October 2025

**Re: 18258 – Cherry Lodge Farm, Shrewton, Wiltshire, SP3 4ET**

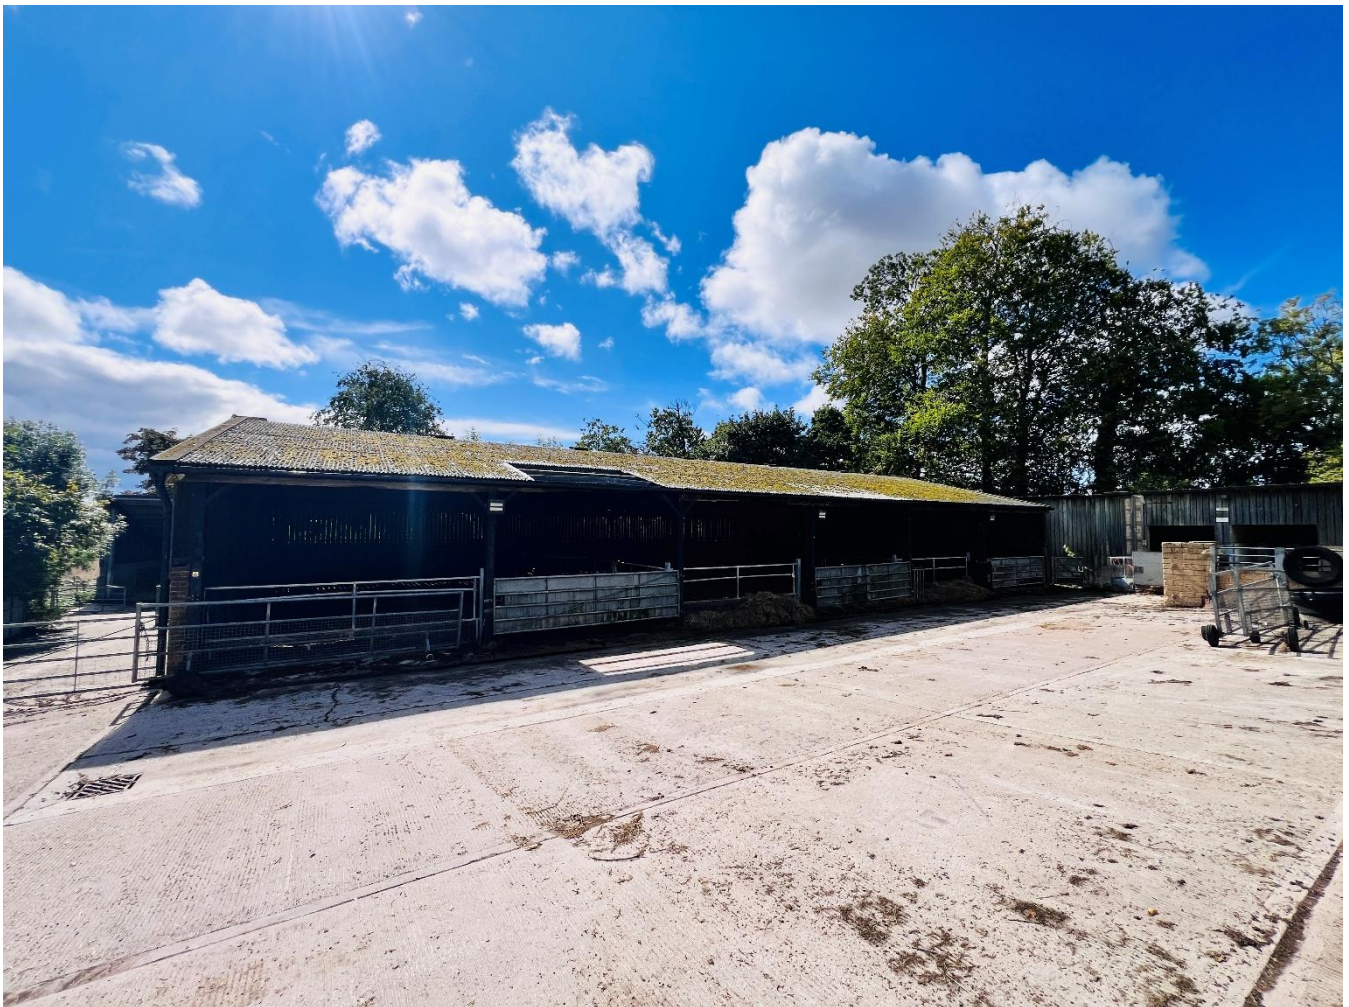
The purlins in the penultimate bay adjacent to the front elevation of the building could be seen to have sustained significant damage and were visibly distorted; these are likely no longer providing any restraint to the principal rafters of the steel portal frames on either side of the affected bay.

The cladding in the affected bay was missing, leaving the internal building envelope and structural steelwork of the portal frames exposed to the elements.

- ***Replaced the damaged purlins with like-for-like cold-formed metal purlins; these should be adequately bolted with metal cleats to the top of the principal rafters of the steel portal frame.***
- ***The missing cladding in the affected bay should be replaced with like-for-like cladding panels and/or lightweight corrugated plastic covering.***
