## **Asbestos Refurbishment Survey Report**

Neeld Hall, Borough Parade, Chippenham, SN15 3WL

### **SWINDON ASBESTOS SURVEYING LTD**

| Job No: | J004955 |

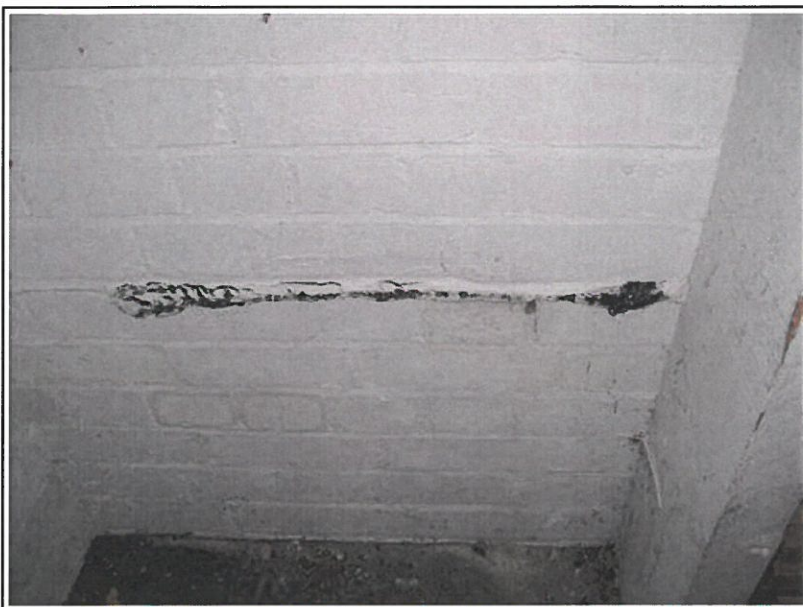
**Survey Data Sheet:** Conclusions & Recommendations  
**Site Location:** Neeld Hall, Borough Parade, Chippenham, SN15 3WL  
**Building Designation:** Building 01  
**Unique item Number:** 7

| Sample Ref | FI | Location | Description | Qty | Analysis Result | Total M.A.S | Licensed Material Y/N |
|---|---|---|---|---|---|---|---|
| AD006179 | Z-Sub Level 1 | Under Stage Area. B03 | Walls - Damp proof course - Well Bound Material | 40lm | NADIS | | N |

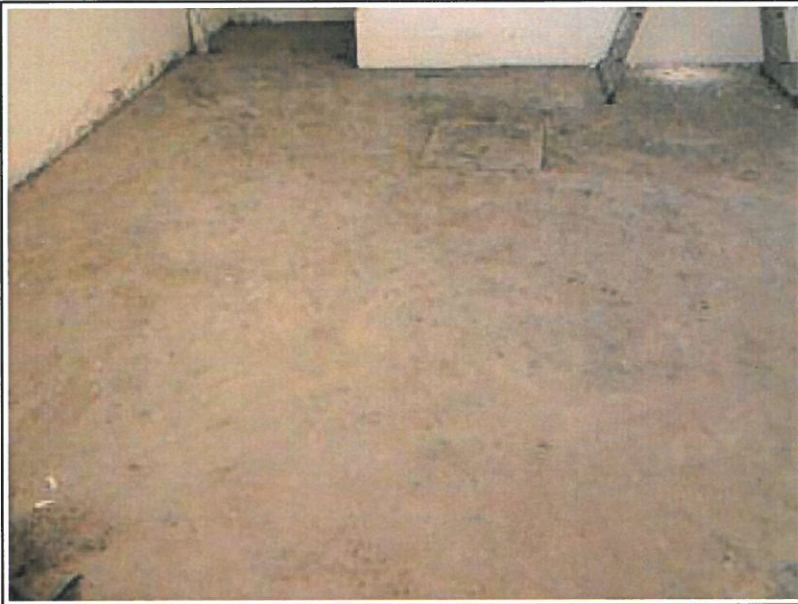
**Survey Data Sheet:** Conclusions & Recommendations  
**Site Location:** Neeld Hall, Borough Parade, Chippenham, SN15 3WL  
**Building Designation:** Building 01  
**Unique item Number:** 8

| Sample Ref | Fl | Location | Description | Qty | Analysis Result | Total M.A.S | Licensed Material Y/N |
|---|---|---|---|---|---|---|---|
| AD006171 | Ground Floor | Baby Boots Unit. 001 | Floor - Screed - Well Bound Material | 40m <sup>2</sup> | NADIS | | N |

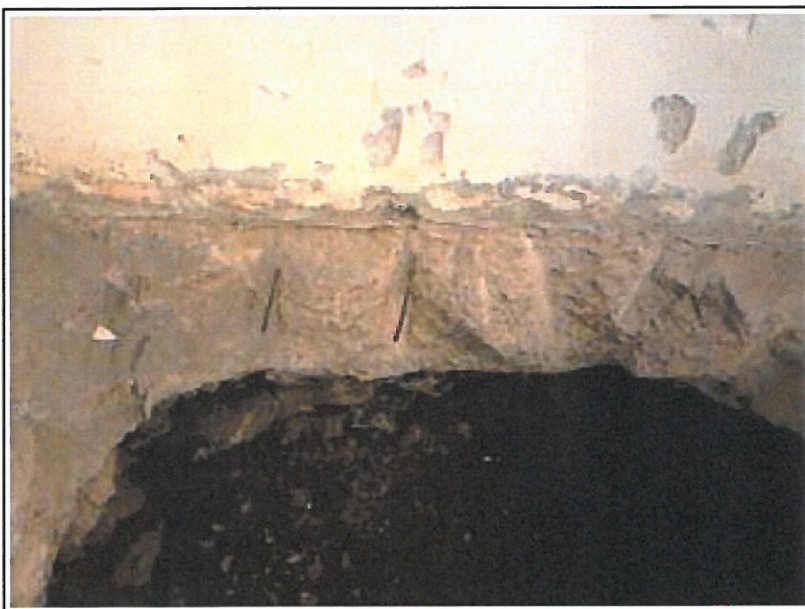
**Survey Data Sheet:** Conclusions & Recommendations  
**Site Location:** Neeld Hall, Borough Parade, Chippenham, SN15 3WL  
**Building Designation:** Building 01  
**Unique item Number:** 9

| Sample Ref | FI | Location | Description | Qty | Analysis Result | Total M.A.S | Licensed Material Y/N |
|---|---|---|---|---|---|---|---|
| AD006172 | Ground Floor | Baby Boots Unit. 001 | Base of walls - Damp proof course - Well Bound Material | 40lm | Chrysotile | 2 | N |

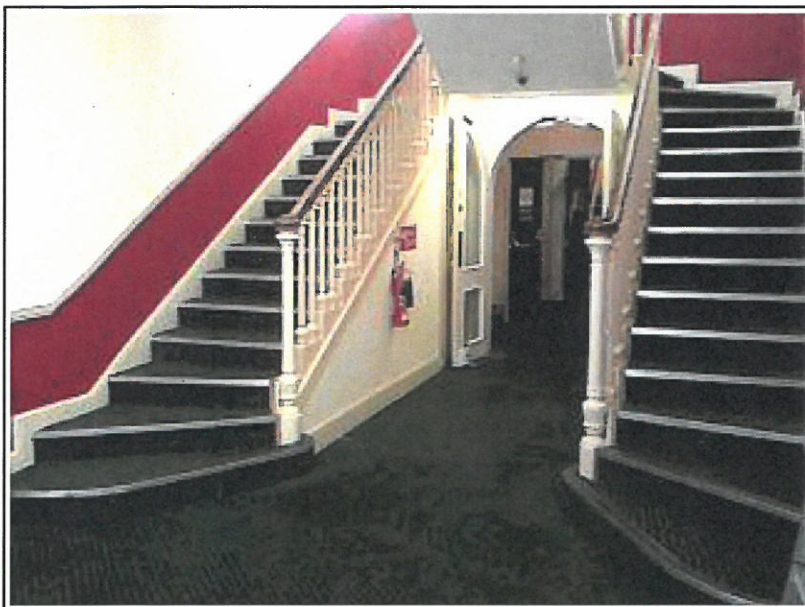
**Survey Data Sheet:** Conclusions & Recommendations  
**Site Location:** Neeld Hall, Borough Parade, Chippenham, SN15 3WL  
**Building Designation:** Building 01  
**Unique item Number:** 11

| Sample Ref | Fl | Location | Description | Qty | Analysis Result | Total M.A.S | Licensed Material Y/N |
|---|---|---|---|---|---|---|---|
| Surveyed | Ground Floor | Stairwell. 003 | No asbestos detected - | | N/A | | N |

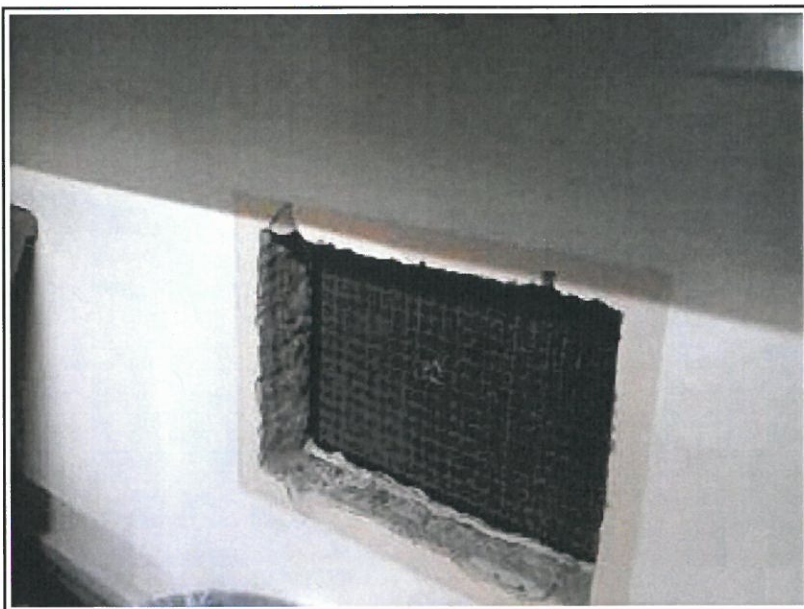
**Survey Data Sheet:** Conclusions & Recommendations  
**Site Location:** Neeld Hall, Borough Parade, Chippenham, SN15 3WL  
**Building Designation:** Building 01  
**Unique item Number:** 12

| Sample Ref | Fl | Location | Description | Qty | Analysis Result | Total M.A.S | Licensed Material Y/N |
|---|---|---|---|---|---|---|---|
| AD006173 | Ground Floor | Office. 004 | Wall below glass screen - Paper within vent - Textiles/Paper | <1m <sup>2</sup> | NADIS | | N |

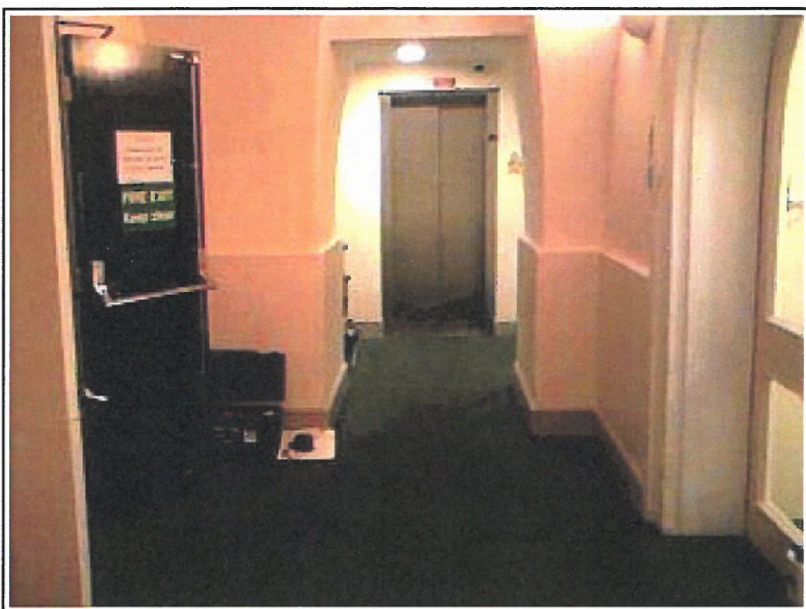
**Survey Data Sheet:** Conclusions & Recommendations  
**Site Location:** Neeld Hall, Borough Parade, Chippenham, SN15 3WL  
**Building Designation:** Building 01  
**Unique item Number:** 13

| Sample Ref | Fl | Location | Description | Qty | Analysis Result | Total M.A.S | Licensed Material Y/N |
|---|---|---|---|---|---|---|---|
| Surveyed | Ground Floor | Circulation. 005 | No asbestos detected - | | N/A | | N |

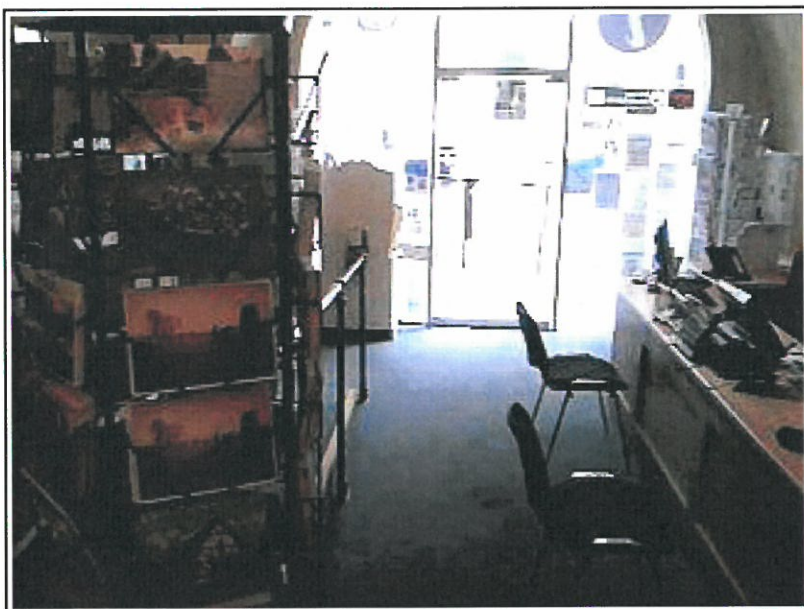
**Survey Data Sheet:** Conclusions & Recommendations  
**Site Location:** Neeld Hall, Borough Parade, Chippenham, SN15 3WL  
**Building Designation:** Building 01  
**Unique item Number:** 14

| Sample Ref | Fl | Location | Description | Qty | Analysis Result | Total M.A.S | Licensed Material Y/N |
|---|---|---|---|---|---|---|---|
| Surveyed | Ground Floor | Tourist Information Area. 006 | No asbestos detected - | | N/A | | N |

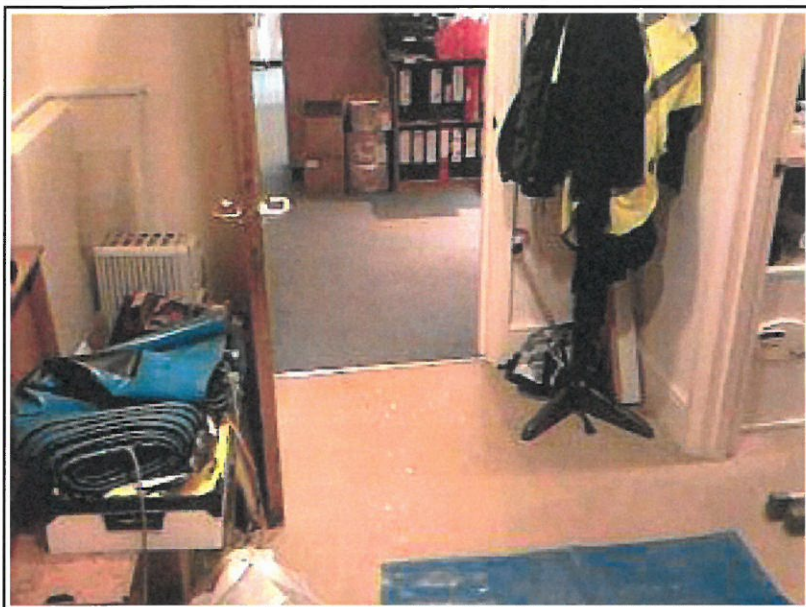
**Survey Data Sheet:** Conclusions & Recommendations  
**Site Location:** Neeld Hall, Borough Parade, Chippenham, SN15 3WL  
**Building Designation:** Building 01  
**Unique item Number:** 15

| Sample Ref | Fl | Location | Description | Qty | Analysis Result | Total M.A.S | Licensed Material Y/N |
|---|---|---|---|---|---|---|---|
| Surveyed | Ground Floor | Circulation. 007 | No asbestos detected - | | N/A | | N |

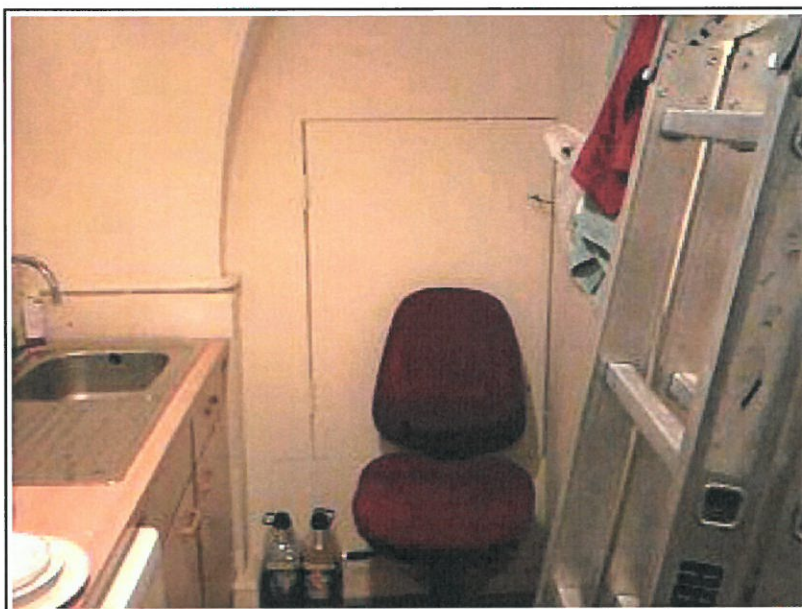
**Survey Data Sheet:** Conclusions & Recommendations  
**Site Location:** Neeld Hall, Borough Parade, Chippenham, SN15 3WL  
**Building Designation:** Building 01  
**Unique item Number:** 16

| Sample Ref | Fl | Location | Description | Qty | Analysis Result | Total M.A.S | Licensed Material Y/N |
|---|---|---|---|---|---|---|---|
| Surveyed | Ground Floor | Kitchen. 008 | No asbestos detected - | | N/A | | N |

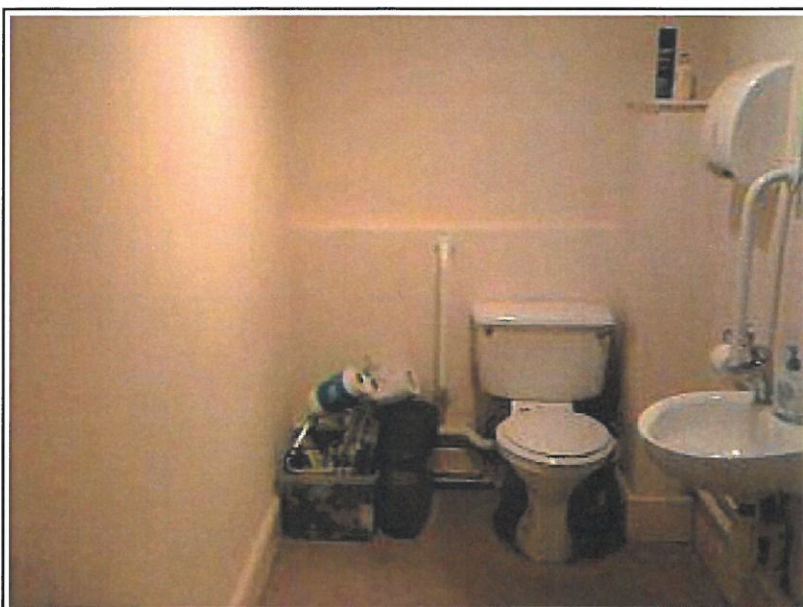
**Survey Data Sheet:** Conclusions & Recommendations  
**Site Location:** Neeld Hall, Borough Parade, Chippenham, SN15 3WL  
**Building Designation:** Building 01  
**Unique item Number:** 17

| Sample Ref | FI | Location | Description | Qty | Analysis Result | Total M.A.S | Licensed Material Y/N |
|---|---|---|---|---|---|---|---|
| Surveyed | Ground Floor | WC. 009 | No asbestos detected - | | N/A | | N |

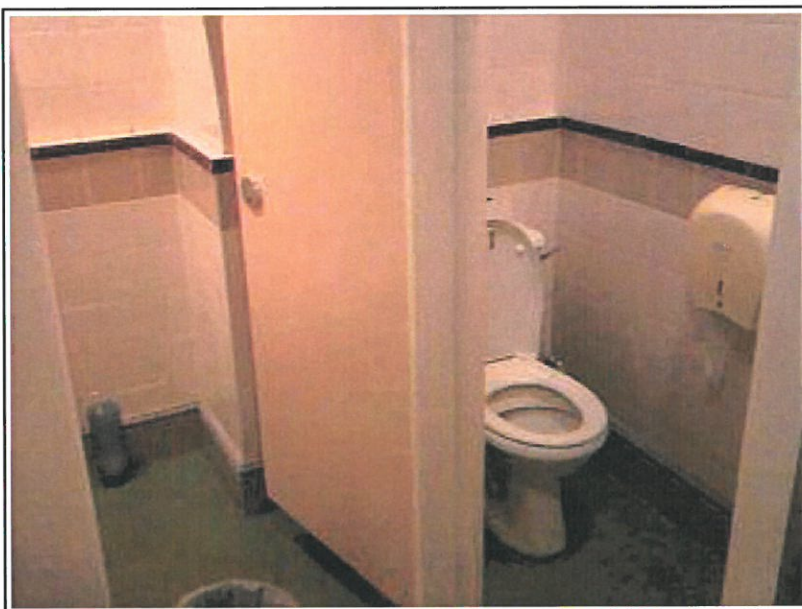
**Survey Data Sheet:** Conclusions & Recommendations  
**Site Location:** Neeld Hall, Borough Parade, Chippenham, SN15 3WL  
**Building Designation:** Building 01  
**Unique item Number:** 18

| Sample Ref | Fl | Location | Description | Qty | Analysis Result | Total M.A.S | Licensed Material Y/N |
|---|---|---|---|---|---|---|---|
| Surveyed | Ground Floor | Female WC. 010 | No asbestos detected - | | N/A | | N |

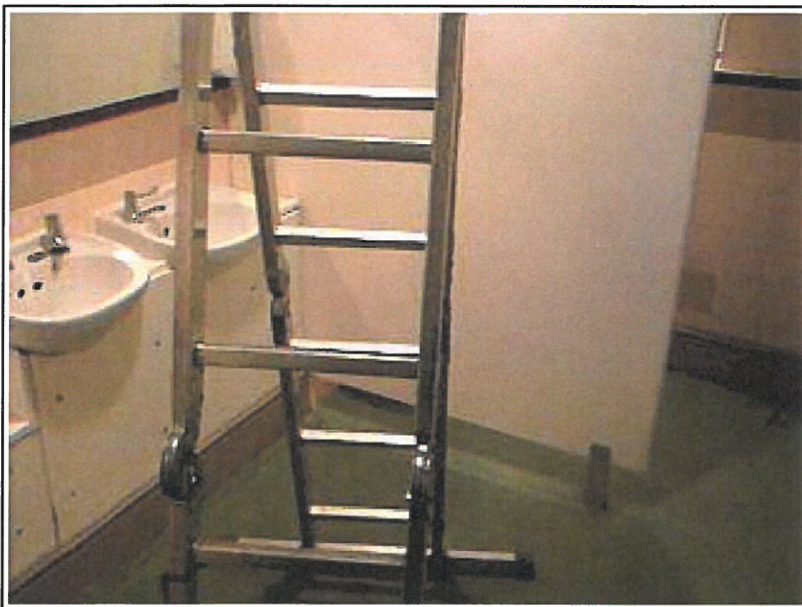
**Survey Data Sheet:** Conclusions & Recommendations  
**Site Location:** Neeld Hall, Borough Parade, Chippenham, SN15 3WL  
**Building Designation:** Building 01  
**Unique item Number:** 19

| Sample Ref | Fl | Location | Description | Qty | Analysis Result | Total M.A.S | Licensed Material Y/N |
|---|---|---|---|---|---|---|---|
| Surveyed | Ground Floor | Male WC. 011 | No asbestos detected - | | N/A | | N |

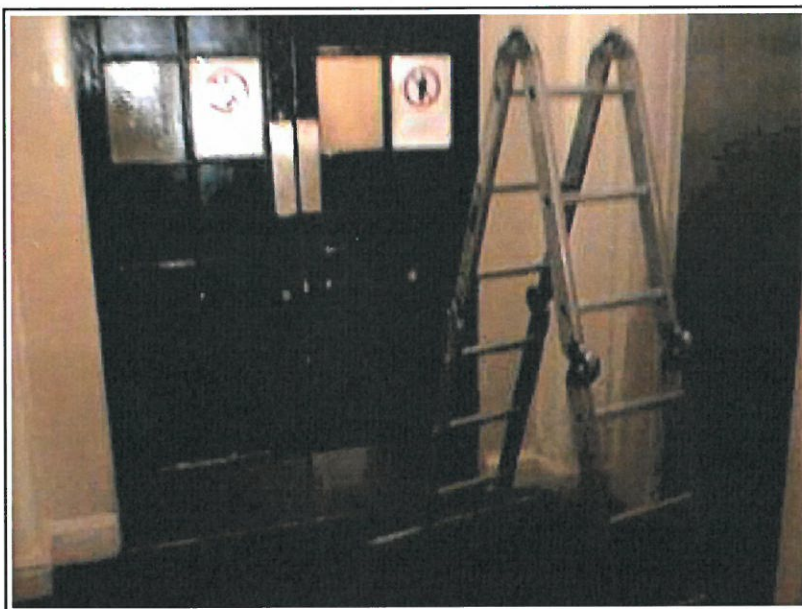
**Survey Data Sheet:** Conclusions & Recommendations  
**Site Location:** Neeld Hall, Borough Parade, Chippenham, SN15 3WL  
**Building Designation:** Building 01  
**Unique item Number:** 20

| Sample Ref | FI | Location | Description | Qty | Analysis Result | Total M.A.S | Licensed Material Y/N |
|---|---|---|---|---|---|---|---|
| Surveyed | Ground Floor | Circulation. 012 | No asbestos detected - | | N/A | | N |

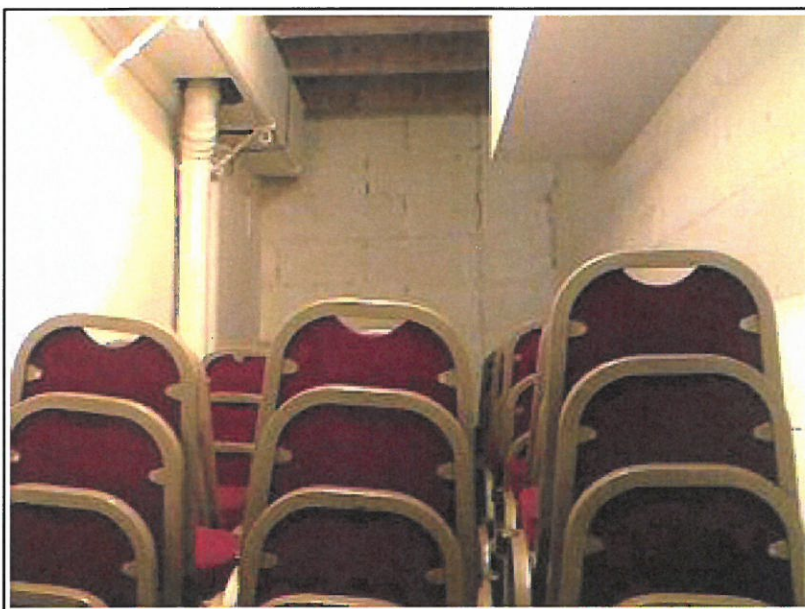
**Survey Data Sheet:** Conclusions & Recommendations  
**Site Location:** Neeld Hall, Borough Parade, Chippenham, SN15 3WL  
**Building Designation:** Building 01  
**Unique item Number:** 21

| Sample Ref | Fl | Location | Description | Qty | Analysis Result | Total M.A.S | Licensed Material Y/N |
|---|---|---|---|---|---|---|---|
| Surveyed | Ground Floor | Chair Store. 013 | No asbestos detected - | | N/A | | N |

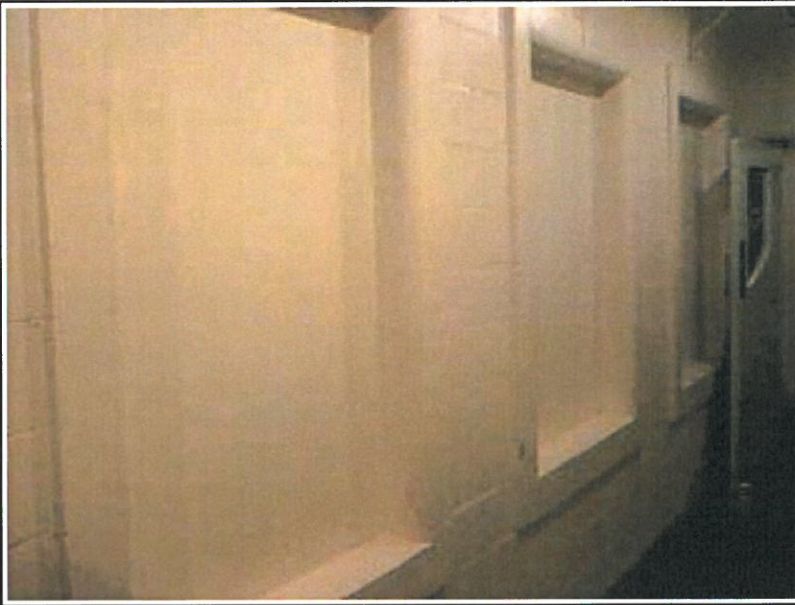
**Survey Data Sheet:** Conclusions & Recommendations  
**Site Location:** Neeld Hall, Borough Parade, Chippenham, SN15 3WL  
**Building Designation:** Building 01  
**Unique item Number:** 22

| Sample Ref | Fl | Location | Description | Qty | Analysis Result | Total M.A.S | Licensed Material Y/N |
|---|---|---|---|---|---|---|---|
| AD006174 | Ground Floor | Link Corridor. 014 | Internal windows - Insulation board panels - Insulating Board | 6m <sup>2</sup> | NADIS | | N |

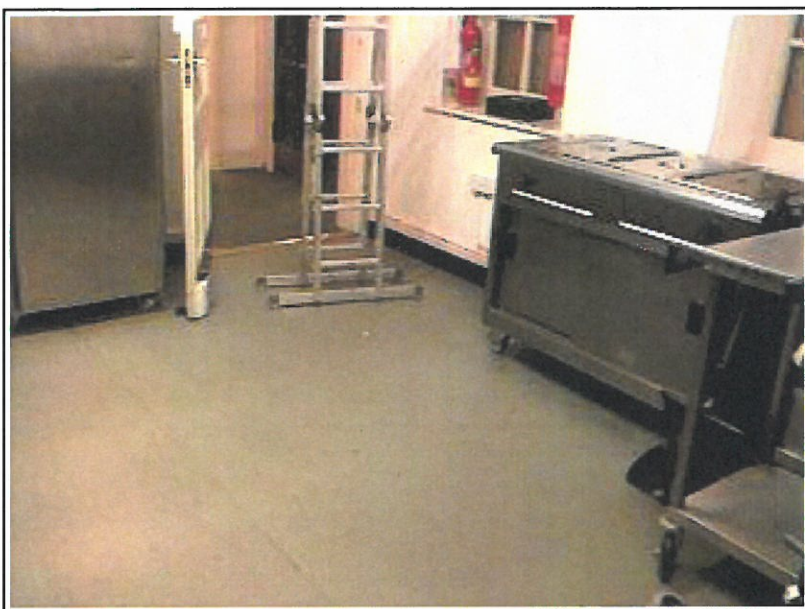
**Survey Data Sheet:** Conclusions & Recommendations  
**Site Location:** Neeld Hall, Borough Parade, Chippenham, SN15 3WL  
**Building Designation:** Building 01  
**Unique item Number:** 23

| Sample Ref | Fl | Location | Description | Qty | Analysis Result | Total M.A.S | Licensed Material Y/N |
|---|---|---|---|---|---|---|---|
| Surveyed | Ground Floor | Kitchen. 015 | No asbestos detected - | | N/A | | N |

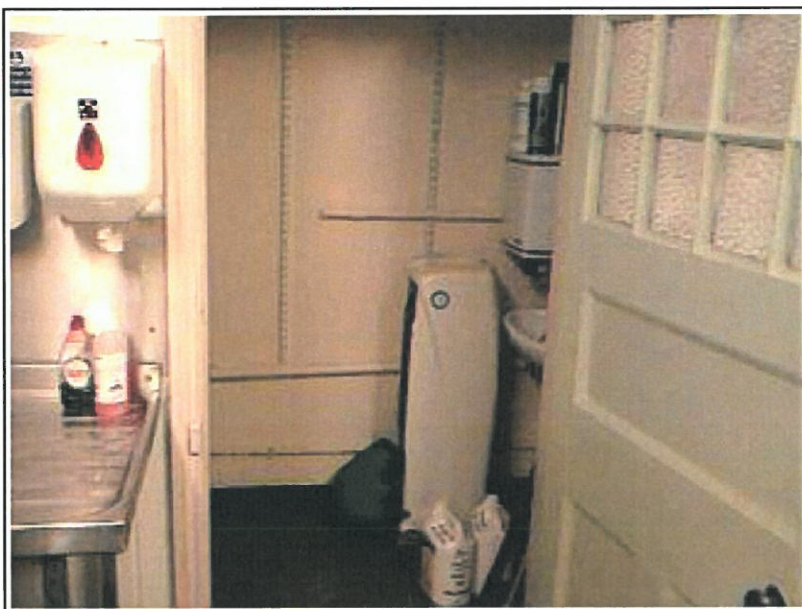
**Survey Data Sheet:** Conclusions & Recommendations  
**Site Location:** Neeld Hall, Borough Parade, Chippenham, SN15 3WL  
**Building Designation:** Building 01  
**Unique item Number:** 24

| Sample Ref | Fl | Location | Description | Qty | Analysis Result | Total M.A.S | Licensed Material Y/N |
|---|---|---|---|---|---|---|---|
| Surveyed | Ground Floor | Cleaners Cupboard. 016 | No asbestos detected - | | N/A | | N |

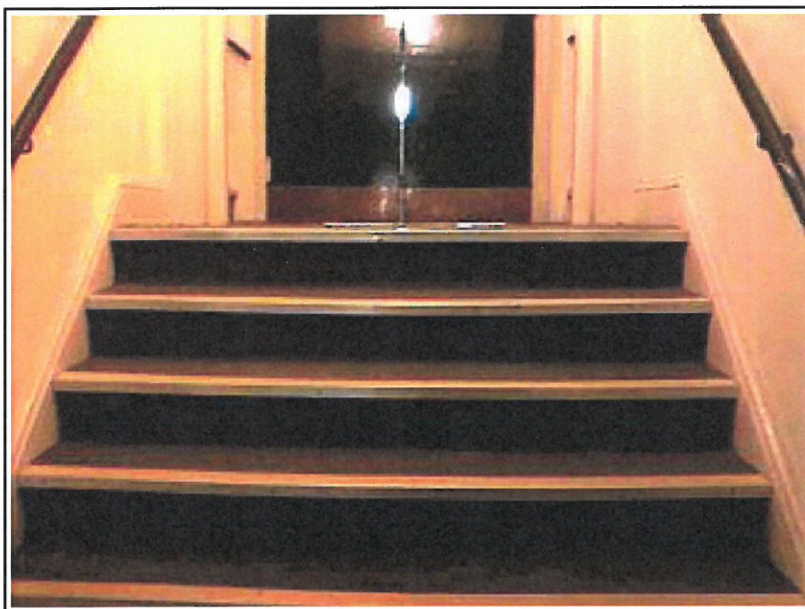
**Survey Data Sheet:** Conclusions & Recommendations  
**Site Location:** Neeld Hall, Borough Parade, Chippenham, SN15 3WL  
**Building Designation:** Building 01  
**Unique item Number:** 25

| Sample Ref | Fl | Location | Description | Qty | Analysis Result | Total M.A.S | Licensed Material Y/N |
|---|---|---|---|---|---|---|---|
| Surveyed | Ground Floor | Circulation. 017 | No asbestos detected - | | N/A | | N |

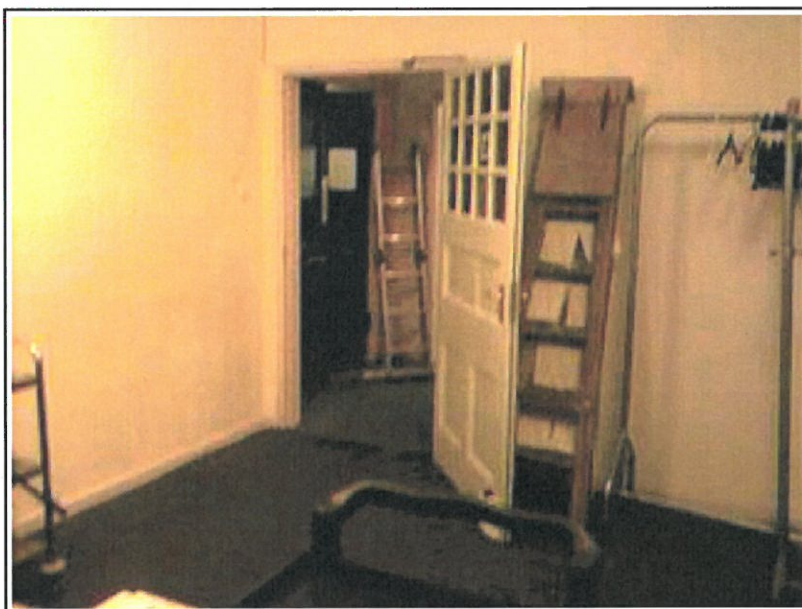
**Survey Data Sheet:** Conclusions & Recommendations  
**Site Location:** Neeld Hall, Borough Parade, Chippenham, SN15 3WL  
**Building Designation:** Building 01  
**Unique item Number:** 26

| Sample Ref | Fl | Location | Description | Qty | Analysis Result | Total M.A.S | Licensed Material Y/N |
|---|---|---|---|---|---|---|---|
| Surveyed | Ground Floor | Office. 018 | No asbestos detected - | | N/A | | N |

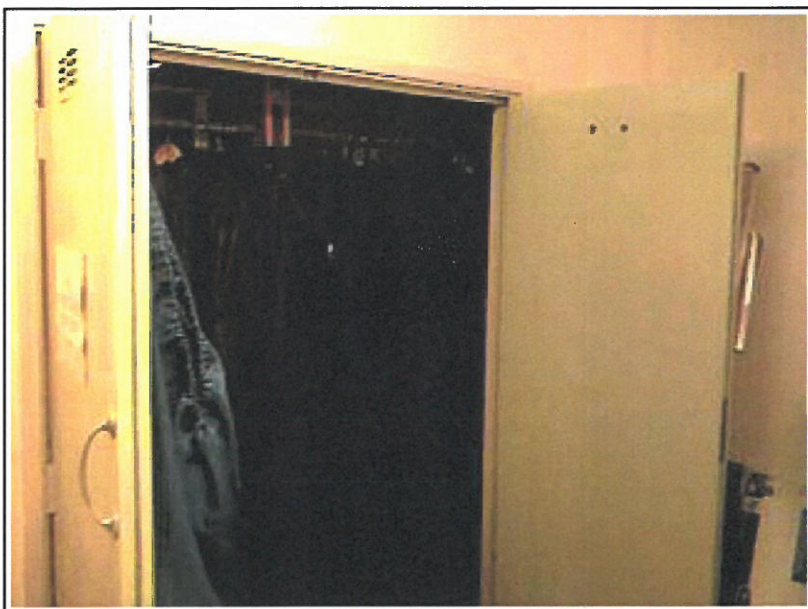
**Survey Data Sheet:** Conclusions & Recommendations  
**Site Location:** Neeld Hall, Borough Parade, Chippenham, SN15 3WL  
**Building Designation:** Building 01  
**Unique item Number:** 27

| Sample Ref | Fl | Location | Description | Qty | Analysis Result | Total M.A.S | Licensed Material Y/N |
|---|---|---|---|---|---|---|---|
| Surveyed | Ground Floor | Cupboard. 019 | No asbestos detected - | | N/A | | N |

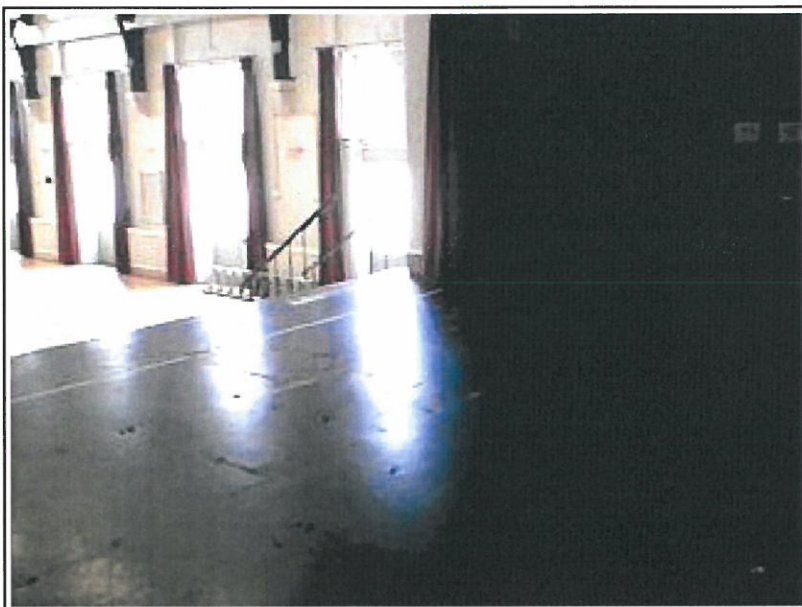
**Survey Data Sheet:** Conclusions & Recommendations  
**Site Location:** Neeld Hall, Borough Parade, Chippenham, SN15 3WL  
**Building Designation:** Building 01  
**Unique item Number:** 28

| Sample Ref | Fl | Location | Description | Qty | Analysis Result | Total M.A.S | Licensed Material Y/N |
|---|---|---|---|---|---|---|---|
| Surveyed | Ground Floor | Stage. 020 | No asbestos detected - | | N/A | | N |

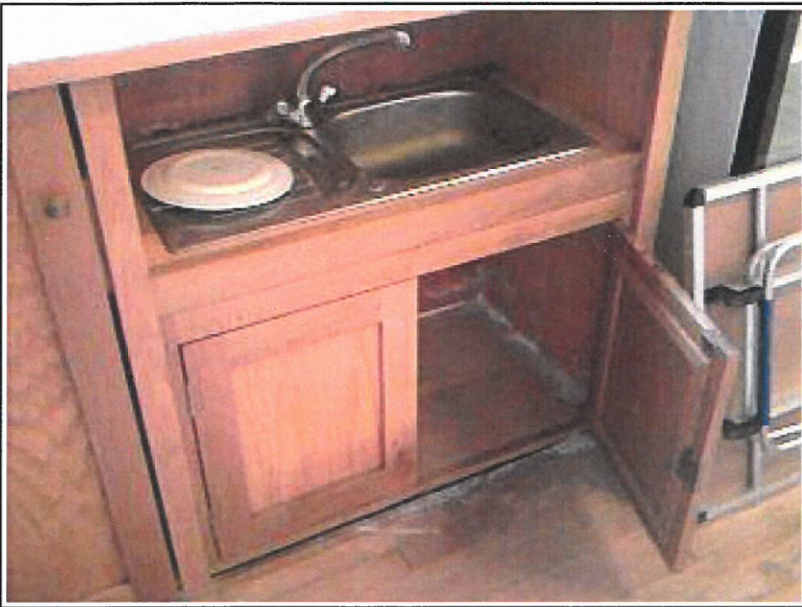
**Survey Data Sheet:** Conclusions & Recommendations  
**Site Location:** Neeld Hall, Borough Parade, Chippenham, SN15 3WL  
**Building Designation:** Building 01  
**Unique item Number:** 29

| Sample Ref | Fl | Location | Description | Qty | Analysis Result | Total M.A.S | Licensed Material Y/N |
|---|---|---|---|---|---|---|---|
| AD006180 | Ground Floor | Main Hall. 021 | Sink - Acoustic pad - Well Bound Material | 1no. | NADIS | | N |

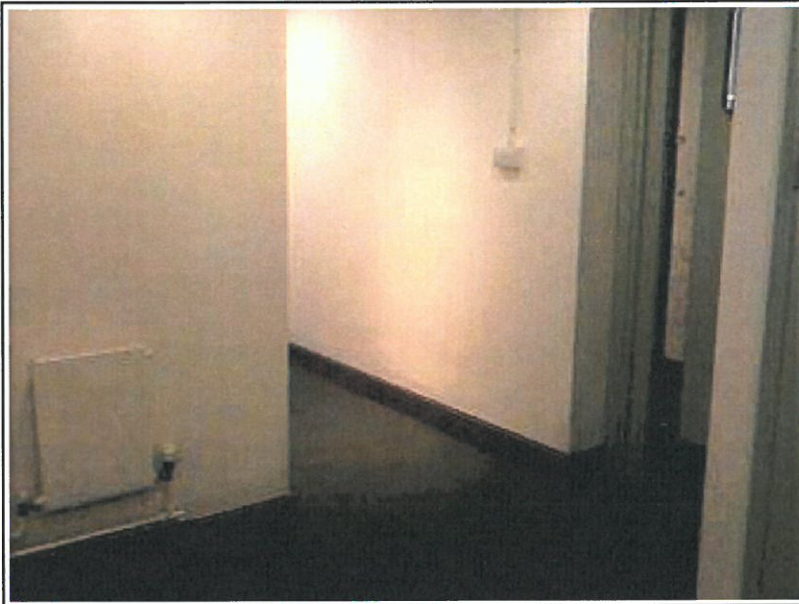
**Survey Data Sheet:** Conclusions & Recommendations  
**Site Location:** Neeld Hall, Borough Parade, Chippenham, SN15 3WL  
**Building Designation:** Building 01  
**Unique item Number:** 30

| Sample Ref | Fl | Location | Description | Qty | Analysis Result | Total M.A.S | Licensed Material Y/N |
|---|---|---|---|---|---|---|---|
| Surveyed | Ground Floor | WC Corridor. 022 | No asbestos detected - | | N/A | | N |

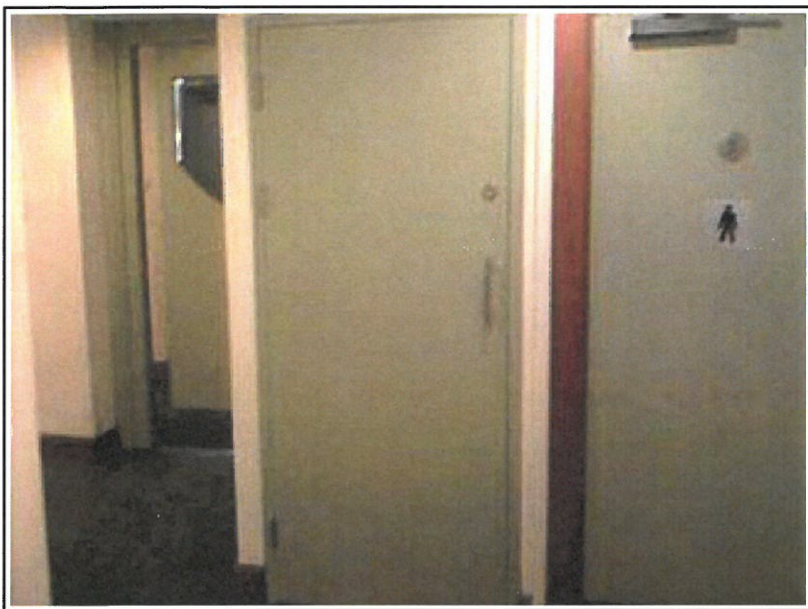
**Survey Data Sheet:** Conclusions & Recommendations  
**Site Location:** Neeld Hall, Borough Parade, Chippenham, SN15 3WL  
**Building Designation:** Building 01  
**Unique item Number:** 31

| Sample Ref | Fl | Location | Description | Qty | Analysis Result | Total M.A.S | Licensed Material Y/N |
|---|---|---|---|---|---|---|---|
| No Access | Ground Floor | Cleaners Cupboard. 023 | | | No Access | | |

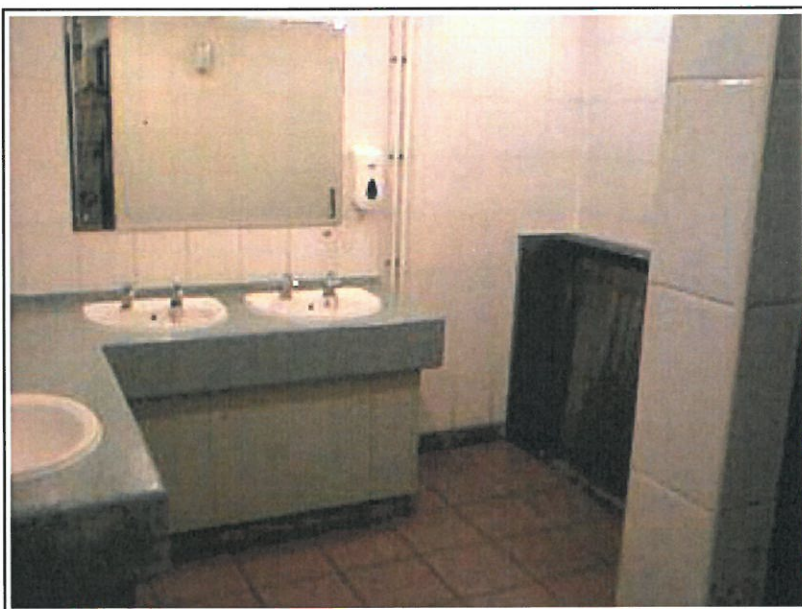
**Survey Data Sheet:** Conclusions & Recommendations  
**Site Location:** Need Hall, Borough Parade, Chippenham, SN15 3WL  
**Building Designation:** Building 01  
**Unique item Number:** 32

| Sample Ref | Fl | Location | Description | Qty | Analysis Result | Total M.A.S | Licensed Material Y/N |
|---|---|---|---|---|---|---|---|
| Surveyed | Ground Floor | Male WC. 024 | No asbestos detected - | | N/A | | N |

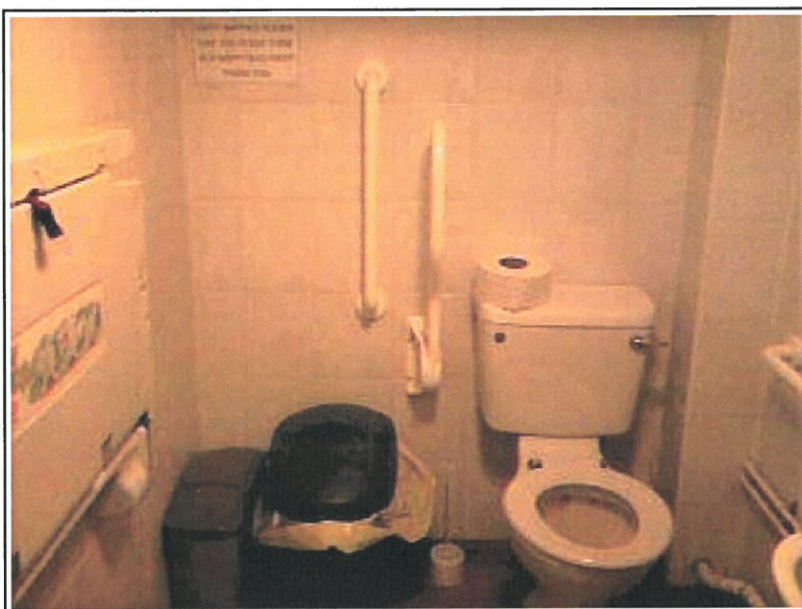
**Survey Data Sheet:** Conclusions & Recommendations  
**Site Location:** Neeld Hall, Borough Parade, Chippenham, SN15 3WL  
**Building Designation:** Building 01  
**Unique item Number:** 34

| Sample Ref | Fl | Location | Description | Qty | Analysis Result | Total M.A.S | Licensed Material Y/N |
|---|---|---|---|---|---|---|---|
| Surveyed | Ground Floor | Disabled WC. 026 | No asbestos detected - | | N/A | | N |

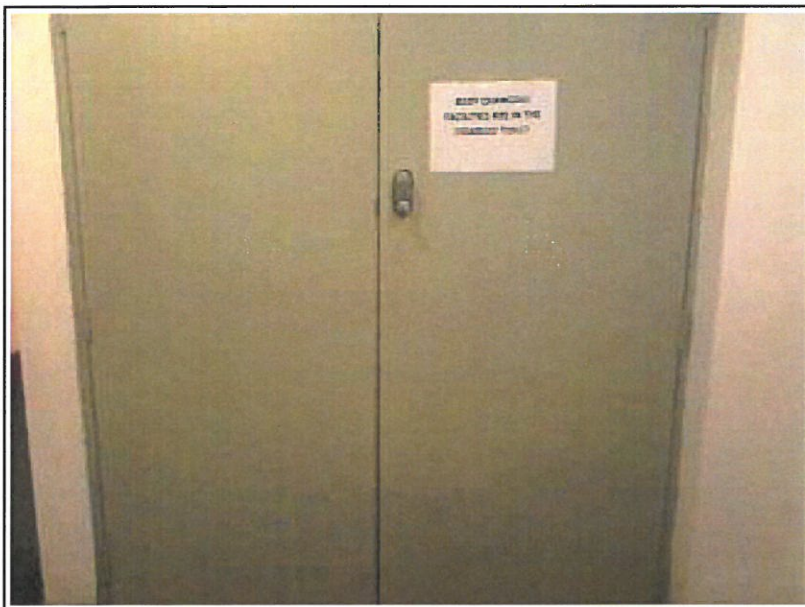
**Survey Data Sheet:** Conclusions & Recommendations  
**Site Location:** Neeld Hall, Borough Parade, Chippenham, SN15 3WL  
**Building Designation:** Building 01  
**Unique item Number:** 35

| Sample Ref | Fl | Location | Description | Qty | Analysis Result | Total M.A.S | Licensed Material Y/N |
|---|---|---|---|---|---|---|---|
| No Access | Ground Floor | Cupboard. 027 | | | No Access | | |

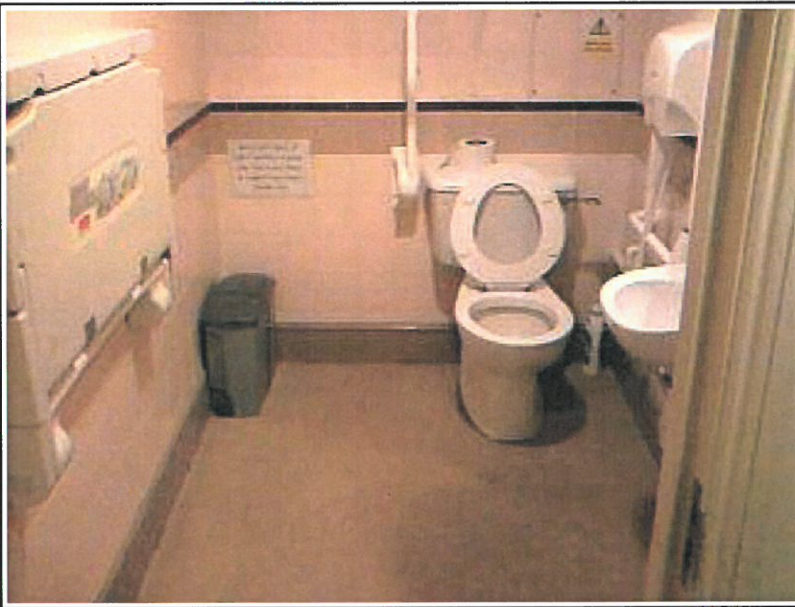
**Survey Data Sheet:** Conclusions & Recommendations  
**Site Location:** Neeld Hall, Borough Parade, Chippenham, SN15 3WL  
**Building Designation:** Building 01  
**Unique item Number:** 36

| Sample Ref | Fl | Location | Description | Qty | Analysis Result | Total M.A.S | Licensed Material Y/N |
|---|---|---|---|---|---|---|---|
| Surveyed | Ground Floor | Disabled WC. 028 | No asbestos detected - | | N/A | | N |

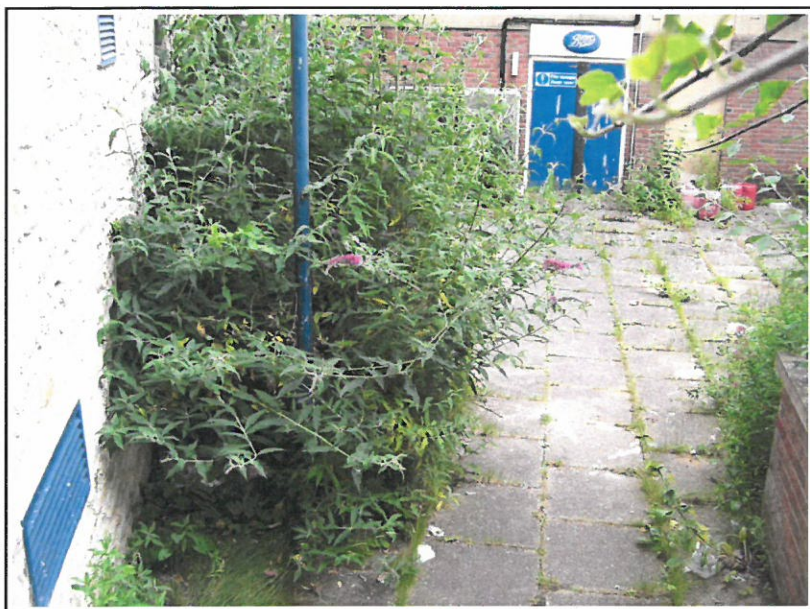
**Survey Data Sheet:** Conclusions & Recommendations  
**Site Location:** Neeld Hall, Borough Parade, Chippenham, SN15 3WL  
**Building Designation:** Building 01  
**Unique item Number:** 37

| Sample Ref | FI | Location | Description | Qty | Analysis Result | Total M.A.S | Licensed Material Y/N |
|---|---|---|---|---|---|---|---|
| Surveyed | External | External Courtyard | No asbestos detected - | | N/A | | N |
