## **ASBESTOS REFURBISHMENT SURVEY REPORT**

**SITE SURVEYED:**  
**Client Specified Areas**  
**Need Hall**  
**Borough Parade**  
**Chippenham**  
**SN15 3WL**

**SURVEYED ON:**  
**4<sup>th</sup> August 2016**

REFERENCE NUMBER - 16/S11348

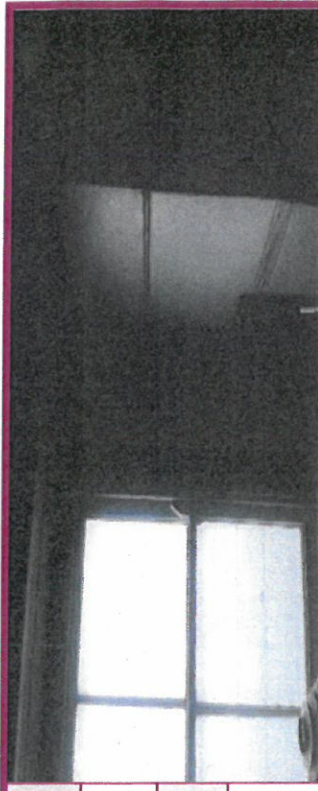
| Incident Reference | Sample Number | Level | Material Location | | | | Quantity | | Comments |
|---|---|---|---|---|---|---|---|---|---|
| NAD | Insulating Board Firebreak Panel to Air Conditioning Vent | | N/A | | N/A | | | | |
| N/A | N/A | N/A | N/A | N/A | N/A | N/A | No Action | Material was found not to contain asbestos. | |

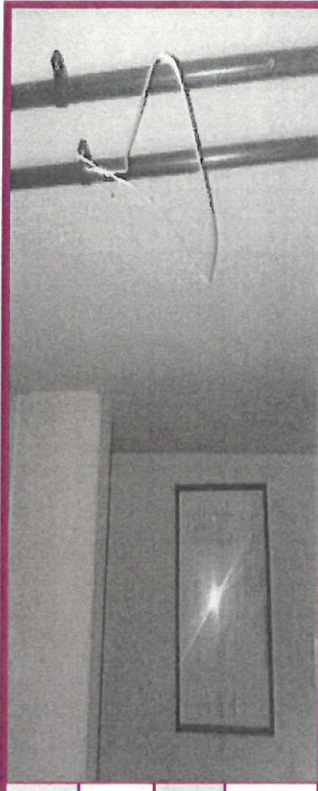
| Incident Reference | Sample Number | Level | Material Location | | | | Quantity | | Comments |
|---|---|---|---|---|---|---|---|---|---|
| 4 | 16/S11348/004 | Second floor | 201 Plant Room | | | | 10m <sup>2</sup> | | |

| Incident Reference | Sample Number | Level | Material Location | | | | Quantity | | Comments |
|---|---|---|---|---|---|---|---|---|---|
| N/A | N/A | N/A | N/A | N/A | N/A | N/A | No Action | Material was found not to contain asbestos. | |

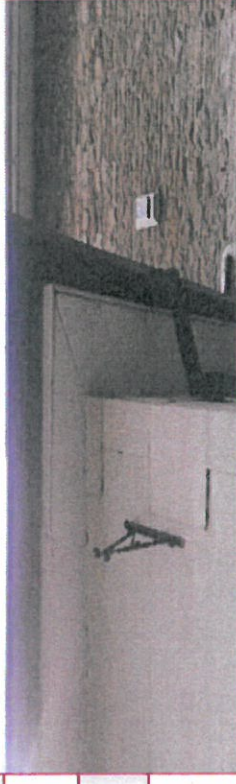
| Incident Reference | Sample Number | Level | Material Location | | | | Quantity | |
|---|---|---|---|---|---|---|---|---|
| 16 | S11348/013 | External | 008 Café Roof | | | | 16 lm | |

| Incident Reference | Sample Number | Level | Material Location | | | | Quantity | |
|---|---|---|---|---|---|---|---|---|
| N/A | N/A | N/A | N/A | N/A | N/A | N/A | No Action | Material was found not to contain asbestos. |
