Tree work specification: Trowbridge Town Council sites, Trowbridge, Wiltshire. BA14

Introduction

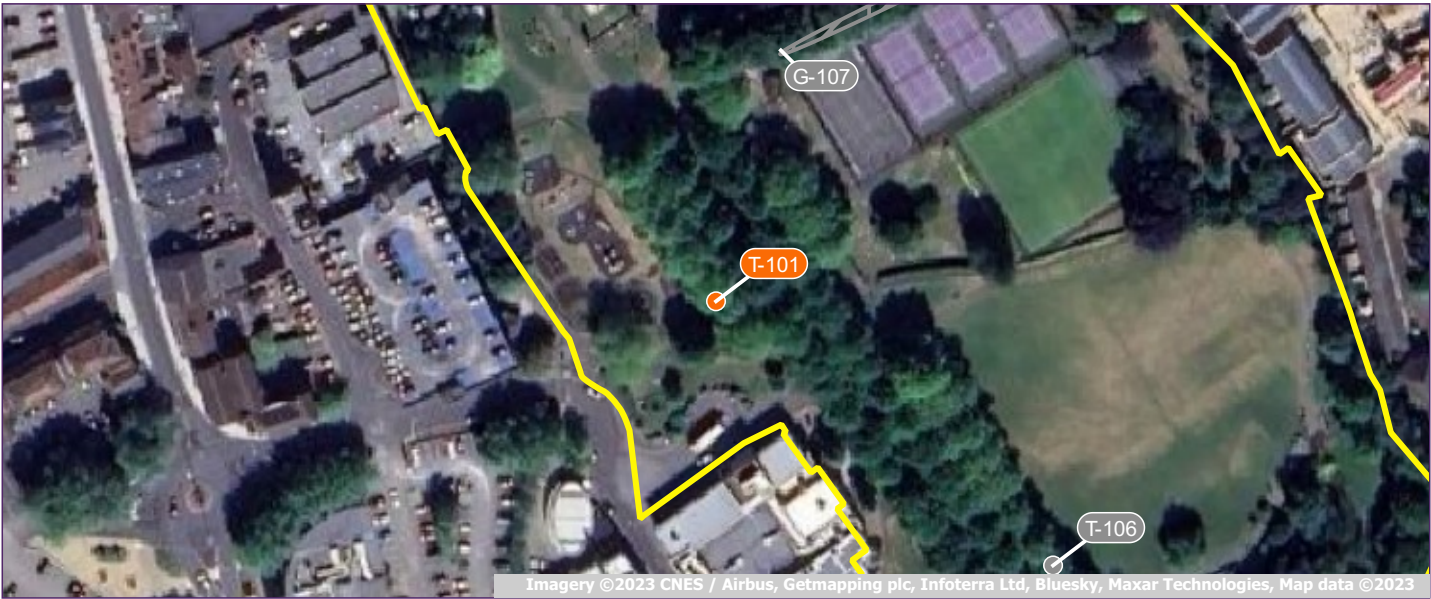
Item	Species	Comments	Recommendations	Price
T-101	Maple	Dead	Fell

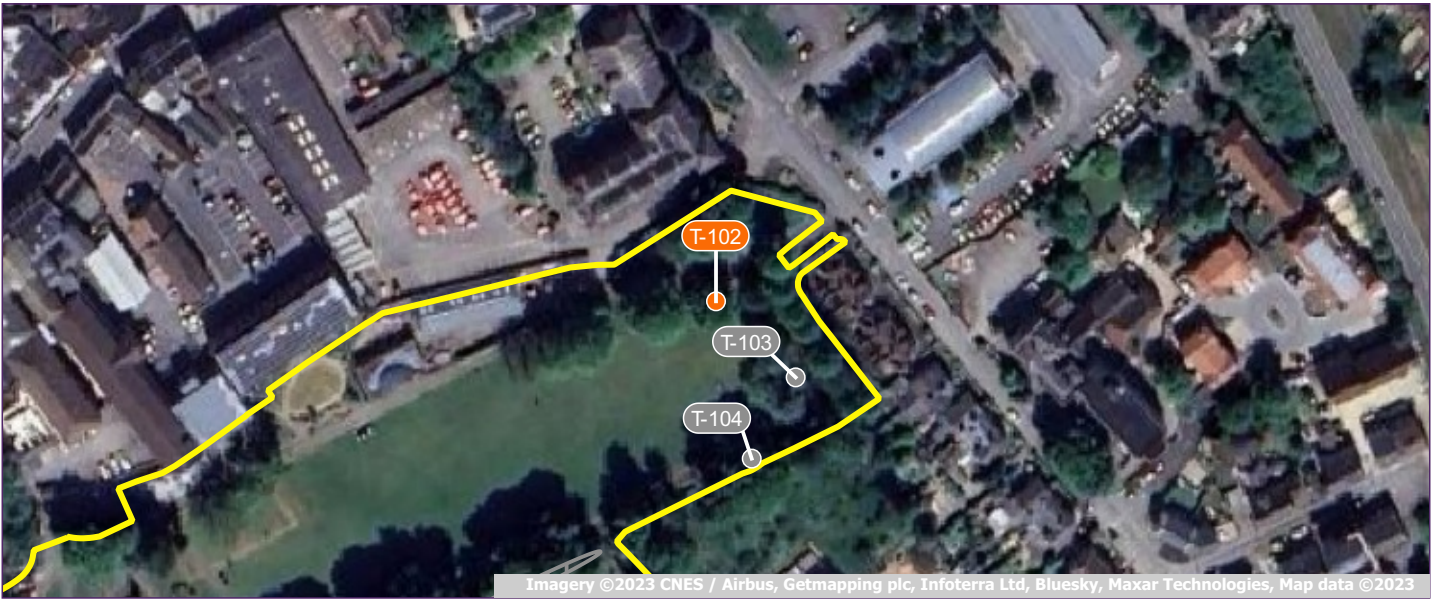
Item	Species	Comments	Recommendations	Price
T-102	Sycamore	Decay in trunk at 1 m, dieback to central stem	Fell

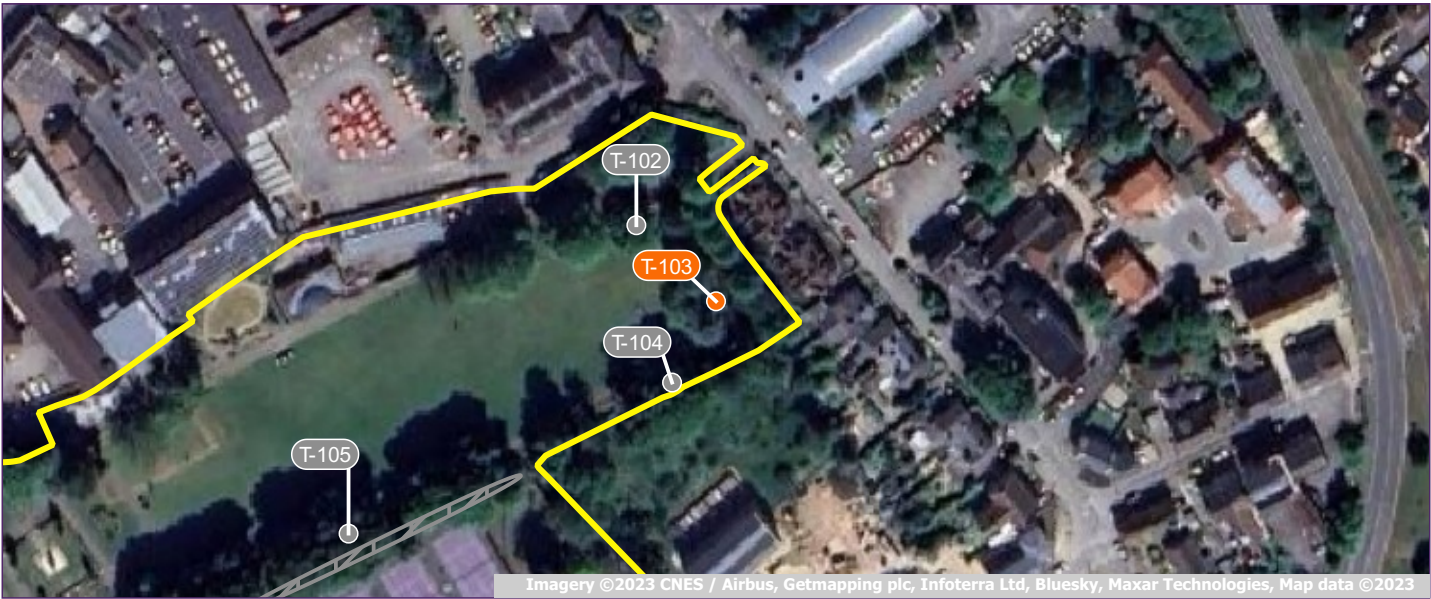
Item	Species	Comments	Recommendations	Price
T-103	Birch	Dead	Fell

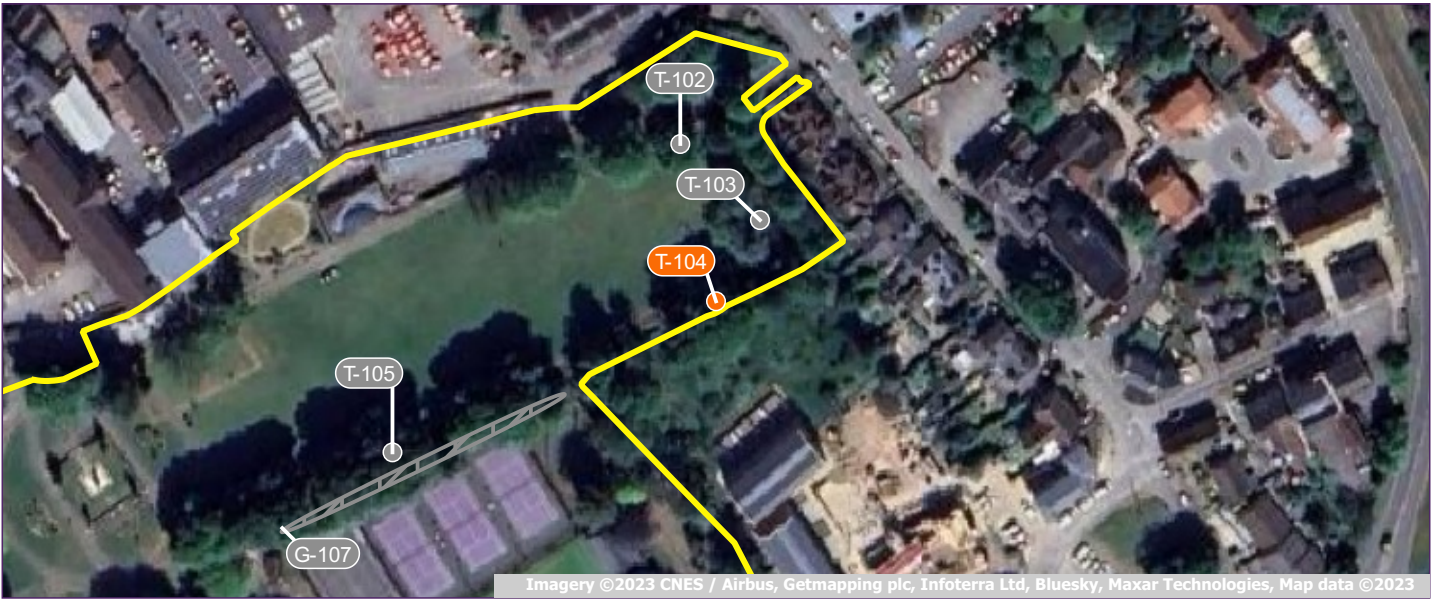
Item	Species	Comments	Recommendations	Price
T-104	Sycamore	Significant deadwood over path and light	Stabilise dead wood

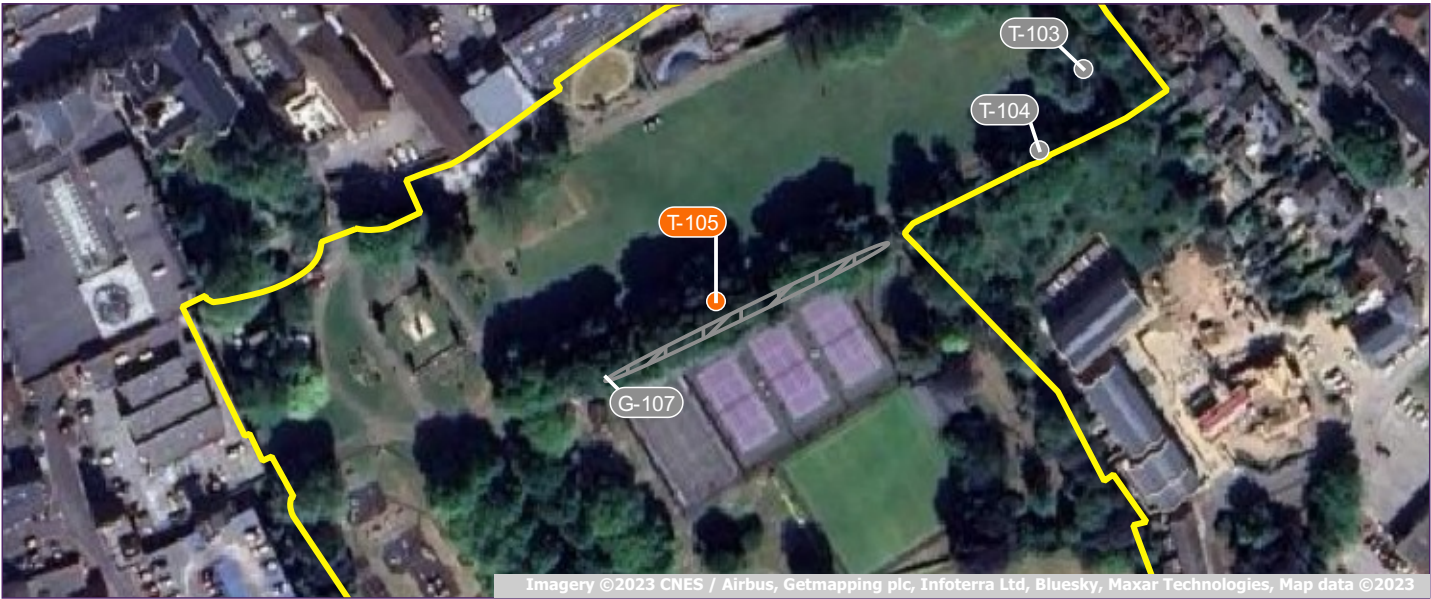
Item	Species	Comments	Recommendations	Price
T-105	Horse chestnut	Decay through stem, spiral crack up to crown break at 5 m	Fell

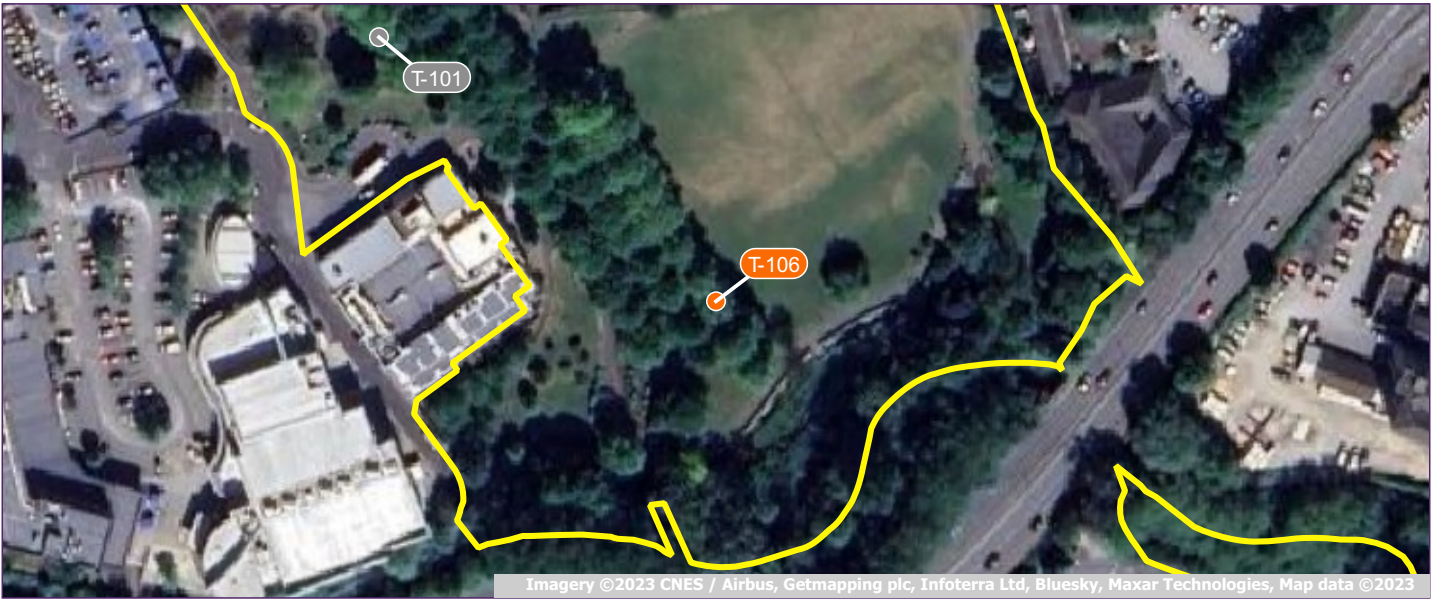
Item	Species	Comments	Recommendations	Price
T-106	Plane	Dead	Fell

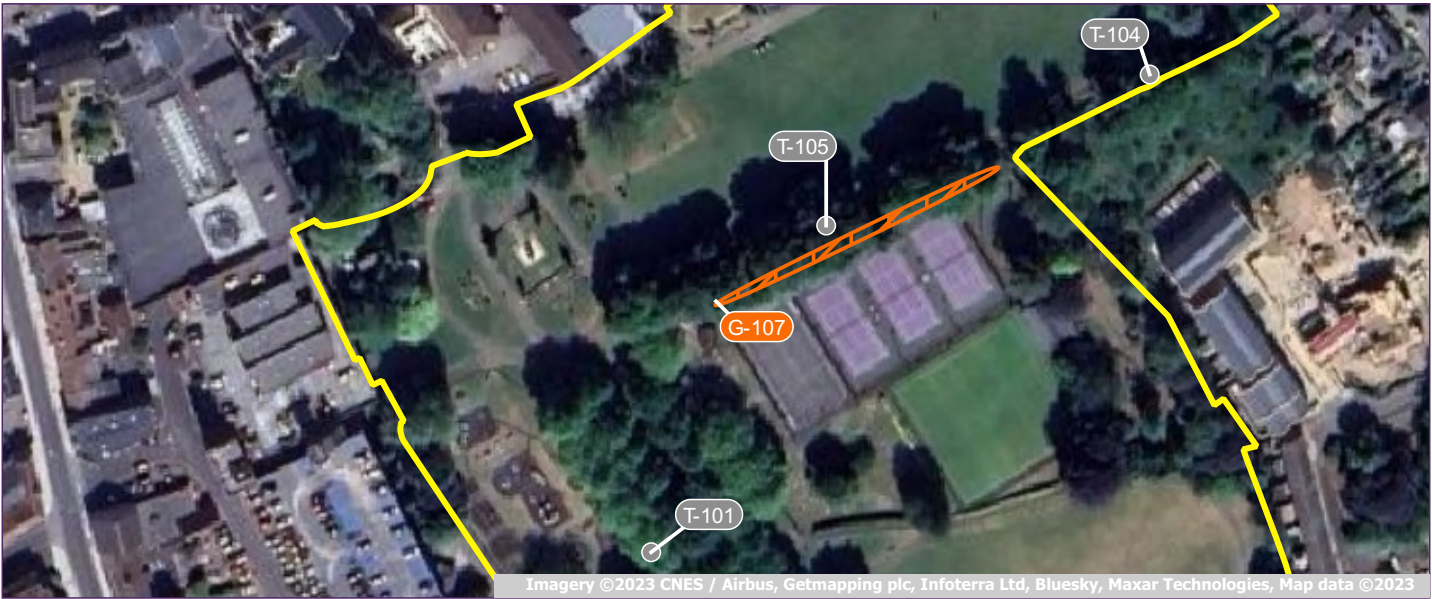
Item	Species	Comments	Recommendations	Price
G-107	Lime	Line of 12 trees, lapsed pollards, poor upper branch structure, overhanging courts	Re-pollard

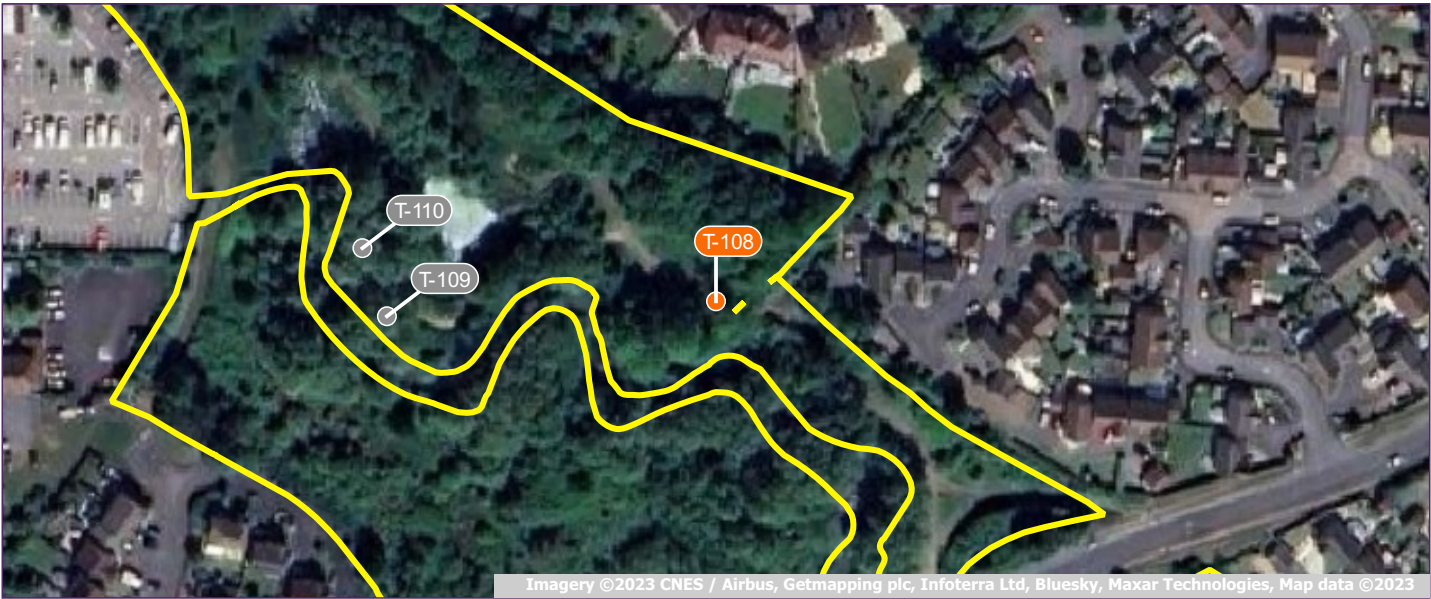
Item	Species	Comments	Recommendations	Price
T-108	Ash	Ash dieback disease (>75% defoliation)	Habitat to 4 m

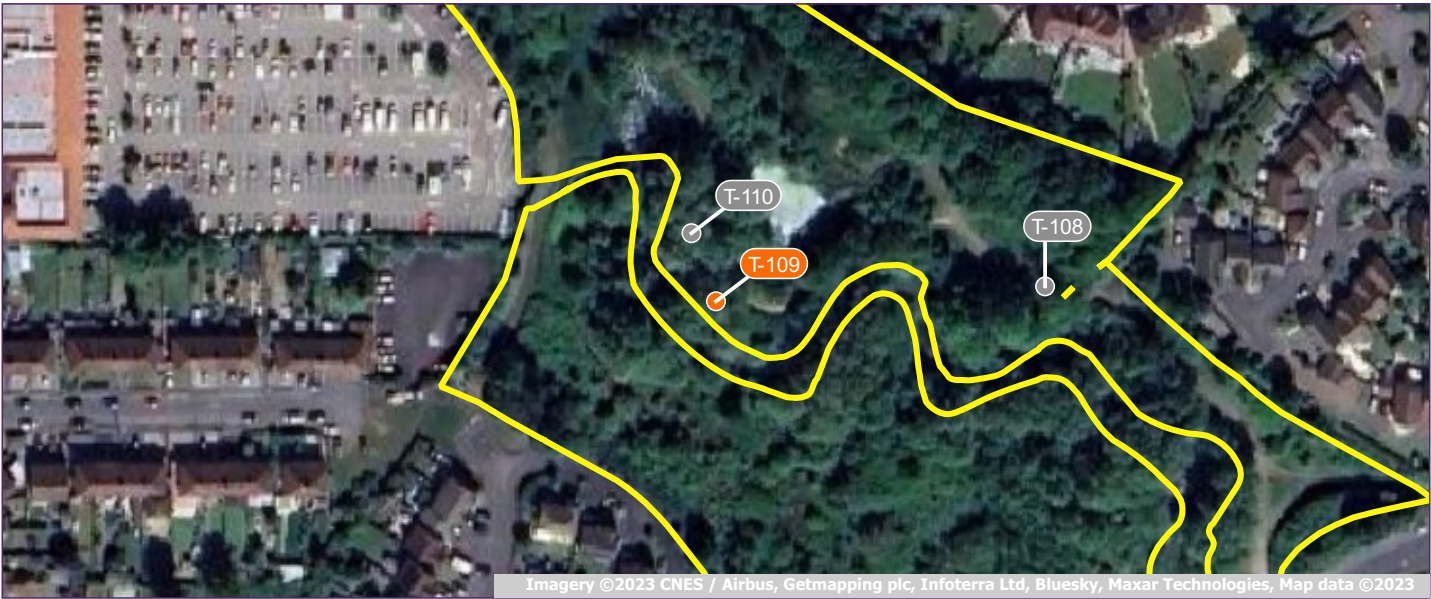
Item	Species	Comments	Recommendations	Price
T-109	Willow	Hazard beam crack through stem over footpath	Reduce defective stem to leave 4 m

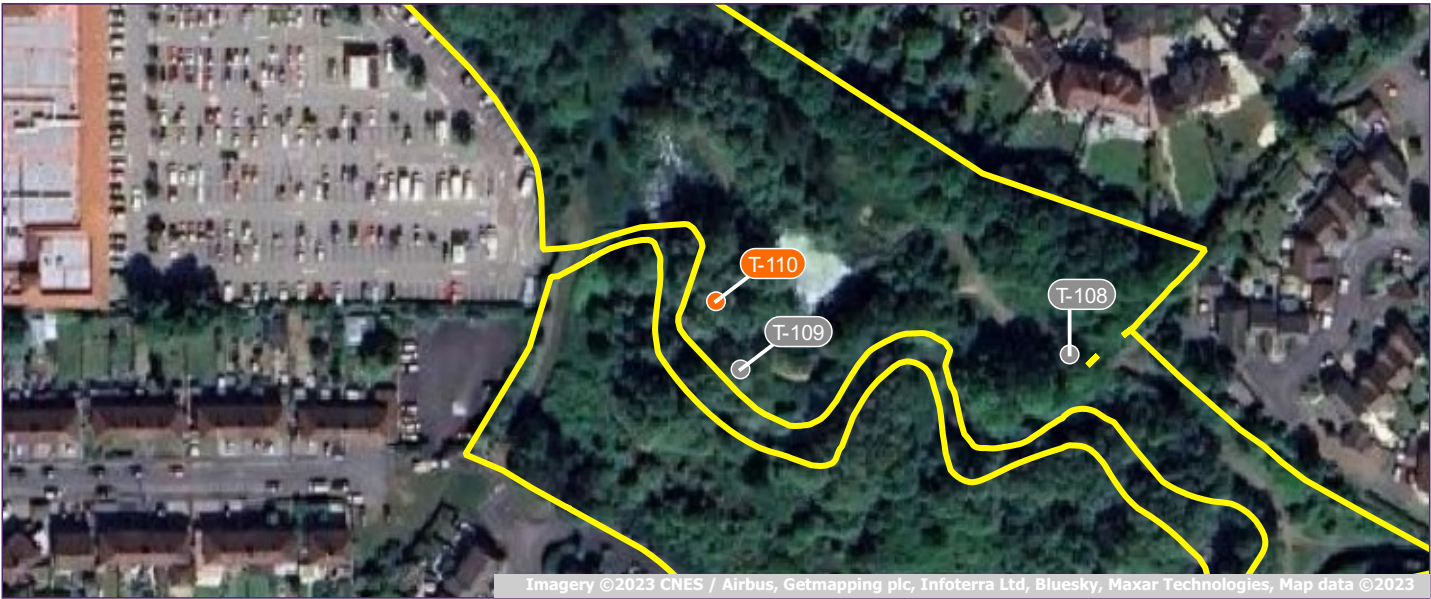
Item	Species	Comments	Recommendations	Price
T-110	Willow	Stem over river cracked at 0.5 m	Reduce stem over river to leave 4 m

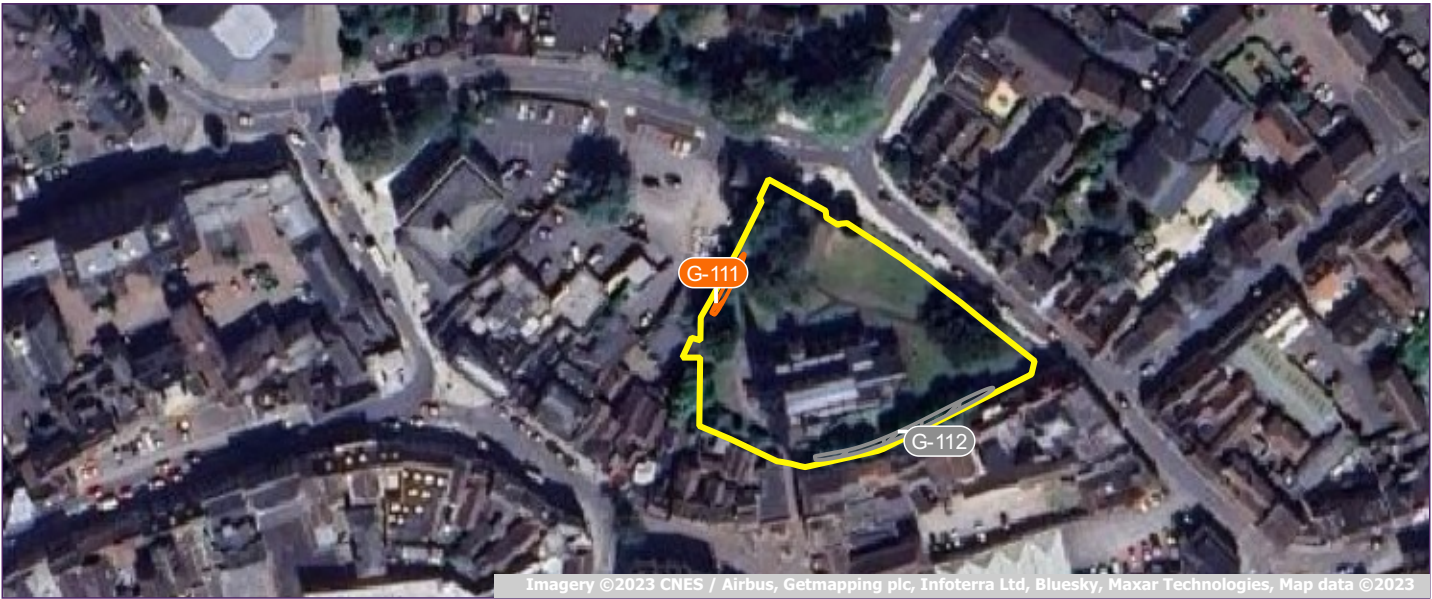
Item	Species	Comments	Recommendations	Price
G-111	Lime	5 no. pollarded trees up against boundary wall. Significant decay through stem of tagged tree.	Pollard 4 trees, fell tagged tree

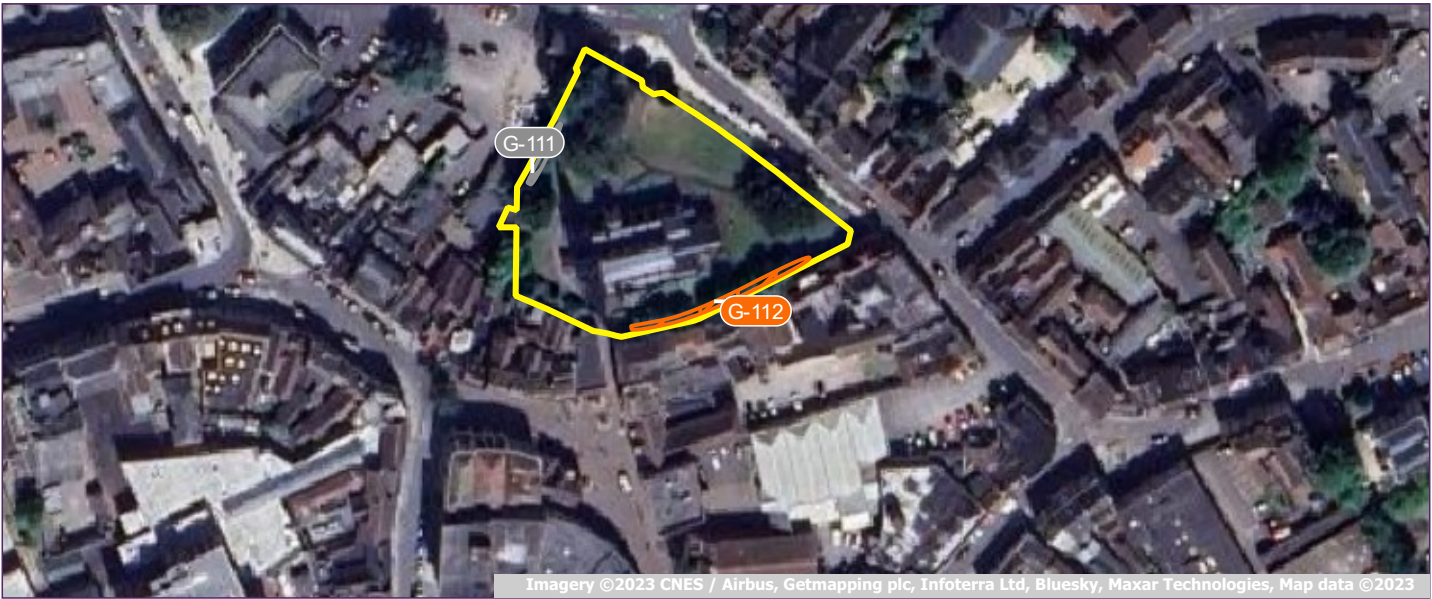
Item	Species	Comments	Recommendations	Price
G-112	Lime, Variegated maple	6 no pollarded trees, significant decay through all trees. Replacements have been initiated, and consideration should be given to replacing all of them.	Re-pollard

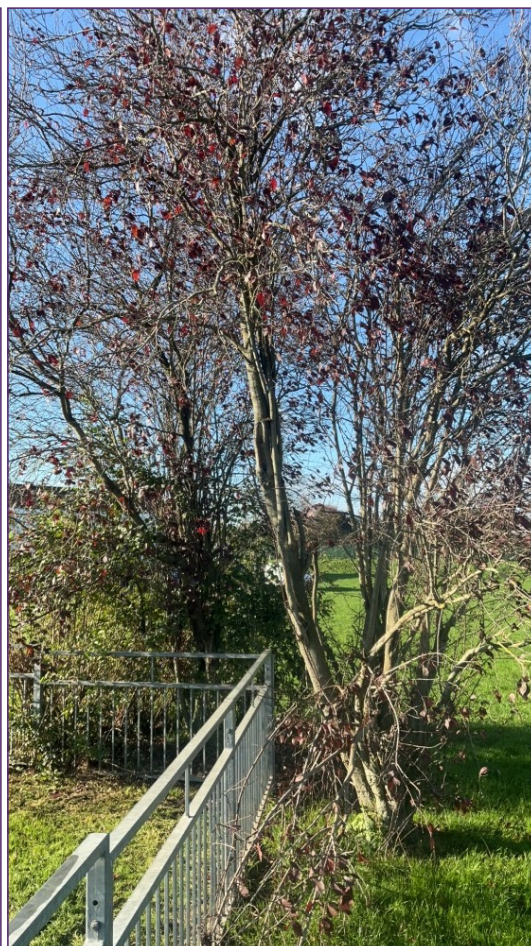
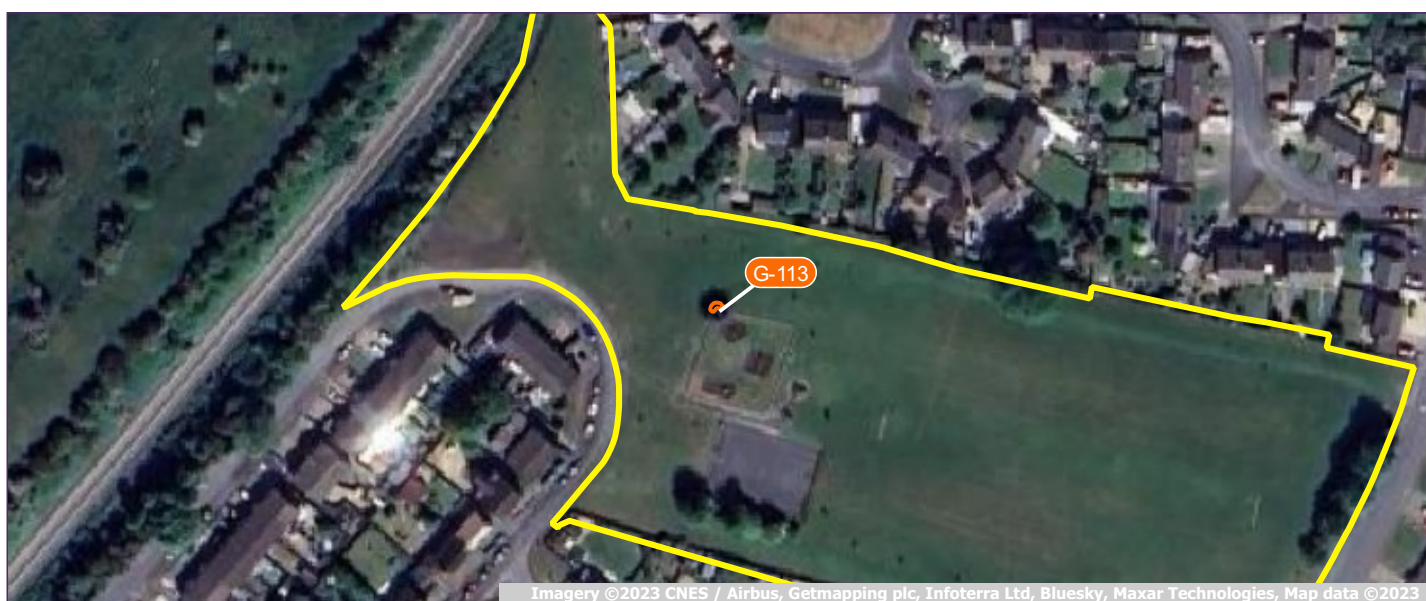
Item	Species	Comments	Recommendations	Price
G-113	Purple plum, hawthorn	Broken limbs over playground boundary	Remove broken limbs

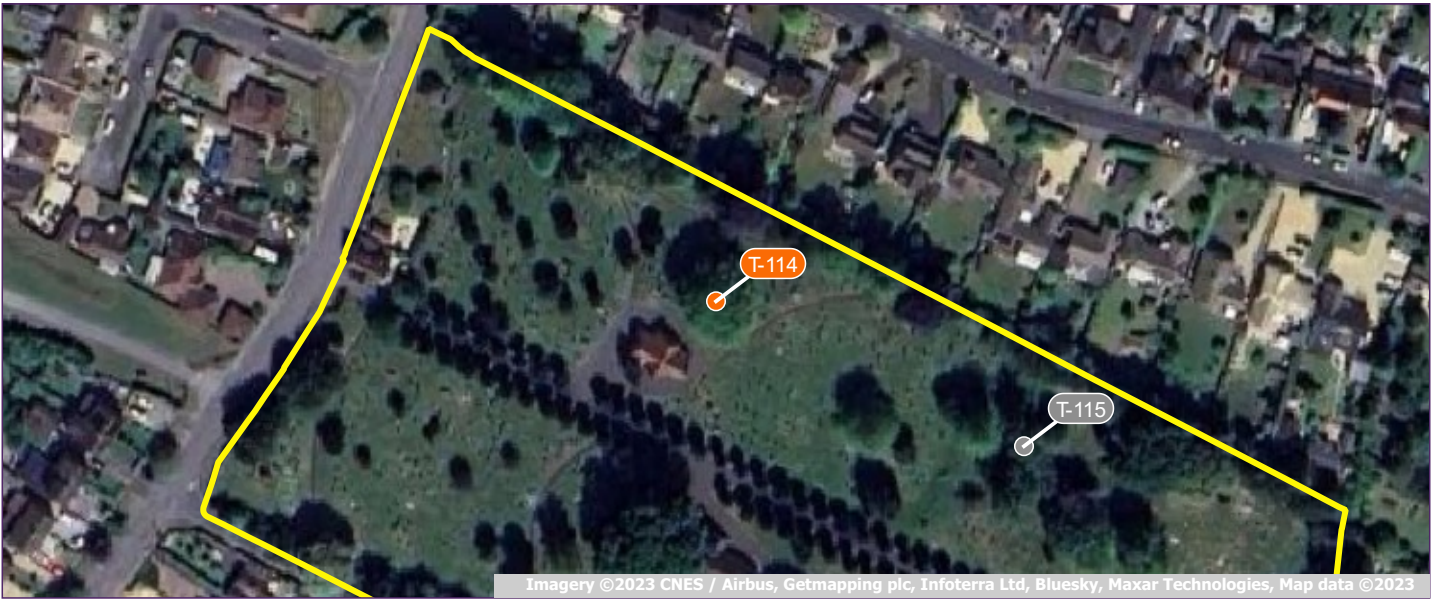
Item	Species	Comments	Recommendations	Price
T-114	Turkey oak	Dead wood (throughout crown)	Stabilise dead wood

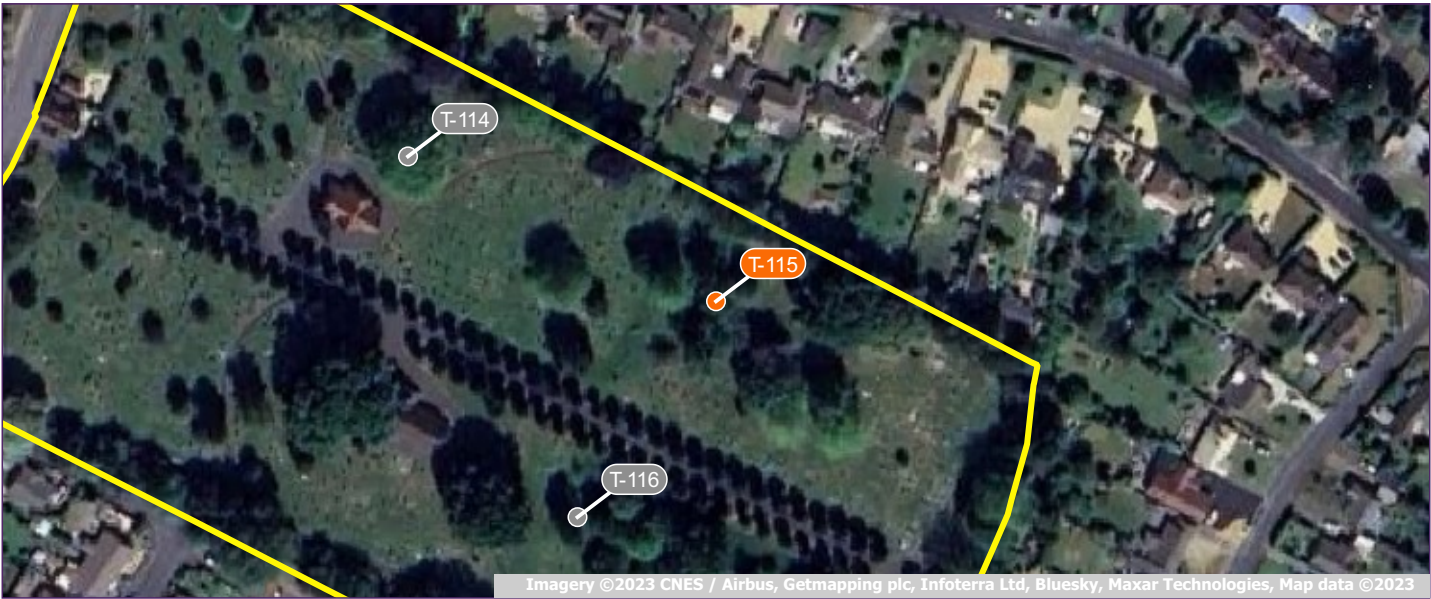
Item	Species	Comments	Recommendations	Price
T-115	Poplar	Storm damage (in upper crown), broken branches	Stabilise deadwood, and remove broken branches

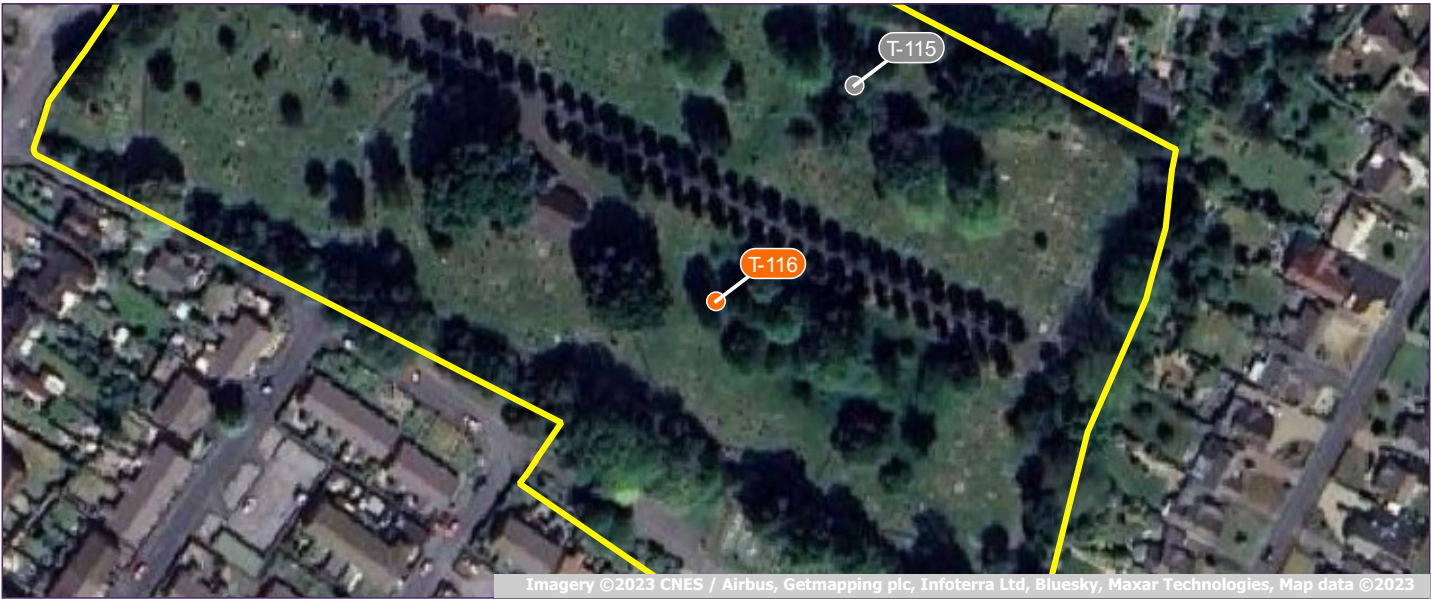
Item	Species	Comments	Recommendations	Price
T-116	Lawson cypress	Storm damage (severe in need of remedial works)	Stabilise vulnerable branches

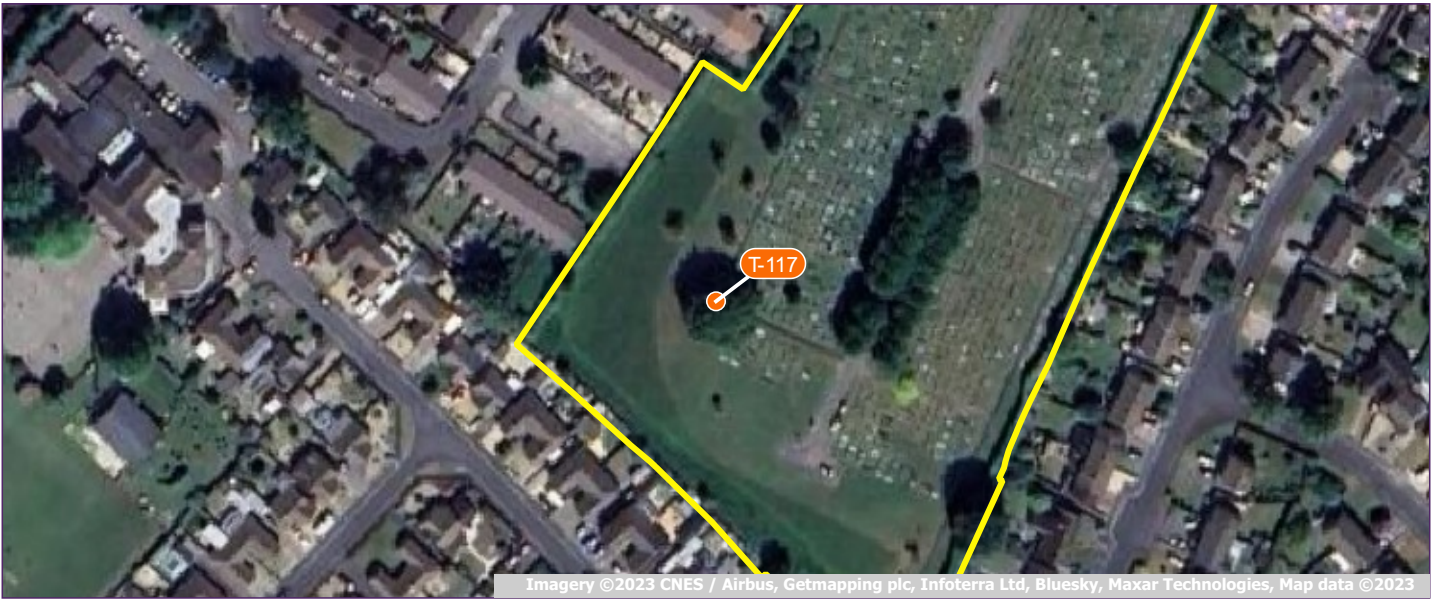
Item	Species	Comments	Recommendations	Price
T-117	Turkey oak	Significant, large and mature fungal brackets present at base. Wide, squat crown, but exposed. Important landscape tree, benches and graves beneath. Retention only possible if tree is fenced off to prevent access beneath. Replacement essential if felled.	Fell

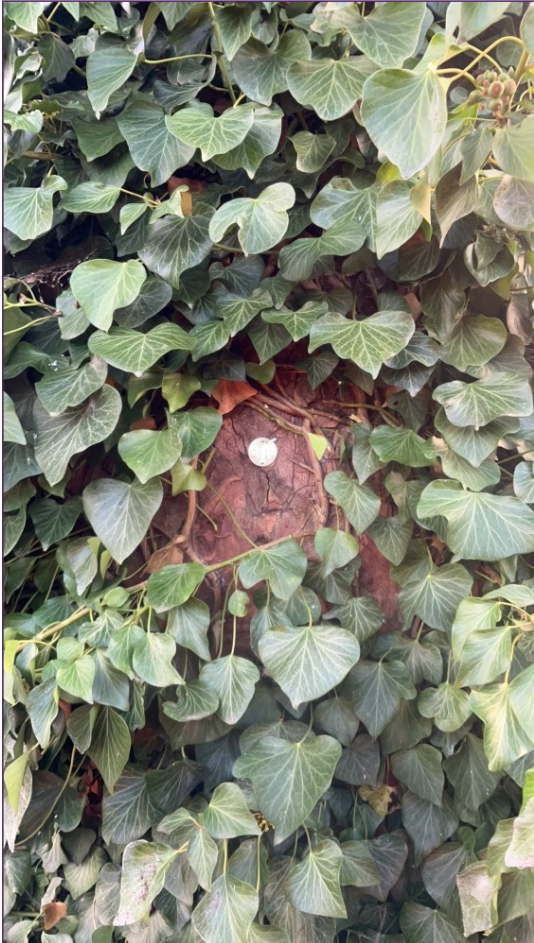
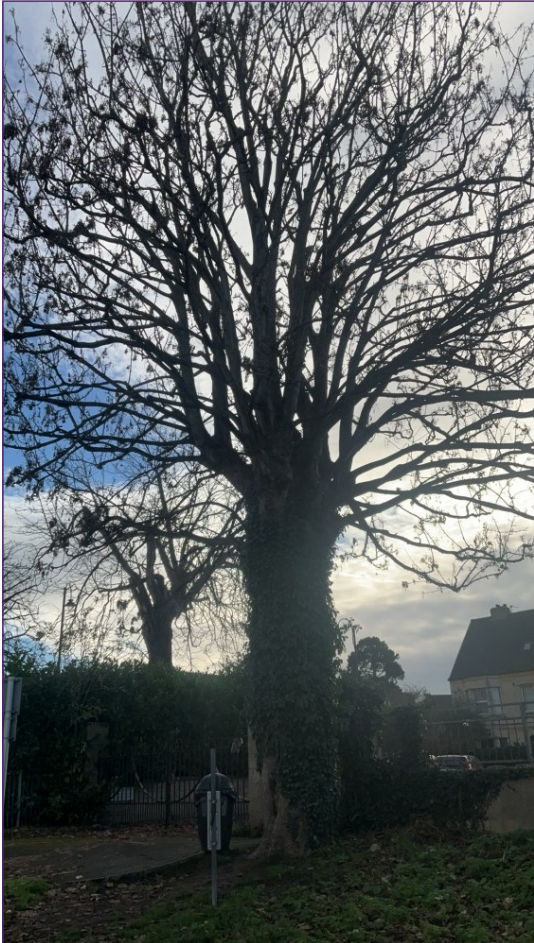
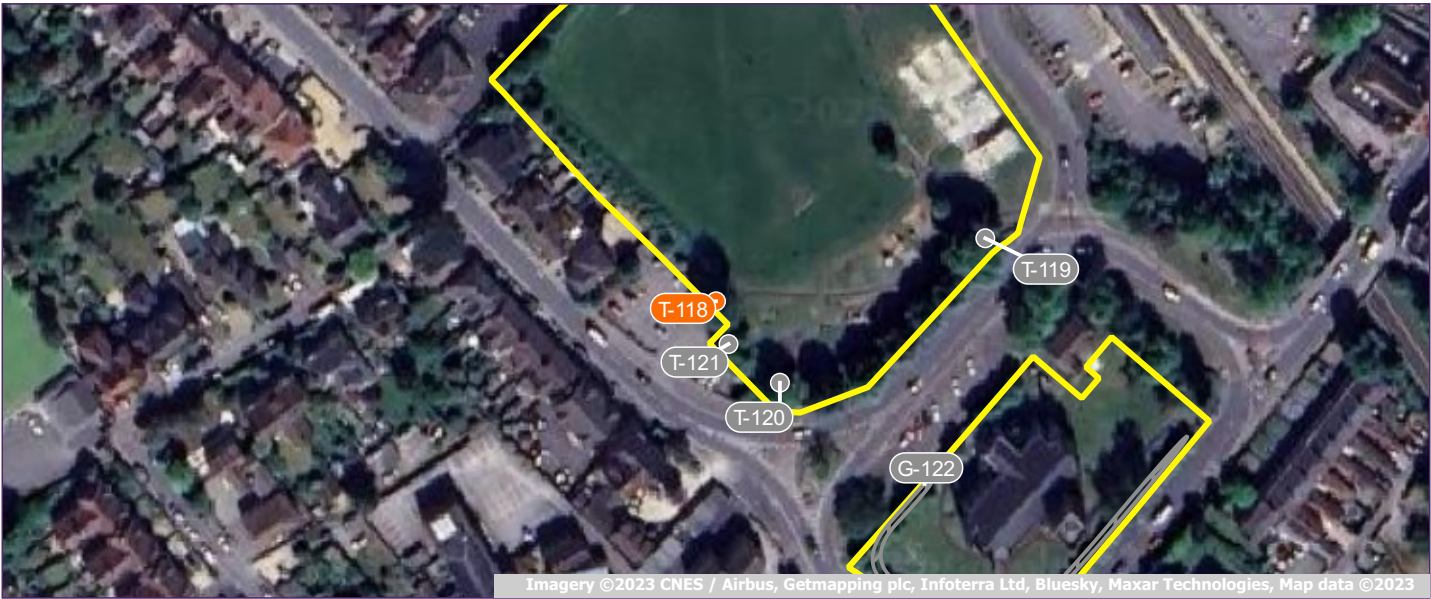
Item	Species	Comments	Recommendations	Price
T-118	Sycamore	Previously pollarded, significant decay through stem, ivy clad	Re-pollard

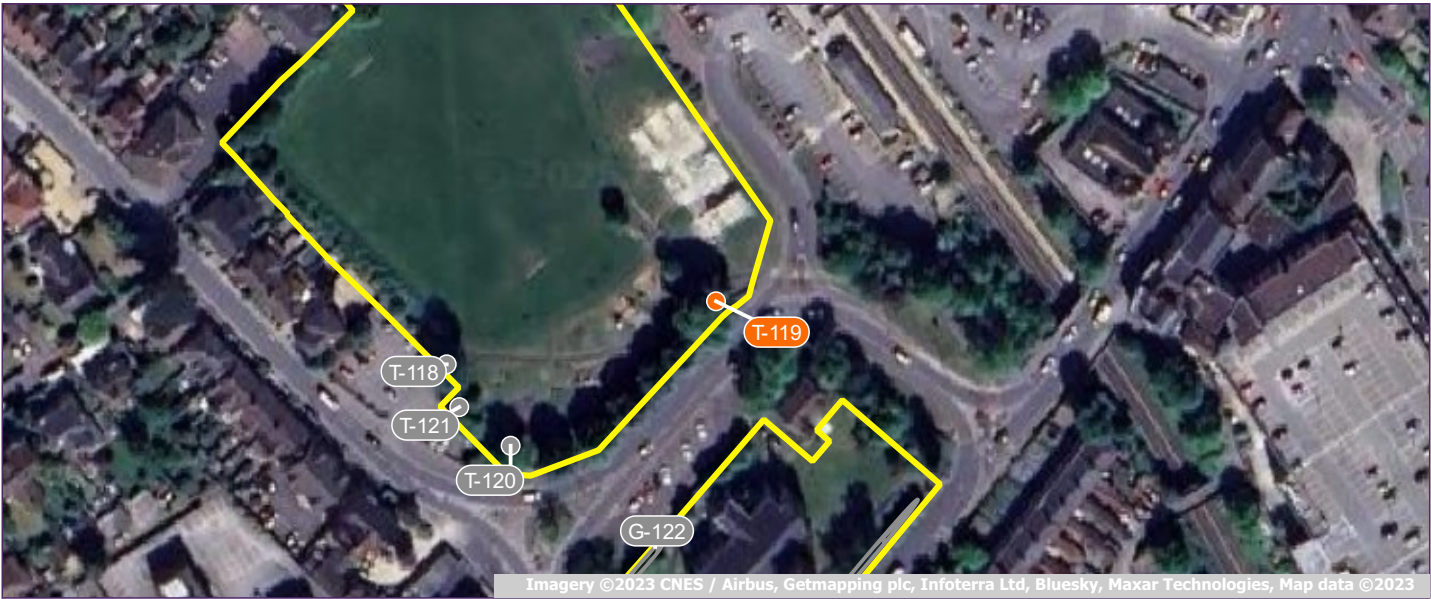
Item	Species	Comments	Recommendations	Price
T-119	Lime	Interference with light column	Prune branches interfering with light column to give a clearance of 2 m

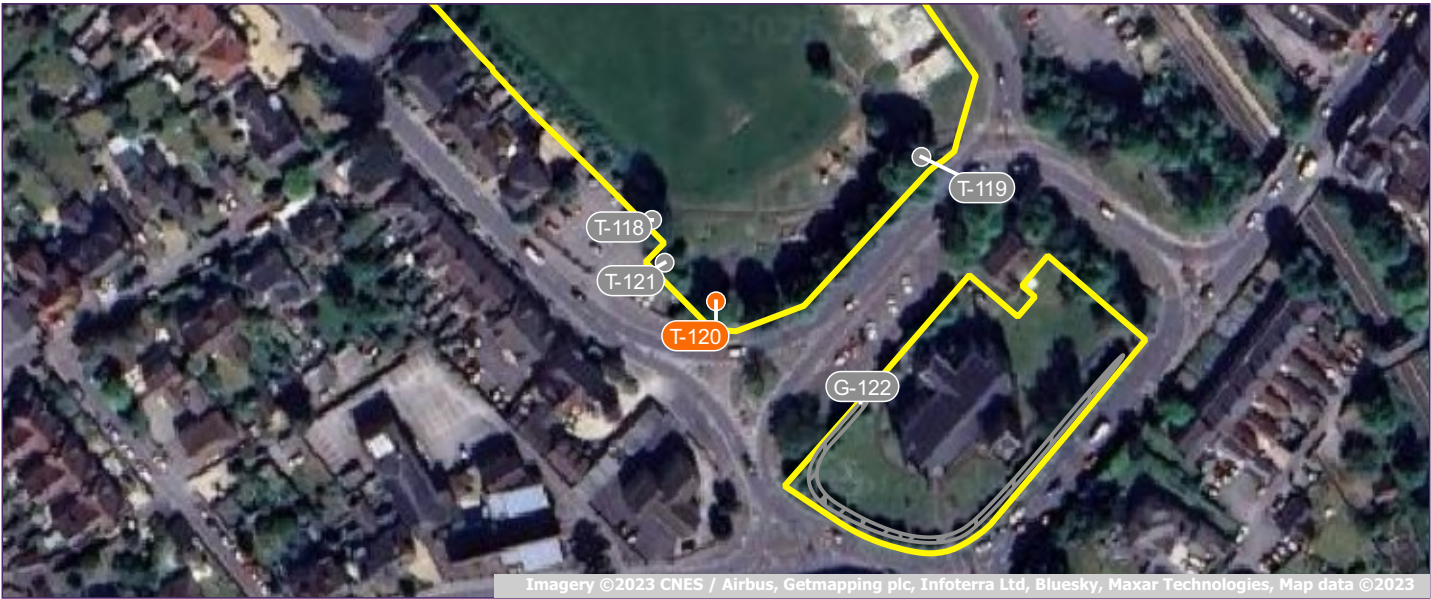
Item	Species	Comments	Recommendations	Price
T-120	Horse chestnut	Decay in trunk at 1 m	Fell

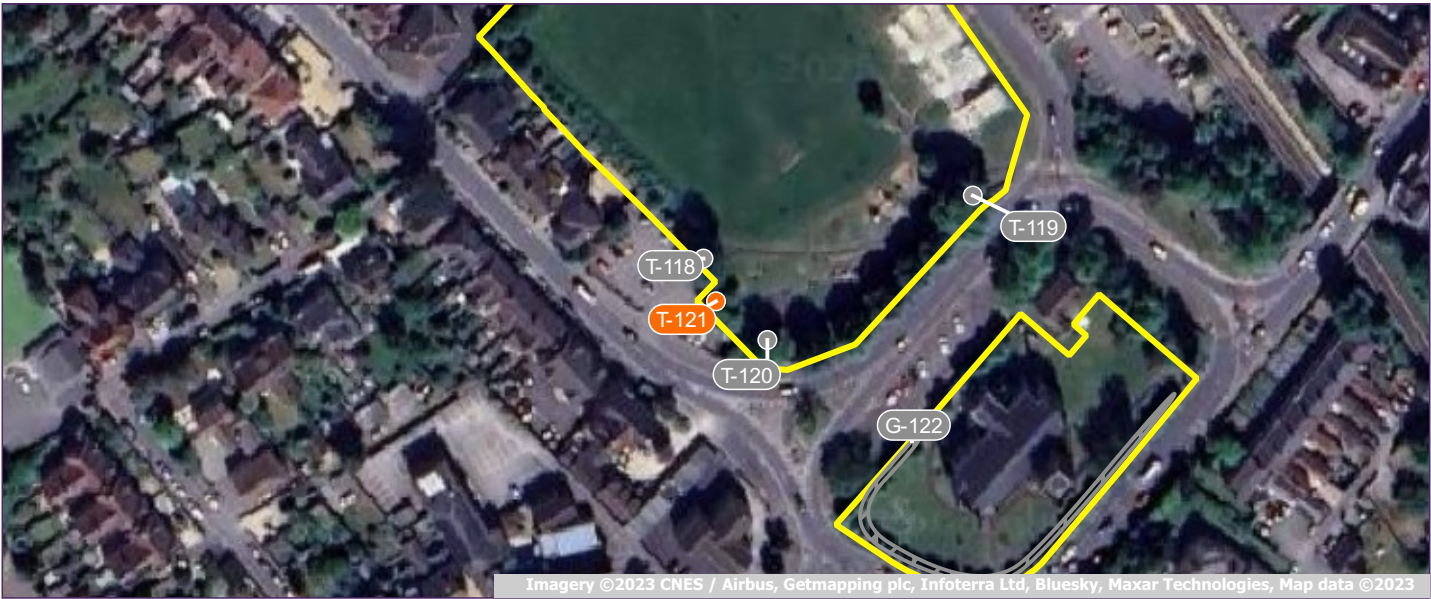
Item	Species	Comments	Recommendations	Price
T-121	Horse chestnut	Failed limbs, significant decay in stem	Fell

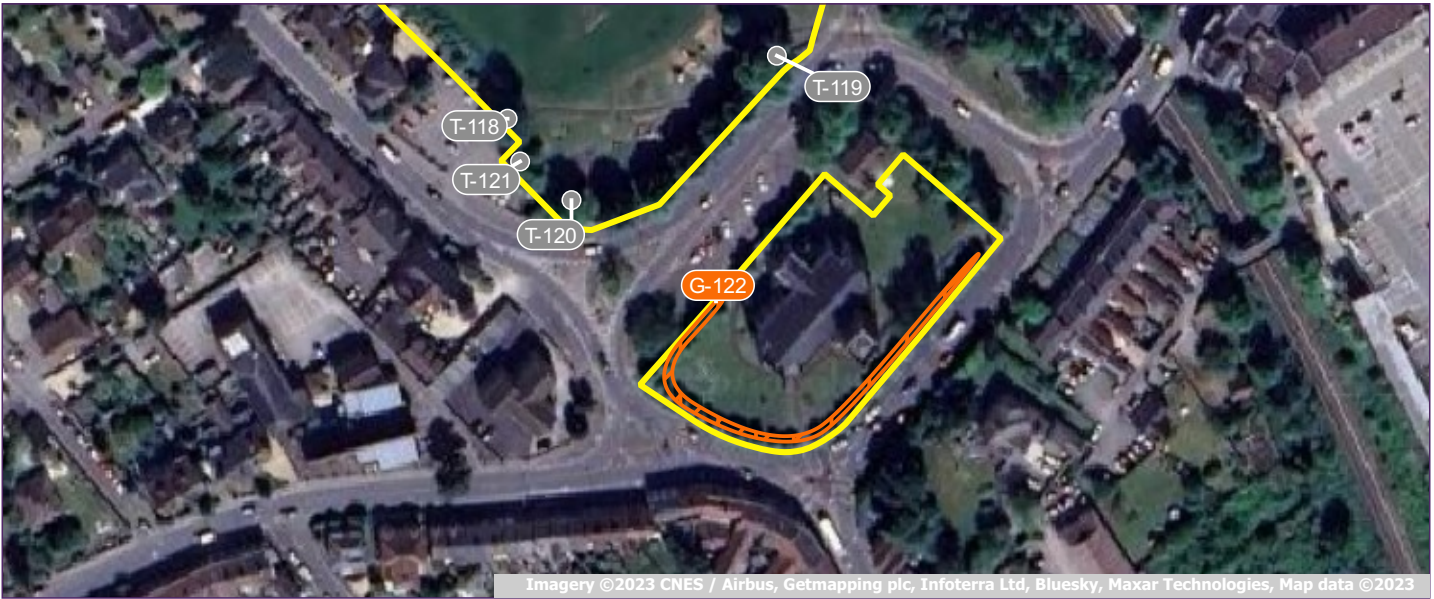
Item	Species	Comments	Recommendations	Price
G-122	Lime	Line of pollarded trees around churchyard.	Re-pollard

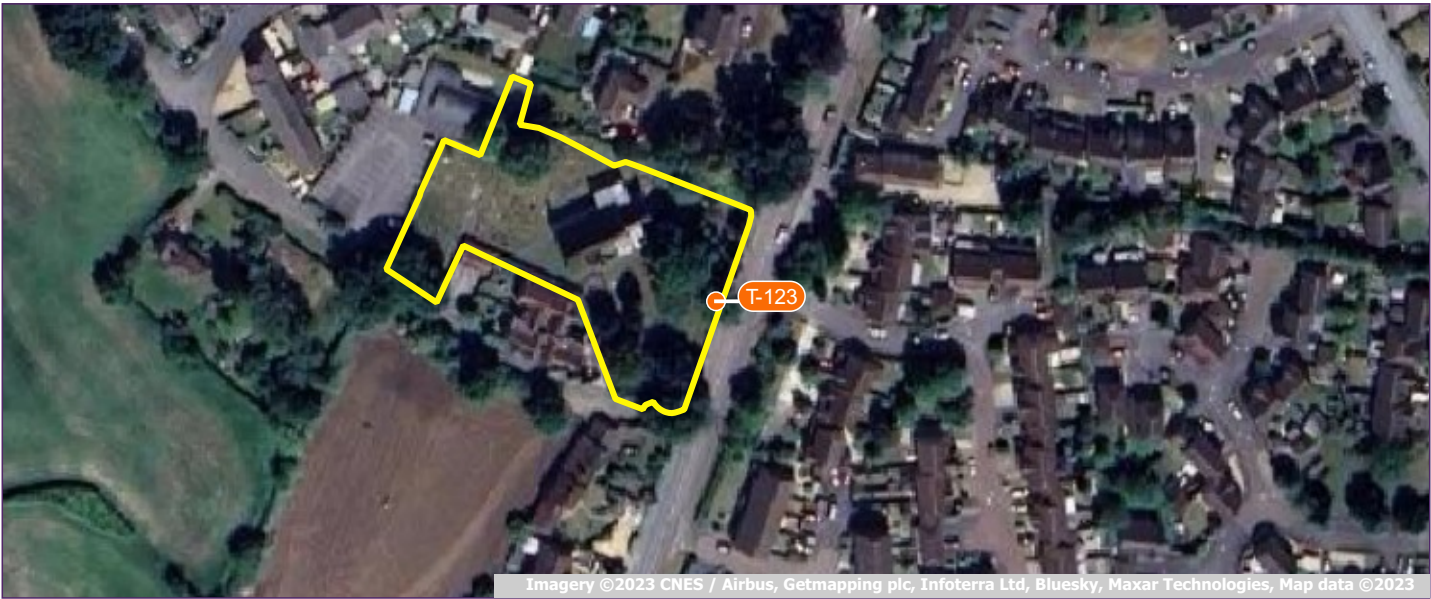
Item	Species	Comments	Recommendations	Price
T-123	Oak	Declining condition, deadwood over road, dieback	Reduce/shape whole tree by 5 m

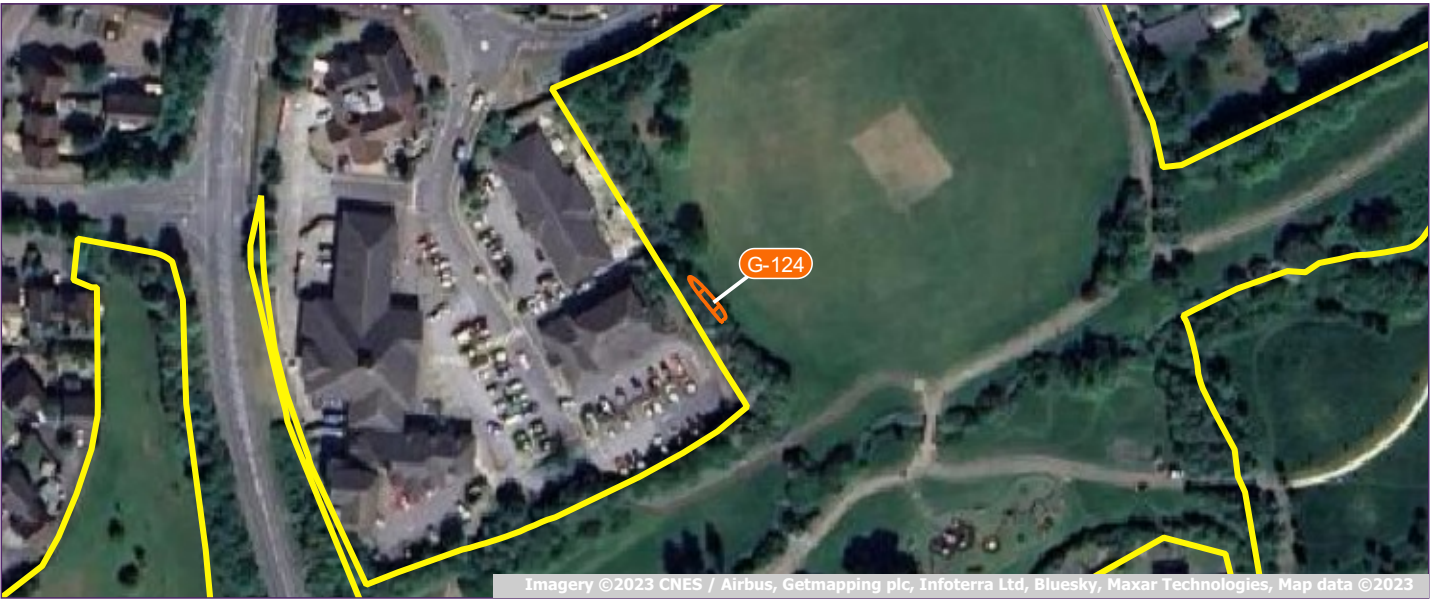
Item	Species	Comments	Recommendations	Price
G-124	Elm	3 dead stems	Fell
