Tree work specification: Trowbridge Town Council sites, Trowbridge, Wiltshire. BA14

Introduction

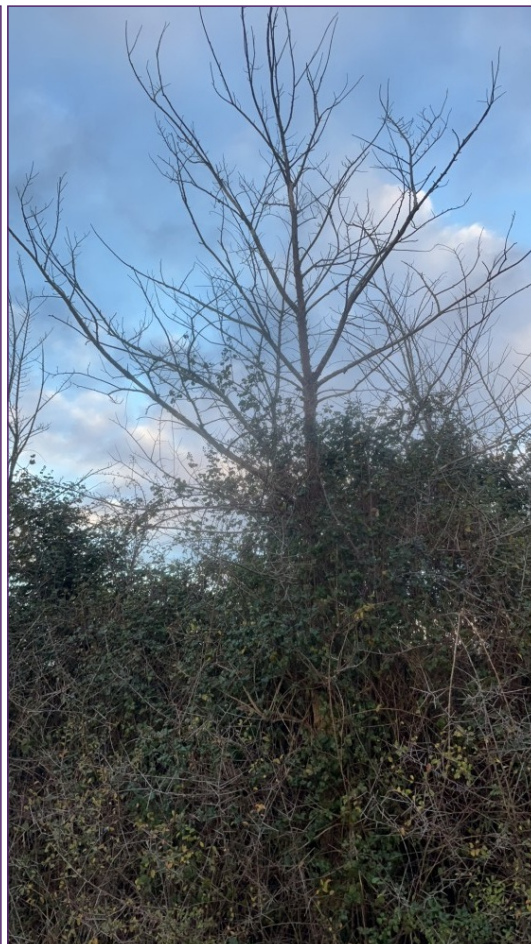
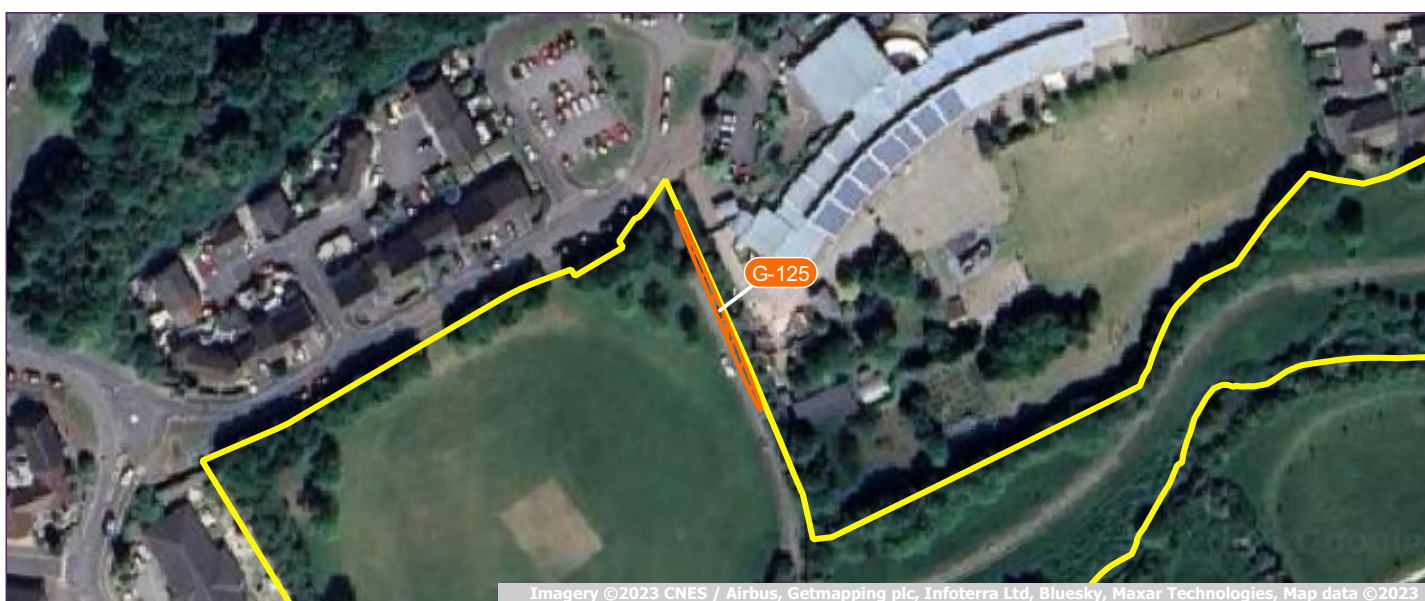
Item	Species	Comments	Recommendations	Price
G-125	Elm	Multiple dead stems	Fell

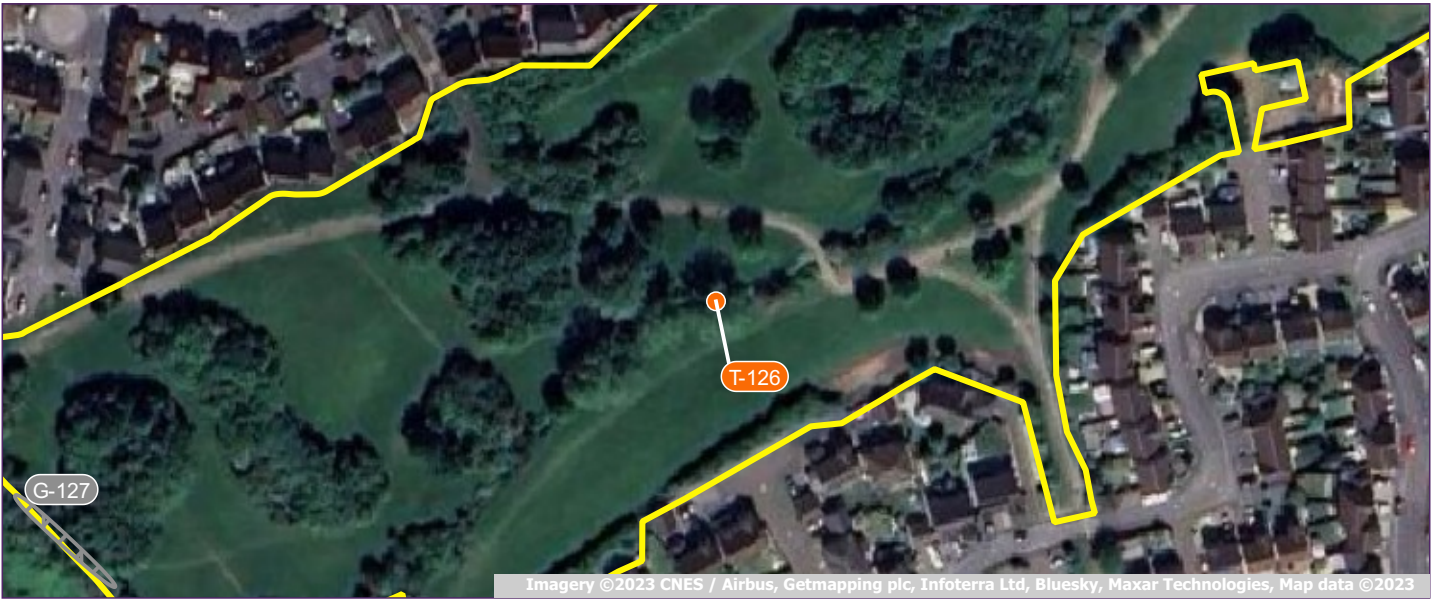
Item	Species	Comments	Recommendations	Price
T-126	Crack willow	Old pollard, several failed limbs, hollow stem	Re-pollard

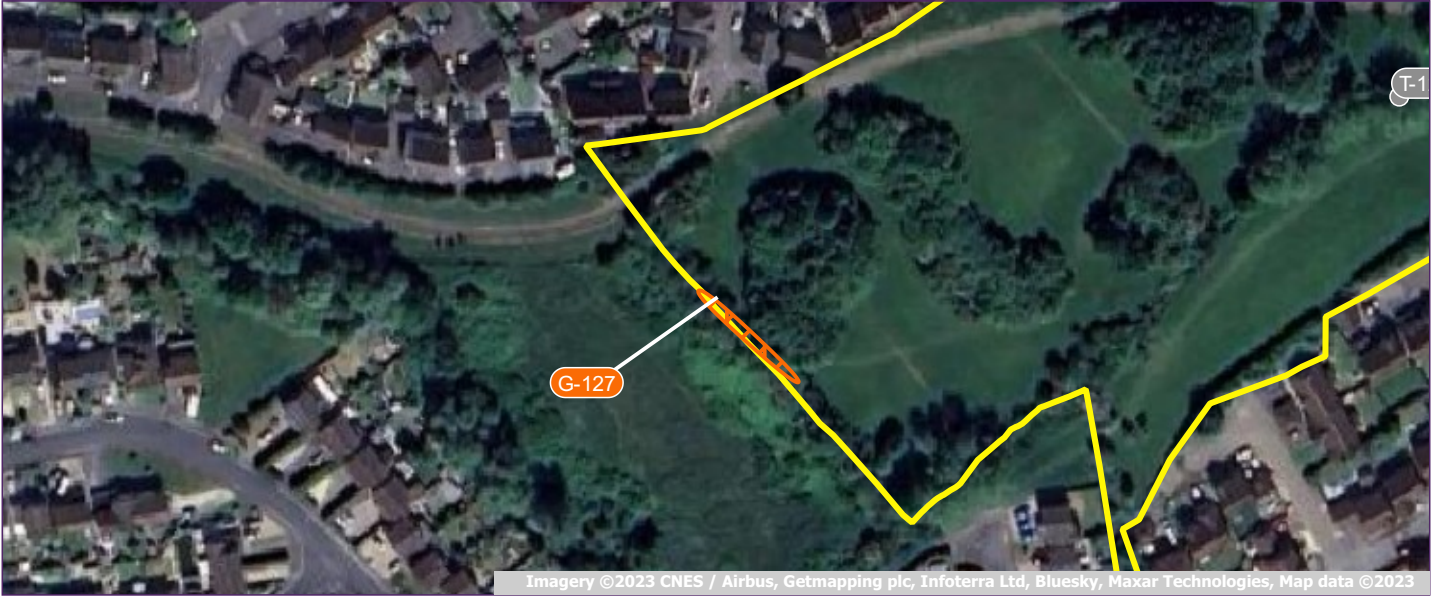
Item	Species	Comments	Recommendations	Price
G-127	Elm	3 dead stems	Habitat to 3 m
