**PRE-CONSTRUCTION  
INFORMATION**

**DEMOLITION &  
CLEARANCE OF  
FORMER ROYAL BRITISH  
LEGION BUILDING**

**MORETON-IN-MARSH**

**GREAT WESTERN  
RAILWAY &  
MORETON-IN-MARSH  
TOWN COUNCIL**

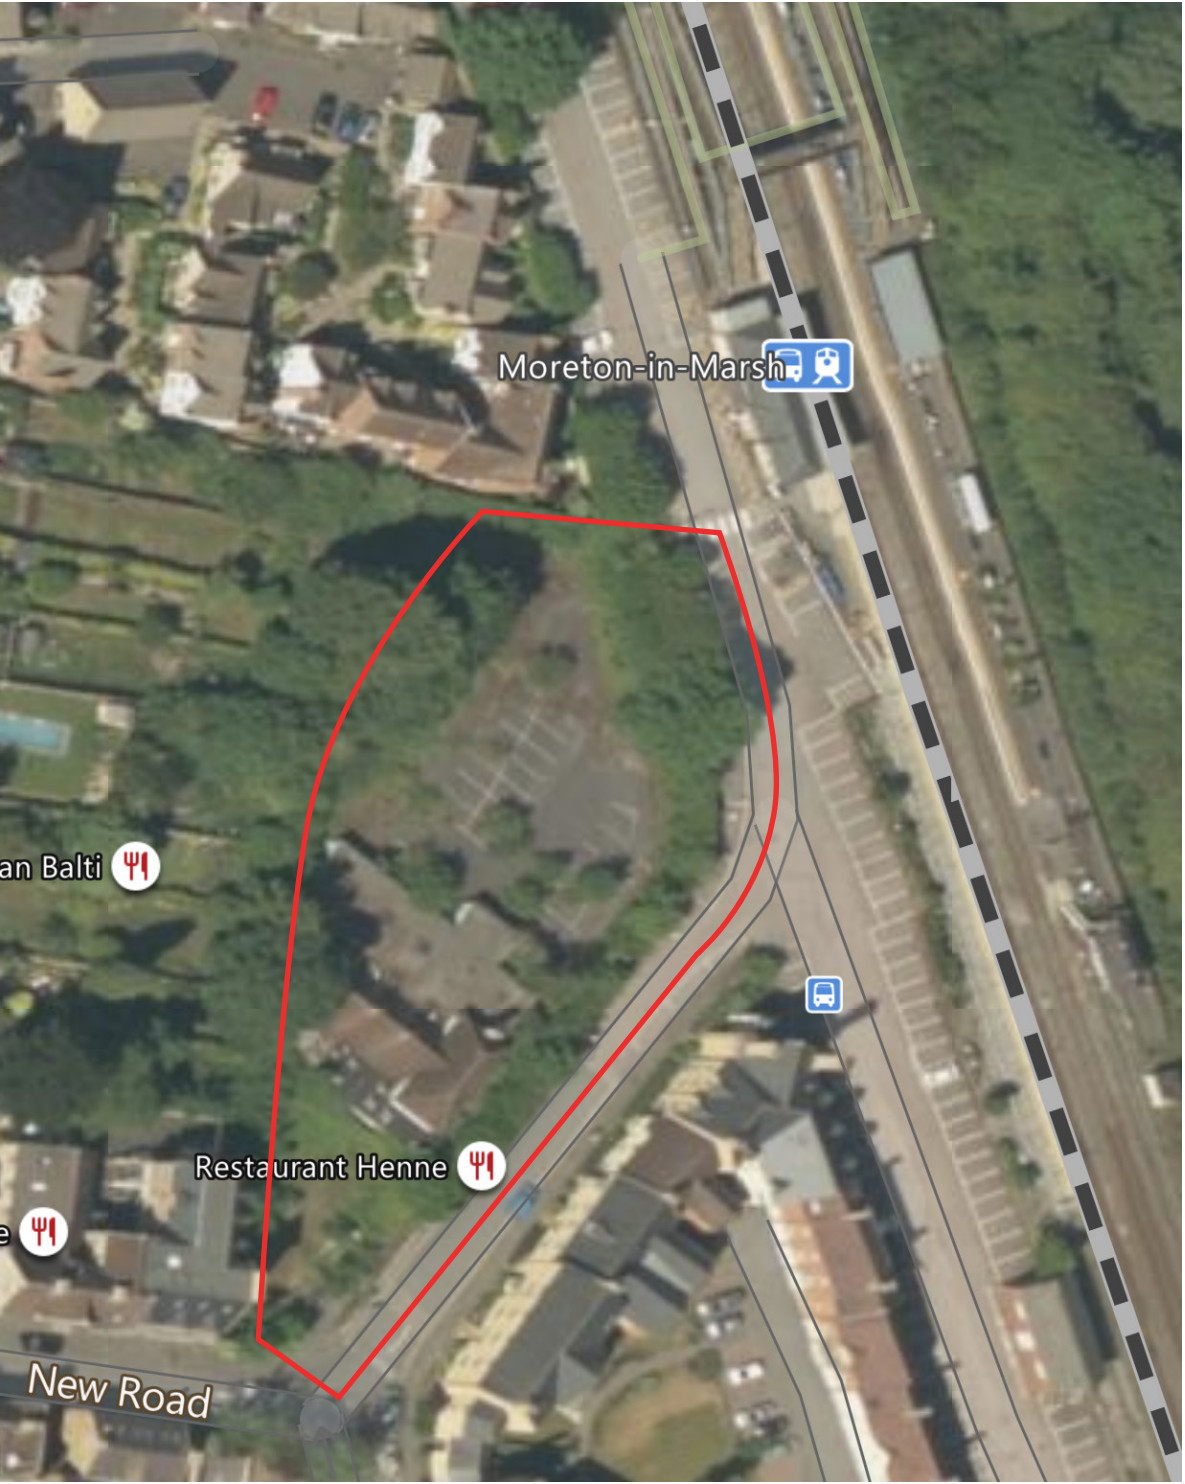
Site compound and welfare

Site access via  
secured gate

Due to the restricted opening sizes of the gates and limited compound area, it may not be possible to utilise large lockable steel containers on site. Smaller lockable containers should be provided for valuable or potentially hazardous materials for both the Principal Contractor and other Contractors use. Clients to agree positions if it is necessary to have these outside of the compound, or alternative off-site storage locations. See indicative Contractors Compound drawing in Appendix C.

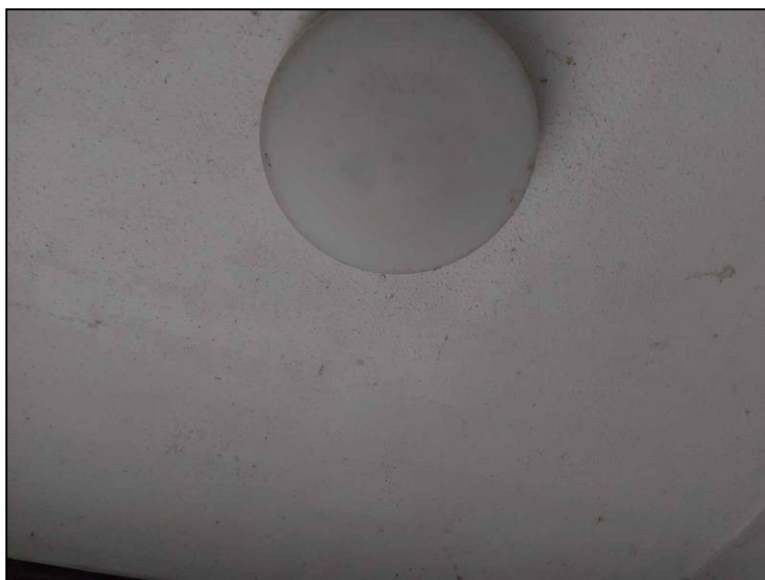
<b>Client:</b>	Great Western Railway	<b>Area No:</b>	001
		<b>Floor:</b>	Ground
<b>Site Address:</b>	Ex-Royal British Legion Building, New Road, Moreton-in-Marsh, Gloucestershire, GL56 0AS	<b>Area Description:</b>	Entrance
<b>Building:</b>	.	<b>Material Description:</b>	Textured coating to ceiling
<b>Building Address:</b>	As Above	<b>Survey Report Reference:</b>	234636-987722-0001

<b>Sample Reference No:</b>	001
<b>Asbestos Type:</b>	0 - No asbestos detected	<b>Position:</b>	Internal
<b>Product Type:</b>		<b>Approx Size of Item:</b>	4 m <sup>2</sup>
<b>Comments:</b>

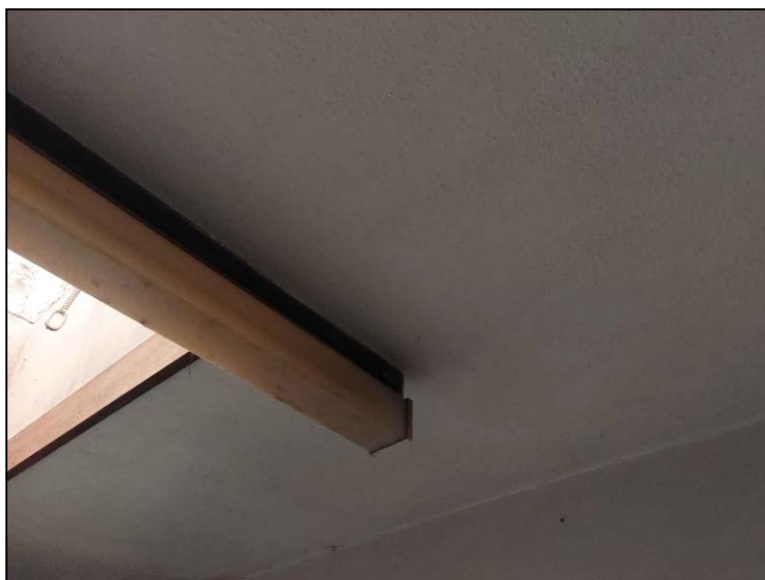
<b>Client:</b>	Great Western Railway	<b>Area No:</b>	002
		<b>Floor:</b>	Ground
<b>Site Address:</b>	Ex-Royal British Legion Building, New Road, Moreton-in-Marsh, Gloucestershire, GL56 0AS	<b>Area Description:</b>	Lobby
<b>Building:</b>	.	<b>Material Description:</b>	Textured coating to ceiling
<b>Building Address:</b>	As Above	<b>Survey Report Reference:</b>	234636-987722-0001

<b>Sample Reference No:</b>	002
<b>Asbestos Type:</b>	1 - Chrysotile	<b>Position:</b>	Internal
<b>Product Type:</b>	1 - Asbestos composites, decorative finishes, AC	<b>Approx Size of Item:</b>	18 m <sup>2</sup>
<b>Comments:</b>	located to ceiling in lobby and stairwell

Sample Reference	Building	Area Description	Material	Action	Timescale for Action
AWS - 002	0001	Ground Floor - 001-Entrance	Textured coating to ceiling	Remove	Prior to Refurbishment
002	0001	Ground Floor - 002-Lobby	Textured coating to ceiling	Remove	Prior to Refurbishment
003	0001	Ground Floor - 003-Phone room	Textured coating to ceiling	Remove	Prior to Refurbishment
004	0001	Ground Floor - 004-Circulation	Textured coating to ceiling	Remove	Prior to Refurbishment
005	0001	Ground Floor - 004-Circulation	Textured coating patch replacement to ceiling	Remove	Prior to Refurbishment
AWS - 008	0001	Ground Floor - 005-Male WC	Textured coating to ceiling	Remove	Prior to Refurbishment
008	0001	Ground Floor - 006-Female WC	Textured coating to ceiling	Remove	Prior to Refurbishment
013	0001	Ground Floor - 008-Stage	Insulating board ceiling panels	Remove	Prior to Refurbishment
015	0001	Ground Floor - 009-Back Stage	Textured coating to ceiling	Remove	Prior to Refurbishment

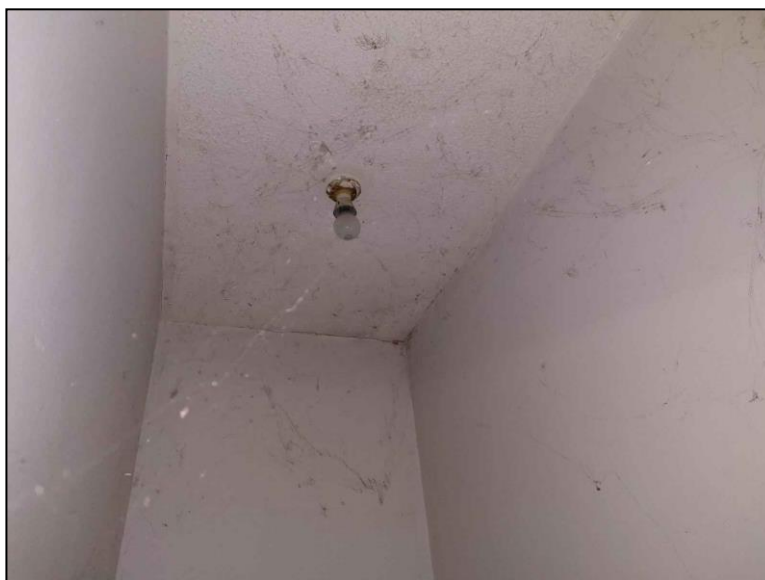
<b>Client:</b>	Great Western Railway	<b>Area No:</b>	003
		<b>Floor:</b>	Ground
<b>Site Address:</b>	Ex-Royal British Legion Building, New Road, Moreton-in-Marsh, Gloucestershire, GL56 0AS	<b>Area Description:</b>	Phone room
<b>Building:</b>	.	<b>Material Description:</b>	Textured coating to ceiling
<b>Building Address:</b>	As Above	<b>Survey Report Reference:</b>	234636-987722-0001

<b>Sample Reference No:</b>	003
<b>Asbestos Type:</b>	1 - Chrysotile	<b>Position:</b>	Internal
<b>Product Type:</b>	1 - Asbestos composites, decorative finishes, AC	<b>Approx Size of Item:</b>	2 m <sup>2</sup>
<b>Comments:</b>

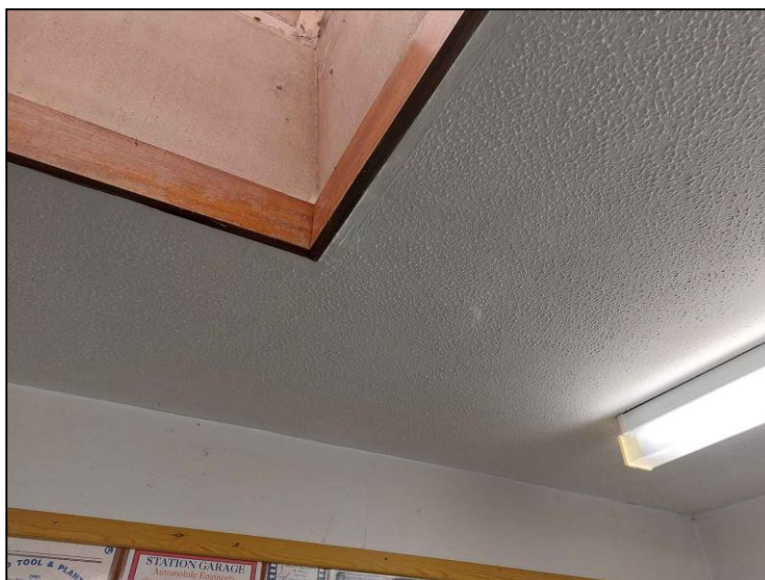
<b>Client:</b>	Great Western Railway	<b>Area No:</b>	004
		<b>Floor:</b>	Ground
<b>Site Address:</b>	Ex-Royal British Legion Building, New Road, Moreton-in-Marsh, Gloucestershire, GL56 0AS	<b>Area Description:</b>	Circulation
<b>Building:</b>	.	<b>Material Description:</b>	Textured coating to ceiling
<b>Building Address:</b>	As Above	<b>Survey Report Reference:</b>	234636-987722-0001

<b>Sample Reference No:</b>	004
<b>Asbestos Type:</b>	1 - Chrysotile	<b>Position:</b>	Internal
<b>Product Type:</b>	1 - Asbestos composites, decorative finishes, AC	<b>Approx Size of Item:</b>	18 m <sup>2</sup>
<b>Comments:</b>

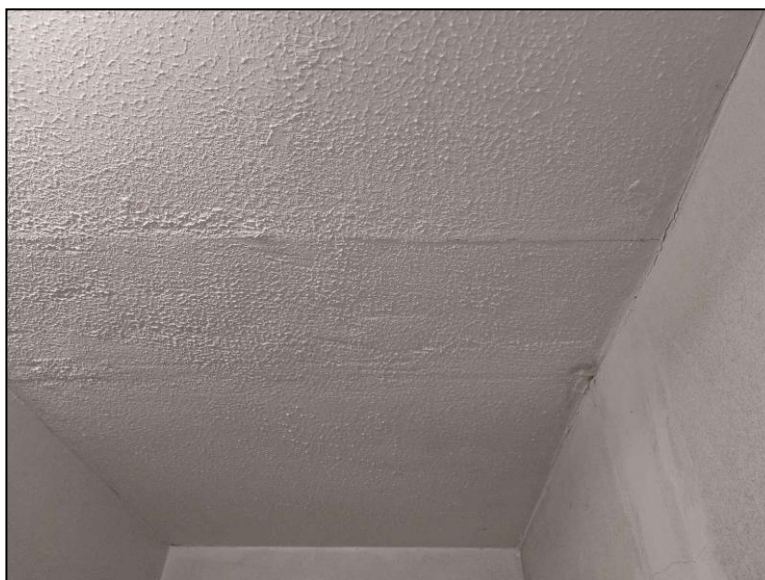
<b>Client:</b>	Great Western Railway	<b>Area No:</b>	004
		<b>Floor:</b>	Ground
<b>Site Address:</b>	Ex-Royal British Legion Building, New Road, Moreton-in-Marsh, Gloucestershire, GL56 0AS	<b>Area Description:</b>	Circulation
<b>Building:</b>	.	<b>Material Description:</b>	Textured coating patch replacement to ceiling
<b>Building Address:</b>	As Above	<b>Survey Report Reference:</b>	234636-987722-0001

<b>Sample Reference No:</b>	005
<b>Asbestos Type:</b>	1 - Chrysotile	<b>Position:</b>	Internal
<b>Product Type:</b>	1 - Asbestos composites, decorative finishes, AC	<b>Approx Size of Item:</b>	2 m <sup>2</sup>
<b>Comments:</b>	Patch replacement located near the female WC

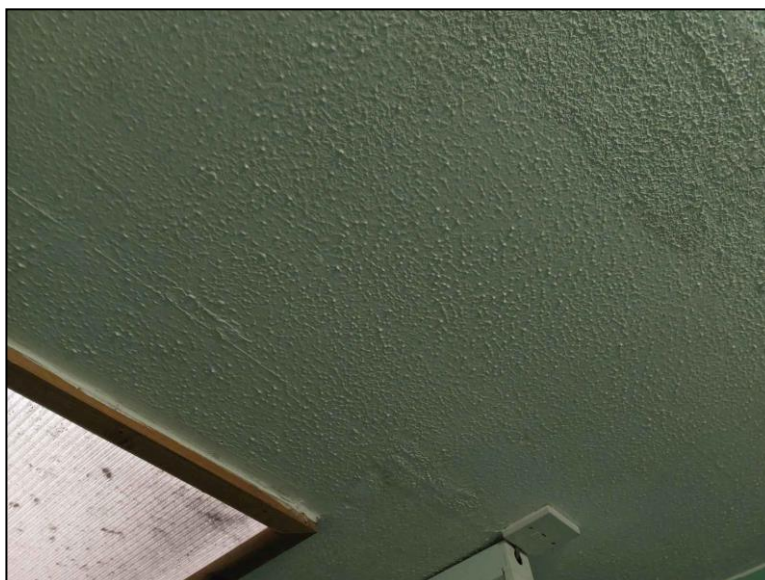
<b>Client:</b>	Great Western Railway	<b>Area No:</b>	005
		<b>Floor:</b>	Ground
<b>Site Address:</b>	Ex-Royal British Legion Building, New Road, Moreton-in-Marsh, Gloucestershire, GL56 0AS	<b>Area Description:</b>	Male WC
<b>Building:</b>	.	<b>Material Description:</b>	Textured coating to ceiling
<b>Building Address:</b>	As Above	<b>Survey Report Reference:</b>	234636-987722-0001

Sample Reference No:	006	
Asbestos Type:	0 - No asbestos detected	Position:	Internal
Product Type:		Approx Size of Item:	12 m <sup>2</sup>
Comments:

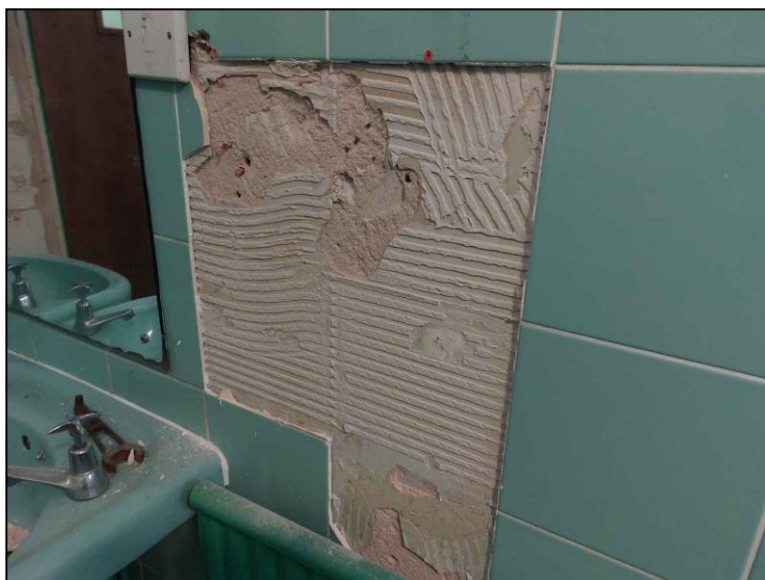
<b>Client:</b>	Great Western Railway	<b>Area No:</b>	005
		<b>Floor:</b>	Ground
<b>Site Address:</b>	Ex-Royal British Legion Building, New Road, Moreton-in-Marsh, Gloucestershire, GL56 0AS	<b>Area Description:</b>	Male WC
<b>Building:</b>	.	<b>Material Description:</b>	Ceramic tile adhesive
<b>Building Address:</b>	As Above	<b>Survey Report Reference:</b>	234636-987722-0001

Sample Reference No:	007	
Asbestos Type:	0 - No asbestos detected	Position:	Internal
Product Type:		Approx Size of Item:	30 m <sup>2</sup>
Comments:	located to walls

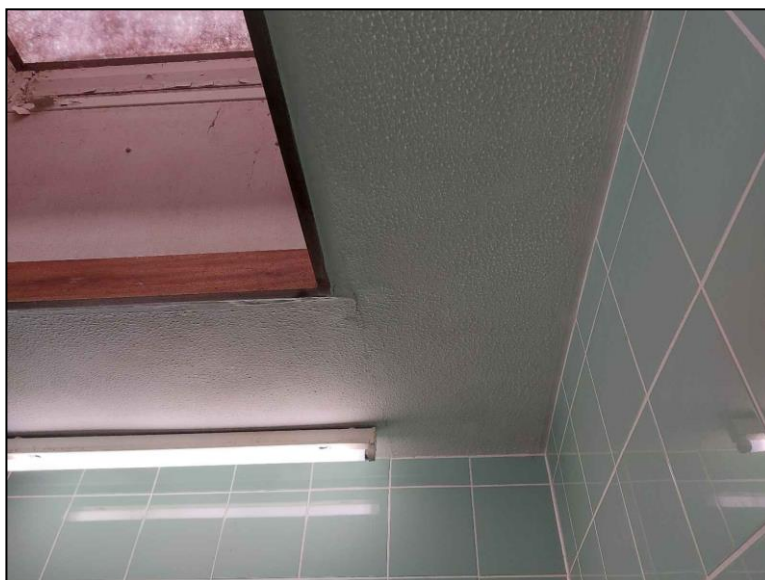
<b>Client:</b>	Great Western Railway	<b>Area No:</b>	006
		<b>Floor:</b>	Ground
<b>Site Address:</b>	Ex-Royal British Legion Building, New Road, Moreton-in-Marsh, Gloucestershire, GL56 0AS	<b>Area Description:</b>	Female WC
<b>Building:</b>	.	<b>Material Description:</b>	Textured coating to ceiling
<b>Building Address:</b>	As Above	<b>Survey Report Reference:</b>	234636-987722-0001

<b>Sample Reference No:</b>	008
<b>Asbestos Type:</b>	1 - Chrysotile	<b>Position:</b>	Internal
<b>Product Type:</b>	1 - Asbestos composites, decorative finishes, AC	<b>Approx Size of Item:</b>	12 m <sup>2</sup>
<b>Comments:</b>

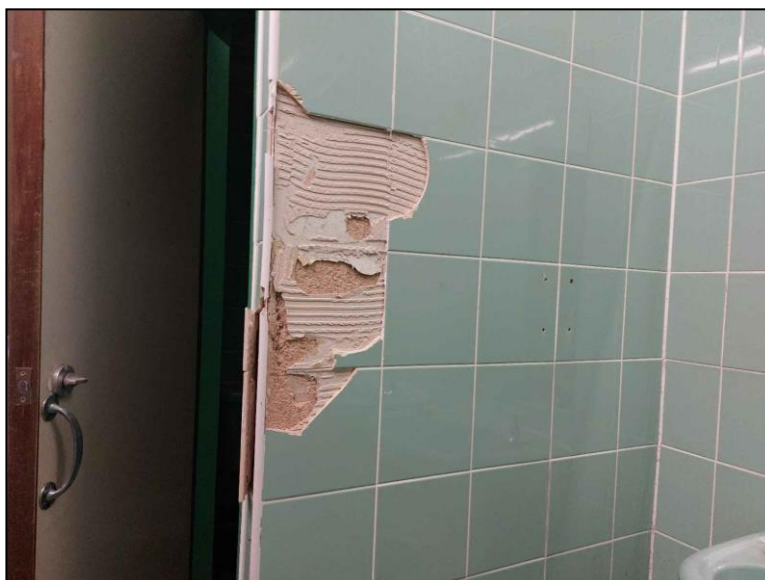
<b>Client:</b>	Great Western Railway	<b>Area No:</b>	006
		<b>Floor:</b>	Ground
<b>Site Address:</b>	Ex-Royal British Legion Building, New Road, Moreton-in-Marsh, Gloucestershire, GL56 0AS	<b>Area Description:</b>	Female WC
<b>Building:</b>	.	<b>Material Description:</b>	Ceramic tile adhesive
<b>Building Address:</b>	As Above	<b>Survey Report Reference:</b>	234636-987722-0001

<b>Asbestos Type:</b>	0 - No asbestos detected	<b>Sample Reference No:</b>	009
		<b>Position:</b>	Internal
<b>Product Type:</b>		<b>Approx Size of Item:</b>	30 m <sup>2</sup>
<b>Comments:</b>

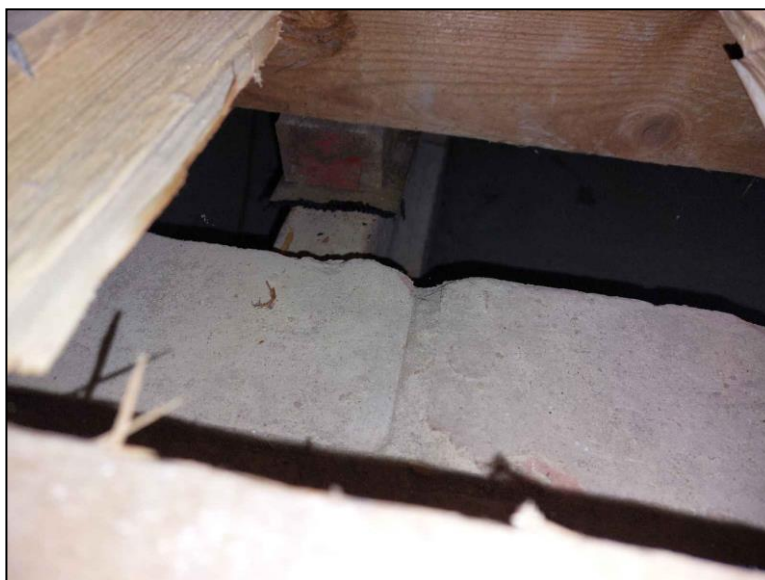
<b>Client:</b>	Great Western Railway	<b>Area No:</b>	007
		<b>Floor:</b>	Ground
<b>Site Address:</b>	Ex-Royal British Legion Building, New Road, Moreton-in-Marsh, Gloucestershire, GL56 0AS	<b>Area Description:</b>	Dance Floor
<b>Building:</b>	.	<b>Material Description:</b>	Bitumen packers to stage
<b>Building Address:</b>	As Above	<b>Survey Report Reference:</b>	234636-987722-0001

Sample Reference No: 010
Asbestos Type: 0 - No asbestos detected	Position: Internal
Product Type:	Approx Size of Item: . Small Amounts
Comments: located to front of stage

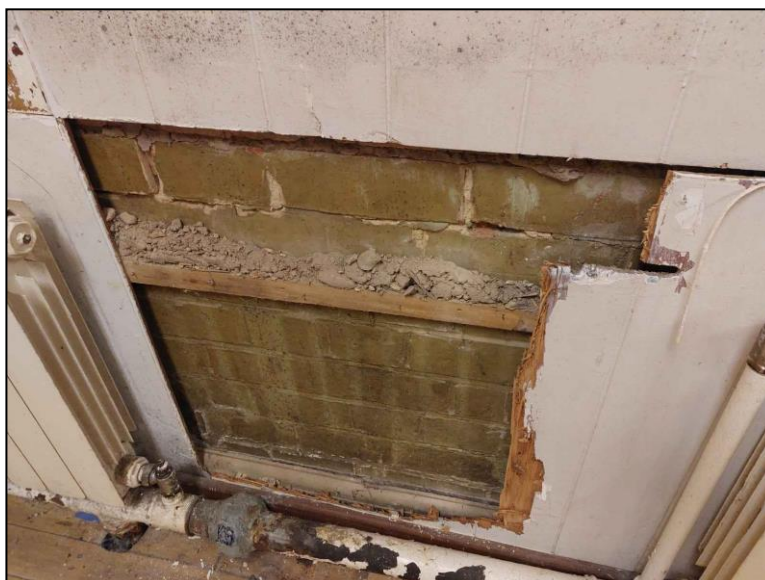
<b>Client:</b>	Great Western Railway	<b>Area No:</b>	007
		<b>Floor:</b>	Ground
<b>Site Address:</b>	Ex-Royal British Legion Building, New Road, Moreton-in-Marsh, Gloucestershire, GL56 0AS	<b>Area Description:</b>	Dance Floor
<b>Building:</b>	.	<b>Material Description:</b>	Paint to walls
<b>Building Address:</b>	As Above	<b>Survey Report Reference:</b>	234636-987722-0001

Sample Reference No: 011
Asbestos Type: 0 - No asbestos detected	Position: Internal
Product Type:	Approx Size of Item: 20 m <sup>2</sup>
Comments: located to low level brickwork wall

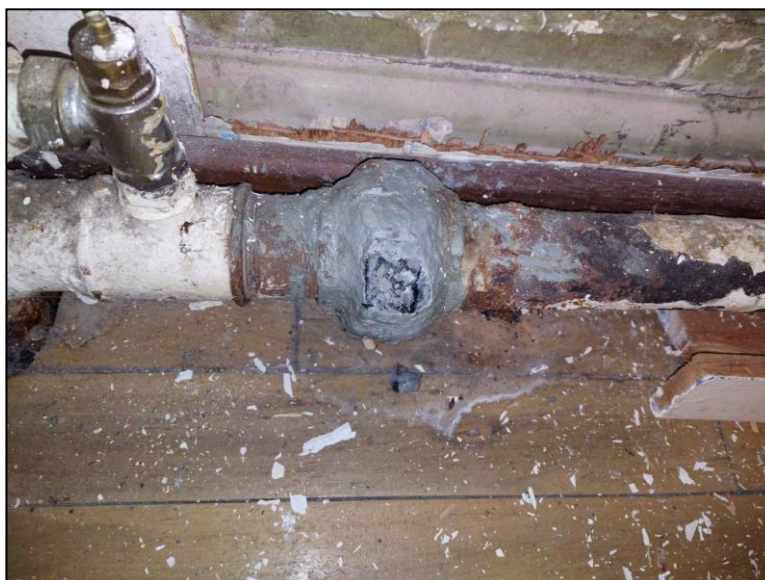
<b>Client:</b>	Great Western Railway	<b>Area No:</b>	007
		<b>Floor:</b>	Ground
<b>Site Address:</b>	Ex-Royal British Legion Building, New Road, Moreton-in-Marsh, Gloucestershire, GL56 0AS	<b>Area Description:</b>	Dance Floor
<b>Building:</b>	.	<b>Material Description:</b>	Hard set resin to pipework
<b>Building Address:</b>	As Above	<b>Survey Report Reference:</b>	234636-987722-0001

<b>Asbestos Type:</b>	0 - No asbestos detected	<b>Sample Reference No:</b>	012
		<b>Position:</b>	Internal
<b>Product Type:</b>		<b>Approx Size of Item:</b>	. Small Amounts
<b>Comments:</b>	Located to low level radiator pipework

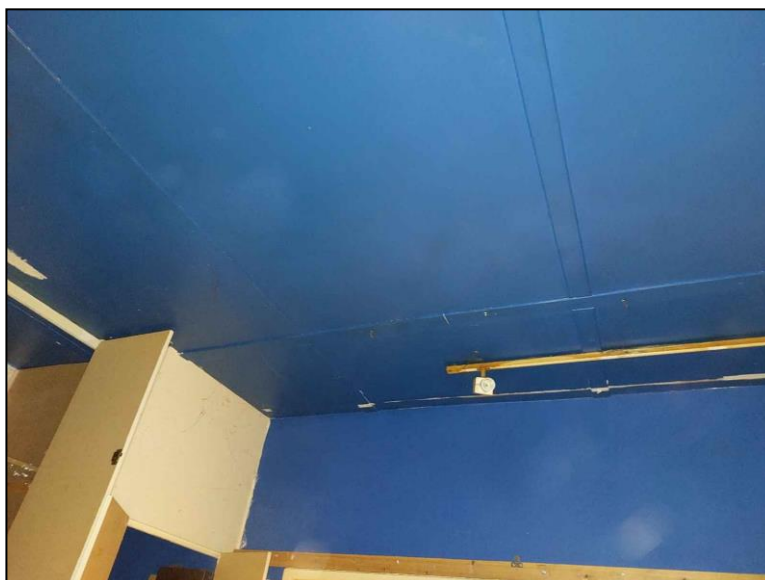
<b>Client:</b>	Great Western Railway	<b>Area No:</b>	008
		<b>Floor:</b>	Ground
<b>Site Address:</b>	Ex-Royal British Legion Building, New Road, Moreton-in-Marsh, Gloucestershire, GL56 0AS	<b>Area Description:</b>	Stage
<b>Building:</b>	.	<b>Material Description:</b>	Insulating board ceiling panels
<b>Building Address:</b>	As Above	<b>Survey Report Reference:</b>	234636-987722-0001

<b>Sample Reference No:</b>	013
<b>Asbestos Type:</b>	2 - Amosite/other amphiboles (not Crocidolite) and Chrysotile	<b>Position:</b>	Internal
<b>Product Type:</b>	2 - AIB, Millboard, gaskets, paper etc	<b>Approx Size of Item:</b>	24 m <sup>2</sup>
<b>Comments:</b>	located to panels and slats to ceiling

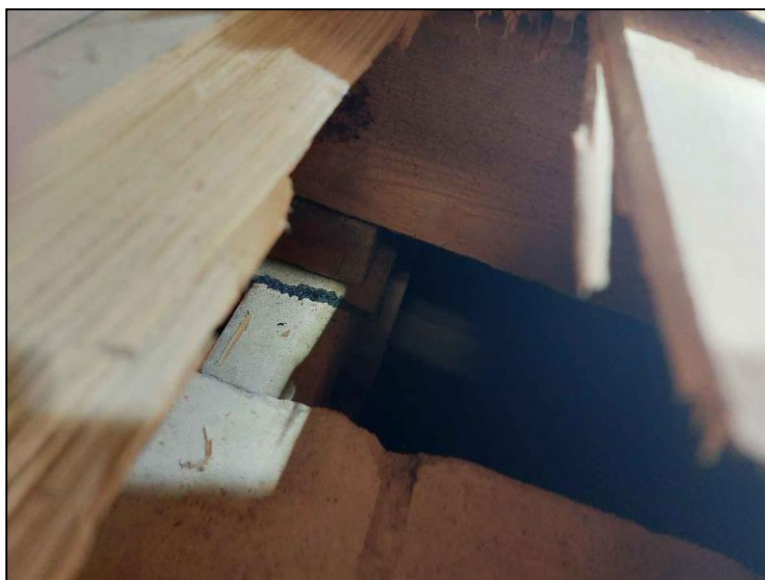
<b>Client:</b>	Great Western Railway	<b>Area No:</b>	008
		<b>Floor:</b>	Ground
<b>Site Address:</b>	Ex-Royal British Legion Building, New Road, Moreton-in-Marsh, Gloucestershire, GL56 0AS	<b>Area Description:</b>	Stage
<b>Building:</b>	.	<b>Material Description:</b>	Bitumen packers to stage
<b>Building Address:</b>	As Above	<b>Survey Report Reference:</b>	234636-987722-0001

<b>Asbestos Type:</b>	0 - No asbestos detected	<b>Sample Reference No:</b>	014
		<b>Position:</b>	Internal
<b>Product Type:</b>		<b>Approx Size of Item:</b>	. Small Amounts
<b>Comments:</b>	located beneath stage within void

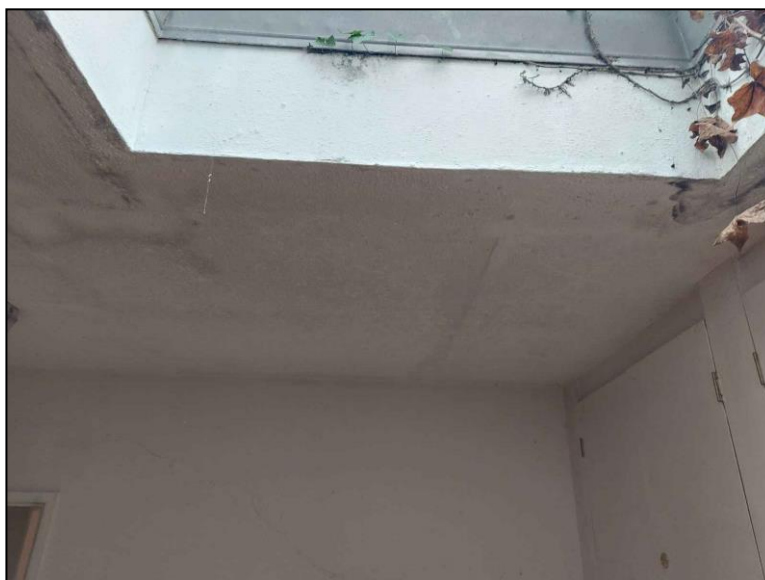
<b>Client:</b>	Great Western Railway	<b>Area No:</b>	009
		<b>Floor:</b>	Ground
<b>Site Address:</b>	Ex-Royal British Legion Building, New Road, Moreton-in-Marsh, Gloucestershire, GL56 0AS	<b>Area Description:</b>	Back Stage
<b>Building:</b>	.	<b>Material Description:</b>	Textured coating to ceiling
<b>Building Address:</b>	As Above	<b>Survey Report Reference:</b>	234636-987722-0001

<b>Sample Reference No:</b>	015
<b>Asbestos Type:</b>	1 - Chrysotile	<b>Position:</b>	Internal
<b>Product Type:</b>	1 - Asbestos composites, decorative finishes, AC	<b>Approx Size of Item:</b>	15 m <sup>2</sup>
<b>Comments:</b>

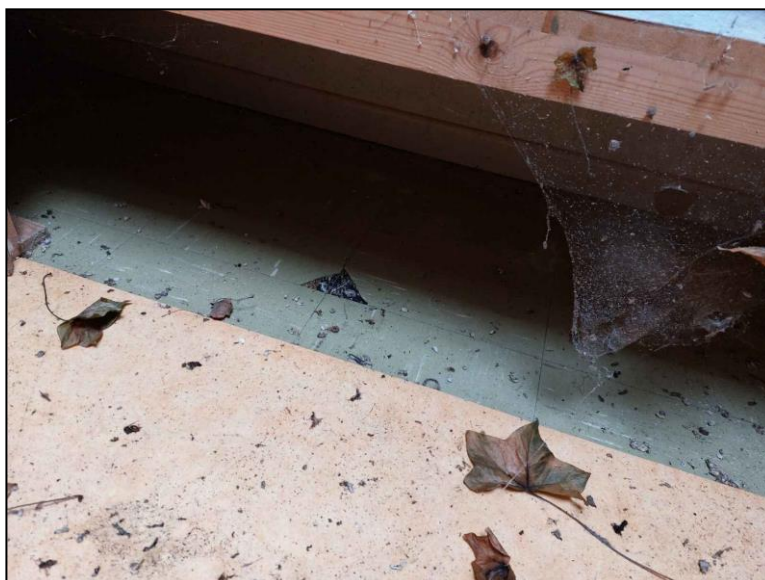
<b>Client:</b>	Great Western Railway	<b>Area No:</b>	009
		<b>Floor:</b>	Ground
<b>Site Address:</b>	Ex-Royal British Legion Building, New Road, Moreton-in-Marsh, Gloucestershire, GL56 0AS	<b>Area Description:</b>	Back Stage
<b>Building:</b>	.	<b>Material Description:</b>	Olive vinyl floor tiles
<b>Building Address:</b>	As Above	<b>Survey Report Reference:</b>	234636-987722-0001

<b>Asbestos Type:</b>	1 - Chrysotile	<b>Sample Reference No:</b>	016A
		<b>Position:</b>	Internal
<b>Product Type:</b>	1 - Asbestos composites, decorative finishes, AC	<b>Approx Size of Item:</b>	15 m <sup>2</sup>
<b>Comments:</b>

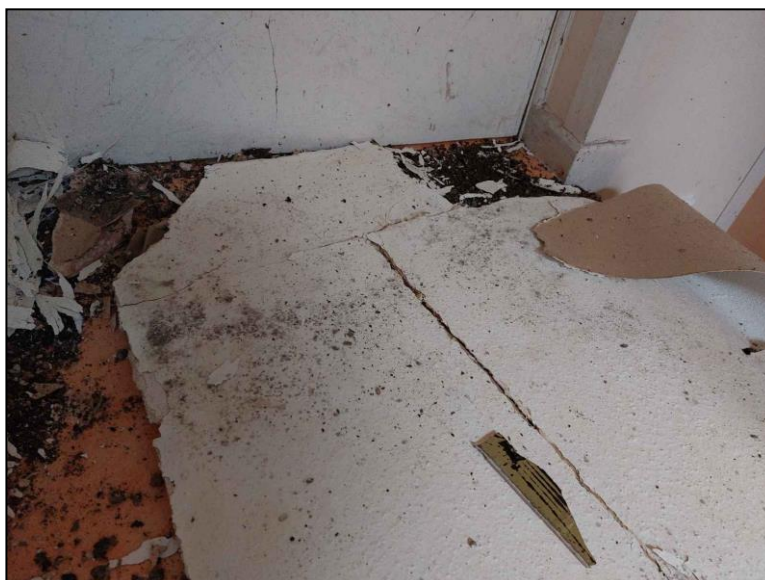
<b>Client:</b>	Great Western Railway	<b>Area No:</b>	009
		<b>Floor:</b>	Ground
<b>Site Address:</b>	Ex-Royal British Legion Building, New Road, Moreton-in-Marsh, Gloucestershire, GL56 0AS	<b>Area Description:</b>	Back Stage
<b>Building:</b>	.	<b>Material Description:</b>	Textured coating debris to floor
<b>Building Address:</b>	As Above	<b>Survey Report Reference:</b>	234636-987722-0001

<b>Asbestos Type:</b>	1 - Chrysotile	<b>Sample Reference No:</b>	017
		<b>Position:</b>	Internal
<b>Product Type:</b>	1 - Asbestos composites, decorative finishes, AC	<b>Approx Size of Item:</b>	. Small Amounts
<b>Comments:</b>

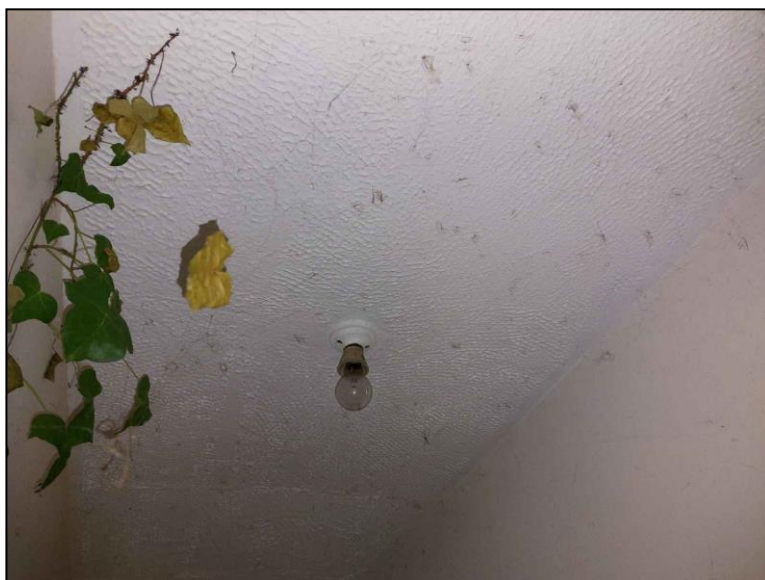
<b>Client:</b>	Great Western Railway	<b>Area No:</b>	010
		<b>Floor:</b>	Ground
<b>Site Address:</b>	Ex-Royal British Legion Building, New Road, Moreton-in-Marsh, Gloucestershire, GL56 0AS	<b>Area Description:</b>	WC
<b>Building:</b>	.	<b>Material Description:</b>	Textured coating to ceiling
<b>Building Address:</b>	As Above	<b>Survey Report Reference:</b>	234636-987722-0001

<b>Sample Reference No:</b>	018
<b>Asbestos Type:</b>	1 - Chrysotile	<b>Position:</b>	Internal
<b>Product Type:</b>	1 - Asbestos composites, decorative finishes, AC	<b>Approx Size of Item:</b>	2 m <sup>2</sup>
<b>Comments:</b>

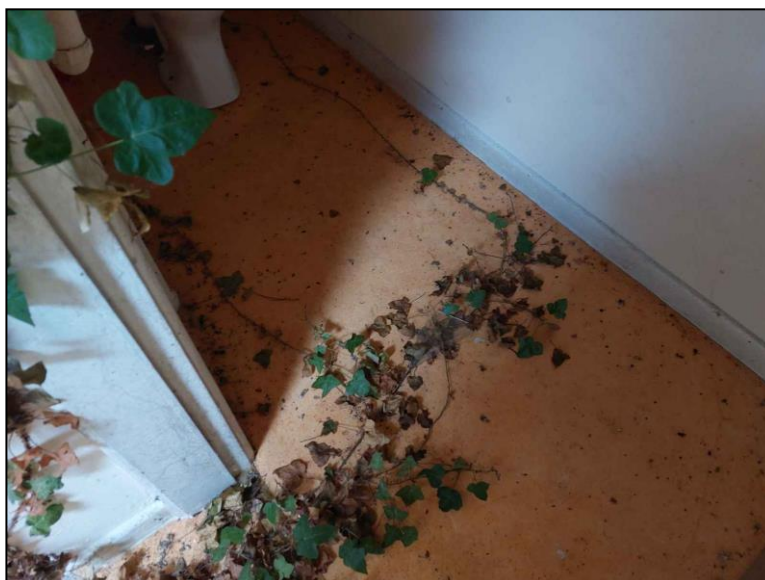
<b>Client:</b>	Great Western Railway	<b>Area No:</b>	010
		<b>Floor:</b>	Ground
<b>Site Address:</b>	Ex-Royal British Legion Building, New Road, Moreton-in-Marsh, Gloucestershire, GL56 0AS	<b>Area Description:</b>	WC
<b>Building:</b>	.	<b>Material Description:</b>	Olive vinyl floor tiles
<b>Building Address:</b>	As Above	<b>Survey Report Reference:</b>	234636-987722-0001

<b>Asbestos Type:</b>	1 - Chrysotile	<b>Sample Reference No:</b>	019A
		<b>Position:</b>	Internal
<b>Product Type:</b>	1 - Asbestos composites, decorative finishes, AC	<b>Approx Size of Item:</b>	2 m <sup>2</sup>
<b>Comments:</b>

Sample Reference	Building	Area Description	Material	Action	Timescale for Action
019A	0001	Ground Floor - 010-WC	Olive vinyl floor tiles	Remove	Prior to Refurbishment
020	0001	Ground Floor - 011-Office	Textured coating to ceiling	Remove	Prior to Refurbishment
021A	0001	Ground Floor - 011-Office	Olive vinyl floor tiles	Remove	Prior to Refurbishment
021B	0001	Ground Floor - 011-Office	Bitumen adhesive to floor tiles	Remove	Prior to Refurbishment
P001	0001	Ground Floor - 012-Lounge	Electrical Switchgear	Recommend Future Sample  Presumption Reasons: No isolation certificate provided .	Prior to Refurbishment
022	0001	Ground Floor - 012-Lounge	Textured coating to ceiling	Remove	Prior to Refurbishment
023	0001	Ground Floor - 013-Bar	Textured coating to ceiling	Remove	Prior to Refurbishment
024	0001	Ground Floor - 014-Bar	Textured coating to ceiling	Remove	Prior to Refurbishment
025	0001	Ground Floor - 015-Lounge	Textured coating to ceiling	Remove	Prior to Refurbishment

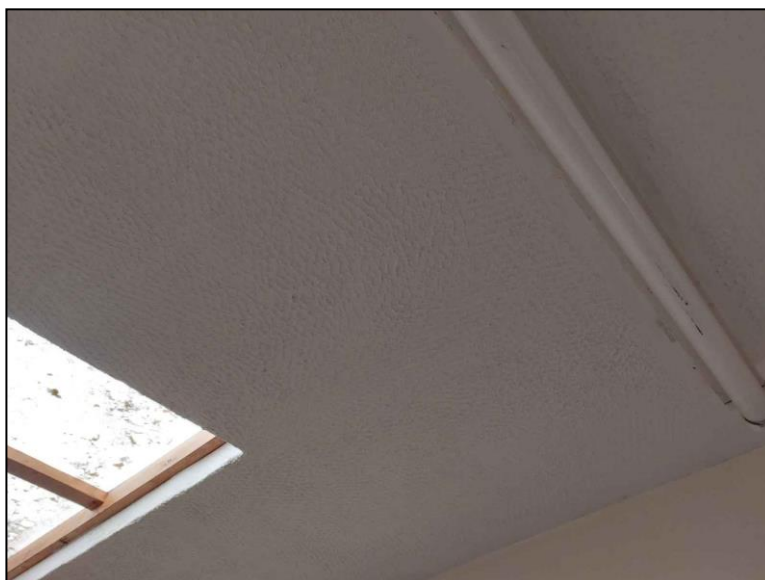
<b>Client:</b>	Great Western Railway	<b>Area No:</b>	011
		<b>Floor:</b>	Ground
<b>Site Address:</b>	Ex-Royal British Legion Building, New Road, Moreton-in-Marsh, Gloucestershire, GL56 0AS	<b>Area Description:</b>	Office
<b>Building:</b>	.	<b>Material Description:</b>	Textured coating to ceiling
<b>Building Address:</b>	As Above	<b>Survey Report Reference:</b>	234636-987722-0001

<b>Sample Reference No:</b>	020
<b>Asbestos Type:</b>	1 - Chrysotile	<b>Position:</b>	Internal
<b>Product Type:</b>	1 - Asbestos composites, decorative finishes, AC	<b>Approx Size of Item:</b>	12 m <sup>2</sup>
<b>Comments:</b>

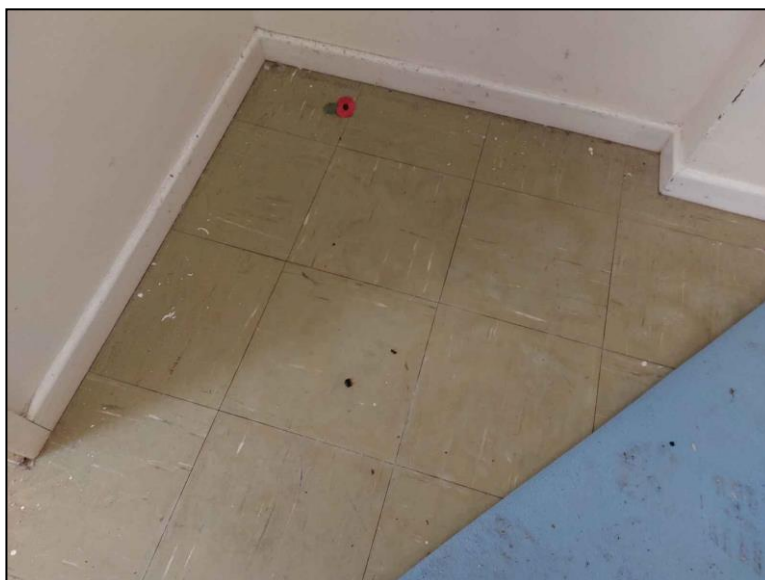
<b>Client:</b>	Great Western Railway	<b>Area No:</b>	011
		<b>Floor:</b>	Ground
<b>Site Address:</b>	Ex-Royal British Legion Building, New Road, Moreton-in-Marsh, Gloucestershire, GL56 0AS	<b>Area Description:</b>	Office
<b>Building:</b>	.	<b>Material Description:</b>	Olive vinyl floor tiles
<b>Building Address:</b>	As Above	<b>Survey Report Reference:</b>	234636-987722-0001

<b>Asbestos Type:</b>	1 - Chrysotile	<b>Sample Reference No:</b>	021A
		<b>Position:</b>	Internal
<b>Product Type:</b>	1 - Asbestos composites, decorative finishes, AC	<b>Approx Size of Item:</b>	12 m <sup>2</sup>
<b>Comments:</b>

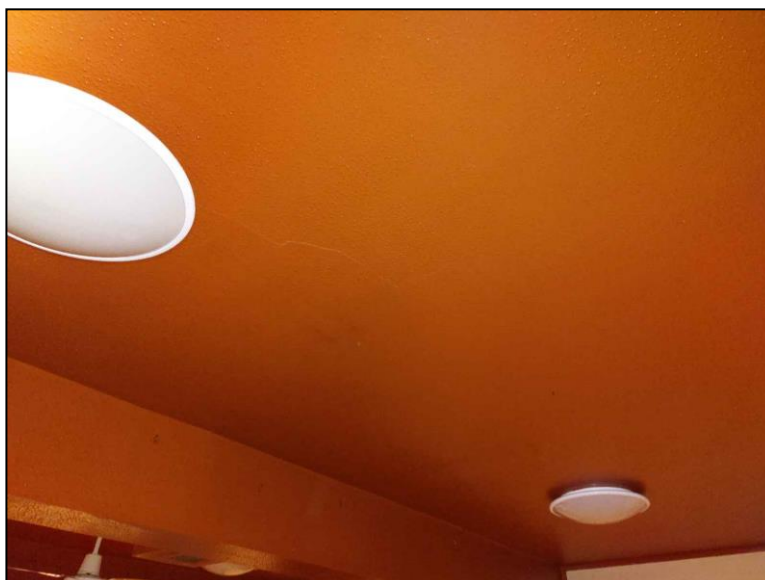
<b>Client:</b>	Great Western Railway	<b>Area No:</b>	012
		<b>Floor:</b>	Ground
<b>Site Address:</b>	Ex-Royal British Legion Building, New Road, Moreton-in-Marsh, Gloucestershire, GL56 0AS	<b>Area Description:</b>	Lounge
<b>Building:</b>	.	<b>Material Description:</b>	Textured coating to ceiling
<b>Building Address:</b>	As Above	<b>Survey Report Reference:</b>	234636-987722-0001

<b>Asbestos Type:</b>	1 - Chrysotile	<b>Sample Reference No:</b>	022
		<b>Position:</b>	Internal
<b>Product Type:</b>	1 - Asbestos composites, decorative finishes, AC	<b>Approx Size of Item:</b>	72 m <sup>2</sup>
<b>Comments:</b>

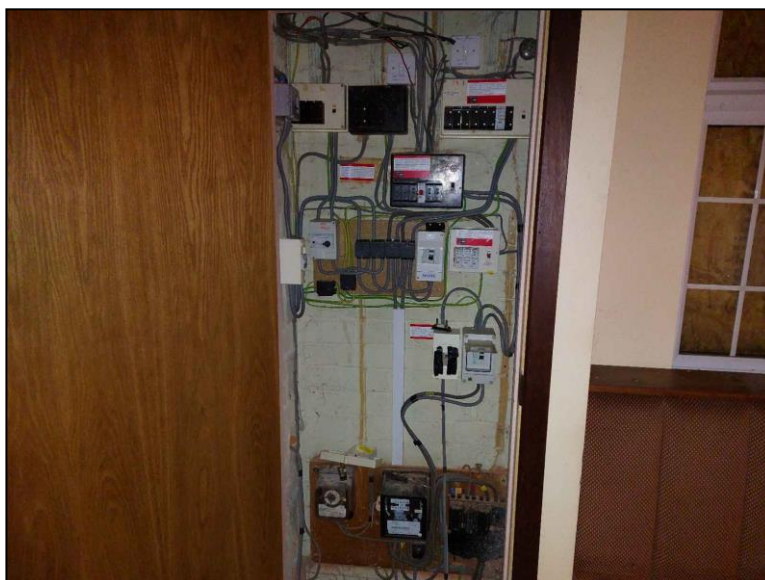
<b>Client:</b>	Great Western Railway	<b>Area No:</b>	012
		<b>Floor:</b>	Ground
<b>Site Address:</b>	Ex-Royal British Legion Building, New Road, Moreton-in-Marsh, Gloucestershire, GL56 0AS	<b>Area Description:</b>	Lounge
<b>Building:</b>	.	<b>Material Description:</b>	Electrical Switchgear
<b>Building Address:</b>	As Above	<b>Survey Report Reference:</b>	234636-987722-0001

Sample Reference No:	P001
Asbestos Type:	1 - Chrysotile	Position: Internal
Product Type:	2 - AIB, Millboard, gaskets, paper etc	Approx Size of Item: 1 Items
Comments:	presume all electrical equipment within cupboard Presumption Reason: No isolation certificate provided

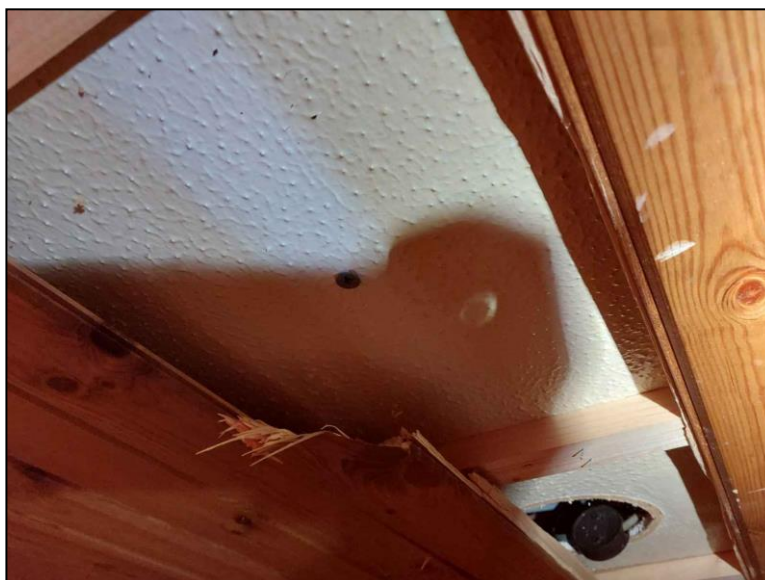
<b>Client:</b>	Great Western Railway	<b>Area No:</b>	013
		<b>Floor:</b>	Ground
<b>Site Address:</b>	Ex-Royal British Legion Building, New Road, Moreton-in-Marsh, Gloucestershire, GL56 0AS	<b>Area Description:</b>	Bar
<b>Building:</b>	.	<b>Material Description:</b>	Textured coating to ceiling
<b>Building Address:</b>	As Above	<b>Survey Report Reference:</b>	234636-987722-0001

<b>Sample Reference No:</b>	023
<b>Asbestos Type:</b>	1 - Chrysotile	<b>Position:</b>	Internal
<b>Product Type:</b>	1 - Asbestos composites, decorative finishes, AC	<b>Approx Size of Item:</b>	10 m <sup>2</sup>
<b>Comments:</b>

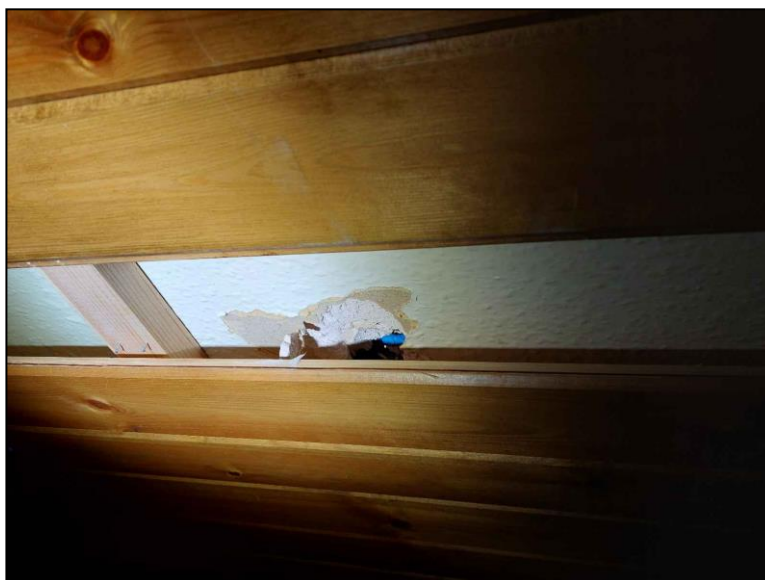
<b>Client:</b>	Great Western Railway	<b>Area No:</b>	014
		<b>Floor:</b>	Ground
<b>Site Address:</b>	Ex-Royal British Legion Building, New Road, Moreton-in-Marsh, Gloucestershire, GL56 0AS	<b>Area Description:</b>	Bar
<b>Building:</b>	.	<b>Material Description:</b>	Textured coating to ceiling
<b>Building Address:</b>	As Above	<b>Survey Report Reference:</b>	234636-987722-0001

<b>Sample Reference No:</b>	024
<b>Asbestos Type:</b>	1 - Chrysotile	<b>Position:</b>	Internal
<b>Product Type:</b>	1 - Asbestos composites, decorative finishes, AC	<b>Approx Size of Item:</b>	10 m <sup>2</sup>
<b>Comments:</b>

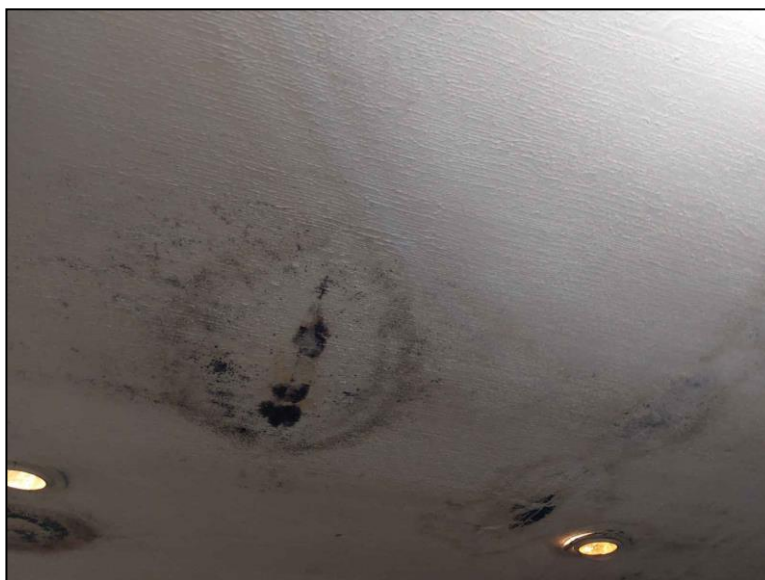
<b>Client:</b>	Great Western Railway	<b>Area No:</b>	015
		<b>Floor:</b>	Ground
<b>Site Address:</b>	Ex-Royal British Legion Building, New Road, Moreton-in-Marsh, Gloucestershire, GL56 0AS	<b>Area Description:</b>	Lounge
<b>Building:</b>	.	<b>Material Description:</b>	Textured coating to ceiling
<b>Building Address:</b>	As Above	<b>Survey Report Reference:</b>	234636-987722-0001

<b>Sample Reference No:</b>	025
<b>Asbestos Type:</b>	1 - Chrysotile	<b>Position:</b>	Internal
<b>Product Type:</b>	1 - Asbestos composites, decorative finishes, AC	<b>Approx Size of Item:</b>	50 m <sup>2</sup>
<b>Comments:</b>

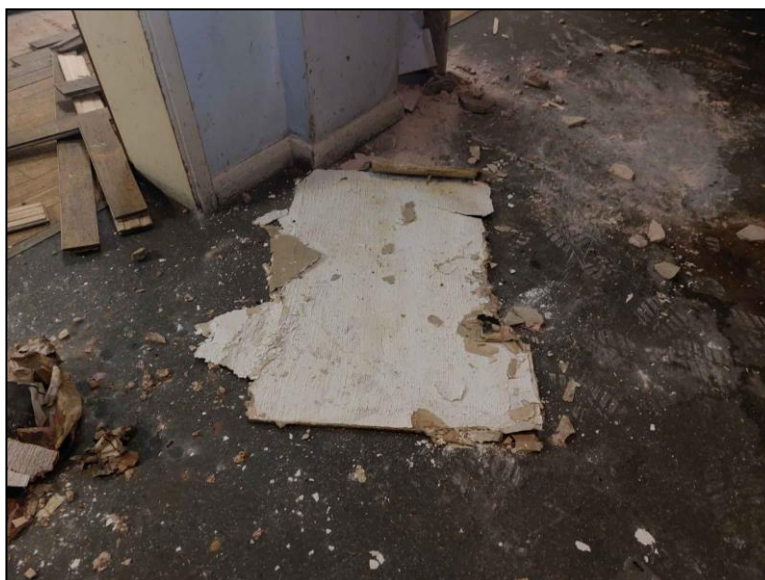
<b>Client:</b>	Great Western Railway	<b>Area No:</b>	015
		<b>Floor:</b>	Ground
<b>Site Address:</b>	Ex-Royal British Legion Building, New Road, Moreton-in-Marsh, Gloucestershire, GL56 0AS	<b>Area Description:</b>	Lounge
<b>Building:</b>	.	<b>Material Description:</b>	Textured coating debris to floor
<b>Building Address:</b>	As Above	<b>Survey Report Reference:</b>	234636-987722-0001

<b>Asbestos Type:</b>	1 - Chrysotile	<b>Sample Reference No:</b>	026
		<b>Position:</b>	Internal
<b>Product Type:</b>	1 - Asbestos composites, decorative finishes, AC	<b>Approx Size of Item:</b>	. Small Amounts
<b>Comments:</b>	located sporadically throughout floor

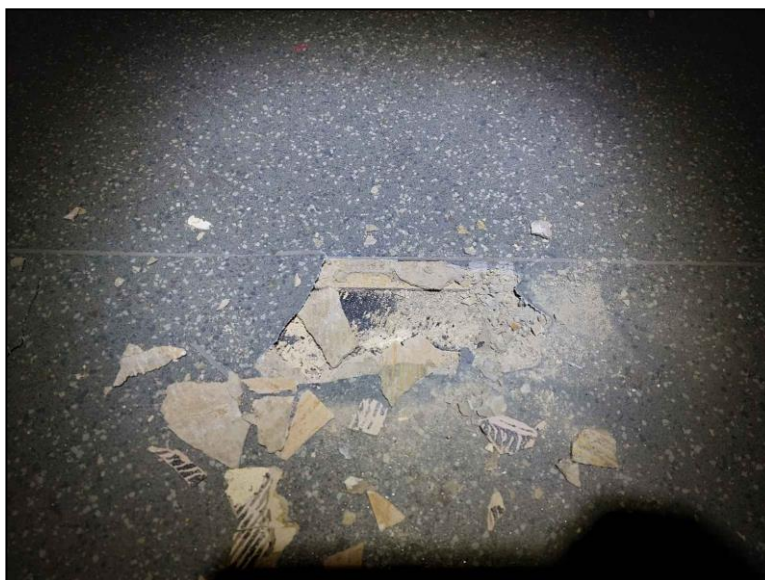
<b>Client:</b>	Great Western Railway	<b>Area No:</b>	015
		<b>Floor:</b>	Ground
<b>Site Address:</b>	Ex-Royal British Legion Building, New Road, Moreton-in-Marsh, Gloucestershire, GL56 0AS	<b>Area Description:</b>	Lounge
<b>Building:</b>	.	<b>Material Description:</b>	Pink vinyl floor tiles
<b>Building Address:</b>	As Above	<b>Survey Report Reference:</b>	234636-987722-0001

<b>Sample Reference No:</b>	027A
<b>Asbestos Type:</b>	1 - Chrysotile	<b>Position:</b>	Internal
<b>Product Type:</b>	1 - Asbestos composites, decorative finishes, AC	<b>Approx Size of Item:</b>	50 m <sup>2</sup>
<b>Comments:</b>	located beneath screed to floor

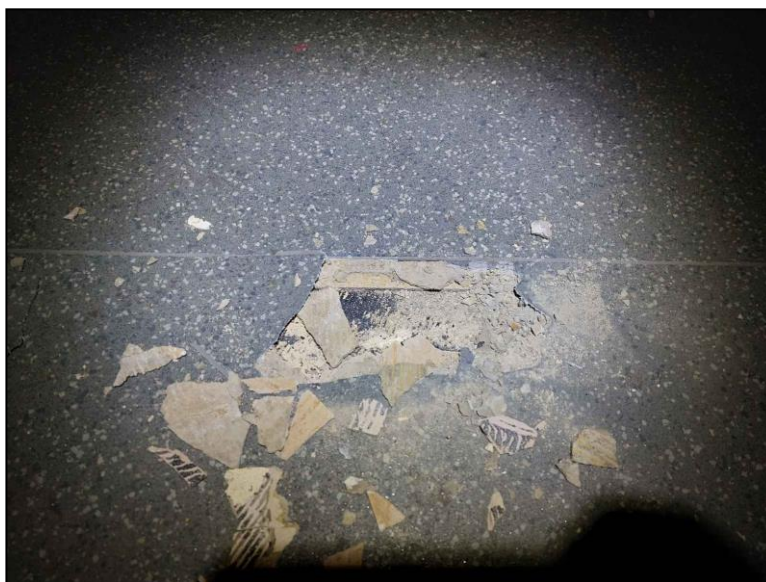
<b>Client:</b>	Great Western Railway	<b>Area No:</b>	015
		<b>Floor:</b>	Ground
<b>Site Address:</b>	Ex-Royal British Legion Building, New Road, Moreton-in-Marsh, Gloucestershire, GL56 0AS	<b>Area Description:</b>	Lounge
<b>Building:</b>	.	<b>Material Description:</b>	Bitumen adhesive to floor tiles
<b>Building Address:</b>	As Above	<b>Survey Report Reference:</b>	234636-987722-0001

<b>Asbestos Type:</b>	1 - Chrysotile	<b>Sample Reference No:</b>	027B
		<b>Position:</b>	Internal
<b>Product Type:</b>	1 - Asbestos composites, decorative finishes, AC	<b>Approx Size of Item:</b>	50 m <sup>2</sup>
<b>Comments:</b>	located beneath screed to floor

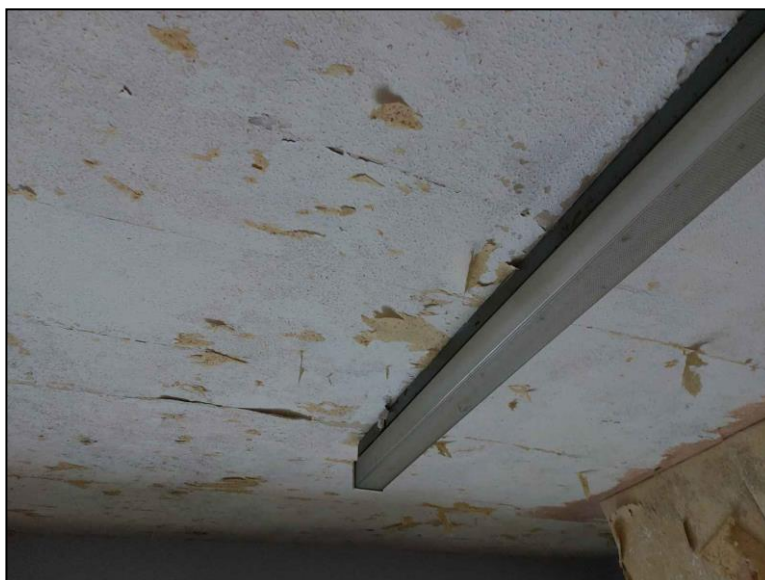
<b>Client:</b>	Great Western Railway	<b>Area No:</b>	016
		<b>Floor:</b>	Ground
<b>Site Address:</b>	Ex-Royal British Legion Building, New Road, Moreton-in-Marsh, Gloucestershire, GL56 0AS	<b>Area Description:</b>	Office
<b>Building:</b>	.	<b>Material Description:</b>	Textured coating to ceiling
<b>Building Address:</b>	As Above	<b>Survey Report Reference:</b>	234636-987722-0001

<b>Asbestos Type:</b>	1 - Chrysotile	<b>Sample Reference No:</b>	028
		<b>Position:</b>	Internal
<b>Product Type:</b>	1 - Asbestos composites, decorative finishes, AC	<b>Approx Size of Item:</b>	12 m <sup>2</sup>
<b>Comments:</b>

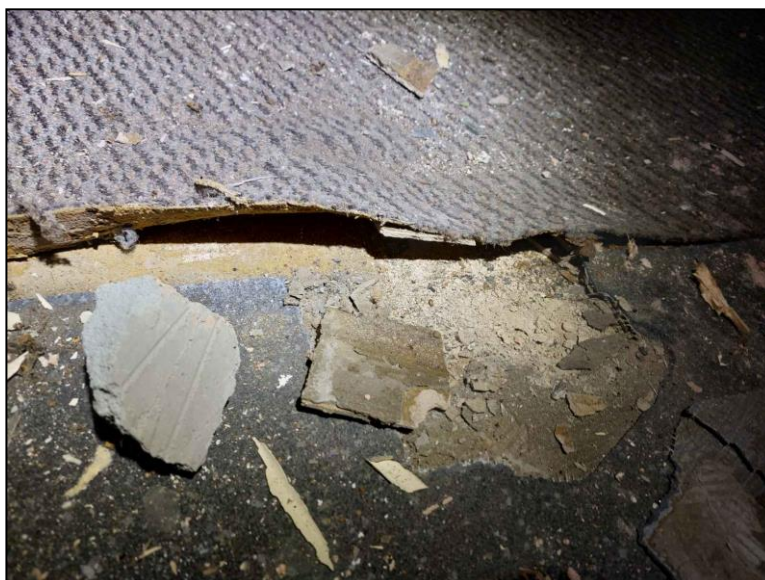
<b>Client:</b>	Great Western Railway	<b>Area No:</b>	016
		<b>Floor:</b>	Ground
<b>Site Address:</b>	Ex-Royal British Legion Building, New Road, Moreton-in-Marsh, Gloucestershire, GL56 0AS	<b>Area Description:</b>	Office
<b>Building:</b>	.	<b>Material Description:</b>	Pink vinyl floor tiles
<b>Building Address:</b>	As Above	<b>Survey Report Reference:</b>	234636-987722-0001

<b>Asbestos Type:</b>	1 - Chrysotile	<b>Sample Reference No:</b>	029A
		<b>Position:</b>	Internal
<b>Product Type:</b>	1 - Asbestos composites, decorative finishes, AC	<b>Approx Size of Item:</b>	12 m <sup>2</sup>
<b>Comments:</b>

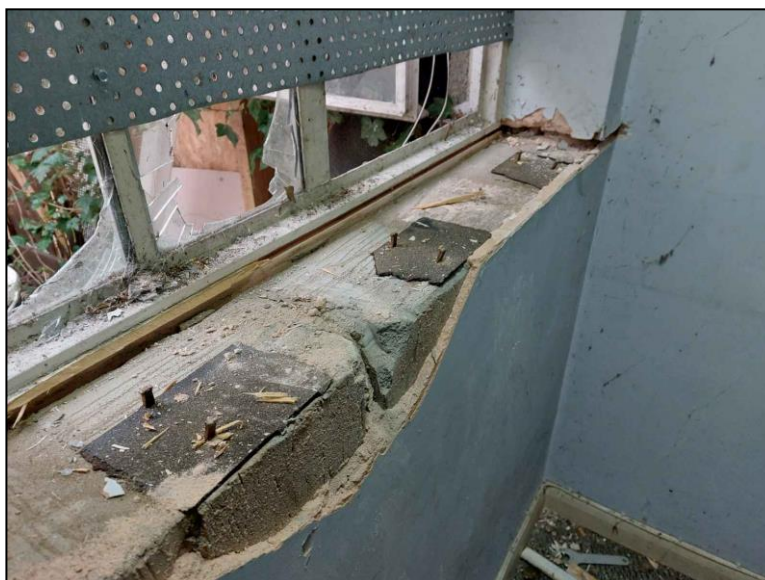
<b>Client:</b>	Great Western Railway	<b>Area No:</b>	016
		<b>Floor:</b>	Ground
<b>Site Address:</b>	Ex-Royal British Legion Building, New Road, Moreton-in-Marsh, Gloucestershire, GL56 0AS	<b>Area Description:</b>	Office
<b>Building:</b>	.	<b>Material Description:</b>	Bitumen packers to window sills
<b>Building Address:</b>	As Above	<b>Survey Report Reference:</b>	234636-987722-0001

<b>Sample Reference No:</b>	030
<b>Asbestos Type:</b>	1 - Chrysotile	<b>Position:</b>	Internal
<b>Product Type:</b>	1 - Asbestos composites, decorative finishes, AC	<b>Approx Size of Item:</b>	. Small Amounts
<b>Comments:</b>	located beneath timber window sills
