**PRE-CONSTRUCTION  
INFORMATION**

**DEMOLITION &  
CLEARANCE OF  
FORMER ROYAL BRITISH  
LEGION BUILDING**

**MORETON-IN-MARSH**

**GREAT WESTERN  
RAILWAY &  
MORETON-IN-MARSH  
TOWN COUNCIL**

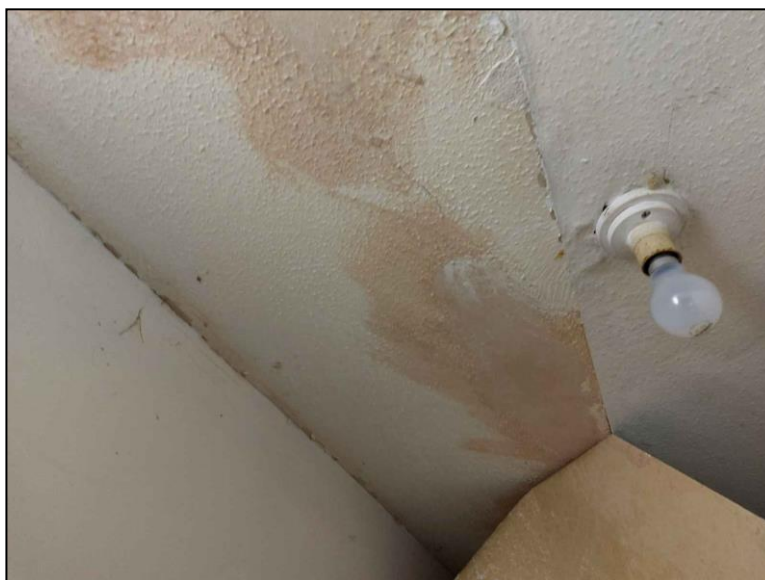
<b>Client:</b>	Great Western Railway	<b>Area No:</b>	017
		<b>Floor:</b>	Ground
<b>Site Address:</b>	Ex-Royal British Legion Building, New Road, Moreton-in-Marsh, Gloucestershire, GL56 0AS	<b>Area Description:</b>	Fire Exit
<b>Building:</b>	.	<b>Material Description:</b>	Textured coating to ceiling
<b>Building Address:</b>	As Above	<b>Survey Report Reference:</b>	234636-987722-0001

<b>Asbestos Type:</b>	1 - Chrysotile	<b>Sample Reference No:</b>	031
		<b>Position:</b>	Internal
<b>Product Type:</b>	1 - Asbestos composites, decorative finishes, AC	<b>Approx Size of Item:</b>	3 m <sup>2</sup>
<b>Comments:</b>

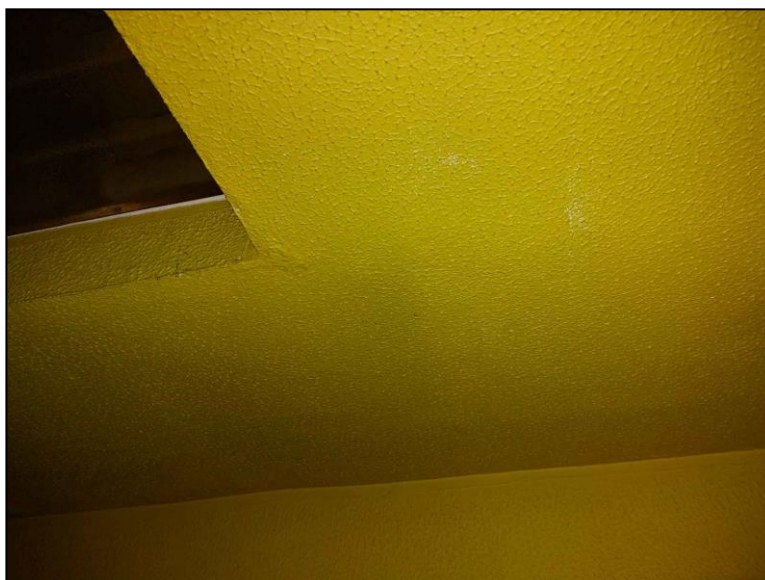
<b>Client:</b>	Great Western Railway	<b>Area No:</b>	018
		<b>Floor:</b>	Ground
<b>Site Address:</b>	Ex-Royal British Legion Building, New Road, Moreton-in-Marsh, Gloucestershire, GL56 0AS	<b>Area Description:</b>	Skittle Room
<b>Building:</b>	.	<b>Material Description:</b>	Textured coating to ceiling
<b>Building Address:</b>	As Above	<b>Survey Report Reference:</b>	234636-987722-0001

<b>Sample Reference No:</b>	032
<b>Asbestos Type:</b>	1 - Chrysotile	<b>Position:</b>	Internal
<b>Product Type:</b>	1 - Asbestos composites, decorative finishes, AC	<b>Approx Size of Item:</b>	60 m <sup>2</sup>
<b>Comments:</b>

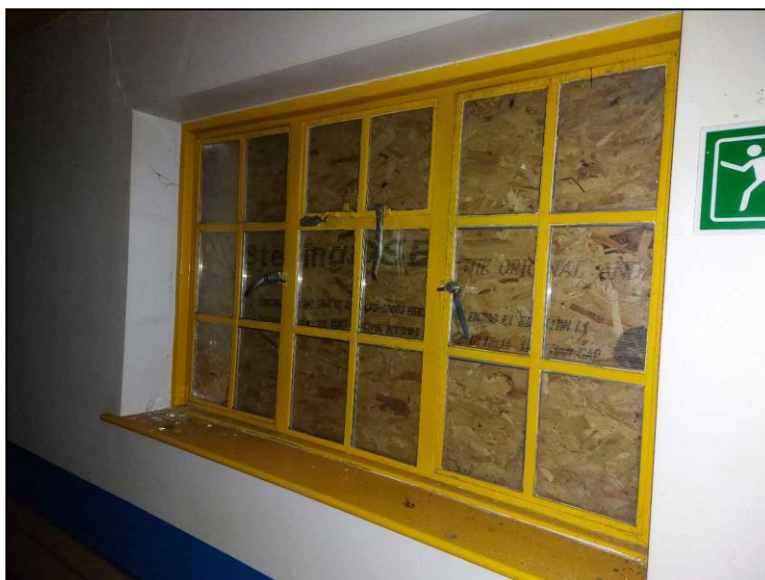
<b>Client:</b>	Great Western Railway	<b>Area No:</b>	018
		<b>Floor:</b>	Ground
<b>Site Address:</b>	Ex-Royal British Legion Building, New Road, Moreton-in-Marsh, Gloucestershire, GL56 0AS	<b>Area Description:</b>	Skittle Room
<b>Building:</b>	.	<b>Material Description:</b>	Putty to windows
<b>Building Address:</b>	As Above	<b>Survey Report Reference:</b>	234636-987722-0001

<b>Sample Reference No:</b> 033
<b>Asbestos Type:</b> 0 - No asbestos detected	<b>Position:</b> Internal/External
<b>Product Type:</b>	<b>Approx Size of Item:</b> 12 Linear M
<b>Comments:</b> representative sample of all windows to building

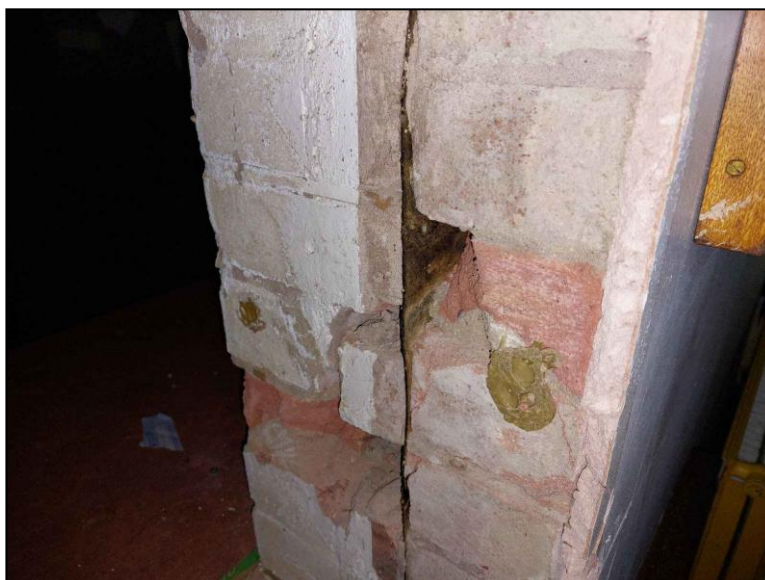
<b>Client:</b>	Great Western Railway	<b>Area No:</b>	018
		<b>Floor:</b>	Ground
<b>Site Address:</b>	Ex-Royal British Legion Building, New Road, Moreton-in-Marsh, Gloucestershire, GL56 0AS	<b>Area Description:</b>	Skittle Room
<b>Building:</b>	.	<b>Material Description:</b>	Bitumen membrane within wall cavity
<b>Building Address:</b>	As Above	<b>Survey Report Reference:</b>	234636-987722-0001

<b>Sample Reference No:</b>	034
<b>Asbestos Type:</b>	1 - Chrysotile	<b>Position:</b>	Internal
<b>Product Type:</b>	1 - Asbestos composites, decorative finishes, AC	<b>Approx Size of Item:</b>	10 m <sup>2</sup>
<b>Comments:</b>	unknown quantity due to visibility within cavity. presume throughout

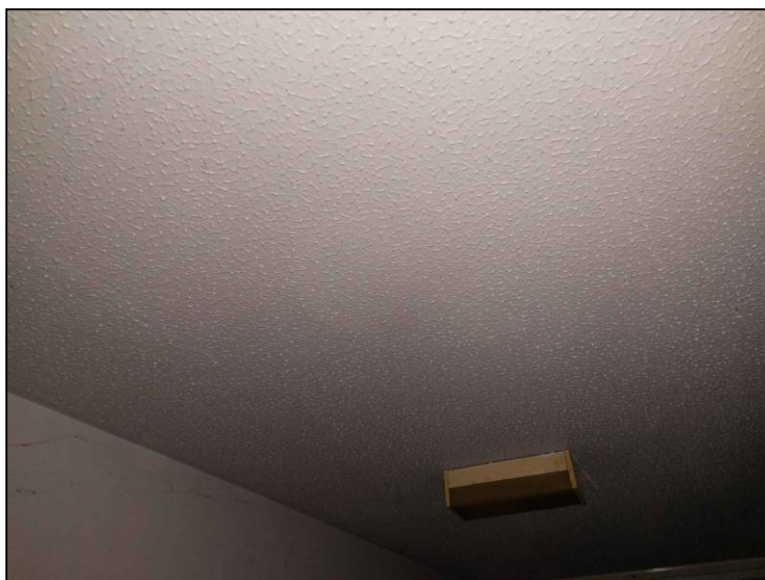
<b>Client:</b>	Great Western Railway	<b>Area No:</b>	019
		<b>Floor:</b>	Ground
<b>Site Address:</b>	Ex-Royal British Legion Building, New Road, Moreton-in-Marsh, Gloucestershire, GL56 0AS	<b>Area Description:</b>	Lobby
<b>Building:</b>	.	<b>Material Description:</b>	Textured coating to ceiling
<b>Building Address:</b>	As Above	<b>Survey Report Reference:</b>	234636-987722-0001

<b>Sample Reference No:</b>	035
<b>Asbestos Type:</b>	1 - Chrysotile	<b>Position:</b>	Internal
<b>Product Type:</b>	1 - Asbestos composites, decorative finishes, AC	<b>Approx Size of Item:</b>	9 m <sup>2</sup>
<b>Comments:</b>

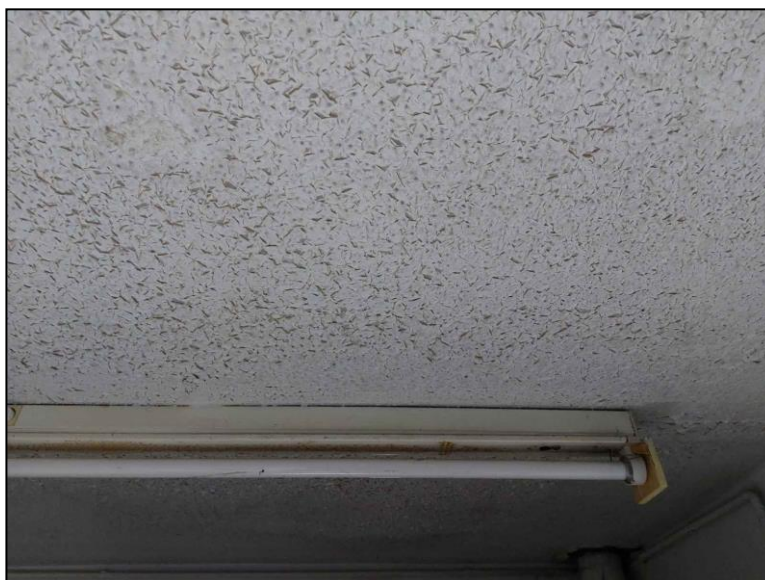
<b>Client:</b>	Great Western Railway	<b>Area No:</b>	020
		<b>Floor:</b>	Ground
<b>Site Address:</b>	Ex-Royal British Legion Building, New Road, Moreton-in-Marsh, Gloucestershire, GL56 0AS	<b>Area Description:</b>	Female WC
<b>Building:</b>	.	<b>Material Description:</b>	Textured coating to ceiling
<b>Building Address:</b>	As Above	<b>Survey Report Reference:</b>	234636-987722-0001

<b>Sample Reference No:</b>	036
<b>Asbestos Type:</b>	1 - Chrysotile	<b>Position:</b>	Internal
<b>Product Type:</b>	1 - Asbestos composites, decorative finishes, AC	<b>Approx Size of Item:</b>	12 m <sup>2</sup>
<b>Comments:</b>

SOCOTEC Asbestos SAMPLE No	CLIENT SAMPLE No	SAMPLE LOCATION & DESCRIPTION*	FIBRE TYPE DETECTED	ANALYSIS No
036		Ground Floor - Female WC 020 - Textured coating to ceiling	CHRYSTILE	234636-987722-0001-036
037		Ground Floor - Female WC 020 - Cement panel within bunny burner	CHRYSTILE	234636-987722-0001-037
038		Ground Floor - Female WC 020 - Cement flue to bunny burner	CHRYSTILE	234636-987722-0001-038
039		Ground Floor - Female WC 020 - Bakelite toilet cistern	NADIS	234636-987722-0001-039
040		Ground Floor - Male WC 021 - Textured coating to ceiling	CHRYSTILE	234636-987722-0001-040
041		Ground Floor - Corridor 022 - Textured coating to ceiling	CHRYSTILE	234636-987722-0001-041
042		Ground Floor - Ante Room 023 - Textured coating to ceiling	CHRYSTILE	234636-987722-0001-042
043		Ground Floor - Cellar 024 - Textured coating to ceiling	CHRYSTILE	234636-987722-0001-043
044		Ground Floor - Cellar 024 - Insulating board wall panels	CHRYSTILE, AMOSITE	234636-987722-0001-044

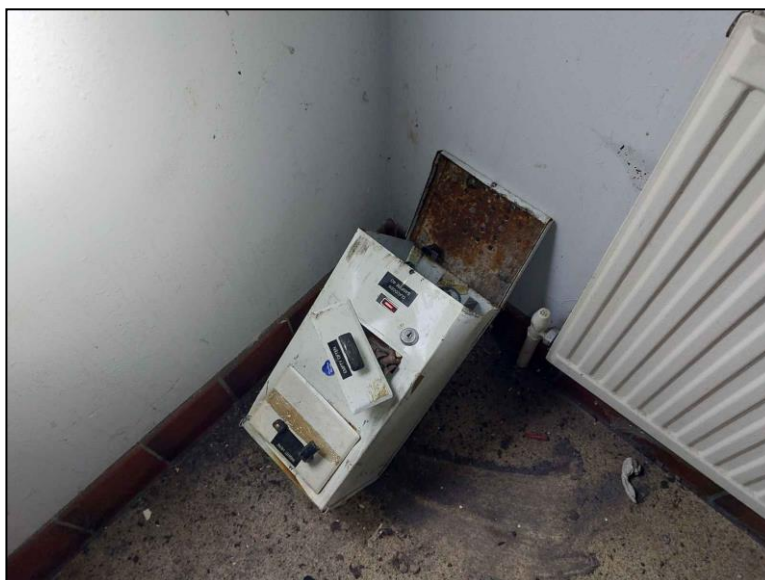
<b>Client:</b>	Great Western Railway	<b>Area No:</b>	020
		<b>Floor:</b>	Ground
<b>Site Address:</b>	Ex-Royal British Legion Building, New Road, Moreton-in-Marsh, Gloucestershire, GL56 0AS	<b>Area Description:</b>	Female WC
<b>Building:</b>	.	<b>Material Description:</b>	Cement panel within bunny burner
<b>Building Address:</b>	As Above	<b>Survey Report Reference:</b>	234636-987722-0001

<b>Asbestos Type:</b>	1 - Chrysotile	<b>Sample Reference No:</b>	037
		<b>Position:</b>	Internal
<b>Product Type:</b>	1 - Asbestos composites, decorative finishes, AC	<b>Approx Size of Item:</b>	1 Items
<b>Comments:</b>

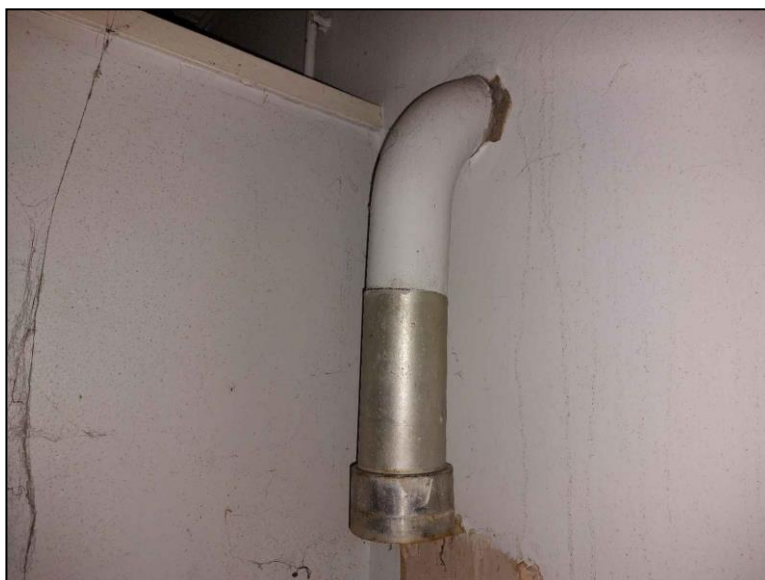
<b>Client:</b>	Great Western Railway	<b>Area No:</b>	020
		<b>Floor:</b>	Ground
<b>Site Address:</b>	Ex-Royal British Legion Building, New Road, Moreton-in-Marsh, Gloucestershire, GL56 0AS	<b>Area Description:</b>	Female WC
<b>Building:</b>	.	<b>Material Description:</b>	Cement flue to bunny burner
<b>Building Address:</b>	As Above	<b>Survey Report Reference:</b>	234636-987722-0001

<b>Sample Reference No:</b>	038
<b>Asbestos Type:</b>	1 - Chrysotile	<b>Position:</b>	Internal/External
<b>Product Type:</b>	1 - Asbestos composites, decorative finishes, AC	<b>Approx Size of Item:</b>	1 Linear M
<b>Comments:</b>

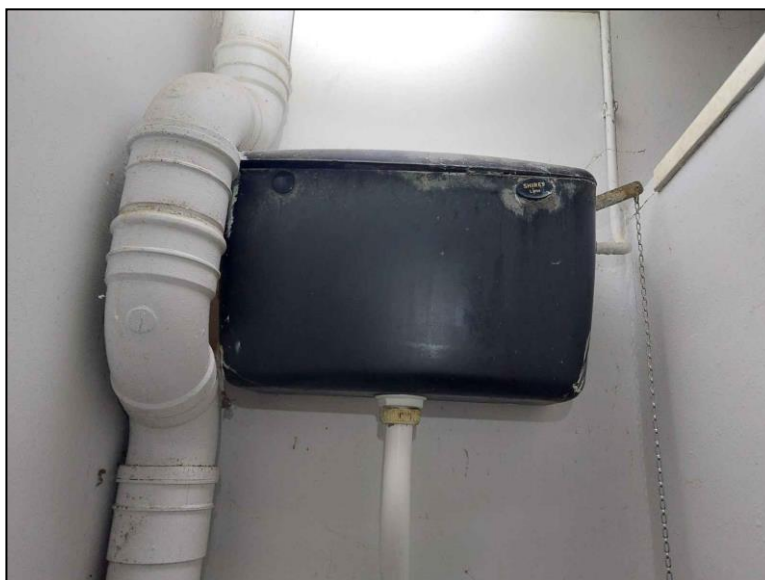
<b>Client:</b>	Great Western Railway	<b>Area No:</b>	020
		<b>Floor:</b>	Ground
<b>Site Address:</b>	Ex-Royal British Legion Building, New Road, Moreton-in-Marsh, Gloucestershire, GL56 0AS	<b>Area Description:</b>	Female WC
<b>Building:</b>	.	<b>Material Description:</b>	Bakelite toilet cistern
<b>Building Address:</b>	As Above	<b>Survey Report Reference:</b>	234636-987722-0001

<b>Asbestos Type:</b>	0 - No asbestos detected	<b>Sample Reference No:</b>	039
		<b>Position:</b>	Internal
<b>Product Type:</b>		<b>Approx Size of Item:</b>	1 Items
<b>Comments:</b>

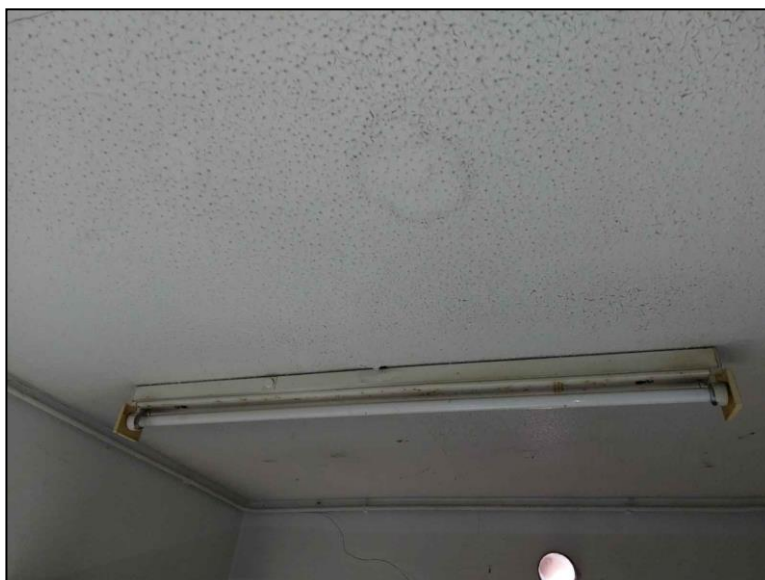
<b>Client:</b>	Great Western Railway	<b>Area No:</b>	021
		<b>Floor:</b>	Ground
<b>Site Address:</b>	Ex-Royal British Legion Building, New Road, Moreton-in-Marsh, Gloucestershire, GL56 0AS	<b>Area Description:</b>	Male WC
<b>Building:</b>	.	<b>Material Description:</b>	Textured coating to ceiling
<b>Building Address:</b>	As Above	<b>Survey Report Reference:</b>	234636-987722-0001

<b>Asbestos Type:</b>	1 - Chrysotile	<b>Sample Reference No:</b>	040
		<b>Position:</b>	Internal
<b>Product Type:</b>	1 - Asbestos composites, decorative finishes, AC	<b>Approx Size of Item:</b>	8 m <sup>2</sup>
<b>Comments:</b>

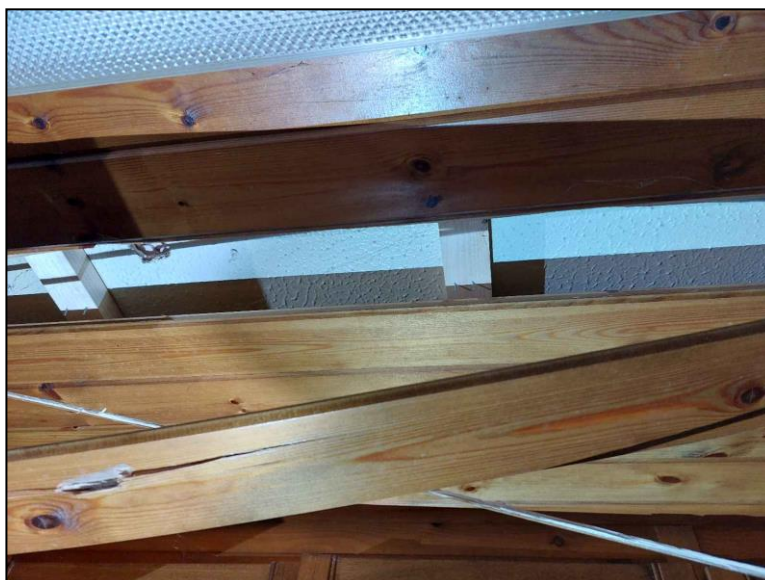
<b>Client:</b>	Great Western Railway	<b>Area No:</b>	022
		<b>Floor:</b>	Ground
<b>Site Address:</b>	Ex-Royal British Legion Building, New Road, Moreton-in-Marsh, Gloucestershire, GL56 0AS	<b>Area Description:</b>	Corridor
<b>Building:</b>	.	<b>Material Description:</b>	Textured coating to ceiling
<b>Building Address:</b>	As Above	<b>Survey Report Reference:</b>	234636-987722-0001

<b>Sample Reference No:</b>	041
<b>Asbestos Type:</b>	1 - Chrysotile	<b>Position:</b>	Internal
<b>Product Type:</b>	1 - Asbestos composites, decorative finishes, AC	<b>Approx Size of Item:</b>	3 m <sup>2</sup>
<b>Comments:</b>

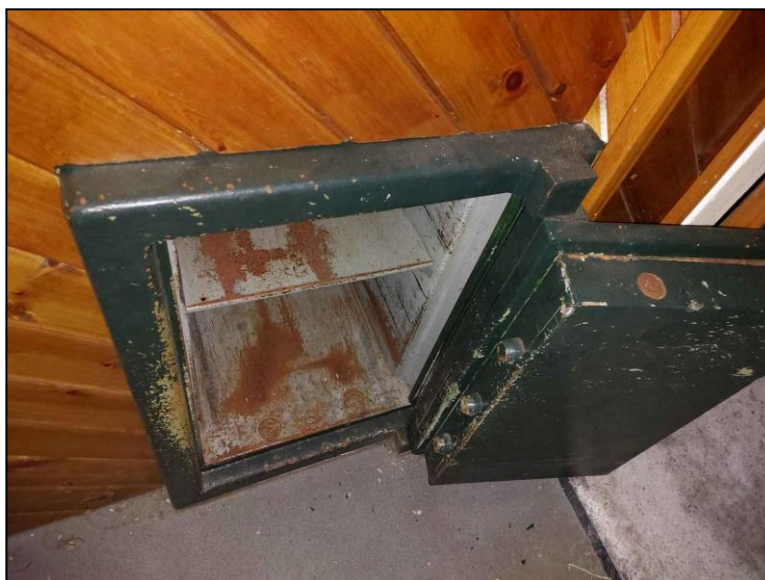
<b>Client:</b>	Great Western Railway	<b>Area No:</b>	022
		<b>Floor:</b>	Ground
<b>Site Address:</b>	Ex-Royal British Legion Building, New Road, Moreton-in-Marsh, Gloucestershire, GL56 0AS	<b>Area Description:</b>	Corridor
<b>Building:</b>	.	<b>Material Description:</b>	Insulation within Safe
<b>Building Address:</b>	As Above	<b>Survey Report Reference:</b>	234636-987722-0001

Sample Reference No:	P002	
Asbestos Type:	1 - Chrysotile	Position:	Internal
Product Type:	2 - AIB, Millboard, gaskets, paper etc	Approx Size of Item:	1 Items
Comments:	Presumption Reason: Sealed unit

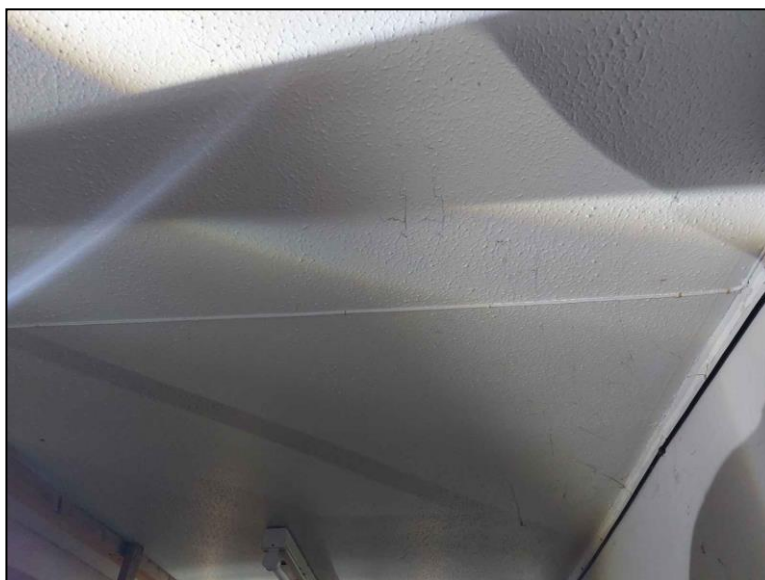
<b>Client:</b>	Great Western Railway	<b>Area No:</b>	023
		<b>Floor:</b>	Ground
<b>Site Address:</b>	Ex-Royal British Legion Building, New Road, Moreton-in-Marsh, Gloucestershire, GL56 0AS	<b>Area Description:</b>	Ante Room
<b>Building:</b>	.	<b>Material Description:</b>	Textured coating to ceiling
<b>Building Address:</b>	As Above	<b>Survey Report Reference:</b>	234636-987722-0001

<b>Sample Reference No:</b>	042
<b>Asbestos Type:</b>	1 - Chrysotile	<b>Position:</b>	Internal
<b>Product Type:</b>	1 - Asbestos composites, decorative finishes, AC	<b>Approx Size of Item:</b>	14 m <sup>2</sup>
<b>Comments:</b>

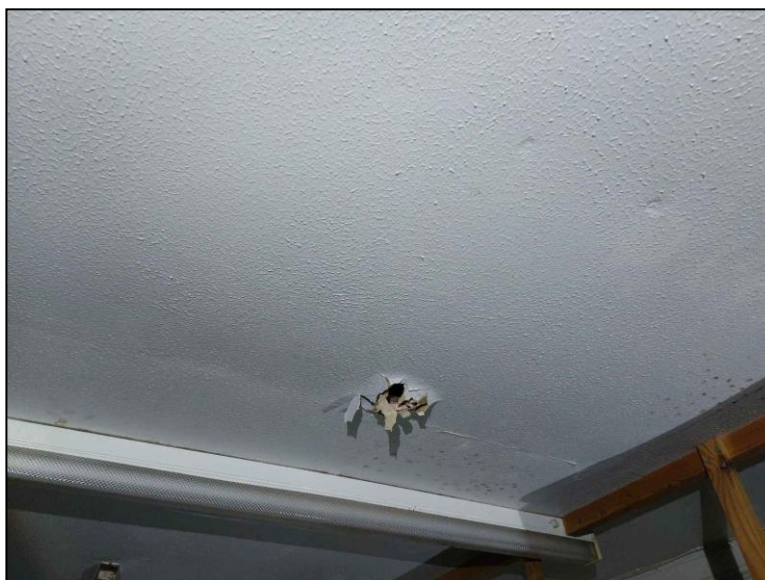
<b>Client:</b>	Great Western Railway	<b>Area No:</b>	024
		<b>Floor:</b>	Ground
<b>Site Address:</b>	Ex-Royal British Legion Building, New Road, Moreton-in-Marsh, Gloucestershire, GL56 0AS	<b>Area Description:</b>	Cellar
<b>Building:</b>	.	<b>Material Description:</b>	Textured coating to ceiling
<b>Building Address:</b>	As Above	<b>Survey Report Reference:</b>	234636-987722-0001

<b>Sample Reference No:</b>	043
<b>Asbestos Type:</b>	1 - Chrysotile	<b>Position:</b>	Internal
<b>Product Type:</b>	1 - Asbestos composites, decorative finishes, AC	<b>Approx Size of Item:</b>	15 m <sup>2</sup>
<b>Comments:</b>

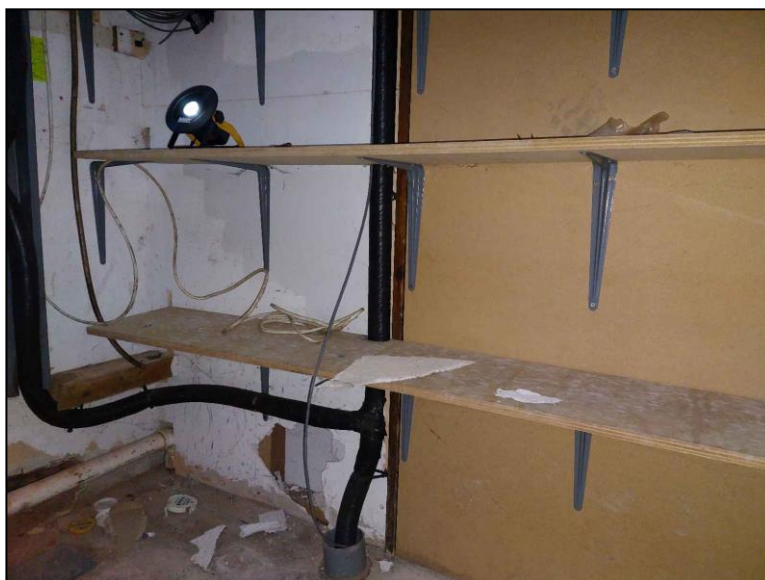
<b>Client:</b>	Great Western Railway	<b>Area No:</b>	024
		<b>Floor:</b>	Ground
<b>Site Address:</b>	Ex-Royal British Legion Building, New Road, Moreton-in-Marsh, Gloucestershire, GL56 0AS	<b>Area Description:</b>	Cellar
<b>Building:</b>	.	<b>Material Description:</b>	Insulating board wall panels
<b>Building Address:</b>	As Above	<b>Survey Report Reference:</b>	234636-987722-0001

<b>Sample Reference No:</b>	044
<b>Asbestos Type:</b>	2 - Amosite/other amphiboles (not Crocidolite) and Chrysotile	<b>Position:</b>	Internal
<b>Product Type:</b>	2 - AIB, Millboard, gaskets, paper etc	<b>Approx Size of Item:</b>	9 m <sup>2</sup>
<b>Comments:</b>

Area No	Area Description	Material Description	Approx size of item	Sample or Associate Sample Reference	Asbestos Type	Product Type	Comments on Limited / No Access
020	Ground Floor - Female WC	Textured coating to ceiling	12 m <sup>2</sup>	036	1	1	
020	Ground Floor - Female WC	Cement panel within bunny burner	1 Items	037	1	1	
020	Ground Floor - Female WC	Cement flue to bunny burner	1 Linear M	038	1	1	
020	Ground Floor - Female WC	Bakelite toilet cistern	1 Items	039	0		
021	Ground Floor - Male WC	Textured coating to ceiling	8 m <sup>2</sup>	040	1	1	
022	Ground Floor - Corridor	Textured coating to ceiling	3 m <sup>2</sup>	041	1	1	
022	Ground Floor - Corridor	Insulation within Safe	1 Items	P002	1	2	
023	Ground Floor - Ante Room	Textured coating to ceiling	14 m <sup>2</sup>	042	1	1	
024	Ground Floor - Cellar	Textured coating to ceiling	15 m <sup>2</sup>	043	1	1	
024	Ground Floor - Cellar	Insulating board wall panels	9 m <sup>2</sup>	044	2	2

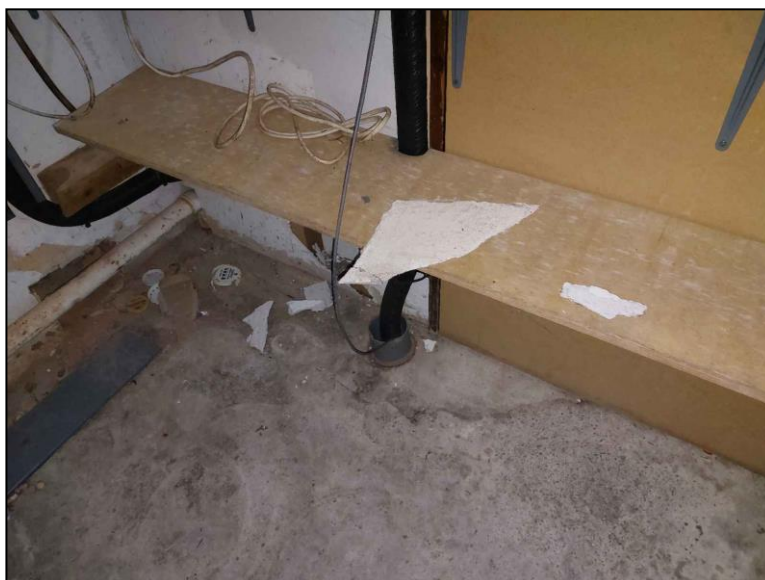
<b>Client:</b>	Great Western Railway	<b>Area No:</b>	024
		<b>Floor:</b>	Ground
<b>Site Address:</b>	Ex-Royal British Legion Building, New Road, Moreton-in-Marsh, Gloucestershire, GL56 0AS	<b>Area Description:</b>	Cellar
<b>Building:</b>	.	<b>Material Description:</b>	Insulating board debris
<b>Building Address:</b>	As Above	<b>Survey Report Reference:</b>	234636-987722-0001

<b>Sample Reference No:</b>	045
<b>Asbestos Type:</b>	2 - Amosite/other amphiboles (not Crocidolite) and Chrysotile	<b>Position:</b>	Internal
<b>Product Type:</b>	2 - AIB, Millboard, gaskets, paper etc	<b>Approx Size of Item:</b>	. Small Amounts
<b>Comments:</b>	located to floor and shelving to room

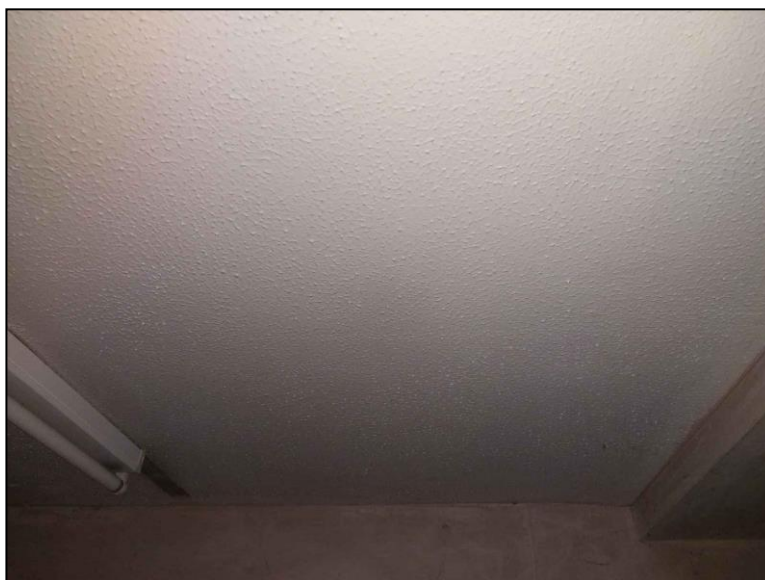
<b>Client:</b>	Great Western Railway	<b>Area No:</b>	025
		<b>Floor:</b>	Ground
<b>Site Address:</b>	Ex-Royal British Legion Building, New Road, Moreton-in-Marsh, Gloucestershire, GL56 0AS	<b>Area Description:</b>	Kitchen
<b>Building:</b>	.	<b>Material Description:</b>	Textured coating to ceiling
<b>Building Address:</b>	As Above	<b>Survey Report Reference:</b>	234636-987722-0001

<b>Sample Reference No:</b>	046
<b>Asbestos Type:</b>	1 - Chrysotile	<b>Position:</b>	Internal
<b>Product Type:</b>	1 - Asbestos composites, decorative finishes, AC	<b>Approx Size of Item:</b>	12 m <sup>2</sup>
<b>Comments:</b>

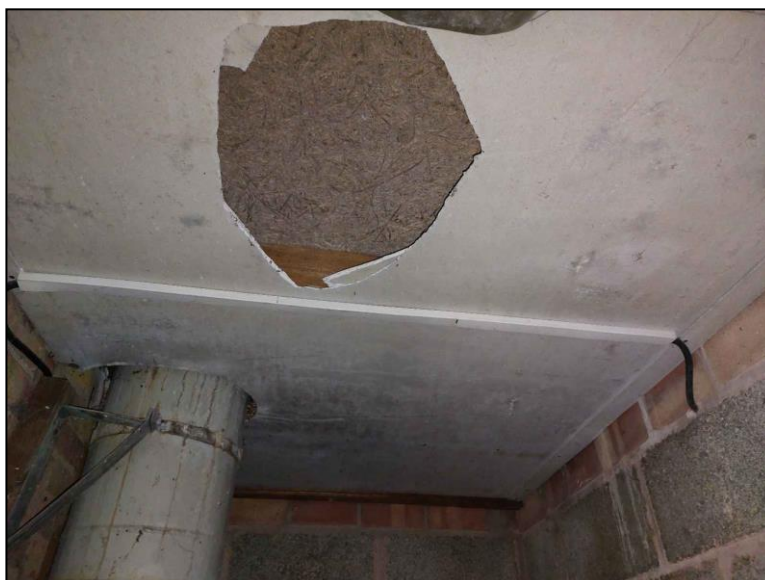
<b>Client:</b>	Great Western Railway	<b>Area No:</b>	026
		<b>Floor:</b>	Ground
<b>Site Address:</b>	Ex-Royal British Legion Building, New Road, Moreton-in-Marsh, Gloucestershire, GL56 0AS	<b>Area Description:</b>	Plant Room
<b>Building:</b>	.	<b>Material Description:</b>	Insulating board ceiling panels
<b>Building Address:</b>	As Above	<b>Survey Report Reference:</b>	234636-987722-0001

<b>Asbestos Type:</b>	2 - Amosite/other amphiboles (not Crocidolite) and Chrysotile	<b>Sample Reference No:</b>	050
		<b>Position:</b>	Internal
<b>Product Type:</b>	2 - AIB, Millboard, gaskets, paper etc	<b>Approx Size of Item:</b>	3 m <sup>2</sup>
<b>Comments:</b>

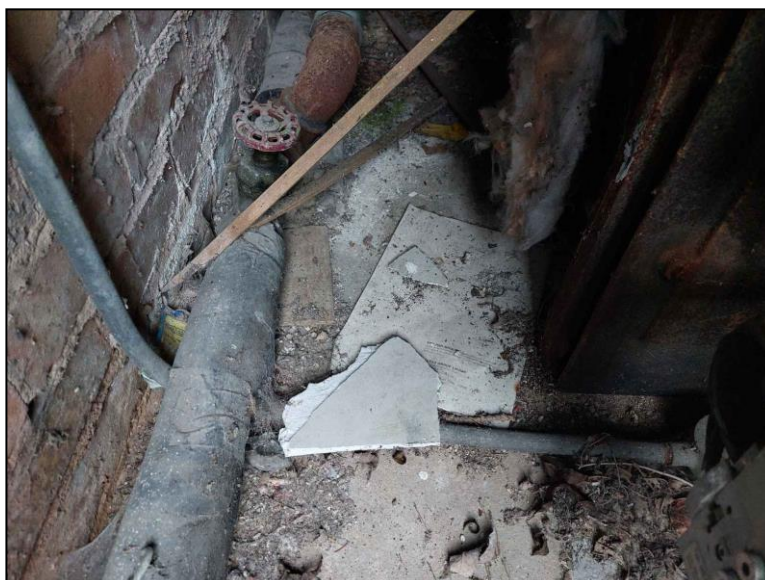
<b>Client:</b>	Great Western Railway	<b>Area No:</b>	026
		<b>Floor:</b>	Ground
<b>Site Address:</b>	Ex-Royal British Legion Building, New Road, Moreton-in-Marsh, Gloucestershire, GL56 0AS	<b>Area Description:</b>	Plant Room
<b>Building:</b>	.	<b>Material Description:</b>	Insulating board debris
<b>Building Address:</b>	As Above	<b>Survey Report Reference:</b>	234636-987722-0001

<b>Sample Reference No:</b>	051
<b>Asbestos Type:</b>	2 - Amosite/other amphiboles (not Crocidolite) and Chrysotile	<b>Position:</b>	Internal
<b>Product Type:</b>	2 - AIB, Millboard, gaskets, paper etc	<b>Approx Size of Item:</b>	. Small Amounts
<b>Comments:</b>	located sporadically throughout floor

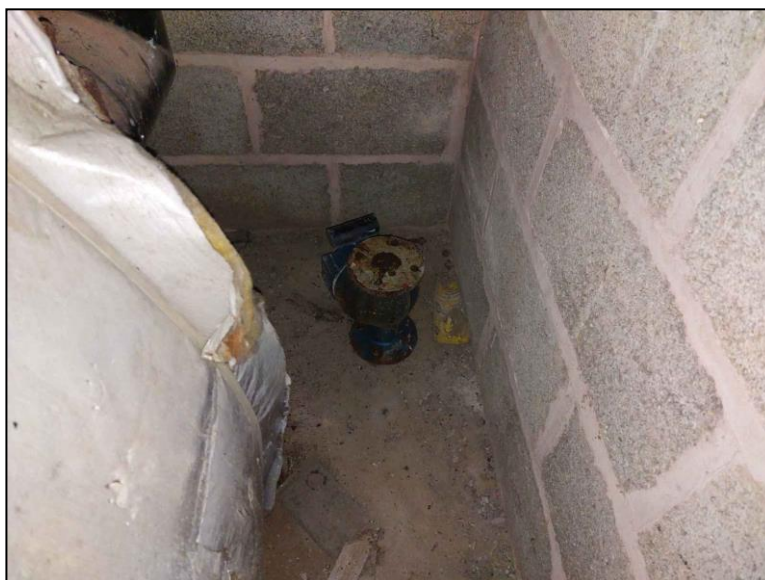
<b>Client:</b>	Great Western Railway	<b>Area No:</b>	026
		<b>Floor:</b>	Ground
<b>Site Address:</b>	Ex-Royal British Legion Building, New Road, Moreton-in-Marsh, Gloucestershire, GL56 0AS	<b>Area Description:</b>	Plant Room
<b>Building:</b>	.	<b>Material Description:</b>	Gaskets to pipework
<b>Building Address:</b>	As Above	<b>Survey Report Reference:</b>	234636-987722-0001

<b>Sample Reference No:</b>	052
<b>Asbestos Type:</b>	1 - Chrysotile	<b>Position:</b>	Internal
<b>Product Type:</b>	2 - AIB, Millboard, gaskets, paper etc	<b>Approx Size of Item:</b>	4 Items
<b>Comments:</b>	located to fixed and redundant pipework

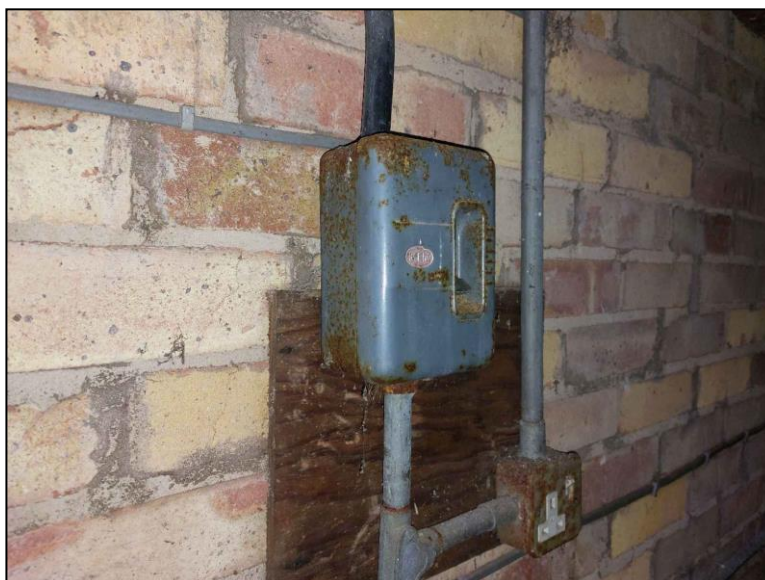
<b>Client:</b>	Great Western Railway	<b>Area No:</b>	026
		<b>Floor:</b>	Ground
<b>Site Address:</b>	Ex-Royal British Legion Building, New Road, Moreton-in-Marsh, Gloucestershire, GL56 0AS	<b>Area Description:</b>	Plant Room
<b>Building:</b>	.	<b>Material Description:</b>	Electrical Switchgear
<b>Building Address:</b>	As Above	<b>Survey Report Reference:</b>	234636-987722-0001

Sample Reference No:	P003
Asbestos Type:	1 - Chrysotile	Position: Internal
Product Type:	2 - AIB, Millboard, gaskets, paper etc	Approx Size of Item: 1 Items
Comments:	MEM box to wall Presumption Reason: No isolation certificate provided

Sample Reference	Building	Area Description	Material	Action	Timescale for Action
P003	0001	Ground Floor - 026-Plant Room	Electrical Switchgear	Recommend Future Sample  Presumption Reasons: No isolation certificate provided .	Prior to Refurbishment
053	0001	Ground Floor - EXT-External	Gaskets to light fittings	Remove	Prior to Refurbishment
055	0001	Ground Floor - EXT-External	Cement debris to floor	Remove	Prior to Refurbishment
056	0001	Ground Floor - EXT-External	Cement flue to wall	Remove	Prior to Refurbishment

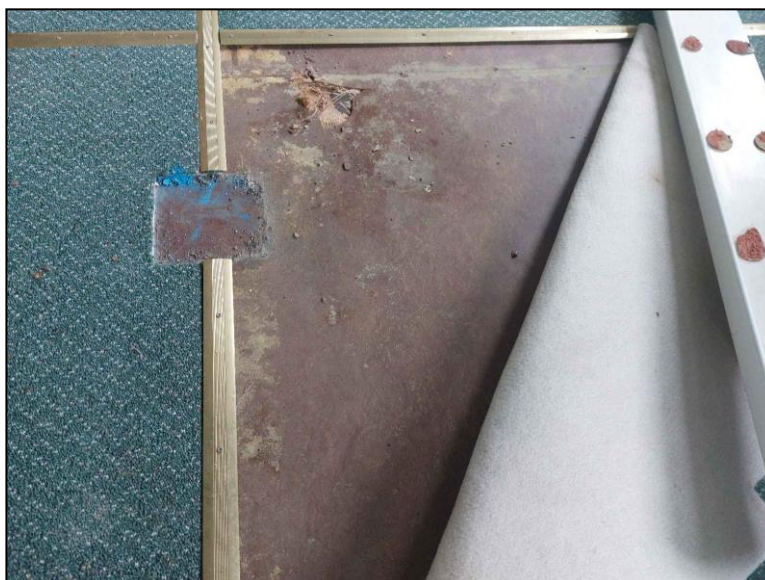
<b>Client:</b>	Great Western Railway	<b>Area No:</b>	027
		<b>Floor:</b>	First
<b>Site Address:</b>	Ex-Royal British Legion Building, New Road, Moreton-in-Marsh, Gloucestershire, GL56 0AS	<b>Area Description:</b>	Snooker Room
<b>Building:</b>	.	<b>Material Description:</b>	Red hessian backed linoleum floor covering to floor
<b>Building Address:</b>	As Above	<b>Survey Report Reference:</b>	234636-987722-0001

<b>Sample Reference No:</b>	048
<b>Asbestos Type:</b>	0 - No asbestos detected	<b>Position:</b>	Internal
<b>Product Type:</b>		<b>Approx Size of Item:</b>	90 m <sup>2</sup>
<b>Comments:</b>

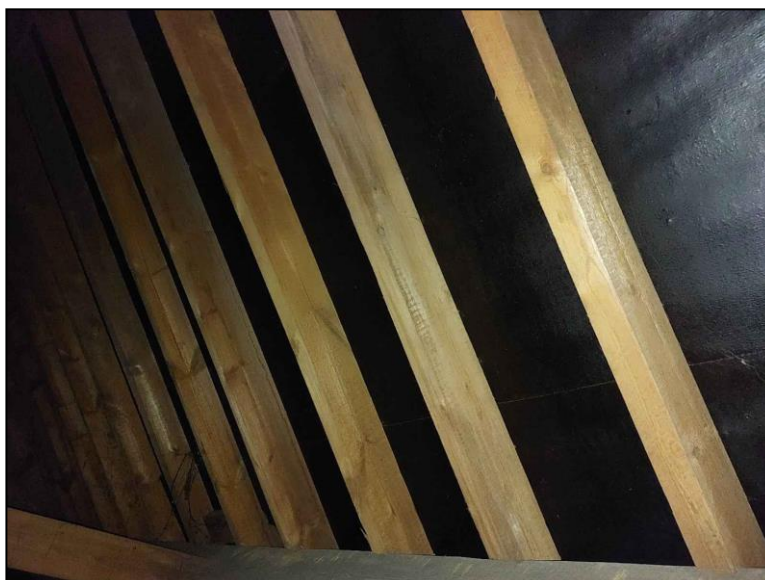
<b>Client:</b>	Great Western Railway	<b>Area No:</b>	028
		<b>Floor:</b>	First
<b>Site Address:</b>	Ex-Royal British Legion Building, New Road, Moreton-in-Marsh, Gloucestershire, GL56 0AS	<b>Area Description:</b>	Loft Space
<b>Building:</b>	.	<b>Material Description:</b>	Sarking felt
<b>Building Address:</b>	As Above	<b>Survey Report Reference:</b>	234636-987722-0001

<b>Asbestos Type:</b>	0 - No asbestos detected	<b>Sample Reference No:</b>	049
		<b>Position:</b>	Internal
<b>Product Type:</b>		<b>Approx Size of Item:</b>	90 m <sup>2</sup>
<b>Comments:</b>

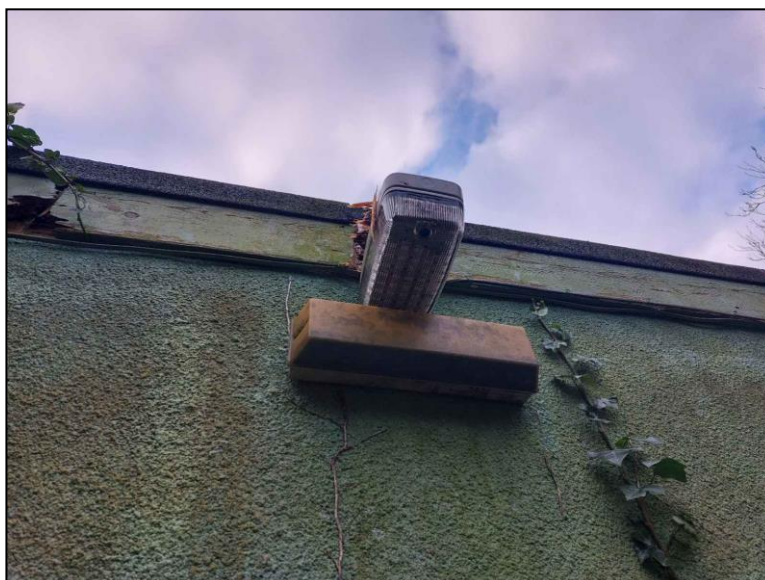
<b>Client:</b>	Great Western Railway	<b>Area No:</b>	EXT
		<b>Floor:</b>	Ground
<b>Site Address:</b>	Ex-Royal British Legion Building, New Road, Moreton-in-Marsh, Gloucestershire, GL56 0AS	<b>Area Description:</b>	External
<b>Building:</b>	.	<b>Material Description:</b>	Gaskets to light fittings
<b>Building Address:</b>	As Above	<b>Survey Report Reference:</b>	234636-987722-0001

<b>Asbestos Type:</b>	1 - Chrysotile	<b>Sample Reference No:</b>	053
		<b>Position:</b>	External
<b>Product Type:</b>	2 - AIB, Millboard, gaskets, paper etc	<b>Approx Size of Item:</b>	6 Items
<b>Comments:</b>	3 x separate light units

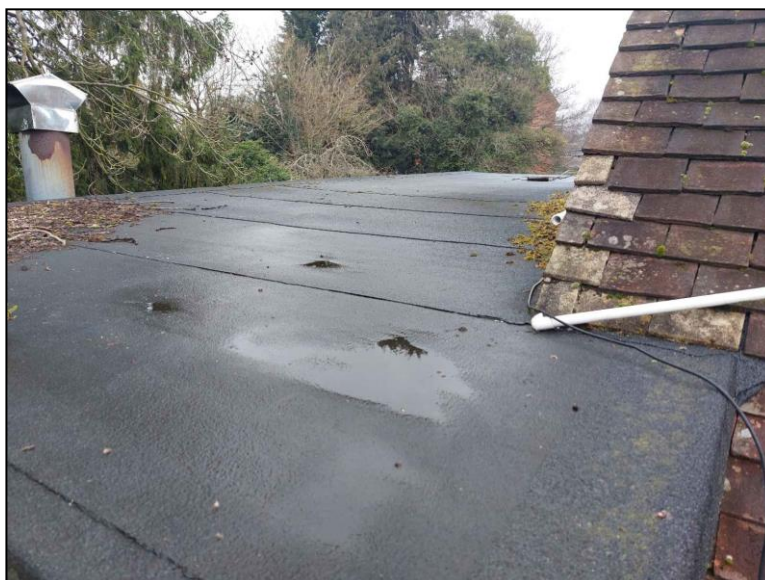
<b>Client:</b>	Great Western Railway	<b>Area No:</b>	EXT
		<b>Floor:</b>	Ground
<b>Site Address:</b>	Ex-Royal British Legion Building, New Road, Moreton-in-Marsh, Gloucestershire, GL56 0AS	<b>Area Description:</b>	External
<b>Building:</b>	.	<b>Material Description:</b>	Bitumen felt to flat roof
<b>Building Address:</b>	As Above	<b>Survey Report Reference:</b>	234636-987722-0001

<b>Asbestos Type:</b>	0 - No asbestos detected	<b>Sample Reference No:</b>	054
		<b>Position:</b>	External
<b>Product Type:</b>		<b>Approx Size of Item:</b>	200 m <sup>2</sup>
<b>Comments:</b>

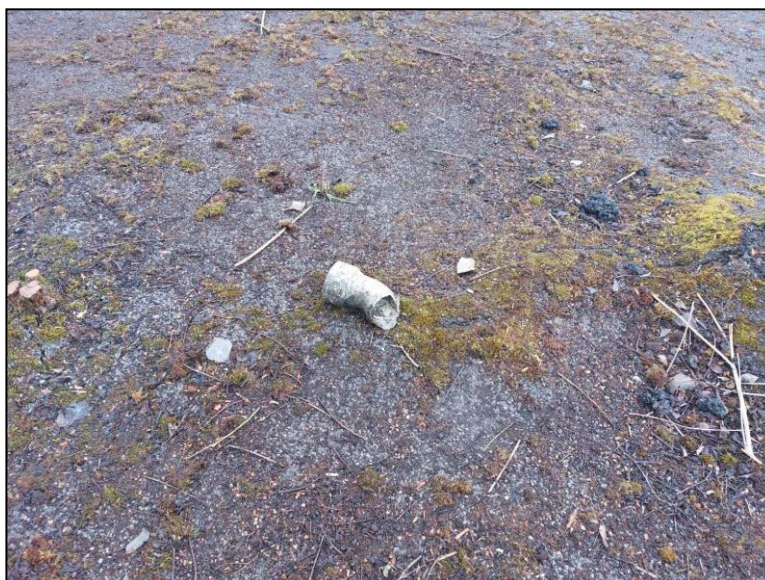
<b>Client:</b>	Great Western Railway	<b>Area No:</b>	EXT
		<b>Floor:</b>	Ground
<b>Site Address:</b>	Ex-Royal British Legion Building, New Road, Moreton-in-Marsh, Gloucestershire, GL56 0AS	<b>Area Description:</b>	External
<b>Building:</b>	.	<b>Material Description:</b>	Cement debris to floor
<b>Building Address:</b>	As Above	<b>Survey Report Reference:</b>	234636-987722-0001

Sample Reference No: 055
Asbestos Type: 1 - Chrysotile	Position: External
Product Type: 1 - Asbestos composites, decorative finishes, AC	Approx Size of Item: . Small Amounts
Comments: located sporadically to floor throughout carpark

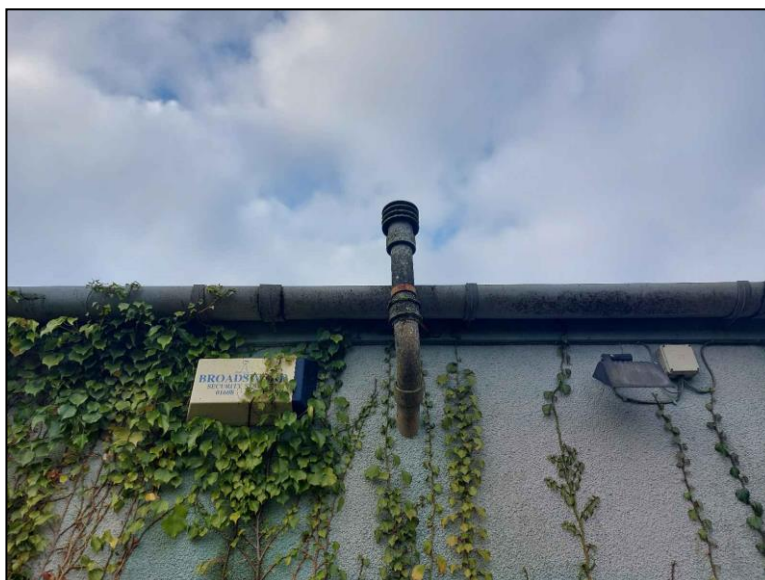
<b>Client:</b>	Great Western Railway	<b>Area No:</b>	EXT
		<b>Floor:</b>	Ground
<b>Site Address:</b>	Ex-Royal British Legion Building, New Road, Moreton-in-Marsh, Gloucestershire, GL56 0AS	<b>Area Description:</b>	External
<b>Building:</b>	.	<b>Material Description:</b>	Cement flue to wall
<b>Building Address:</b>	As Above	<b>Survey Report Reference:</b>	234636-987722-0001

<b>Asbestos Type:</b>	1 - Chrysotile	<b>Sample Reference No:</b>	056
		<b>Position:</b>	External
<b>Product Type:</b>	1 - Asbestos composites, decorative finishes, AC	<b>Approx Size of Item:</b>	1 Linear M
<b>Comments:</b>	located to wall adjacent to female toilets

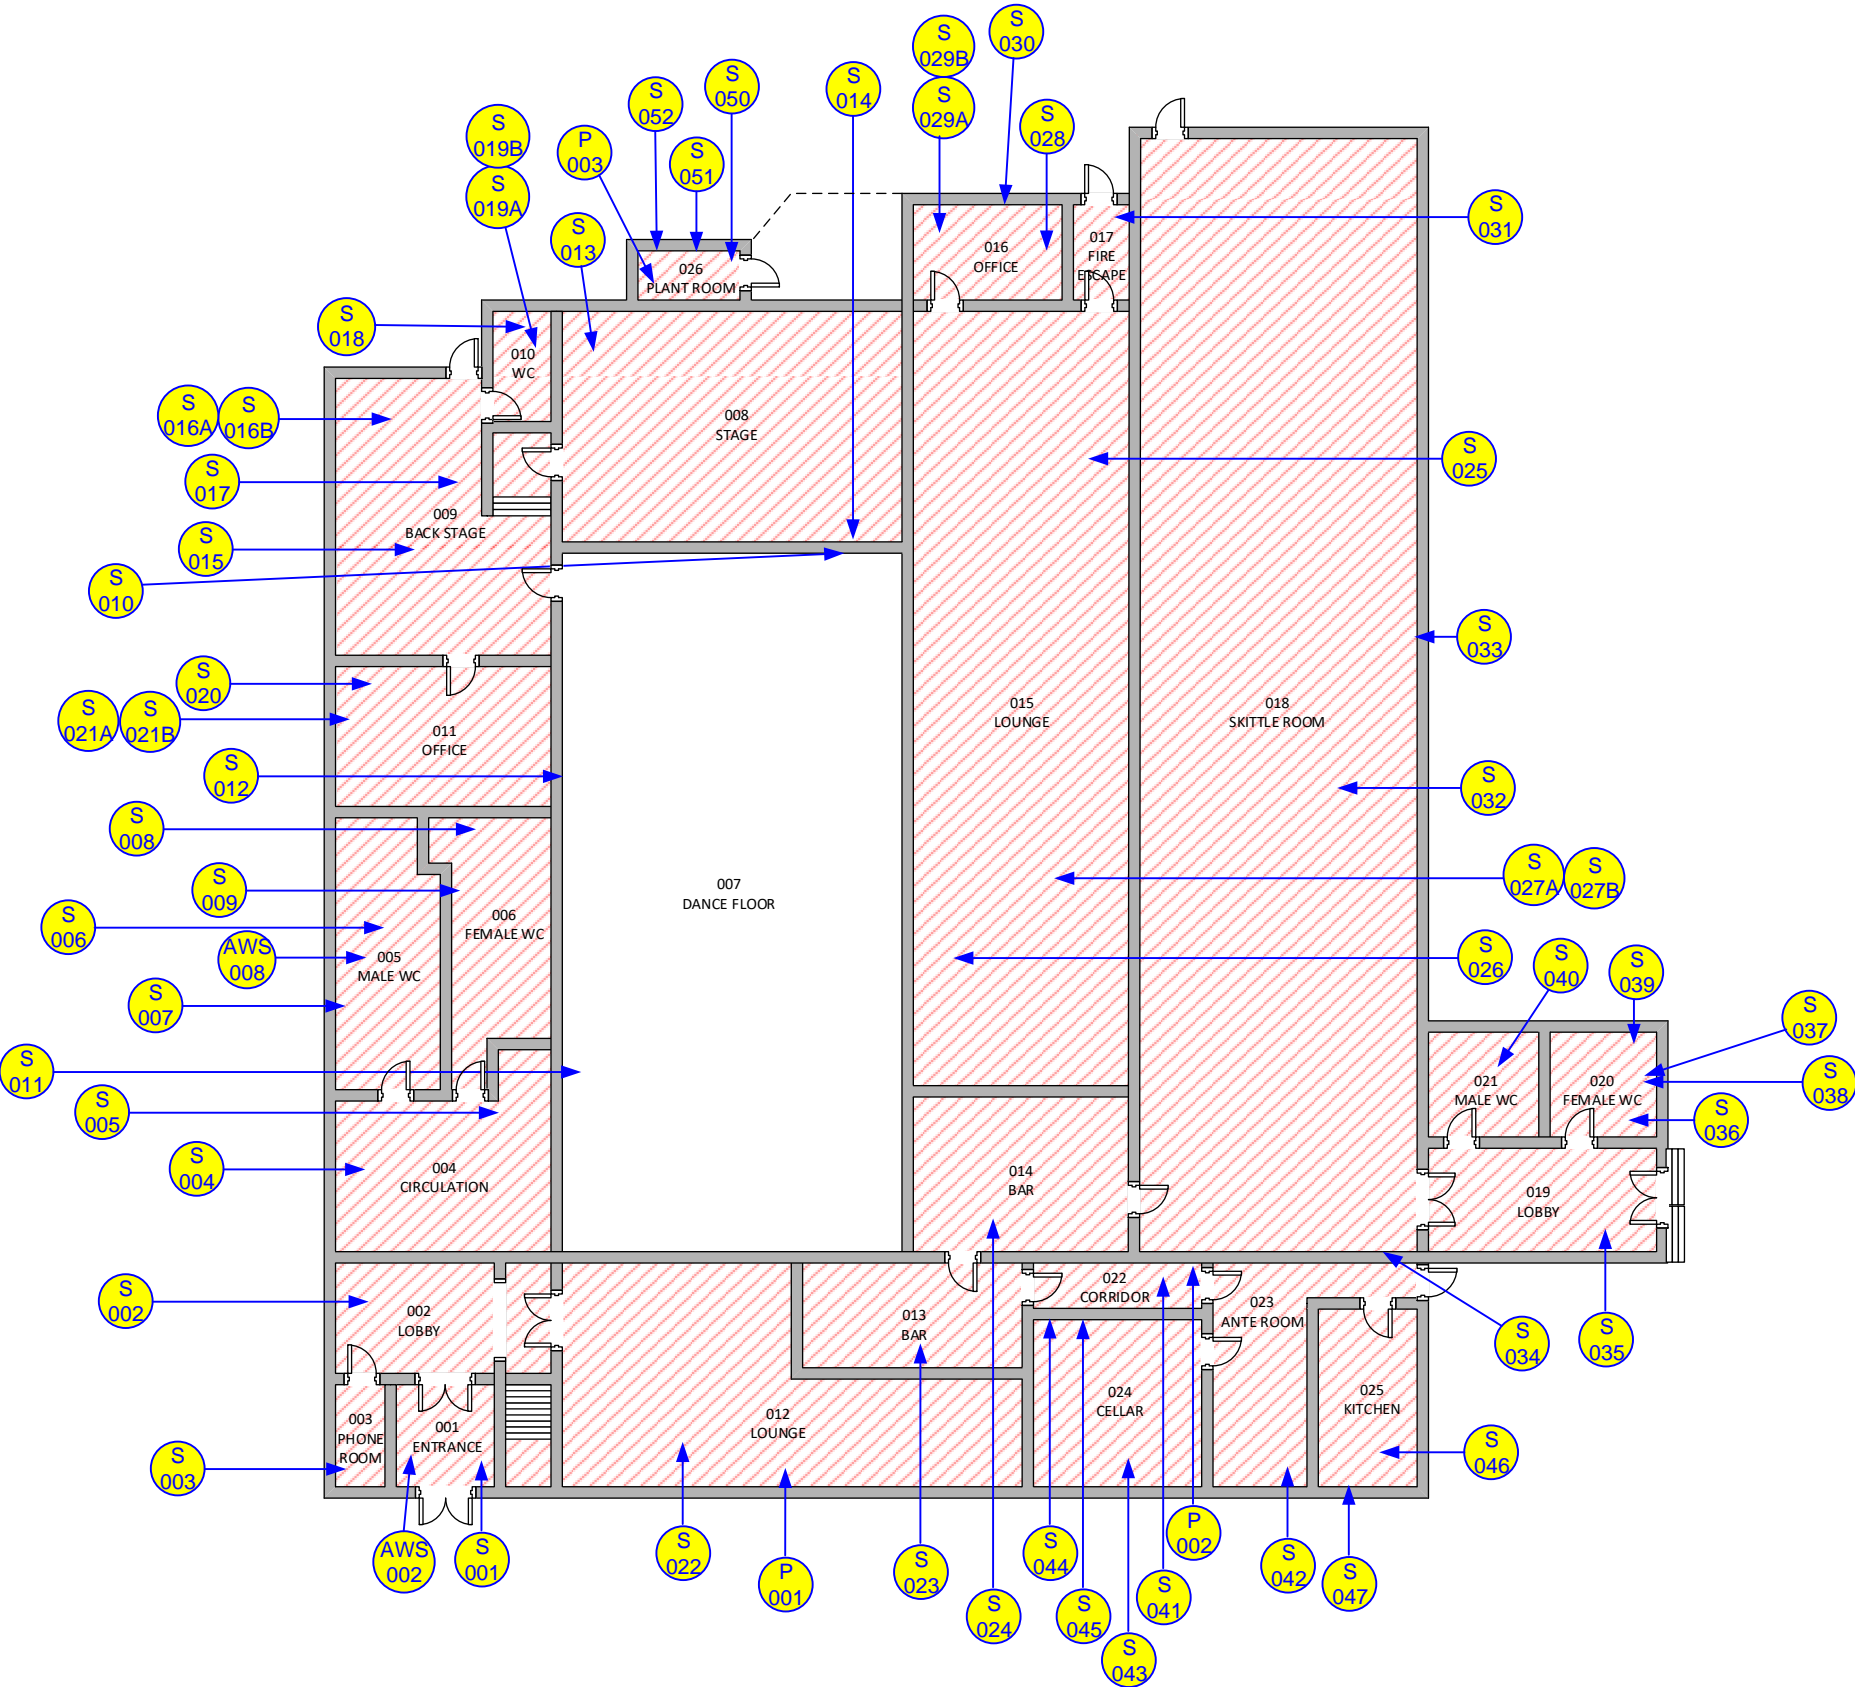
GROUND FLOOR:

Site Address	Ex-Royal British Legion, New Road, Moreton-in-Marsh, Gloucestershire, GL56 0AA		
Survey Reference	234636-987722		
Date of Survey/Inspection	27/02/2023		
Surveyors	C Howells & O Howells		
PAGE 1 OF 4		Not to Scale
