**PRE-CONSTRUCTION  
INFORMATION**

**DEMOLITION &  
CLEARANCE OF  
FORMER ROYAL BRITISH  
LEGION BUILDING**

**MORETON-IN-MARSH**

**GREAT WESTERN  
RAILWAY &  
MORETON-IN-MARSH  
TOWN COUNCIL**

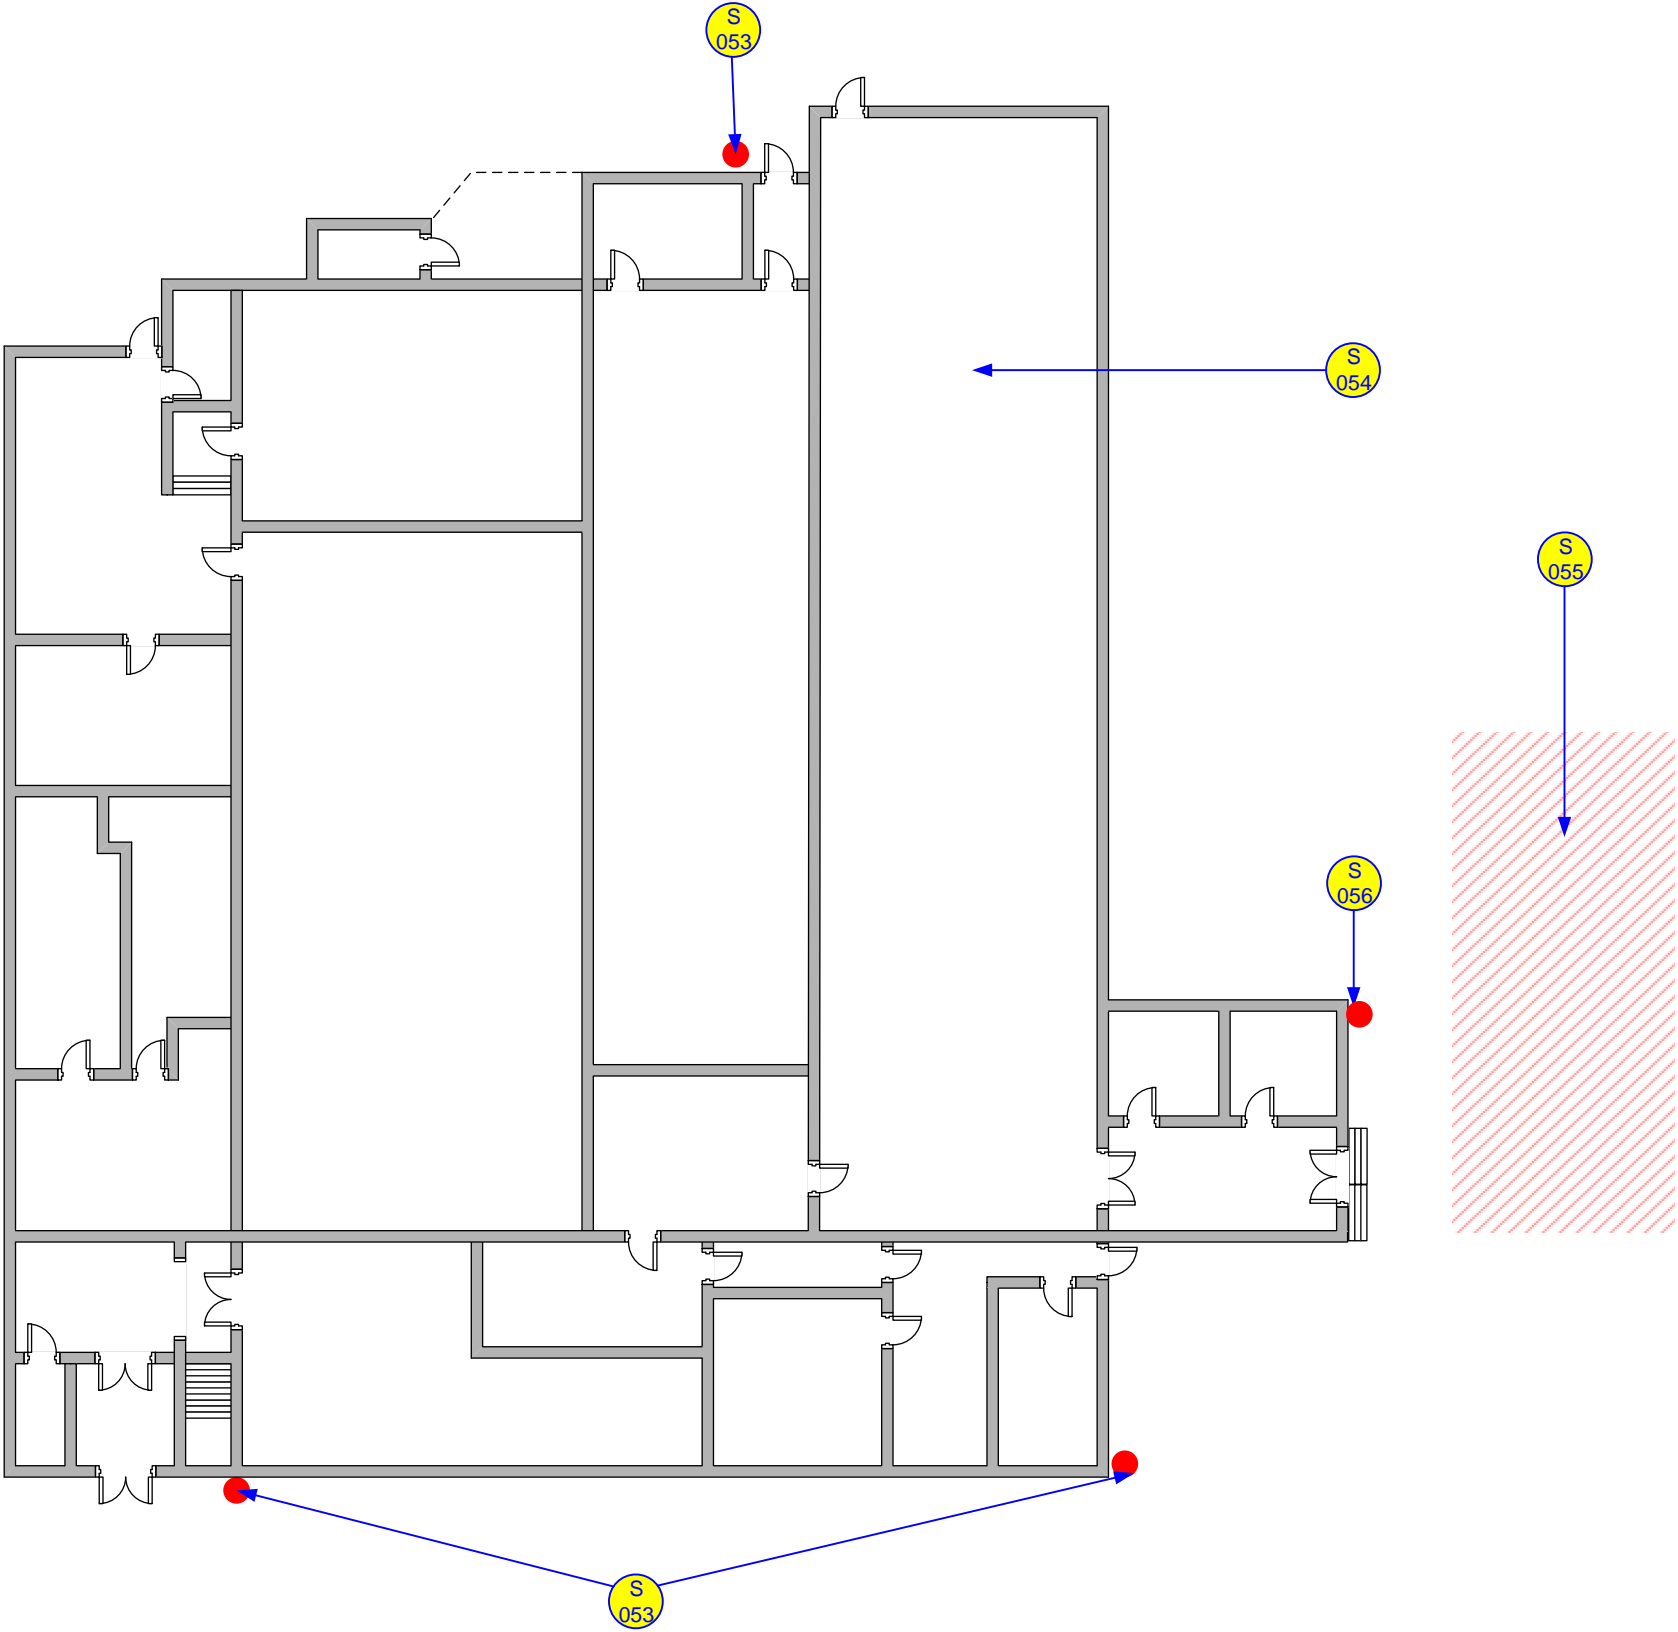
EXTERNAL

Client	Great Western Rail	Key:  AWS = As With Sample P = Presumed	Inspection Reference Location  Asbestos Present  Inaccessible Areas  Beyond Remit of Survey
Site Address	Ex-Royal British Legion, New Road, Moreton-in-Marsh, Gloucestershire, GL56 0AA		
Survey Reference	234636-987722		
Date of Survey/Inspection	27/02/2023		
Surveyors	C Howells & O Howells		
PAGE 4 OF 4		Not to Scale

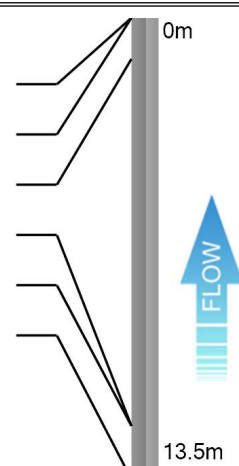
Position	Code	Description	CD	Pic	Video Ref	
00.00m	IC	Start node type, inspection chamber		0_0		
00.00m	R	S1 Roots	S1	0_2	0:00:00	
01.20m	CU	S2 Loss of vision	S2	0_3	0:00:10	
11.94m	CU	F2 Loss of vision	F2	0_-3	0:00:10	
11.94m	R	F1 Roots	F1	0_-2	0:00:00	
13.50m	ICF	Finish node type, inspection chamber		0_99

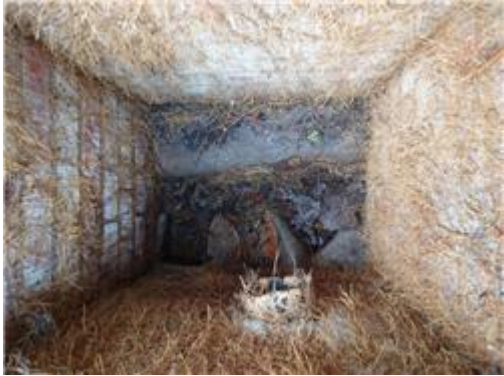
Pos	Video Ref	Code	Description	Image
00.00m		IC	Start node type, inspection chamber 1a	Image Provided - Ref: 0_0

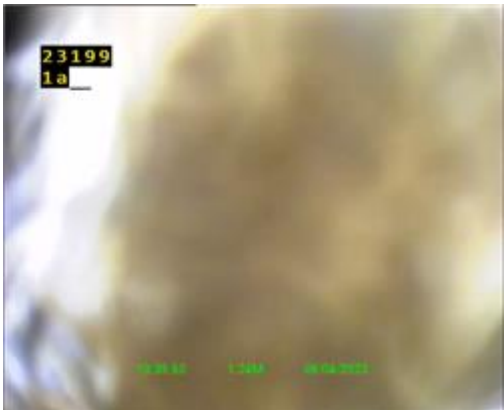
00.00m	0:00:00	S1 R	Roots 0m - 11.94m - Severity 3	Image Provided - Ref: 0_2  
01.20m	0:00:10	S2 CU	Loss of vision 1.2m - 11.94m Roots	Image Provided - Ref: 0_3

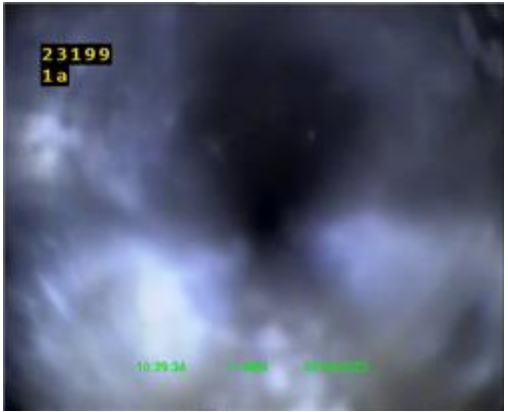
Pos	Video Ref	Code	Description	Image
11.94m	0:00:10	F2 CU	Loss of vision Defect End Roots	Image Provided - Ref: 0_-3

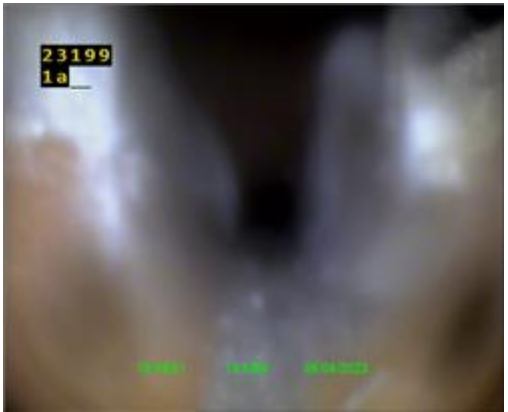
11.94m	0:00:00	F1 R	Roots Defect End - Severity 3	
13.50m		ICF	Finish node type, inspection chamber 6	Image Provided - Ref: 0_9999

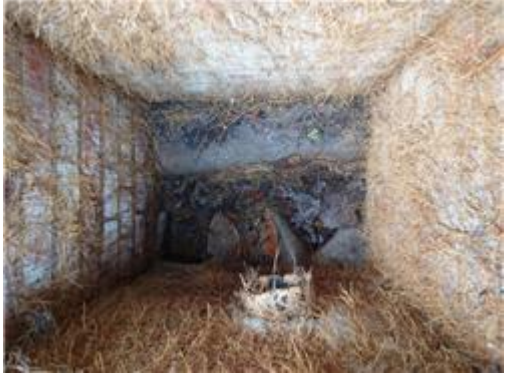
Pos	Video Ref	Code	Description	Image
00.00m		IC	Start node type, inspection chamber 1b	Image Provided - Ref: 1_0

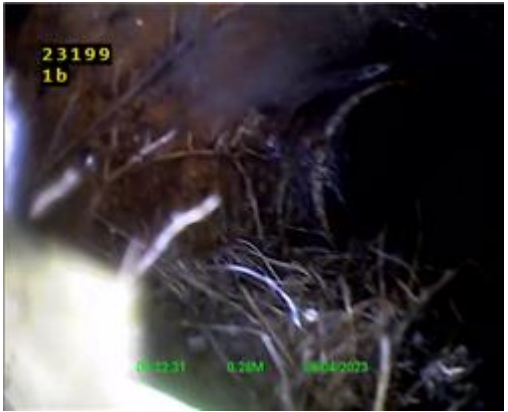
00.00m	0:00:09	S1 R	Roots 0m - 4.3m - Severity 3	Image Provided - Ref: 1_2

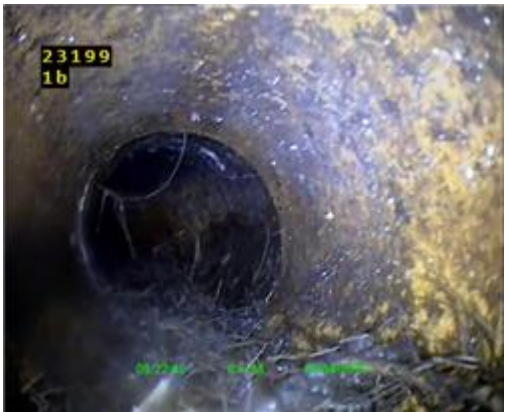
00.50m	0:00:25	LLH	Line of drain/sewer deviates left [half]	Image Provided - Ref: 1_3

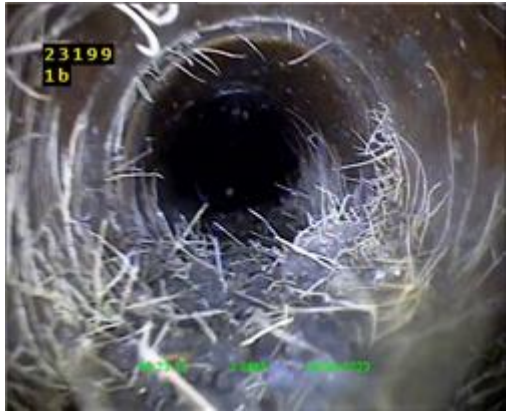
Pos	Video Ref	Code	Description	Image
03.84m	0:00:52	DES	Settled deposits fine: 10% Cross sectional area loss - Severity 3	Image Provided - Ref: 1_4

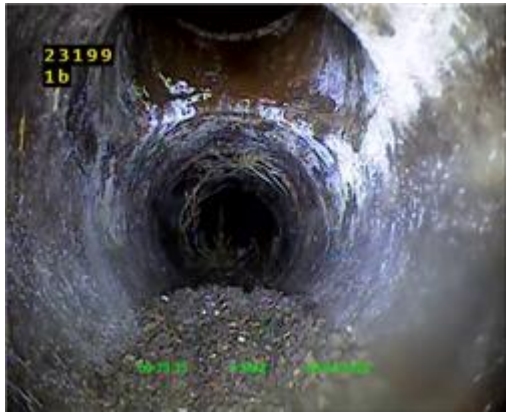
04.30m	0:00:09	F1 R	Roots Defect End - Severity 3	
08.30m	0:01:15	JN	Junction at 12 o'clock: 100mm Diameter	Image Provided - Ref: 1_5

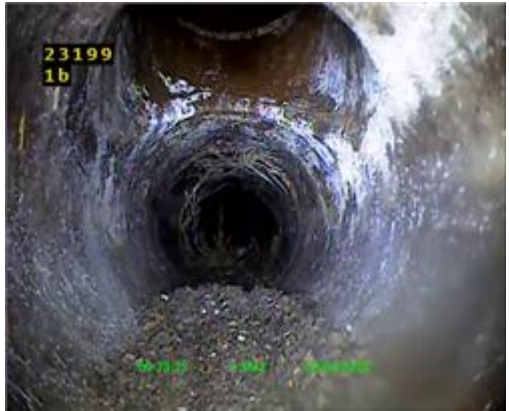
08.30m	0:01:15	DES	Settled deposits fine: 10% Cross sectional area loss - Severity 3	Image Provided - Ref: 1_6

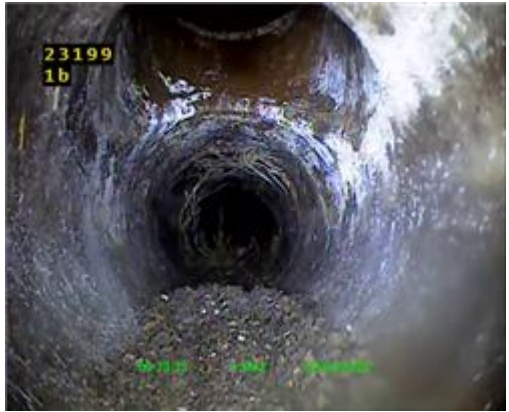
Pos	Video Ref	Code	Description	Image
08.30m	0:01:15	R	Roots - Severity 3	Image Provided - Ref: 1_7

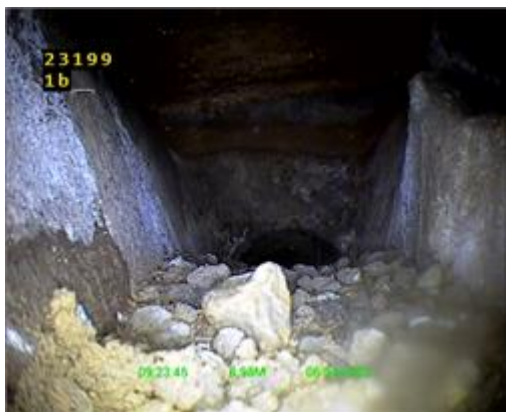
08.93m	0:01:22	DES	Settled deposits fine: 30% Cross sectional area loss - Severity 3	Image Provided - Ref: 1_8

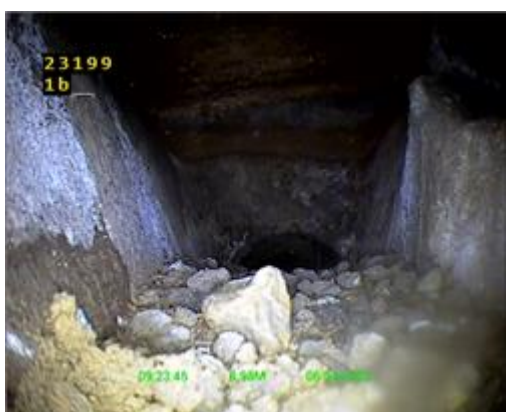
08.93m		ICF	Finish node type, inspection chamber Internal IC	Image Provided - Ref: 1_9999

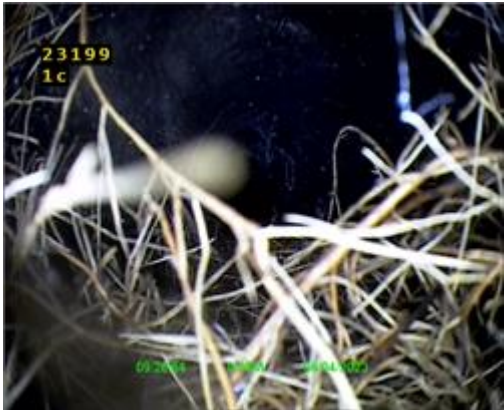
00.00m	0:00:00	R	Roots - Severity 3	Image Provided - Ref: 2_2

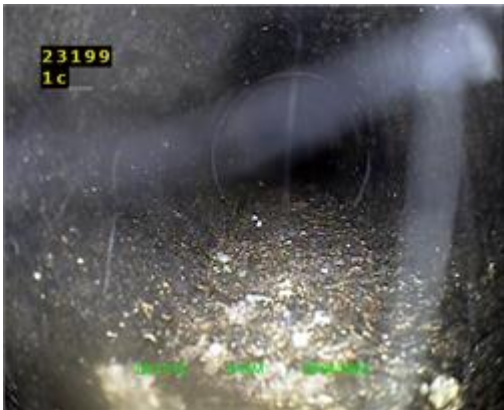
00.57m	0:00:23	DES	Settled deposits fine: 10% Cross sectional area loss - Severity 3	Image Provided - Ref: 2_3

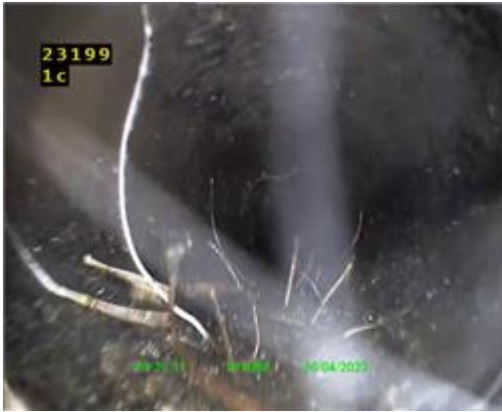
Pos	Video Ref	Code	Description	Image
10.60m	0:01:16	S1 R	Roots 10.6m - 13.31m - Severity 3	Image Provided - Ref: 2_4

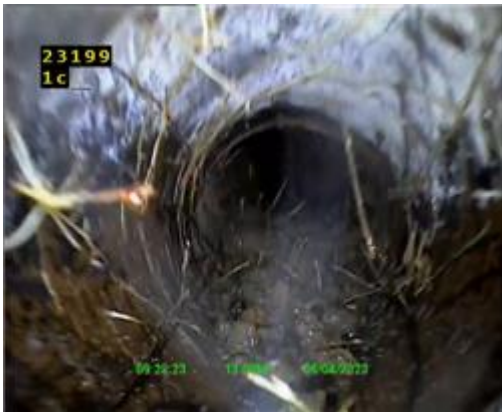
13.00m	0:01:28	DES	Settled deposits fine: 20% Cross sectional area loss - Severity 3	Image Provided - Ref: 2_5

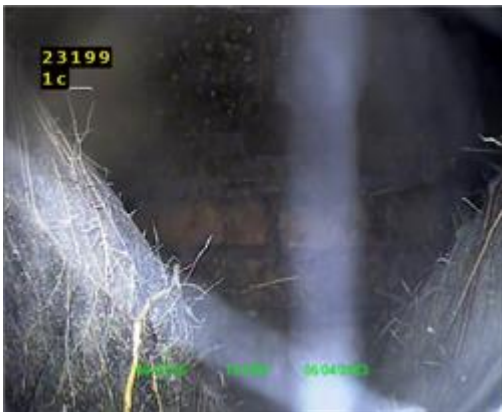
13.31m	0:01:16	F1 R	Roots Defect End - Severity 3	
13.31m		ICF	Finish node type, inspection chamber 2	Image Provided - Ref: 2_9999

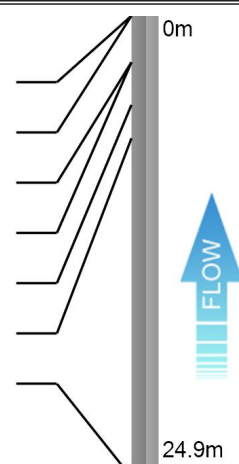
Position	Code	Description	CD	Pic	Video Ref	
00.00m	IC	Start node type, inspection chamber		3_0		
00.00m	R	S1 Roots	S1	3_2	0:00:00	
02.50m	R	F1 Roots	F1	3_-2	0:00:00	
02.50m	WL	Water level 10%		3_1	0:00:00	
04.80m	CU	S2 Loss of vision	S2	3_3	0:00:28	
06.60m	CU	F2 Loss of vision	F2	3_-3	0:00:28	
24.90m	ICF	Finish node type, inspection chamber		3_99

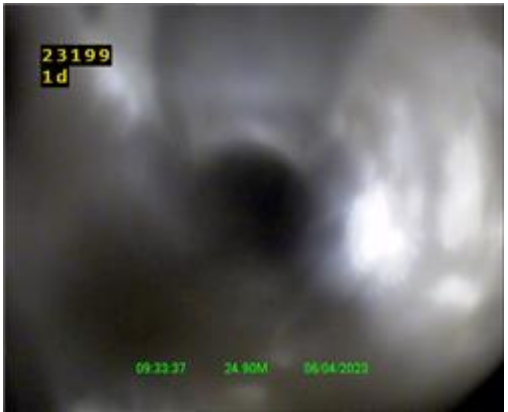
06.60m	0:00:28	F2 CU	Loss of vision Defect End	
24.90m		ICF	Finish node type, inspection chamber 3	Image Provided - Ref: 3_9999

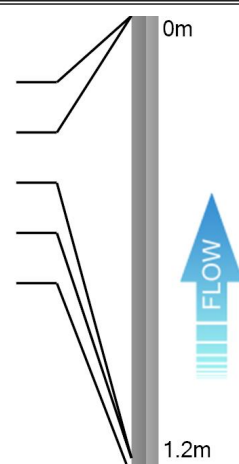
Position	Code	Description	CD	Pic	Video Ref	
00.00m	IC	Start node type, inspection chamber		4_0		
00.00m	R	S1 Roots	S1	4_2	0:00:00	
01.15m	R	F1 Roots	F1	4_-2	0:00:00	
01.15m	LDF	Line of drain/sewer deviates down [full]		4_3	0:00:33	
01.20m	GYF	Finish node type Gully		4_99

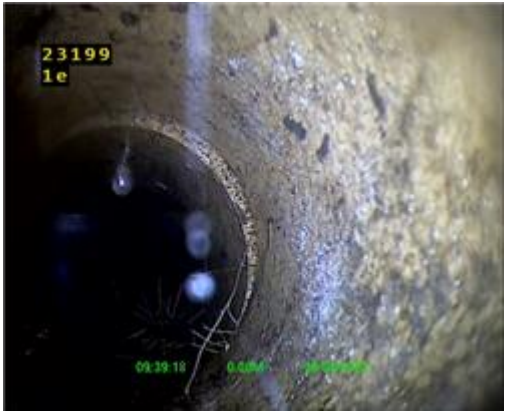
00.00m	0:00:00	S1 R	Roots 0m - 1.15m - Severity 3	Image Provided - Ref: 4_2

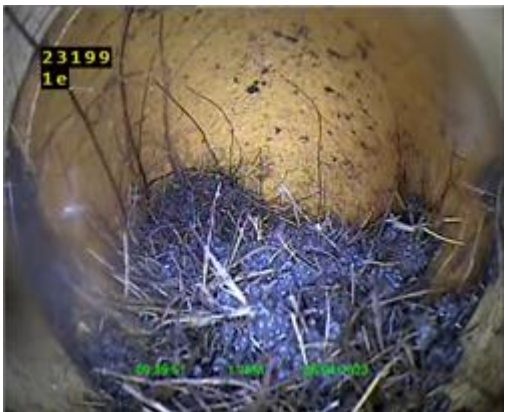
01.15m	0:00:00	F1 R	Roots Defect End - Severity 3	
01.15m	0:00:33	LDF	Line of drain/sewer deviates down [full]	Image Provided - Ref: 4_3

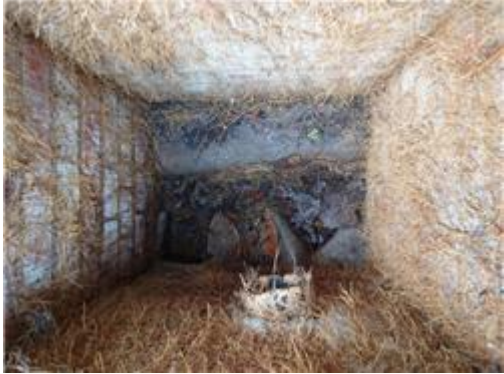
Pos	Video Ref	Code	Description	Image
00.00m		IC	Start node type, inspection chamber 1x	Image Provided - Ref: 5_0

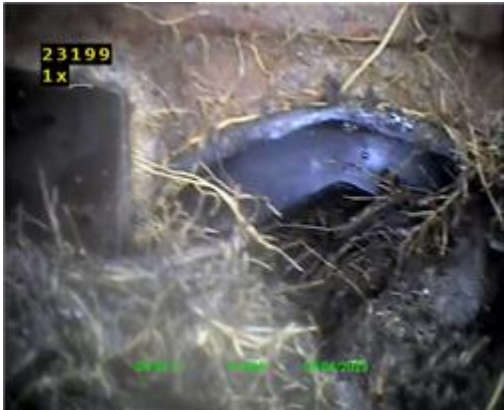
00.00m	0:00:10	R	Roots - Severity 3	Image Provided - Ref: 5_2

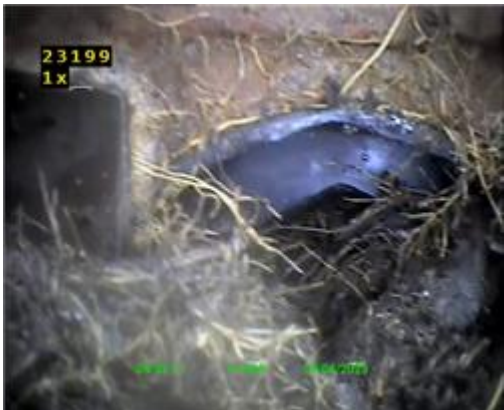
00.00m		SA	Survey abandoned Unable to push	Image Provided - Ref: 5_9999

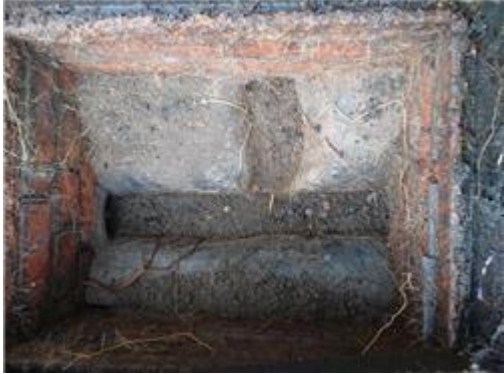
Pos	Video Ref	Code	Description	Image
00.00m		IC	Start node type, inspection chamber 2a	Image Provided - Ref: 6_0

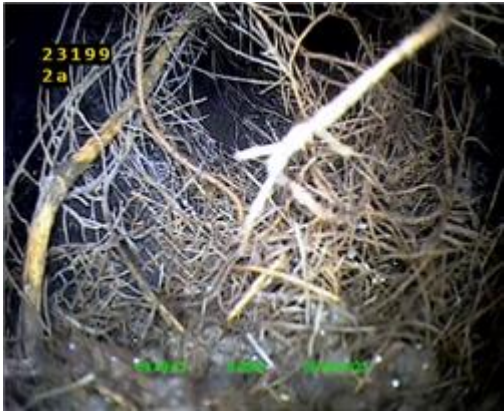
00.00m	0:00:00	S1 R	Roots 0m - 1.2m - Severity 3	Image Provided - Ref: 6_2

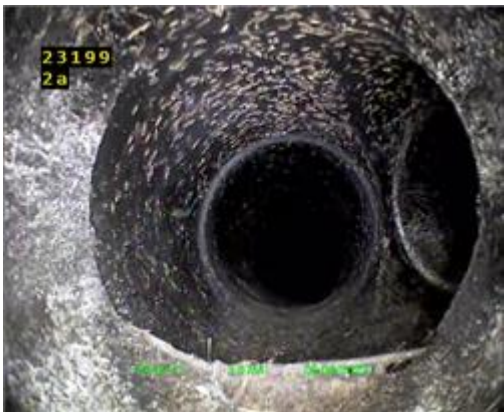
01.20m	0:00:00	F1 R	Roots Defect End - Severity 3	
03.90m	0:00:24	JN	Junction at 03 o'clock: 100mm Diameter	Image Provided - Ref: 6_3

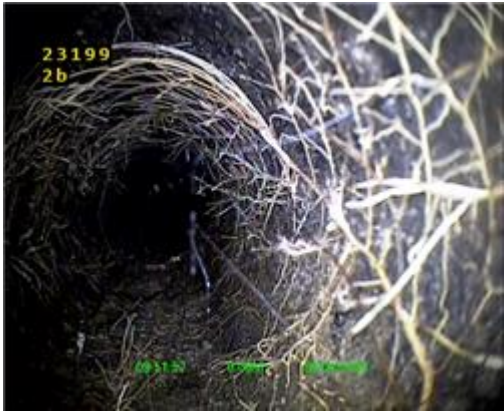
00.00m	0:00:00	R	Roots - Severity 3	Image Provided - Ref: 7_2

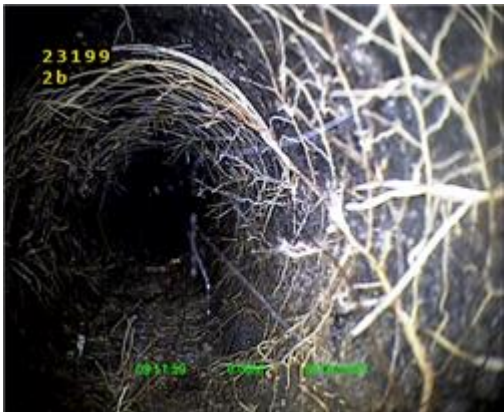
00.00m	0:00:02	S1 DES	Settled deposits fine 0m - 3m: 10% Cross sectional area loss - Severity 3	Image Provided - Ref: 7_3

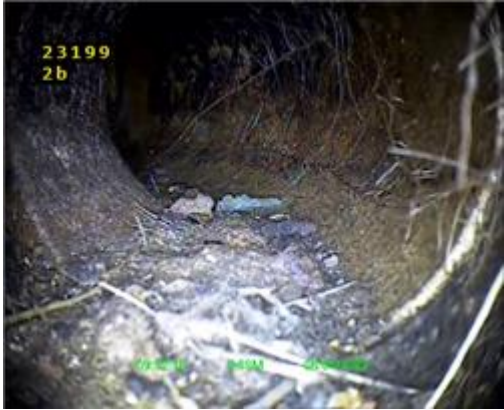
Pos	Video Ref	Code	Description	Image
02.68m	0:00:18	LLH	Line of drain/sewer deviates left [half]	Image Provided - Ref: 7_4

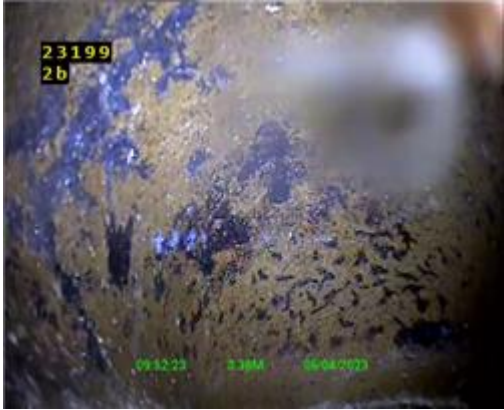
03.00m	0:00:02	F1 DES	Settled deposits fine Defect End: 10% Cross sectional area loss - Severity 3	
03.36m	0:00:26	LDF	Line of drain/sewer deviates down [full]	Image Provided - Ref: 7_5

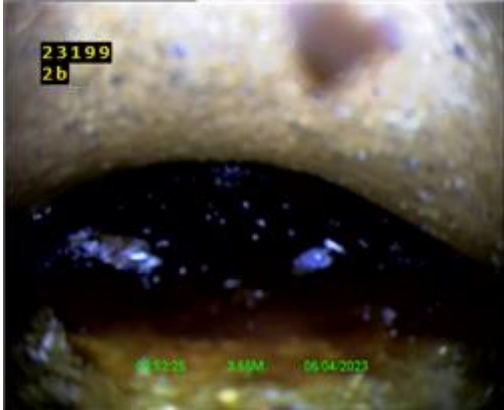
03.55m		GYF	Finish node type Gully Winser trap	Image Provided - Ref: 7_9999

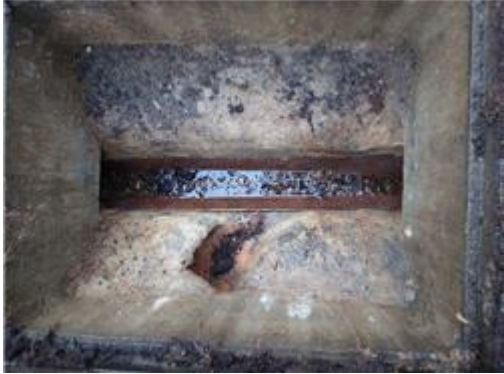
Pos	Video Ref	Code	Description	Image
00.00m		IC	Start node type, inspection chamber 3b	Image Provided - Ref: 9_0

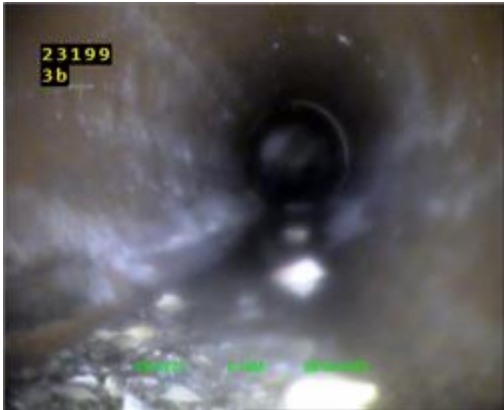
00.00m	0:00:00	WL	Water level: 5% Height/Diameter	Image Provided - Ref: 9_1

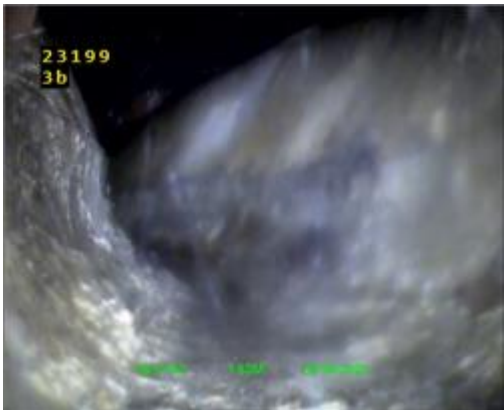
01.63m		ICF	Finish node type, inspection chamber 4	Image Provided - Ref: 9_9999

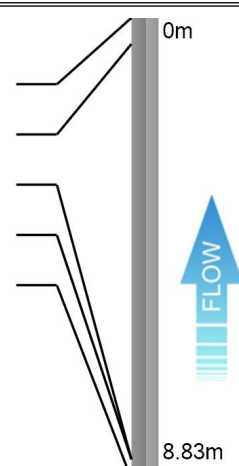
Position	Code	Description	CD	Pic	Video Ref	
00.00m	IC	Start node type, inspection chamber		10_0		
00.50m	WL	Water level 5%		10_1	0:00:00	
08.45m	SC	Dimension of drain/sewer changes : 100mm		10_2	0:00:39	
08.45m	R	Roots		10_3	0:00:38	
08.83m	ICF	Finish node type, inspection chamber		10_9

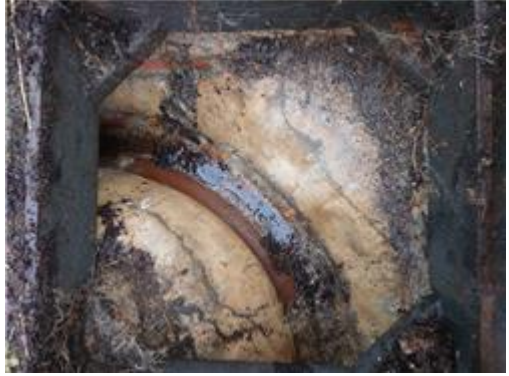
Pos	Video Ref	Code	Description	Image
00.00m		IC	Start node type, inspection chamber 4a	Image Provided - Ref: 10_0

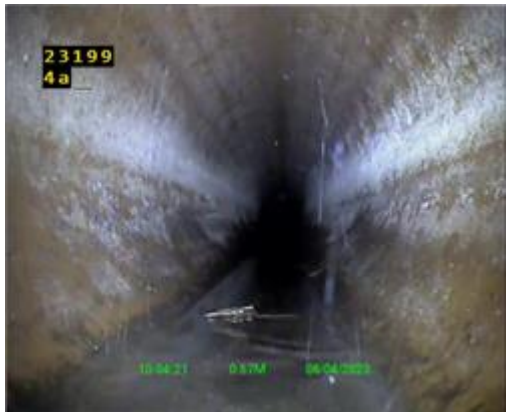
00.50m	0:00:00	WL	Water level: 5% Height/Diameter	Image Provided - Ref: 10_1

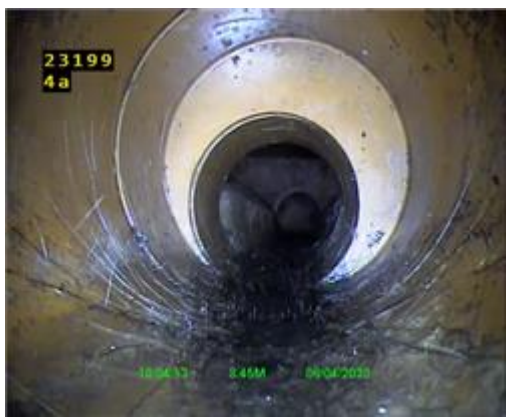
08.45m	0:00:39	SC	Dimension of drain/sewer changes: 100mm Diameter	Image Provided - Ref: 10_2

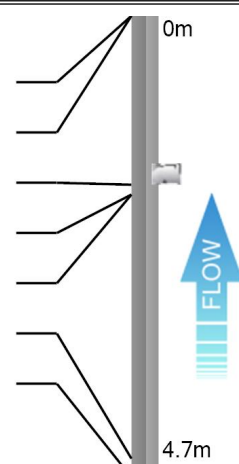
Position	Code	Description	CD	Pic	Video Ref	
00.00m	IC	Start node type, inspection chamber		11_0		
00.00m	R	S1 Roots	S1	11_2	0:00:00	
01.72m	JN	Junction 09 : 100mm Diameter		11_3	0:00:12	
01.82m	R	F1 Roots	F1	11_-	0:00:00	
01.82m	LLH	Line of drain/sewer deviates left [half]		11_4	0:00:16	
04.51m	LDF	Line of drain/sewer deviates down [full]		11_5	0:00:27	
04.70m	BRF	Finish node type, major connection without		11_9

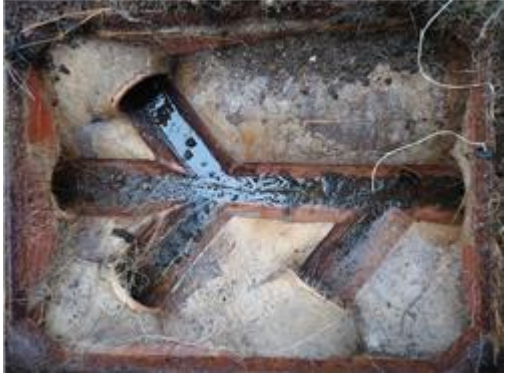
Pos	Video Ref	Code	Description	Image
00.00m		IC	Start node type, inspection chamber 5a	Image Provided - Ref: 11_0

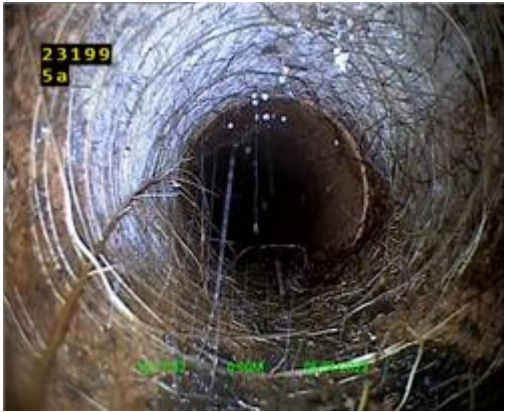
00.00m	0:00:00	S1 R	Roots 0m - 1.82m - Severity 3	Image Provided - Ref: 11_2

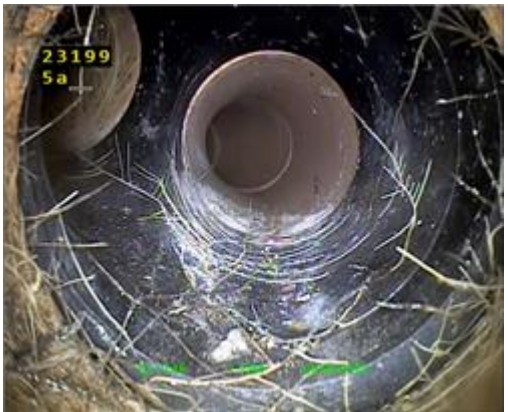
01.72m	0:00:12	JN	Junction at 09 o'clock: 100mm Diameter	Image Provided - Ref: 11_3

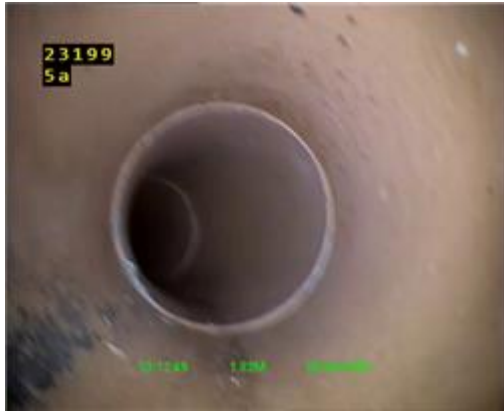
Pos	Video Ref	Code	Description	Image
01.82m	0:00:16	LLH	Line of drain/sewer deviates left [half]	Image Provided - Ref: 11_4

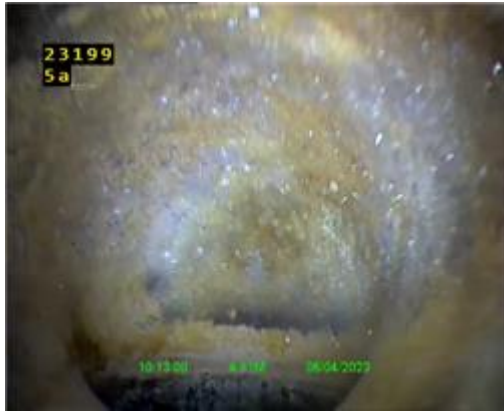
04.51m	0:00:27	LDF	Line of drain/sewer deviates down [full]	Image Provided - Ref: 11_5

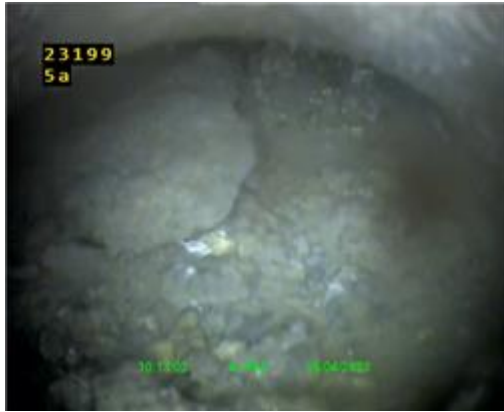
04.70m		BRF	Finish node type, major connection without manhole Winner trap	Image Provided - Ref: 11_9999

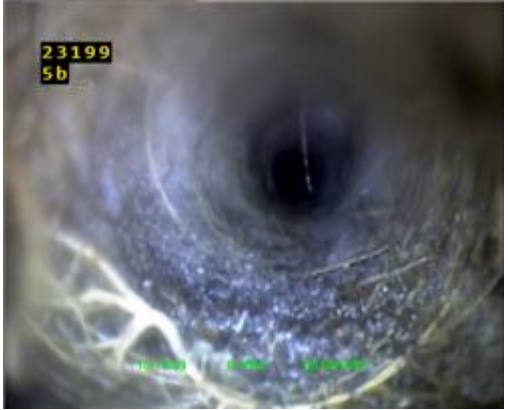
00.76m	0:00:07	R	Roots - Severity 3	Image Provided - Ref: 12_2

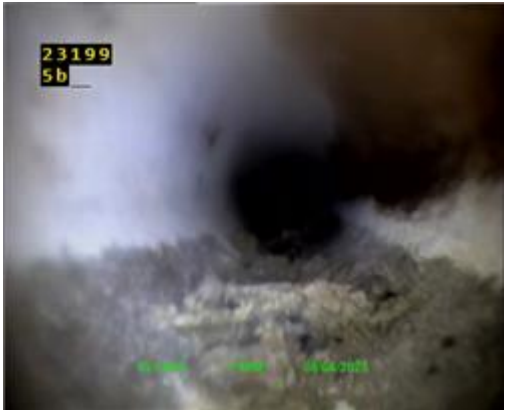
01.92m	0:00:14	DES	Settled deposits fine: 10% Cross sectional area loss - Severity 3	Image Provided - Ref: 12_3

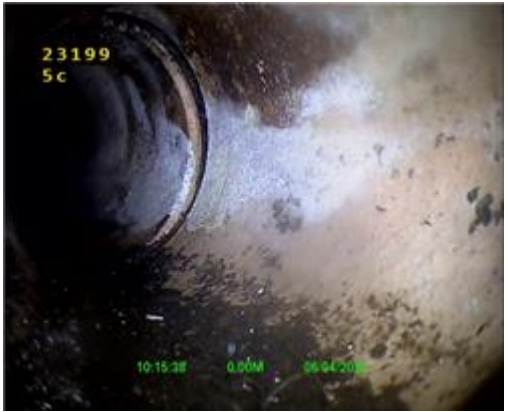
00.00m	0:00:00	LLQ	Line of drain/sewer deviates left [quarter]	Image Provided - Ref: 13_2

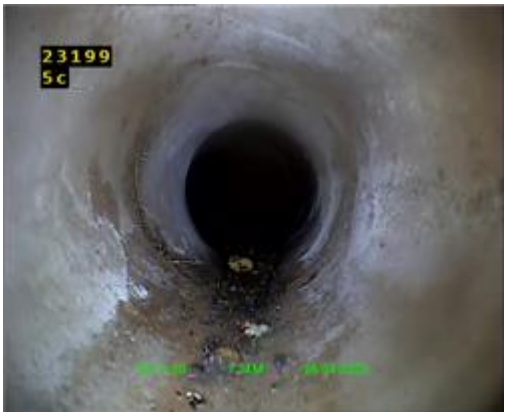
01.24m	0:00:11	R	Roots - Severity 3	Image Provided - Ref: 13_3

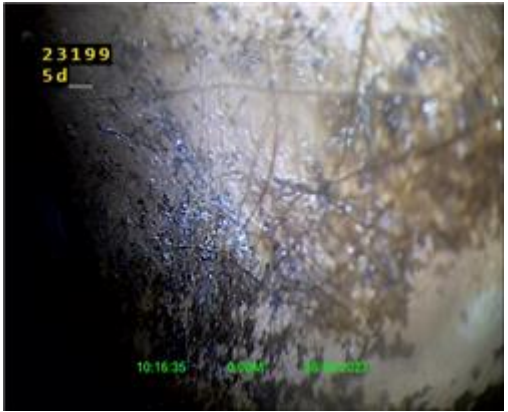
00.00m	0:00:00	S1 R	Roots 0m - 3.93m - Severity 3	Image Provided - Ref: 14_2

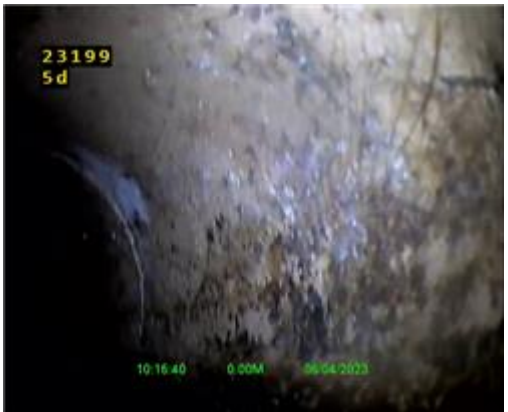
00.00m	0:00:04	LLF	Line of drain/sewer deviates left [full]	Image Provided - Ref: 14_3

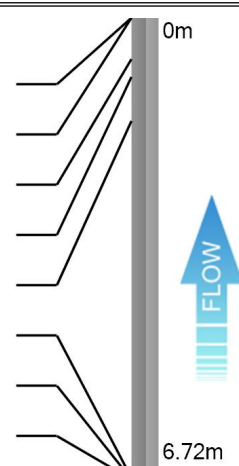
Position	Code	Description	CD	Pic	Video Ref	
00.00m	IC	Start node type, inspection chamber		15_0		
00.00m	DES	S1 Settled deposits fine 10%	S1	15_2	0:00:00	
00.60m	DER	Settled deposits coarse 70%		15_3	0:00:16	
00.86m	R	Roots		15_4	0:00:18	
01.50m	CU	S2 Loss of vision	S2	15_5	0:00:24	
06.70m	CU	F2 Loss of vision	F2	15_-	0:00:24	
06.72m	DES	F1 Settled deposits fine 10%	F1	15_-	0:00:00	
06.72m	SA	Survey abandoned		15_9

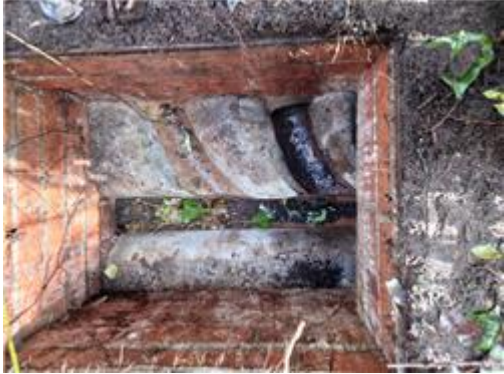
Pos	Video Ref	Code	Description	Image
00.00m		IC	Start node type, inspection chamber 6a	Image Provided - Ref: 15_0

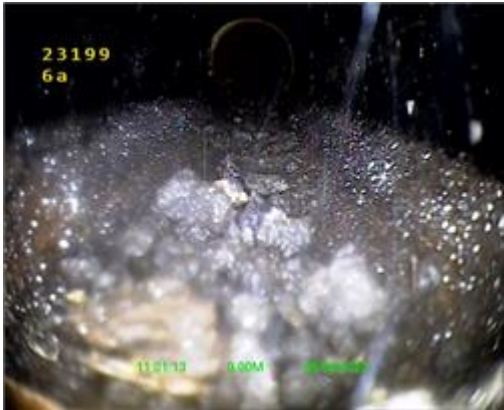
00.00m	0:00:00	S1 DES	Settled deposits fine 0m - 6.72m: 10% Cross sectional area loss - Severity 3	Image Provided - Ref: 15_2

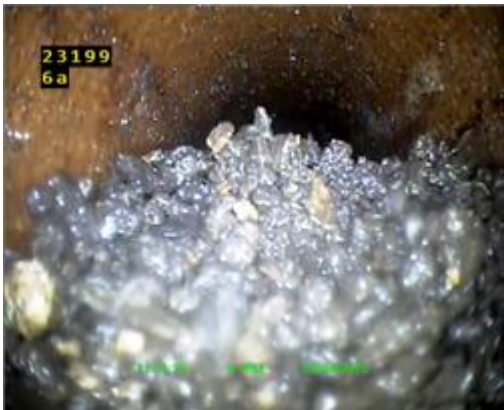
00.60m	0:00:16	DER	Settled deposits coarse: 70% Cross sectional area loss - Severity 3	Image Provided - Ref: 15_3

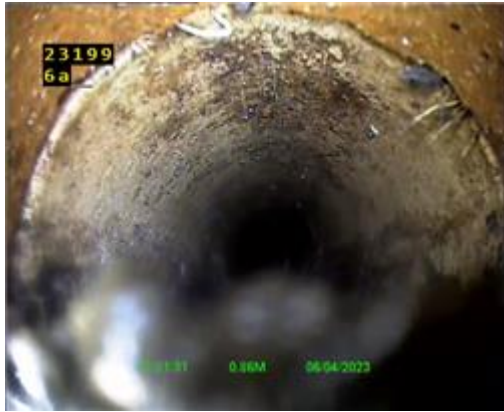
Pos	Video Ref	Code	Description	Image
00.86m	0:00:18	R	Roots - Severity 3	Image Provided - Ref: 15_4

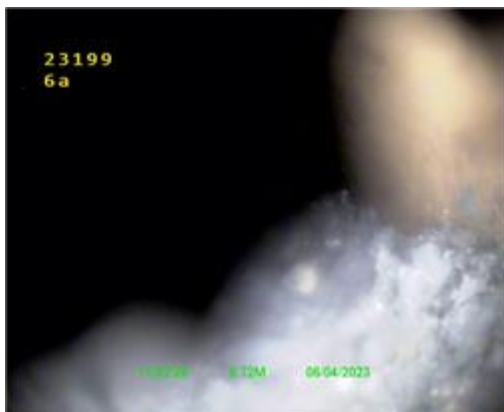
01.50m	0:00:24	S2 CU	Loss of vision 1.5m - 6.7m	Image Provided - Ref: 15_5

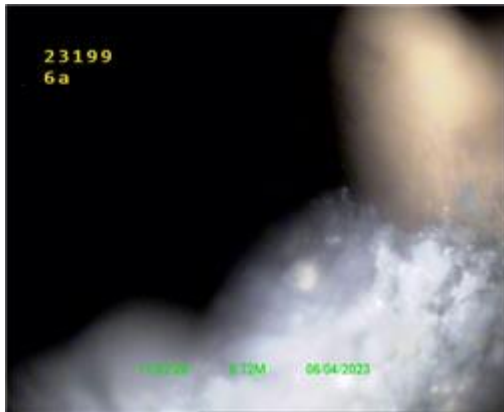
06.70m	0:00:24	F2 CU	Loss of vision Defect End	
06.72m	0:00:00	F1 DES	Settled deposits fine Defect End: 10% Cross sectional area loss - Severity 3	
06.72m		SA	Survey abandoned Blockage	Image Provided - Ref: 15_9999

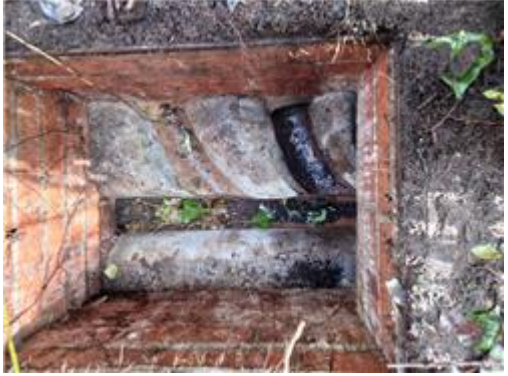
Pos	Video Ref	Code	Description	Image
00.00m		IC	Start node type, inspection chamber 6b	Image Provided - Ref: 16_0

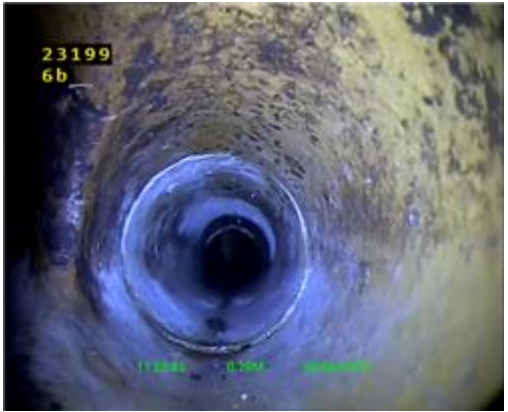
00.28m	0:00:12	JN	Junction at 09 o'clock: 100mm Diameter	Image Provided - Ref: 16_2

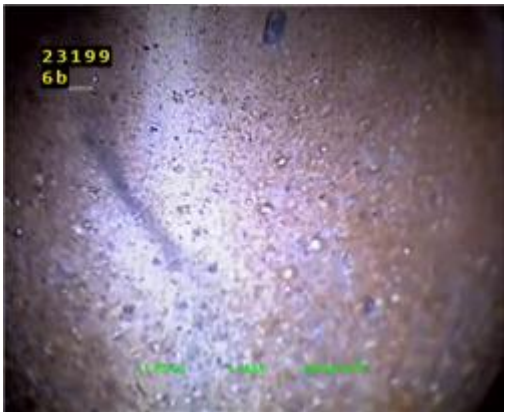
01.14m	0:00:17	LUF	Line of drain/sewer deviates up [full]	Image Provided - Ref: 16_3

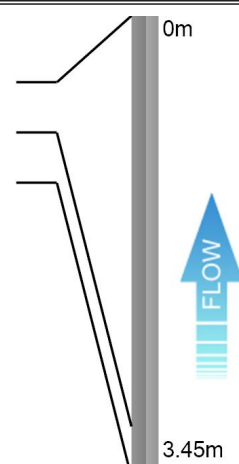
Position	Code	Description	CD	Pic	Video Ref	
00.00m	IC	Start node type, inspection chamber		17_0		
03.07m	LUF	Line of drain/sewer deviates up [full]		17_2	0:00:17	
03.45m	BRF	Finish node type, major connection without		17_9

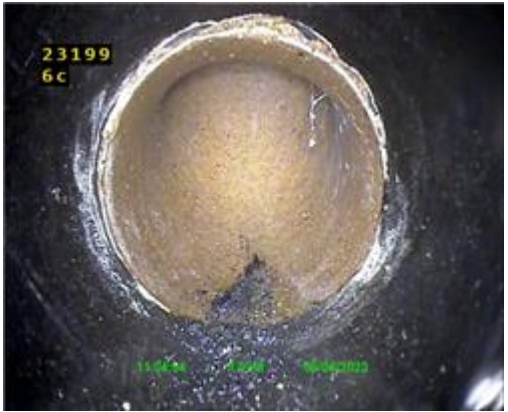
03.07m	0:00:17	LUF	Line of drain/sewer deviates up [full]	Image Provided - Ref: 17_2

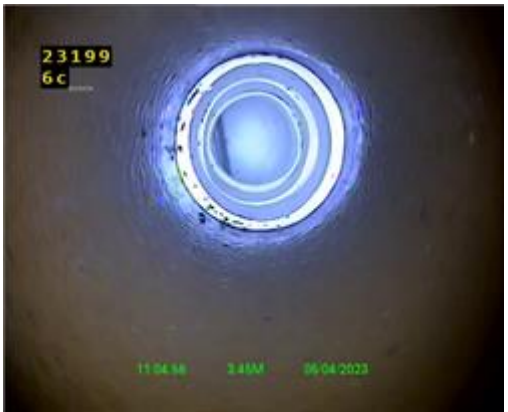
03.45m		BRF	Finish node type, major connection without manhole Internal	Image Provided - Ref: 17_9999

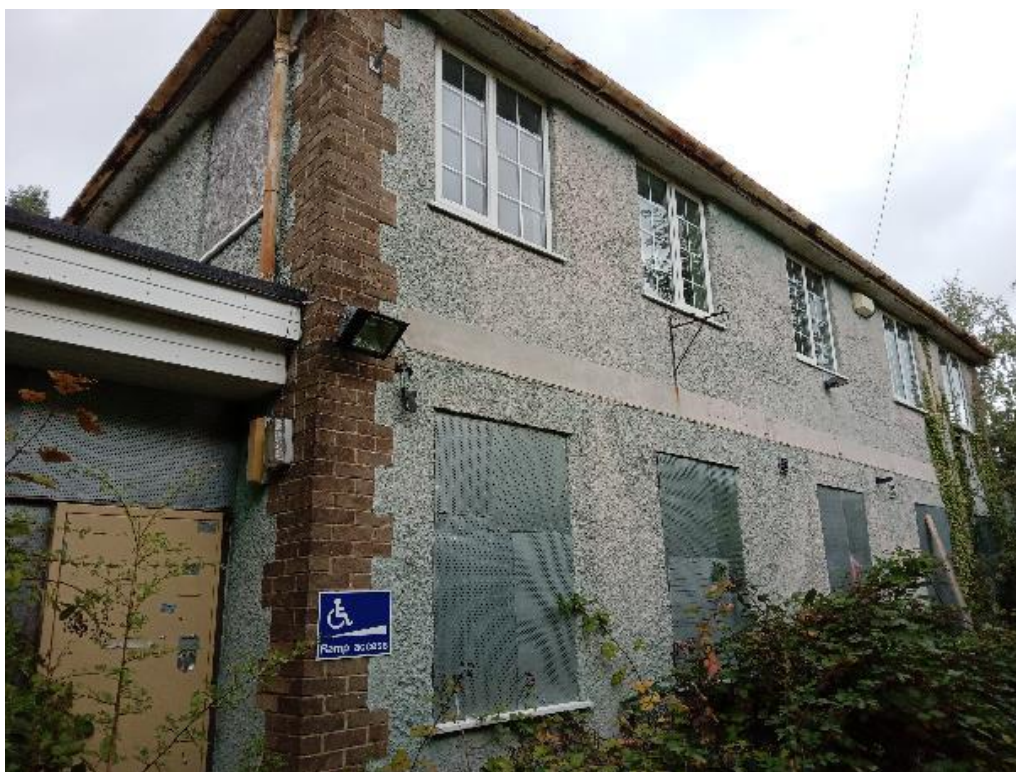
Photograph 1. South-east elevation of the derelict building.

- 4.2.4 The rendered brick walls have no gaps or cracks. The plastic fascia boarding (flat roof sections) is in good condition and well-sealed to the external walls. The flat, felt roofs have no gaps. The uPVC-framed windows on the first floor of the main building are well-sealed to the surrounding walls.

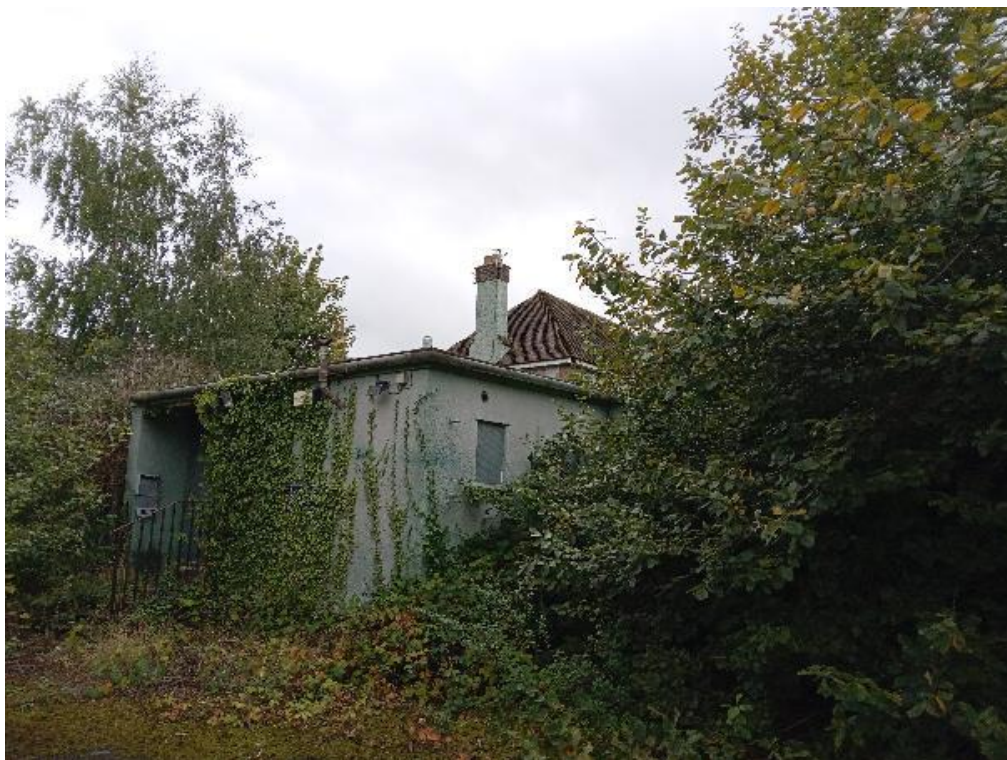
Photograph 2. Single-storey, flat-roofed section, showing overgrown surrounding scrub and trees.

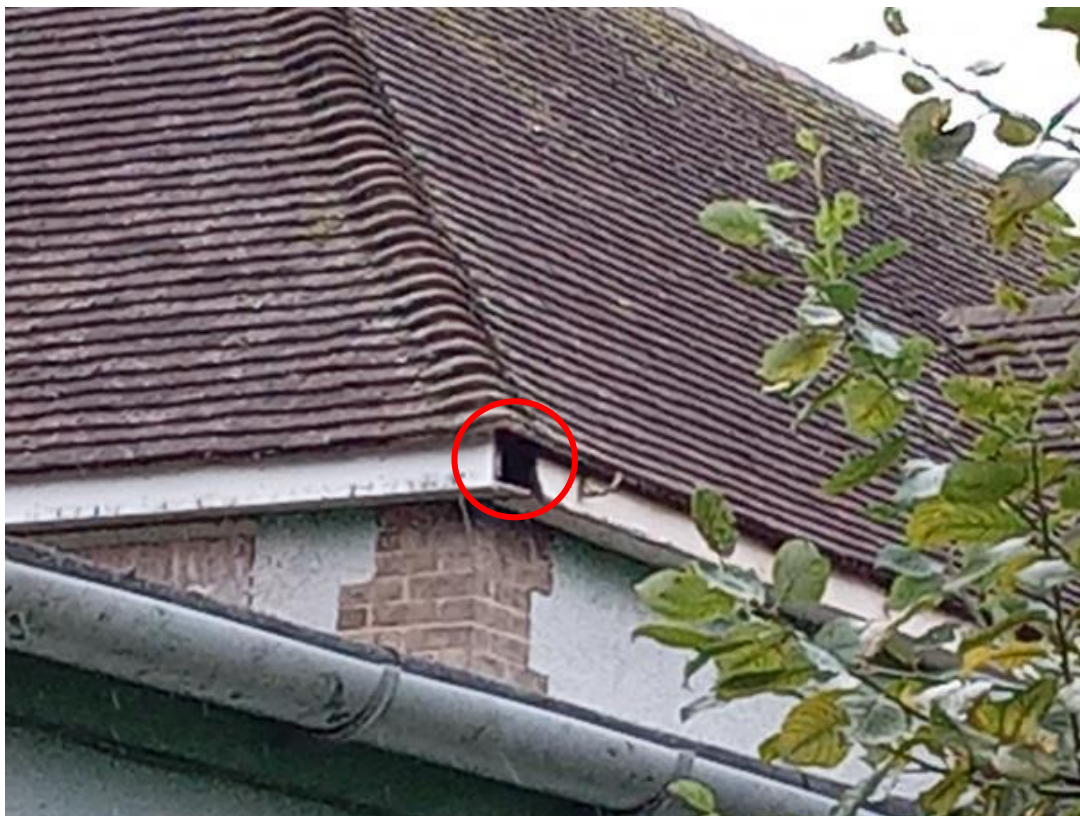
Photograph 3. Broken section of timber soffit on the main building's north-east elevation (Target Note 1).

- 4.2.5 There is a missing section of timber soffit on the north-east elevation of the main building (Target Note 1, Annex 2). Several missing and broken roof tiles are visible on the roof, particularly on the north-east facing roof pitch (Target Note 2, Annex 2). A vent is located on the north-west elevation gable end of the main building with broken slats (Target Note 3, Annex 2).
