**PRE-CONSTRUCTION  
INFORMATION**

**DEMOLITION &  
CLEARANCE OF  
FORMER ROYAL BRITISH  
LEGION BUILDING**

**MORETON-IN-MARSH**

**GREAT WESTERN  
RAILWAY &  
MORETON-IN-MARSH  
TOWN COUNCIL**

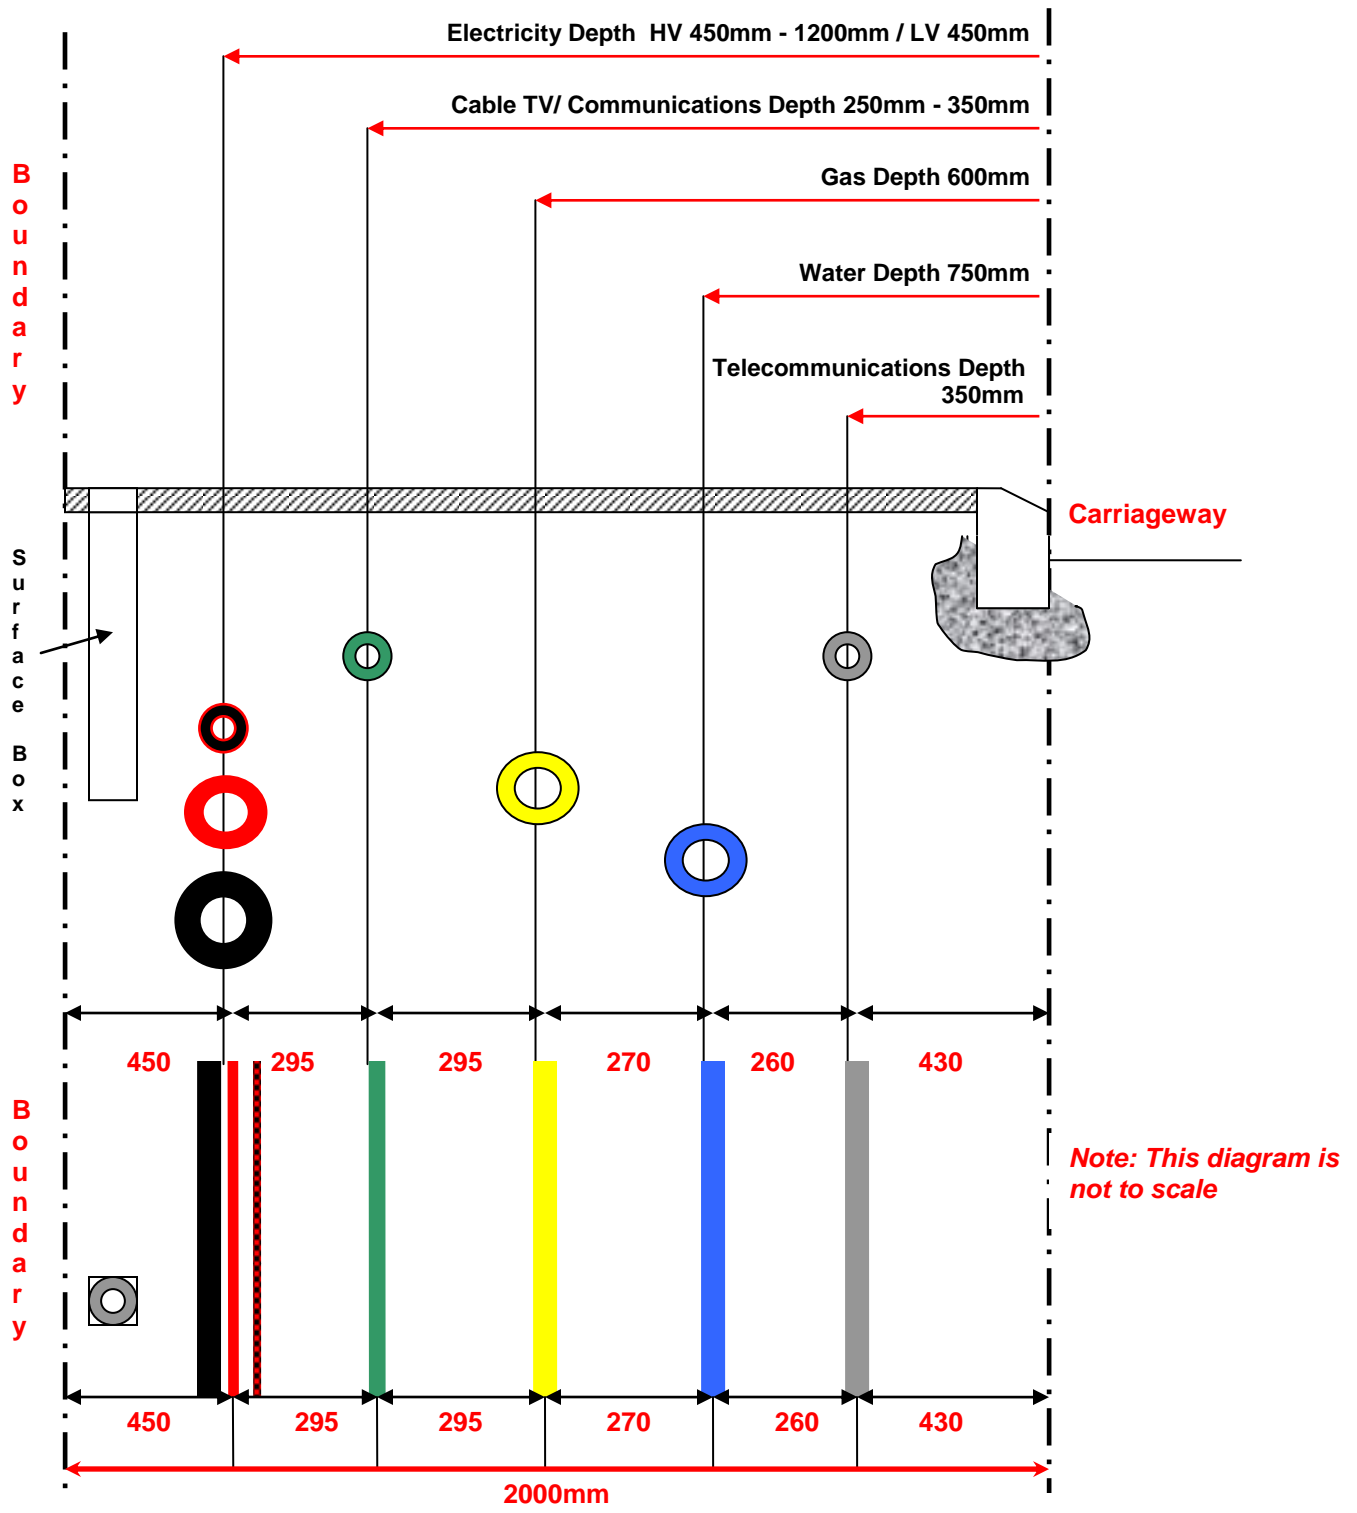
## Recommended Positioning of Utility Apparatus in a 2m Footway

Note – the same positioning should apply in the carriageway/service strip (if safe and practical to do so) where a development has no footway(s) available for services and/or the boundary of the property is on the carriageway (please refer to minimum depths in carriageways). For further advice please contact the asset owner.

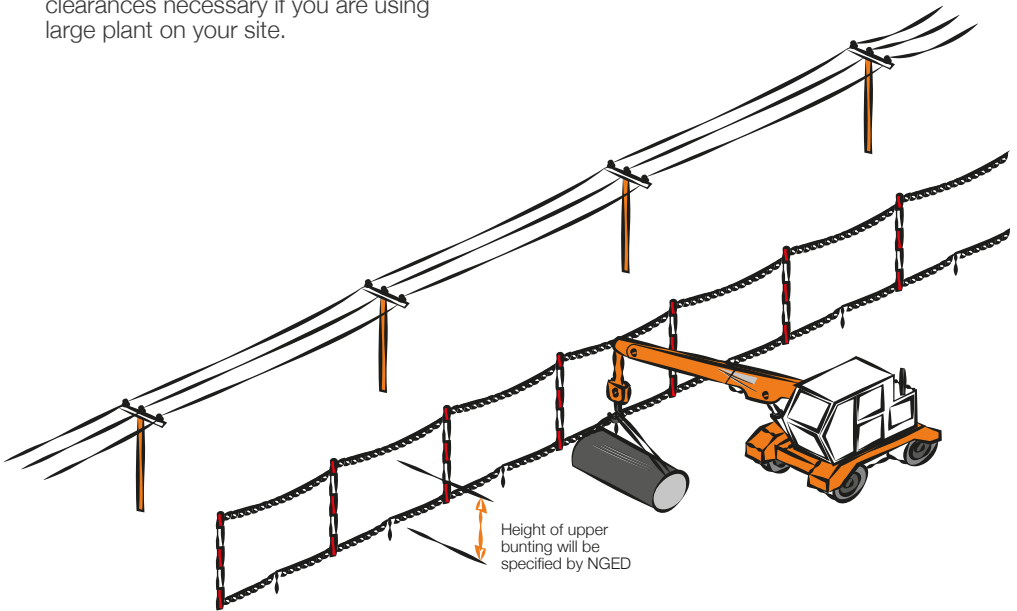
- The supports may be supported by rubble or concrete filled barrels or buried directly in the ground.
- Danger notices should be fixed to all of your high level supports.

- The ground enclosed within these barriers is best regarded as "dead ground" in which all foot and vehicular traffic is forbidden, in all circumstances, for the duration of your work.

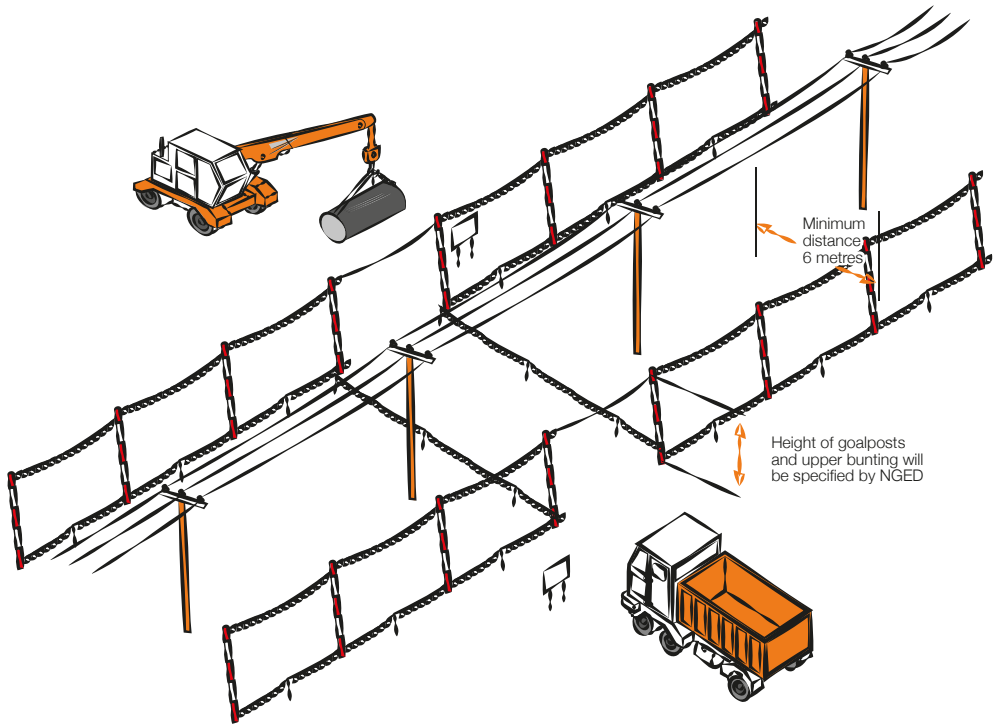
- Where it is necessary for foot and vehicular traffic to pass under the line, you will need to form a marked access way between the barriers as shown below.

- This access way should comprise of bunting erected 1m above ground, supplemented by high level “goal-posts” erected at either end.
- The goal post cross bars should be rigid, made of insulating material and positioned in a location and at a height specified by us.

- The access route should be as narrow as possible and should not normally exceed 10m in width.
- If it is necessary to make the access route wider than this, you may find it impractical to use rigid cross bars, so you may use a tensioned rope and bunting instead. If you use rope and bunting as a cross bar, you should move the entrance to the access route out to a minimum distance of 12m from the outermost conductor of the line. This is to allow for any stretching of the rope if pulled by your plant.

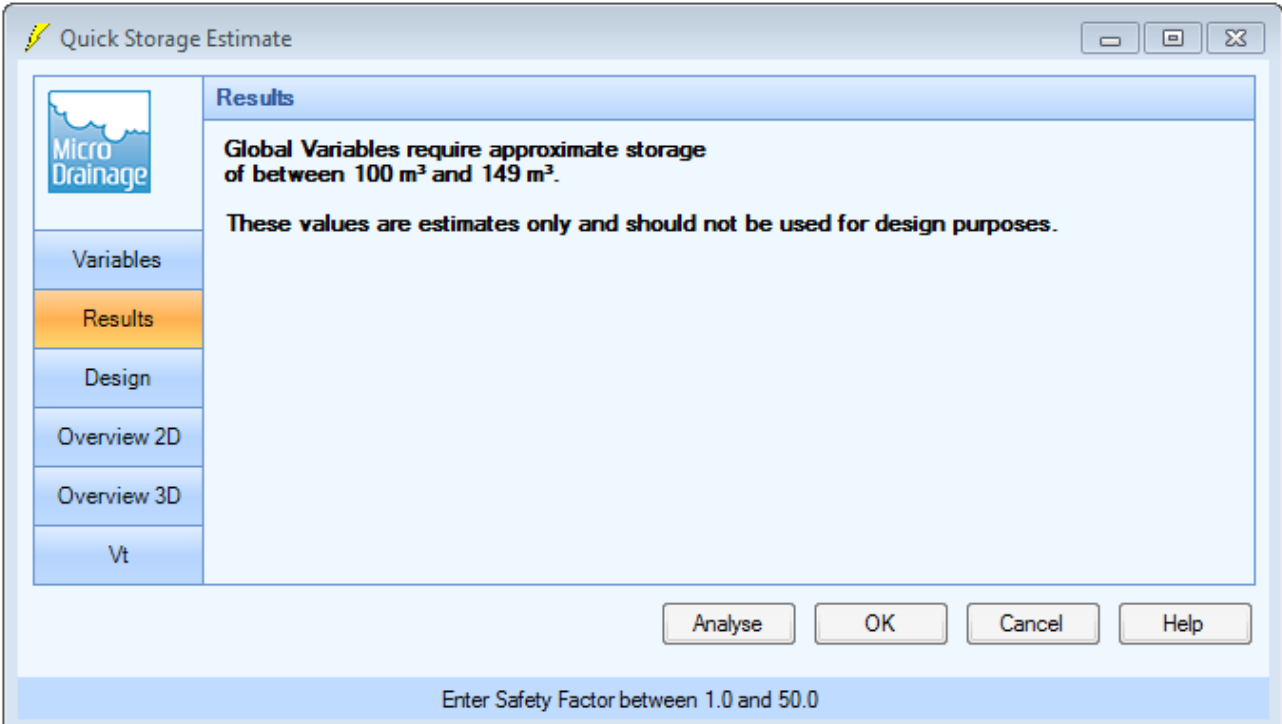
The screenshot shows the 'Results' tab of the 'Quick Storage Estimate' window. The left sidebar contains a vertical menu with 'Results' selected. The main area displays the following text: 'Global Variables require approximate storage of between 100 m<sup>3</sup> and 149 m<sup>3</sup>. These values are estimates only and should not be used for design purposes.' At the bottom, there are buttons for 'Analyse', 'OK', 'Cancel', and 'Help'. A footer note states 'Enter Safety Factor between 1.0 and 50.0'.

Global Variables require approximate storage of between 100 m<sup>3</sup> and 149 m<sup>3</sup>.  
These values are estimates only and should not be used for design purposes.

Variable	Value
FSR Rainfall	M5-60 (mm)
Return Period (years)	100
Region	England and Wales
M5-60 (mm)	19.000
Ratio R	0.354
Cv (Summer)	0.750
Cv (Winter)	0.840
Impemeable Area (ha)	0.283
Maximum Allowable Discharge (l/s)	5.0
Infiltration Coefficient (m/hr)	0.00000
Safety Factor	3.0
Climate Change (%)	20
