BUILDING SURVEY

PROPERTY: Gwenton Farm, Cury Cross Lanes, Helston,
Cornwall, TR12 7AZ

CLIENT: Richard Glasson, Senior Reserve Manager, Natural
England

INSPECTED ON: 30 November 2024

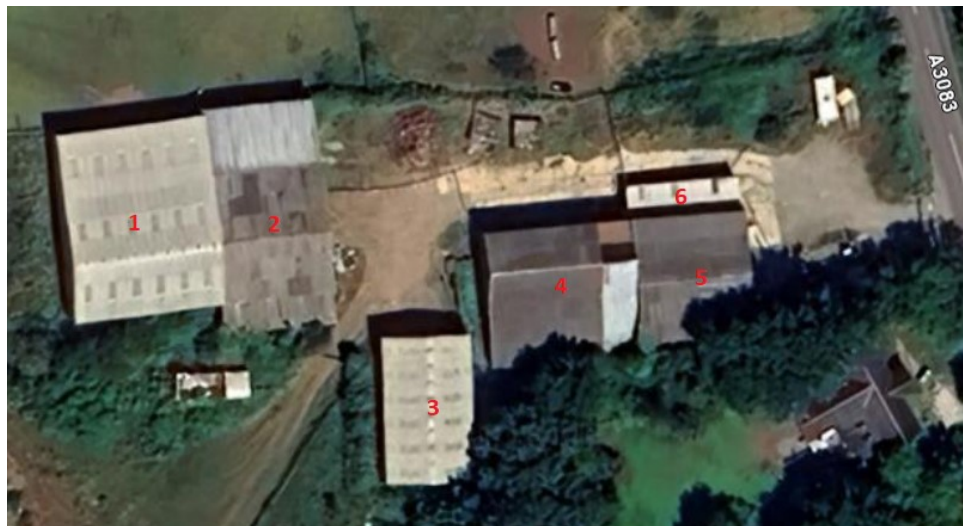
The property is a collection of agricultural buildings. The buildings include 5No. barns, one of which has a lean-to garage and workshop building attached.

For clarity, the buildings have been labelled on the following google maps image, and are referred to in accordance with these labels throughout the report.

All directions in this report will be given with reference to compass orientations.

The barns appear to have been constructed at various dates, which are unknown. Barns 1 and 3 are relatively modern, with the remaining buildings being of older construction.
