## Church Lane Carpark, Bearsted

### Project Summary

This project summary has been prepared for Bearsted Parish Council to outline the proposed drainage works to the existing Church Lane carpark to alleviate flooding downstream.

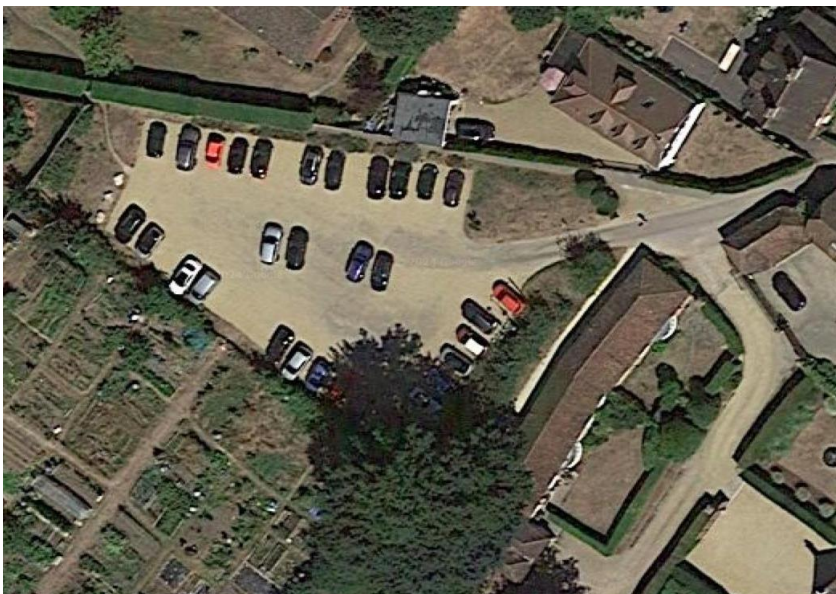
Current car park extent of surfacing (Google, 2024)

The car park has a tarmac and chipping surface and falls from west to east. There is a relatively even crossfall, which results in the surface water being directed towards the kerbs along the lower (eastern) end of the car park. Some of these kerbs have been removed in a hit and miss pattern, which allows surface runoff to make its way to the grassed verges. The car park is served by a channel drain across the entrance, but this has been found to be poorly maintained and with no sump unit for silt collection. There is anecdotal mention of there being a rubble soakaway adjacent the channel drain, but no evidence is visible on site in the way of access covers for maintenance.

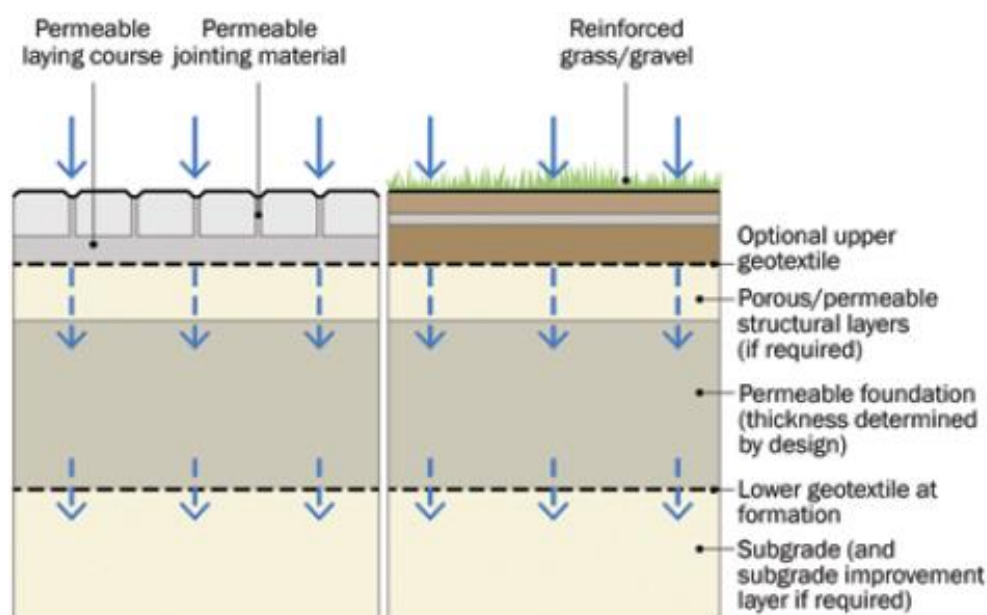
Source: CIRIA 753 SuDS Manual

As a general rule SuDS techniques should be utilised wherever possible to discharge surface water runoff. A drainage hierarchy is detailed in Ciria 753 The SuDS Manual. Assessing these in turn starting with the most preferred, the soils on site are slightly permeable, so there is an opportunity for using infiltration methods into the subsoils. The design solution is therefore to send surface water into a new below ground soakaway system where it can then infiltrate into the underlying subsoils. Infiltration testing has been undertaken in a series of trial pits which have been described above.

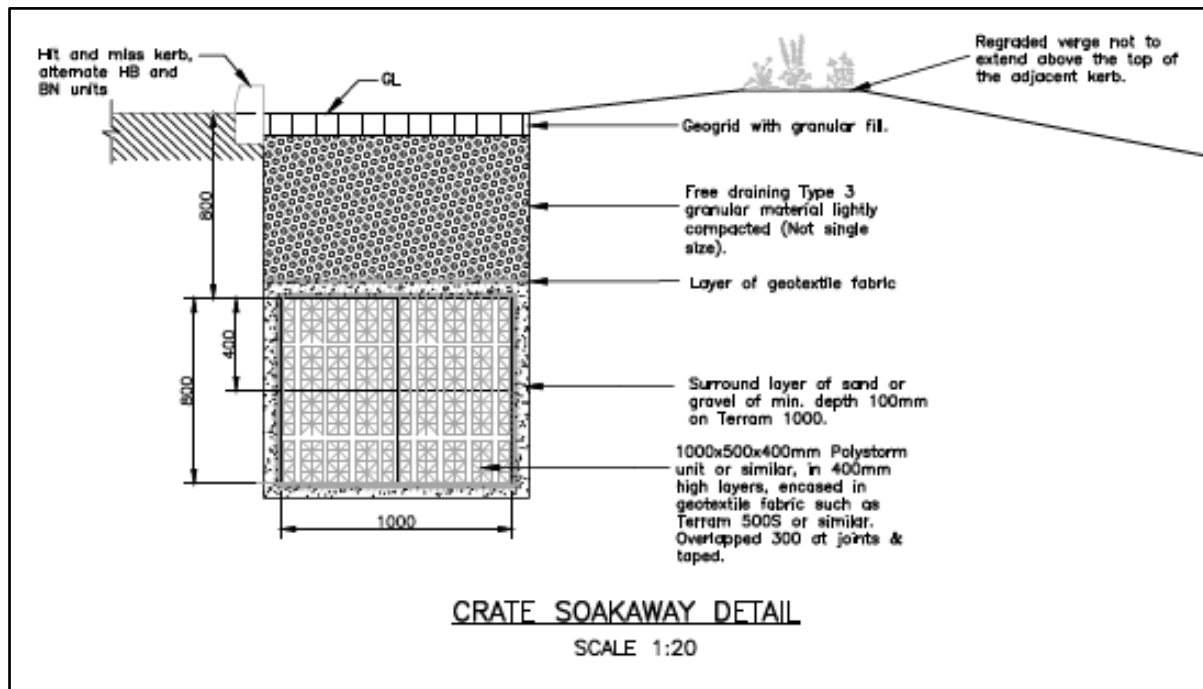
Whilst this would provide many benefits, due to the infiltration rates the carpark would require significant rebuilding, which is well in excess of the funding available. Therefore a grassed area over crate soakaways have been adopted as the preferred design as it will help deal with the short duration 'flash' storm events. Replacing and upsizing the existing channel drainage, as well as reprofiling the verges, will also have a significant impact upon the operation of the system.

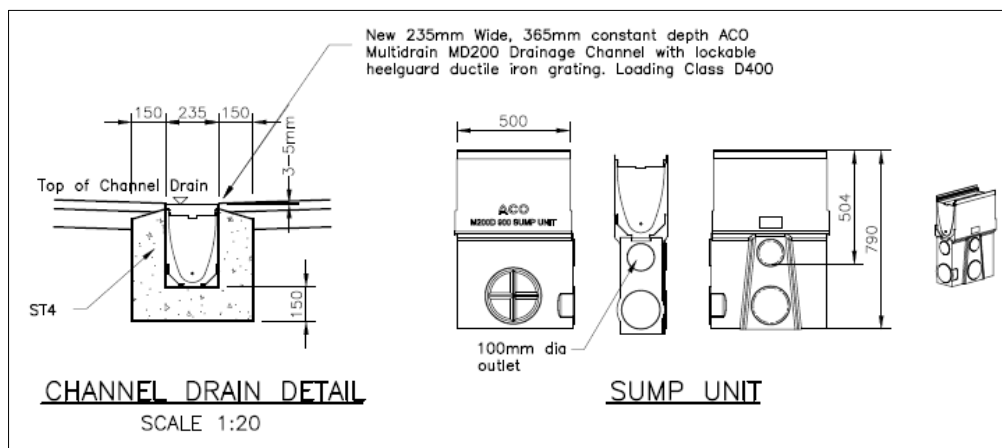
As noted above, the existing channel drain will need to be replaced with a wider unit of greater capacity, and is to be installed with a sump to capture silt and allow for easy cleaning/maintenance to prevent blockage.
