**CONDITION SURVEY REPORT
OF
SHIRE HALL
WOODBRIDGE
SUFFOLK
IP12 4LP**

Client: Woodbridge Town Council
Market Hill
Woodbridge
Suffolk
IP12 4LP

Date: May 2019

Ref: CT/FA/19552~rep

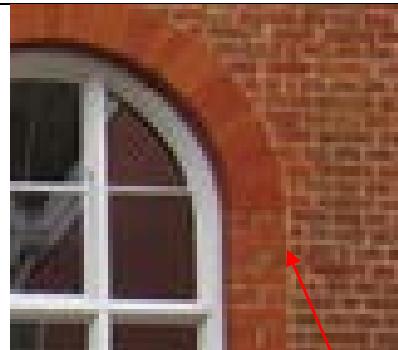
Photograph 07

- 3.2.5 It was observed that the smaller arched windows do not have the same brickwork to the arches. This leads to the assumption that these smaller windows were again cut out of the original brickwork. **See photos 6, 7 and 8.**

This photo shows where the existing brickwork was cut vertically straight, to allow for the new brickwork to the window opening.
The new and old brickwork was not bonded as it should have been if original.

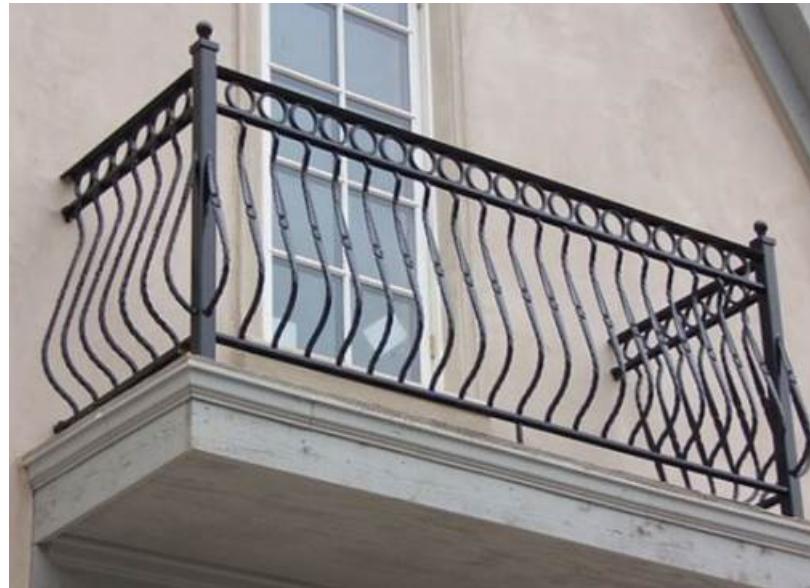
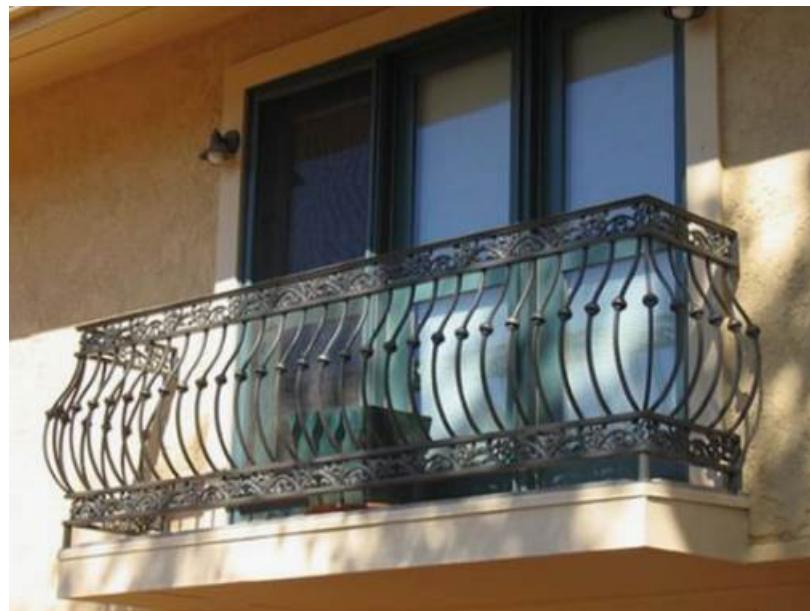
3 number photos of typical Bow shaped balcony railings

Note these all have a 2-rail detail at the top

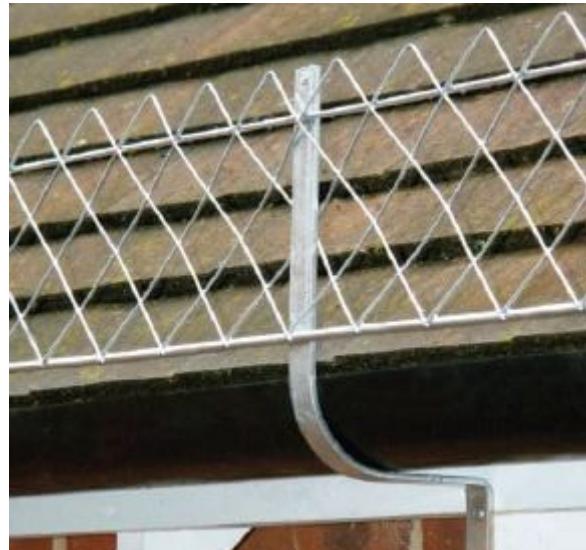
Gutter Guard

Note This could be painted a dark colour to be sympathetic and other makes and types are available.

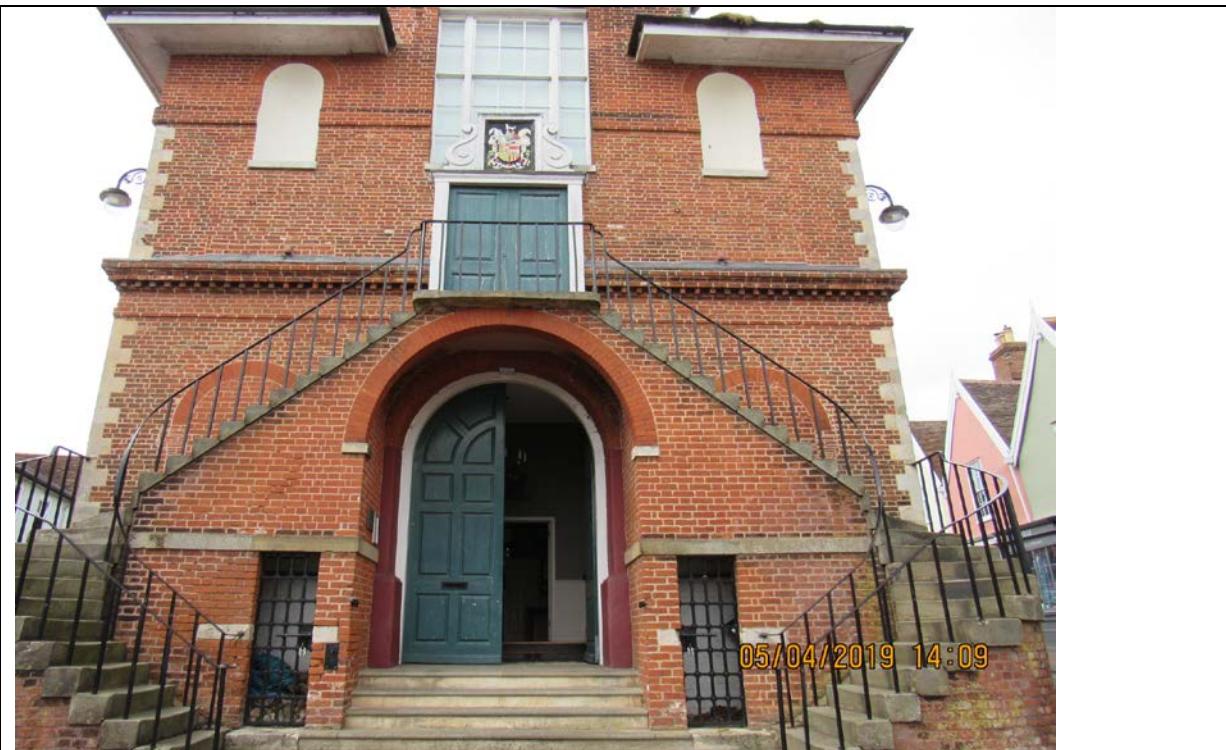
Photograph E1
Main front (EAST) Staircase.
