REPORT ON CONDITION OF:

**Municipal Building
The Moor
Falmouth
TR11 2RT**

Falmouth Town Council

30th August 2023

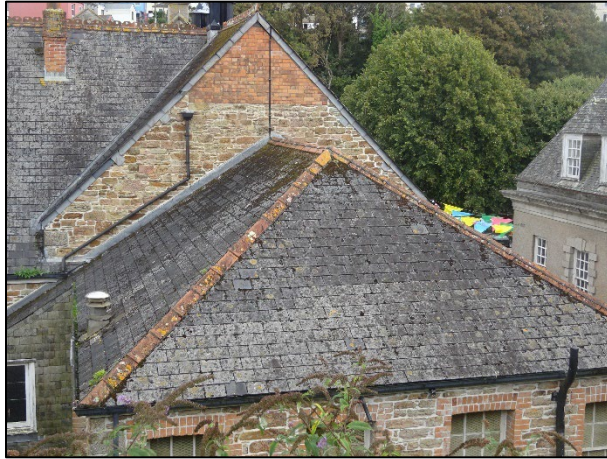
The rear left wing has a double pitched and hipped roof covered in fibre cement slate. This is set at a slightly lower level and there are a series of lead flashings at the junction with the main building. The same comment applies here as elsewhere in that the roof covering is performing adequately at present but now showing signs of notable weathering. We advise allowance to renew this section of roof relatively short term.

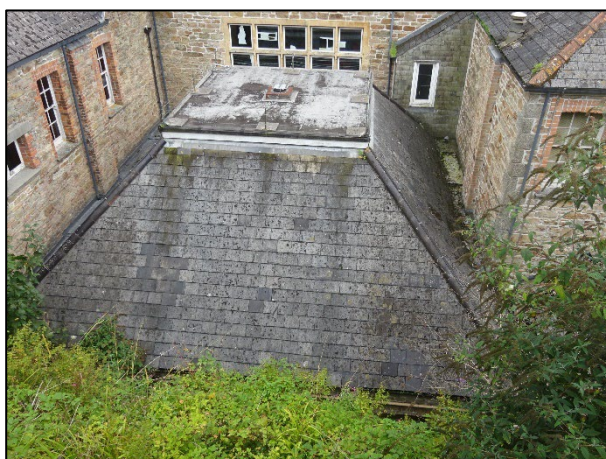
There is a lower level roof to the central rear section of the building, over the library. This is pitched on four sides and covered in fibre cement slate. There are clay hip tiles and the head of this roof is flat and covered in built-up mineral felt.

This roof is also performing adequately at present but showing signs of general weathering to fibre cement slate roof covering. Several individual slates have been replaced or refixed with lead tingles

We advise that allowance is made to replace this roof covering also relatively short term, although, again, there is no immediate concern.

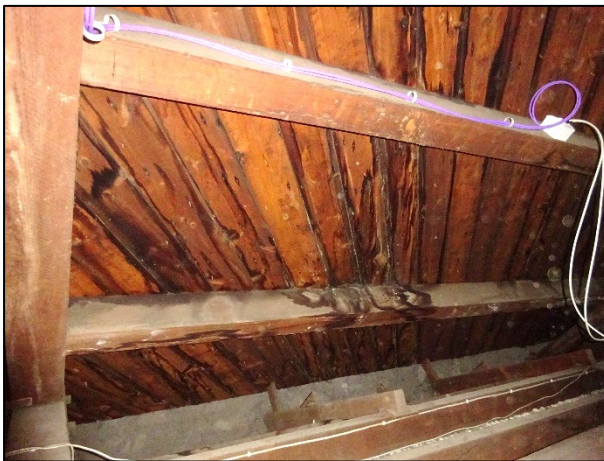
Roofing felt (sarking felt) is fitted in modern construction as a second line of defence against water penetration but it also counters the effects of wind movement.

In this case, there are timber sarking boards fitted beneath the main roof covering, which prevents visibility above and thus it is difficult to confirm the extent and condition of any existing sarking felt.

Where visible, this appears serviceable but is certainly now showing some signs of fatigue and is generally tired.

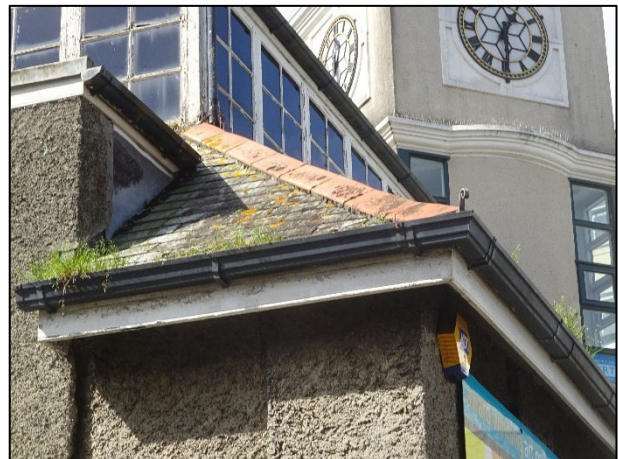
The rainwater goods remain in reasonable order but are now starting to show signs of fading to the surface finish with UV degradation and there is now quite a build-up of vegetation within various gutters.

Despite the general serviceability of the current rainwater goods, it would be sensible to consider replacement alongside any works to renew roof

coverings in order to make best use of high level access. The additional cost would not be overly significant. As a minimum, we advise allowance for preparation and redecoration.

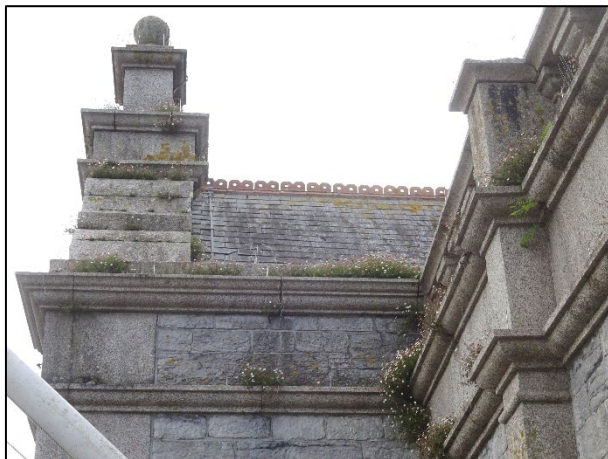
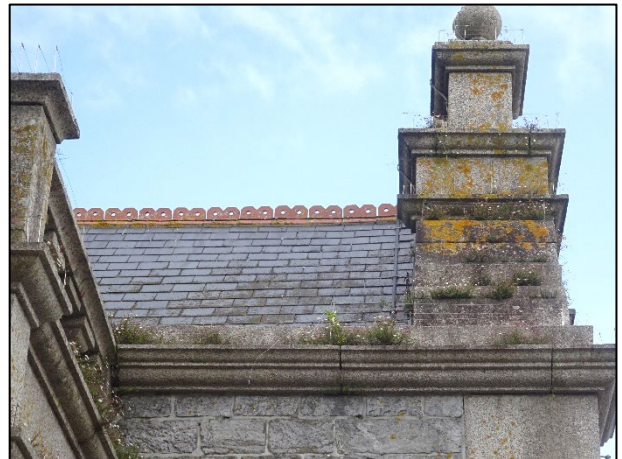
Whilst the building is sound, the most significant issue is that there is quite notable dampness affecting internal finishes - primarily to the front of the building and particularly at high level. This is the result of penetrating dampness and almost certainly due to deterioration of the various mortar joints between the stonework and detailing.

The quality of the stonework to the principal front elevations is very good and, from a distance, all appears in good order. However, upon closer inspection, it can be seen that there is now extensive vegetation growth from the various joints between stones and detailing, which is a clear indicator of deterioration to the various mortar joints and weakness for water ingress.

Generally, whilst the various projecting details and parapets etc., all add to the aesthetics of the building, conversely, these are all areas of weakness in terms of water ingress and reliance is placed upon keeping the property well maintained to prevent water ingress as much as possible.

It would be very difficult to entirely resolve all penetrating dampness, without significant upgrading of external finishes and detailing, much of which would not be permitted given its Listed status. However, careful raking out and repointing of the various mortar joints would certainly help matters significantly and we advise a programme of extensive careful repair and maintenance to the stonework across the principal elevations at the earliest opportunity. A significant but necessary task.

It may be possible to gain Listed Building Consent to introduce additional leadwork to the most exposed areas of the building – for example, the raised parapets and various high level band course details. This will require some input from a Conservation Officer as to what would be deemed acceptable. We advise this is considered at such time that a specification of works is prepared.

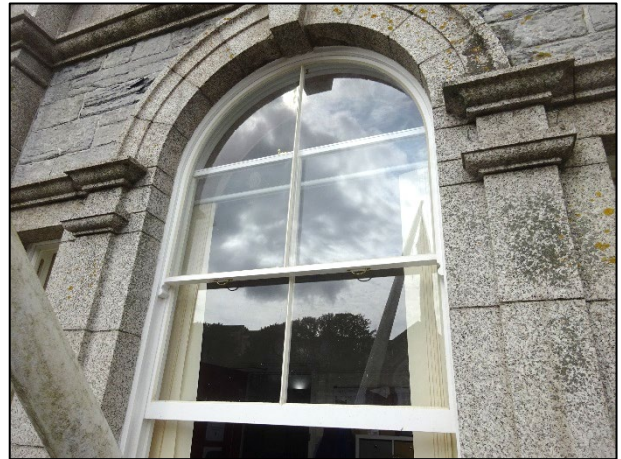
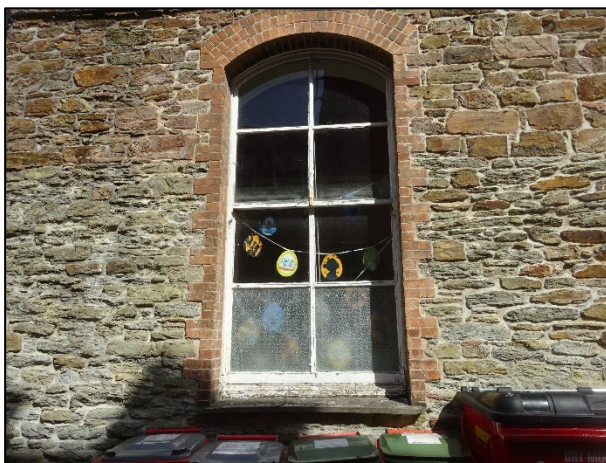
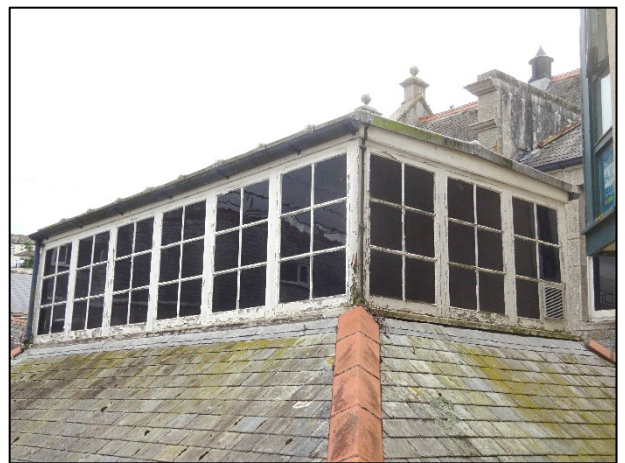
The property is served by a series of single glazed timber framed windows. These vary between traditional sash units and various timber casement units.

Three windows have recently been replaced at first floor level, to the centre of the front elevation, above the entrance portico. These are in good order. Elsewhere, windows are generally serviceable but paint finishes are certainly fading. In particular, windows to the left hand elevation are now in quite a poor state of repair, with some timber decay evident at low level. Furthermore, as identified above, the raised glazed lantern detail above the front right hand elevation is also now quite tired in terms of decorative finish with some localised decay beginning to form.

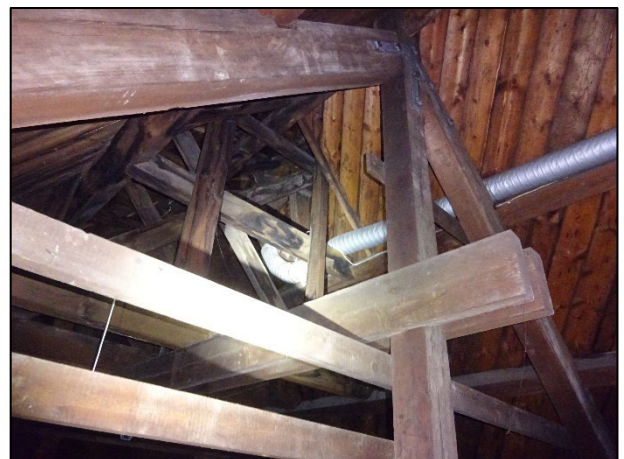
3.1.0 ROOF VOID

A substantial roof void over the front main sections of the building, accessed via a hatch through the ceiling within the central first floor landing area. The roof structure is largely visible and comprises a substantial traditionally cut structure with a series of trusses supporting horizontal purlins. This main section of roof is entirely clad in sarking boards above the principal trusses and purlins, before the battens and slates above. This in lieu of more commonly found rafters (individual timbers supporting the battens and slates). Consequently, this does significantly reduce visibility of the sarking felt and underside of the covering beyond.

Generally the structure is substantial and in sound condition. It can be seen where various repairs have been carried out previously where timber have suffered decay. Primarily relating to where timbers bear into the principal front sections of masonry. Several sections of timber have previously been cut out and replaced, or timber cut away and sections of steel plating inserted and fixed around timbers. Similarly, where ceiling joists bear into the external stonework, several timbers have been replaced in the past – again, largely relating to the front elevation.

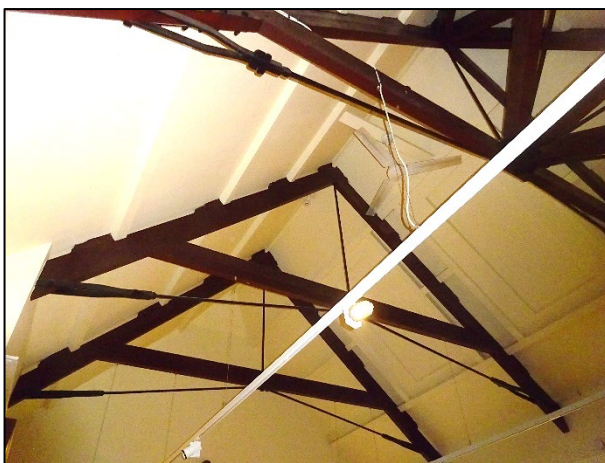
The roof structure is sound where visible but sarking felt now certainly tired and there is evidence of some water staining to a number of timbers in localised areas. Some timber repair has been carried out in the past and we advise allowance for some further localised repair alongside replacement roof covering. Generally, the roof structure is sound here.

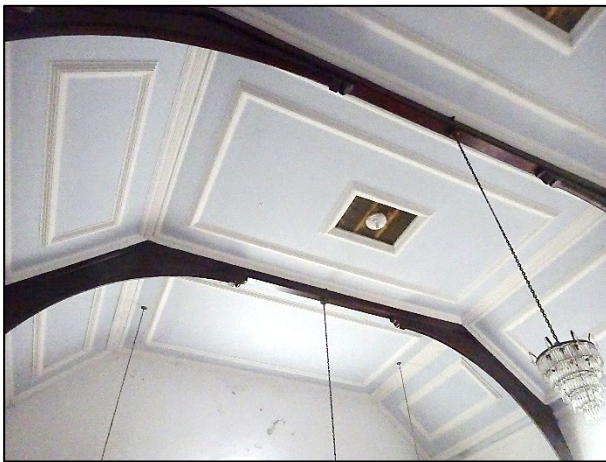
The ceilings are a particular feature of the principal library and council chamber accommodation. These are in traditional lath and plaster, partly vaulted in with various decorative mouldings and band course details etc.

The lath and plaster ceilings are generally in sound condition. There are one or two areas where some repair has been carried out previously, primarily where ceilings adjoin the principal front

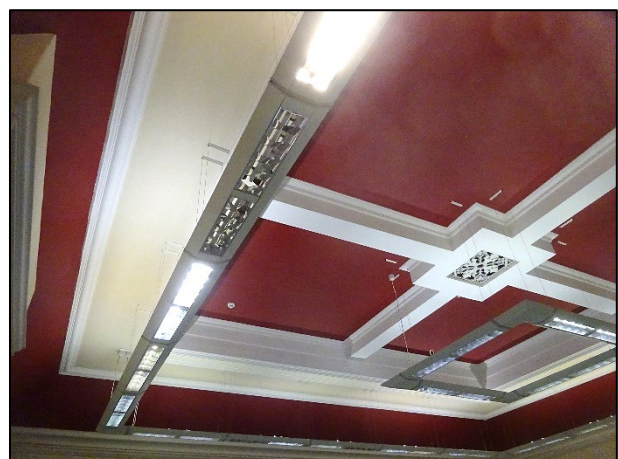
elevations and owing to penetrating dampness. For example, within the front left of the main roof void, it can be seen that original ceiling joists have been cut away and replaced and there is a small section of plasterboard incorporated to repair the existing lath and plaster structure.

requirement for some further repair to timber structure above ceilings adjacent to the front elevations in particular.

It would be sensible to approach upcoming refurbishments on the assumption that there will be a

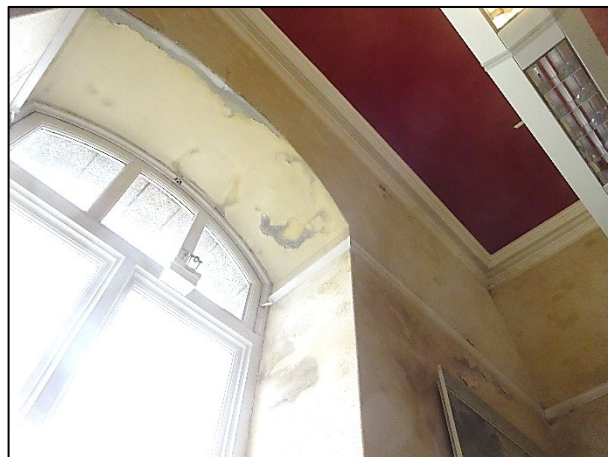
The wall surfaces are considered sound but it is clear that plaster finishes have suffered notable deterioration owing to prolonged penetrating dampness over the years. This is particularly the case to the inside face of the principal front and right hand side elevations.

there are modern gypsum based plasters present (pink in colour) and/or cement based material. Such material is very intolerant to moisture and salts typically found in older buildings of this nature and is not really appropriate. Indeed, such plasterwork will tend to make problems with dampness/water ingress seem more significant than is often the case.

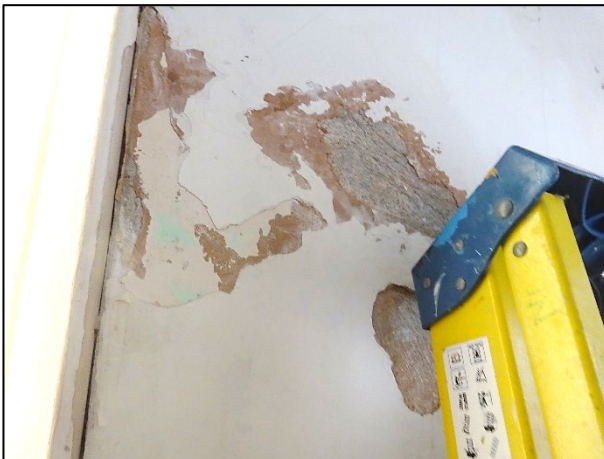
Over the years, the plasterwork in older premises deteriorates not only through fracturing and loss of key, but also as a result of rising and penetrating dampness and condensation. Even where the plaster surfaces appear to be sound beneath old decoration, when these are stripped it is frequently necessary for repairs to be carried out to the surface of the old lime plaster and this must be carefully borne in mind when considering the cost of future internal decorations.

As identified above, quite notable damp affected plaster is evident to the inside face of the principal front and front right elevations in particular. There will need to be allowance for plaster repair, following external repairs and maintenance. A traditional lime based material would be most appropriate, and there may be opportunity to specify a suitable material with improved thermal performance.

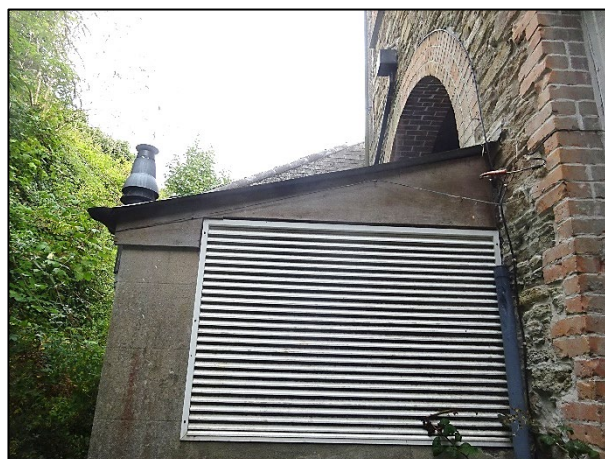
The boiler housing to the rear is effectively a basic lean-to structure, formed in concrete blockwork

construction with a sheet roof covering over. We suggest consideration is given to demolition of this structure, to make better use of the external space. This of course depending on the solution for replacement of the current boilers in due course.

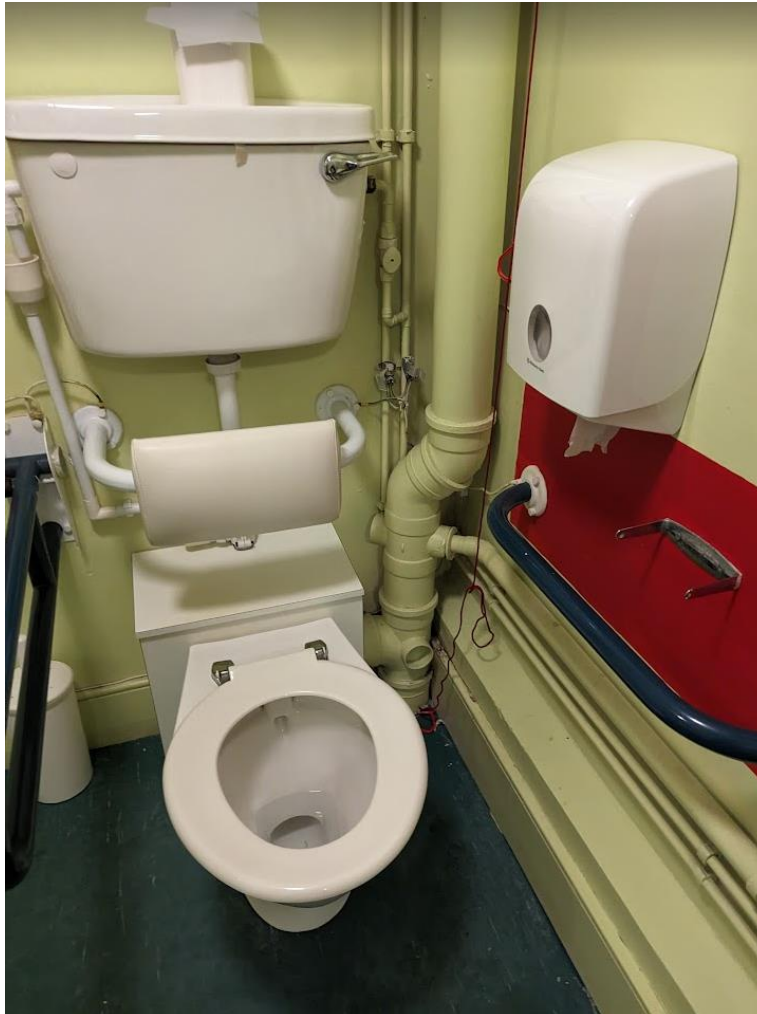
Photo 4.2.1 Internal uPVC SVP along with branch connections to WC and WHB.

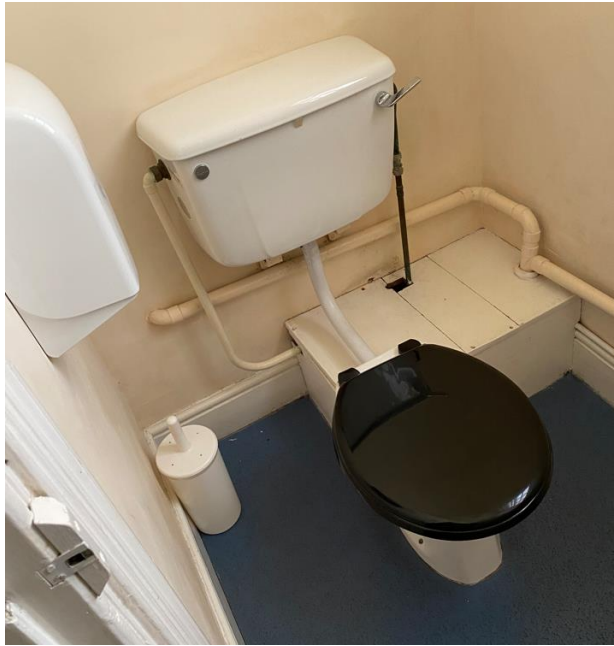
Photo 4.2.2 WC with boxed in drainage to below and horizontal drainage to WHB

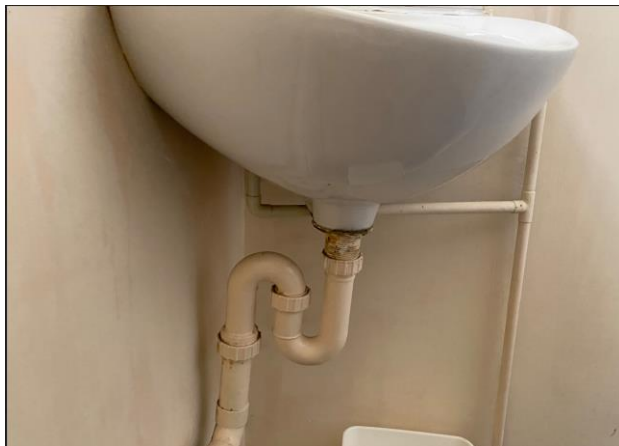
Photo 4.2.3 WHB drainage connection

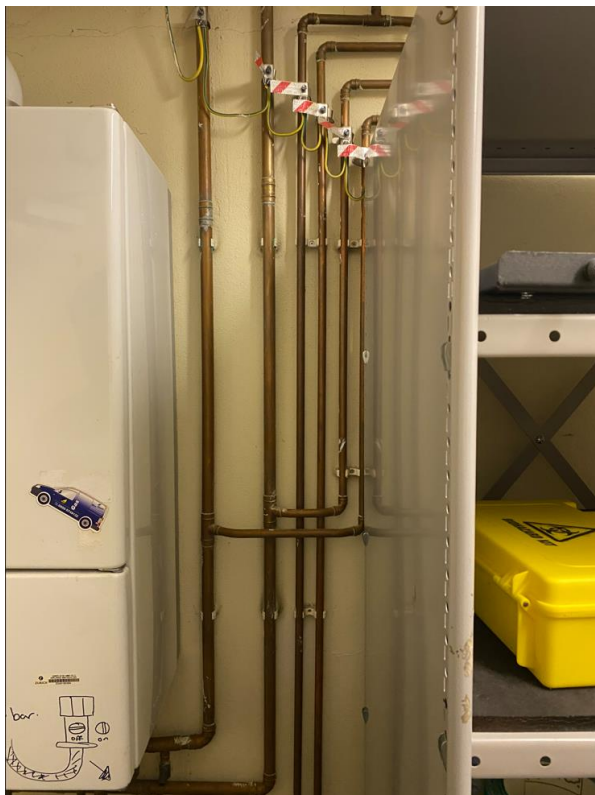
Photo 5.2.1 Example of copper distribution pipework leaving combi boiler.

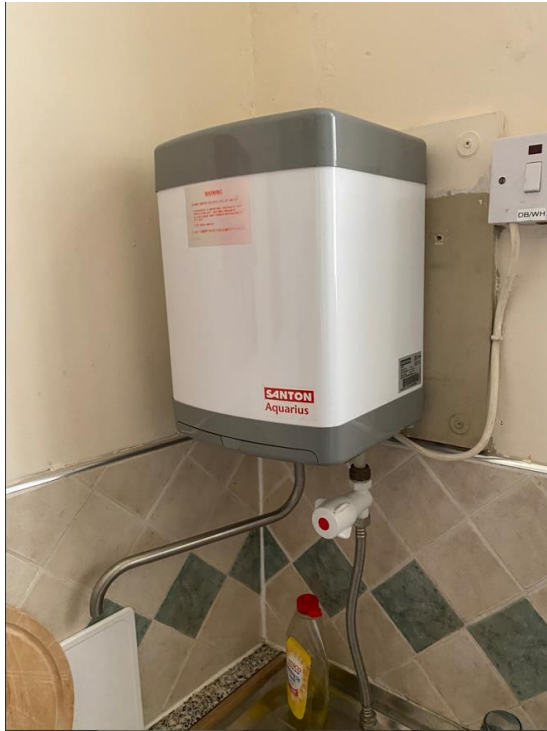
Photo 5.2.2 Above sink water heater

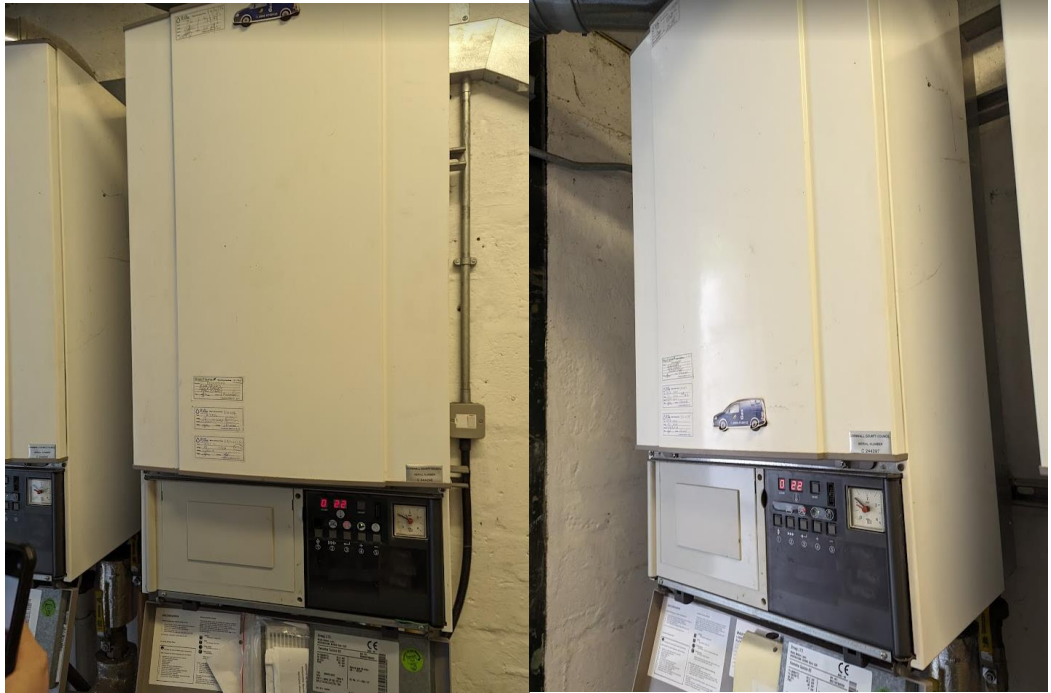
Photo 6.2.1 External plant room Vaillant boilers

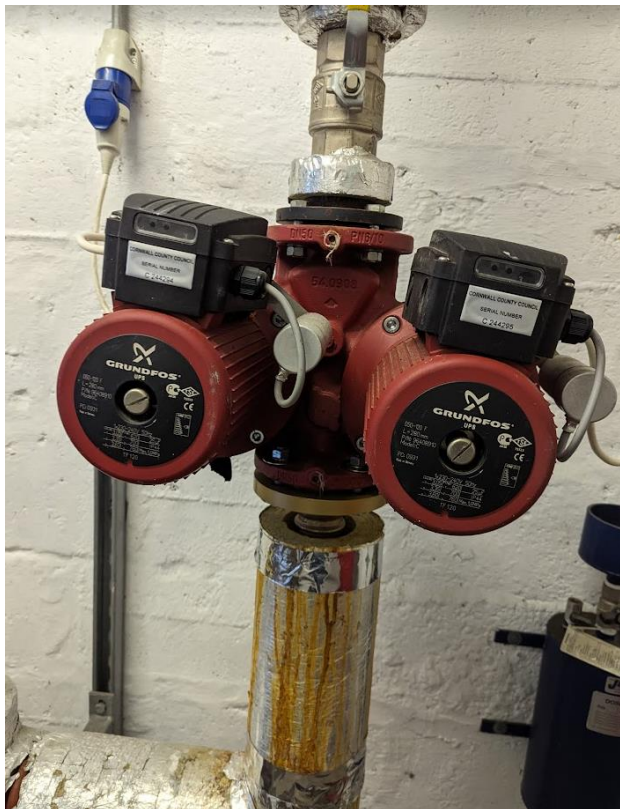
Photo 6.2.2 CT circuit pumps.

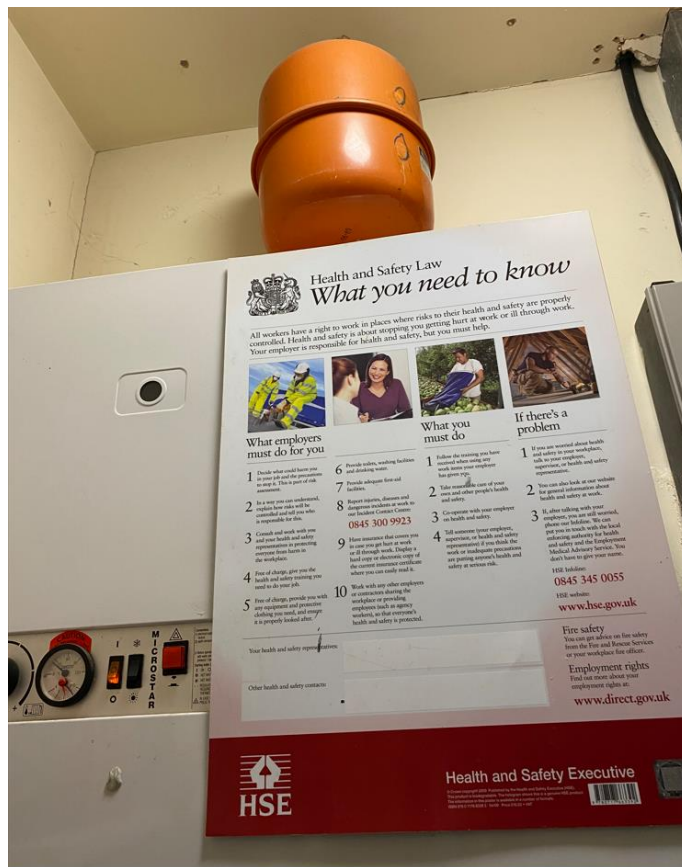
Photo 6.2.3 Gallery Boiler

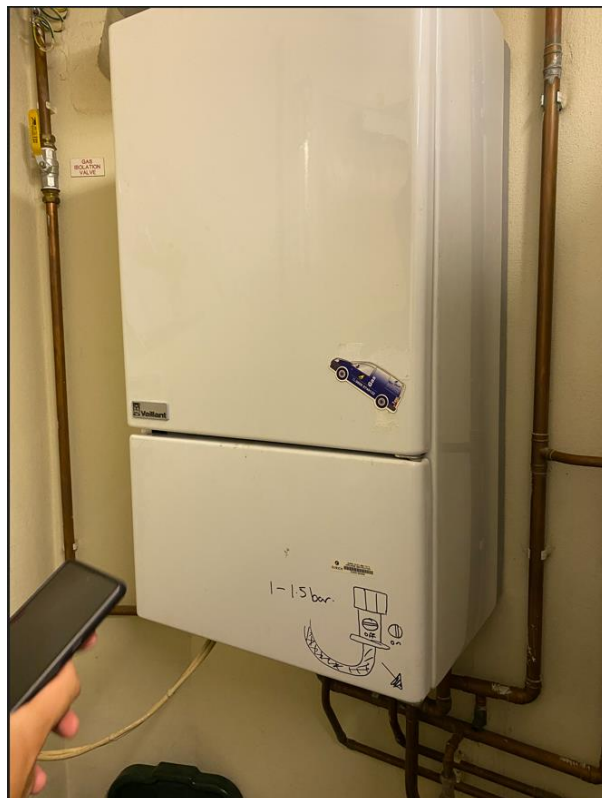
Photo 6.2.4 Lift room boiler

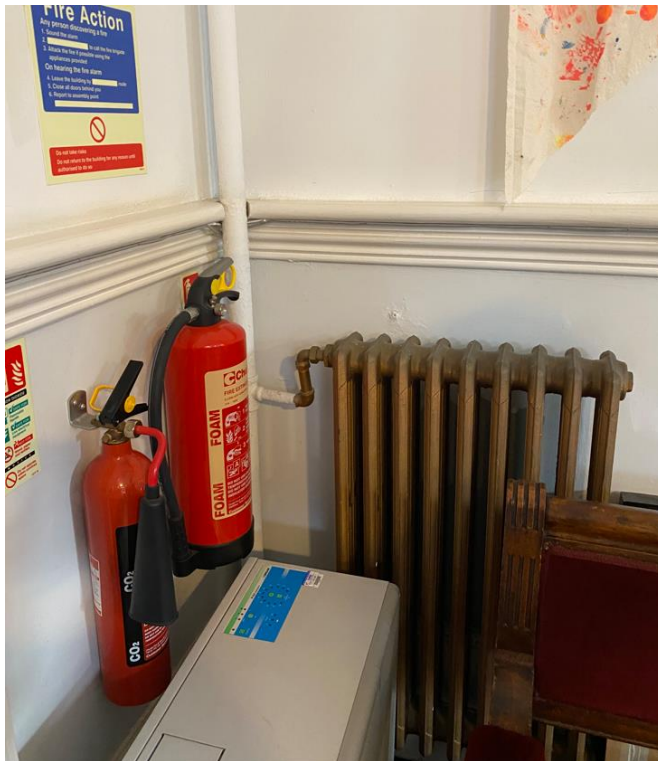
Photo 6.2.5 Example of radiators in town council chambers

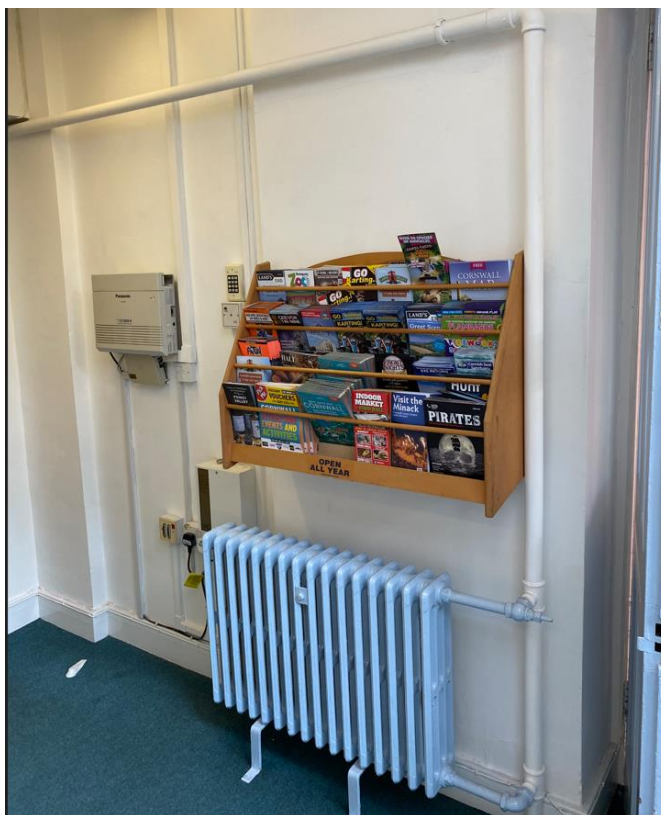
Photo 6.2.6 example of radiator in library

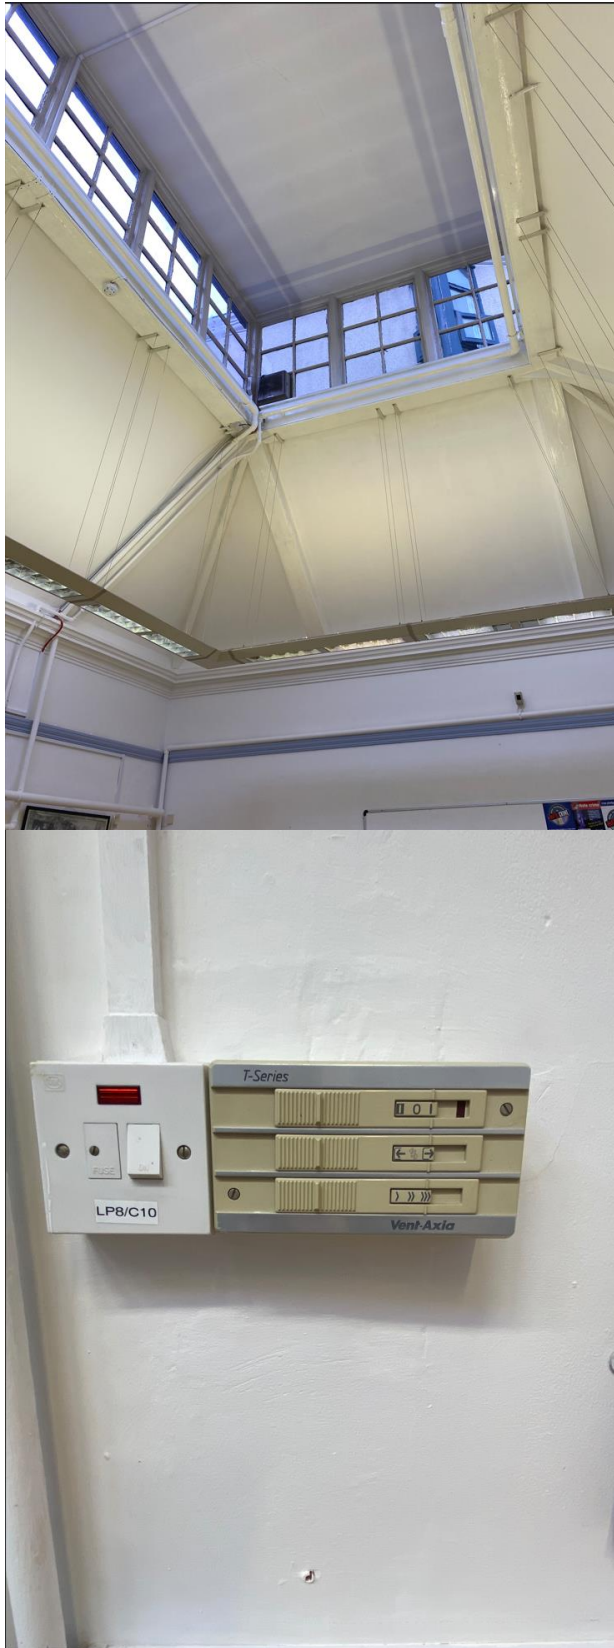
Photo 7.2.2 Extract fans to library computer room

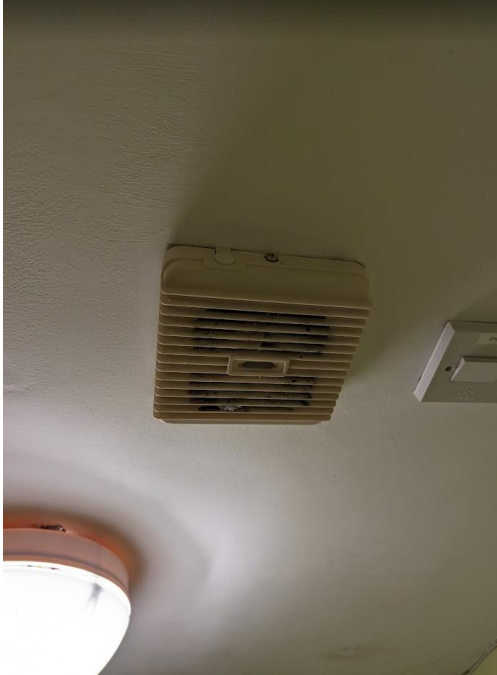
Photo 7.2.3 WC extract fan

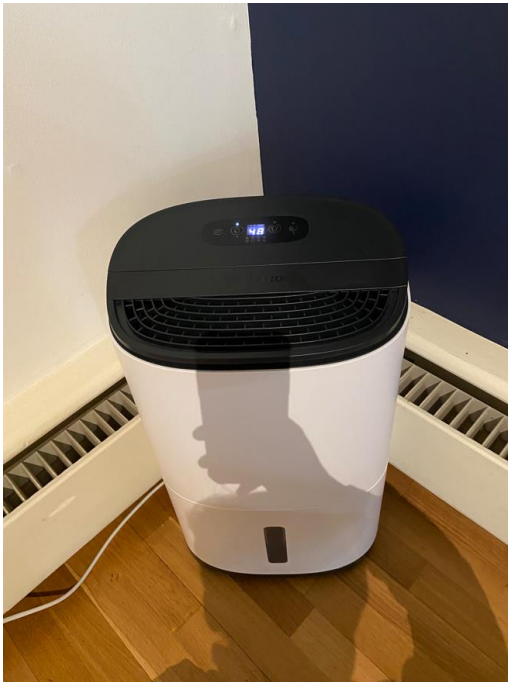
reasonable working condition, however, reports are that the units struggle to maintain the required humidity levels, particularly in the basement.	fully plumbed units with greater daily capacity.			
--	--	--	--	--	--

Photo 7.2.4 Dehumidification unit

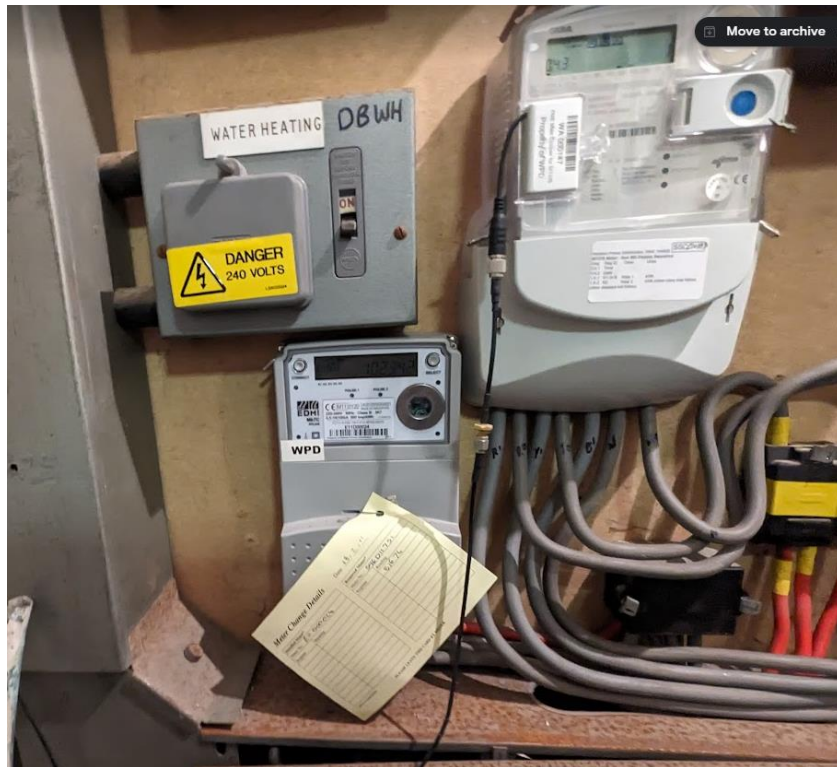
Photo 8.2.1 Incoming electric meter

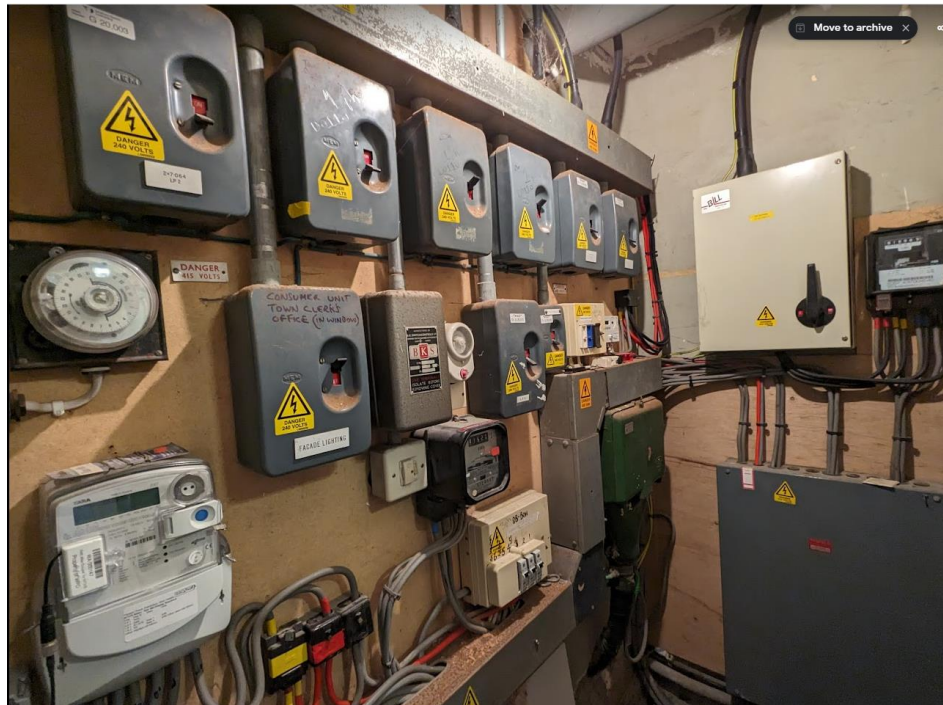
<p>parts/breakers are hard to come by.</p> <p>RCD missing to most circuits which would class as a C3 status (improvement recommended) on EICRs.</p> <p>No surge protection devices present these should be added to primary switchgear and submains distribution board (C3).</p>				
Final circuit wiring	In reasonable condition where visible, not visible in many locations. Some instances of relatively old cable. testing continues to comply then	Continue to carry out routine electrical continuity and resistance testing and carry out ad-hoc repairs when required.	N/A	£2,500	£5,000
Socket outlets	Generally in reasonable working condition. Non-colour contrasting and therefore non-part M compliant for new design standards.	Consider upgrading socket outlets to colour contrasting part M compliant outlets	N/A	£15,000	N/A

Photo 8.2.2 Primary switchgear

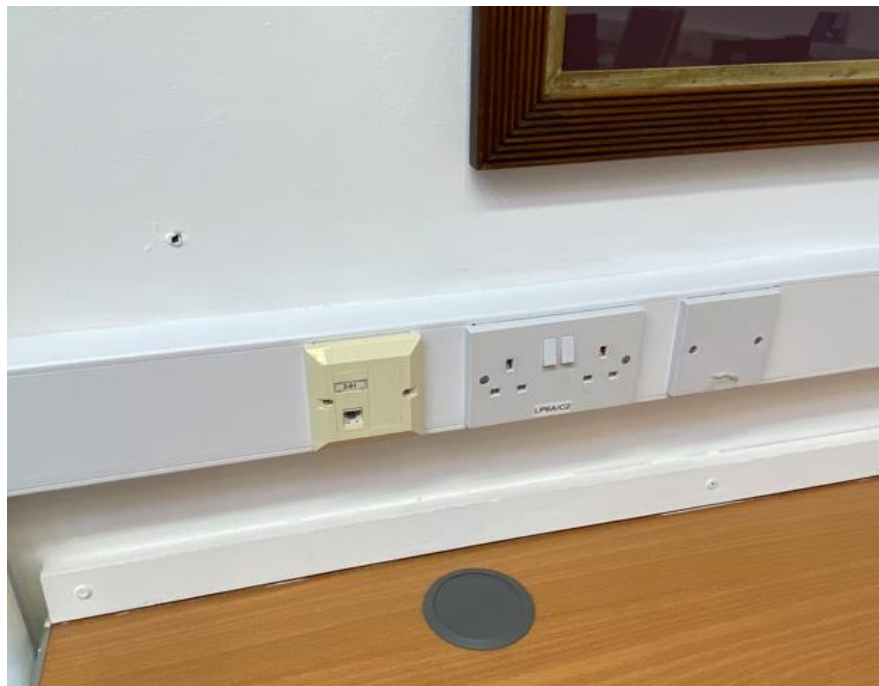
Photo 8.2.4 Socket outlets in library computer room

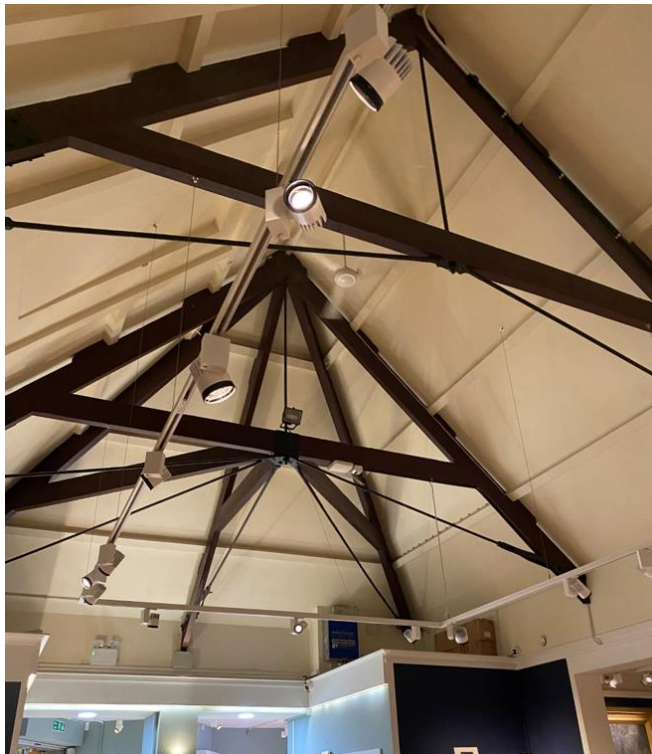
Photo 9.2.2 Track mounted lighting in gallery spaces, appears to be halogen based fittings

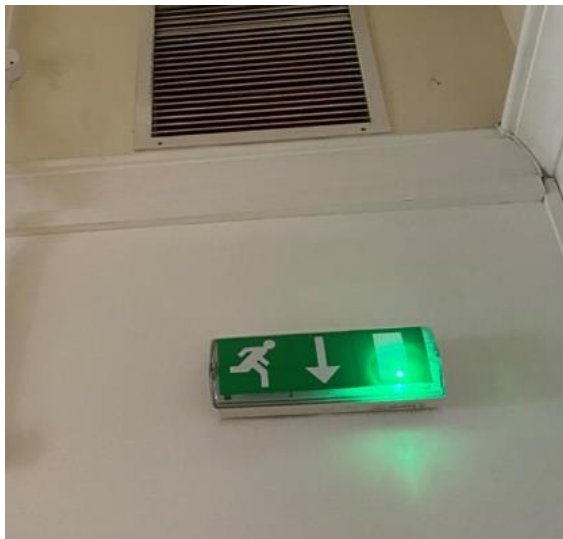
Photo 9.2.4 Non-maintained escape route lighting

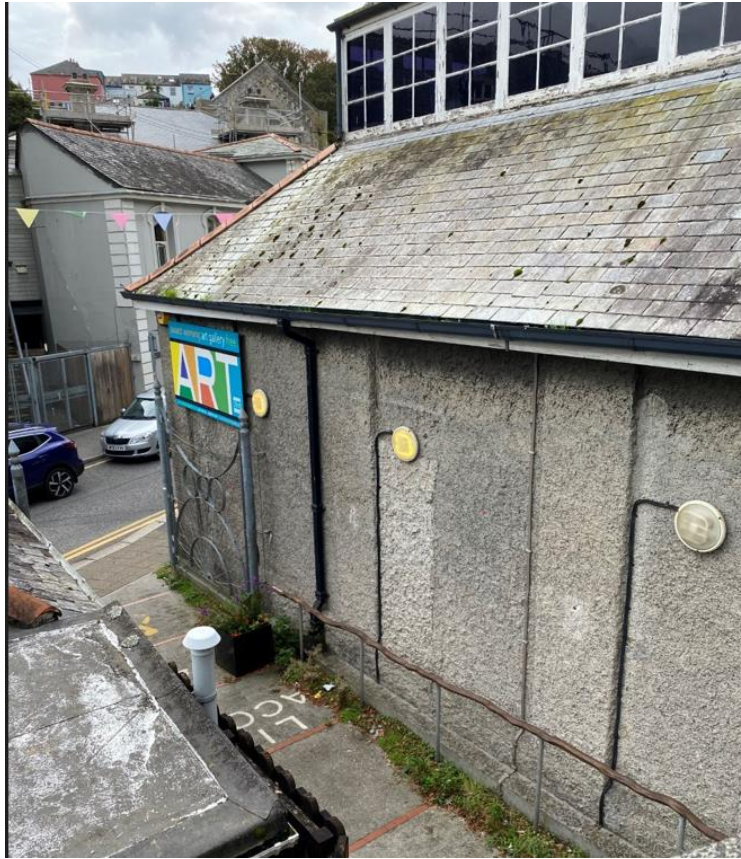
Photo 9.2.5 External bulkhead lighting

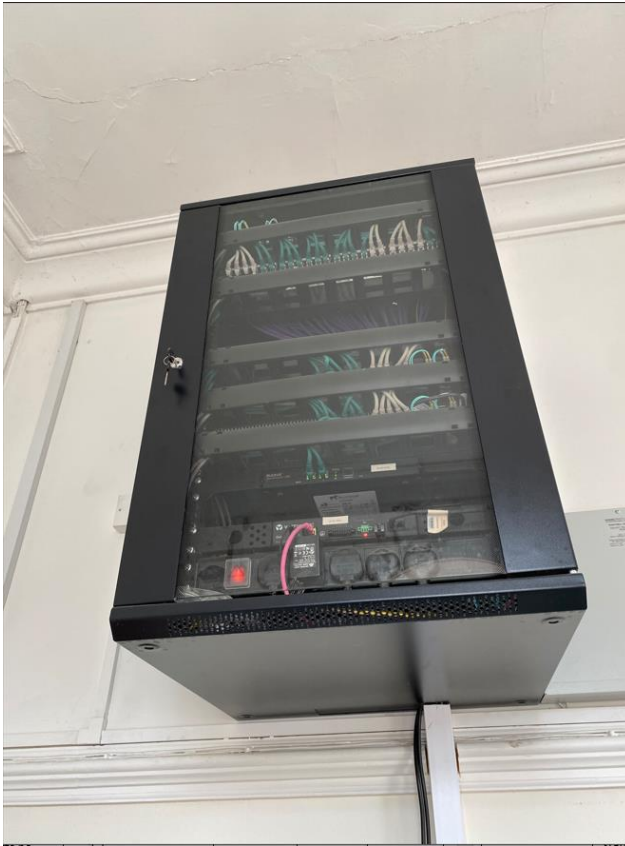
Photo 10.2.1 Wall mounted 29U data cabinet in council offices

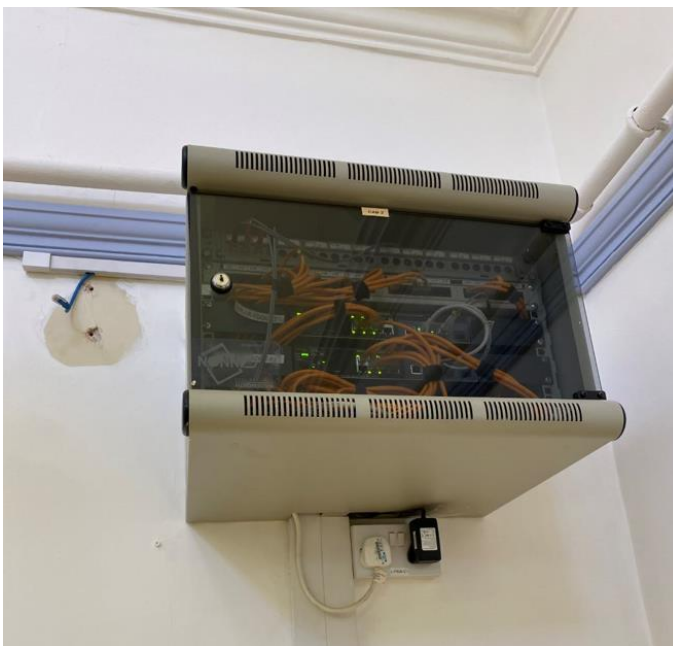
Photo 10.2.2 Wall mounted 19U data cabinet in library

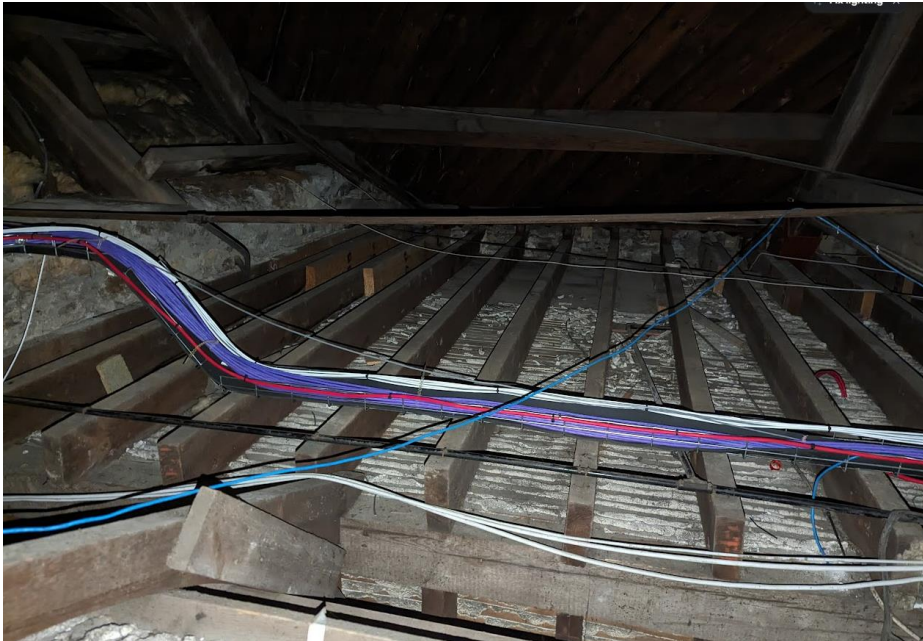
Photo 10.2.3 Cat 5e data wiring (in purple) running in loft space

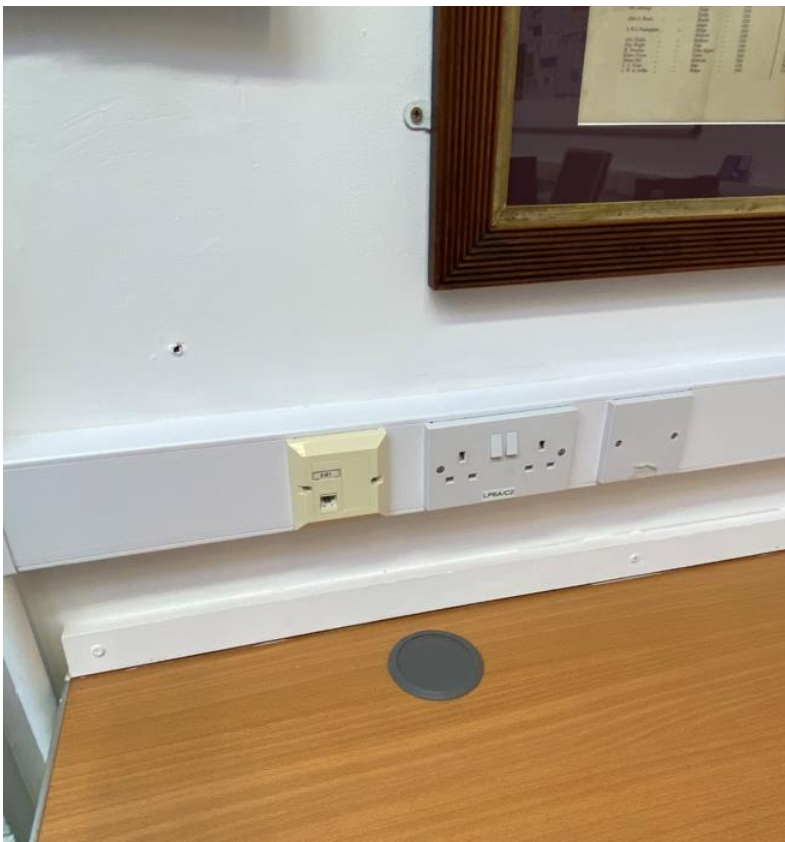
Photo 10.2.4 RJ45 data outlet in library computer room

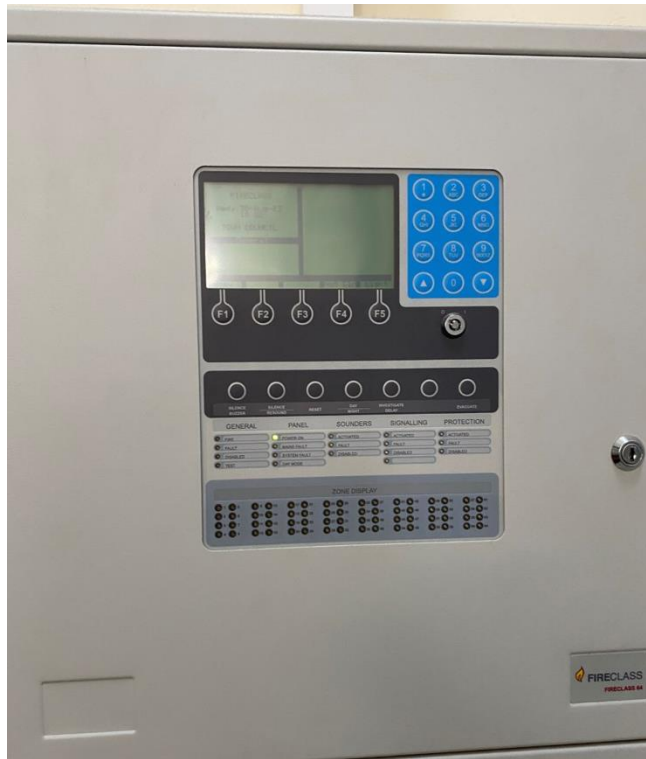
Photo 11.2.1 Addressable Fire Alarm Panel

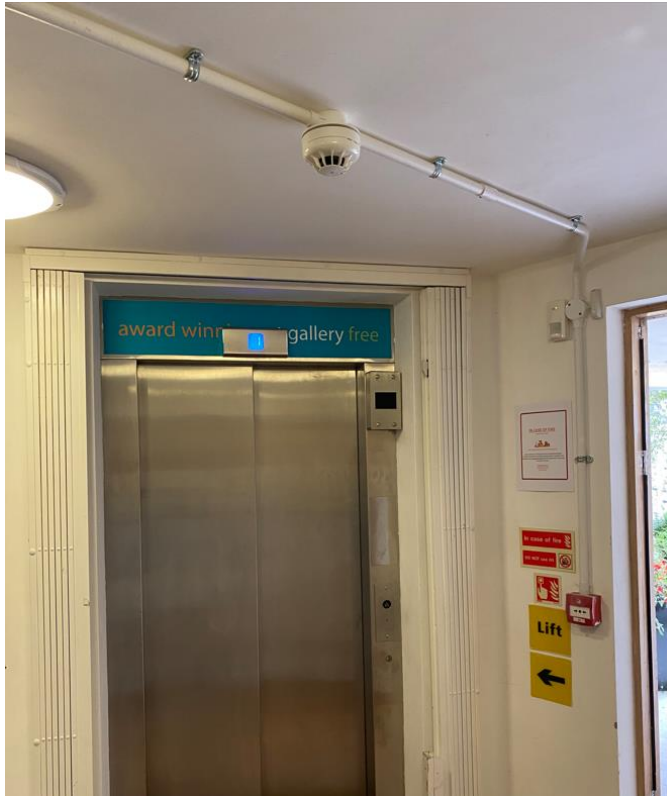
Photo 11.2.3 Smoke detector and manual call point

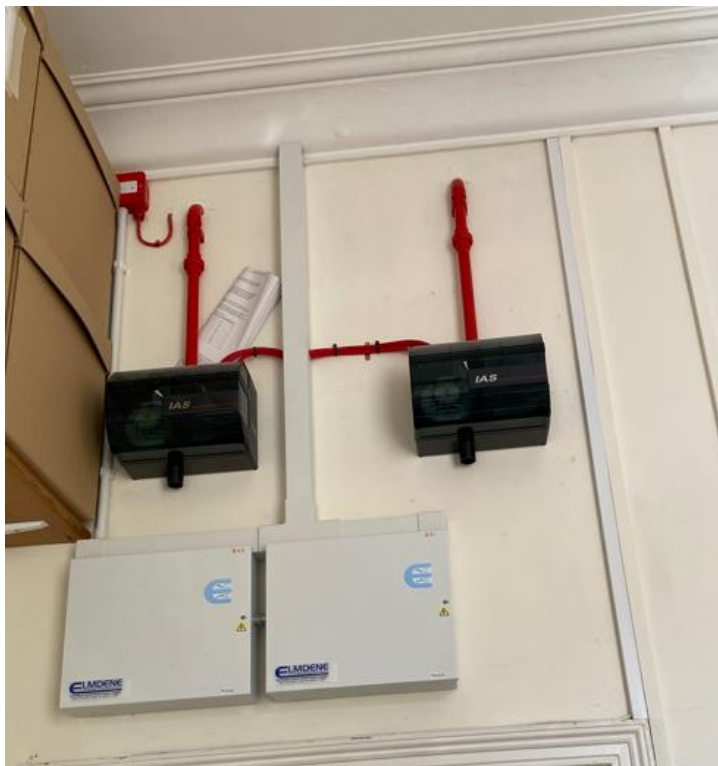
Photo 11.2.4 Aspirating smoke detection system for the loft space

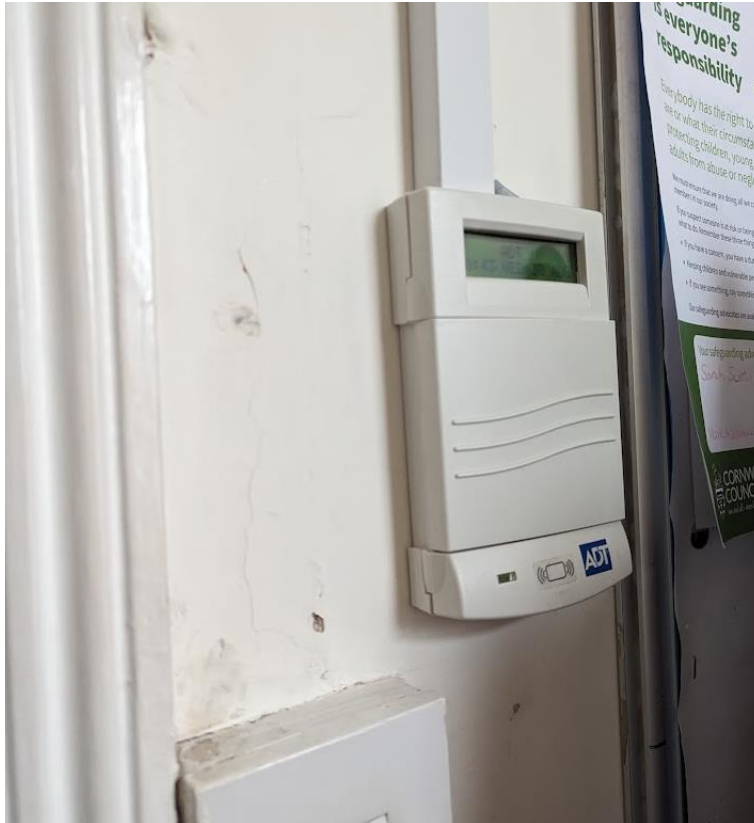
Photo 12.2.1 Security Alarm Keypad
