REPORT ON CONDITION OF:

**Municipal Building
The Moor
Falmouth
TR11 2RT**

Falmouth Town Council

30th August 2023

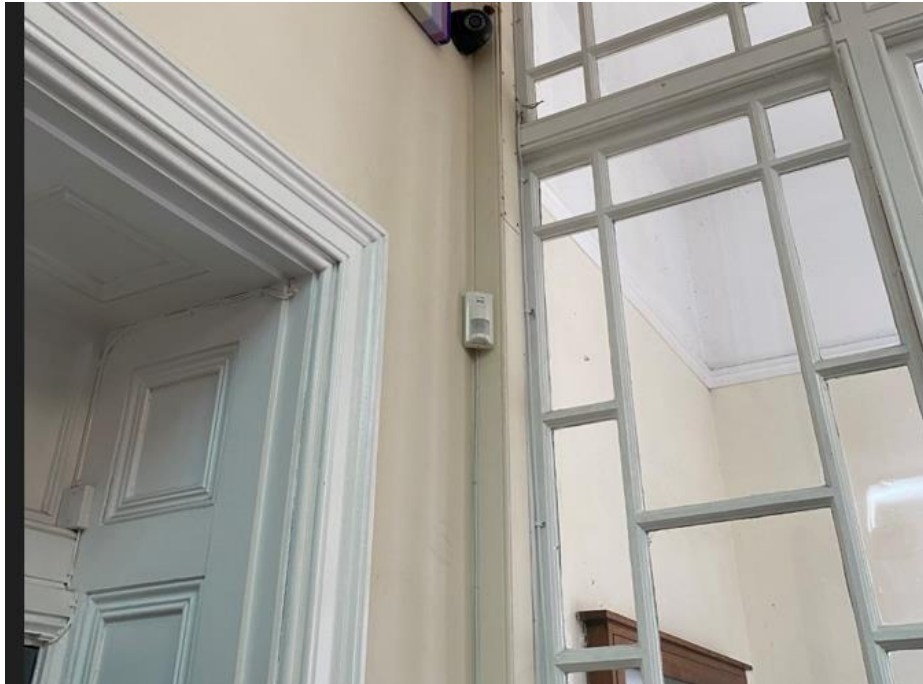
Photo 12.2.2 Security alarm detector

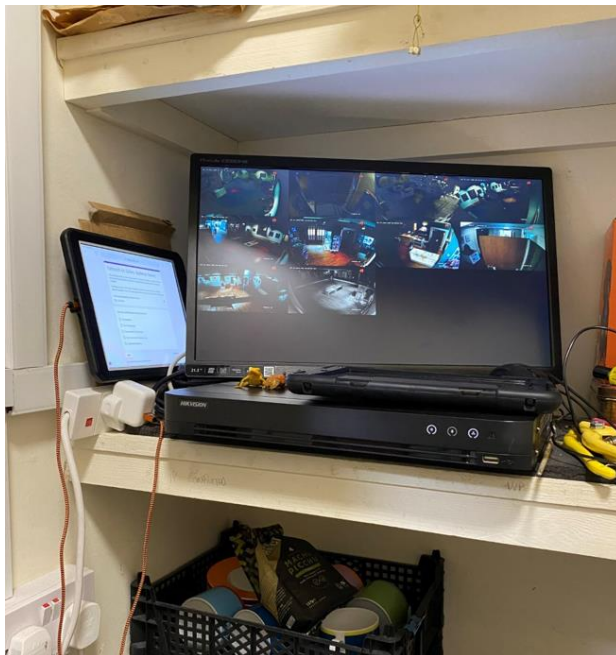
Photo 12.2.3 CCTV DVR and Monitoring Station

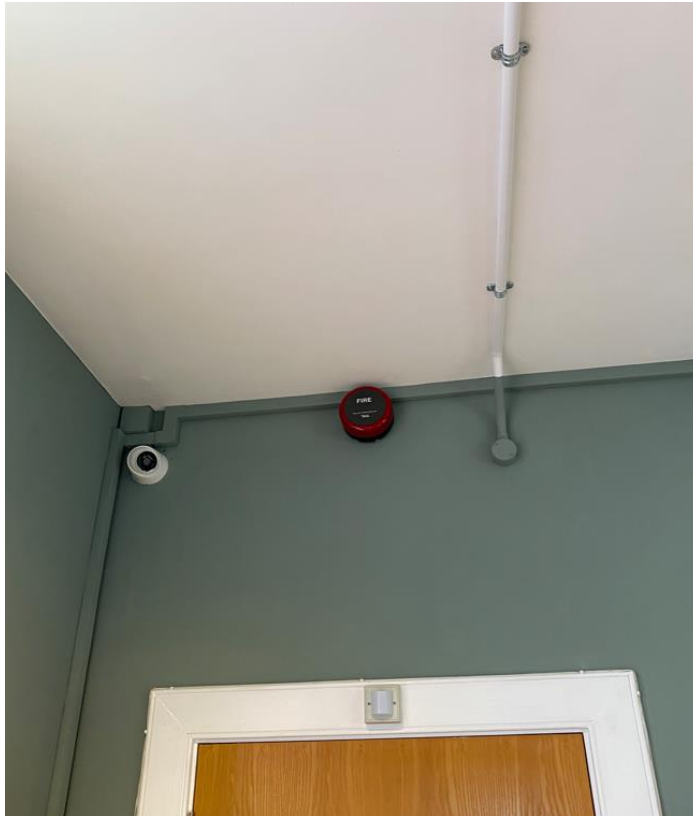
Photo 12.2.4 CCTV Camera

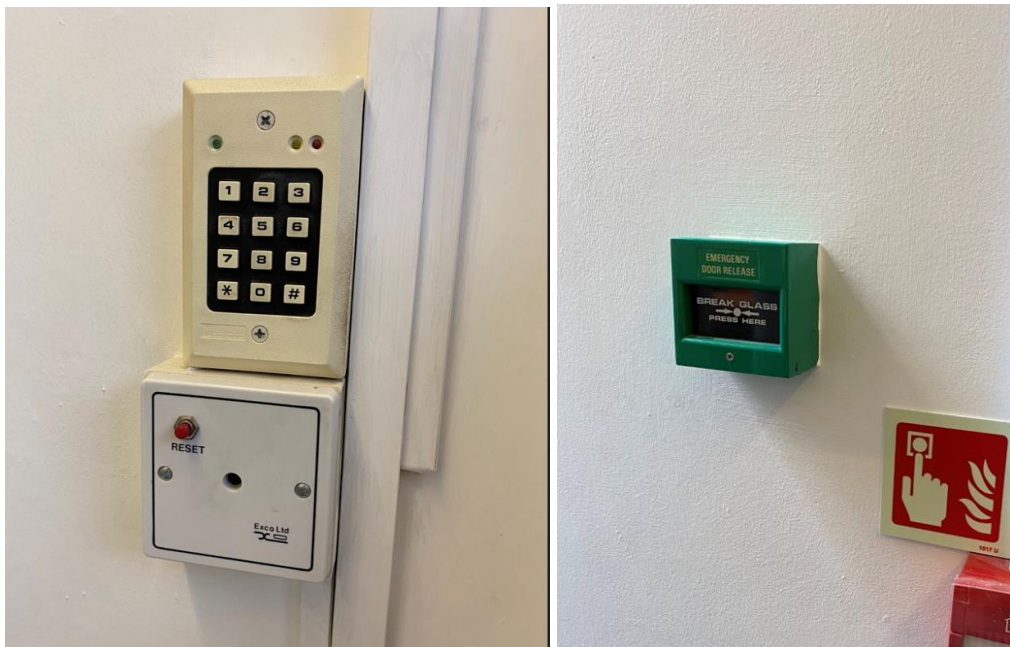
Photo 12.2.5 Keypad Access Controlled Door

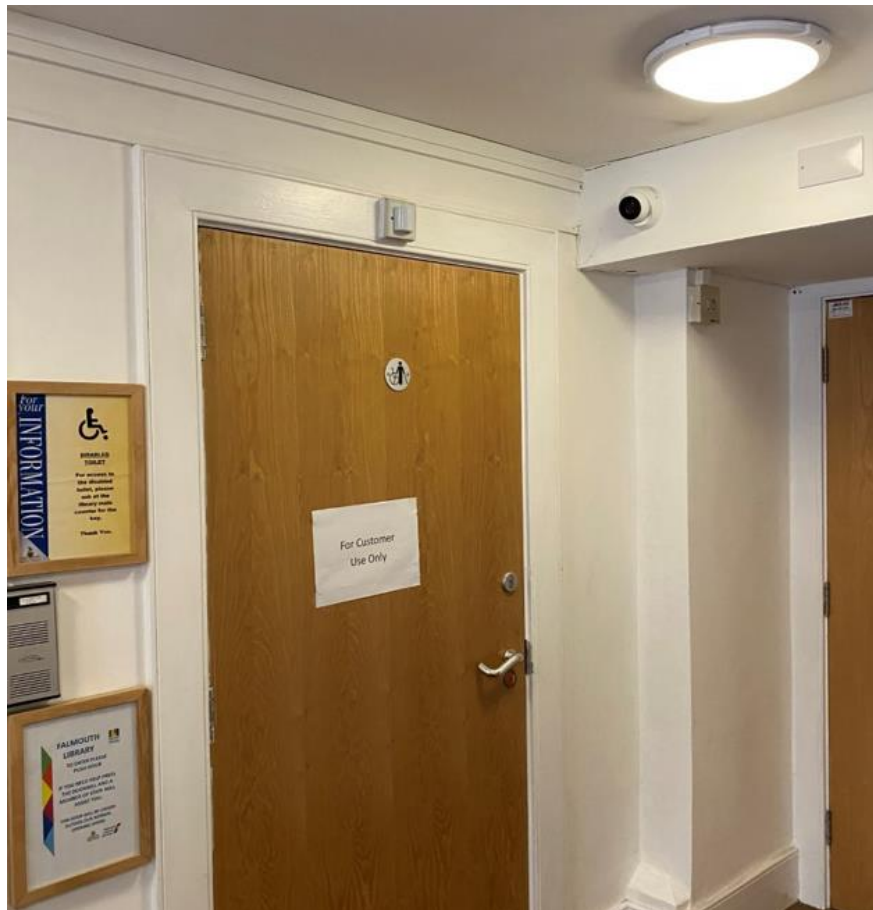
Component	Current status	Maintenance Requirements	Maintenance Costs		
			0-2 years	2-5 years	5-10 years
AWC call alarm	AWC call alarm present in downstairs AWC appears to be in reasonable working condition.	N/A	N/A	N/A	N/A

Photo 13.2.1 AWC Call alarm

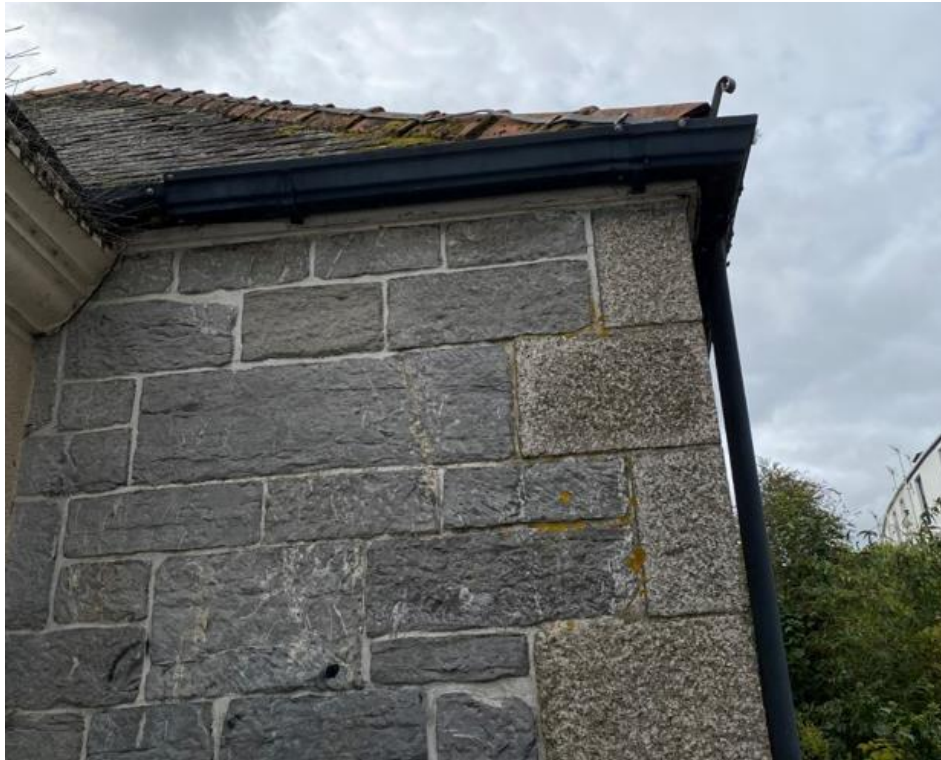
Component	Current status	Maintenance Requirements	Maintenance Costs		
			0-2 years	2-5 years	5-10 years
Lightning protection	Roof bonding conductor and down conductor seen and no visual damage observed, but a specialist such as St Ives Steeplejacks should be commissioned to review the condition in full.	Unknown	N/A	N/A	N/A

Photo 14.2.1 Lightning protection roof bonding conductor

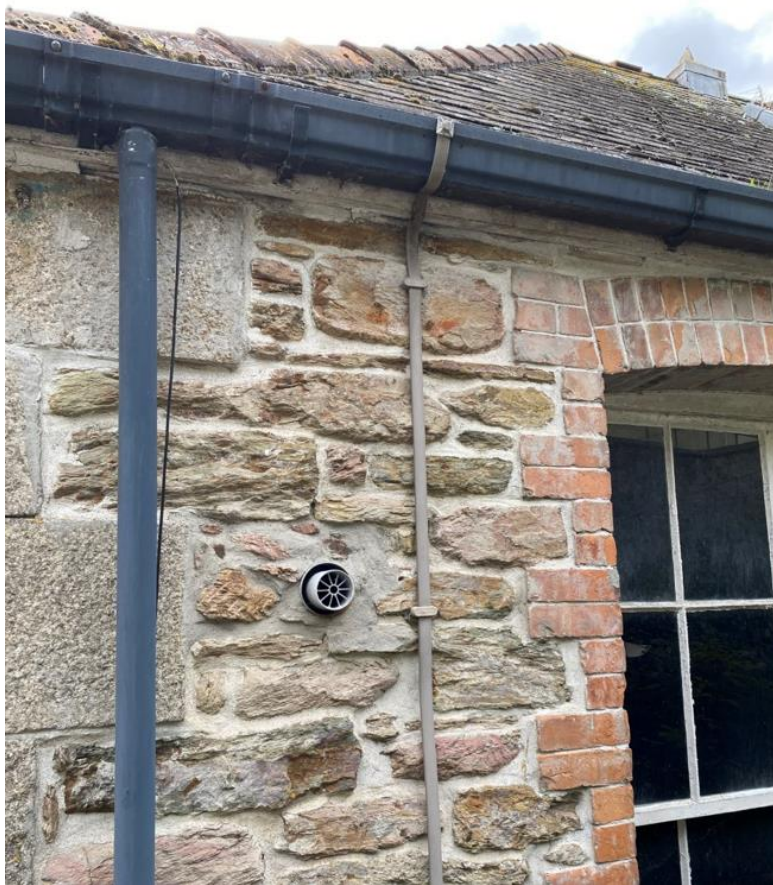
Photo 14.2.2 Lightning protection down conductor

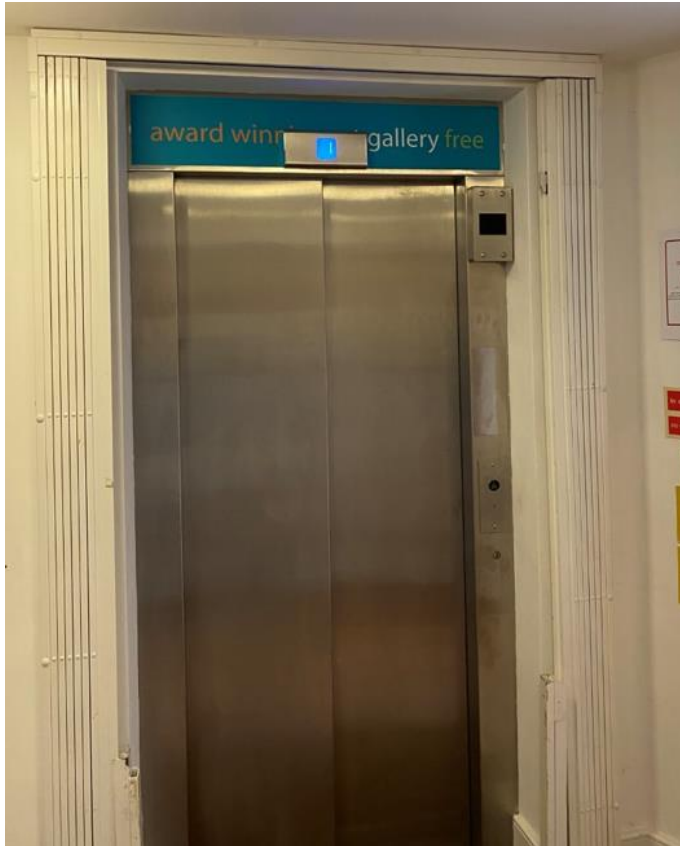
Component	Current status	Maintenance Requirements	Maintenance Costs		
			0-2 years	2-5 years	5-10 years
Lift	Lift was in working condition when used. Refer to lift specialists annual maintenance report for further details.	Unknown	N/A	N/A	N/A

Photo 15.2.1 Lift
