EDWINSTOWE VILLAGE HALL

BUILDING CONDITION SURVEY

THURSDAY 20TH JULY 2023

Smith and Roper
Architects and Surveyors
65-67 Church Street
Sutton in Ashfield, NG17 1FE

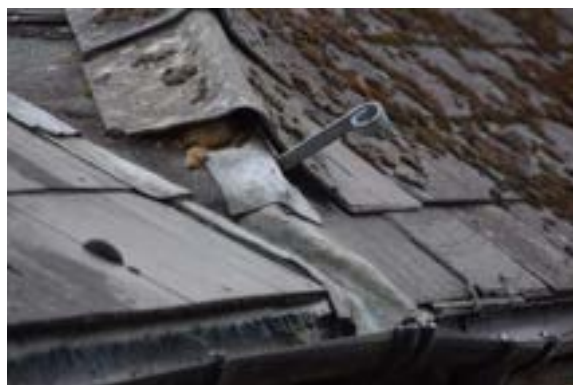
4.1.3 The hipped lean-to roof over the kitchen and south east entrance lobby abuts the east gable wall of the northern section of the hall. Roof coverings are synthetic slate with blue clayware hip tiles; a significant number of lower slates have been renewed in Welsh slate, possibly when the valley gutter was constructed. There is a lead apron flashing at the head of the roof, the abutments with the hall gable have lead soakers and stepped lead cover flashings. The hip iron at the foot of the northern hip above the kitchen appears to be dislodged and requires re-fixing.

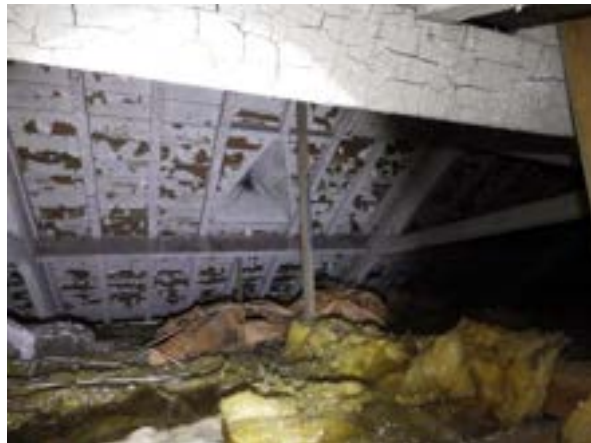
5.1.5 The roof over the southern section of the main hall is hipped and consists of primary A-frame trusses with a raised tie, purlins, rafters and ridge beam. The roof is fully over-boarded which at some stage has been painted. Within the southern roof slope are two gabled ventilators, which are provided with hinged openings. These were closed at the time of inspection. Decoration failure is noted throughout, making inspection of the timbers difficult. The roof is insulated at ceiling level with approximately 100mm of mineral wool insulation. Daylight is however apparent at the apex of the gabled ventilator at the eastern end of the southern roof slope.

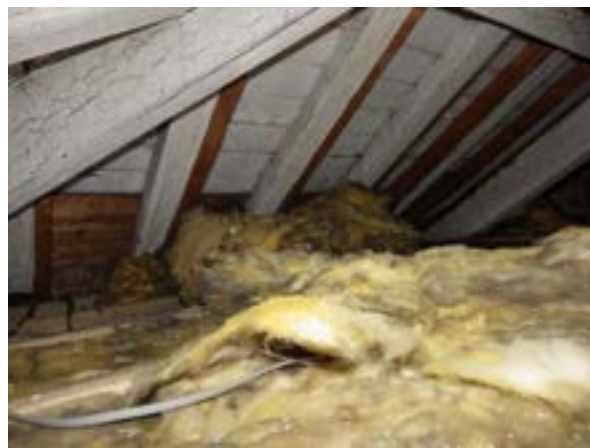
5.1.6 The roof above the council offices is constructed similar to that over the southern end of the main hall, with primary raised tie attic trusses, exposed purlins, hip rafters, rafters and over-boarded with timber boarding. At some stage the entire roof structure has been decorated, the decoration to which is failing significantly in a number of places. New boarding and additional rafters are noted towards the northern end of the eastern roof slope. The ceiling is insulated with approximately 100mm mineral wood insulation. Whilst externally the roof appears "L" shaped, there is no access between the southern end of this roof and the roof over the main hall. Rafters and boarding are continuous down to the wall plate.

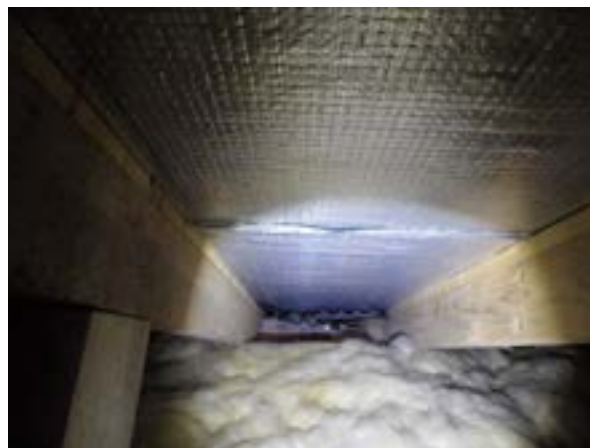
5.1.7 The roof over the locker room is fully hipped and has exposed rafters, hip rafters and ridge. The rafters have been increased in height by the application of a counter batten, above which appears to be a foil based roofing felt. The roof is provided with cavity trays to ensure a ventilation gap at the eaves, although a number of these are dislodged. The area is insulated with approximately 150–200mm of mineral wool insulation, although this is disturbed in a number of places and a roll is left unlaidd. A section of foil membrane is dislodged at its overlap on the eastern end of the northern slope and there is a hole within the membrane towards the northern end of the western slope. The valley board is evident between the western roof slope and the adjoining kitchen roof slope. The top side of the access hatch into the roof void above the locker room is provided with polystyrene insulation approximately 100mm in thickness.

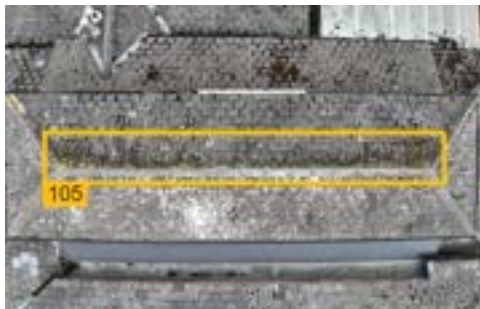
201193 (4).JPG

105 Moss & lichen growth

Severity: 2

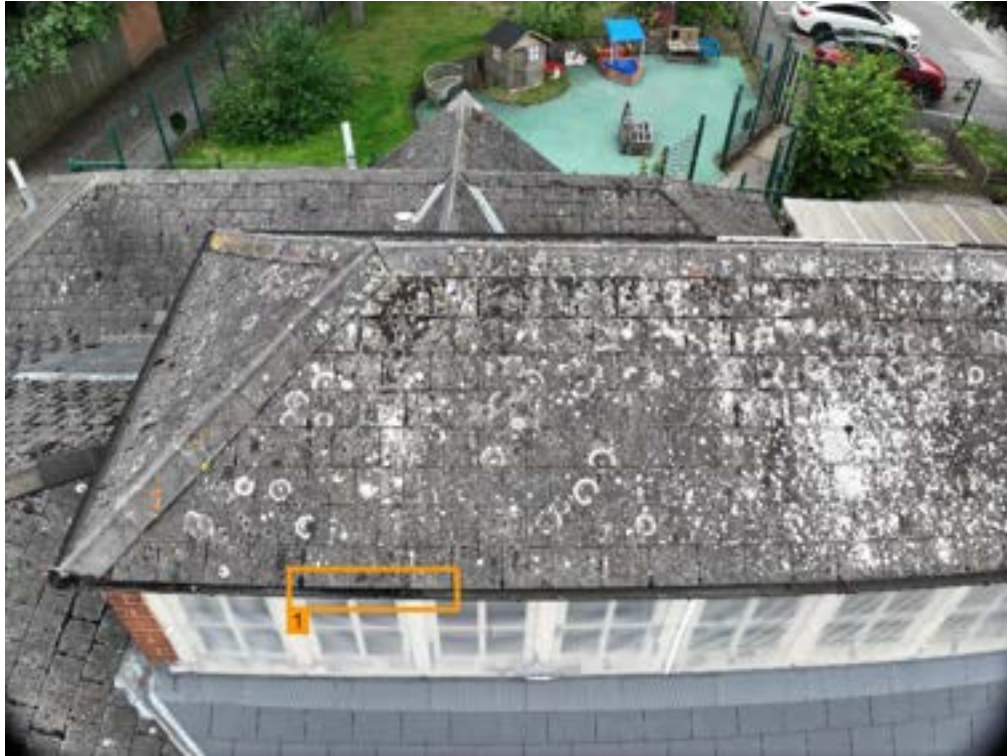
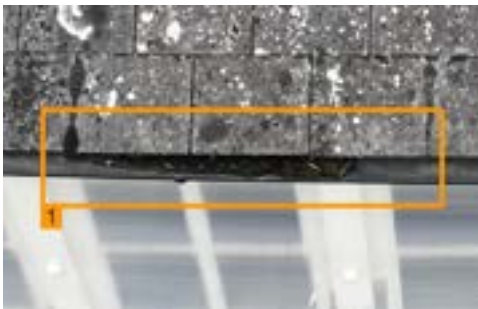
201193 (5).JPG

1 Debris in gutter

Severity: 3

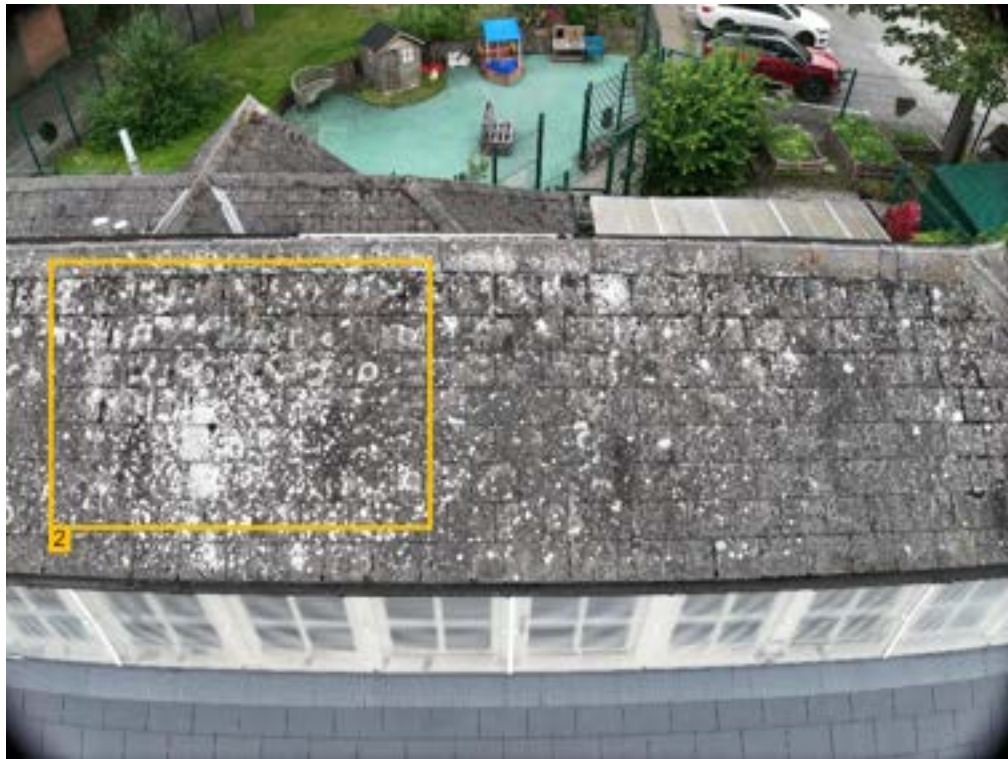
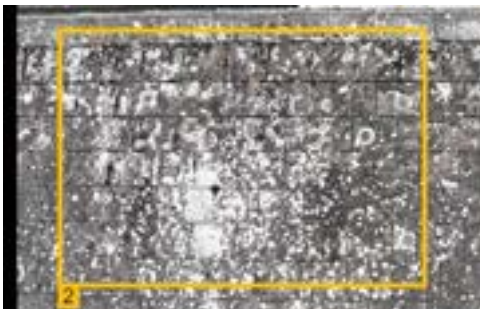
201193 (6).JPG

2 Lichen growth

Severity: 2

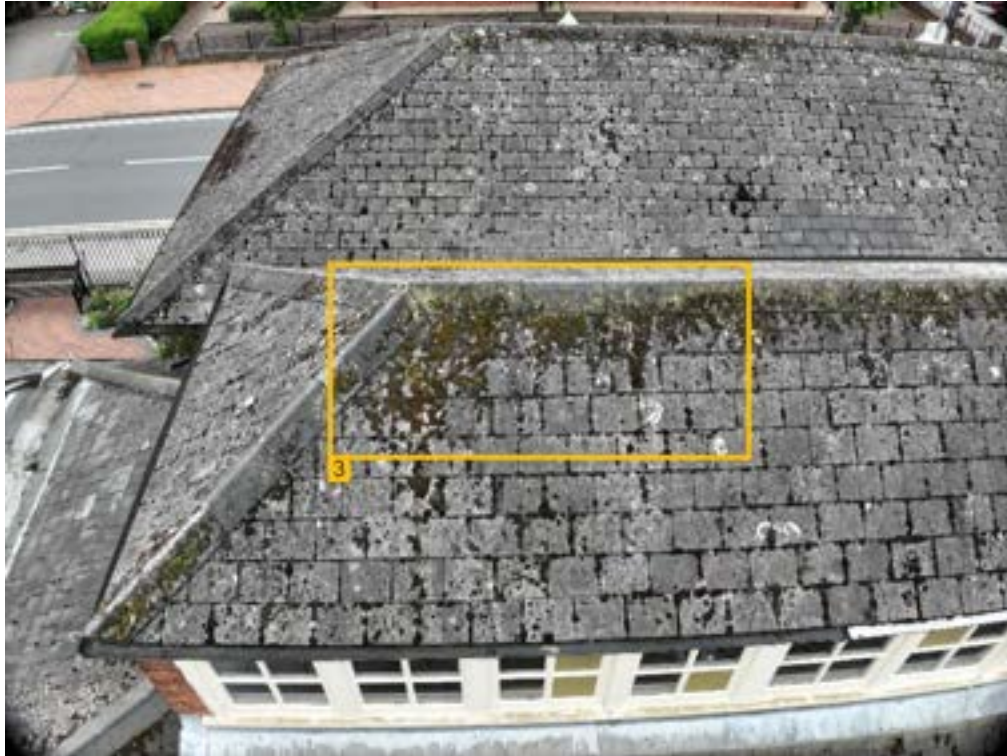
201193 (9).JPG

3 Moss growth

Severity: 2

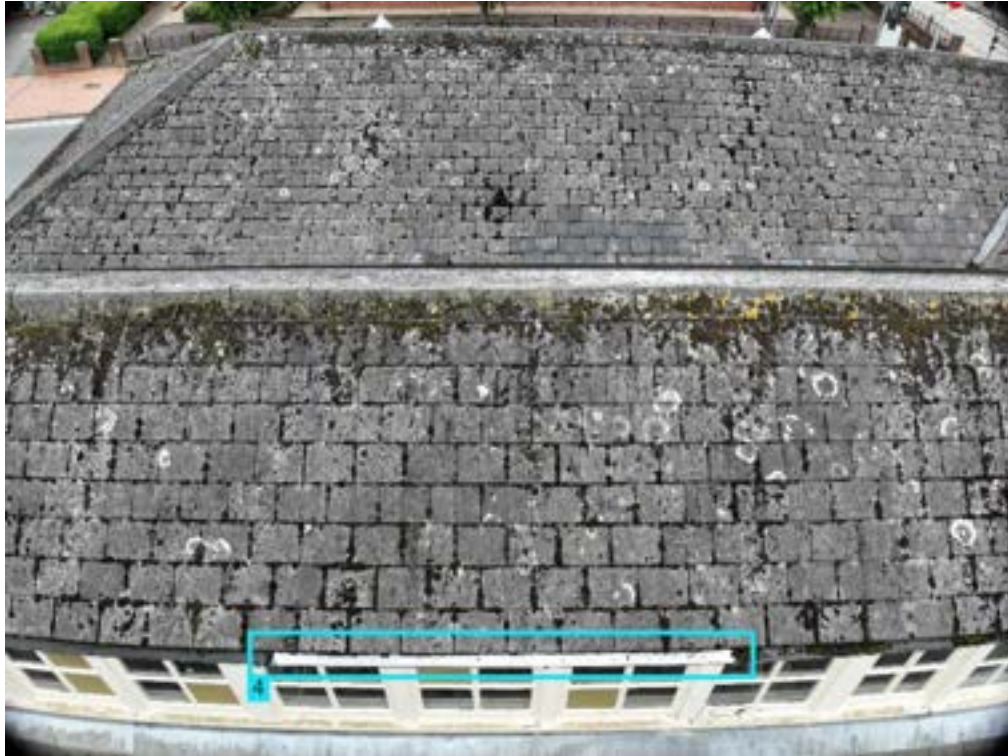
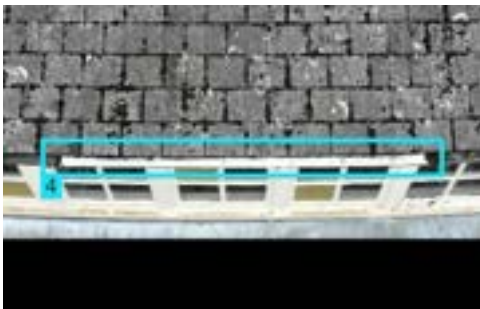
201193 (10).JPG

4 Historic repair

Severity: 0

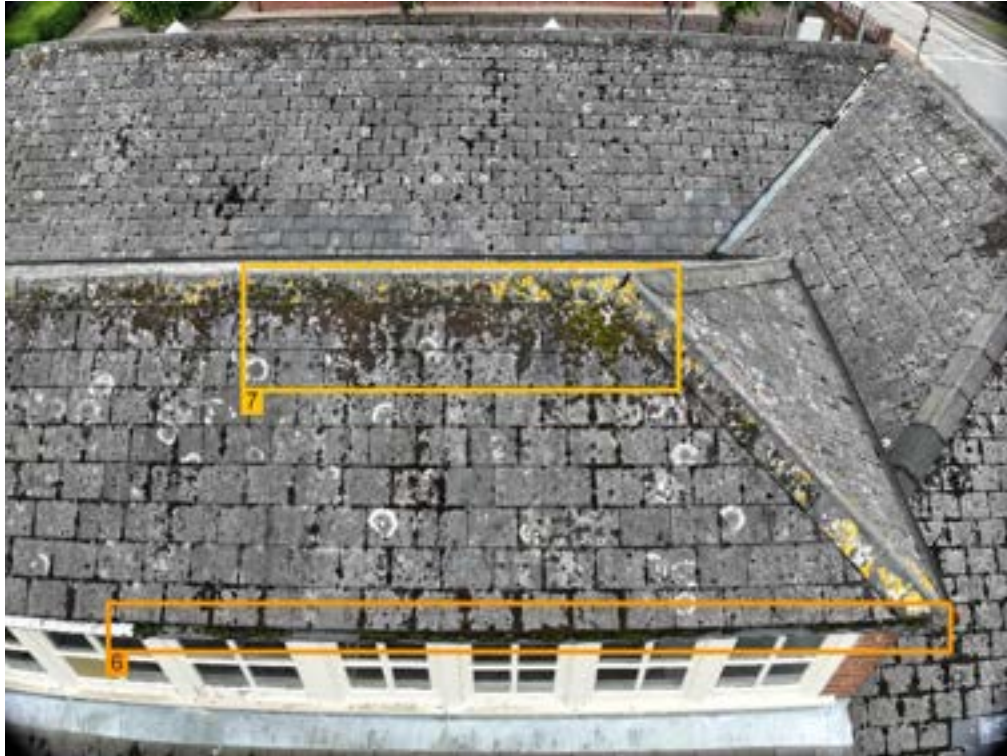
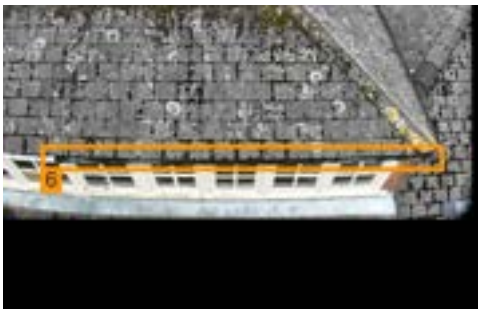
201193 (11).JPG

6 Moss growth in gutter

Severity: 3

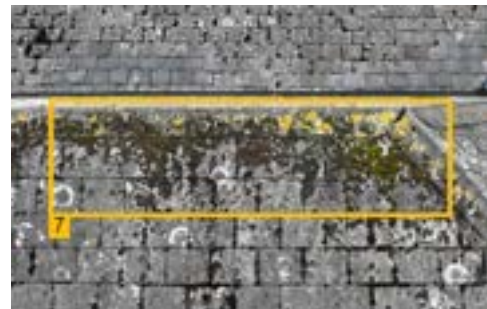
7 Moss growth

Severity: 2

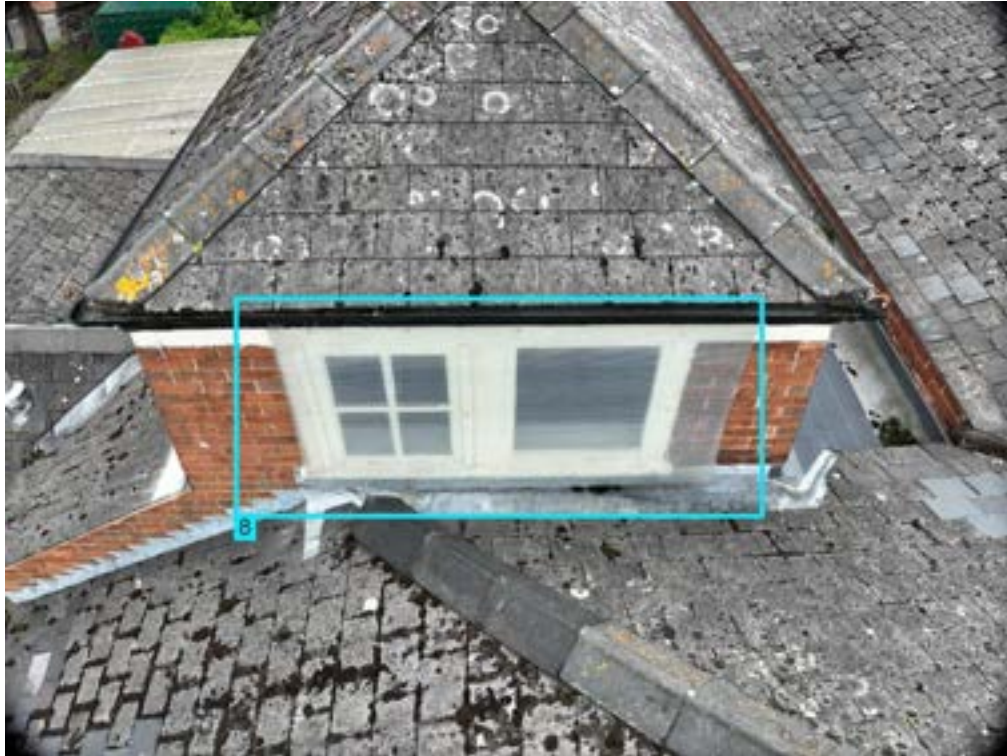
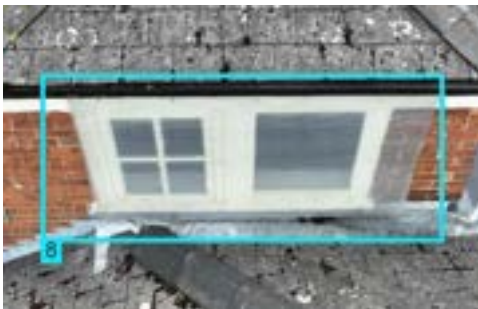
201193 (13).JPG

**# 8** Historic repair

Severity: 0

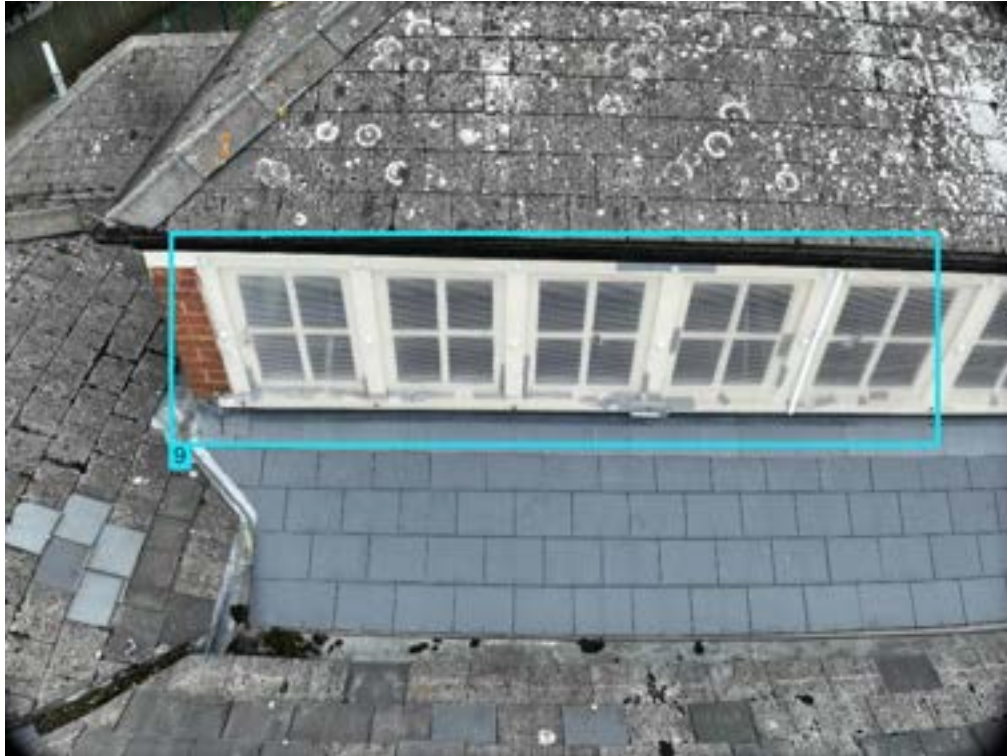
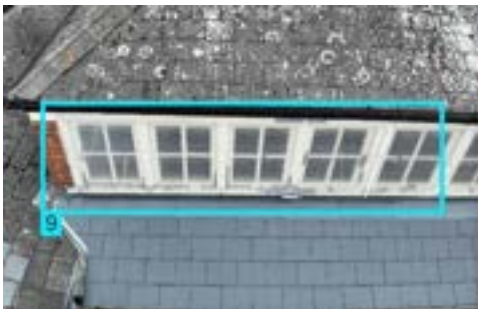
201193 (14).JPG

**# 9** Historic repair**Severity: 0**

Plastic corrugated board over window.

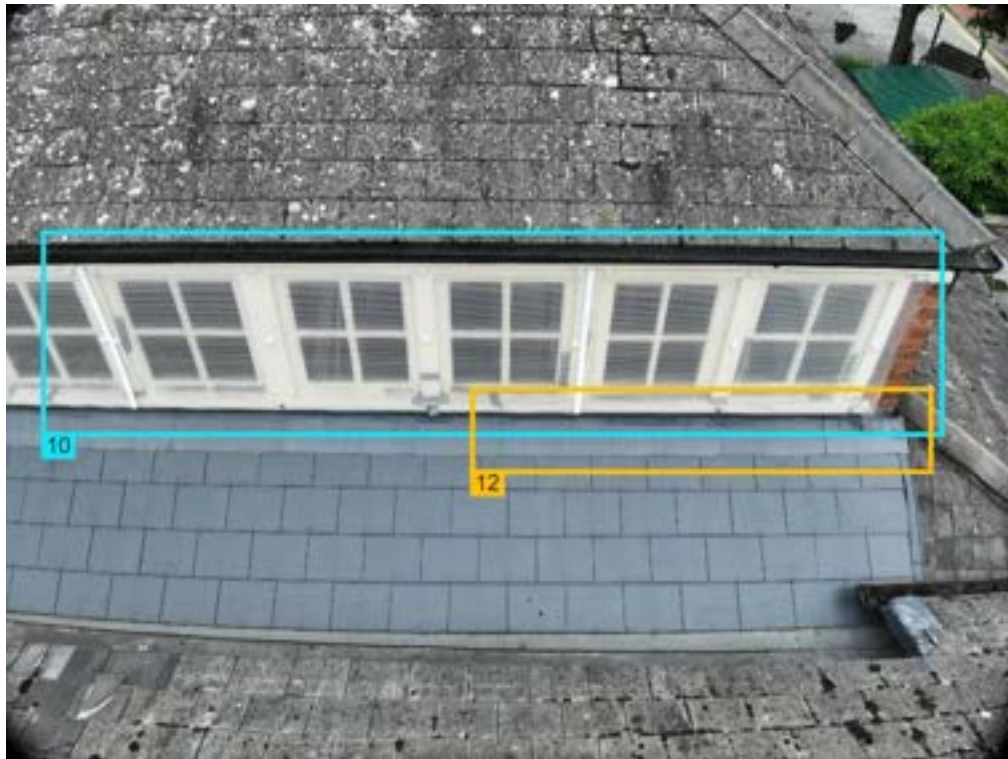
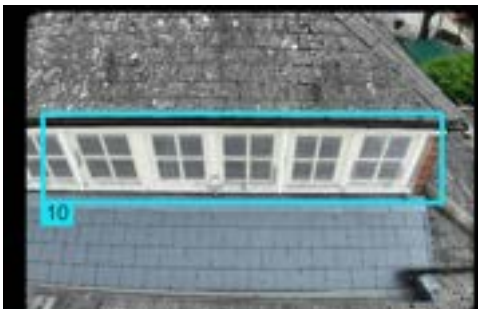
201193 (16).JPG

**# 10** Historic repair

Severity: 0

Plastic corrugated board over window.

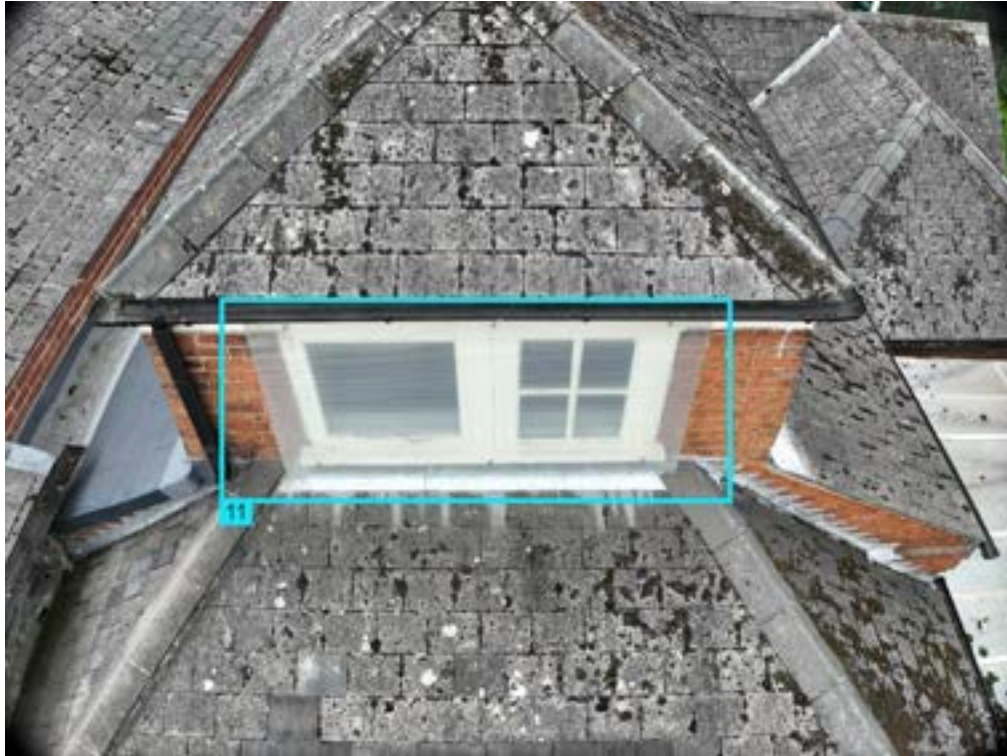
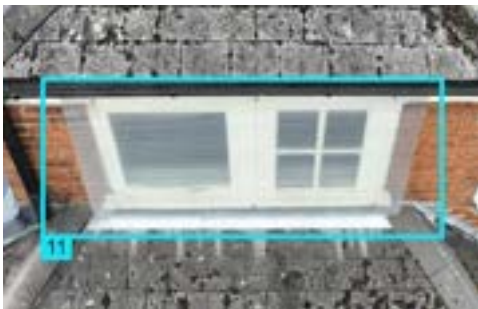
201193 (17).JPG

**# 11 Historic repair****Severity: 0**

Plastic corrugated board over window.

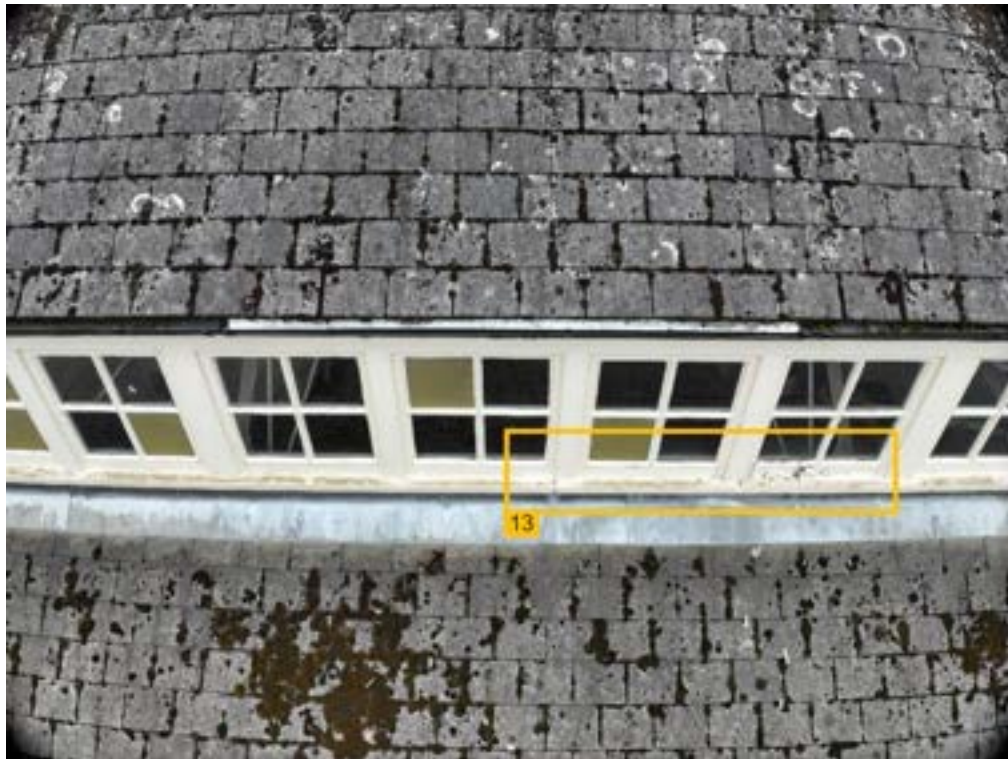
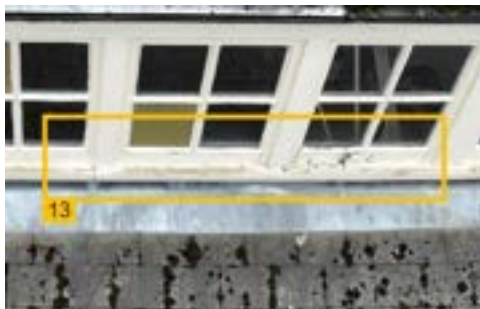
201193 (19).JPG

13 Paint coat failed

Severity: 2

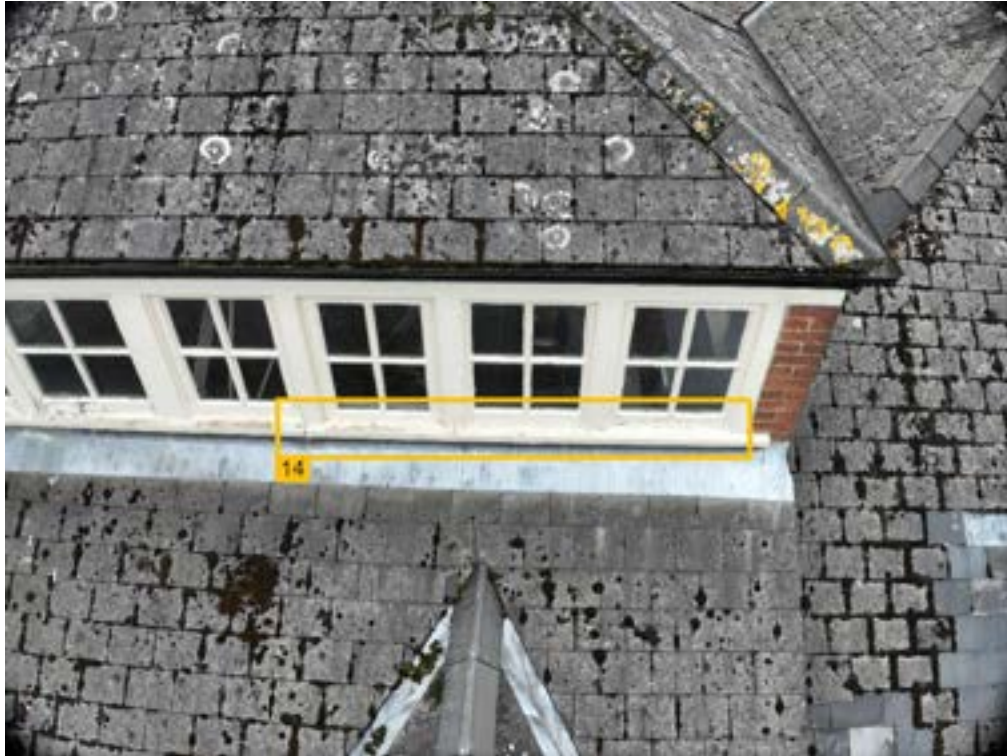
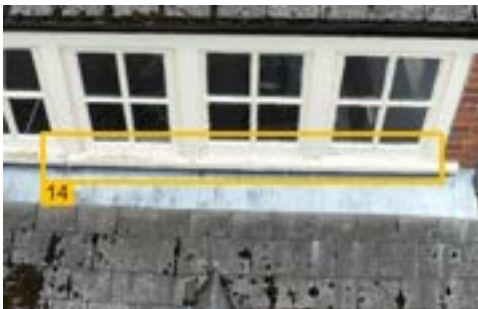
201193 (20).JPG

14 Paint coat failed

Severity: 2

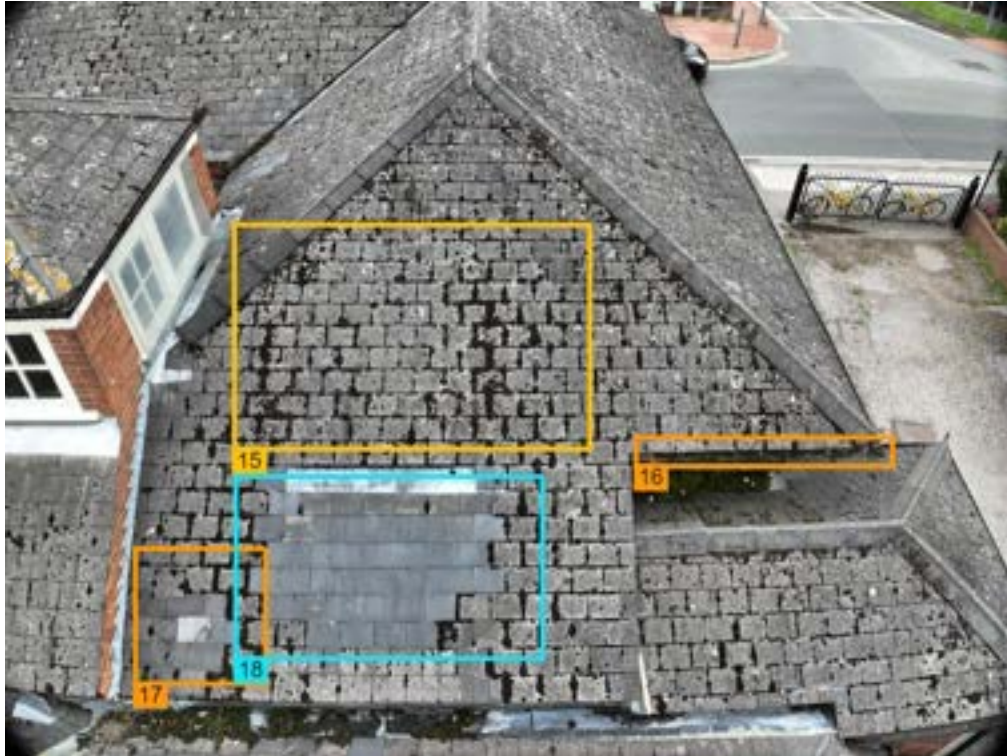
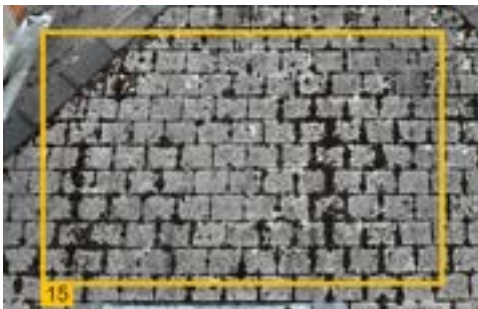
201193 (22).JPG

15 Moss growth

Severity: 2

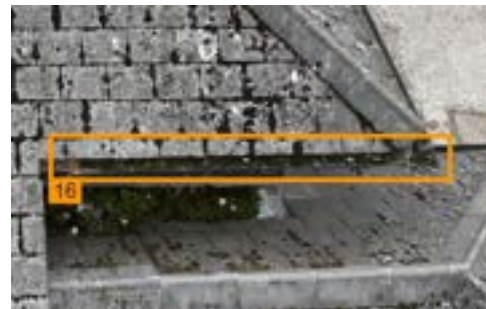
16 Moss growth in gutter

Severity: 3

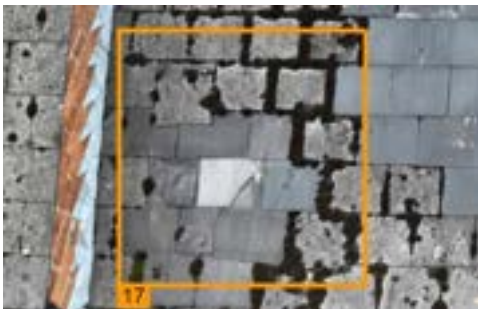
17 Damaged slate

Severity: 3

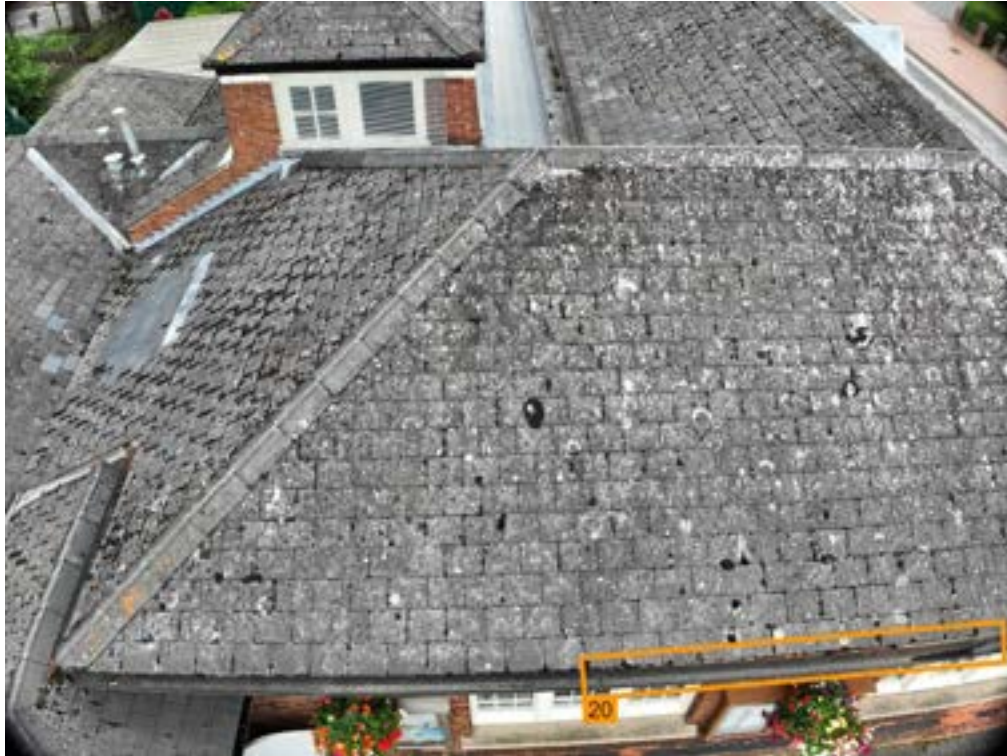
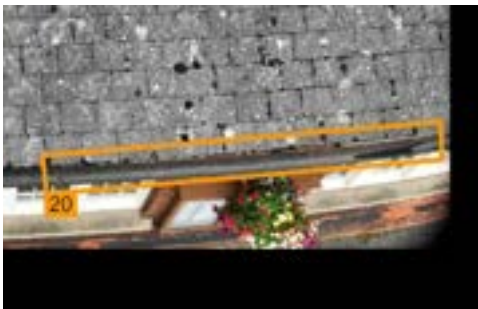
201193 (23).JPG

**# 20 Deformed gutter****Severity: 3**

Check for sufficient gutter brackets.

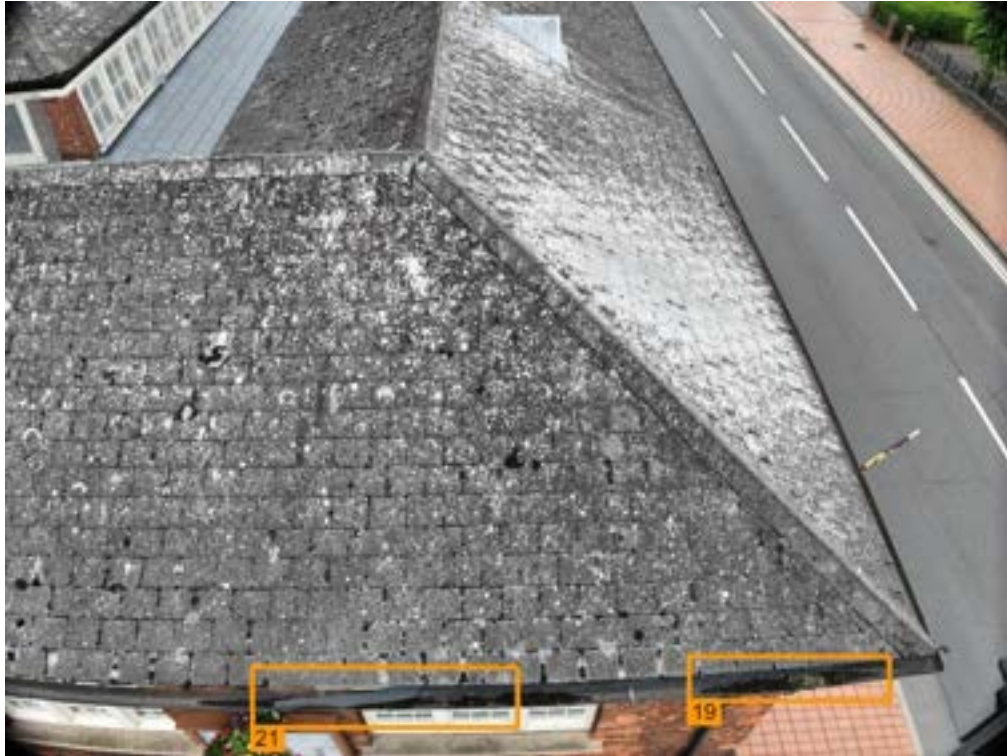
201193 (24).JPG

19 Blocked gutter/outlet

Severity: 3

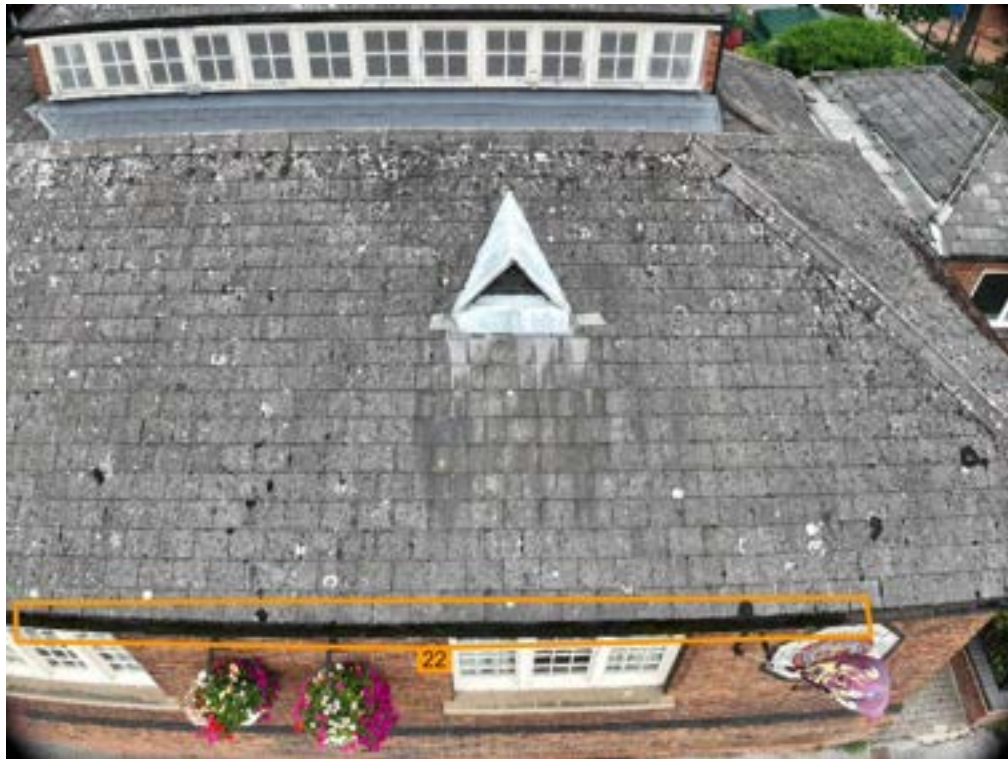
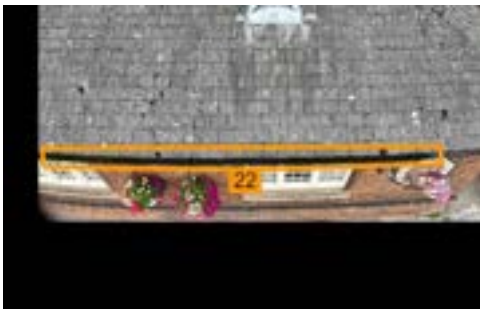
201193 (27).JPG

22 Moss growth in gutter

Severity: 3

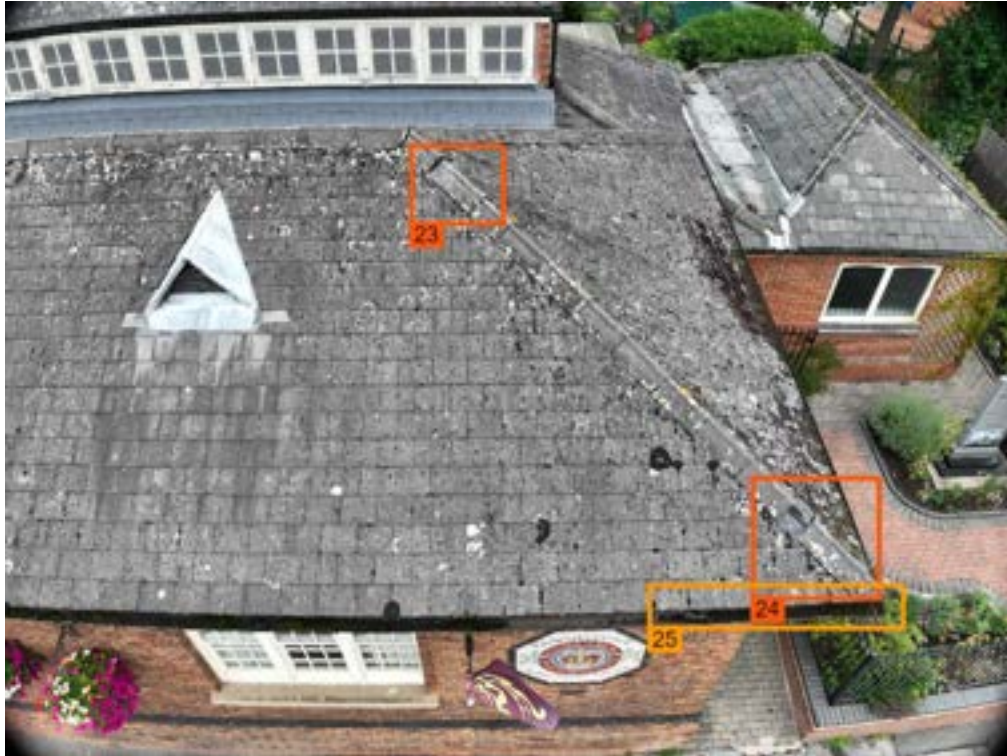
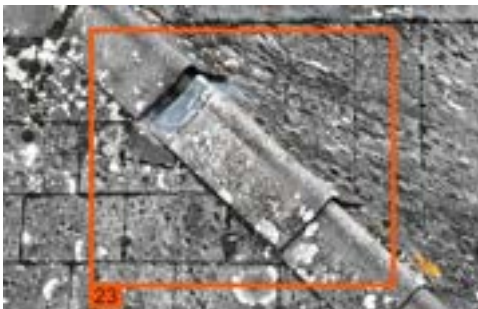
201193 (28).JPG

23 Slipped hip tile

Severity: 4

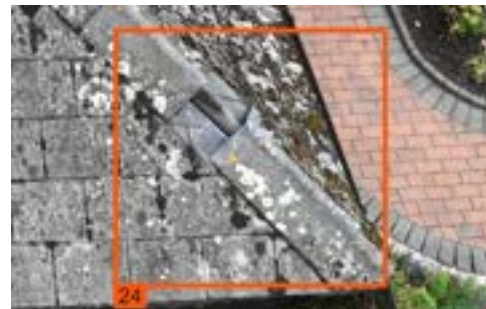
24 Slipped hip tile

Severity: 4

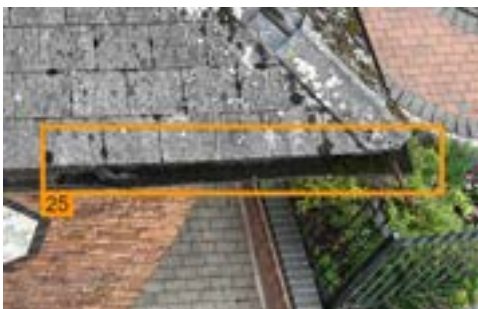
25 Moss growth in gutter

Severity: 3

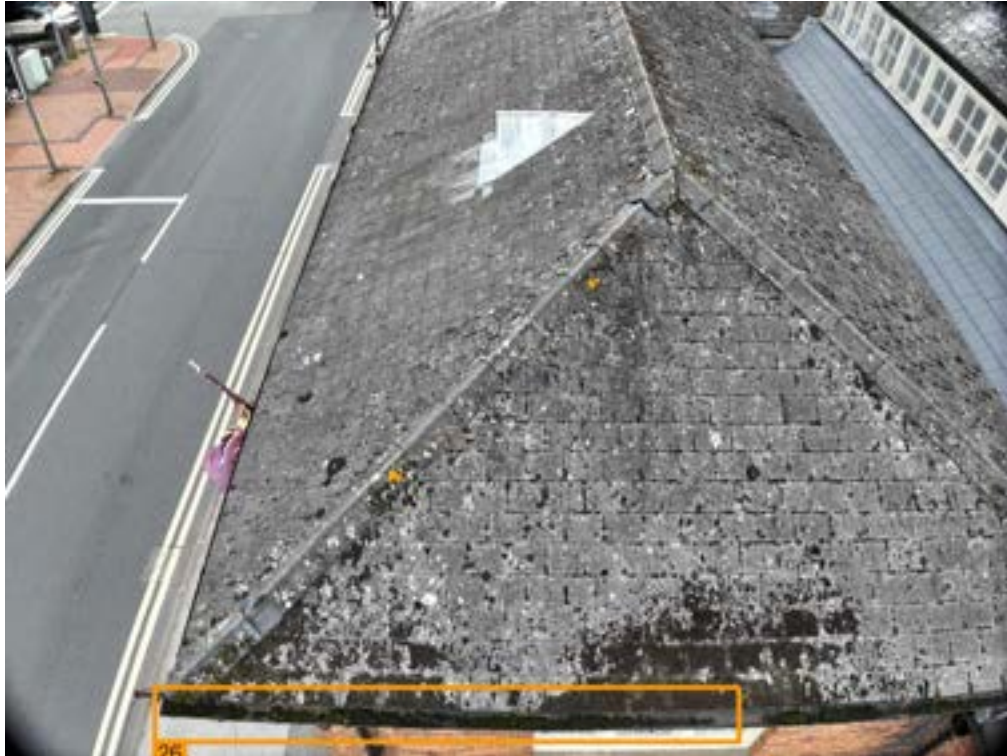
201193 (29).JPG

26 Moss growth in gutter

Severity: 3

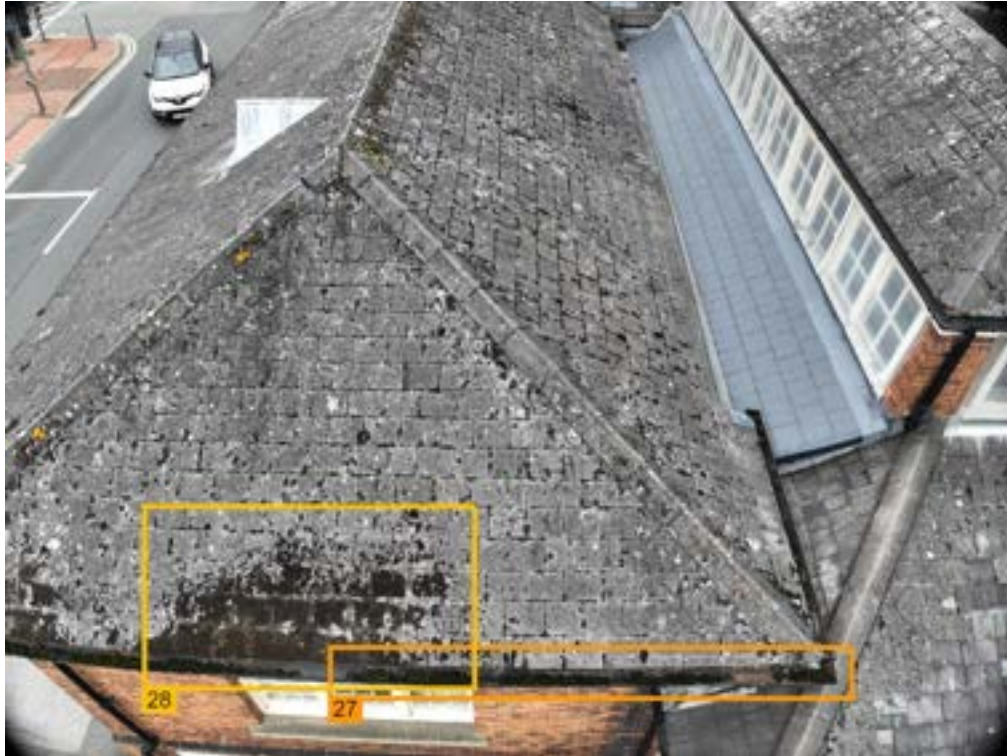
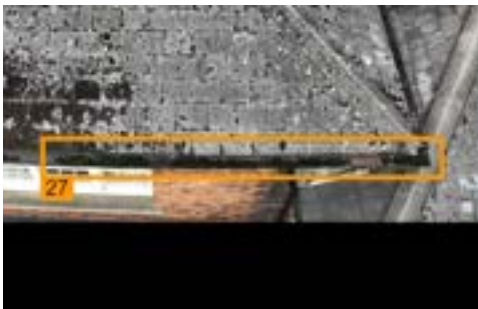
201193 (30).JPG

27 Moss growth in gutter

Severity: 3

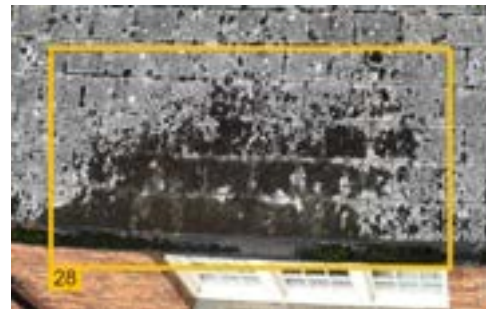
28 Moss growth

Severity: 2

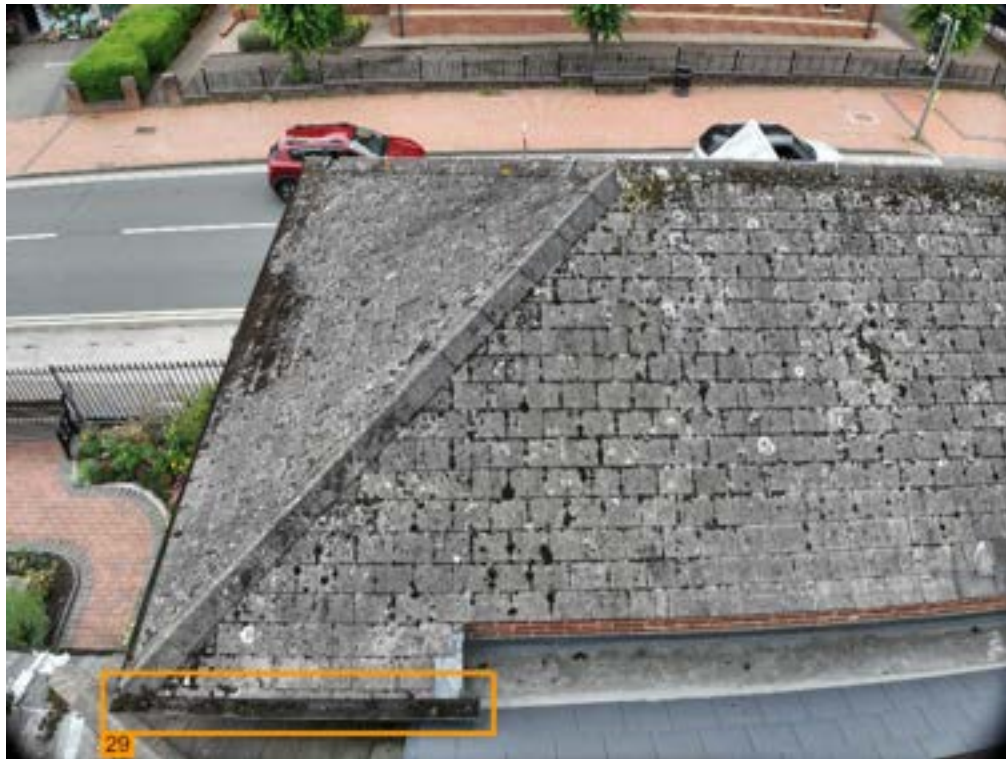
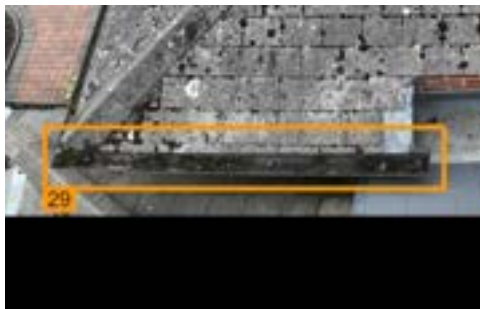
201193 (31).JPG

29 Moss growth in gutter

Severity: 3

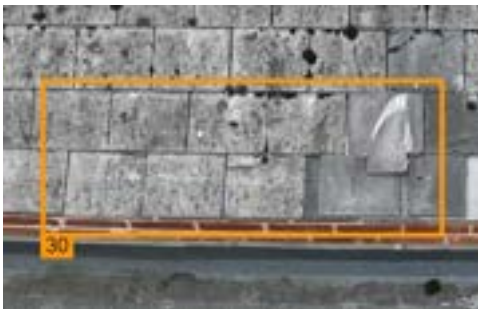
201193 (32).JPG

30 Damaged slate

Severity: 3

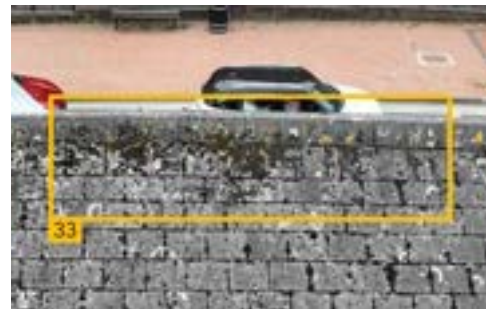
33 Moss growth

Severity: 2

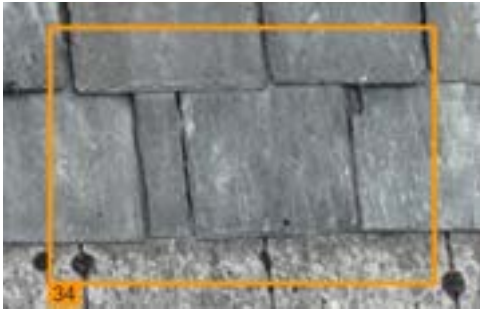
**# 34 Poor detailing****Severity: 3**

Ensure area is watertight.

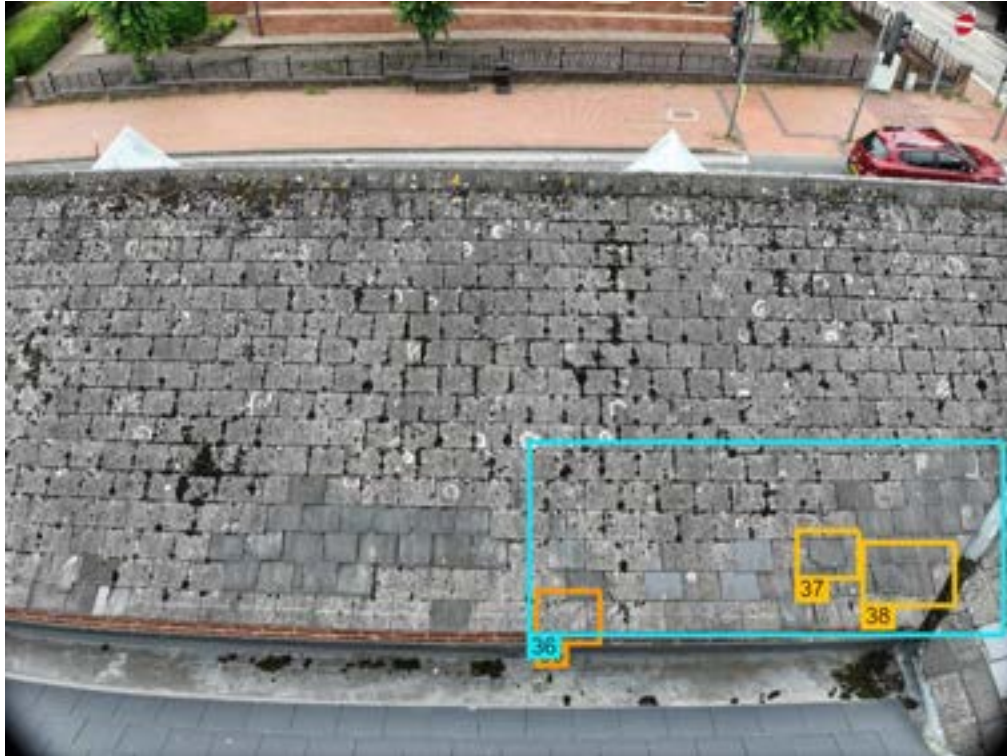
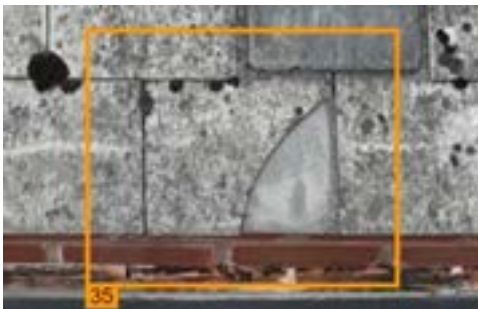
201193 (33).JPG

35 Damaged slate

Severity: 3

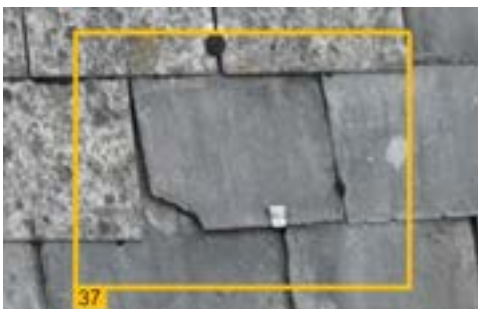
37 Damaged slate

Severity: 2

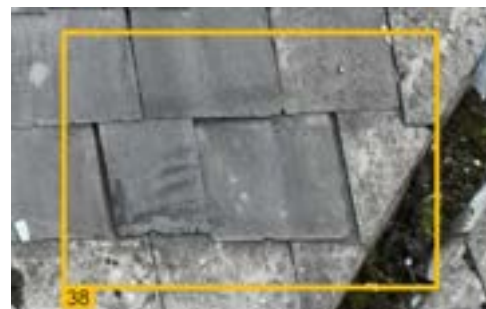
38 Misaligned slate

Severity: 2

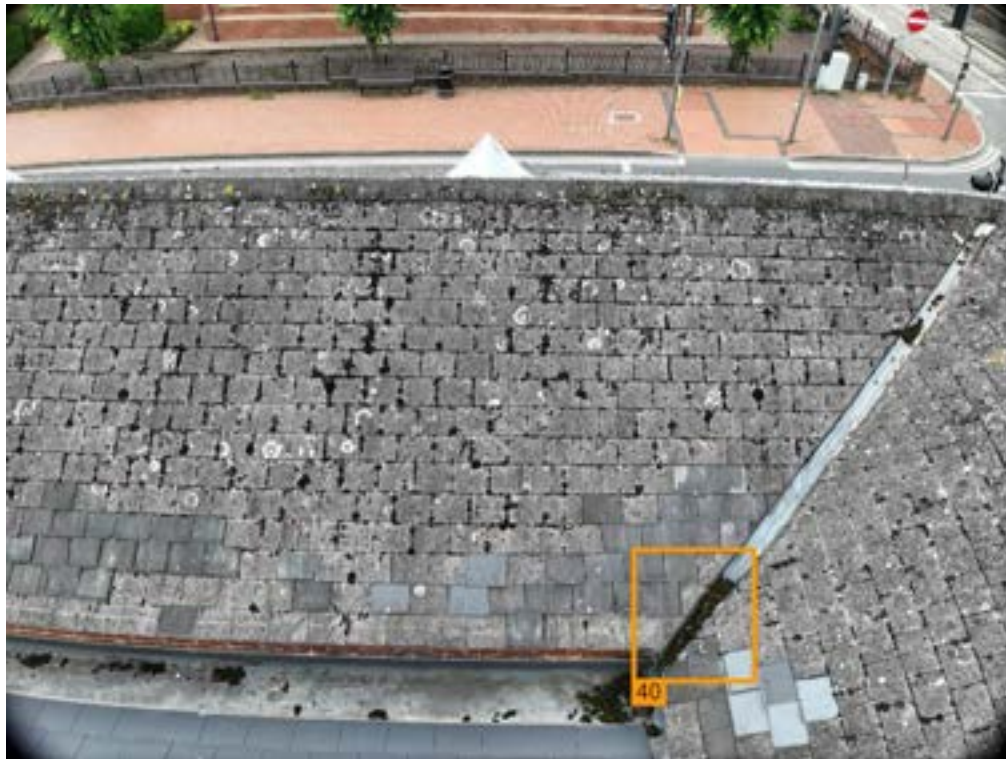
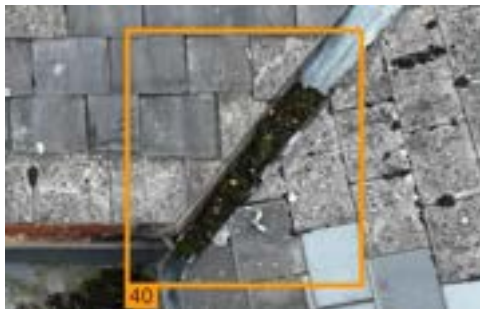
201193 (34).JPG

40 Moss growth in valley

Severity: 3
