EDWINSTOWE VILLAGE HALL

BUILDING CONDITION SURVEY

THURSDAY 20TH JULY 2023

Smith and Roper
Architects and Surveyors
65-67 Church Street
Sutton in Ashfield, NG17 1FE

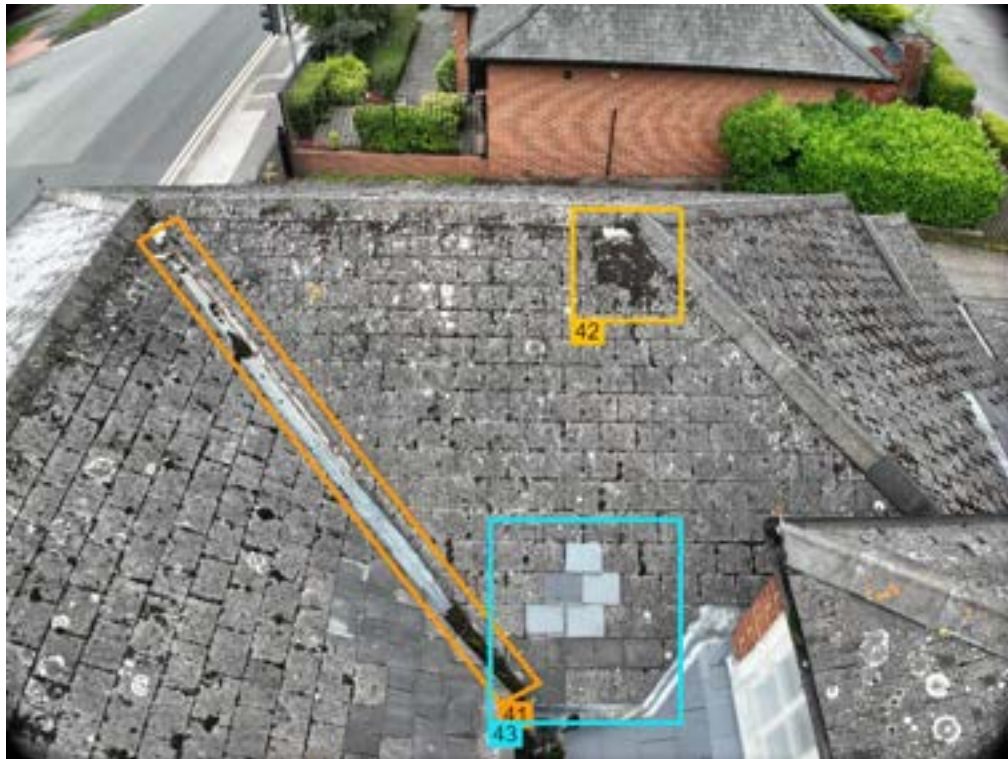
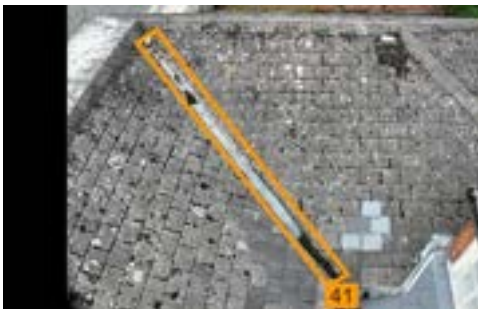
201193 (35).JPG

41 Loose mortar in valley

Severity: 3

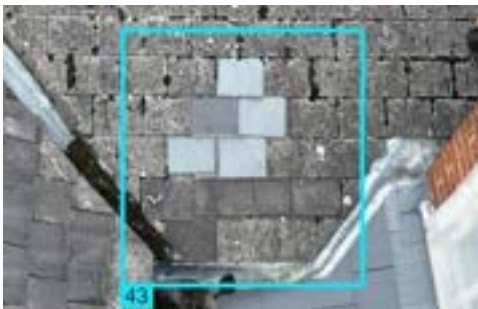
43 Historic repair

Severity: 0

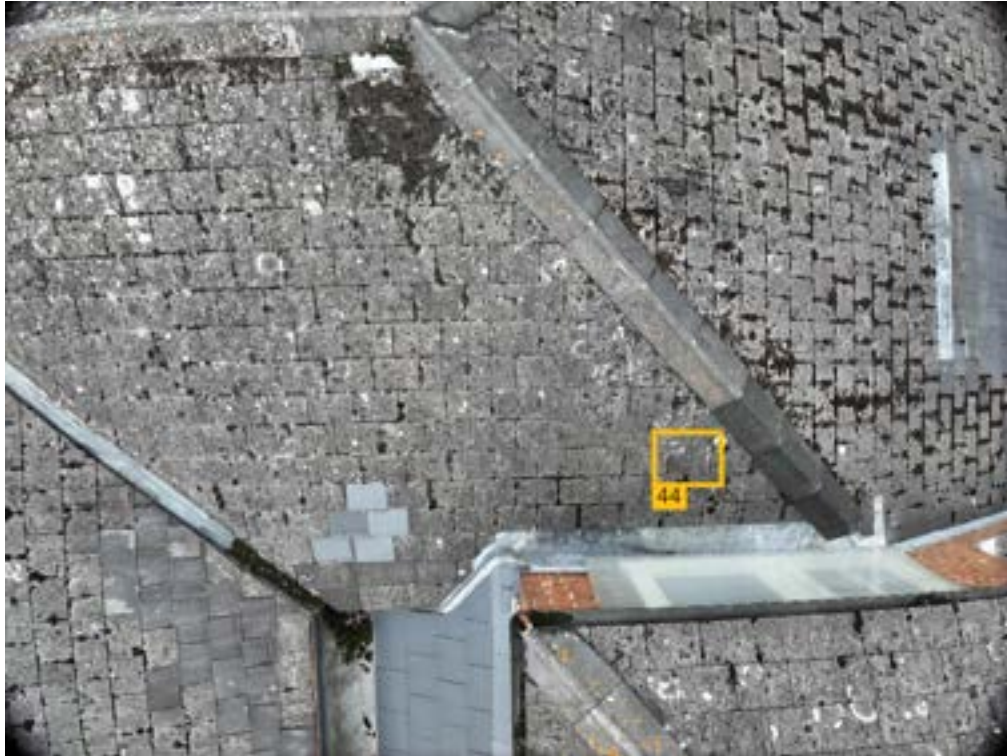
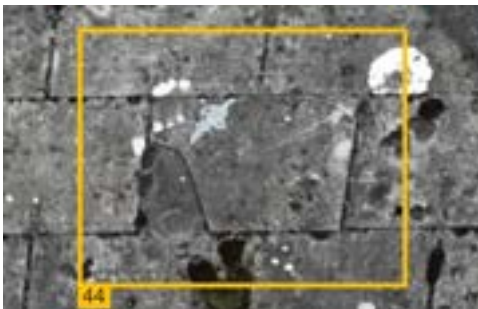
201193 (36).JPG

44 Damaged slate

Severity: 2

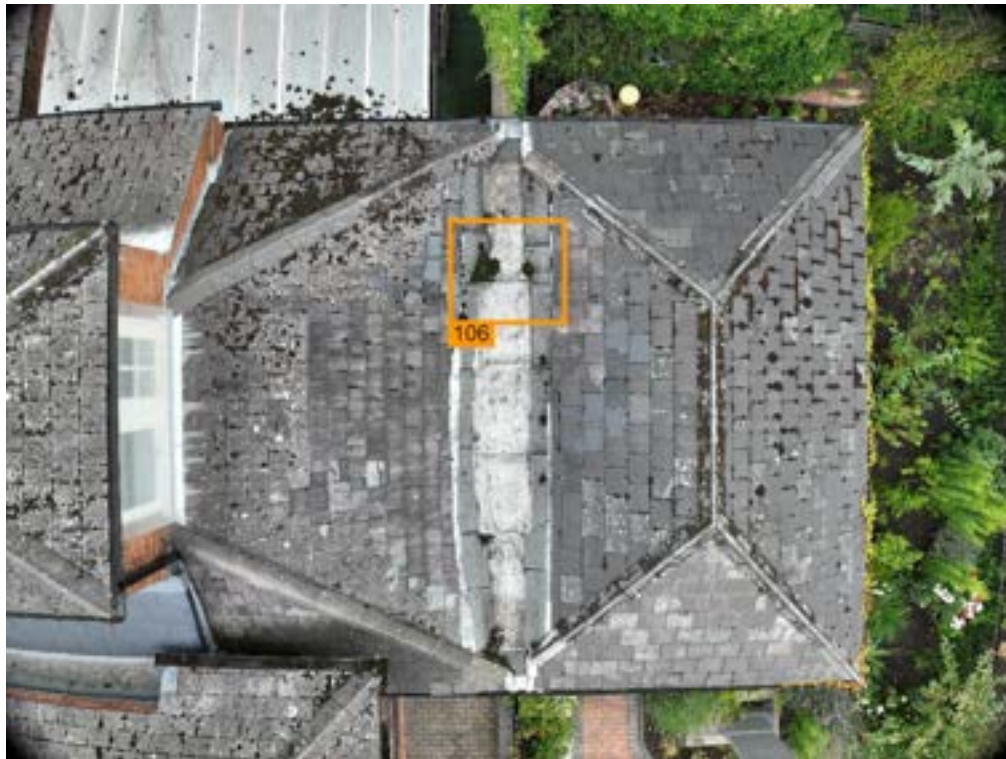
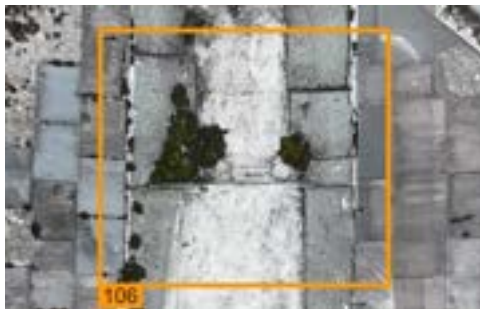
201193 (37).JPG

106 Moss growth in valley

Severity: 3

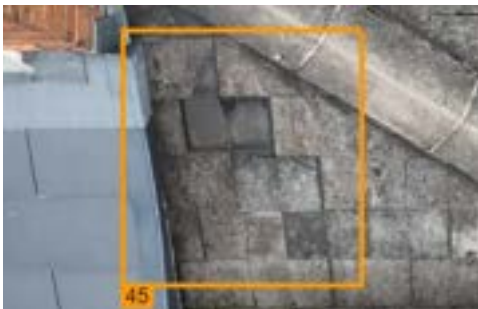
201193 (38).JPG

45 Damaged slate

Severity: 3

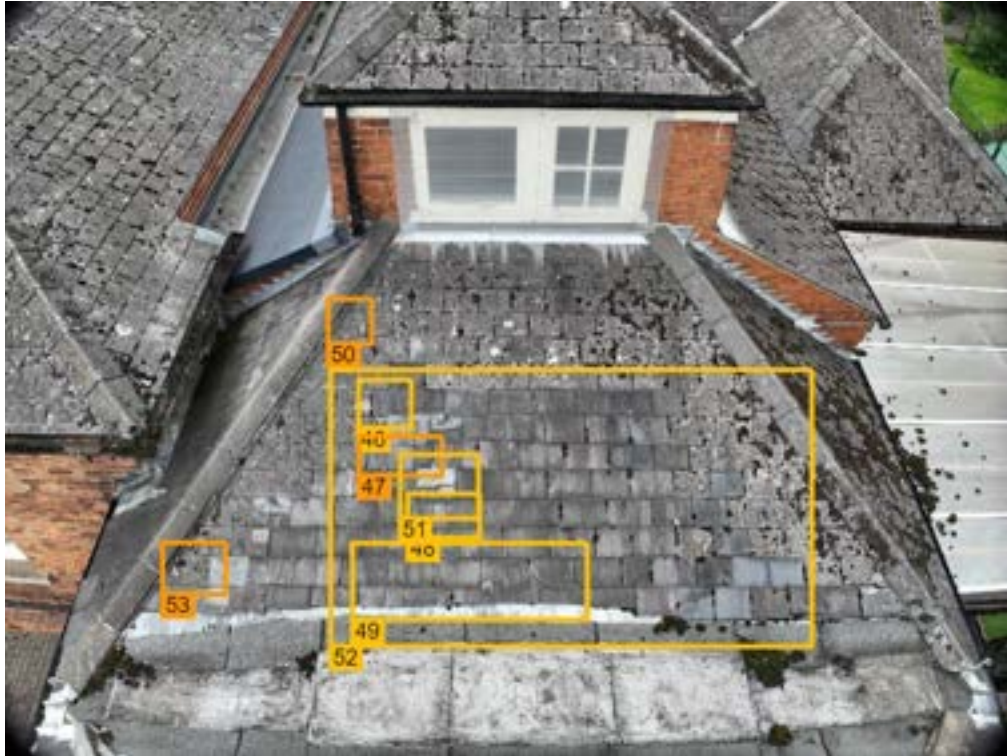
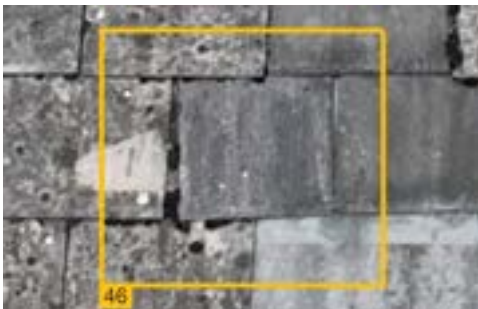
201193 (40).JPG

46 Misaligned slate

Severity: 2

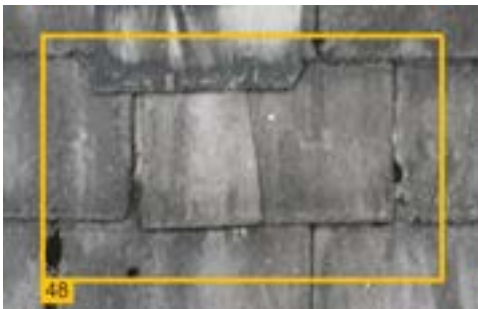
47 Damaged slate

Severity: 3

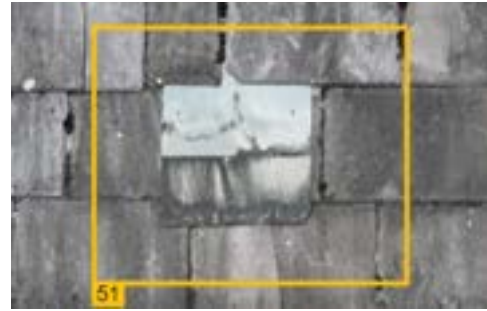
50 Damaged slate

Severity: 3

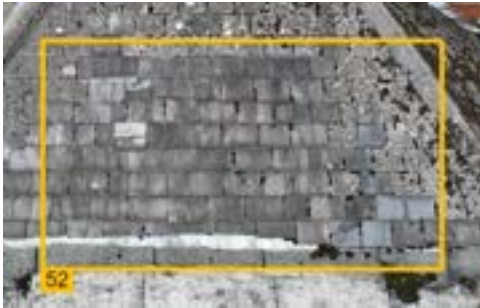
51 Further clarification needed

Severity: 2

Slate laid incorrectly.

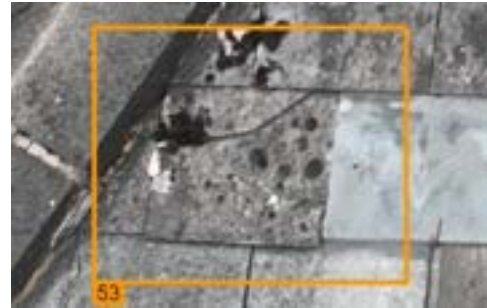
52 Historic repair failed

Severity: 2

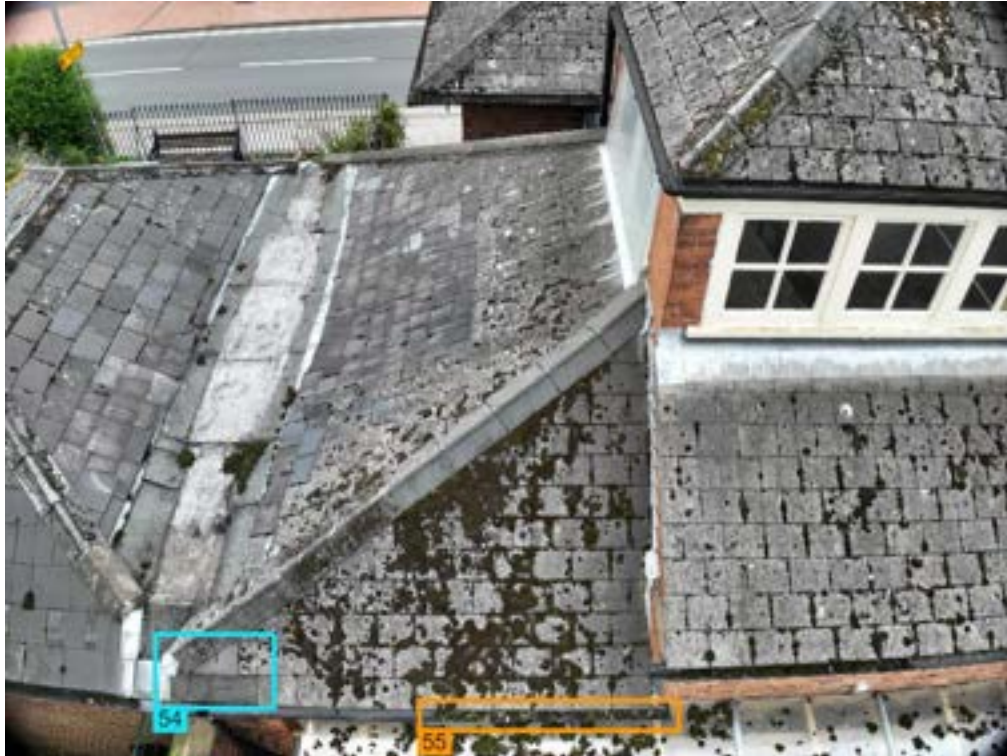
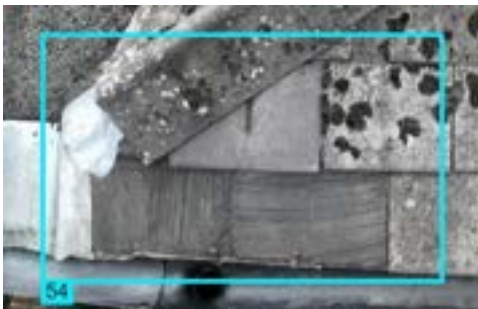
201193 (41).JPG

53 Damaged slate

Severity: 3

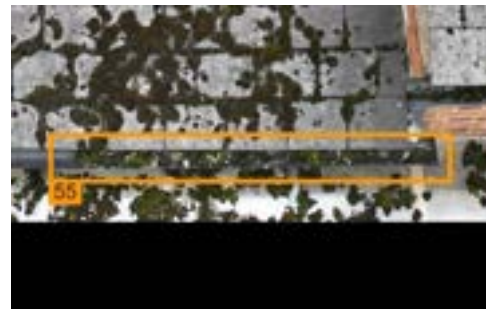
54 Historic repair

Severity: 0

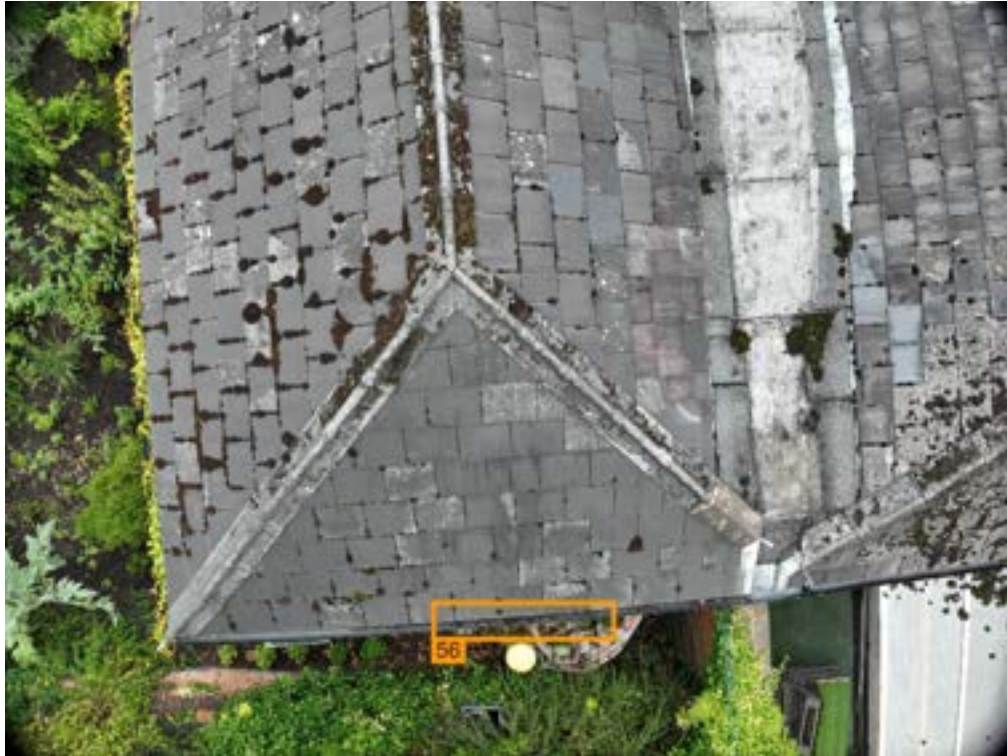
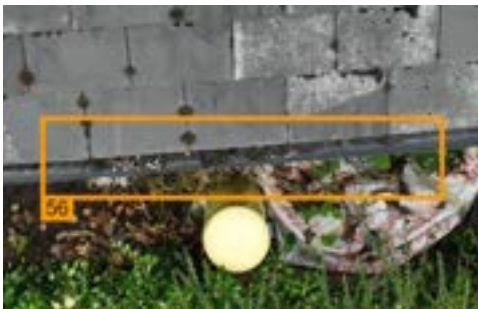
201193 (42).JPG

55 Moss growth in gutter

Severity: 3

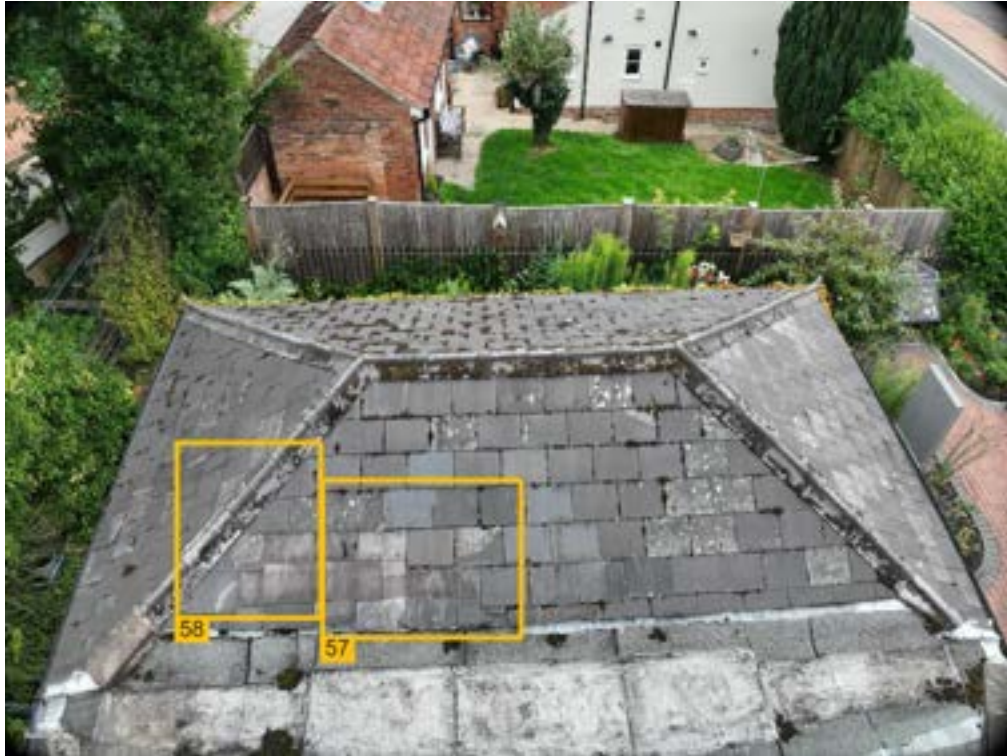
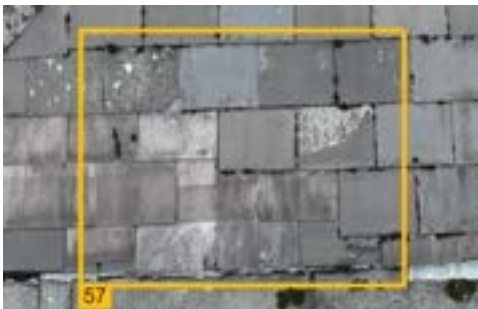
201193 (43).JPG

56 Moss growth in gutter

Severity: 3

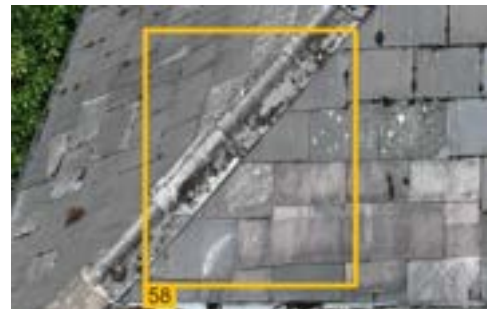
57 Damaged slate

Severity: 2

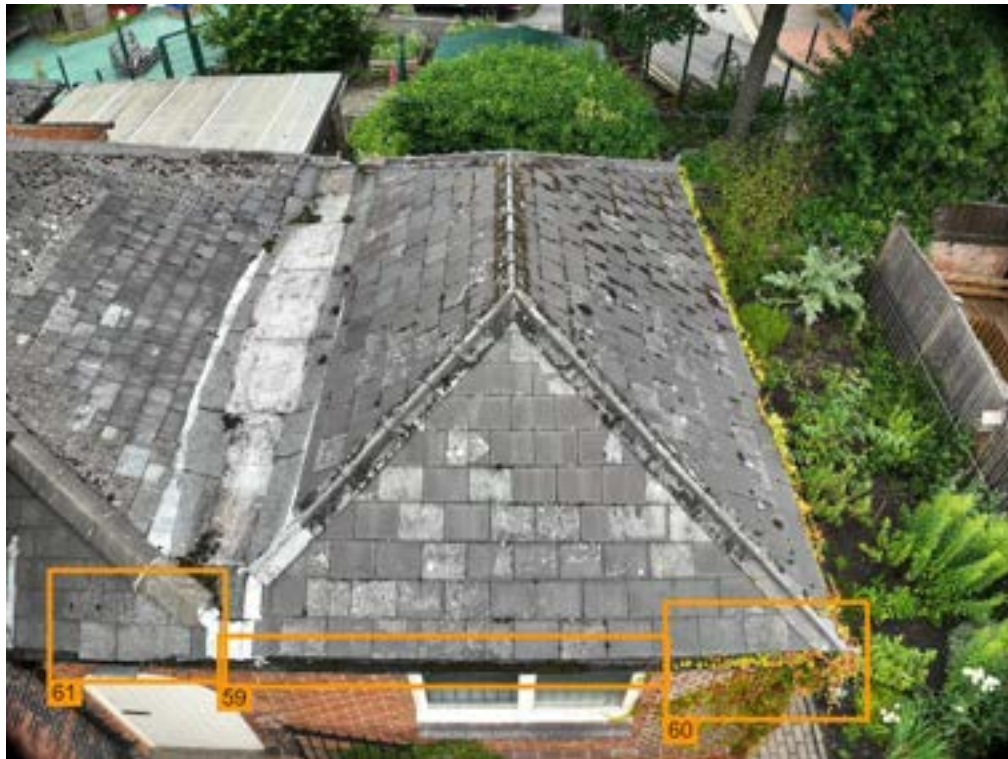
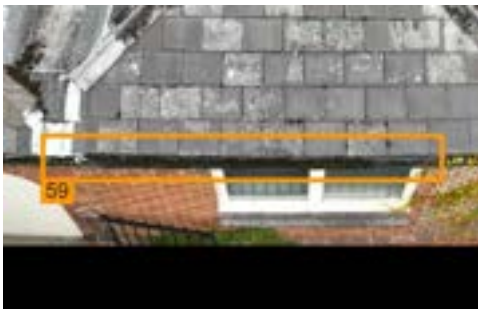
201193 (44).JPG

58 Misaligned slate

Severity: 2

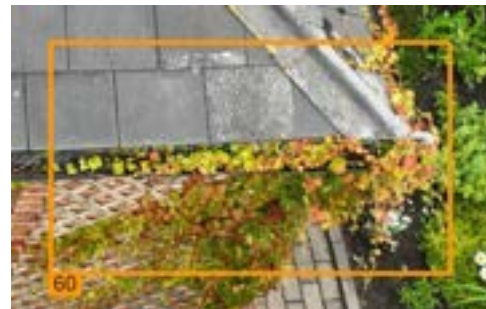
59 Moss growth in gutter

Severity: 3

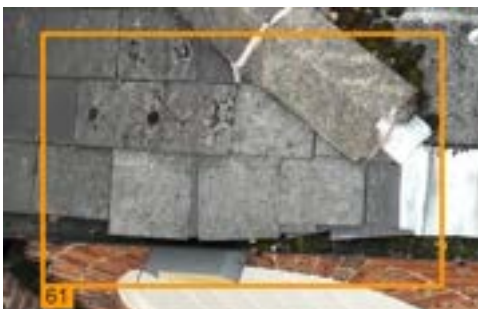
60 Vegetation growth

Severity: 3

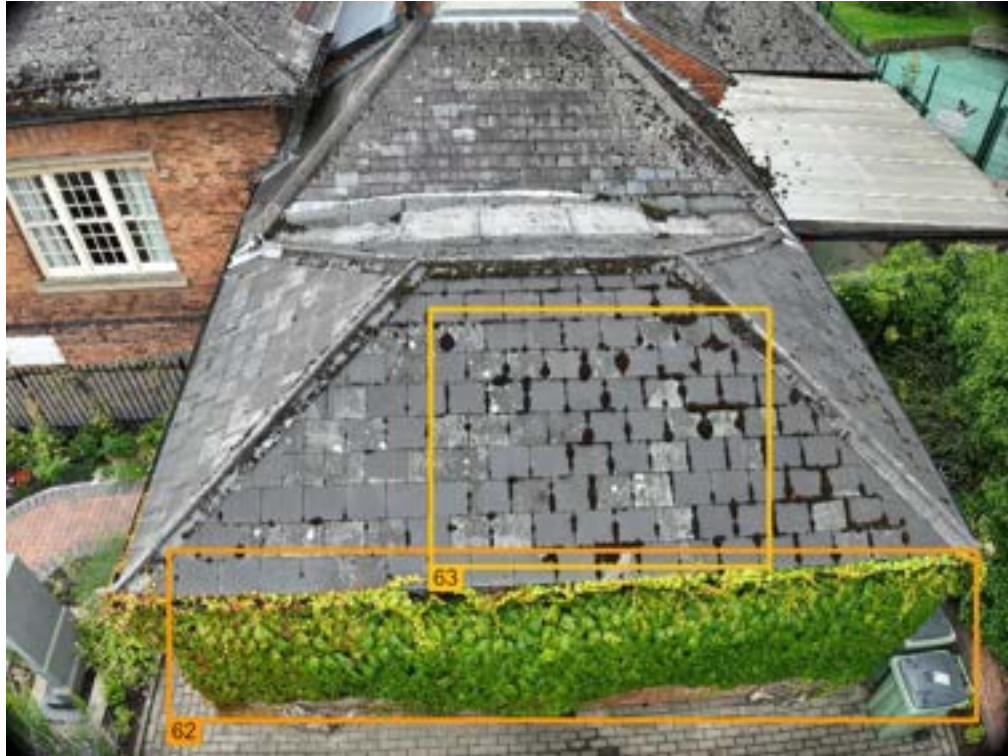
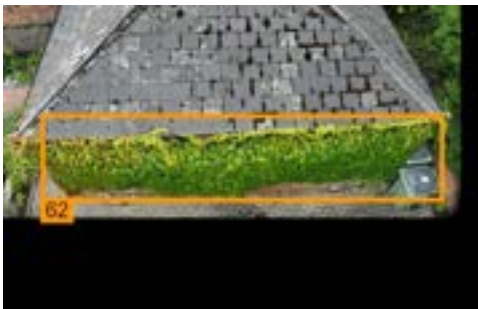
201193 (45).JPG

61 Misaligned slate

Severity: 3

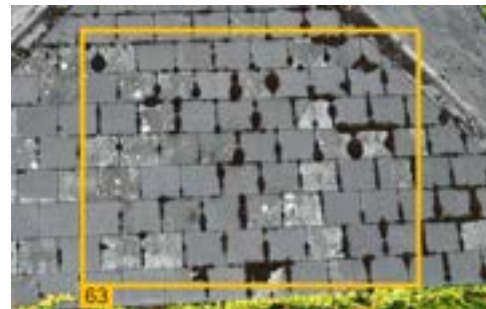
62 Vegetation growth

Severity: 3

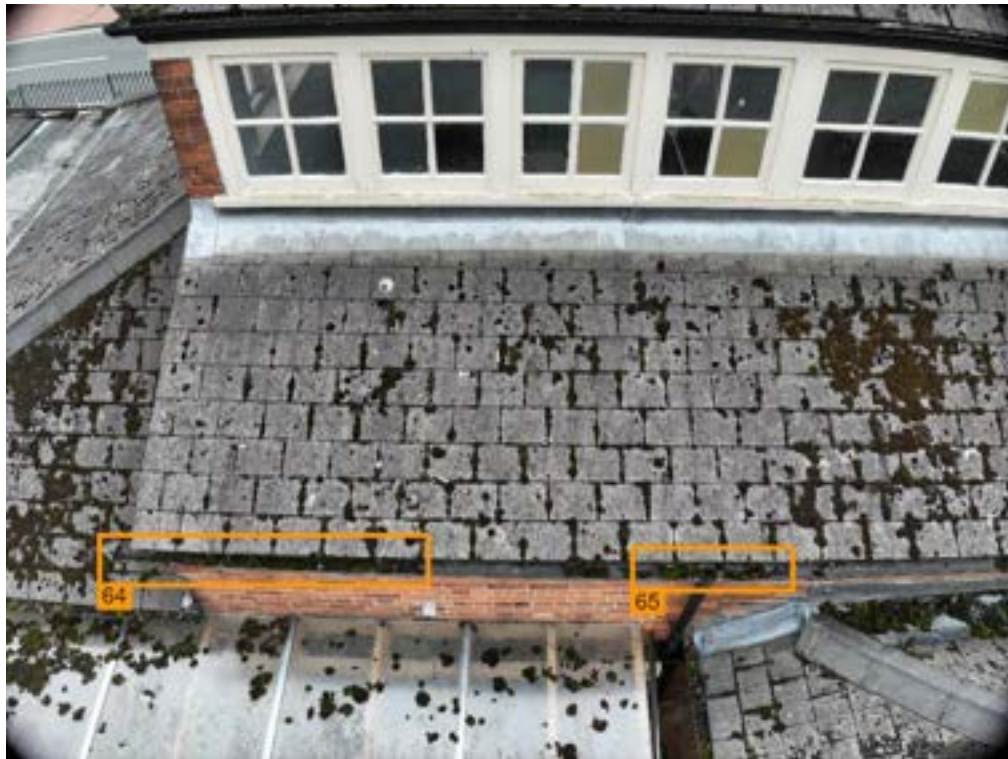
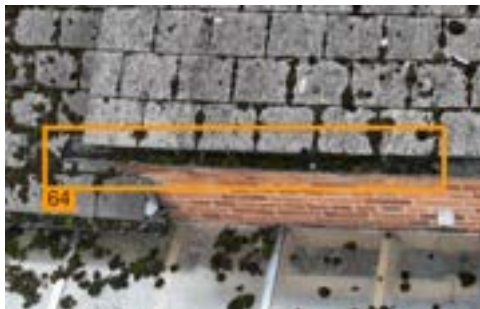
201193 (46).JPG

63 Moss growth

Severity: 2

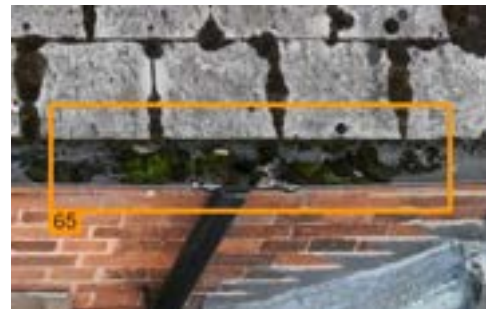
64 Moss growth in gutter

Severity: 3

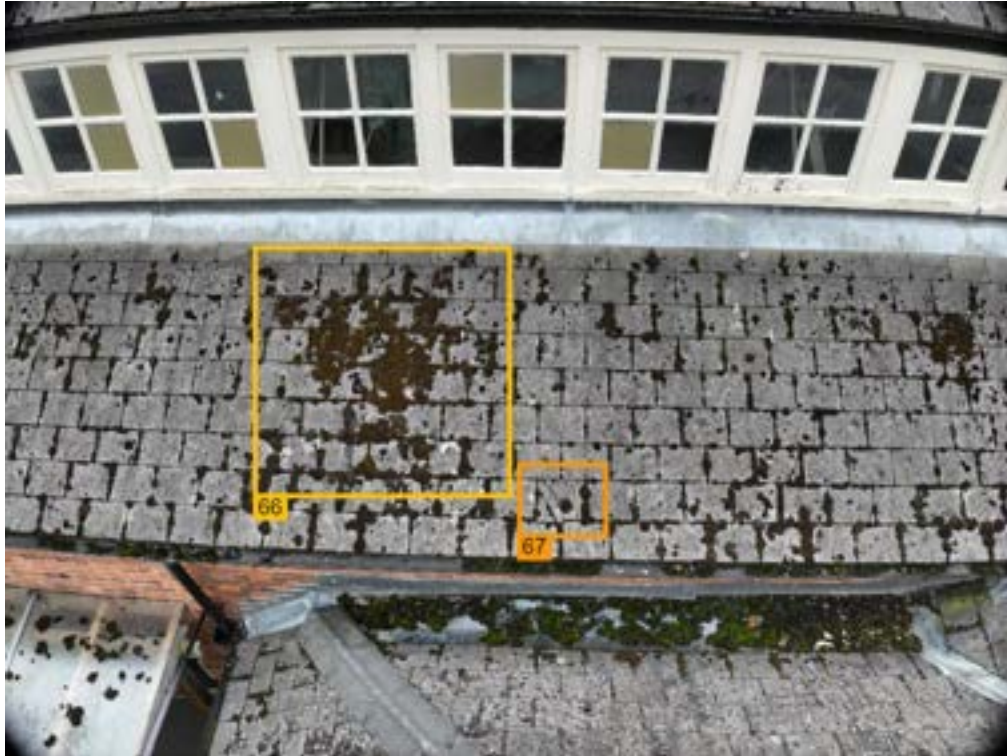
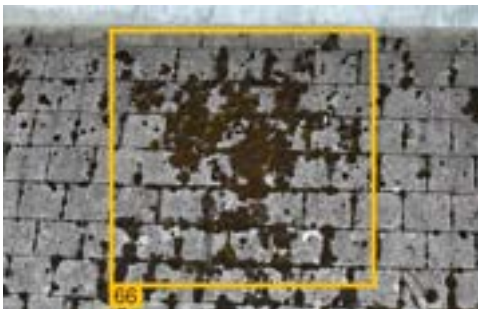
201193 (47).JPG

65 Blocked gutter/outlet

Severity: 3

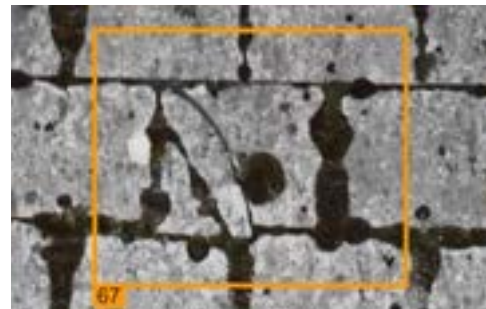
66 Moss growth

Severity: 2

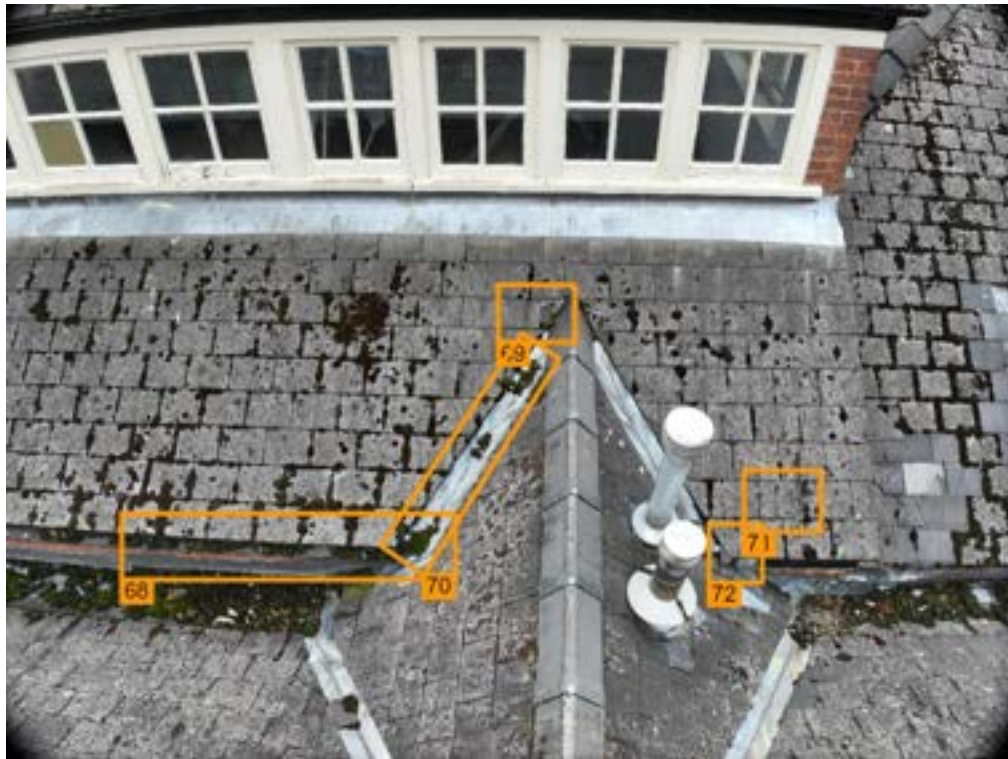
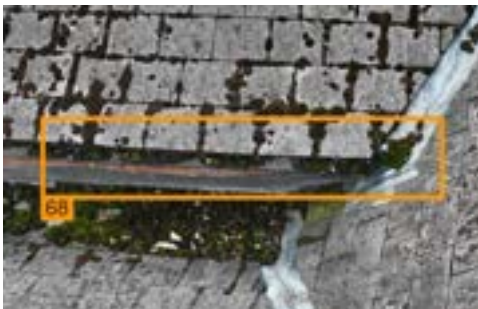
201193 (48).JPG

67 Damaged slate

Severity: 3

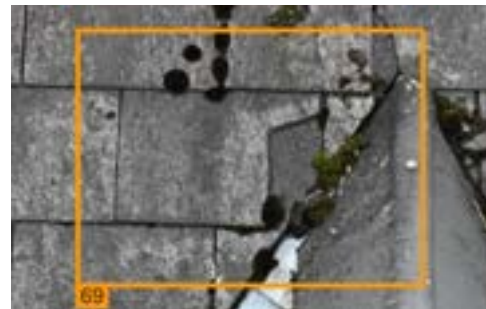
68 Moss growth in gutter

Severity: 3

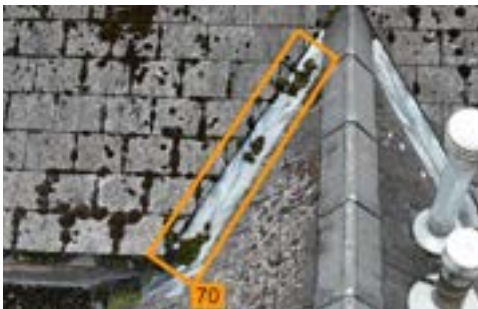
69 Damaged slate

Severity: 3

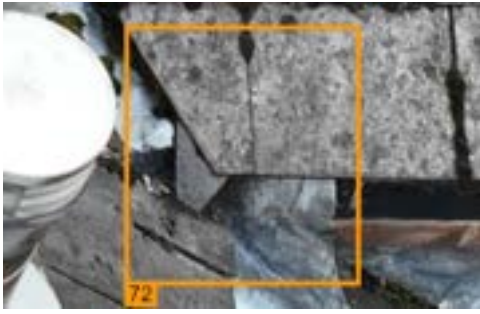
71 Damaged slate

Severity: 3

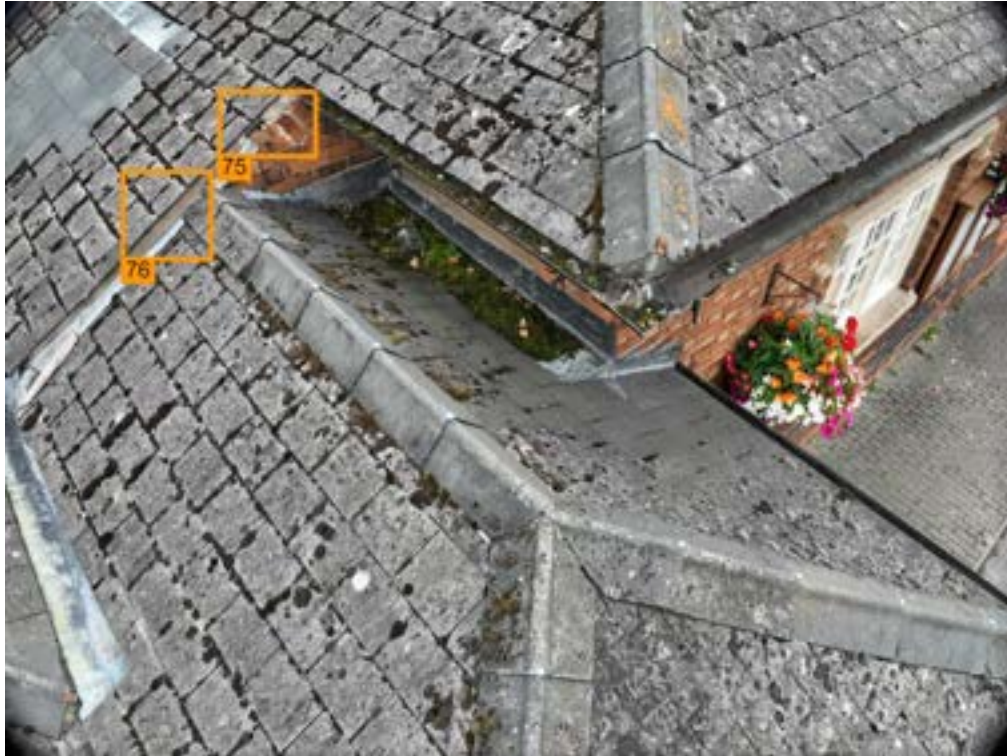
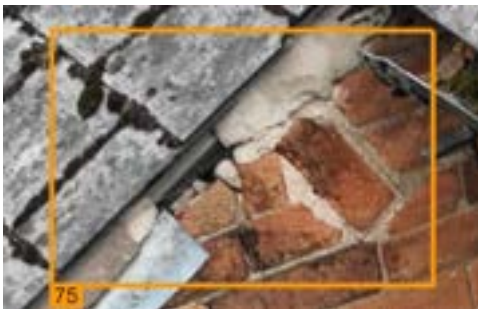
201193 (52).JPG

74 Missing mortar to verge

Severity: 3

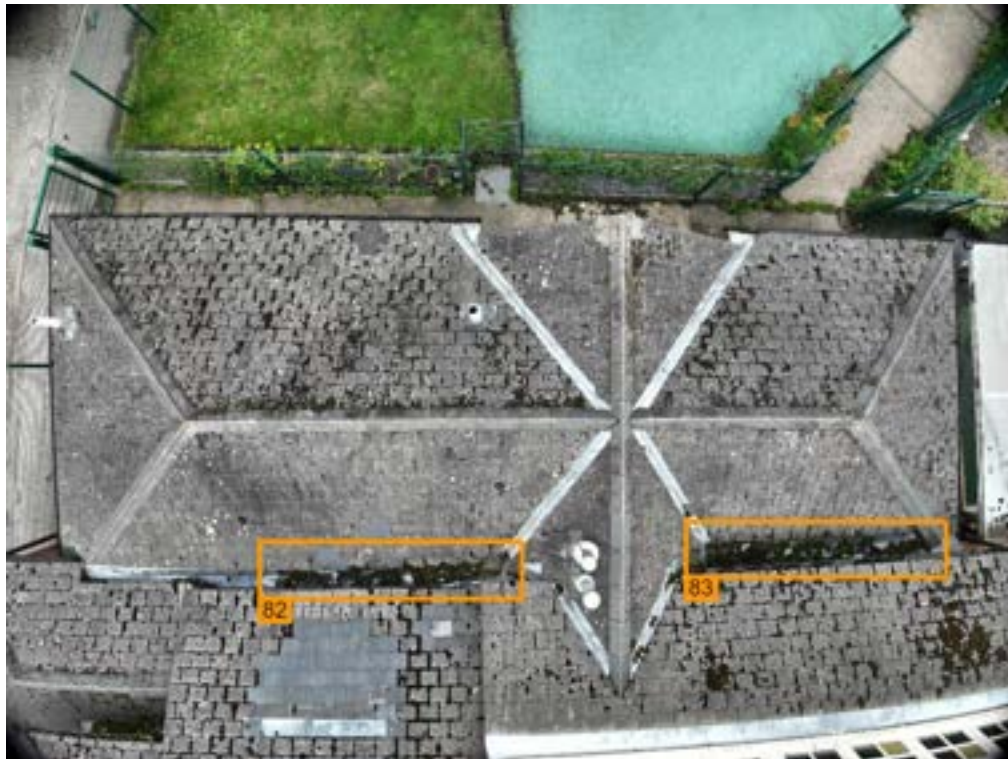
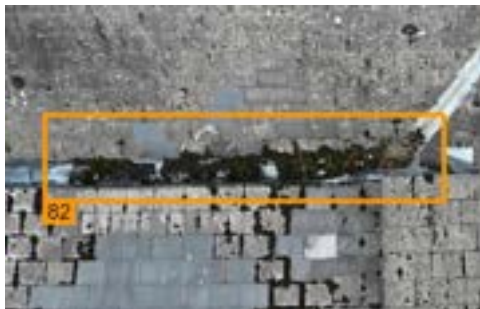
201193 (53).JPG

82 Moss growth in valley

Severity: 3

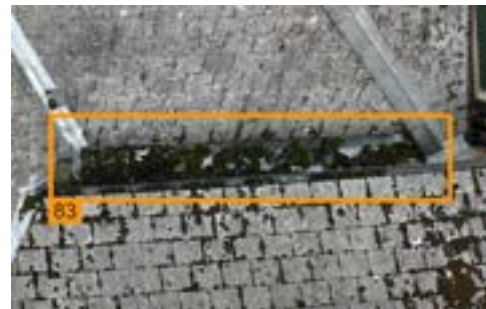
83 Moss growth in valley

Severity: 3

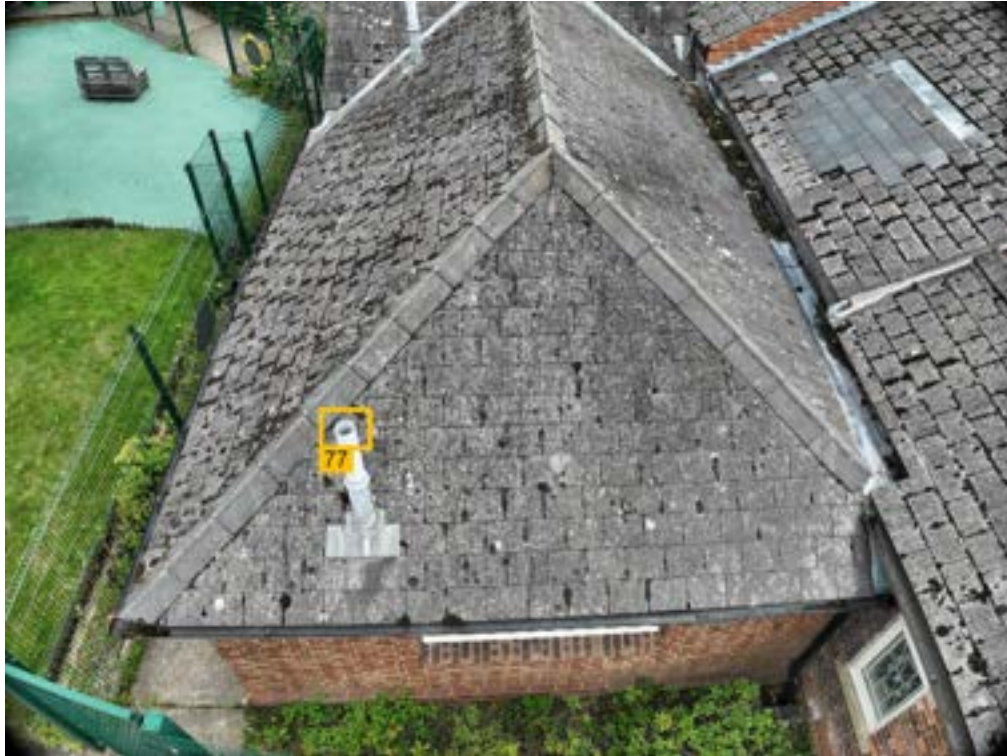
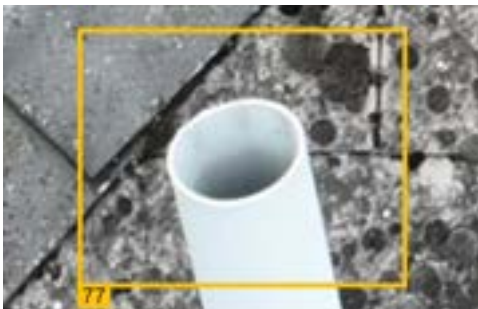
201193 (54).JPG

77 Missing bird cage

Severity: 2

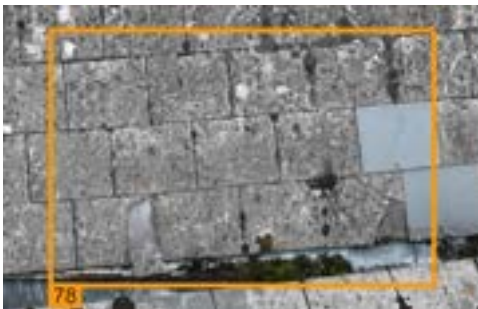
201193 (55).JPG

78 Damaged slate

Severity: 3

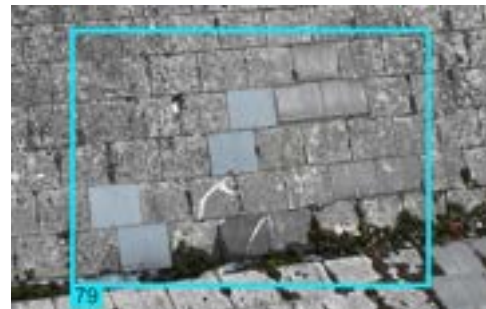
79 Historic repair

Severity: 0

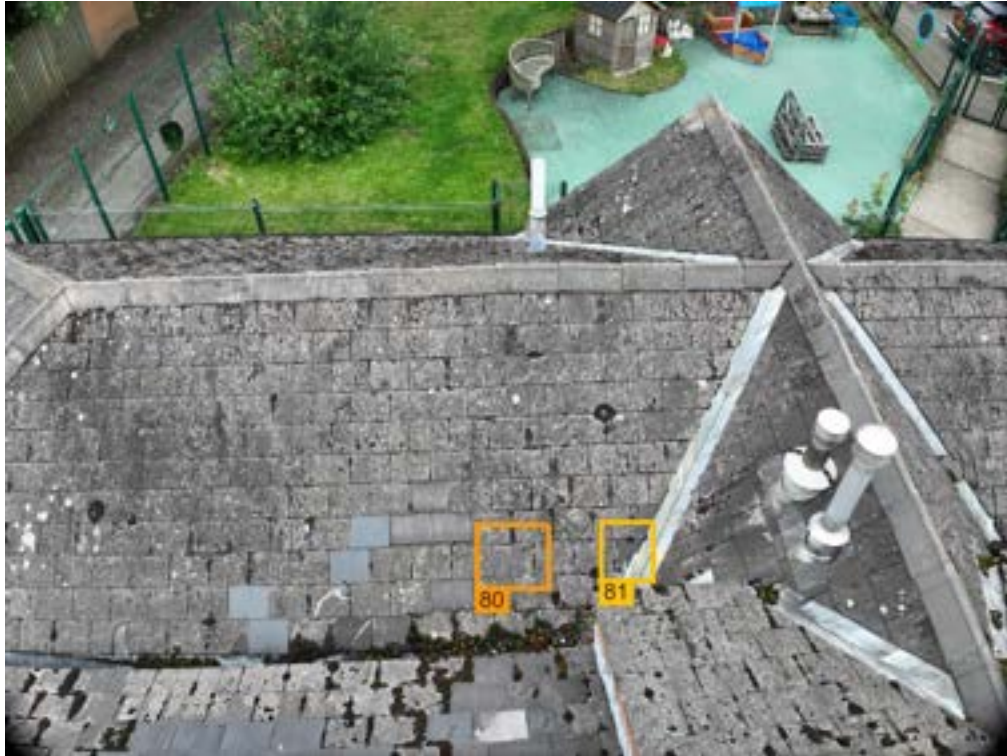
201193 (56).JPG

80 Damaged slate

Severity: 3

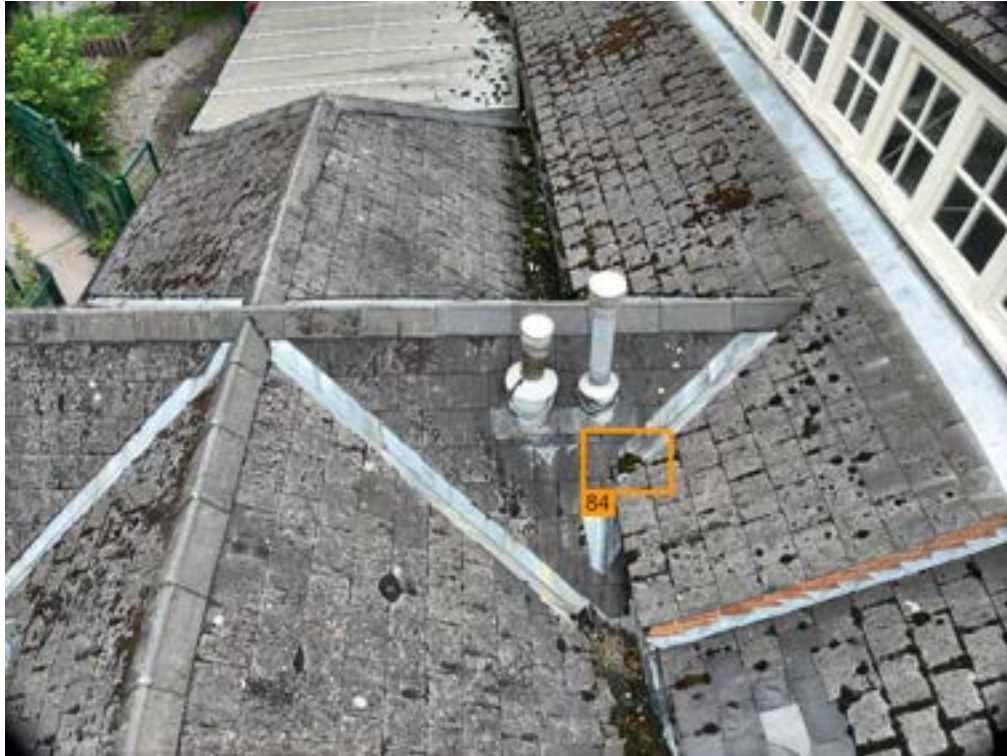
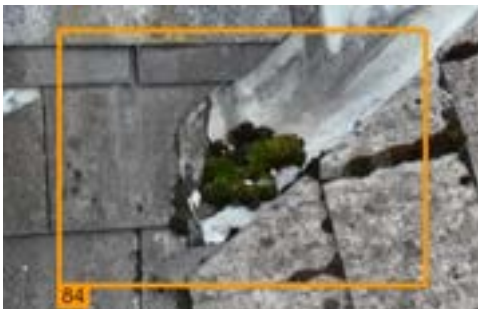
201193 (57).JPG

84 Moss growth in valley

Severity: 3

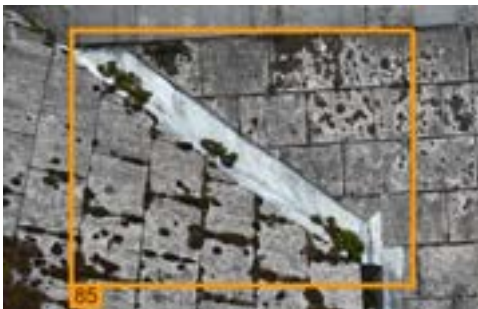
201193 (58).JPG

85 Moss growth in valley

Severity: 3

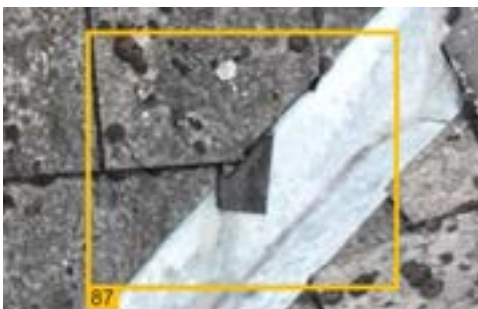
87 Slipped slate

Severity: 2

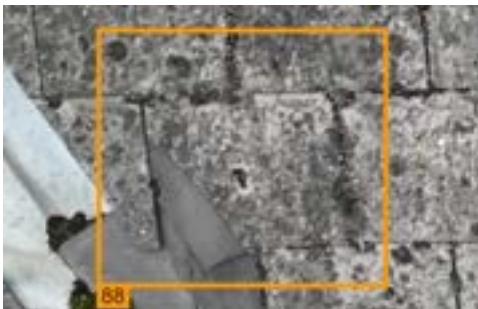
201193 (59).JPG

88 Damaged slate

Severity: 3

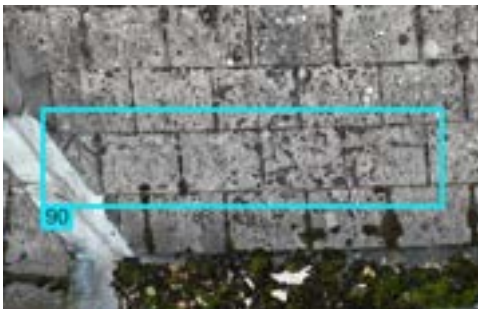
90 Historic repair

Severity: 0

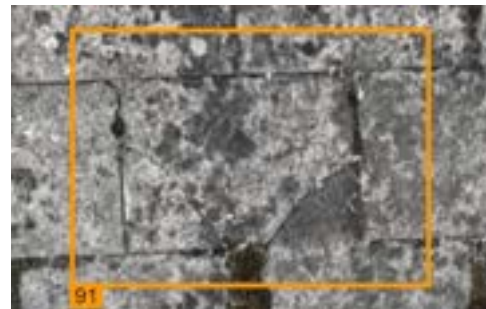
91 Damaged slate

Severity: 3

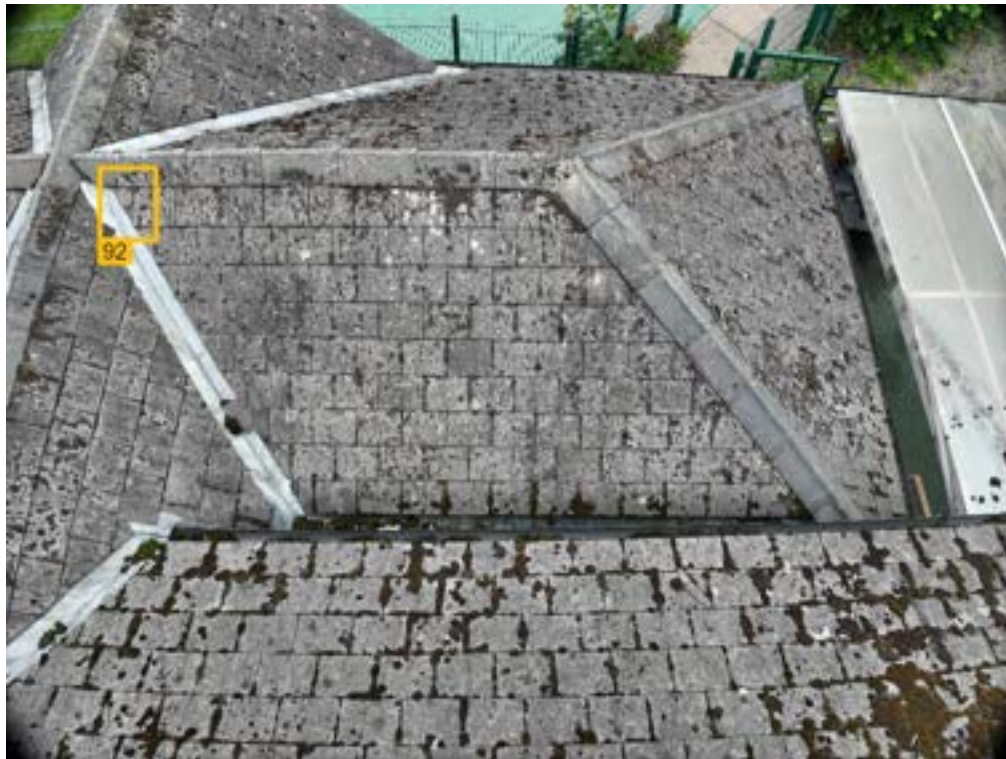
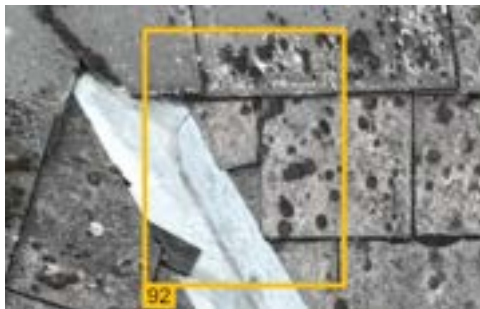
201193 (60).JPG

92 Damaged slate

Severity: 2

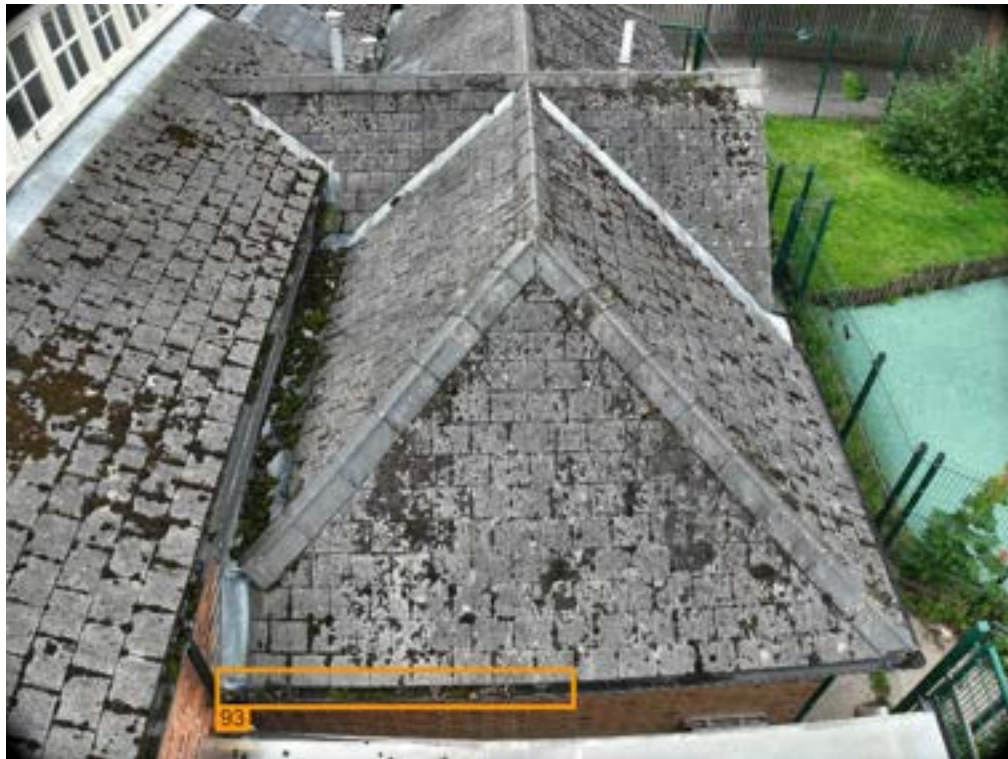
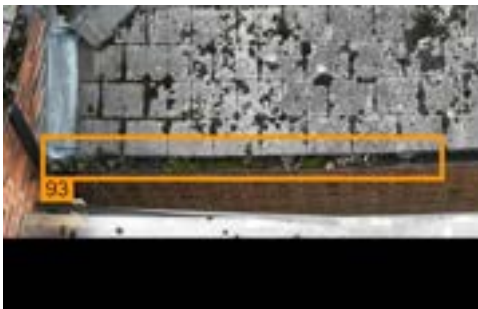
201193 (61).JPG

93 Moss growth in gutter

Severity: 3

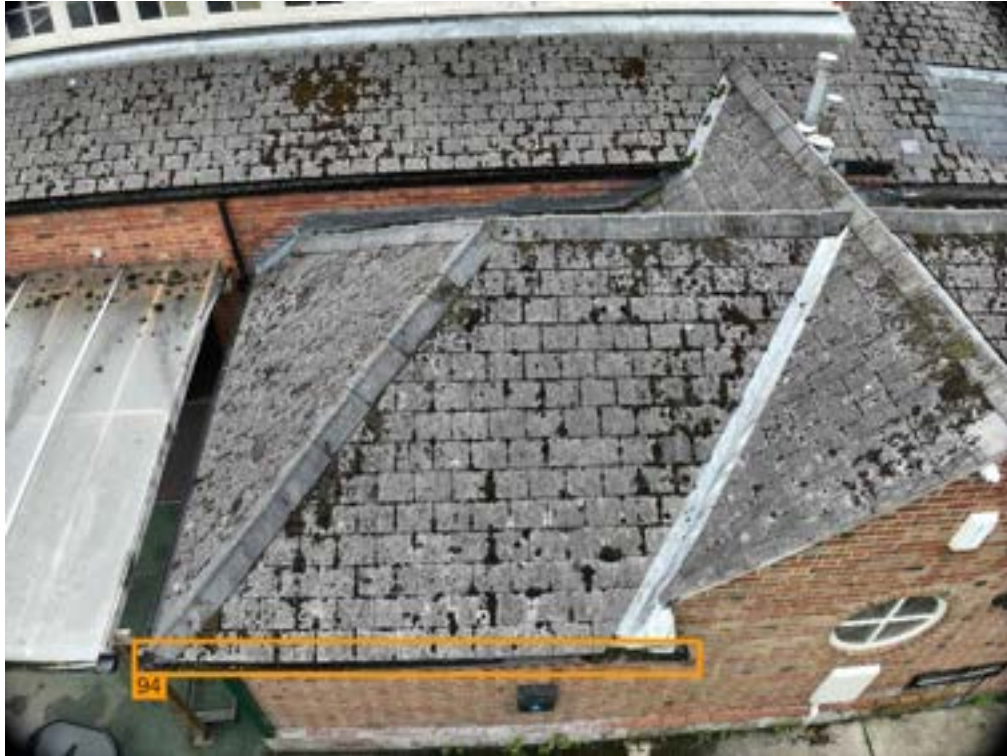
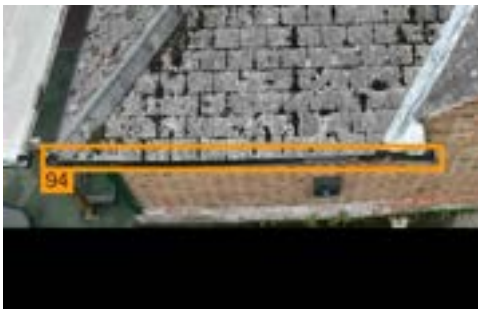
201193 (62).JPG

94 Moss growth in gutter

Severity: 3

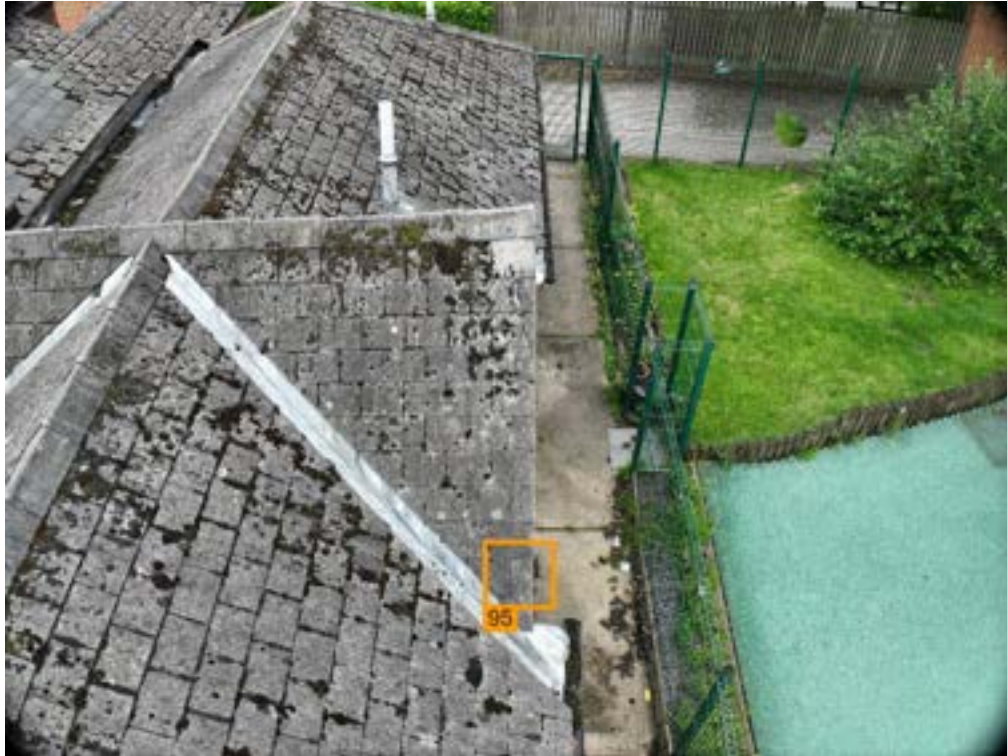
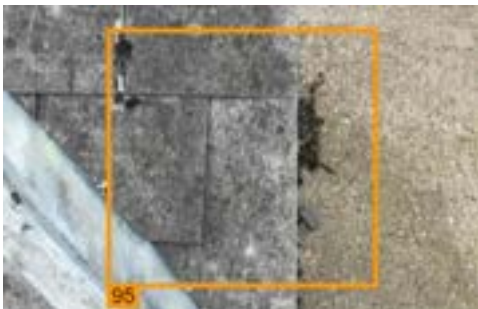
201193 (63).JPG

95 Missing slate

Severity: 3
