EDWINSTOWE VILLAGE HALL

BUILDING CONDITION SURVEY

THURSDAY 20TH JULY 2023

Smith and Roper
Architects and Surveyors
65-67 Church Street
Sutton in Ashfield, NG17 1FE

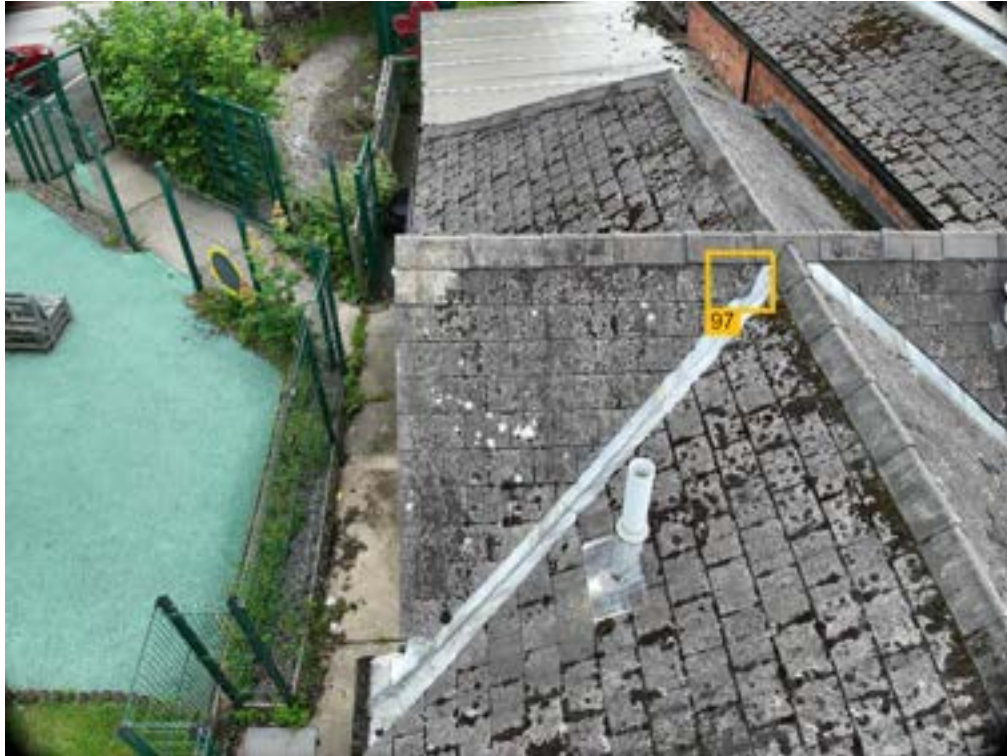
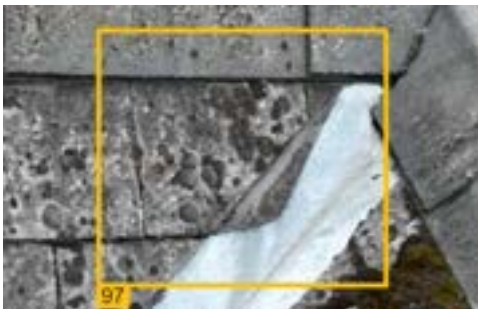
201193 (65).JPG

97 Slipped slate

Severity: 2

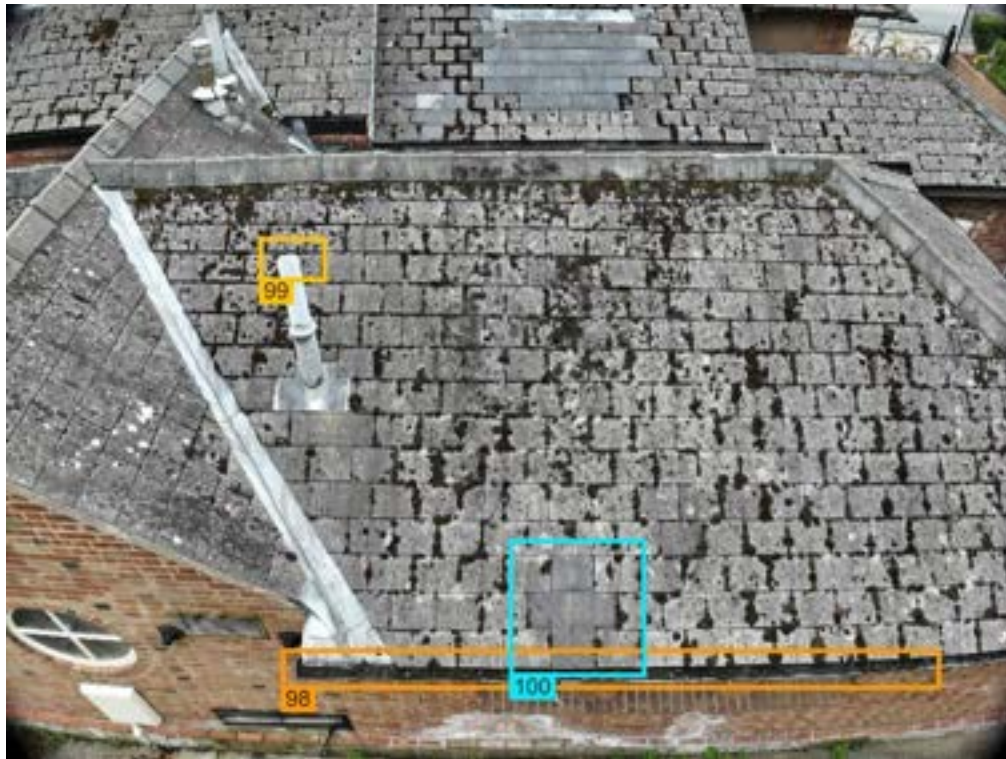
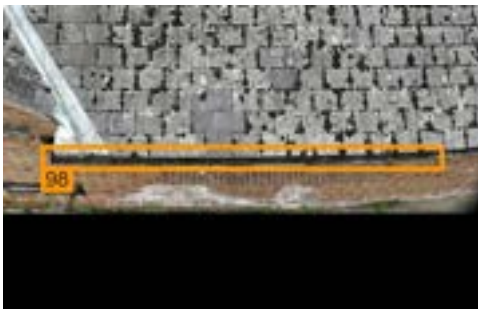
201193 (66).JPG

98 Moss growth in gutter

Severity: 3

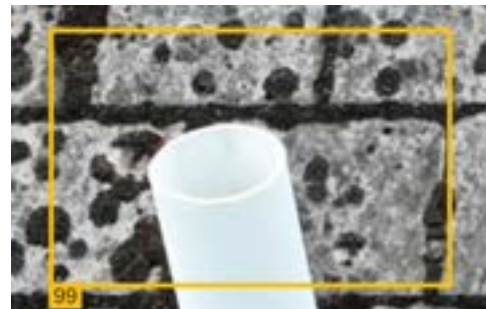
99 Missing bird cage

Severity: 2

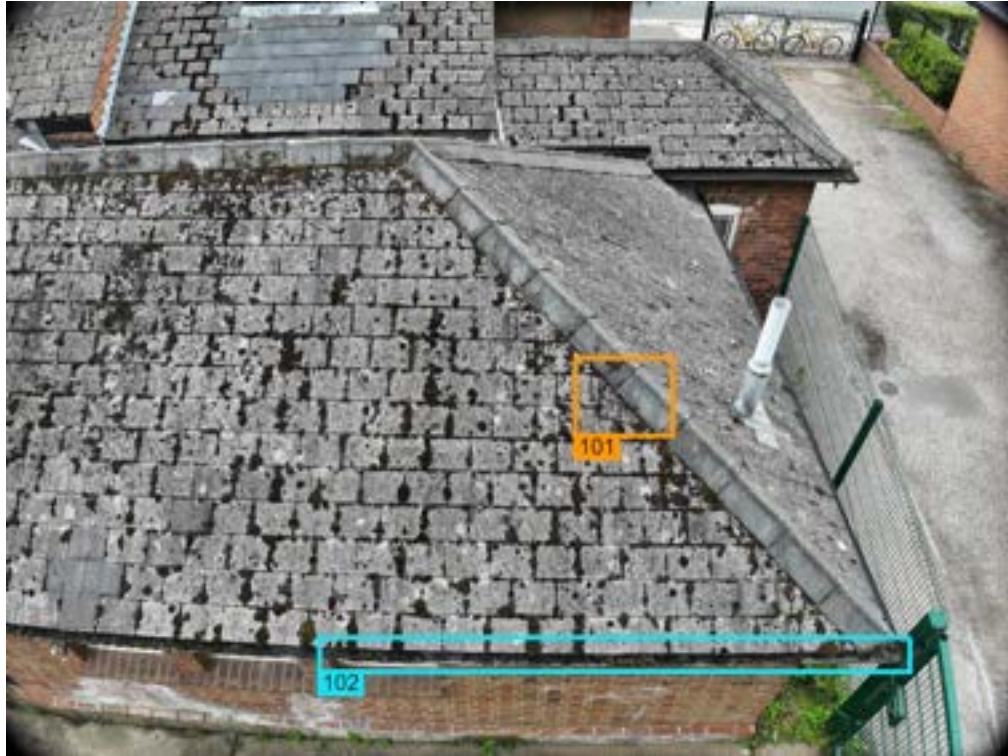
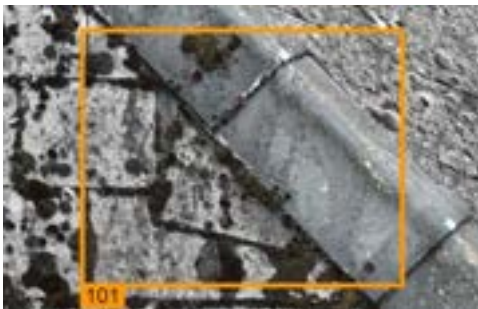
201193 (67).JPG

101 Slipped slate

Severity: 3

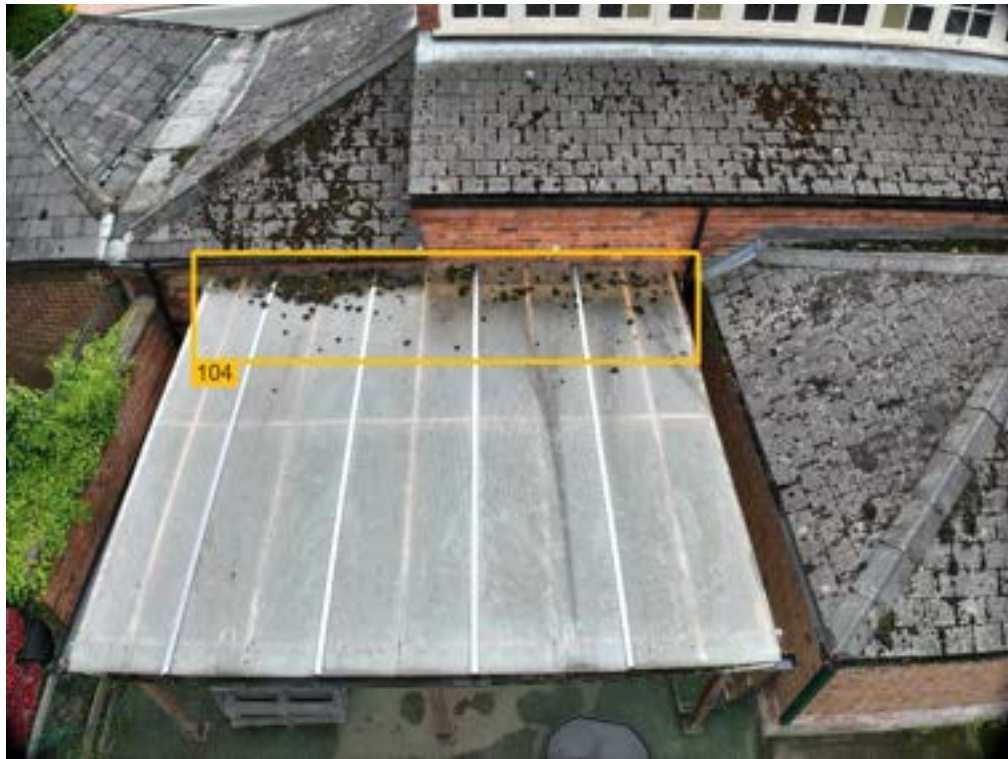
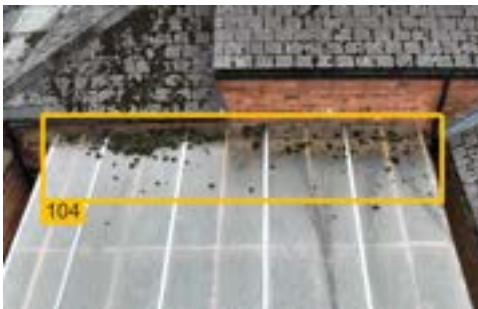
201193 (69).JPG

104 Moss growth

Severity: 2
