**CONDITION REPORT**

**OSWALDTWISTLE CIVIC THEATRE**

**26<sup>th</sup> JANUARY 2024**

**Job Reference Number: BS 1250**

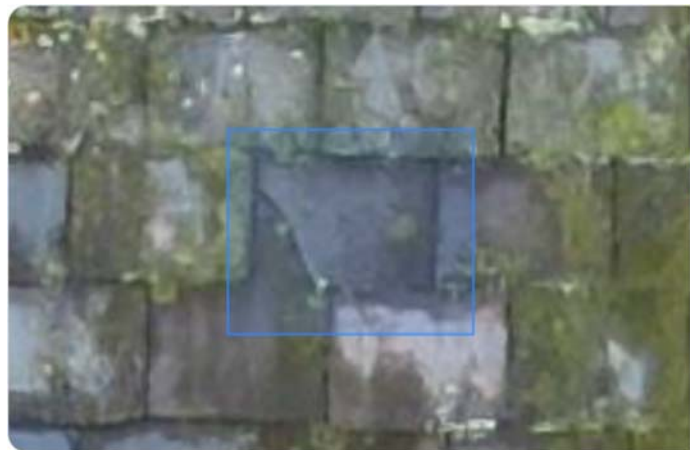
## Broken slate

Severity: 3

Broken Slate

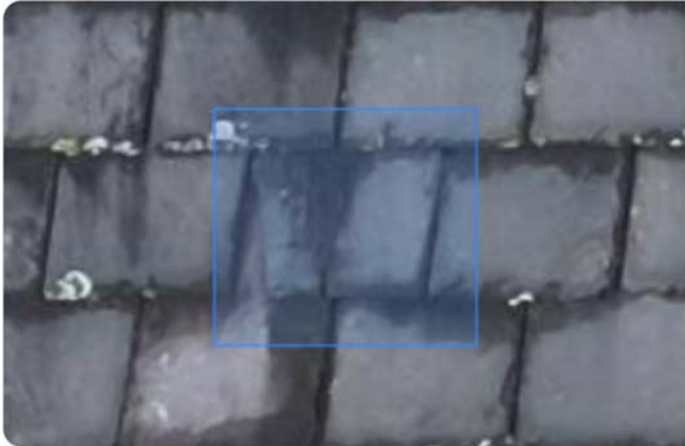
Broken slate

Severity: 3

Broken Slate

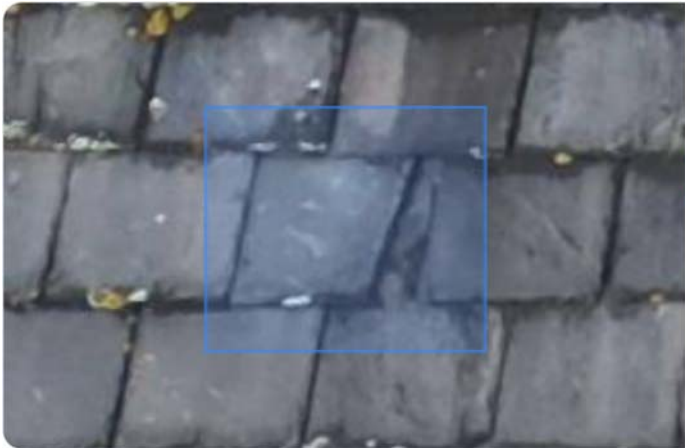
Broken slate

Severity: 3

Broken Slate

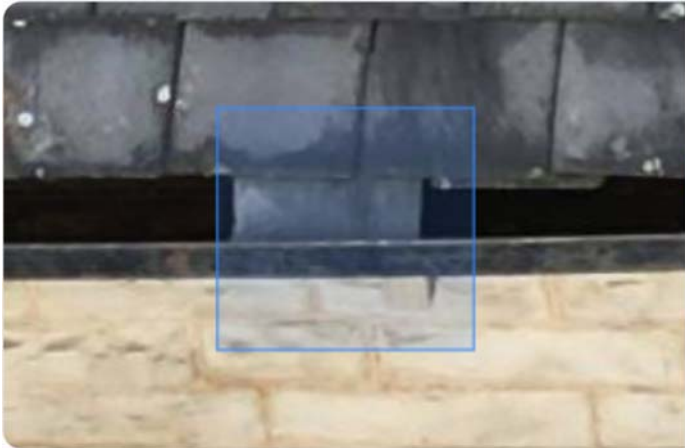
Slipped slate

Severity: 3

Loose Slate

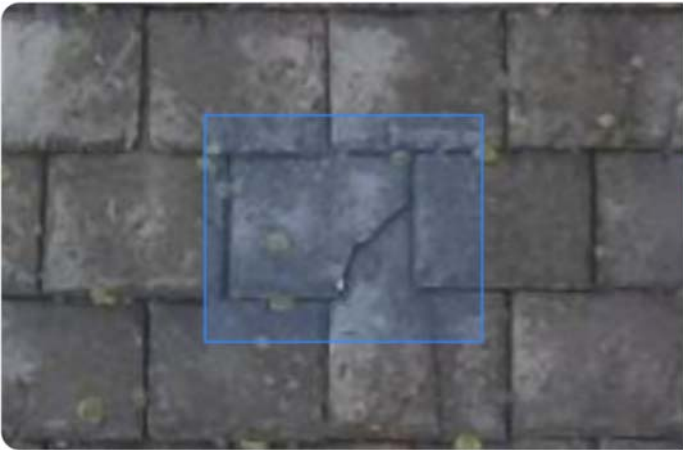
Broken slate

Severity: 3

Broken Slate

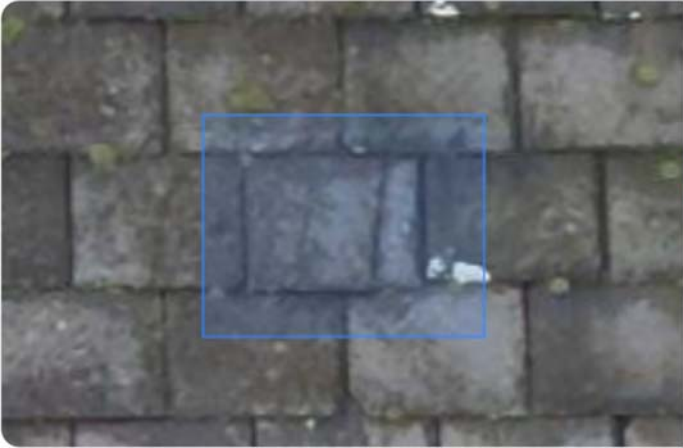
Broken slate

Severity: 3

Broken Slate

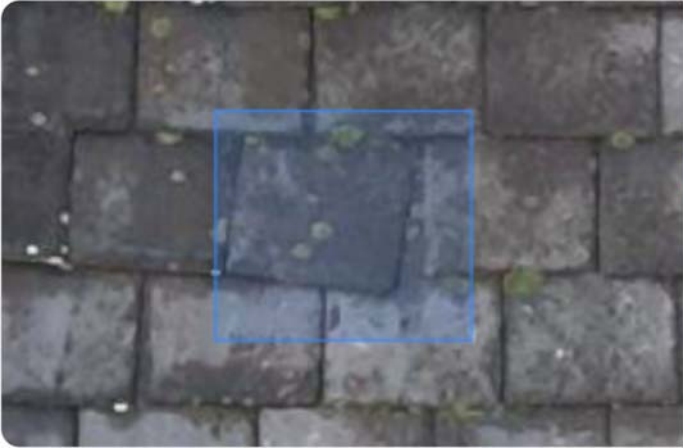
Slipped slate

Severity: 3

Loose Slate

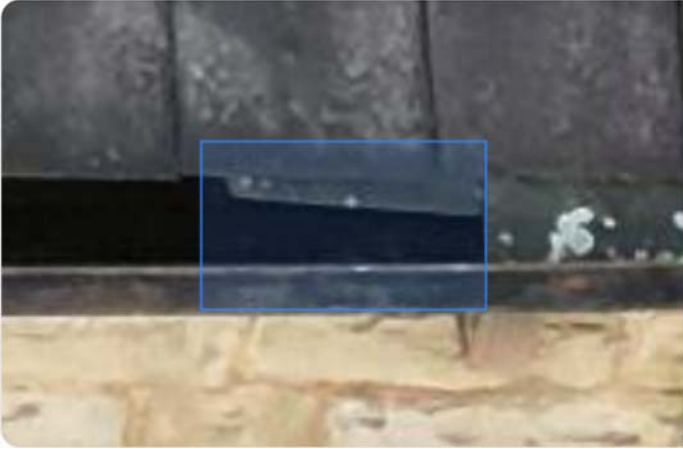
Slipped slate

Severity: 3

Loose Slate

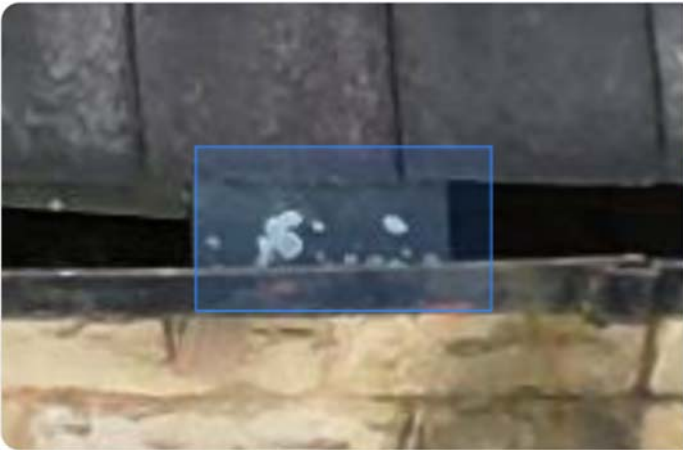
Slipped slate

Severity: 3

Loose Slate

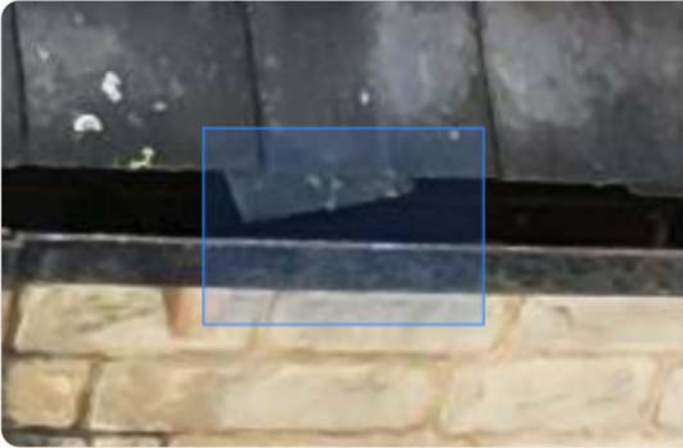
Slipped slate

Severity: 3

Loose Slate

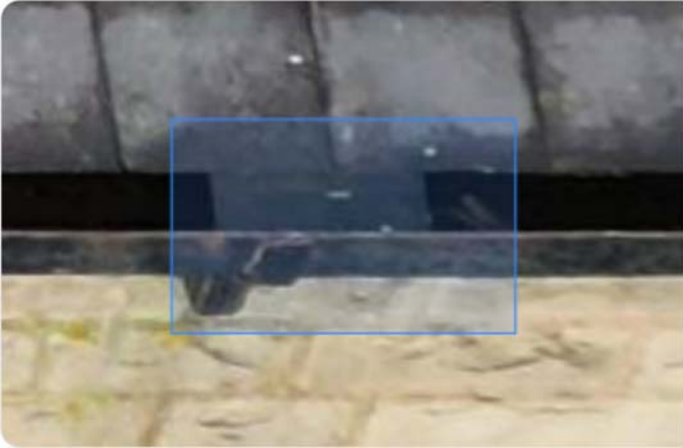
Slipped slate

Severity: 3

Loose Slate

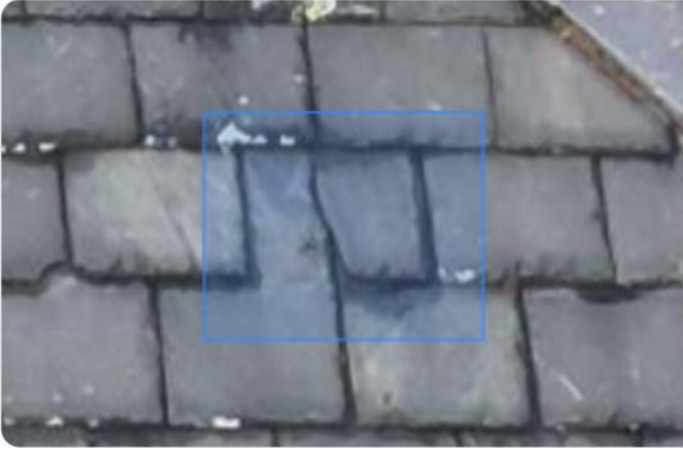
Broken slate

Severity: 3

Broken Slate

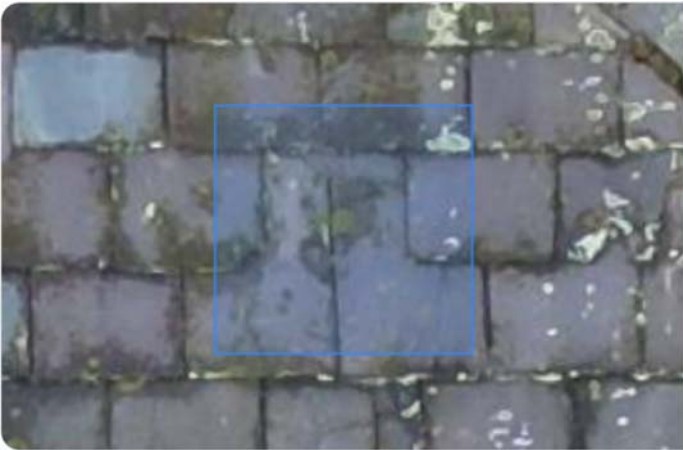
Slipped slate

Severity: 3

Missing Slate

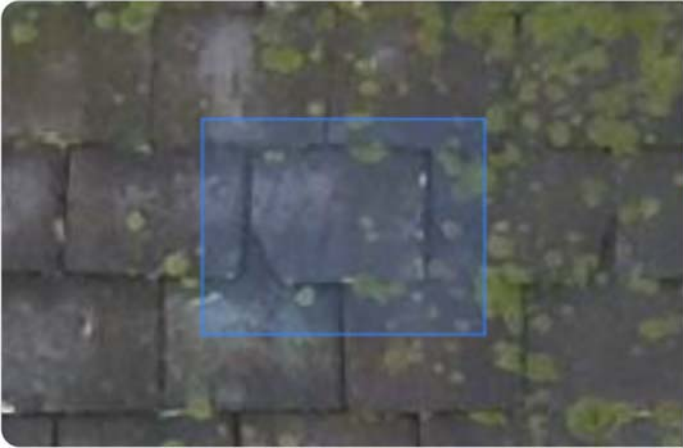
Broken slate

Severity: 3

Broken Slate

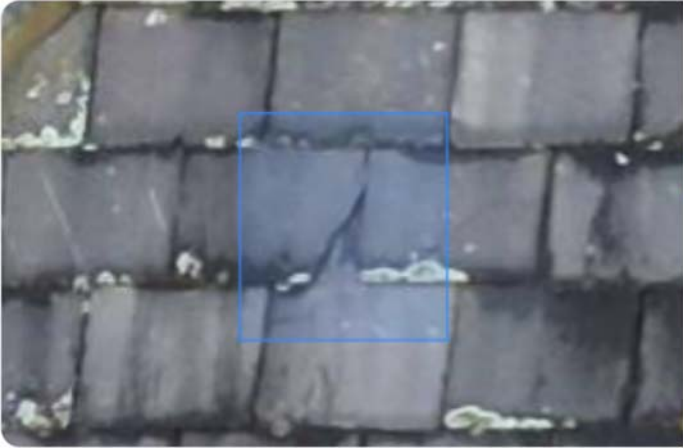
Broken slate

Severity: 3

Broken Slate

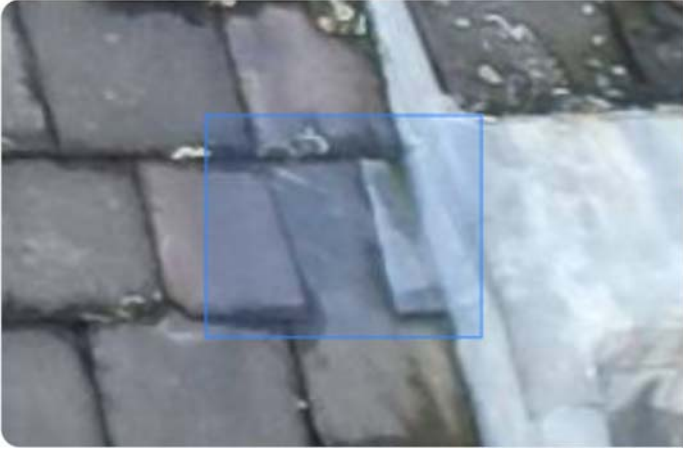
Slipped slate

Severity: 3

Missing Slate

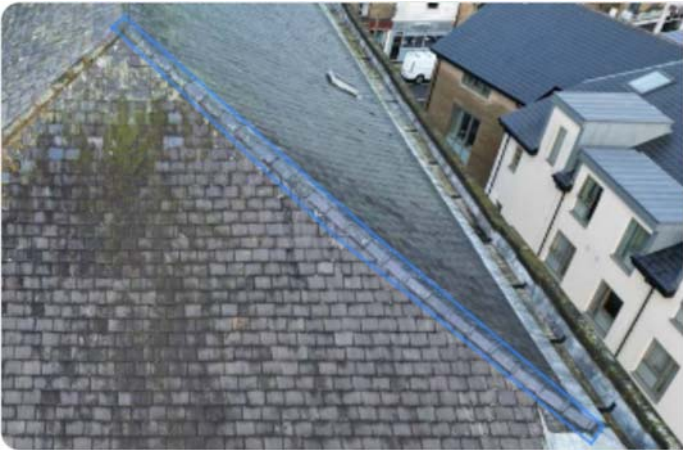
# Eroded pointing to hip tiles

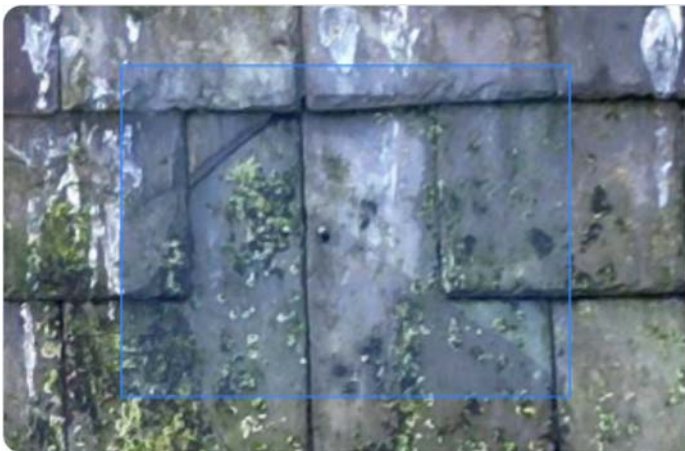
Broken slate

Severity: 3

Broken Slate

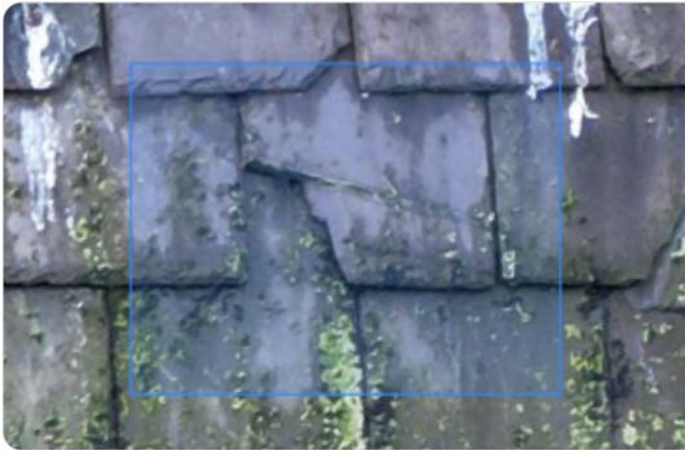
Broken slate

Severity: 3

Broken Slate

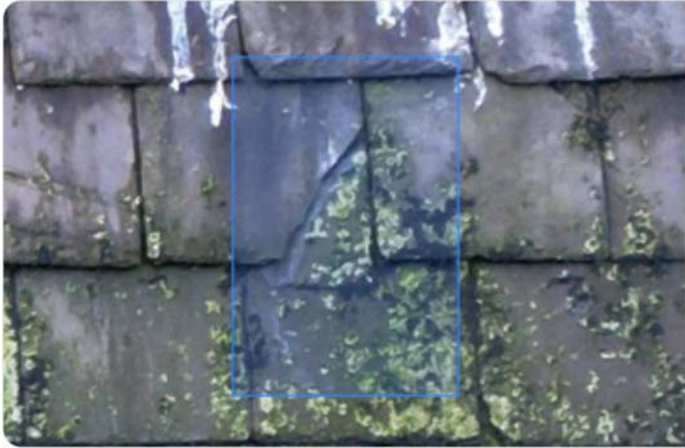
Broken slate

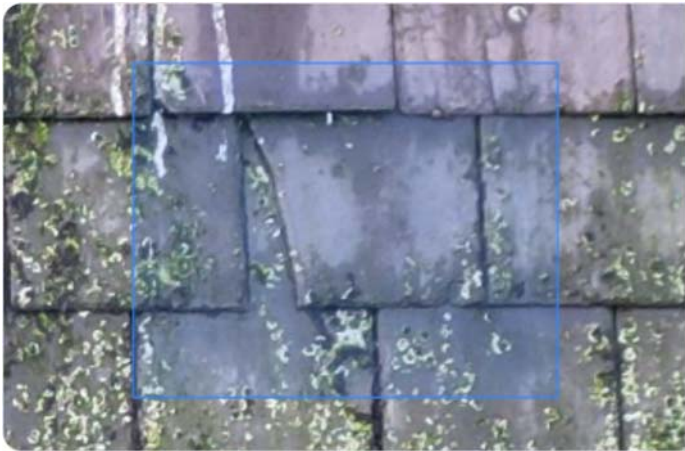
Broken slate

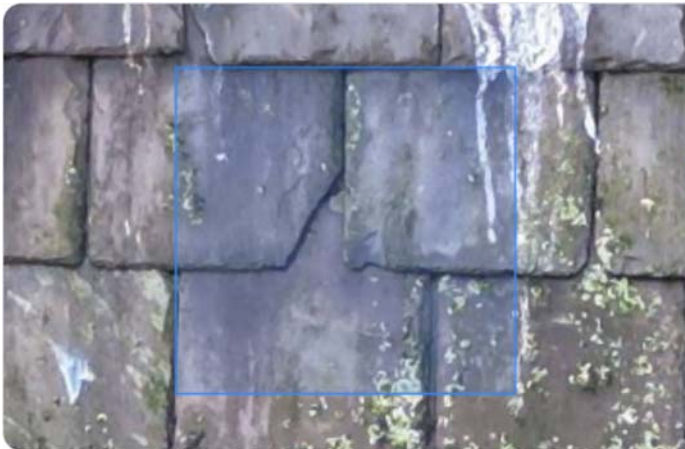
Broken slate

Severity: 3

Broken Slate

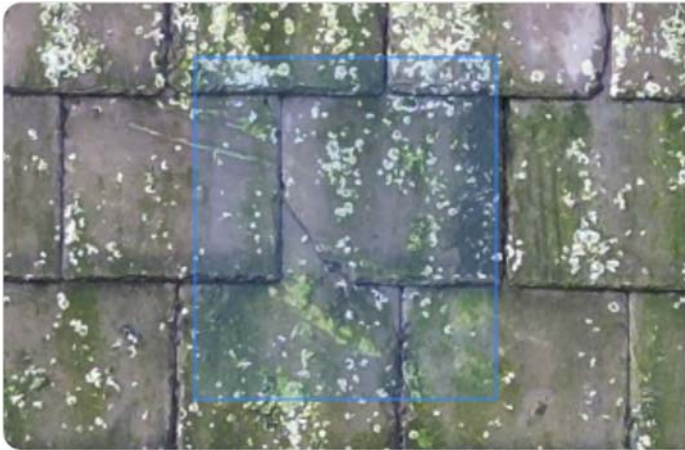
# Broken slate

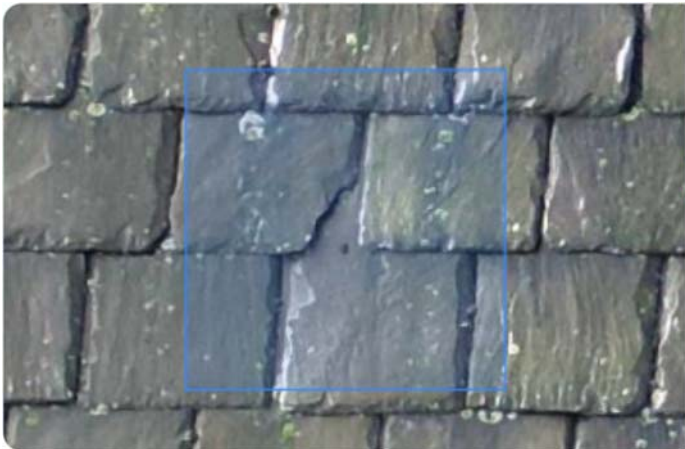
Broken slate

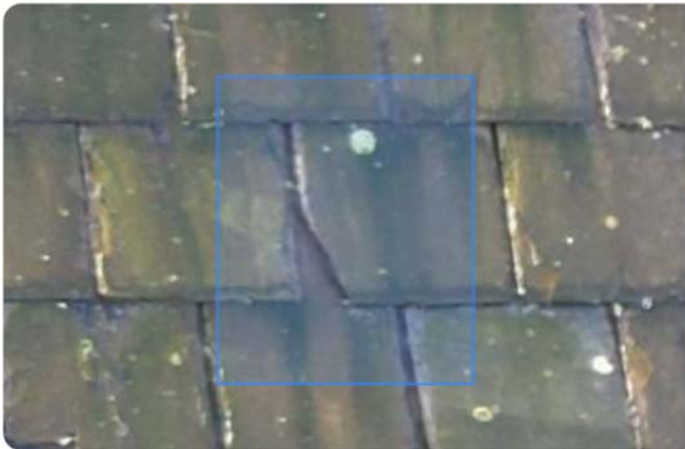
Broken slate

Description: corner only

Severity: 2

Broken Slate

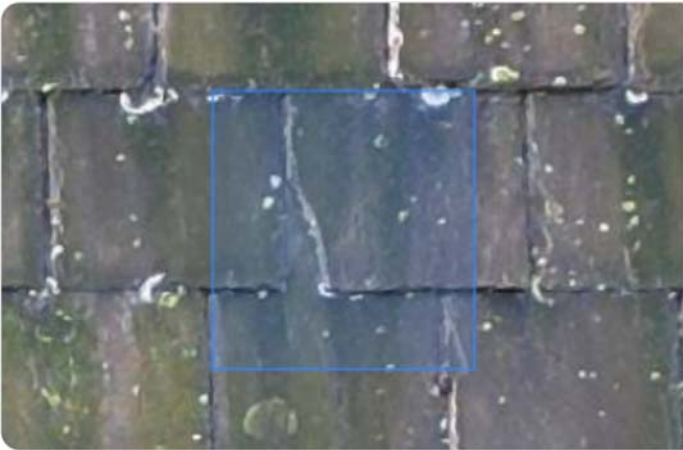
Broken slate

Description: corner only

Severity: 2

Broken Slate

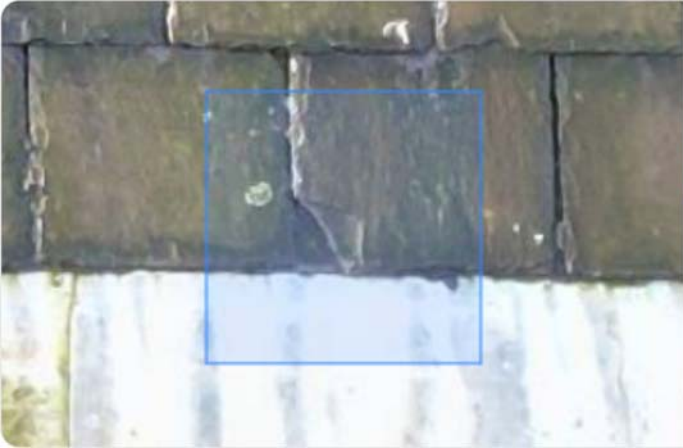
Broken slate

Description: corner only

Severity: 2

Broken Slate

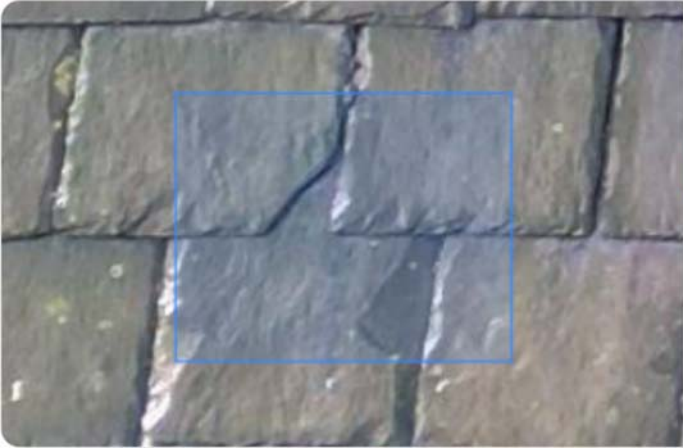
Broken slate

Description: corner only

Severity: 2

Broken Slate

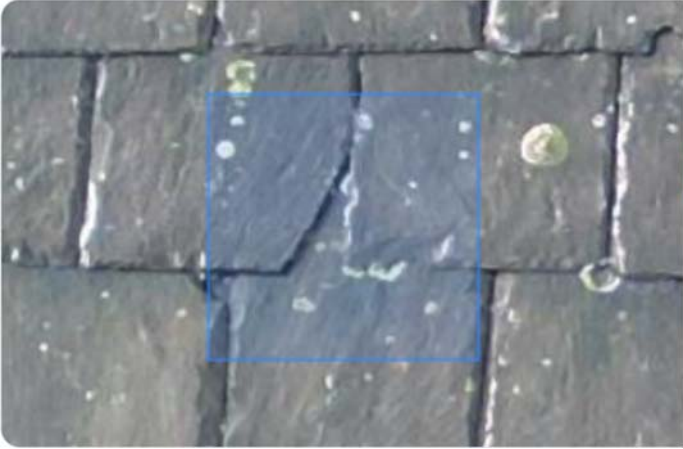
Broken slate

Description: corner only

Severity: 2

Broken Slate

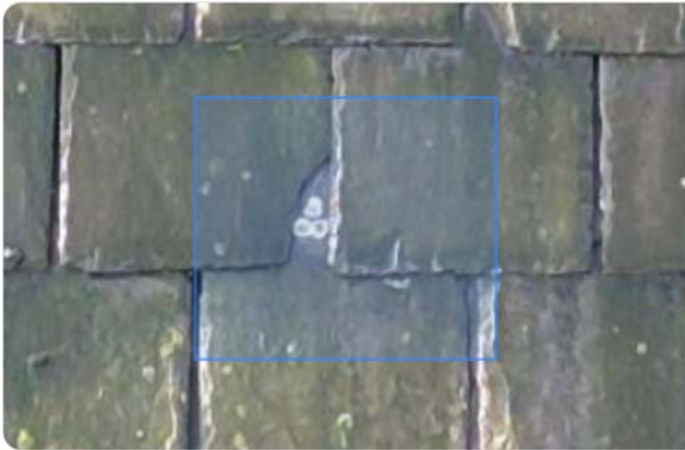
Broken slate

Description: corner only

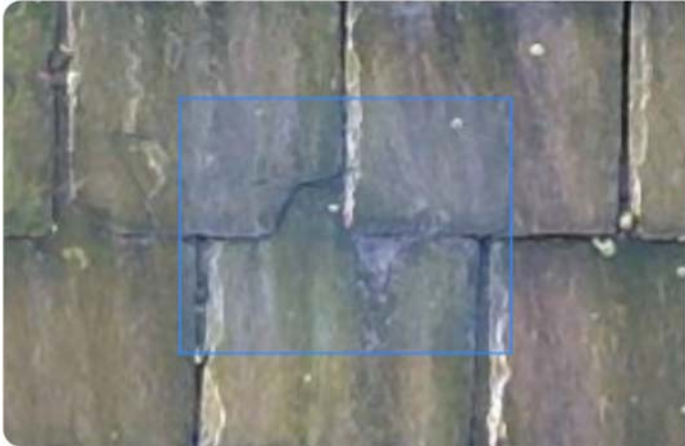
Severity: 2

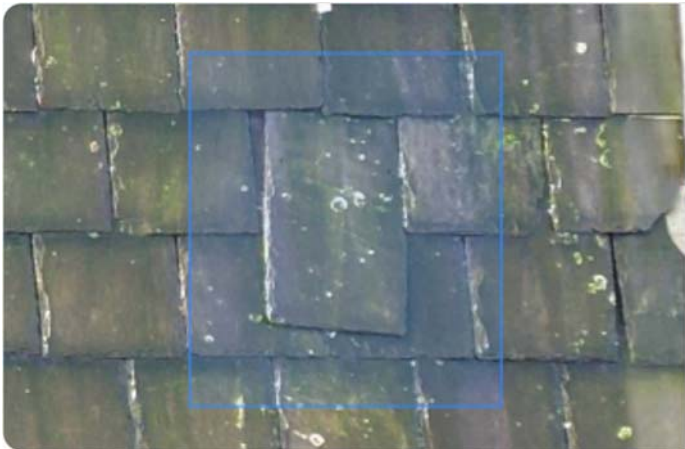
Slipped slate

Severity: 3

Loose Slate

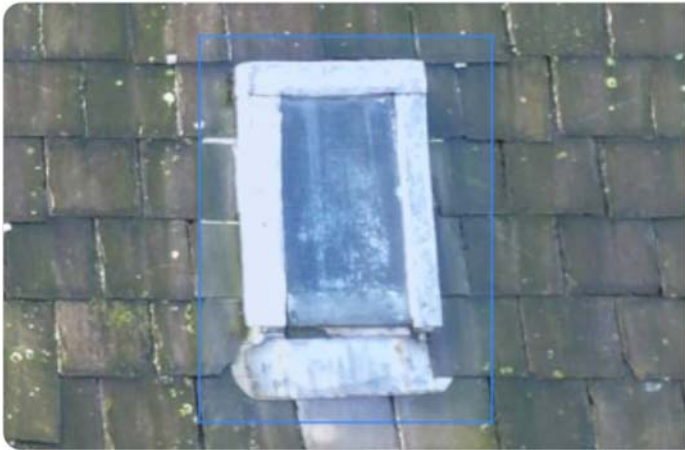
Defective rooflight

Severity: 4

Skylight Defect

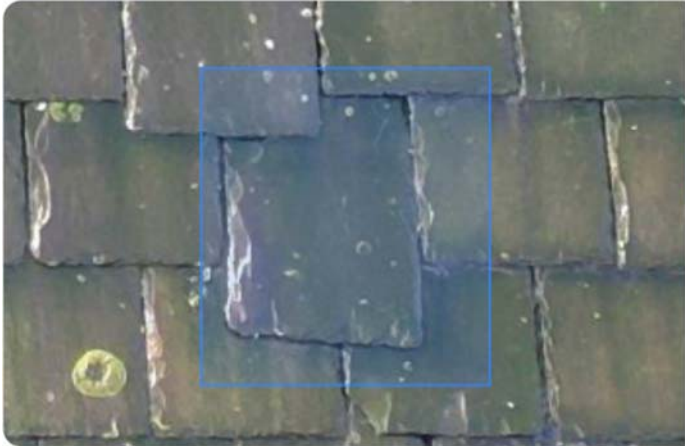
Slipped slate

Severity: 3

Loose Slate

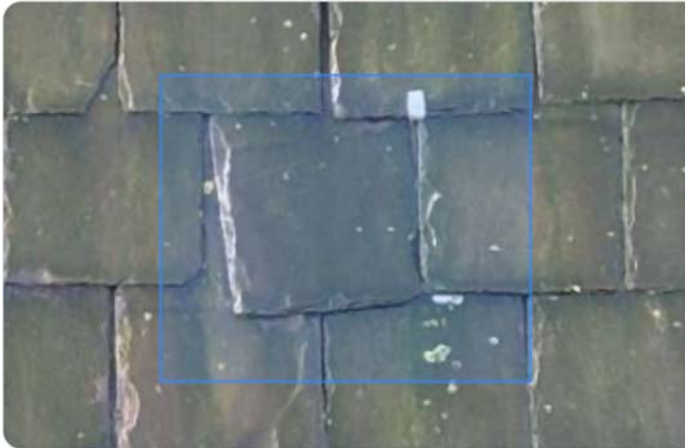
Slipped slate

Severity: 3

Loose Slate

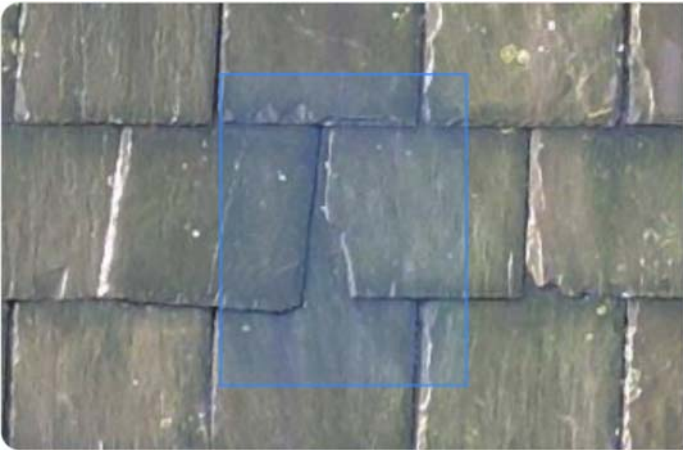
Broken slate

Severity: 3

Broken Slate

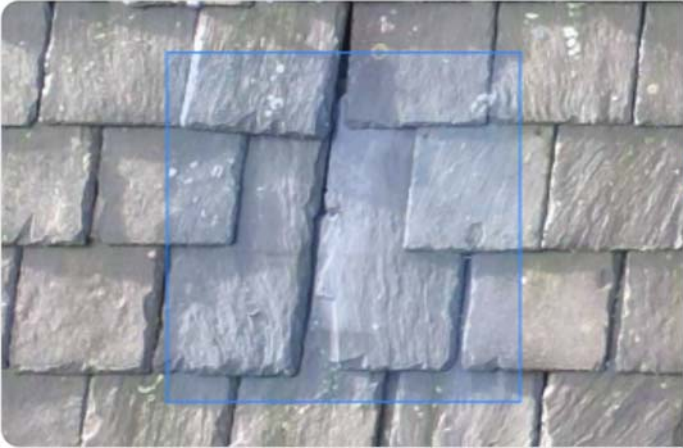
Slipped slate

Missing Slate

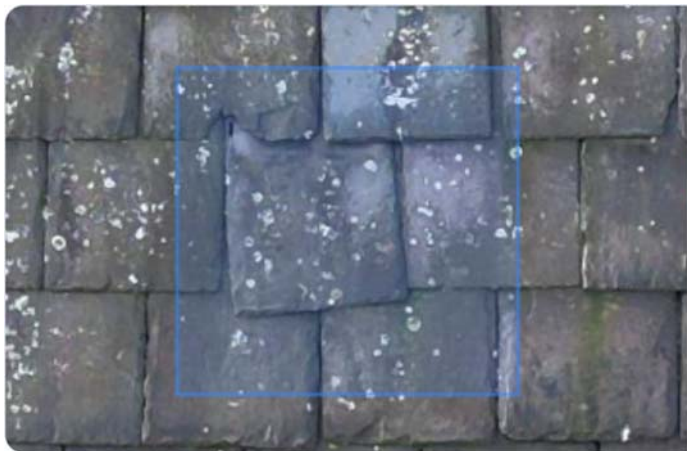
Slipped slate

Severity: 3

Loose Slate

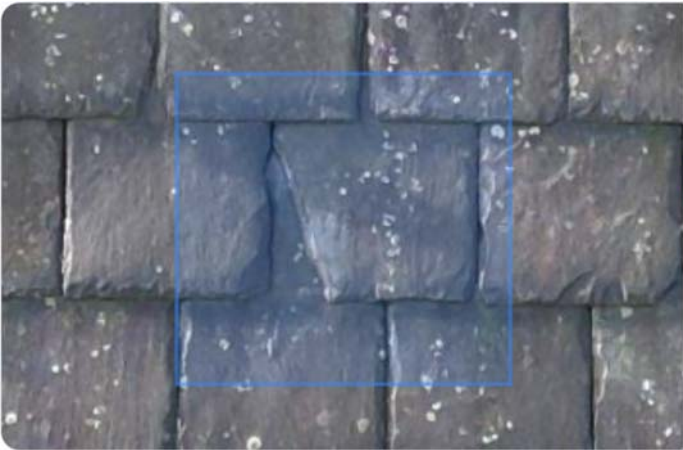
Broken slate

Severity: 3

Broken Slate

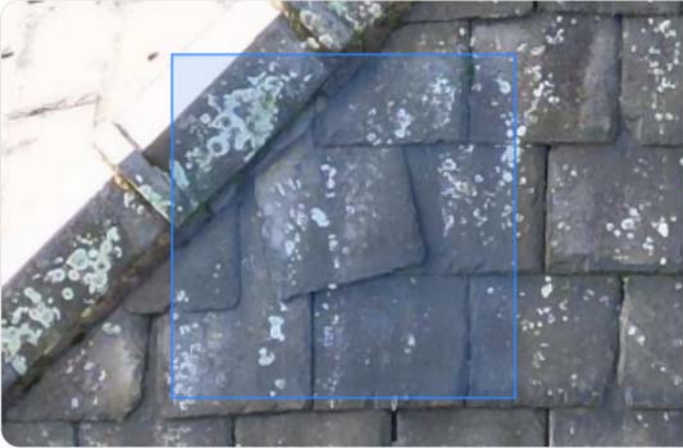
Slipped slate

Severity: 3

Loose Slate

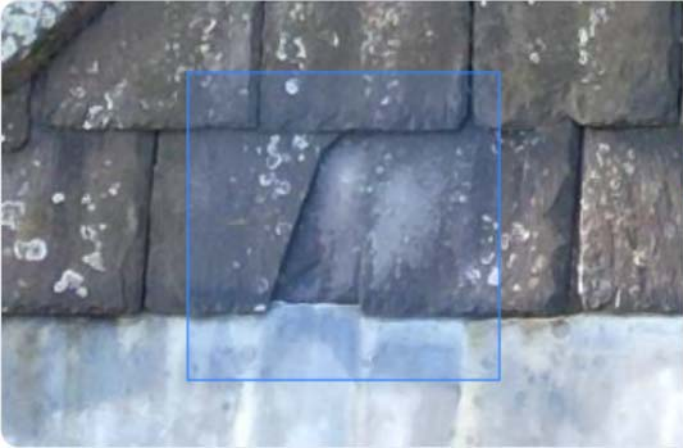
Broken slate

Broken Slate

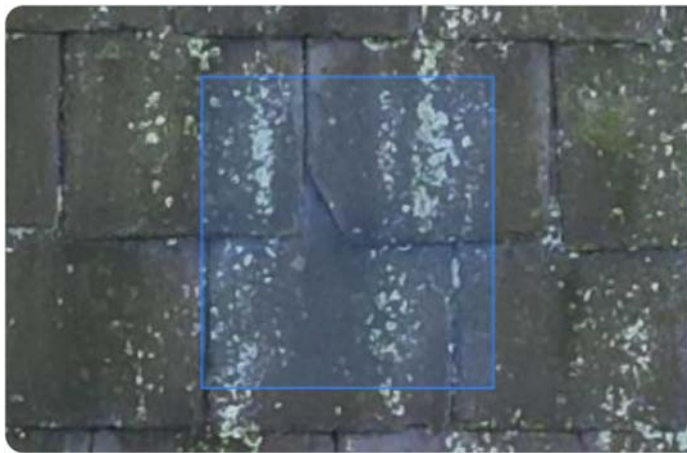
Broken slate

Description: corner only

Severity: 2

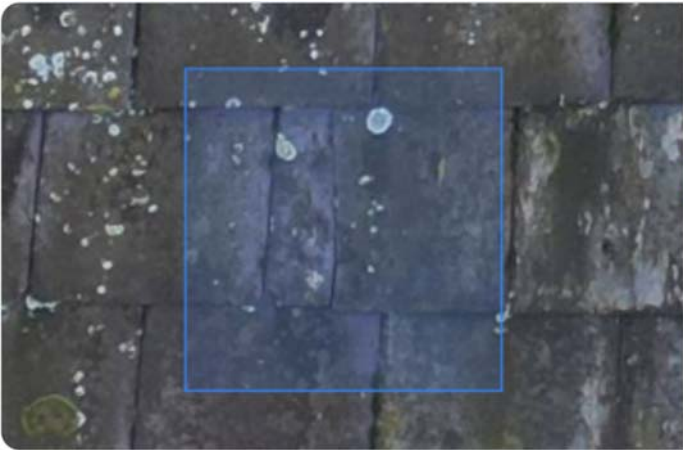
Broken slate

Severity: 3

Broken Slate

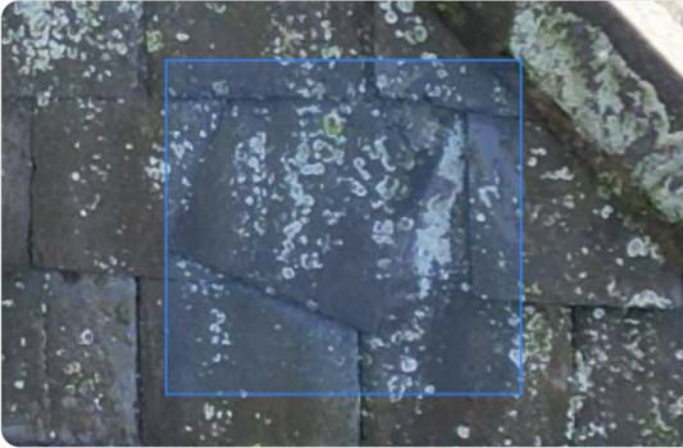
Slipped slate

Severity: 3

Loose Slate

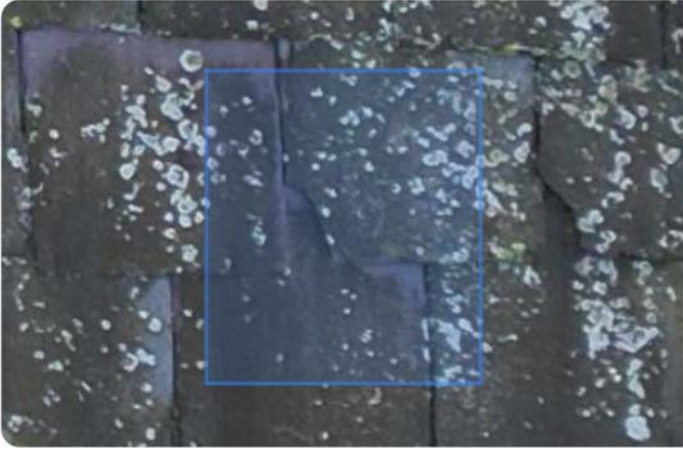
Broken slate

Description: corner only

Severity: 2

Broken Slate

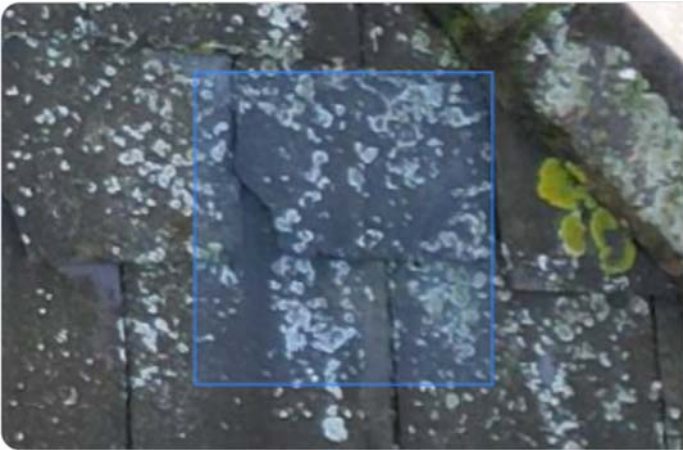
# Broken slate

Broken Slate

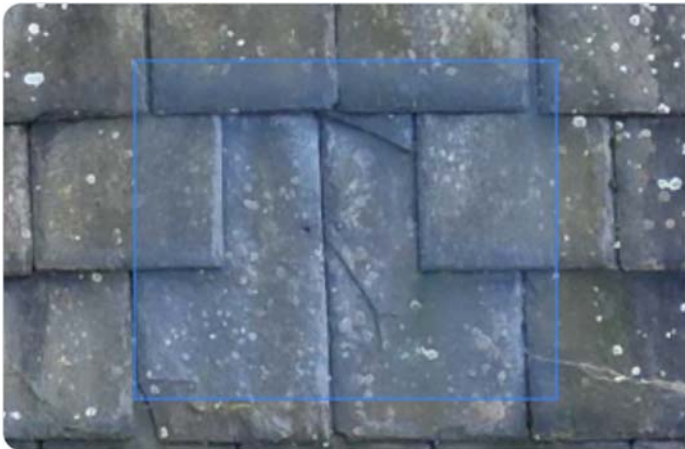
Broken slate

Severity: 3

Broken Slate

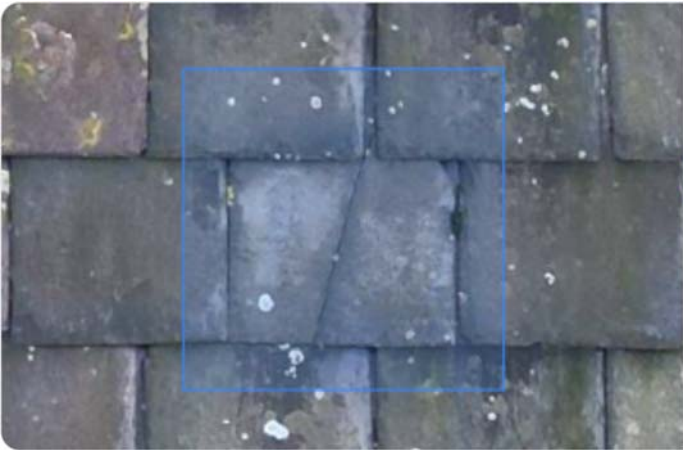
Broken slate

Severity: 3

Broken Slate

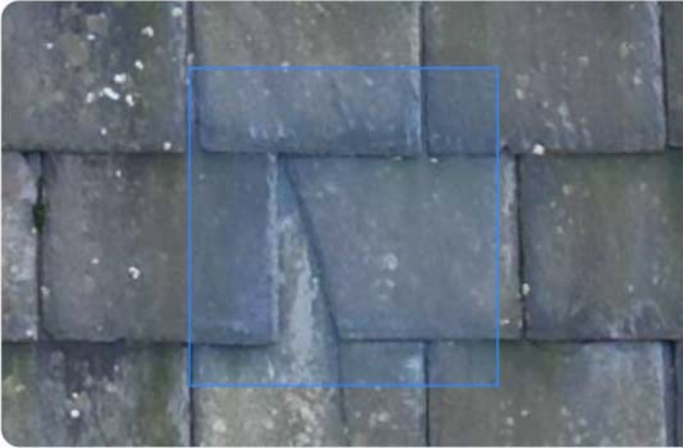
Broken slate

Severity: 3

Broken Slate

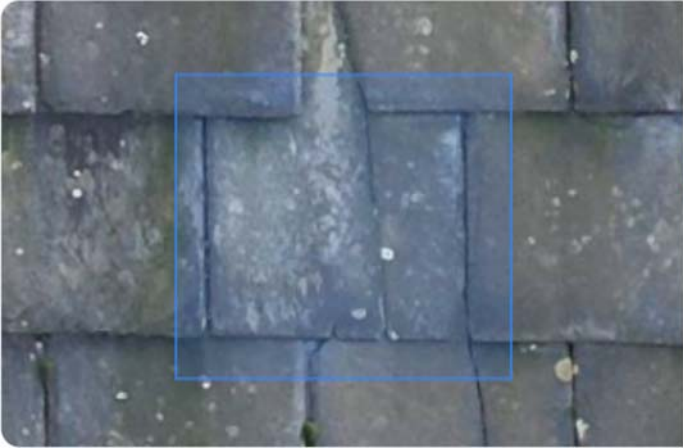
Broken slate

Severity: 3

Broken Slate

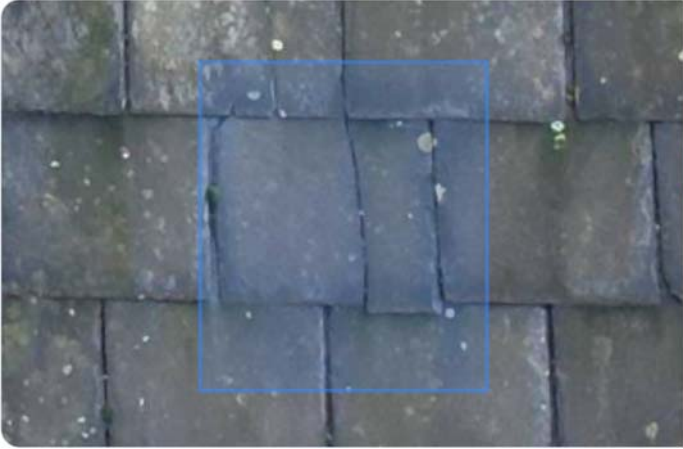
Broken slate

Severity: 3

Broken Slate

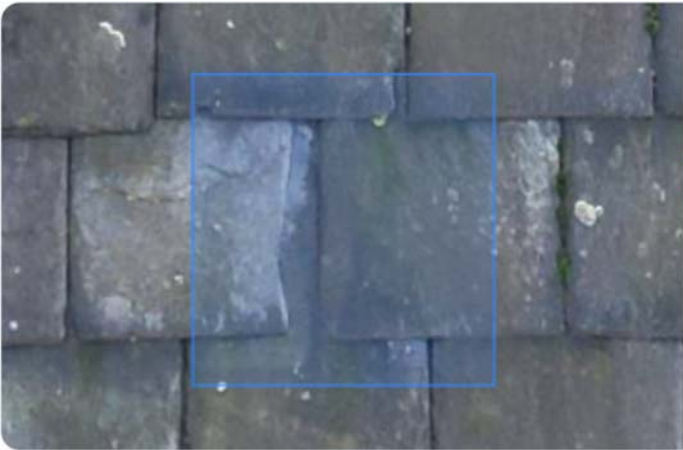
Broken slate

Severity: 3

Broken Slate

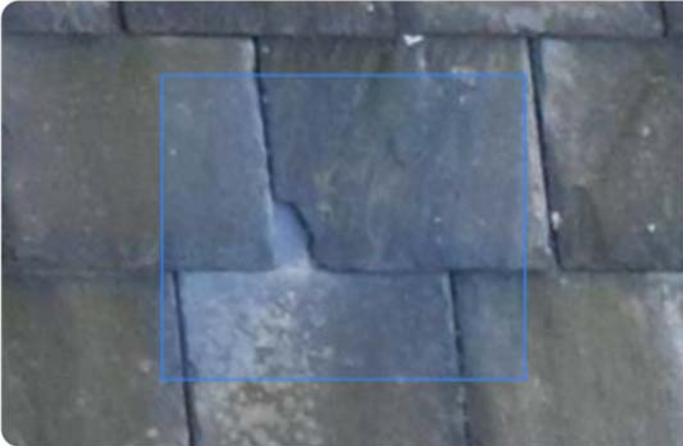
Broken slate

Description: corner only

Severity: 2

Broken Slate

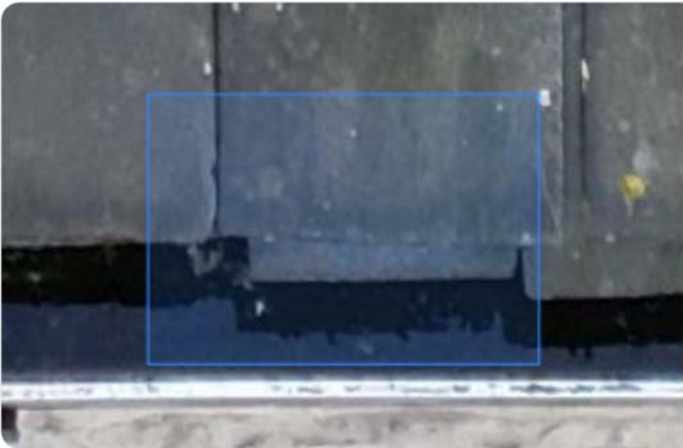
Slipped slate

Severity: 3

Loose Slate

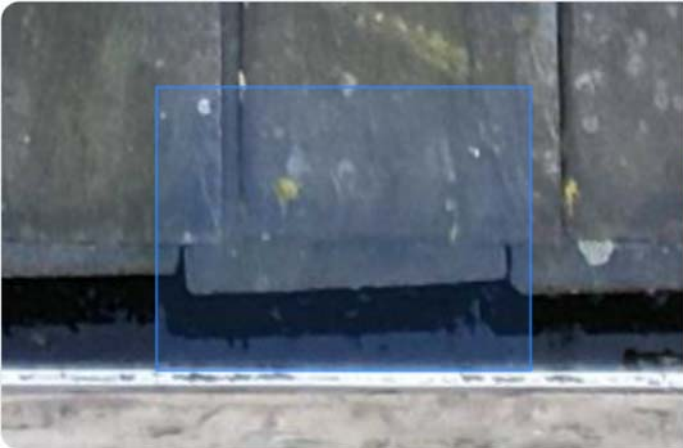
Slipped slate

Severity: 3

Loose Slate

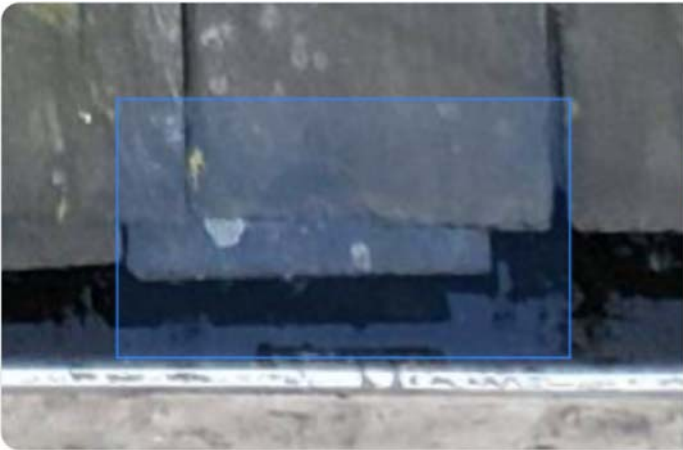
Slipped slate

Severity: 3

Loose Slate

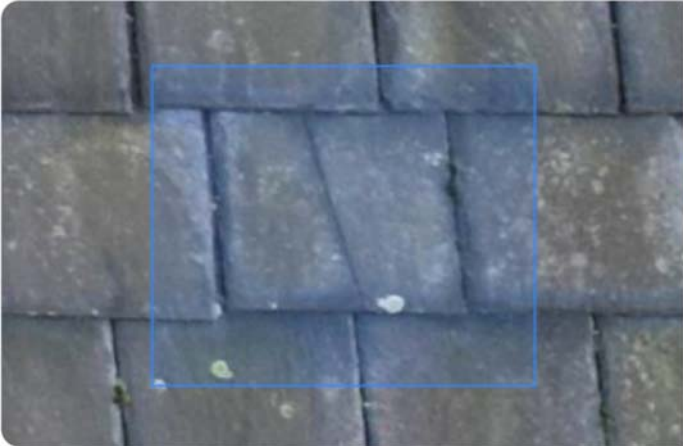
Broken slate

Broken Slate

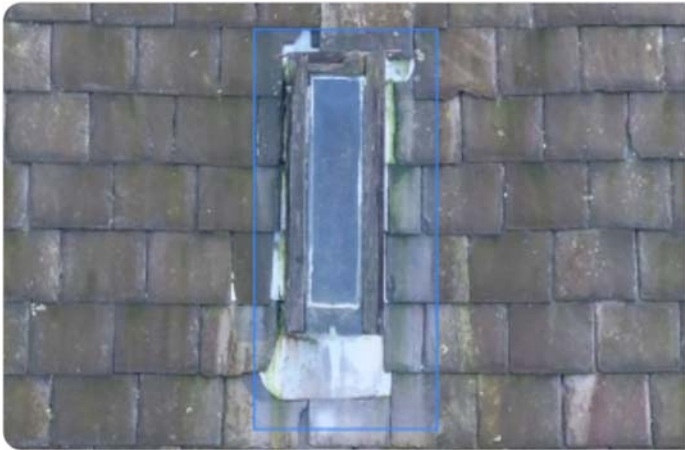
Defective rooflight

Severity: 4

Skylight Defect

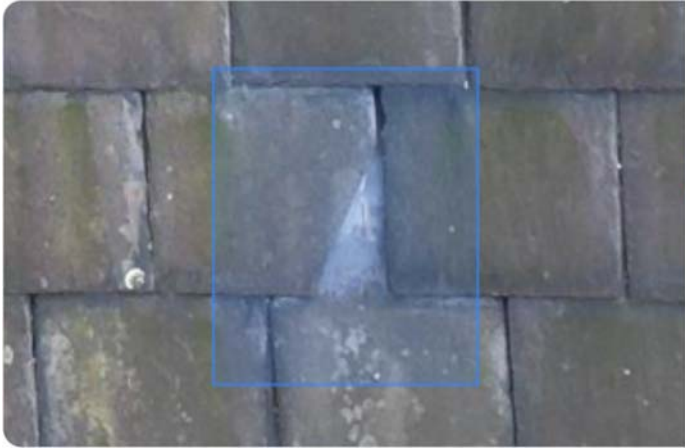
Broken slate

Broken Slate

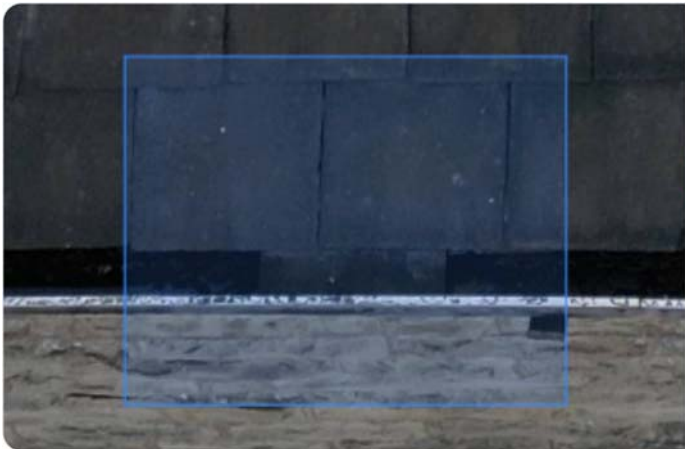
Slipped slate

Severity: 3

Loose Slate

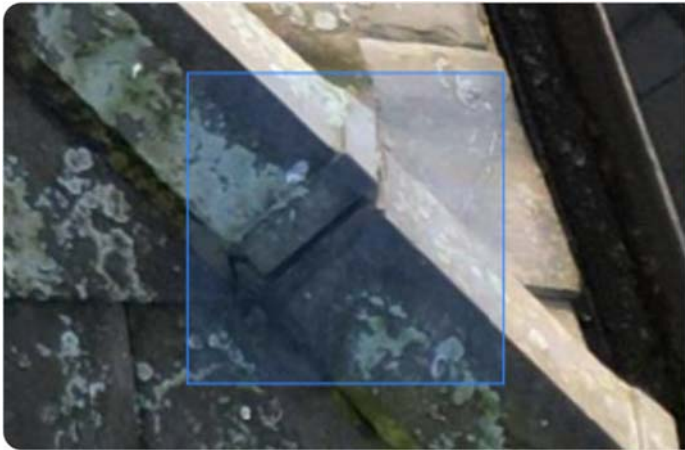
## Defective pointing

Description: cracked cement to hip tile

Cement / Mortar Defect

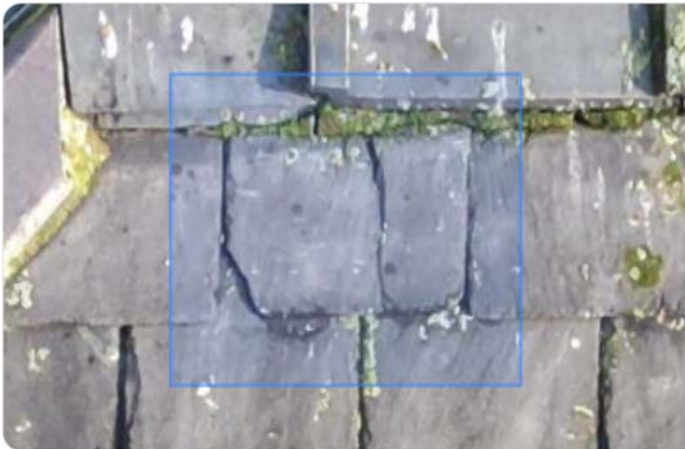
Broken slate

Severity: 3

Broken Slate

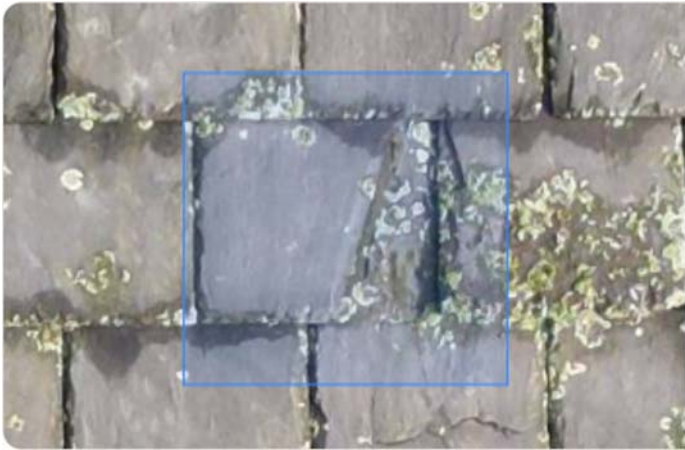
### Broken slate

Severity: 3

Broken Slate

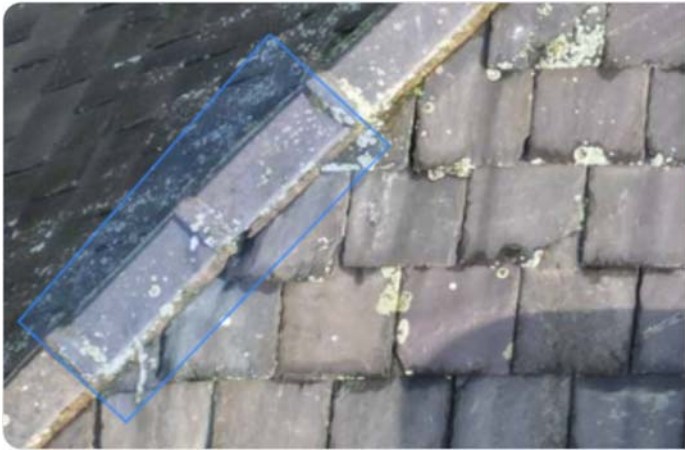
### Eroded pointing to hip tiles

Severity: 3

Cement / Mortar Defect

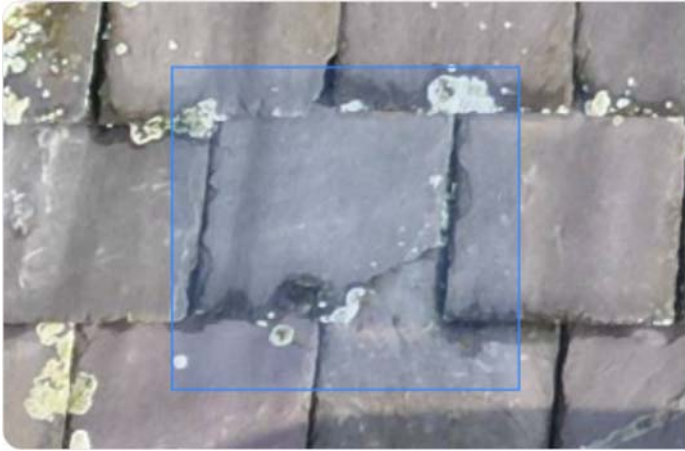
### Broken slate

Severity: 3

Broken Slate

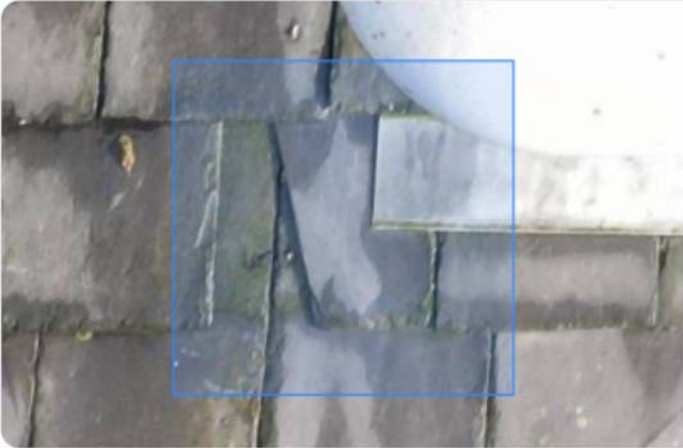
Broken slate

Severity: 3

Broken Slate

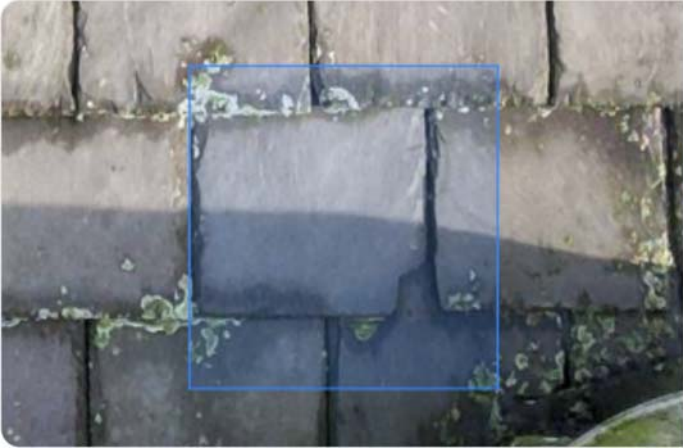
Broken slate

Description: corner only

Severity: 2

Broken Slate

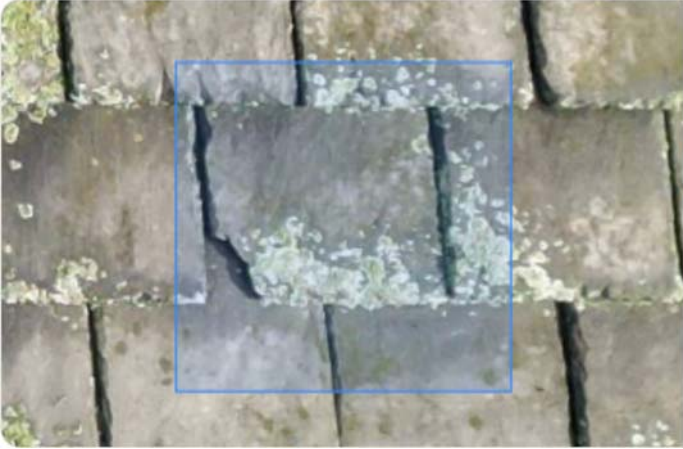
Broken slate

Description: corner only

Severity: 2

Broken Slate

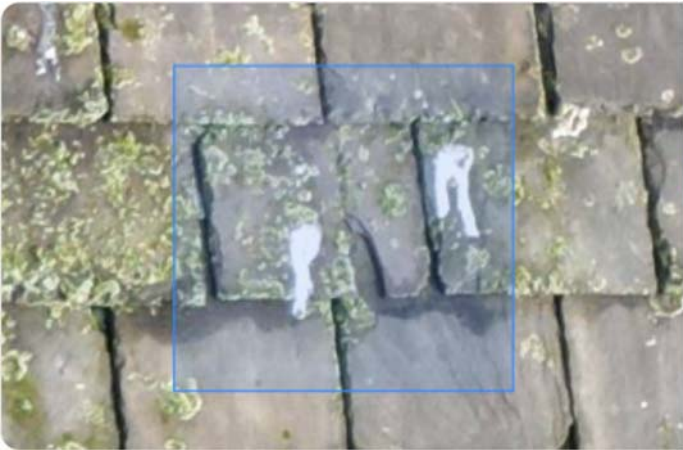
Broken slate

Severity: 3

Broken Slate

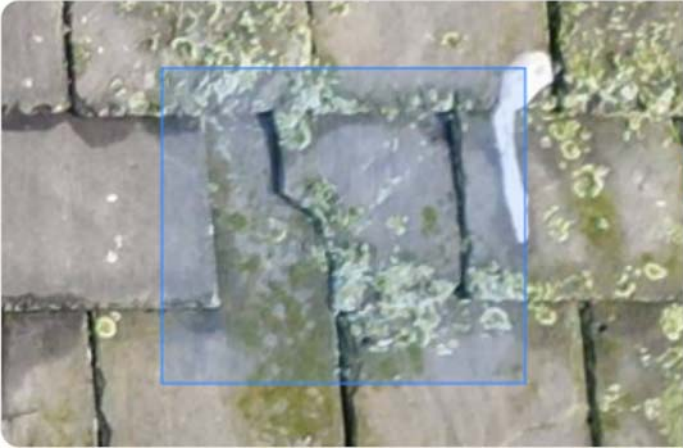
Broken slate

Severity: 3

Broken Slate

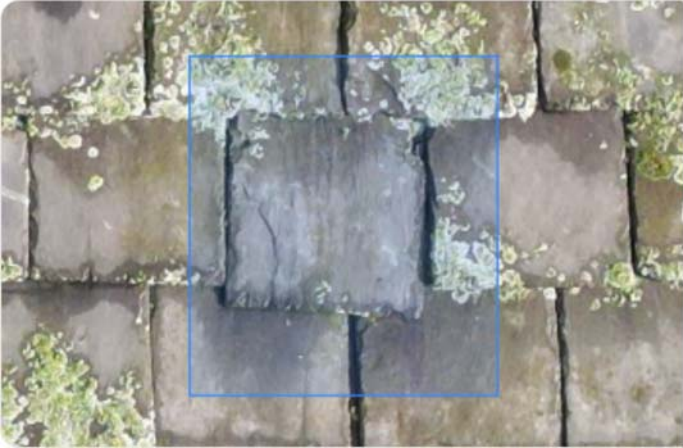
Slipped slate

Severity: 3

Loose Slate

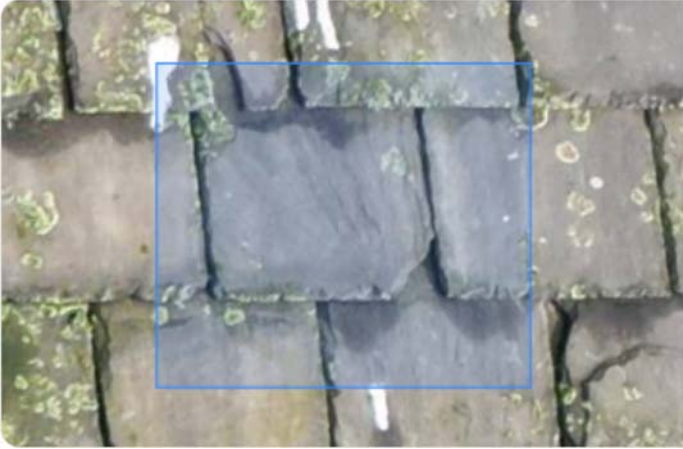
Broken slate

Description: corner only

Severity: 2

Broken Slate

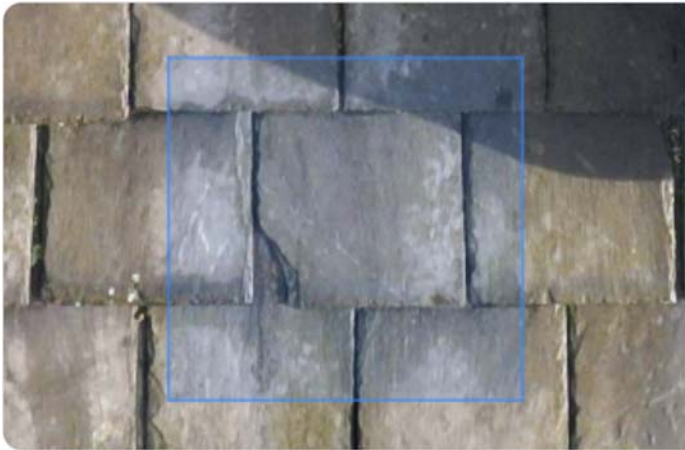
# Broken slate

Description: corner only

Broken Slate
