**CONDITION REPORT**

**OSWALDTWISTLE CIVIC THEATRE**

**26<sup>th</sup> JANUARY 2024**

**Job Reference Number: BS 1250**

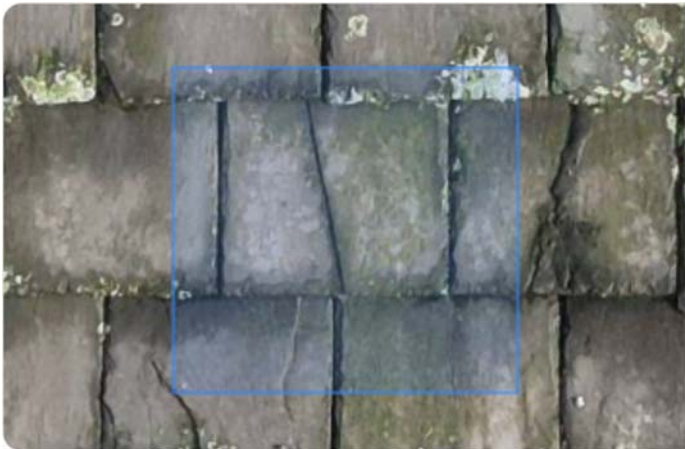
Broken slate

Severity: 3

Broken Slate

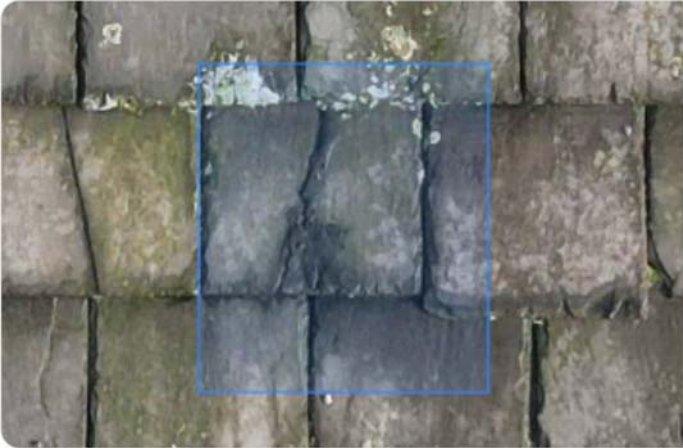
Broken slate

Severity: 3

Broken Slate

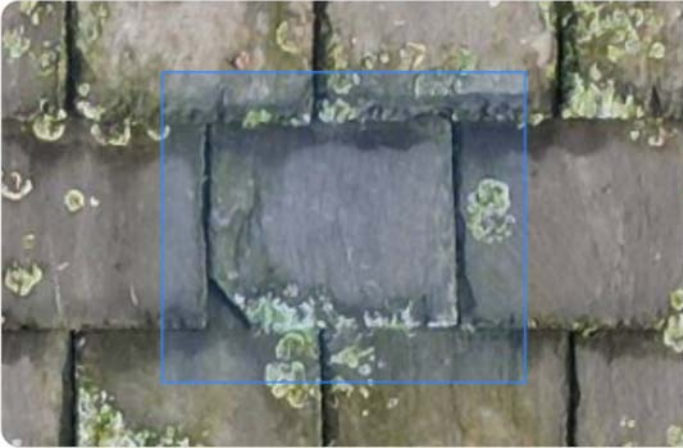
Broken slate

Description: corner only

Severity: 2

Broken Slate

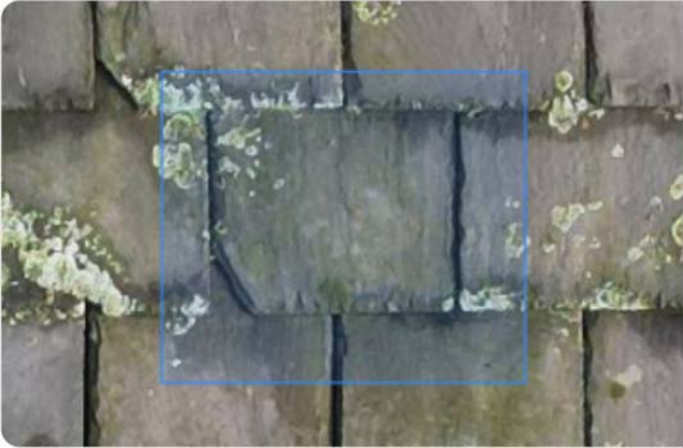
Broken slate

Description: corner only

Severity: 2

Broken Slate

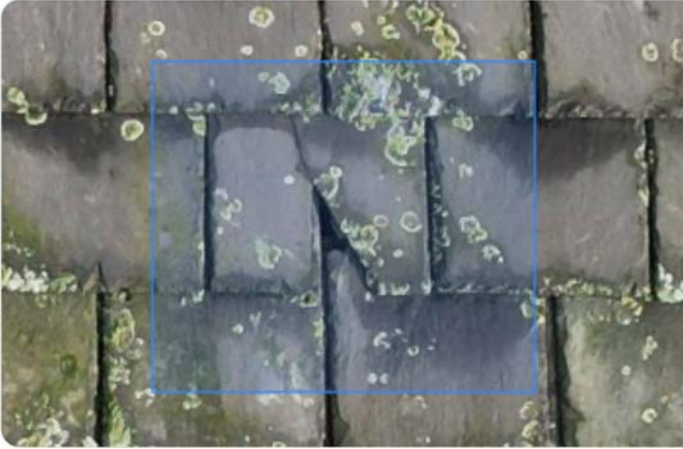
Broken slate

Severity: 3

Broken Slate

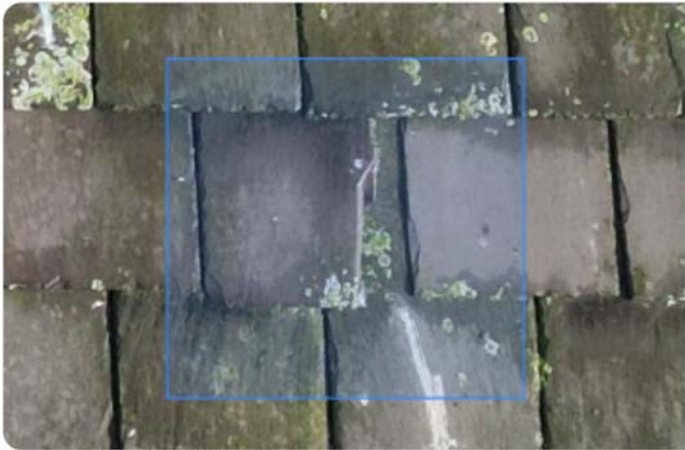
Broken slate

Severity: 3

Broken Slate

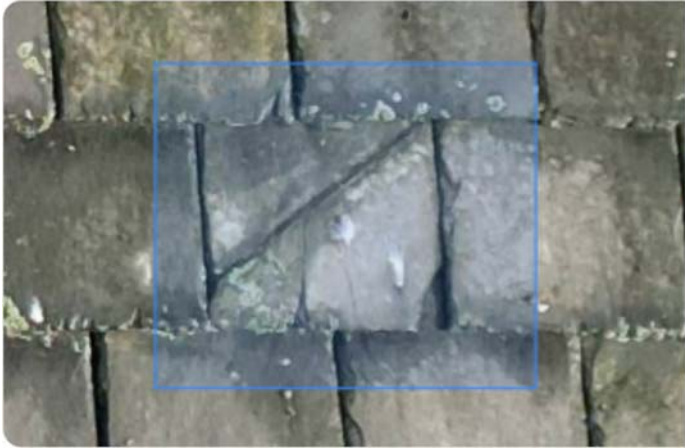
Broken slate

Severity: 3

Broken Slate

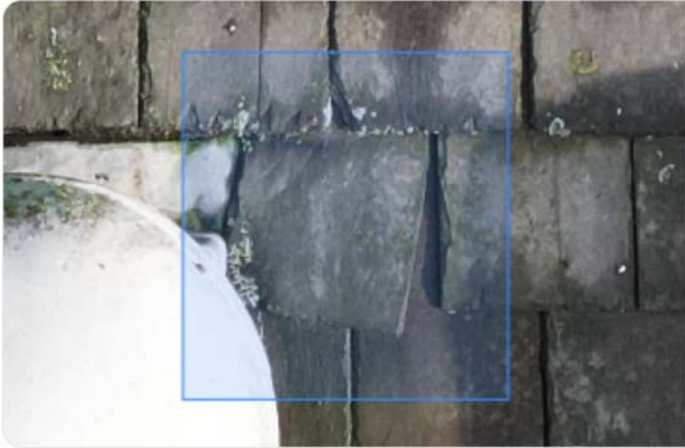
Slipped slate

Severity: 3

Loose Slate

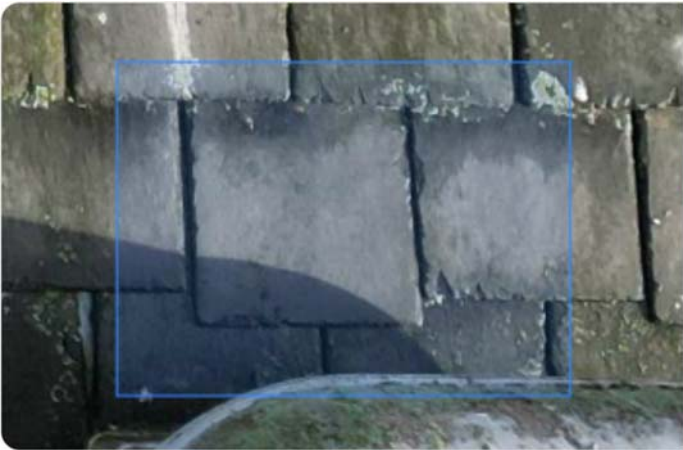
# Slipped slate

Loose Slate

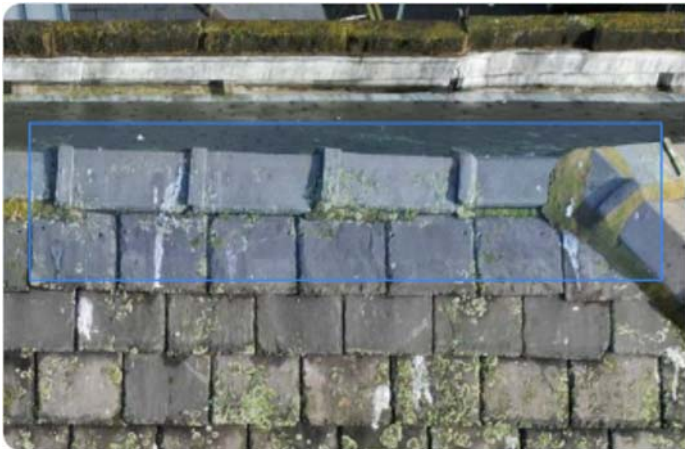
Defective pointing

Description: defective pointing to ridge tiles

Severity: 3

Cement / Mortar Defect

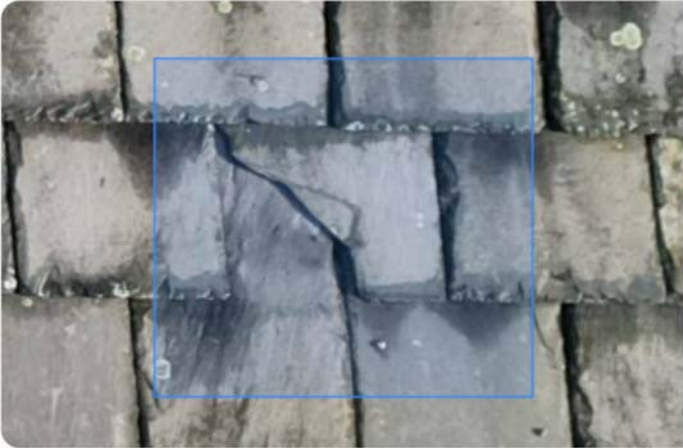
Broken slate

Severity: 3

Broken Slate

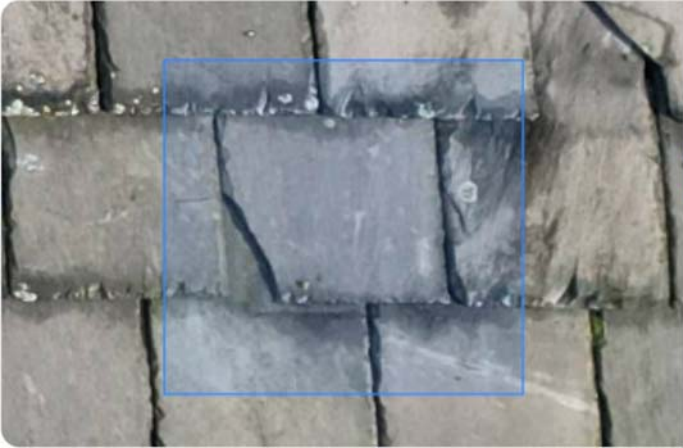
Broken slate

Broken Slate

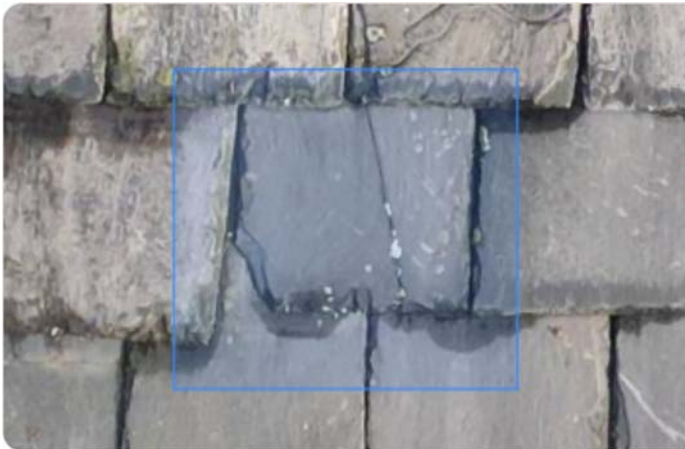
Broken slate

Severity: 3

Broken Slate

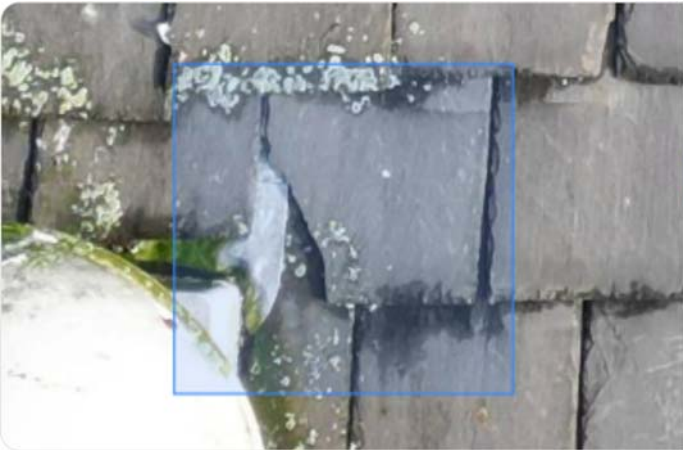
Broken slate

Severity: 3

Broken Slate

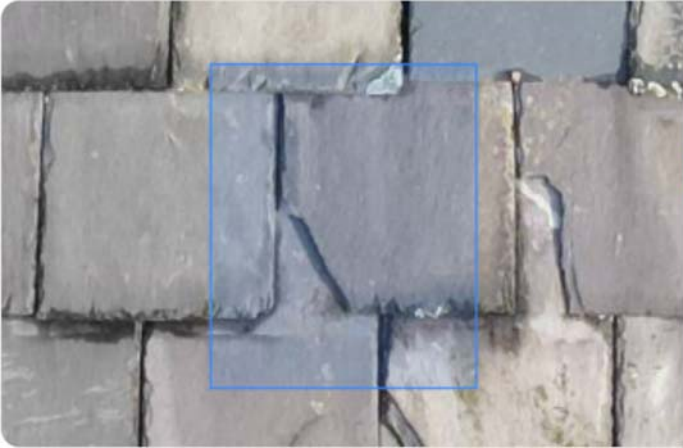
Broken slate

Severity: 3

Broken Slate

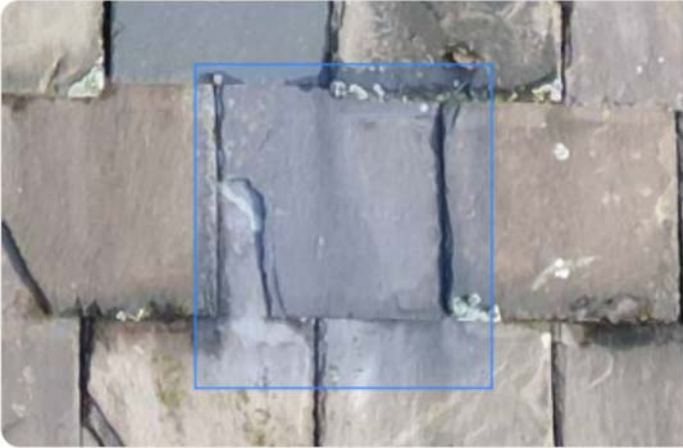
Broken slate

Severity: 3

Broken Slate

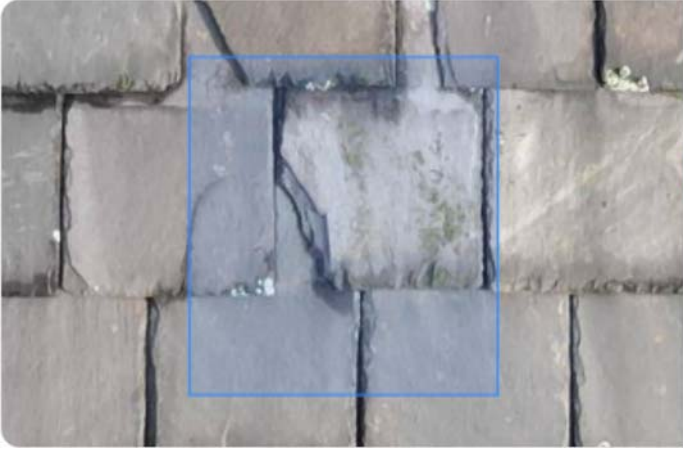
Broken slate

Broken Slate

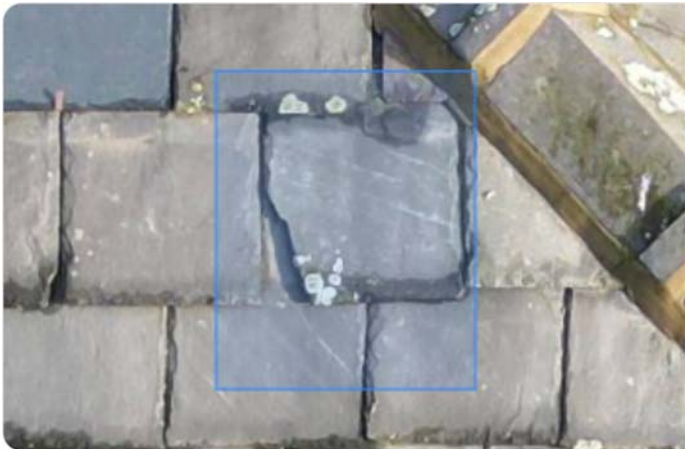
Broken slate

Severity: 3

Broken Slate

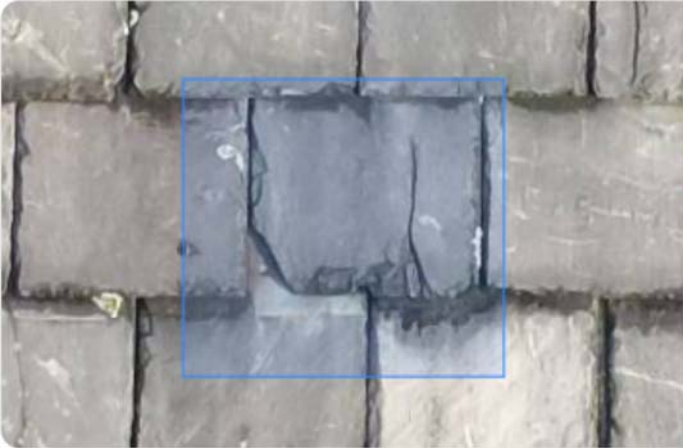
Broken slate

Description: corner only

Severity: 2

Broken Slate

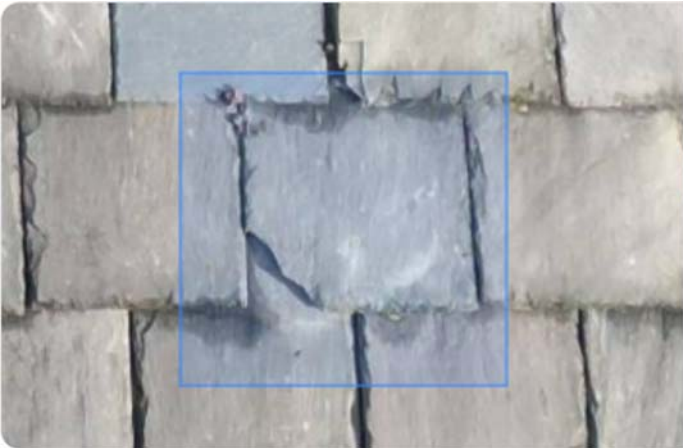
Broken slate

Description: corner only

Broken Slate

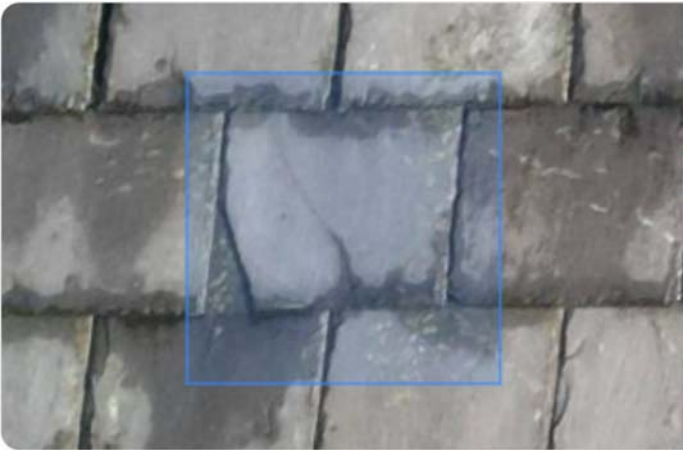
Slipped slate

Severity: 3

Loose Slate

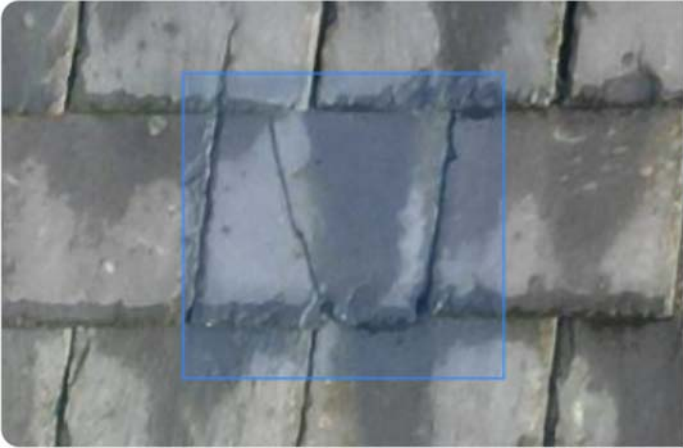
Broken slate

Description: corner only

Severity: 2

Broken Slate

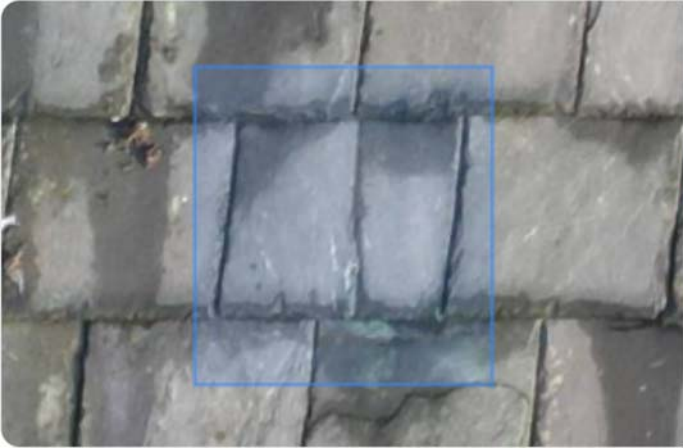
Broken slate

Severity: 3

Broken Slate

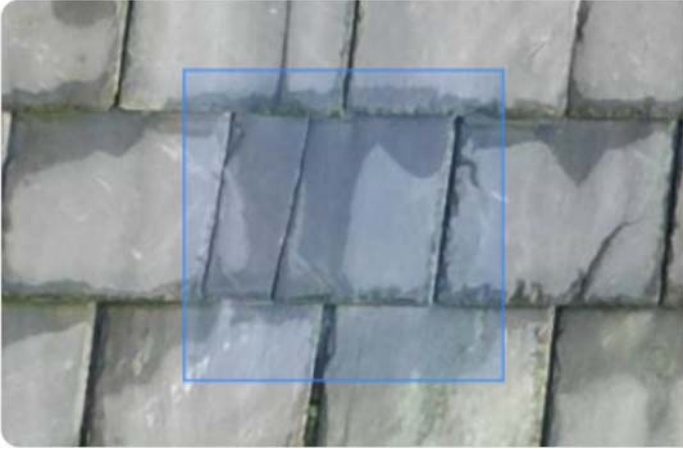
Broken slate

Severity: 3

Broken Slate

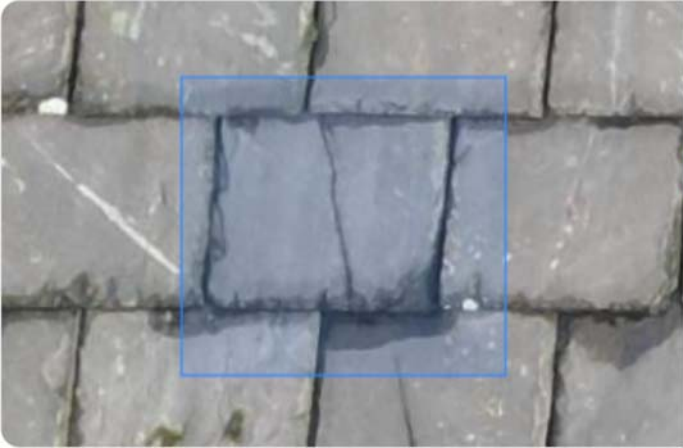
Broken slate

Severity: 3

Broken Slate

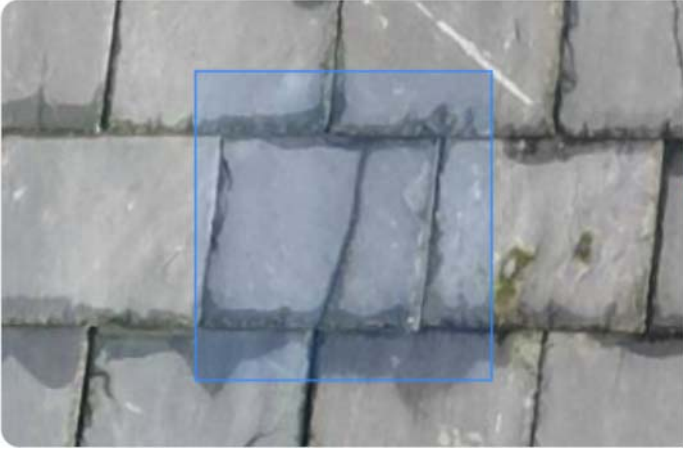
Broken slate

Severity: 3

Broken Slate

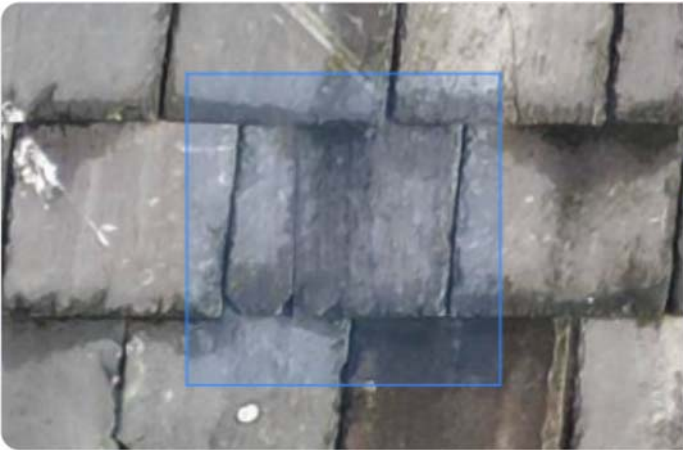
Broken slate

Severity: 3

Broken Slate

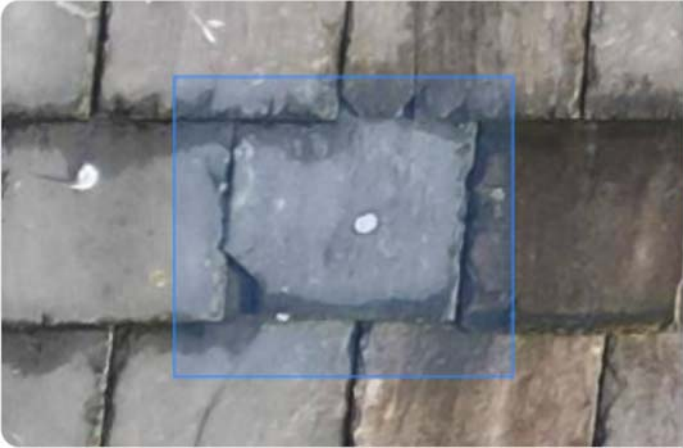
Broken slate

Severity: 3

Broken Slate

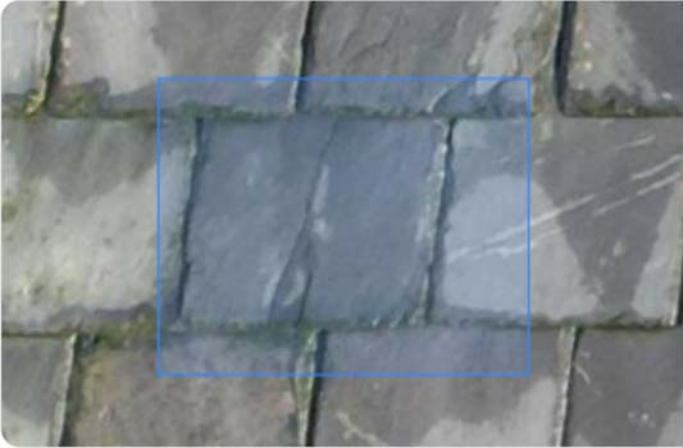
Broken slate

Description: corner only

Severity: 2

Broken Slate

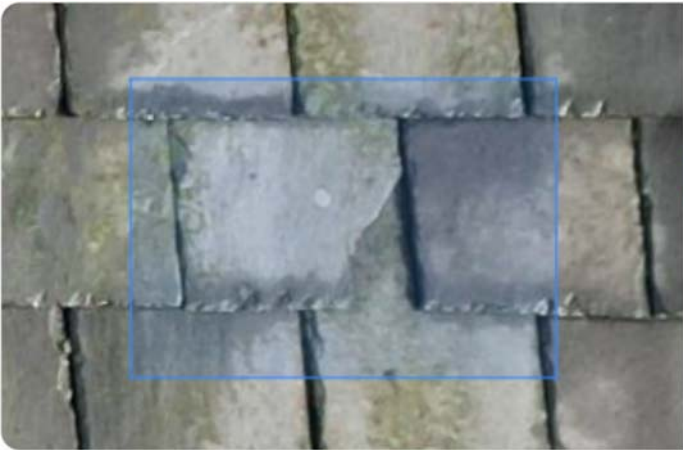
Slipped slate

Severity: 3

Loose Slate

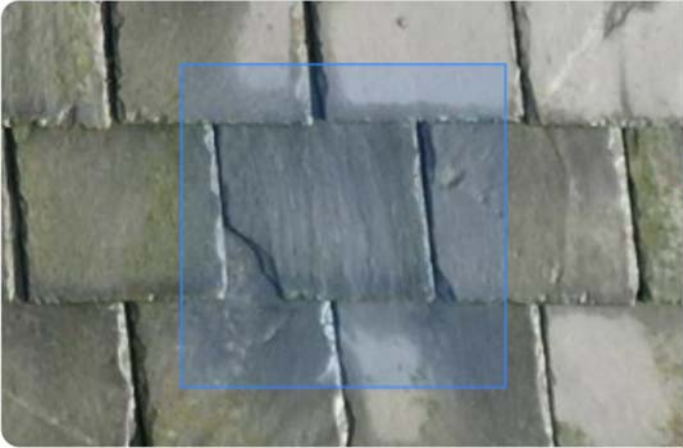
Broken slate

Severity: 3

Broken Slate

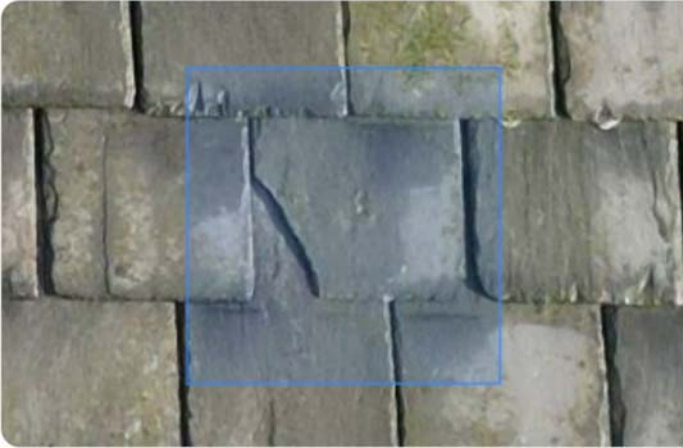
Broken slate

Severity: 3

Broken Slate

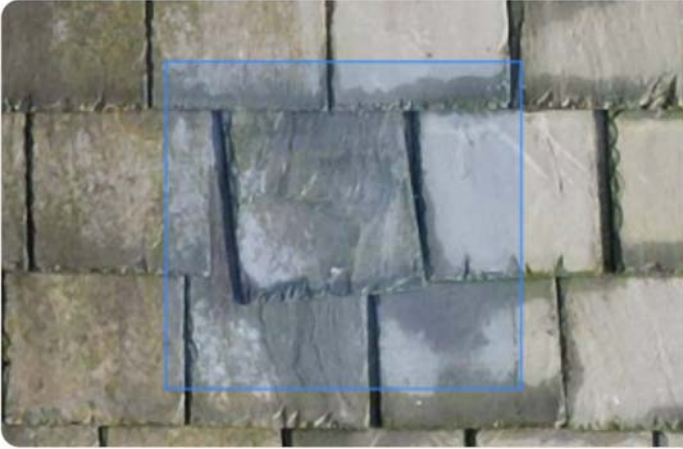
Broken slate

Severity: 3

Broken Slate

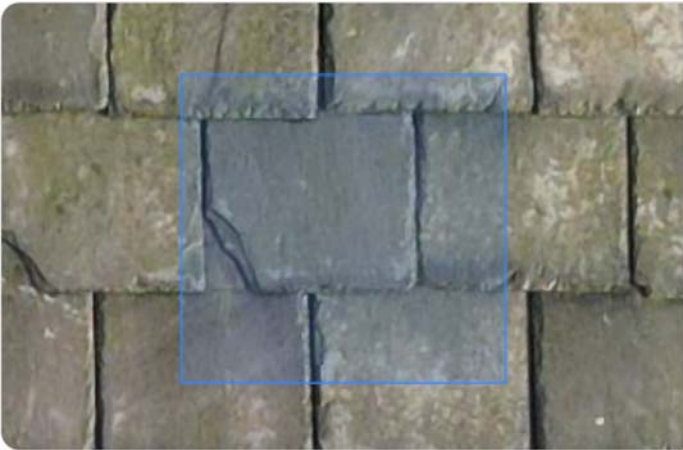
Slipped slate

Severity: 3

Loose Slate

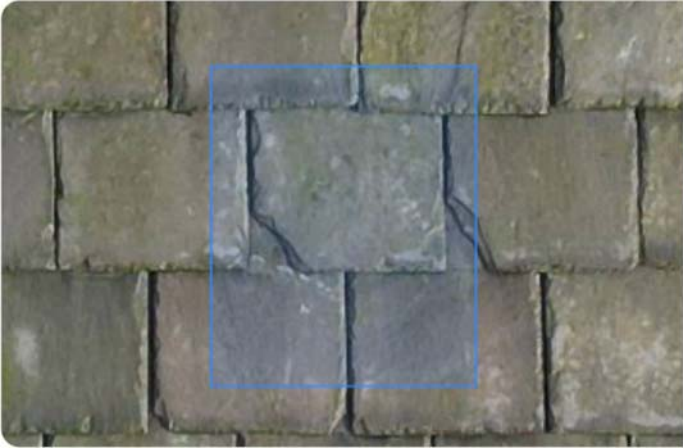
Broken slate

Description: corner only

Severity: 2

Broken Slate

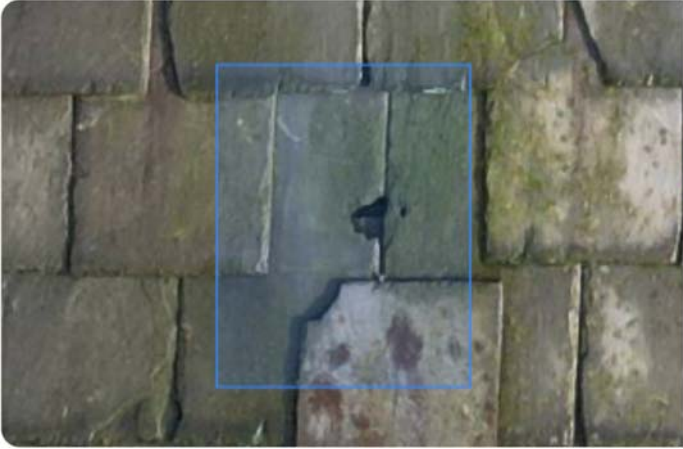
Slipped slate

Severity: 3

Missing Slate

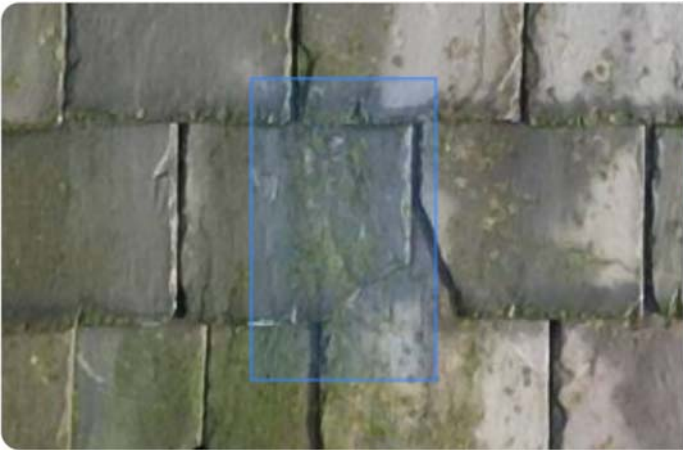
Broken slate

Severity: 3

Broken Slate

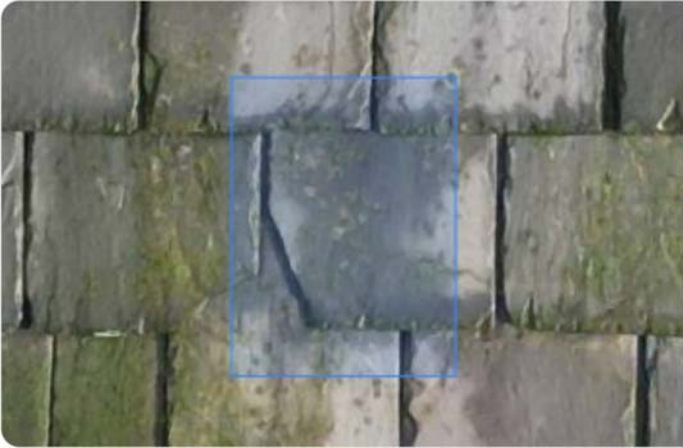
Broken slate

Severity: 3

Broken Slate

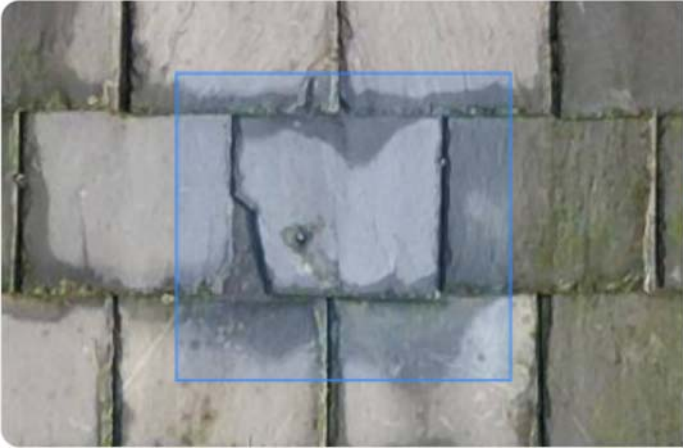
Broken slate

Severity: 3

Broken Slate

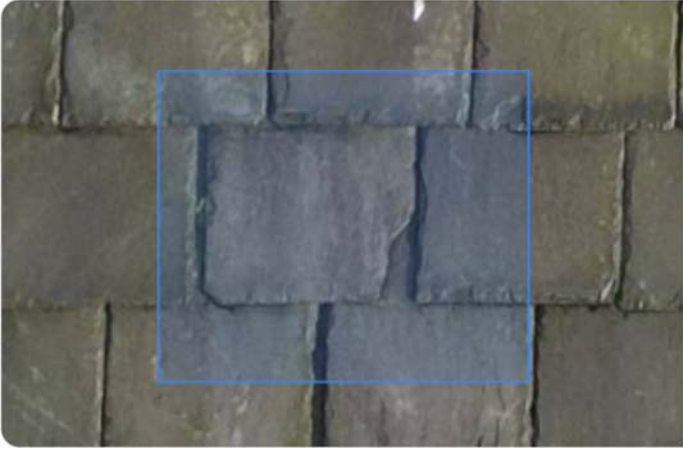
Broken slate

Severity: 3

Broken Slate

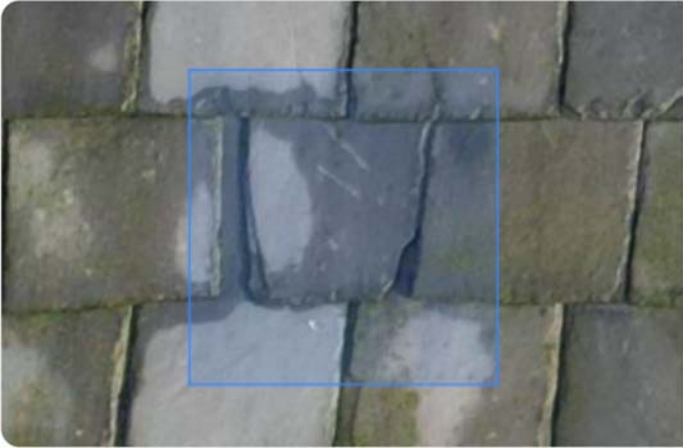
Broken slate

Description: corner only

Severity: 2

Broken Slate

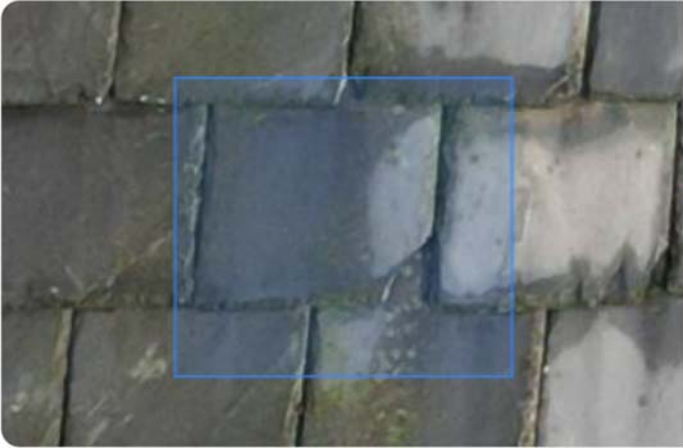
Broken slate

Severity: 3

Broken Slate

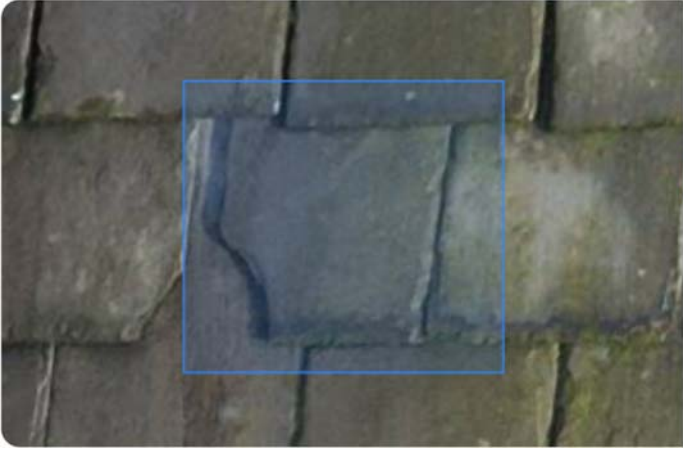
Broken slate

Description: corner only

Severity: 2

Broken Slate

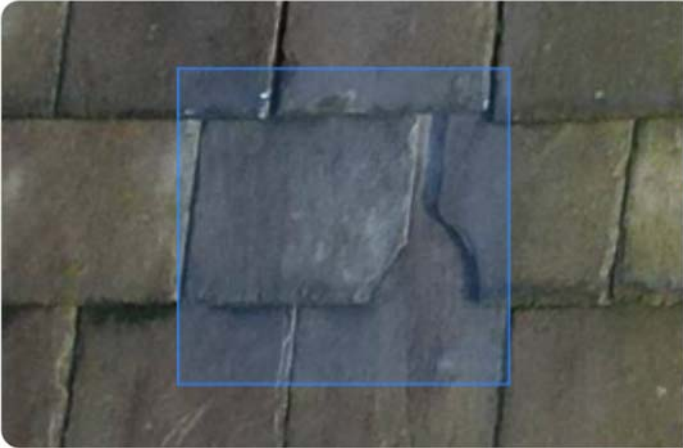
Broken slate

Severity: 3

Broken Slate

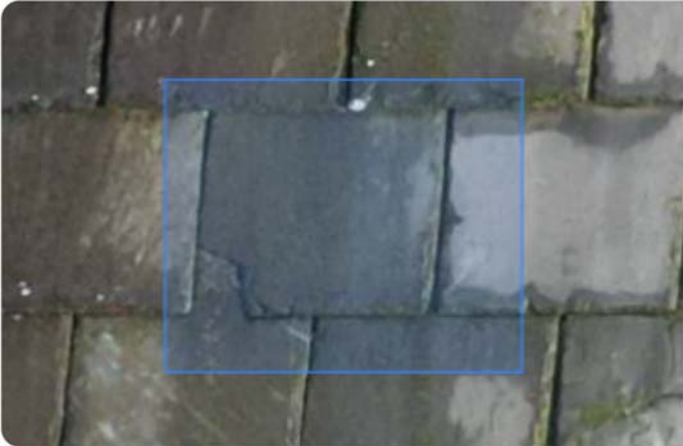
Broken slate

Severity: 3

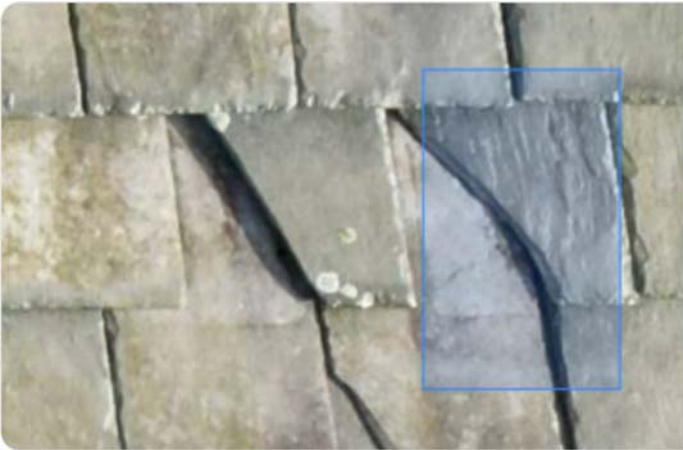
Broken slate

Severity: 3

Broken Slate

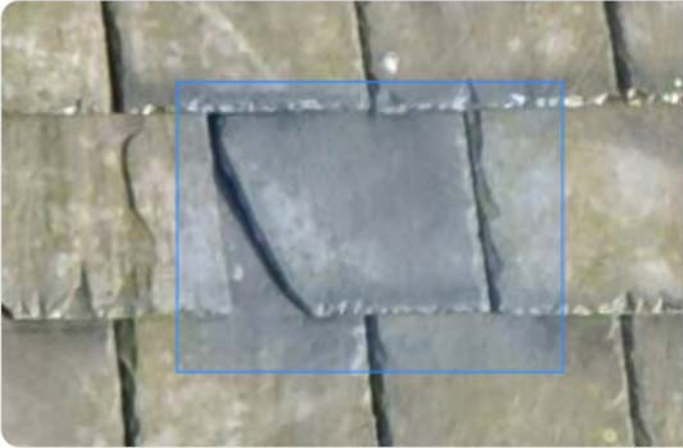
Broken slate

Severity: 3

Broken Slate

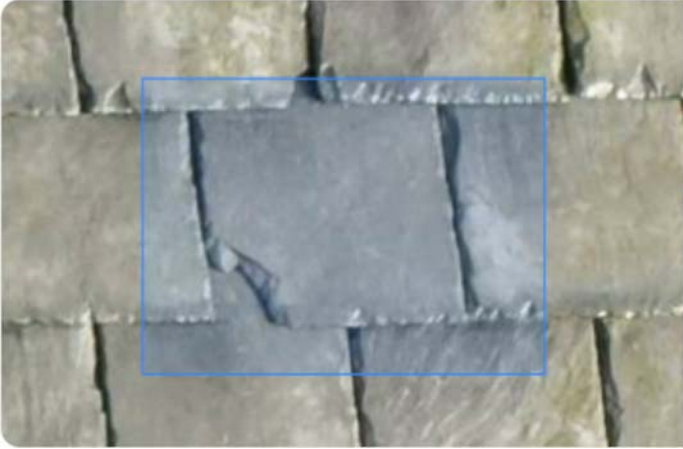
Broken slate

Description: corner only

Severity: 2

Broken Slate

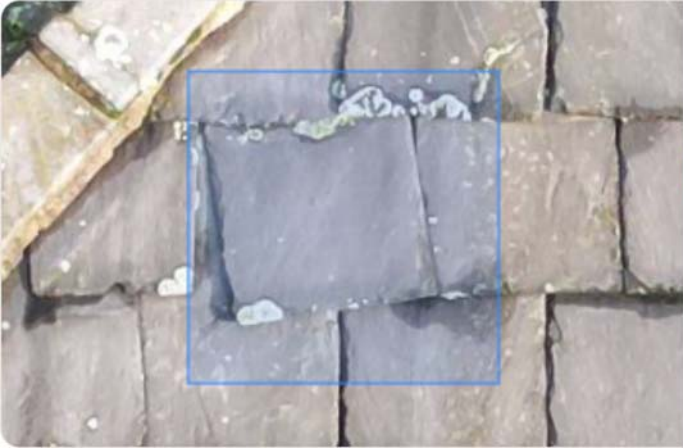
Broken slate

Severity: 3

Broken Slate

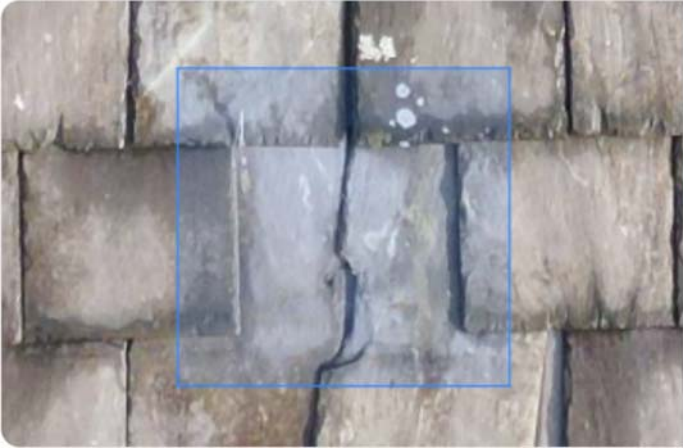
Slipped slate

Severity: 3

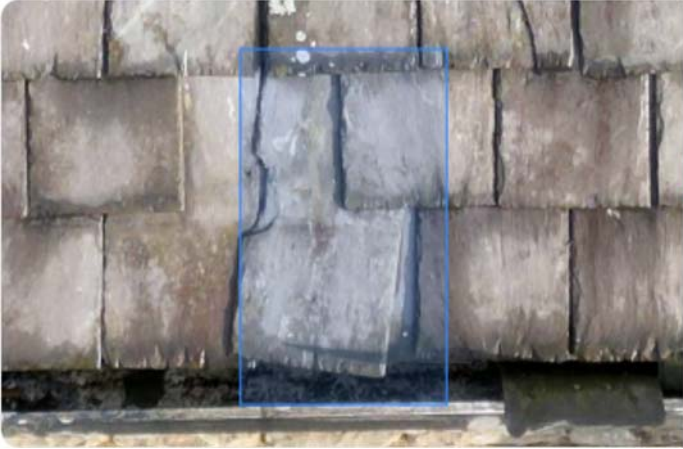
Slipped slate

Severity: 3

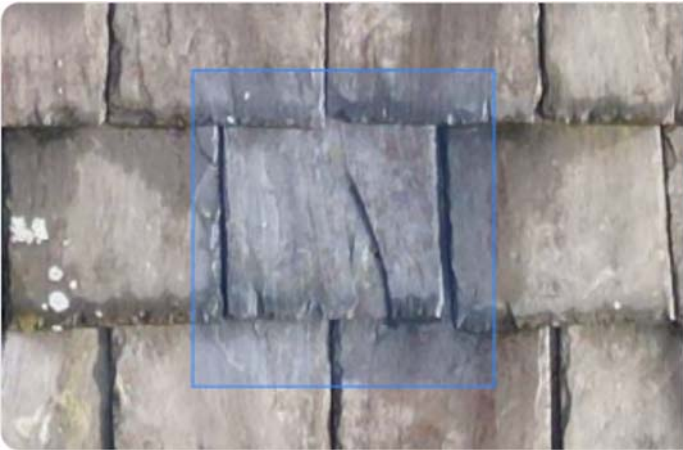
Broken slate

Severity: 3

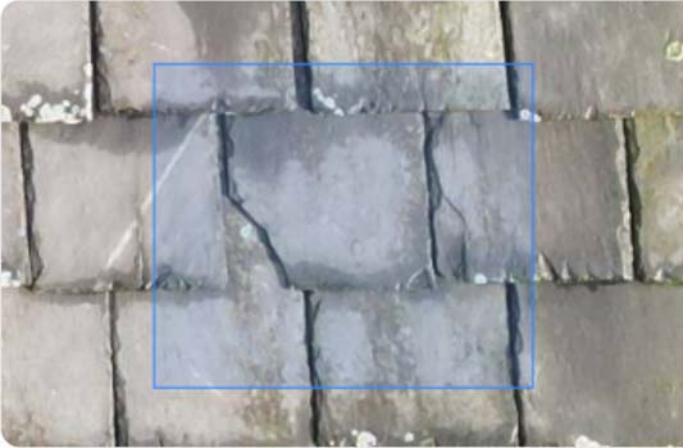
Broken slate

Severity: 3

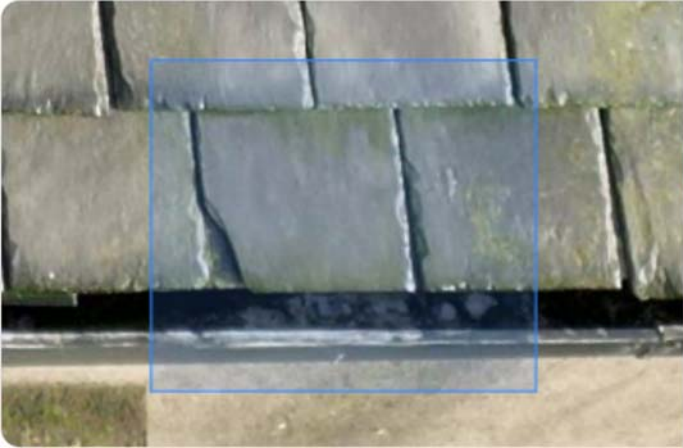
Broken slate

Description: corner only

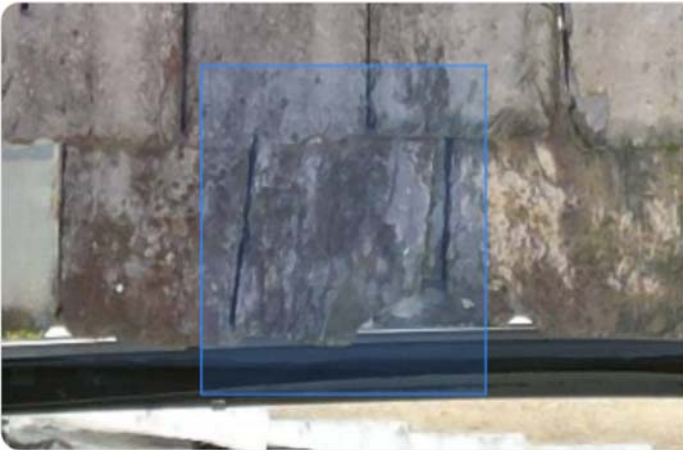
Broken slate

Severity: 3

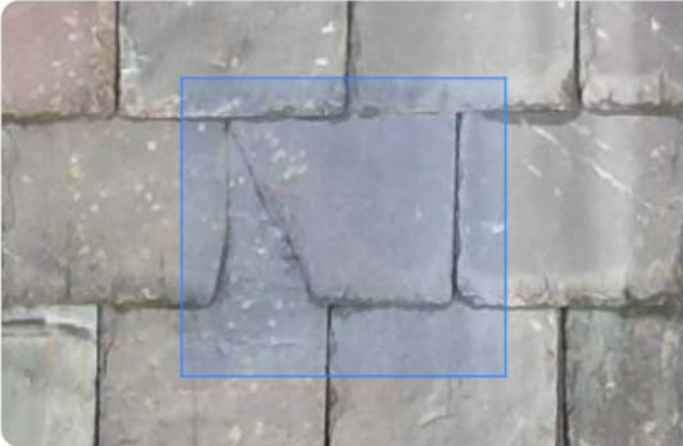
Broken slate

Severity: 3

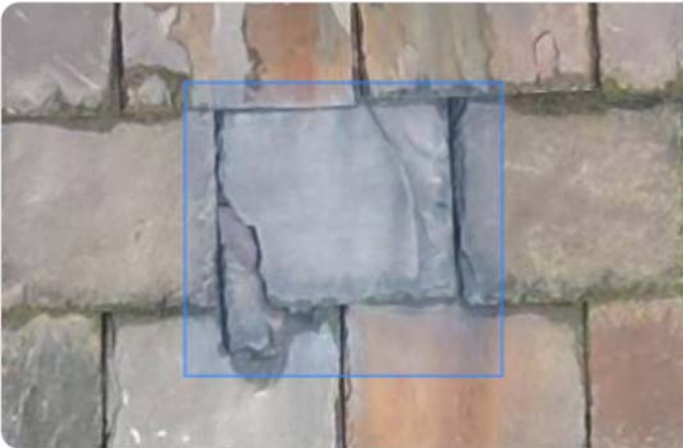
Broken slate

Severity: 3

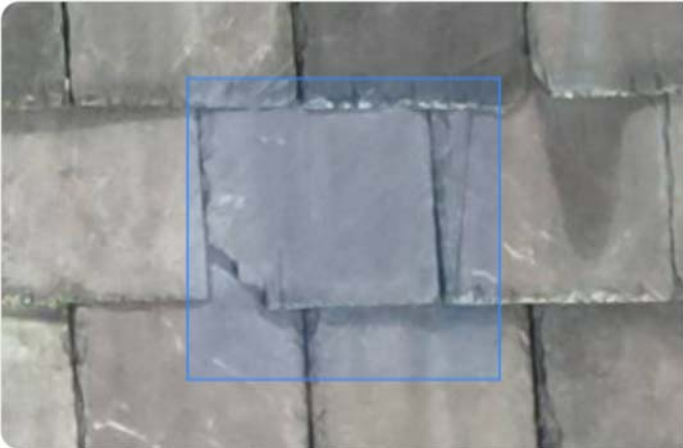
Broken slate

Description: corner only

Severity: 2

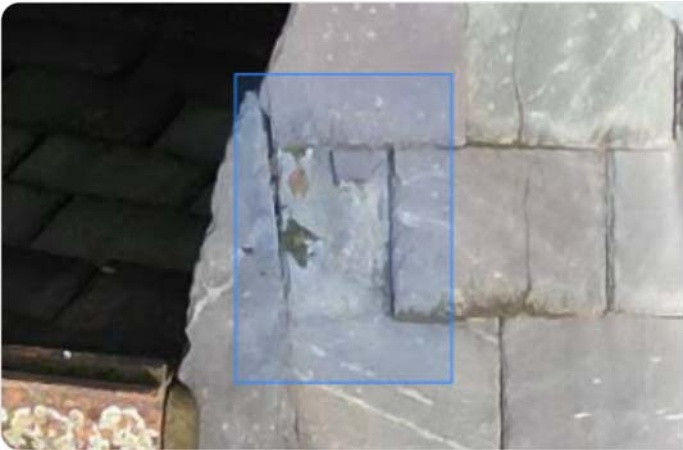
Broken slate

Severity: 3

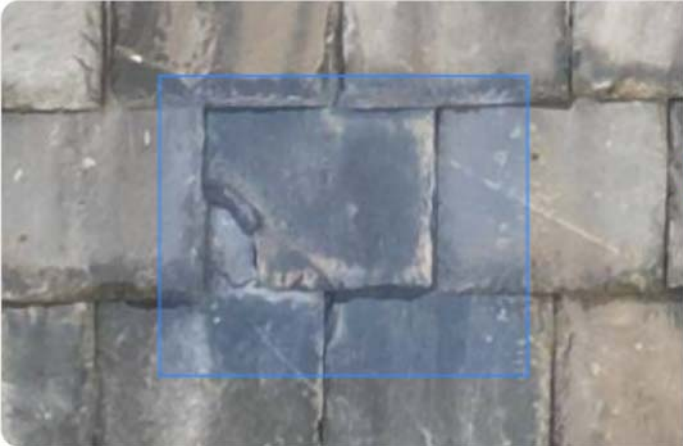
Broken slate

Severity: 3

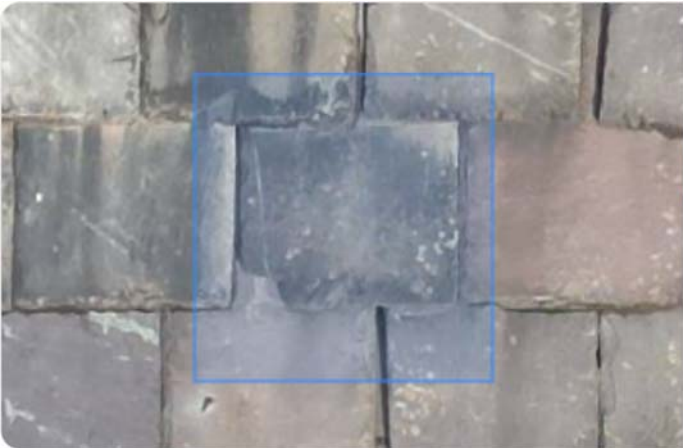
Broken slate

Description: corner only

Severity: 2

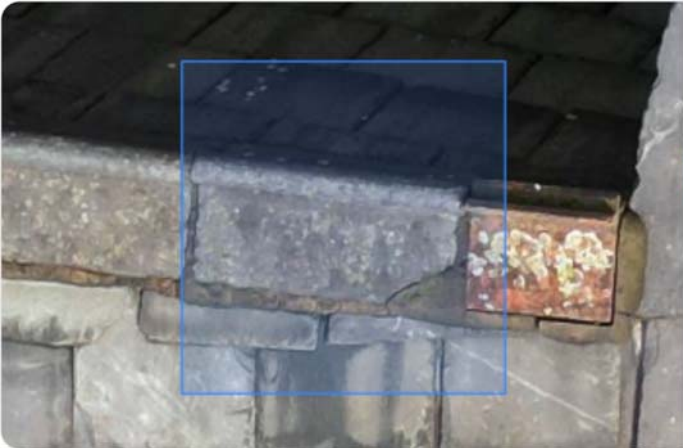
Defective ridge tile

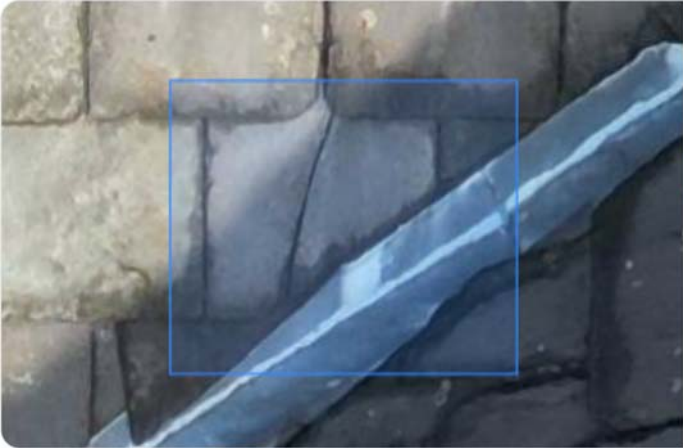
Broken slate

Severity: 3

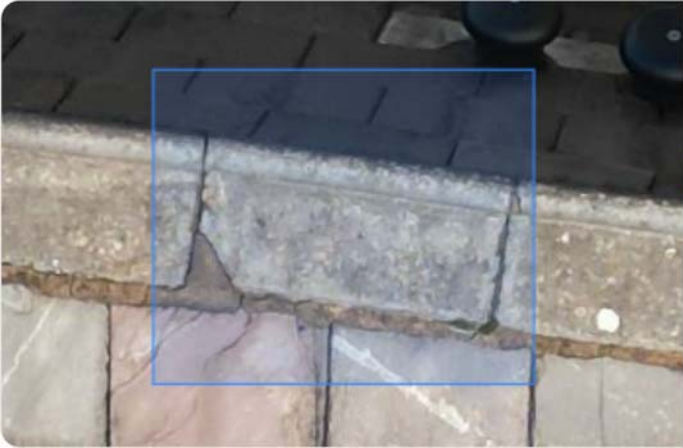
Defective ridge tile

Severity: 3

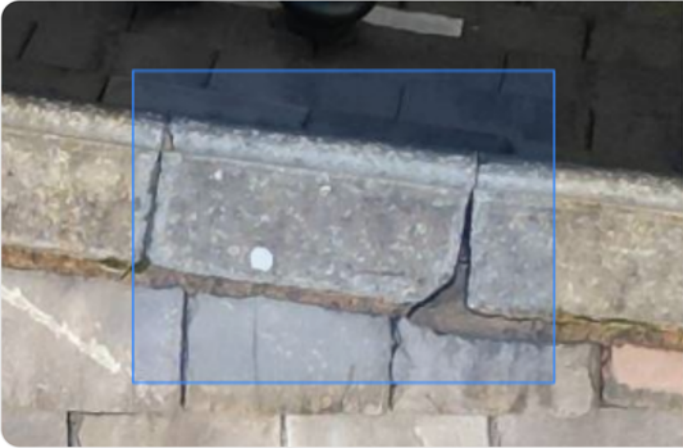
Defective ridge tile

Severity: 3

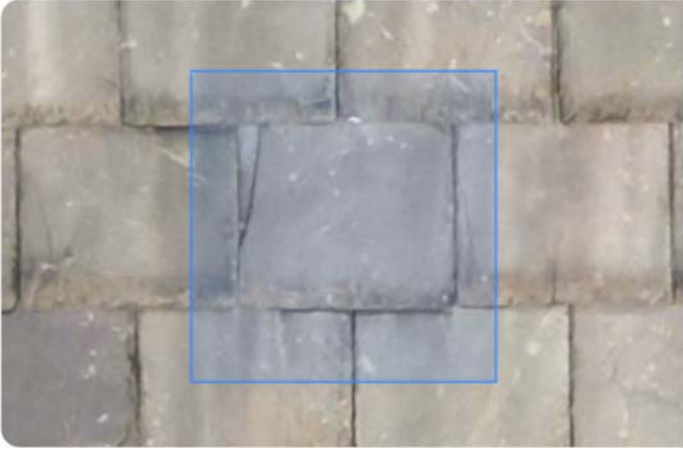
Broken slate

Severity: 3

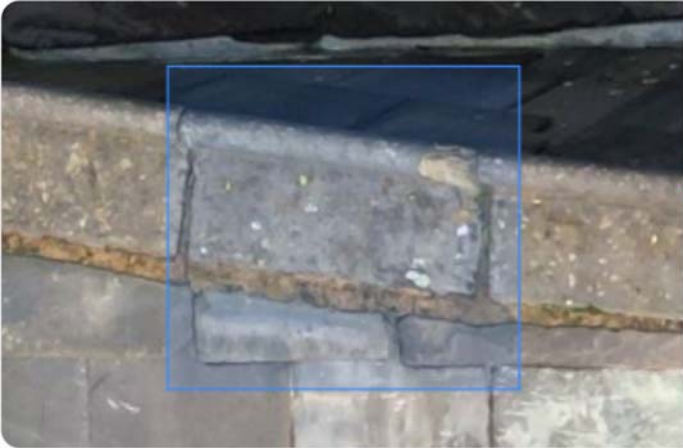
Defective ridge tile

Severity: 3

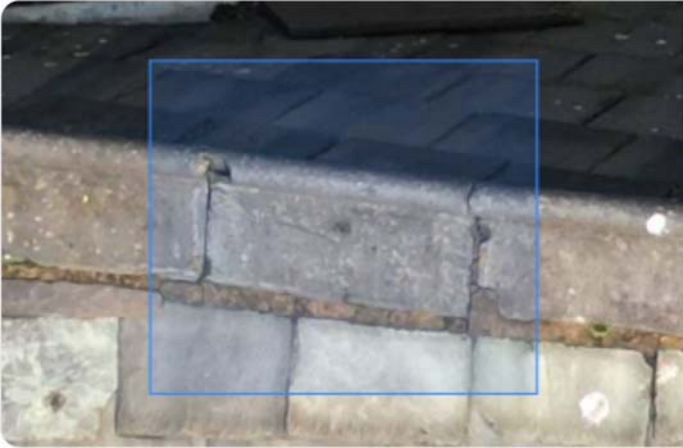
Defective ridge tile

Severity: 3

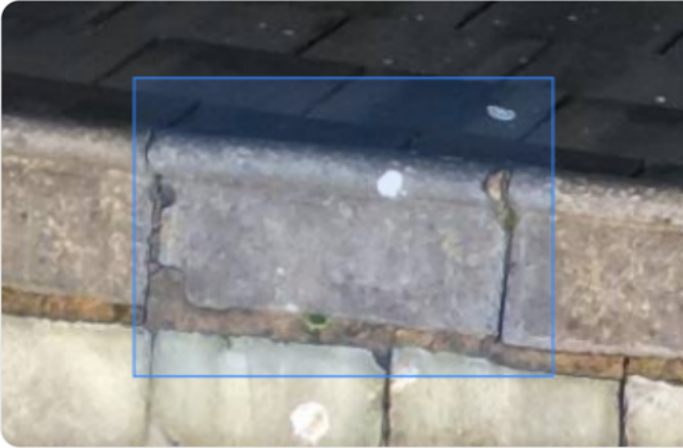
Defective ridge tile

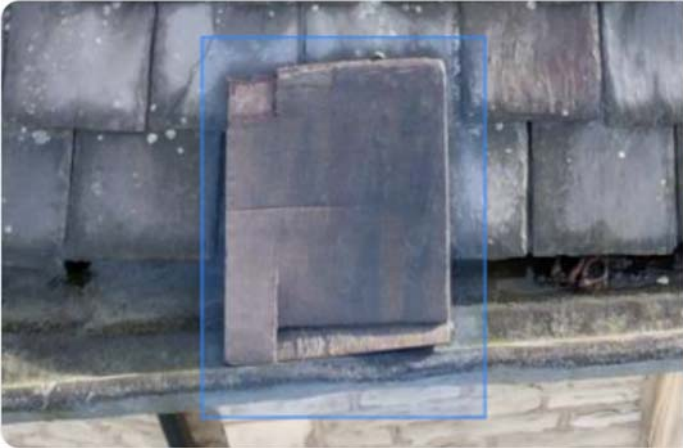
Loose debris

Description: Health & Safety - risk to public

Severity: 5

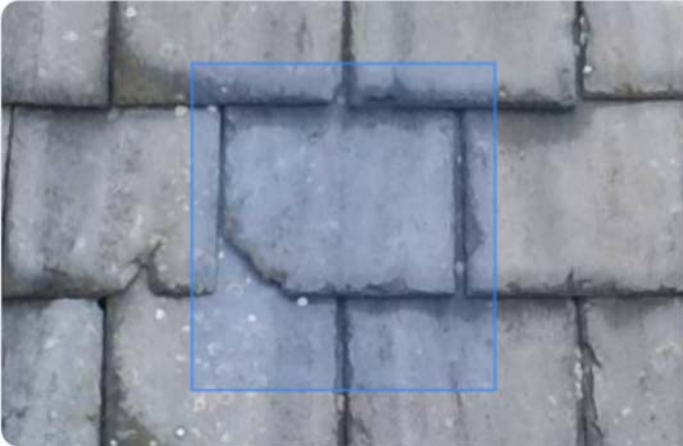
Broken slate

Description: corner only

Severity: 2

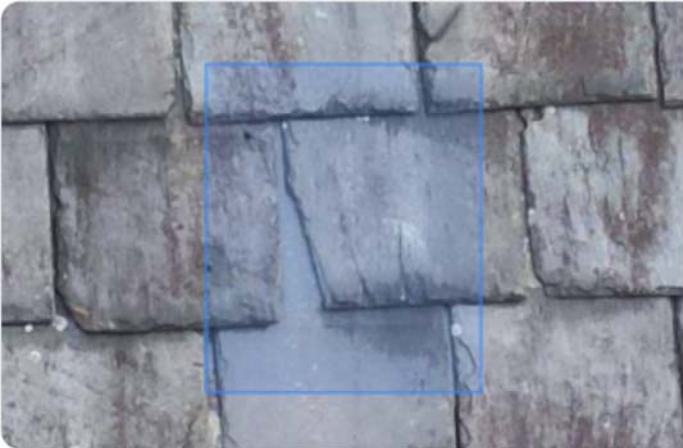
Broken slate

Severity: 3

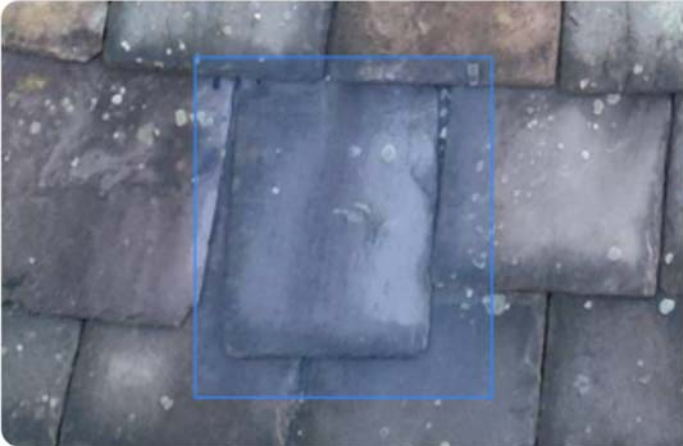
Slipped slate
