**CONDITION REPORT**

**OSWALDTWISTLE CIVIC THEATRE**

**26<sup>th</sup> JANUARY 2024**

**Job Reference Number: BS 1250**

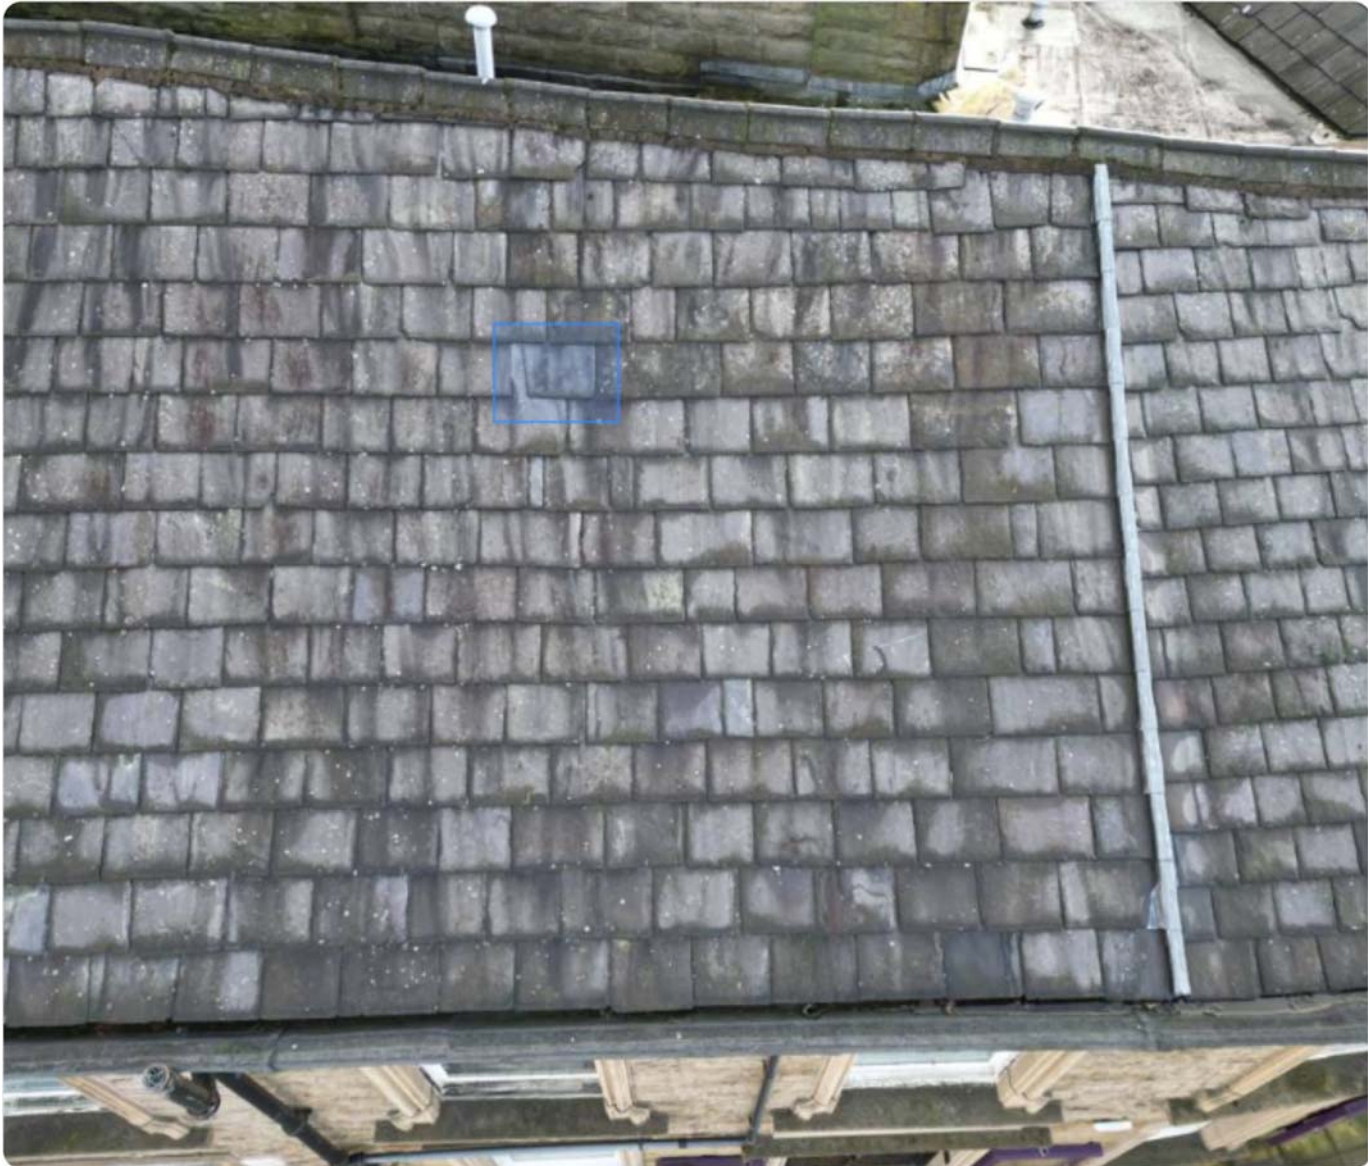
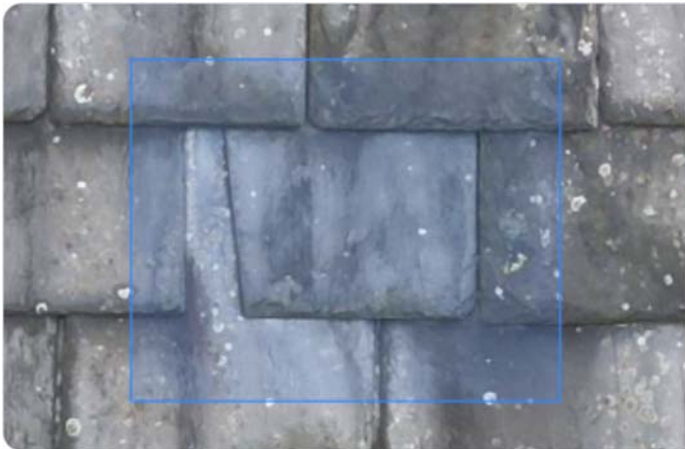
53.7453075°, -2.3940263°

Broken slate

Broken Slate

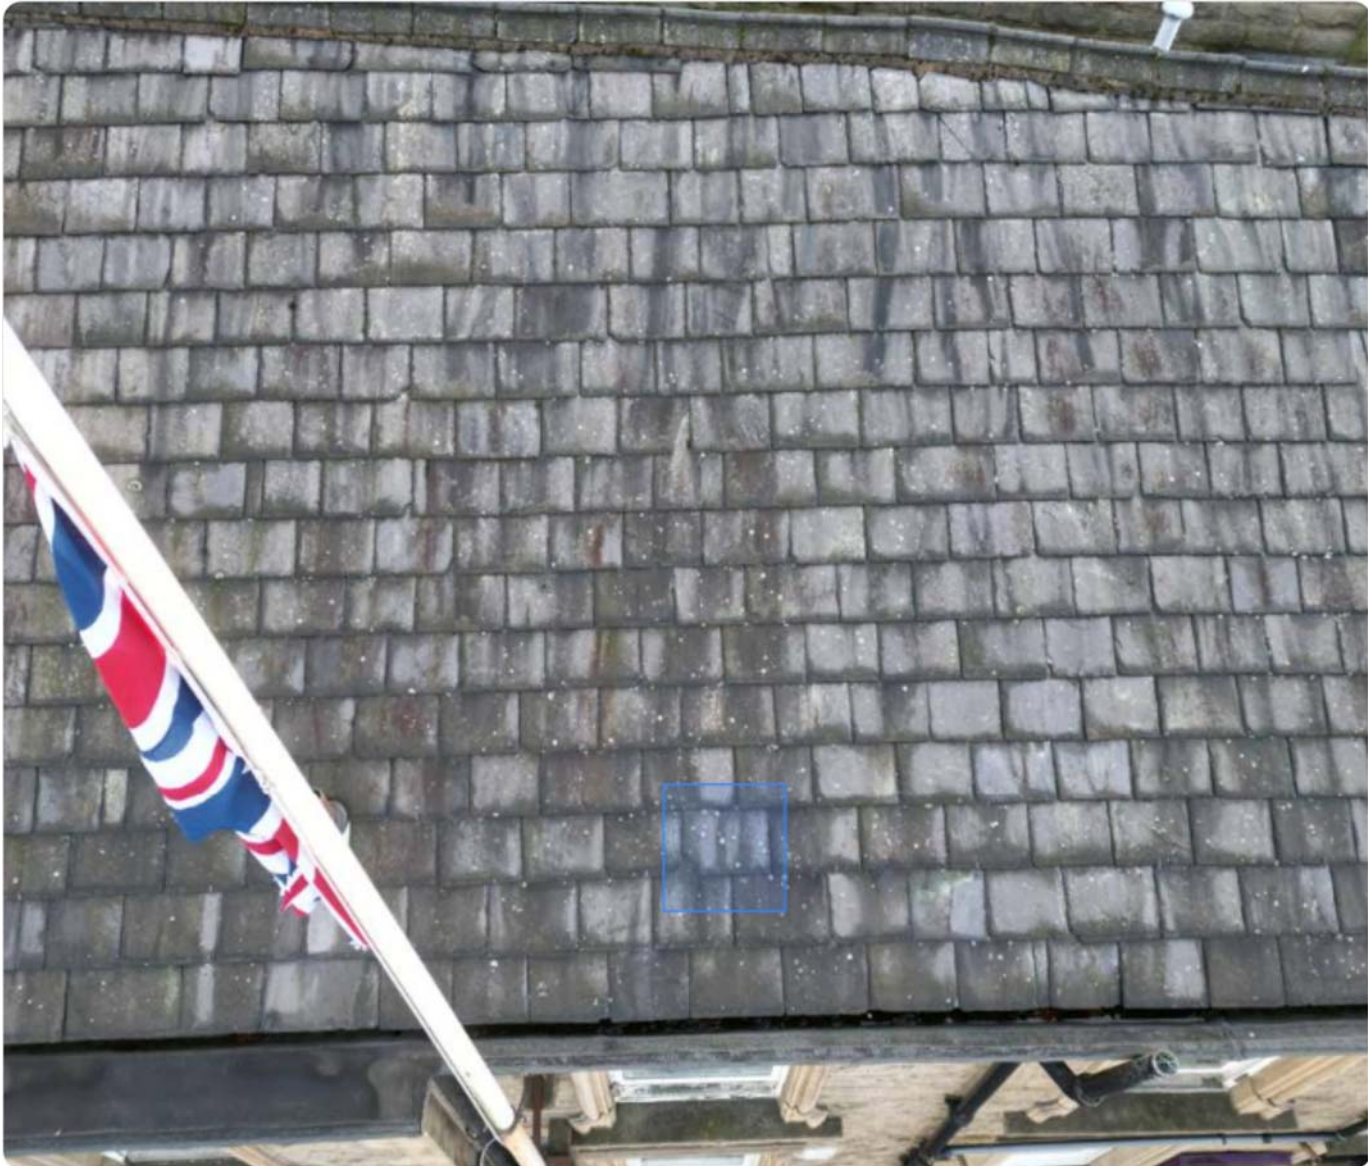
53.7453379°, -2.3939819°

### Broken slate

Description: corner only

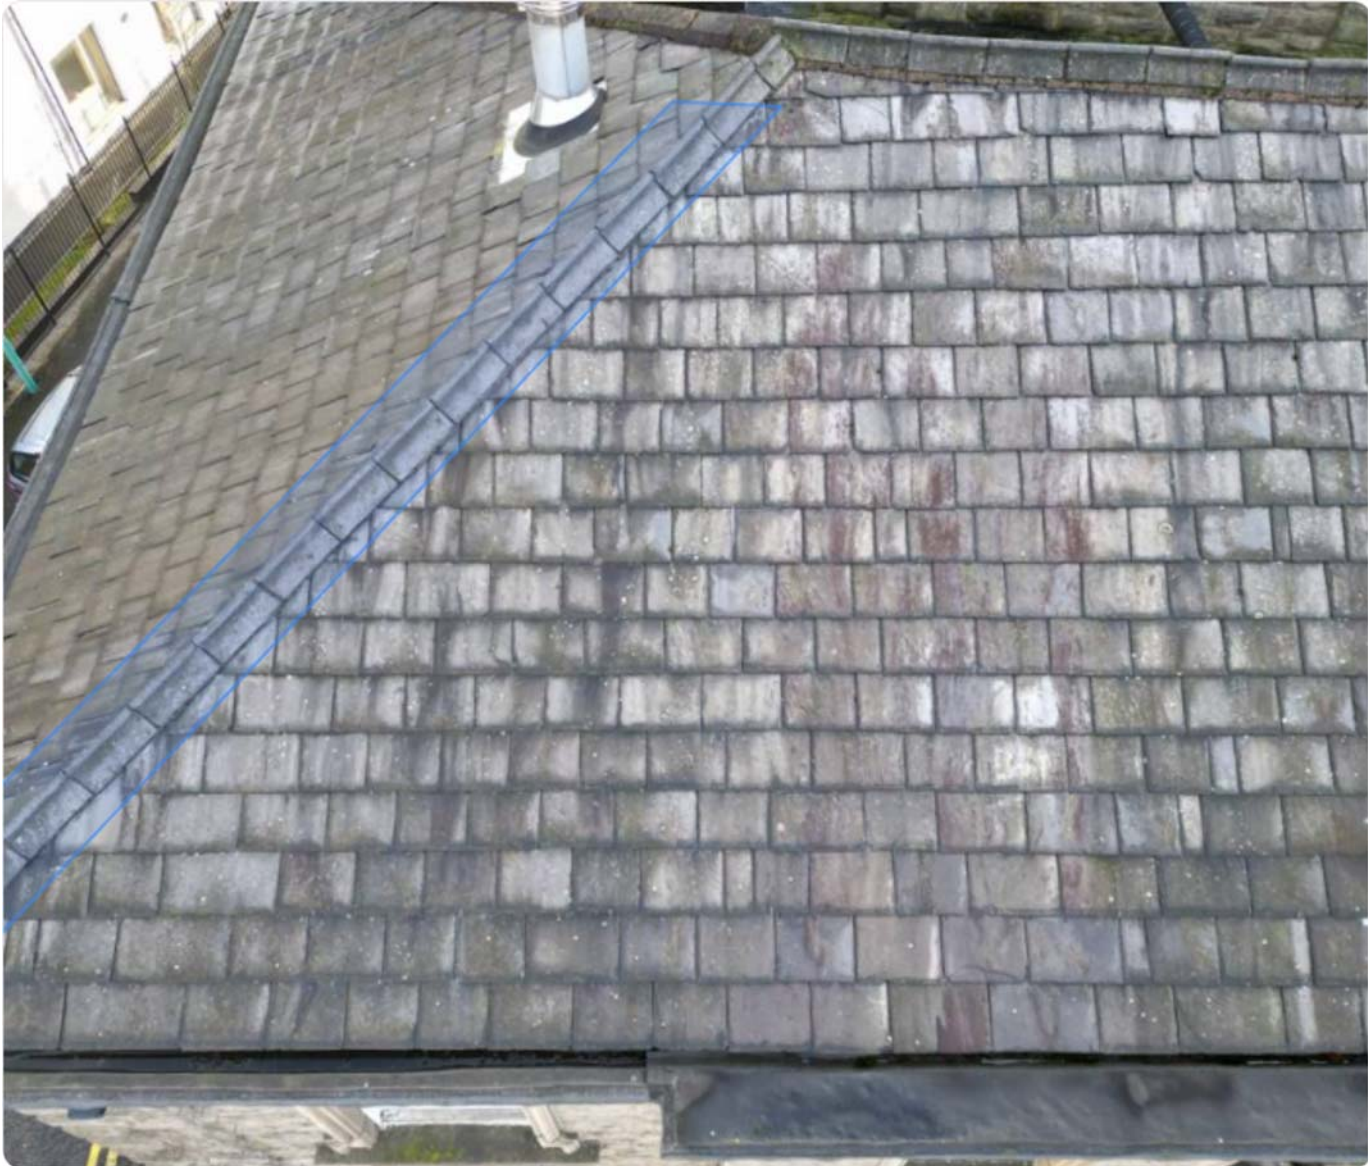
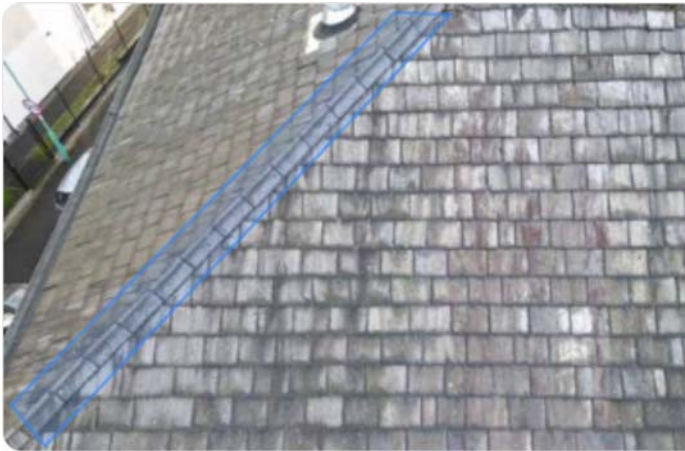
53.7453699°, -2.3939293°

### Eroded pointing to hip tiles

Cement / Mortar Defect

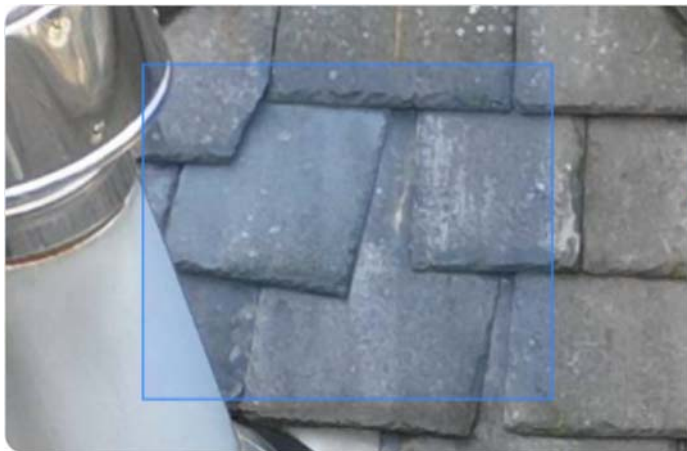
Slipped slate

Severity: 3

Loose Slate

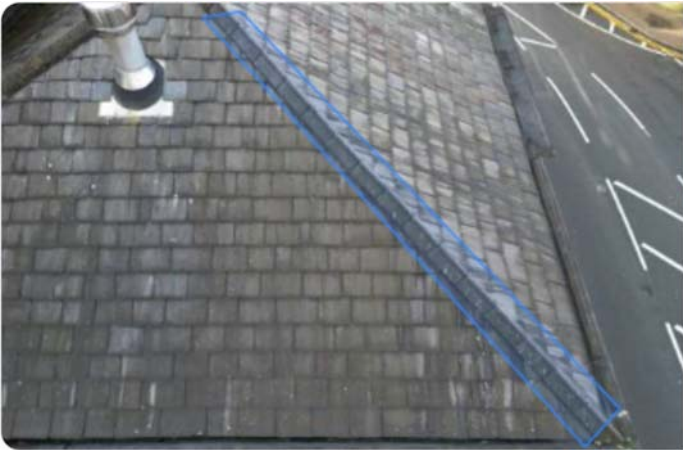
# Eroded pointing to hip tiles

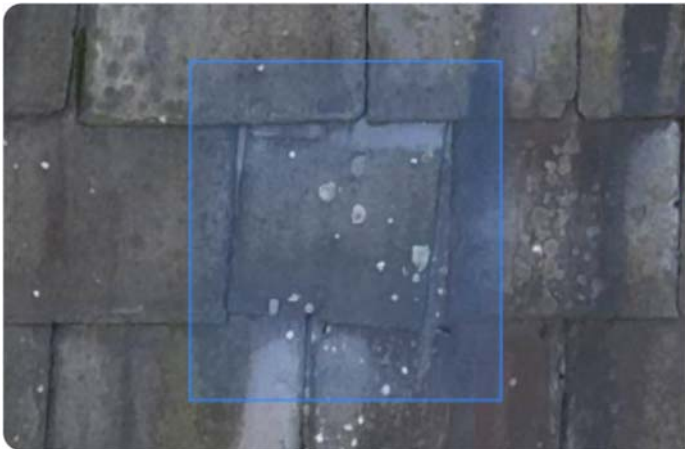
53.7453556°, -2.3937569°

Slipped slate

Severity: 3

Loose Slate

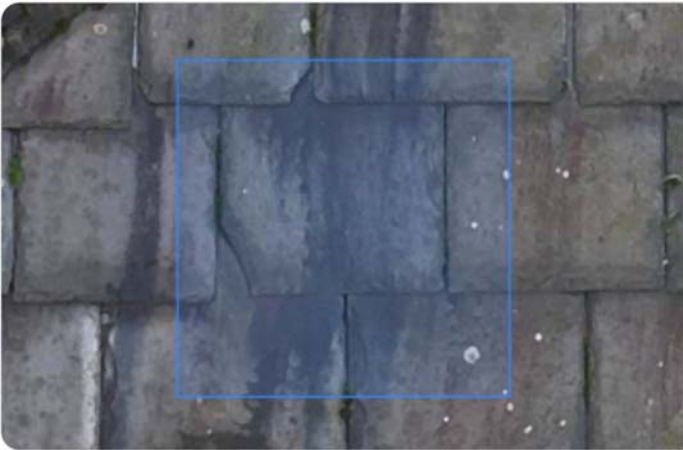
# Broken slate

Description: corner only

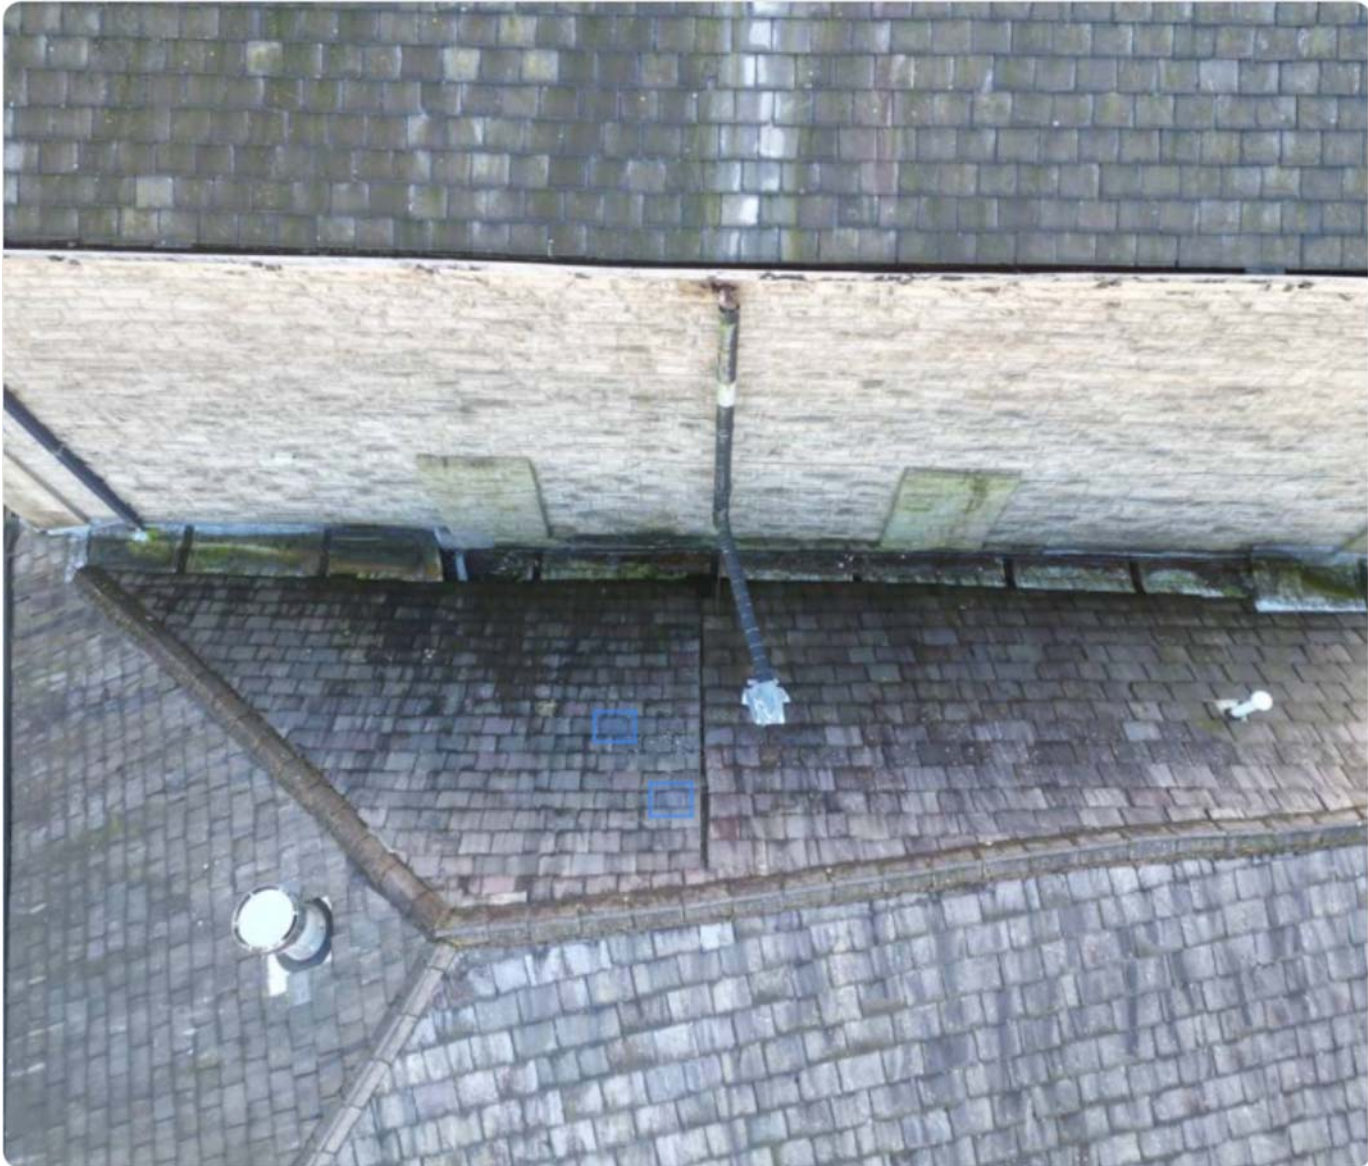
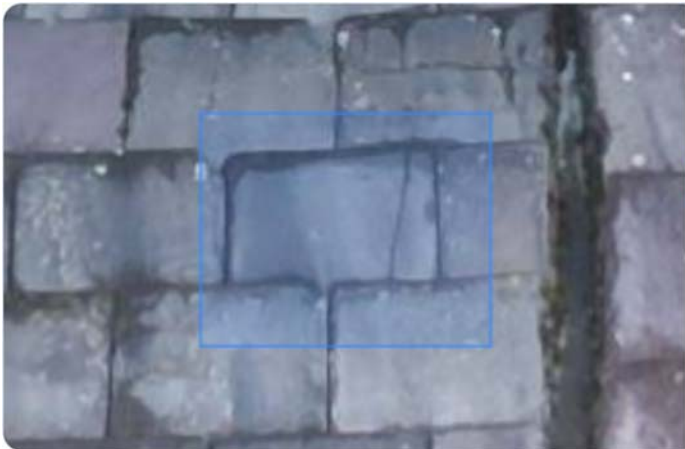
53.7453200°, -2.3938935°

Broken slate

Severity: 3

Broken Slate

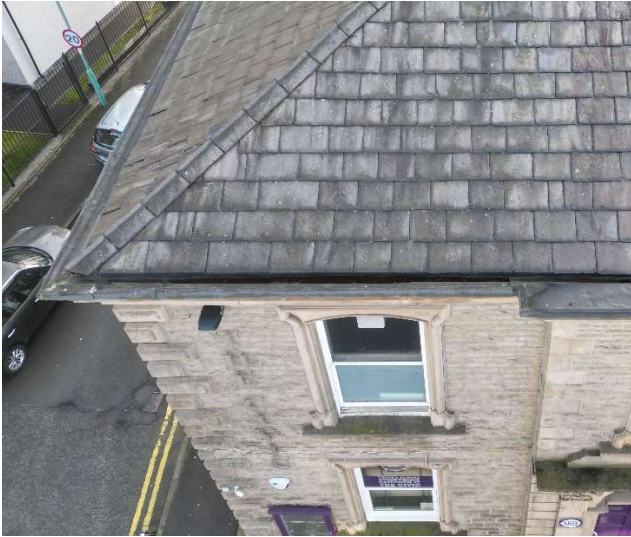
At the front the property is believed to comprise of stone trough gutters formed within the top cornice of the stone external walls which would originally have been lined with leadwork. The stonework has been lined with bitumen roofing felt which appears to be performing adequately **[Photo 1]** although we did note that the down stand to the face of the wall is not fully adhered and lifting up in places. At the right-hand end there appears to be some remnants of a cast iron gutter which can be seen where the roofing felt is lifted up. The cast iron appeared heavily corroded **[Photo 2]**.

Photo 1 – Bitumen felt lining to gutters

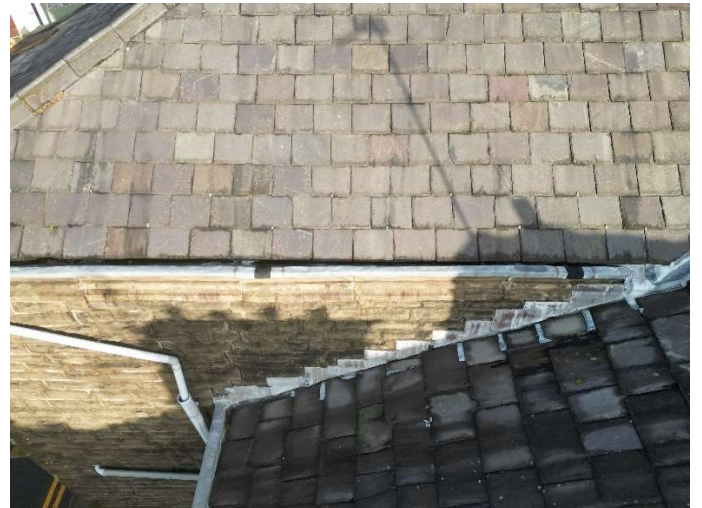
At the front of the adjoining dwelling to the right-hand elevation the stone trough is lined with leadwork which appears to be in satisfactory condition although we did not that the joints to the leadwork have been sealed with strips of bitumen **[Photo 4]**. The gutter falls in both directions discharging onto the adjoining dwelling roof at the rear and into a uPVC hopper at the front. The downpipe is then connected into a uPVC soil vent pipe which is not good practice. The uPVC then connects to an old painted cast iron downpipe which also serves the adjoining dwelling.

Photo 4 – Leadwork lining to gutter

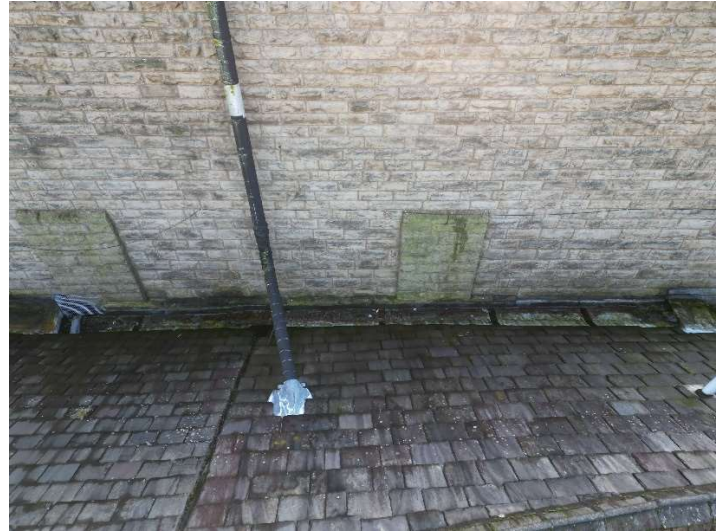
Photo 8 – Rainwater pipe penetrates roof to front block

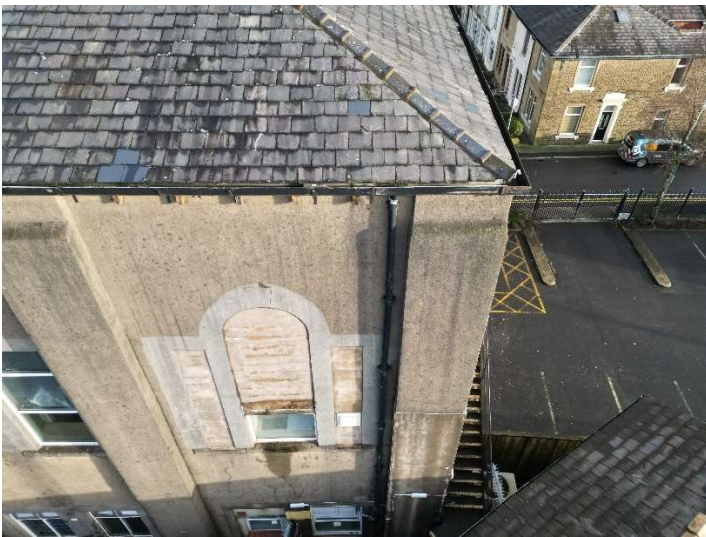
At the right side the majority of the gutter looks to be painted aluminium other than a length at either end where the original painted cast iron remains **[Photo 9]**. The gutter is supported by projecting stone corbels. There is evidence of water leaking from the joints to the gutters on this side in a couple of locations, but the majority of the guttering appears serviceable although of some age.

Photo 9 – Painted aluminium gutter

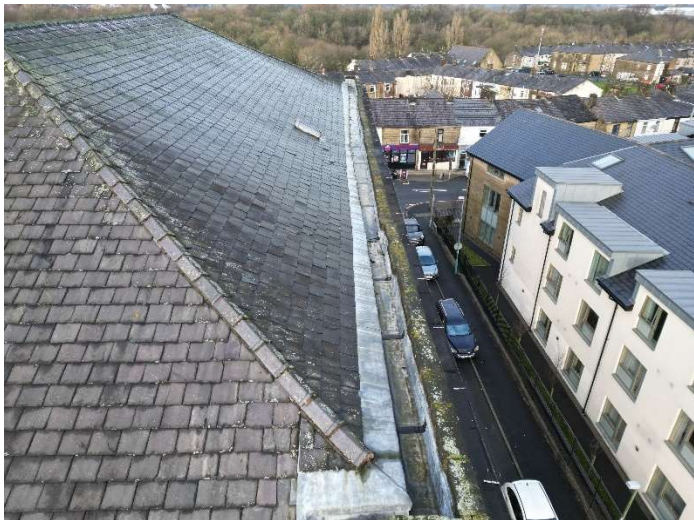
The main frontage has lead lined gutters at the top of the external wall behind a stone parapet **[Photo 13]**. The lead to the gutter has an upstand with a cover flashing on either side. One side is taken up under the lowest course of slates and the other dressed into a chase in the parapet wall. The leadwork falls from the middle to either end to downpipes on the front and rear elevations with water being discharged via leadwork spitters into hoppers **[Photos 14-15]**. No obvious defects were noted to the leadwork which appears to be well detailed although of some age. As per the other lead lined gutters the joints to the individual lengths of lead have been sealed with bitumen strips **[Photo 16]**.

Photo 13 – Lead lined gutter behind parapet wall

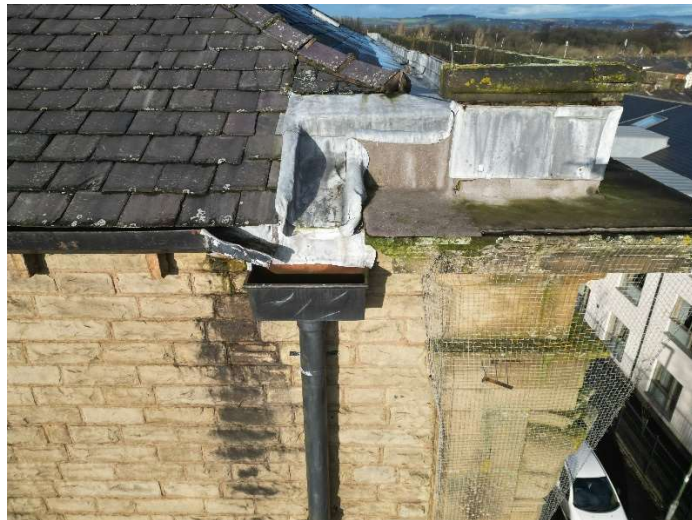
Photo 14 – Lead spitter to hopper

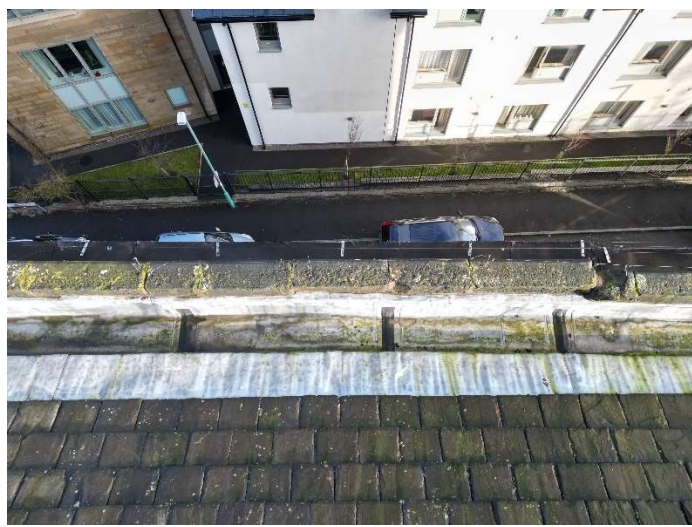
Photo 16 – Joints to leadwork sealed with bitumen strips

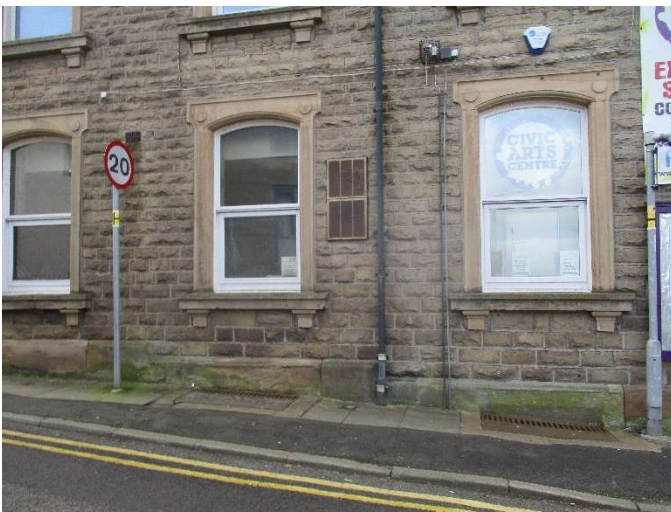
The sandstone used for the detailing is weathered and in some places in poor condition and will require repair/consolidation. The sandstone plinth is damp and weathered in places at low level where it is exposed to the most moisture and salt spray from road traffic [Photo 21]. The stone at high level to the cornice is discoloured and the gutters may have leaked previously before the bitumen felt lining was added [Photo 22]. The dressed stone surround to the entrance door at the right-hand side which leads to the front staircase is in poor condition [Photo 23-26]. At this point the full height of the wall appears to be damp as is apparent from the discolouration and weathering to the stone quoins [Photo 27]. This may be related to a defect with the gutters / hopper outlet directly above. Defects were noted to the decorative stone mullion to the right-hand window which will require repair [Photo 28]. Isolated repairs were noted to the stone at low level around the main entrance door where new sections of stone have been pieced in.

Photo 21 – Damp and weathered stone plinth

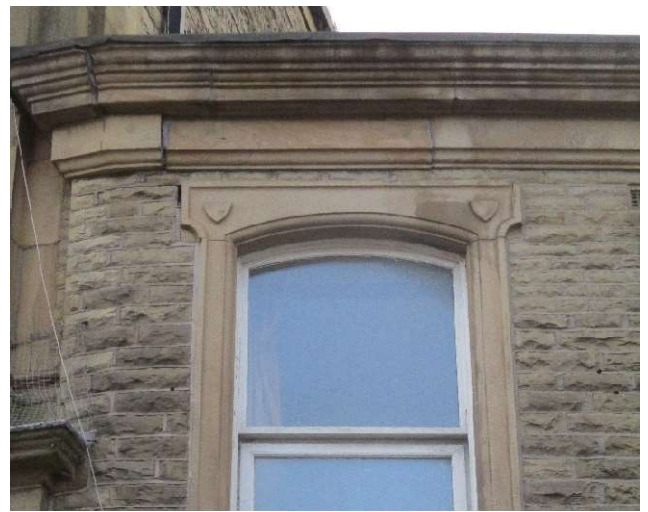
Photo 22 – Dampness to stone cornice

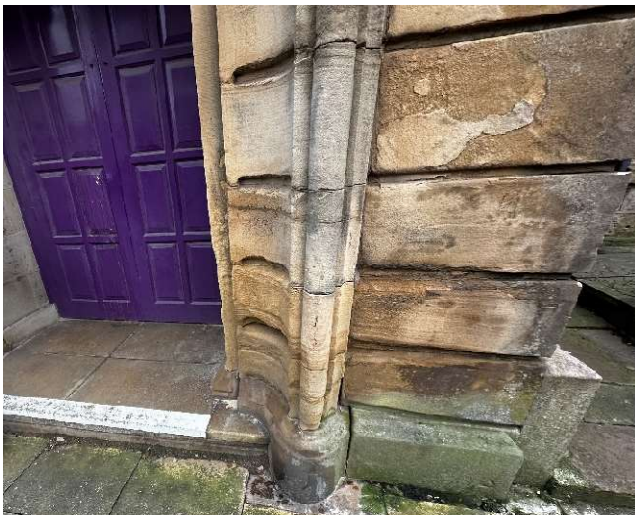
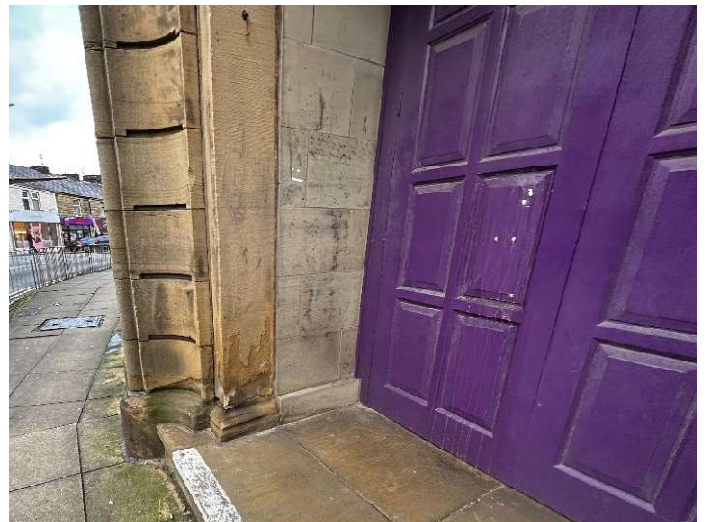
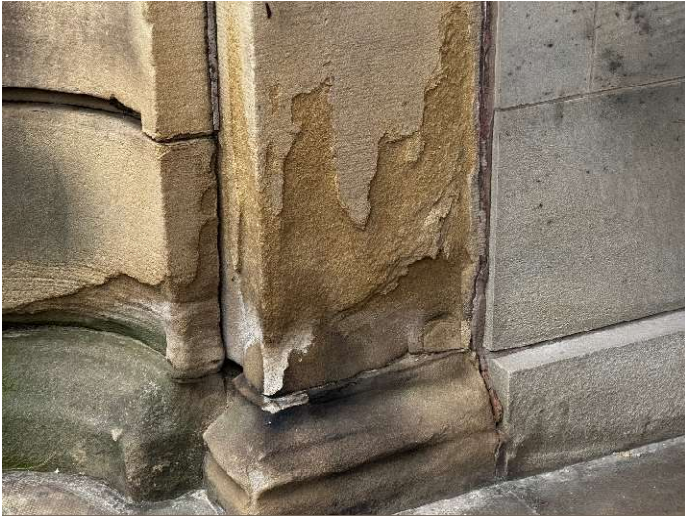
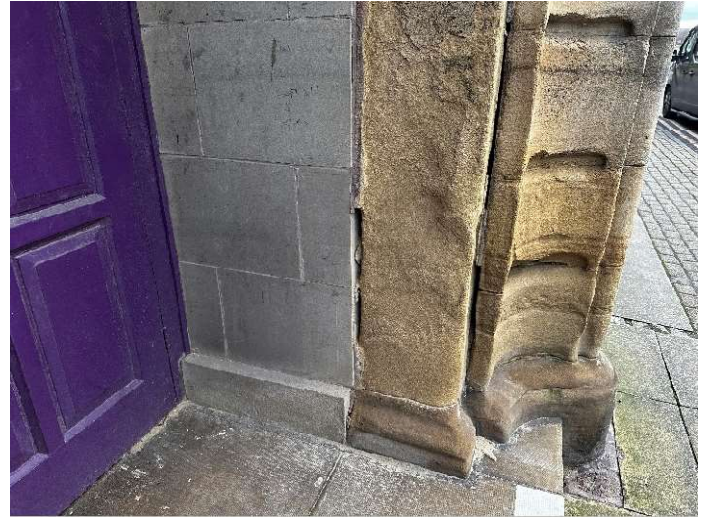
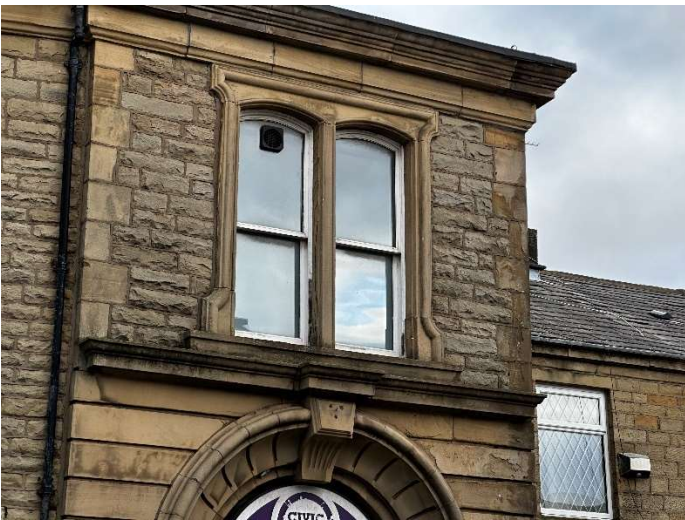
Photo 23 – Weathered dressed stone

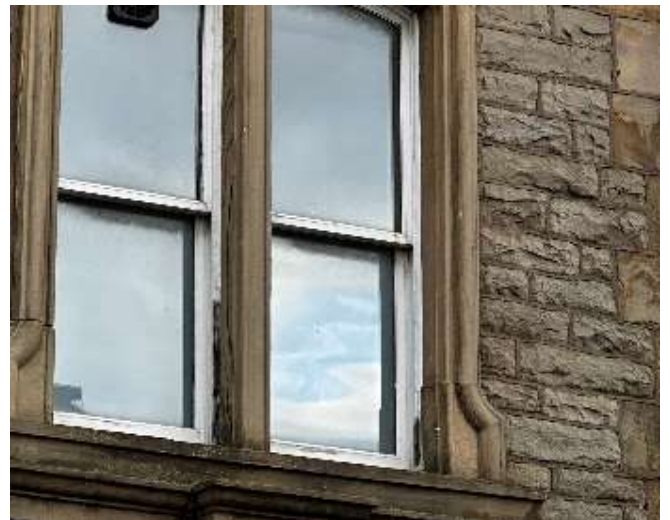
Photo 28 – Weathered stone mullion

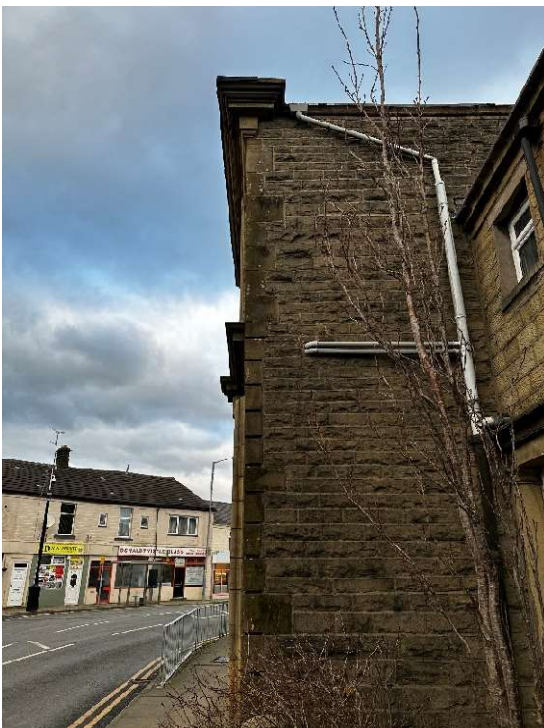
We noted that the front elevation appears to be leaning outwards slightly from vertical when viewed from this side **[Photo 29]**. A vertical crack is visible where a gap has opened up between the stone quoins and the coursed stonework to the top half of the wall **[Photo 30]**. We would advise that the cracking be monitored to determine if it is progressive.

Photo 29 – Front elevation not perfectly plumb to the eye

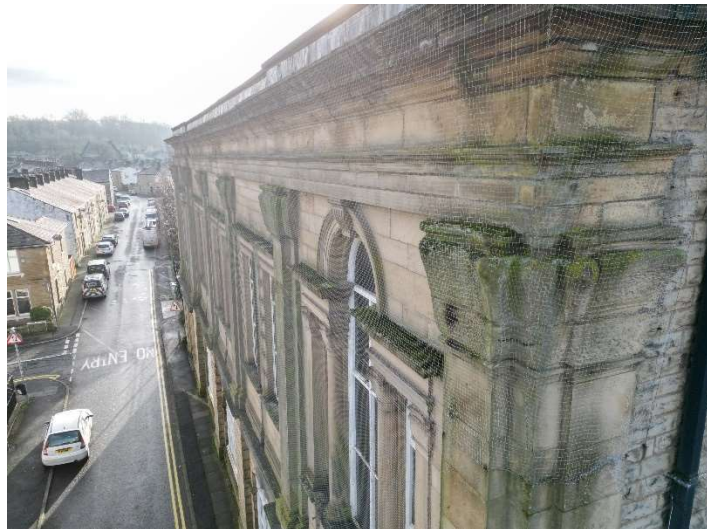
Photo 38 – Dampness and weathering to stone at high level

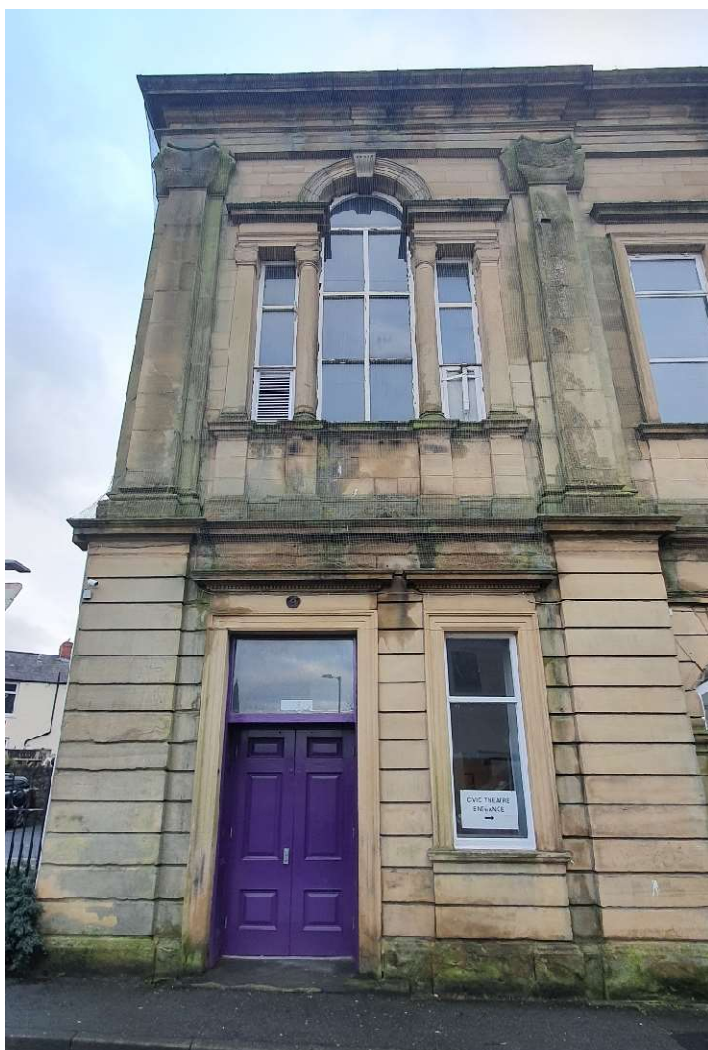
Photo 39 - Dampness and weathering to stone

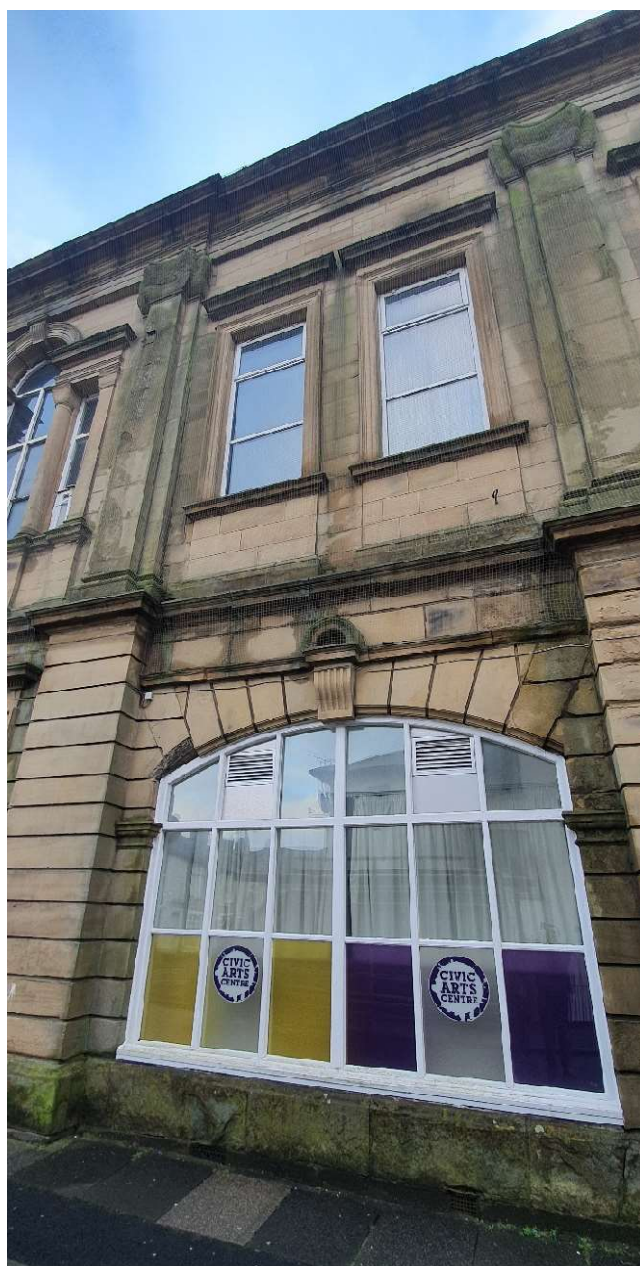
Photo 40 - Dampness and weathering to stone

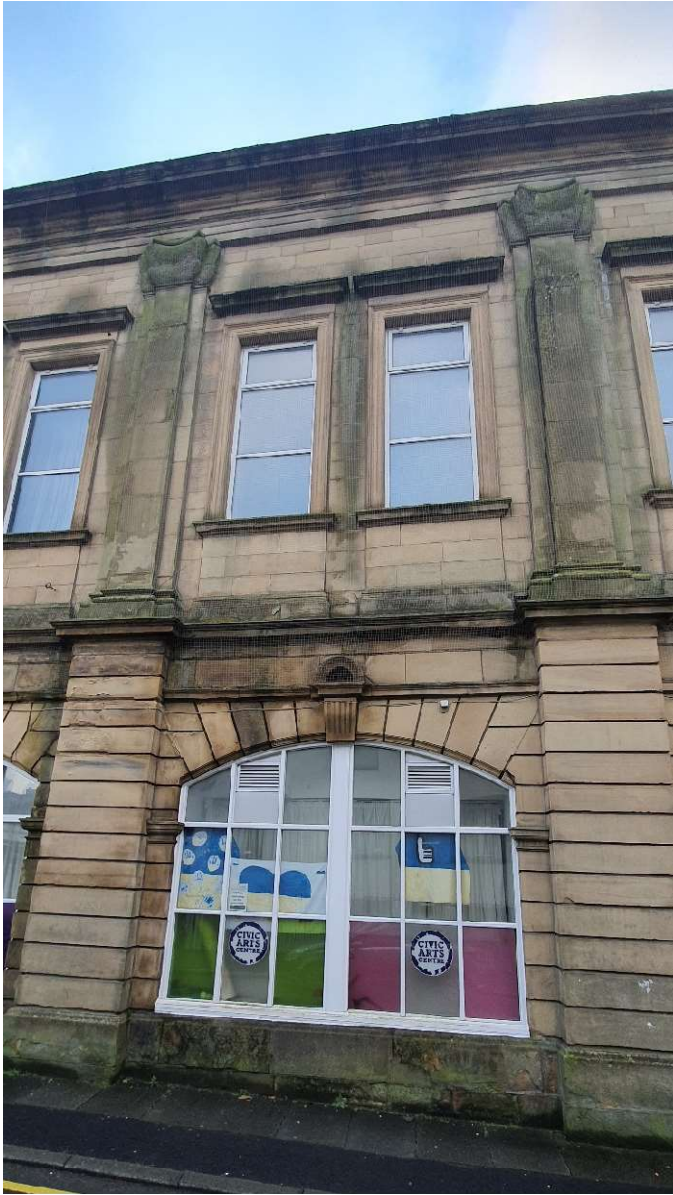
Photo 41 - Dampness and weathering to stone

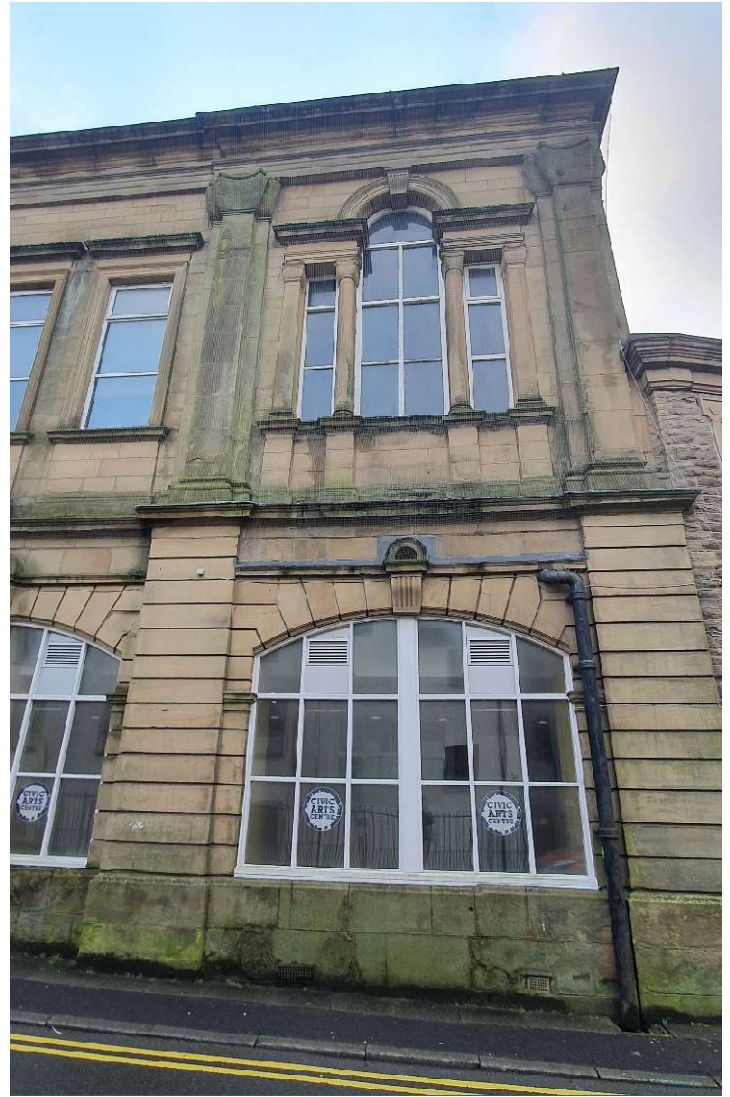
Photo 42 - Dampness and weathering to stone

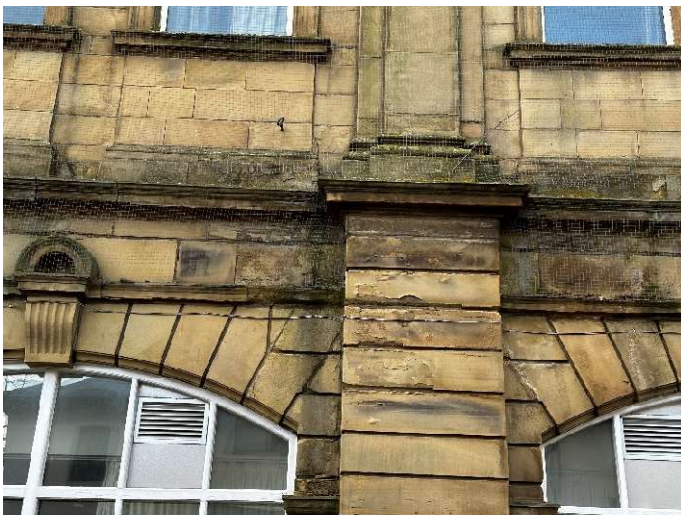
Photo 43 – Dampness and weathering to stone

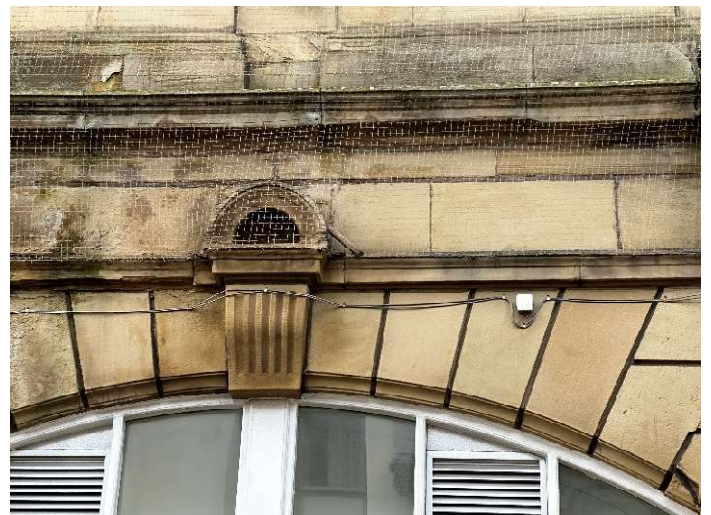
Photo 44 - Dampness and weathering to stone

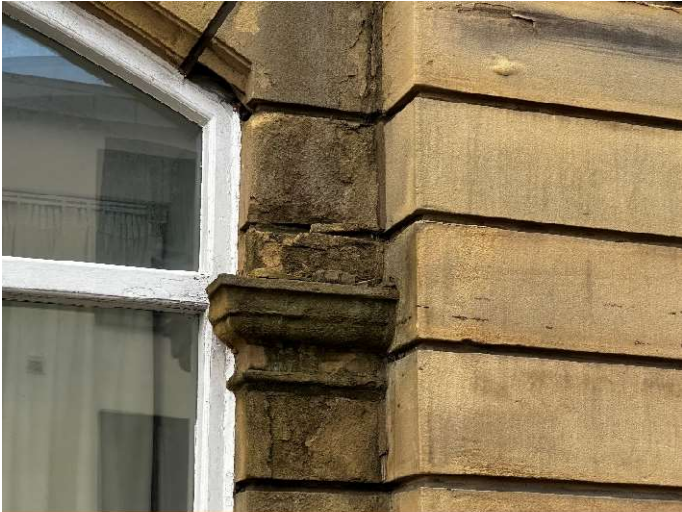
Photo 45 - Dampness and weathering to stone

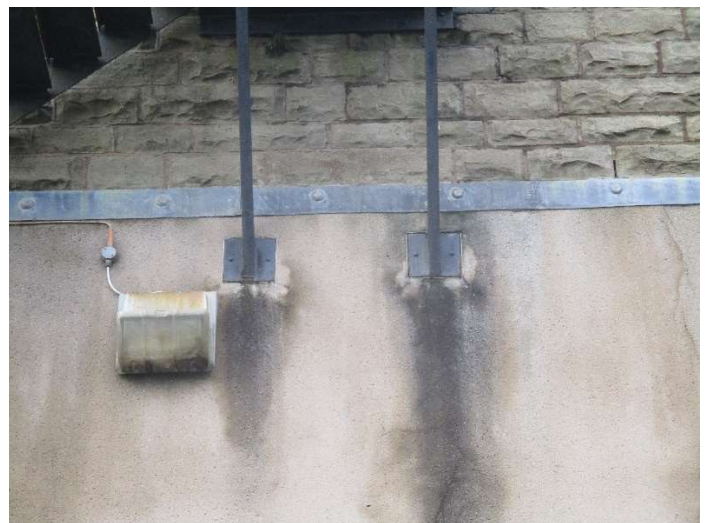
Photo 50 – Staircase fixings causing render to become damp

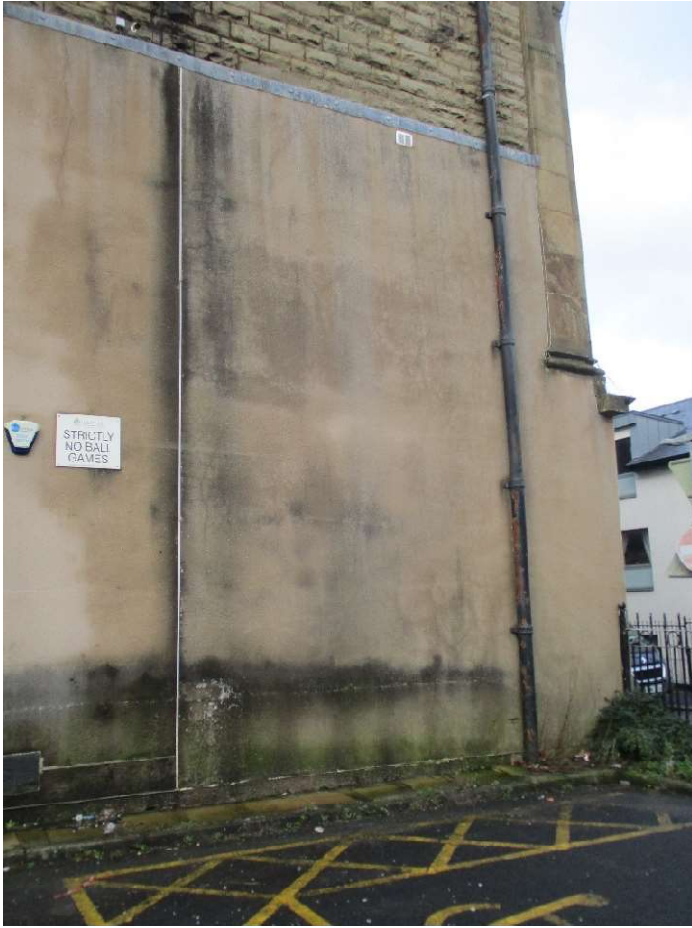
Photo 51 – Dampness to render

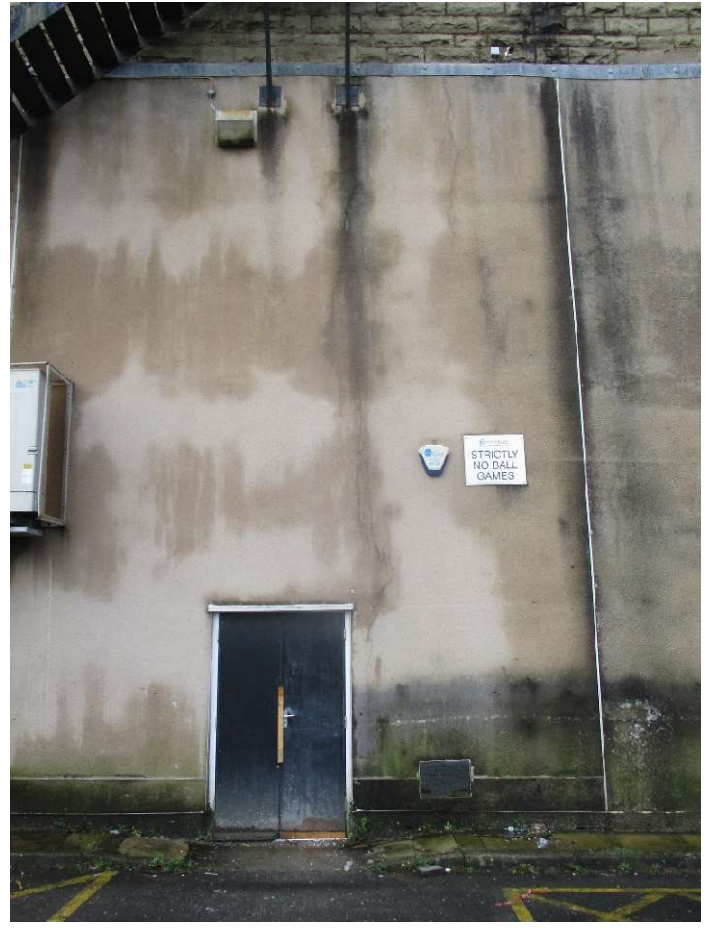
Photo 52 - Dampness to render

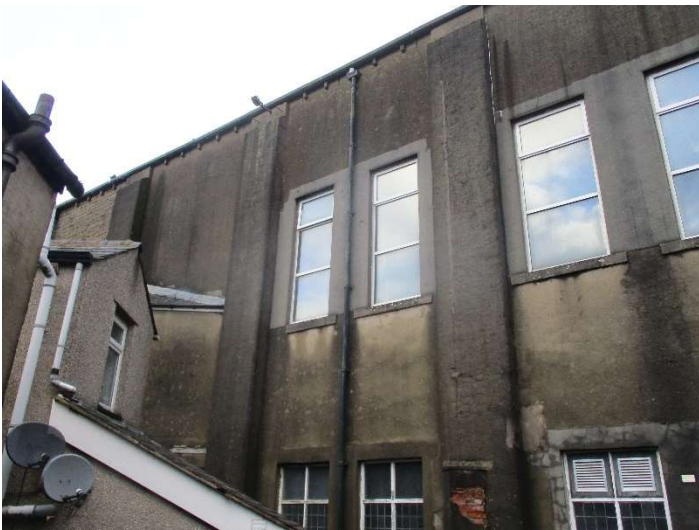
Photo 57 – Render appears damp

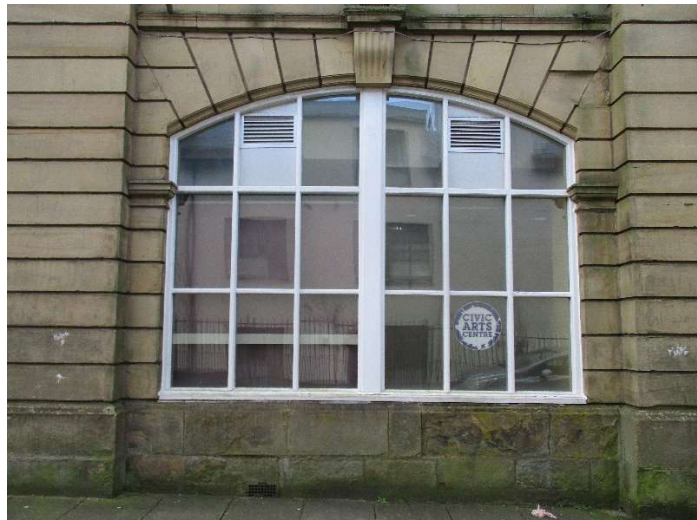
At ground floor level to the main frontage the building has large, fixed pane single glazed painted timber windows which were generally in fair condition although we found some spots of wet rot timber decay in the corners and to the sills. The paintwork to the windows is in poor condition and therefore the windows require full redecoration together with isolated repairs to the rotten timber **[Photo 62]**.

Photo 62 – Painted timber ground floor windows to main frontage
