**CONDITION REPORT**

**OSWALDTWISTLE CIVIC THEATRE**

**26<sup>th</sup> JANUARY 2024**

**Job Reference Number: BS 1250**

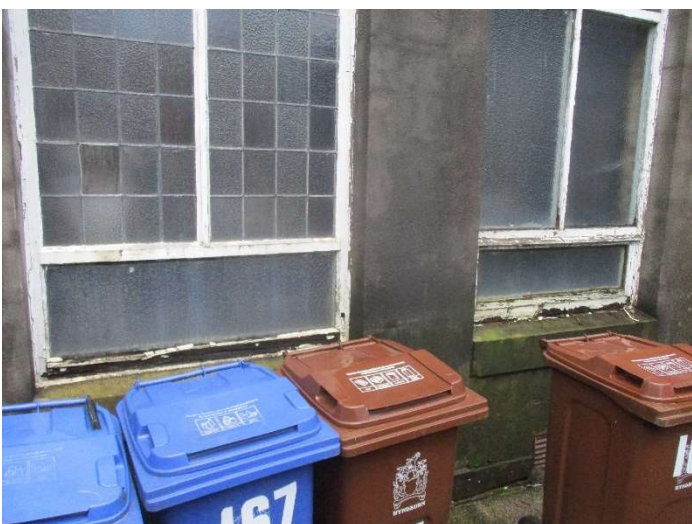
To the right-side elevation, the windows are painted timber single glazed units and in poor condition being beyond repair **[Photo 63]**. Internally the openings are blocked up. Some of the original window openings have already been blocked up to the first floor.

Photo 63 – Rotten windows to right side elevation

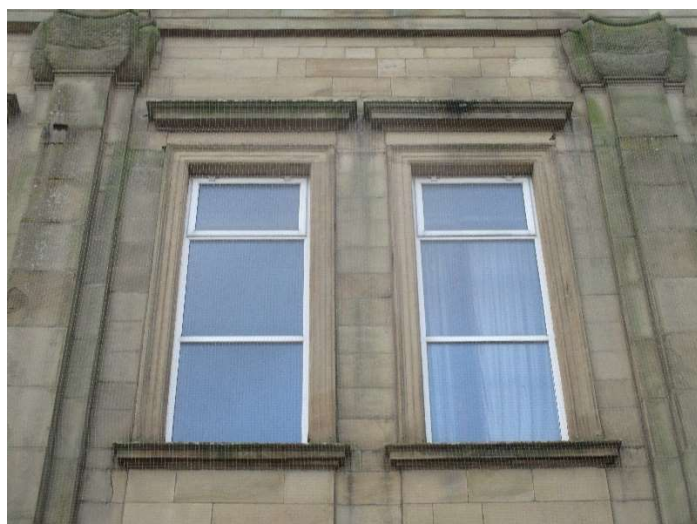
At first floor level the main theatre area has tall, uPVC double glazed windows with top hung top opening lights which are largely satisfactory to the left side elevation **[Photo 64]** and were exhibiting condensation within the glazing to the right-side elevation which tends to suggest that the units have failed **[Photo 65]**. The windows have a cable linked to a handle which when cranked operates the opening light at the top of the window. Where tested the mechanism did not always work as intended as so it is likely to require servicing to allow the windows to be opened. At either end of the theatre there are painted timber single glazed windows which appear to be in similar condition to those on the ground floor below **[Photo 66]**.

Photo 64 – uPVC windows to theatre to main frontage

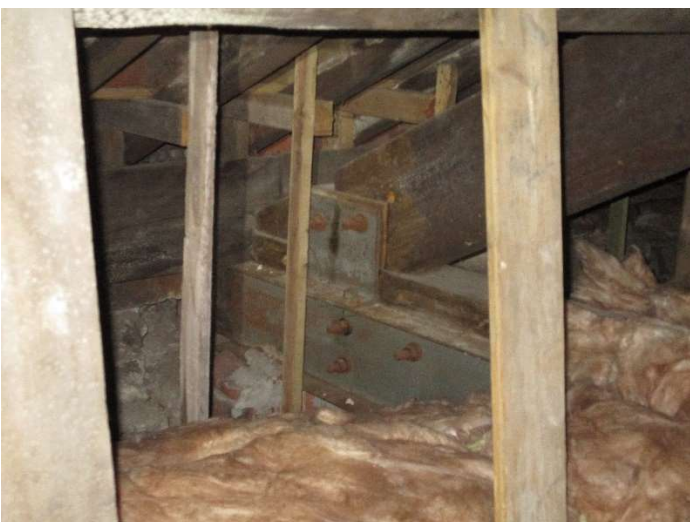
the masonry **[Photo 77]**. There is no supplementary steelwork to the left side [main frontage] and upon inspection the ends of the trusses appear to be damp **[Photos 78-79]**. The stonework to the external wall on this side is saturated from the top of the wall and so the timber should be expected to be damp also. Access to the ends of the rafters is difficult as the ceiling underneath is at a lower level and we did not deem it was safe to reach the timber to test with our moisture meter. The timber is obviously discoloured and appears damp where it is built into the stonework. This is essential to rectify as if it is left unattended there is the potential for the timber to become rotten. If the ends of the trusses become rotten the roof structure could become compromised as the trusses are supporting a large amount of weight imposed by the purlins, rafters and slates. If found to be rotten then it seems likely that all of the trusses on this side of the roof will need steel plates adding to reinforce the structure and possibly the masonry reinforcing also. Further investigation should be carried out without delay.

Photo 77 – Steel plates added to bearing ends of rafters

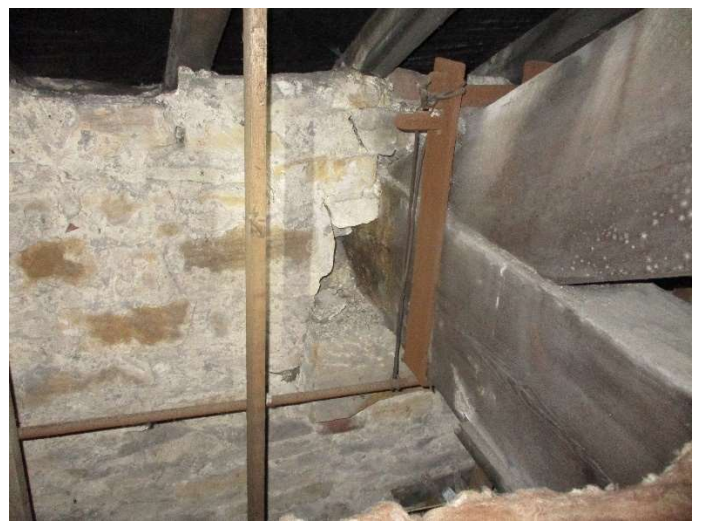
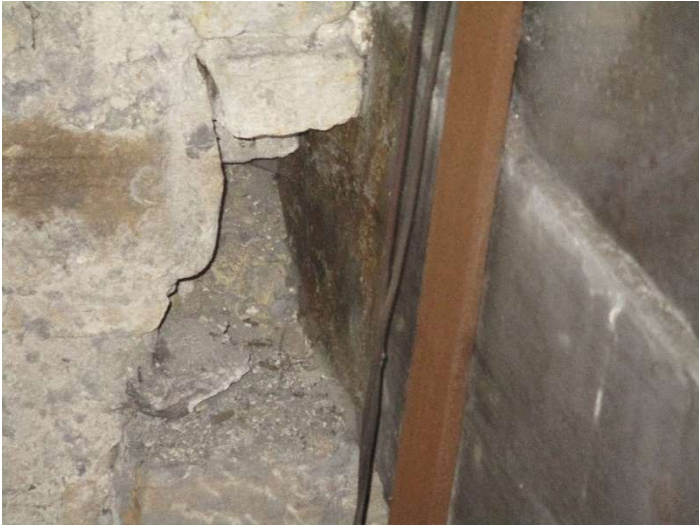
Photo 78 – Bearing ends of trusses appear discoloured and damp

Photo 79 - Bearing ends of trusses appear discoloured and damp

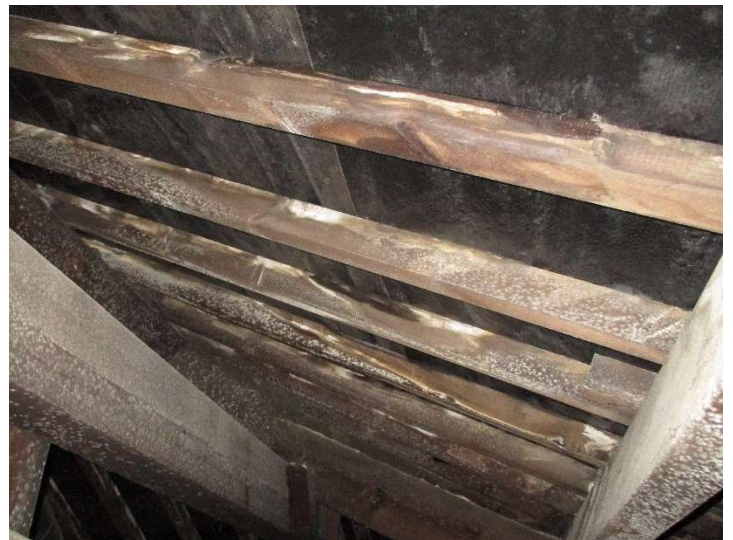
Water ingress was noted to be occurring in several locations which is not surprising considering the number of defects noted to the slates **[Photo 82]**. Both roof lights are dilapidated and leaking **[Photos 83-84]**.

Photo 82 – Visible moisture to rafters

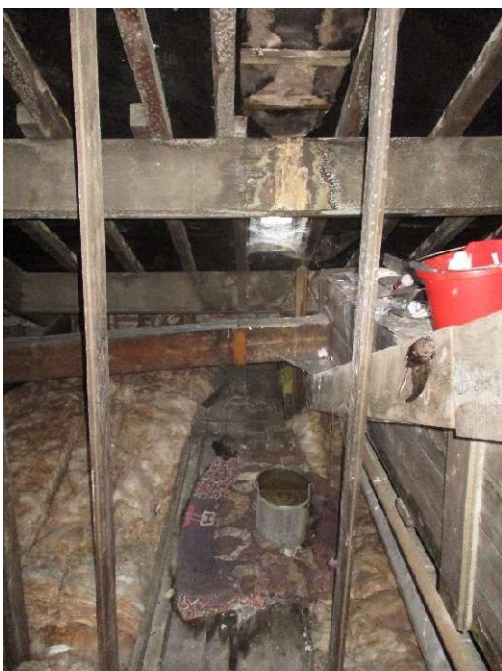
Photo 83 – Water ingress above roof light

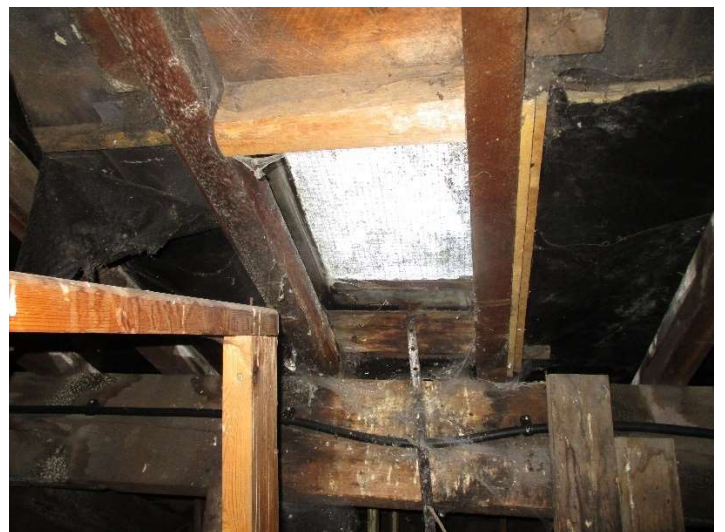
Photo 84 – Dilapidated roof light

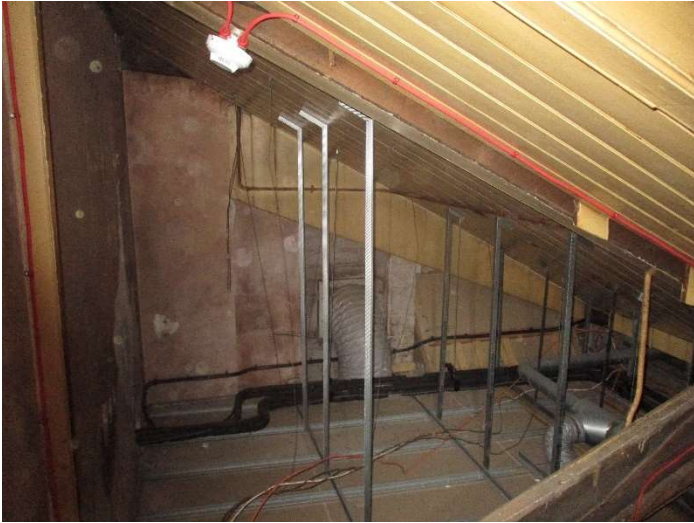
Fireline plasterboard was also noted to the void area beneath the balcony seating area and so the large timber trusses which support the raking seating area **[Photo 85]** are considered likely to be supplemented by steelwork.

Photo 85 – Timber trusses supporting balcony seating area

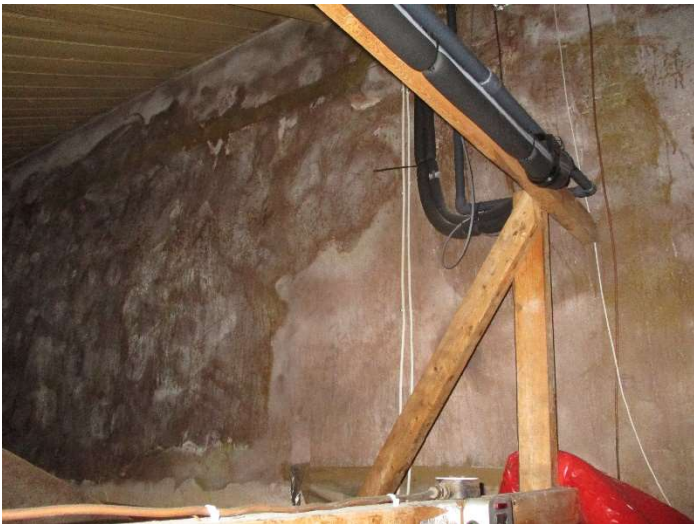
Significant dampness was found within the rear wall of the rear block, the right-side elevation of the rear block and to the left side elevation to the side entrance which leads to the rear staircase [**Photos 87-89**]. The damp areas internally can be explained in the main by significant defects to the external walls and gutters which are outlined earlier in the report. Within the small lobby to the rear staircase the skirting board was found to be rotten and damaged and fungus mycelium was visible to the back of the skirting board [**Photo 90**]. We noted that in this area the timber to the door frames / architraves have already been cut back and removed and the skirtings removed from the part of the built in cupboards in the rear corridor have been stripped out which we consider likely due to rotten timber. The rotten timber should be removed, and surrounding timbers chemically treated, and we would advise that you undertake further investigations together with a specialist contractor to ensure there is no further rotten timber. Based upon the wet rot decay and the extent of dampness and condition of the stonework externally to this elevation we would anticipate that the remainder of the ground floor walls to this elevation will also be damp however as the walls are dry lined the damp is likely hidden. We would advise that any re-plastering work is delayed until the defects and source of the water ingress is addressed and the structure has thoroughly dried out.

Photo 87 - Rear block - dampness to wall to rear elevation

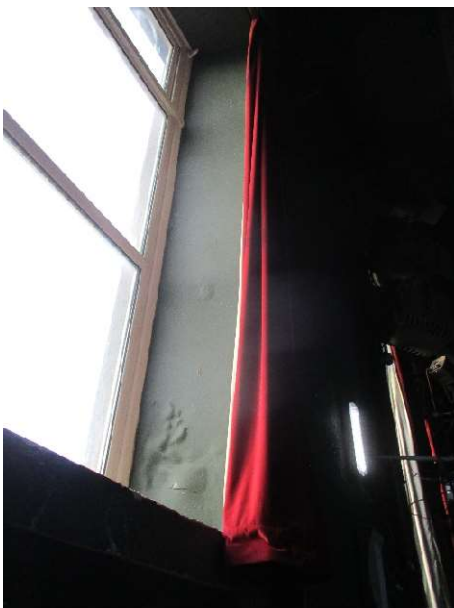
Photo 89 - Rear block - dampness to wall at window reveals

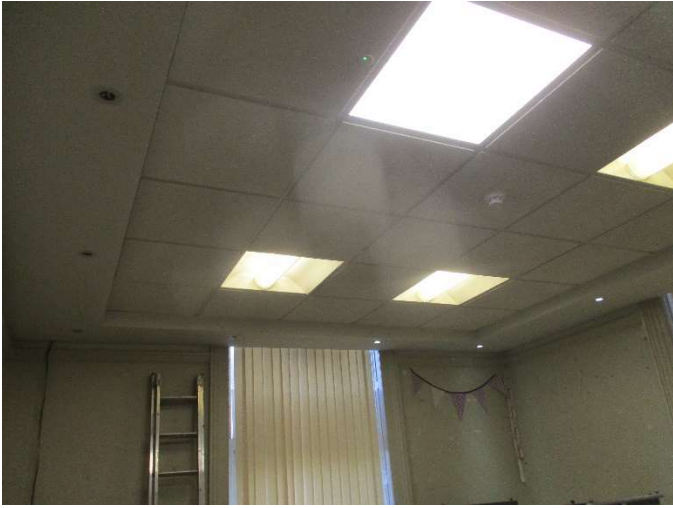
from view by modern suspended ceiling grids with infill tiles **[Photo 91]** which were largely in satisfactory condition although did show some signs of water ingress in places.

Photo 91 – Typical condition of finishes

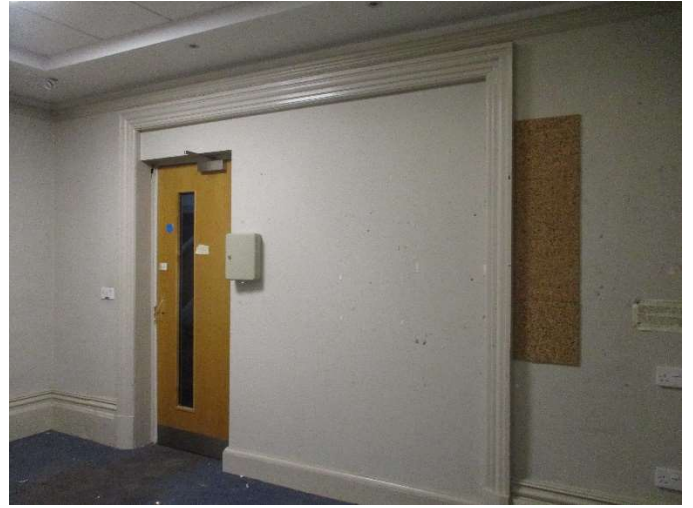
Photo 92 – Typical condition of finishes (door handle removed)

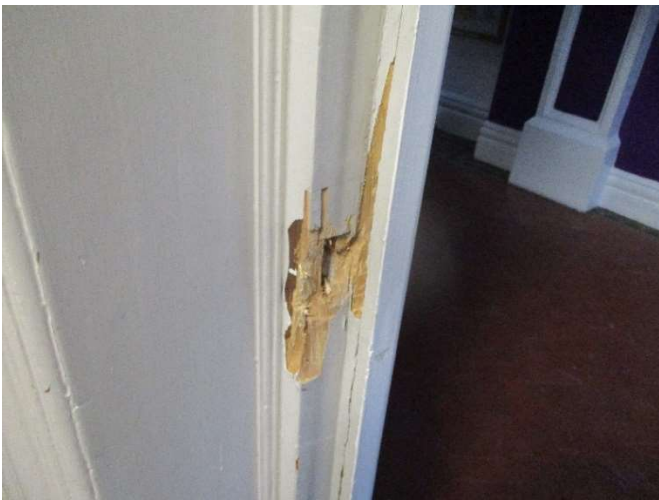
Photo 93 – Example of typical damage to door

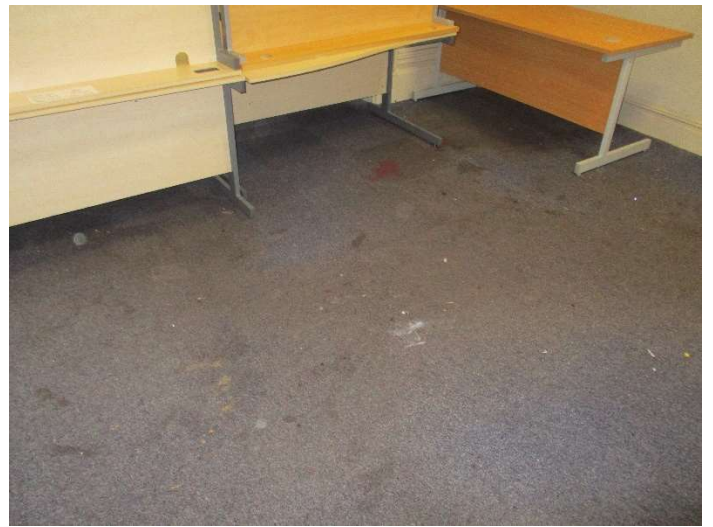
Where rooms do not have suspended ceilings, they are painted with emulsion and the majority of the walls are also painted. Some rooms which have had light or infrequent use are in fair condition however the majority of the rooms are not in good decorative condition and require painting not having been redecorated for some time and are tired looking. The WC areas have ceramic wall tiles / splashbacks which are all satisfactory. Floor finishes are predominately carpet tiles or sheet vinyl although the main entrance hall has the original tiles laid in a herringbone pattern. The condition of the floor finishes varies between fair condition and poor condition depending upon age and the frequency of use of the room **[Photo 94]**.

Photo 94 – Typical condition of floor finishes

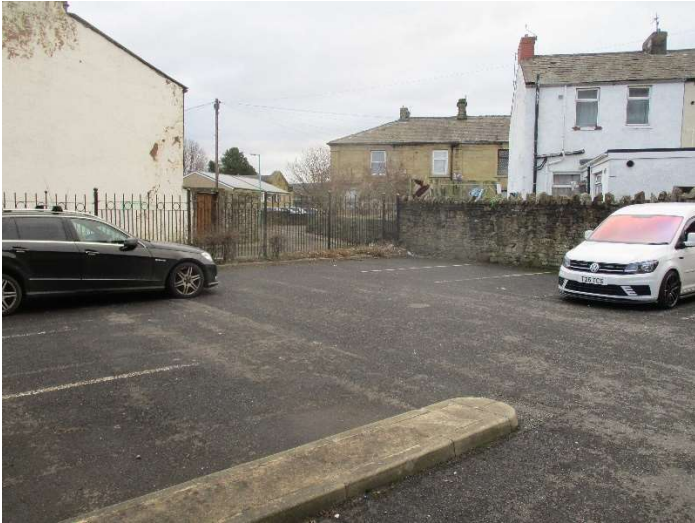
A small car park is positioned to the rear of the premises accessed from Lord Street comprising of 12 spaces plus a single disabled space [**Photo 108**]. The car park itself is

Photo 108 – Tarmacadam surfaced car park

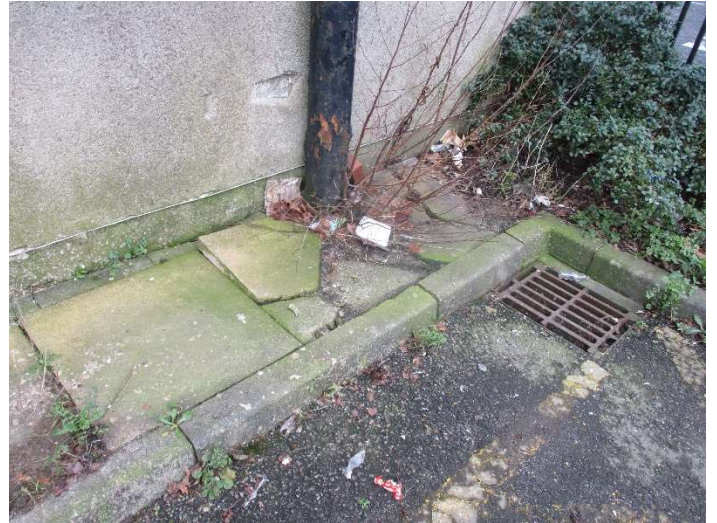
At the junction with the rear elevation there is a strip of concrete paving slabs which was predominately in fair condition although damaged around the rainwater pipe where vegetation growth is becoming established **[Photo 109]**.

Photo 109 – Concrete paving slabs, vegetation to remove

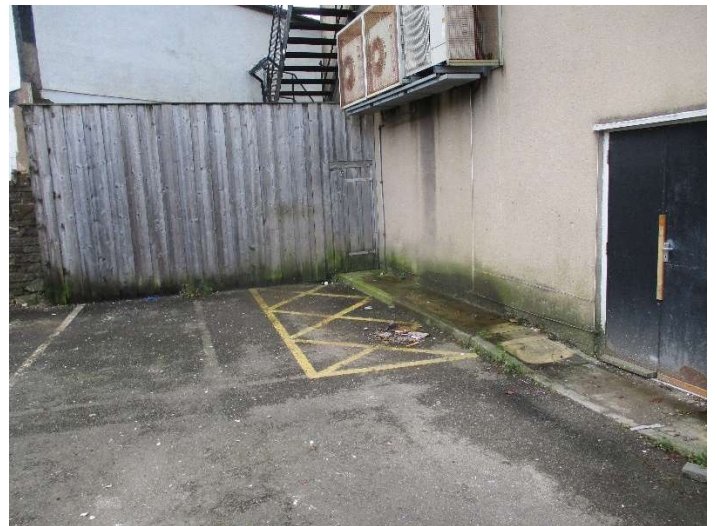
A timber fence and timber gate enclose the corner of the car park below the external stair and is saturated at low level and likely to become rotten soon. Ideally this should be redecorated in the short term **[Photo 111]**.

Photo 111 – Timber fencing damp at low level

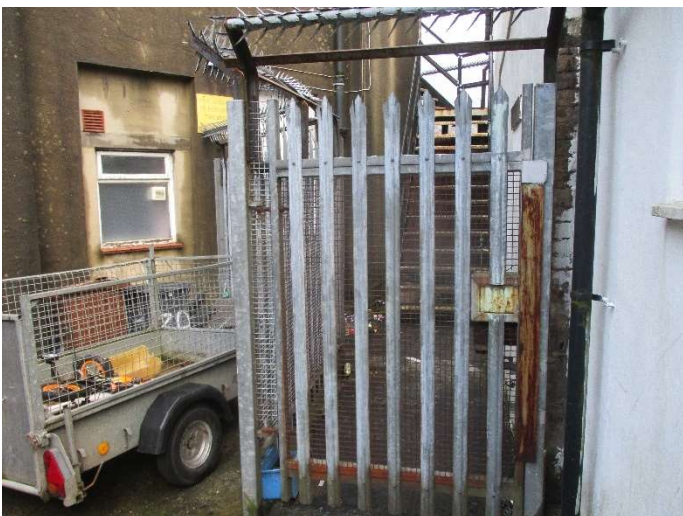
On the other side of the staircase is a steel palisade fence and gate complete with security spikes enclosing the foot of the staircase to the back street which was in fair condition **[Photo 112]**.

Photo 112 – Steel palisade fencing
